TENNESSEE DEPARTMENT OF TRANSPORTATION ASBESTOS INSPECTION REPORT

SR-378 Bridge over Little Richland Creek, LM 1.58 in Dayton
Bridge No. 72SR0292003
TDOT PE: 72003-4201-04
TDOT PIN: 119957.00
Dayton, Rhea County, Tennessee

April 18, 2014
Terracon Project Number: E2147027

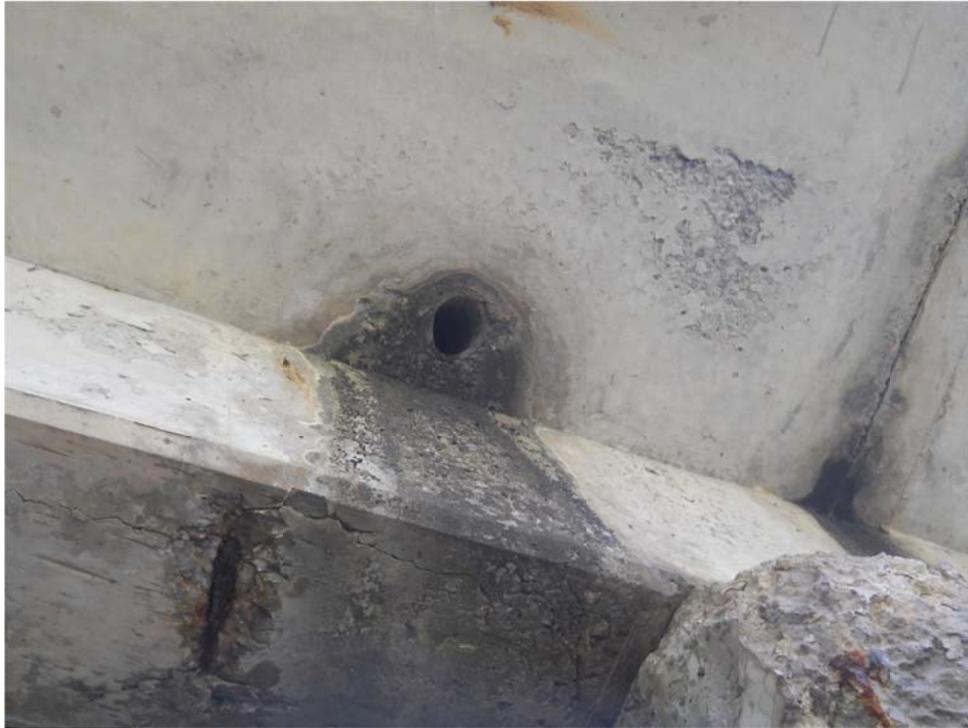
40 Transite Cement Asbestos Drain Pipes – (13% Chrysotile/2% Crocidolite)
located underside of bridge and southern abutment

ASBESTOS-CONTAINING MATERIALS WERE IDENTIFIED IN THE DRAIN PIPES

Photo #1: View of drain pipe at underside of bridge.

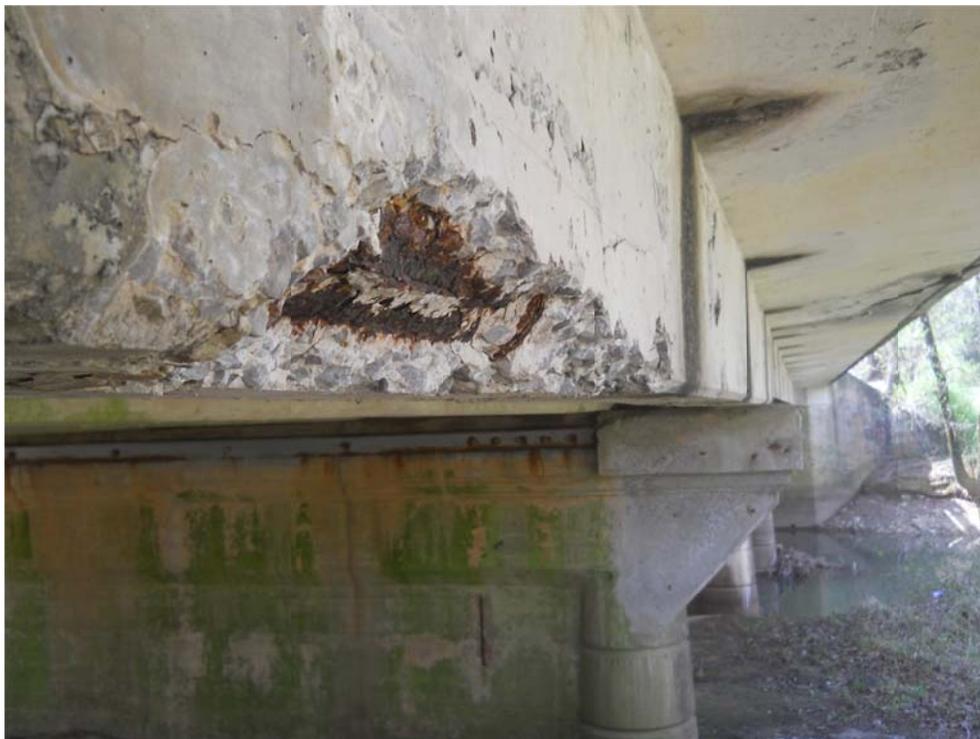
Photo #2: View of drain pipes at underside of bridge.

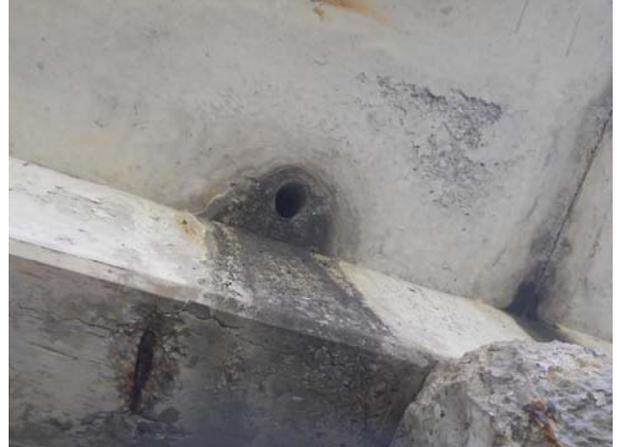
Photo #14 View of transite drain pipe at underside of bridge decking.

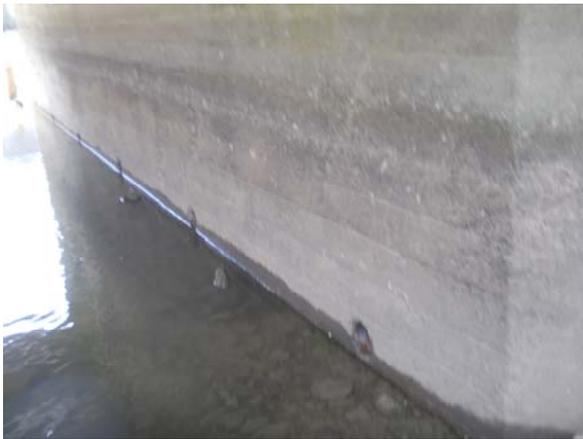
Photo #15 View of transite drain pipes at southern abutment.
