Re: Asbestos Inspection Report
Montgomery County; SR237 Bridge Over Westbound I-24
Bridge #: 63I00240026 (2.31)
TDOT Project # 63030-1209-04, PIN 119831.00
TDOT Contract: E1647; Work Order: 058

TENNESSEE DEPARTMENT OF TRANSPORTATION ASBESTOS INSPECTION REPORT

Bridge Over Westbound I-24
Bridge No. 63I00240026 (2.31)
SR-237
Montgomery County

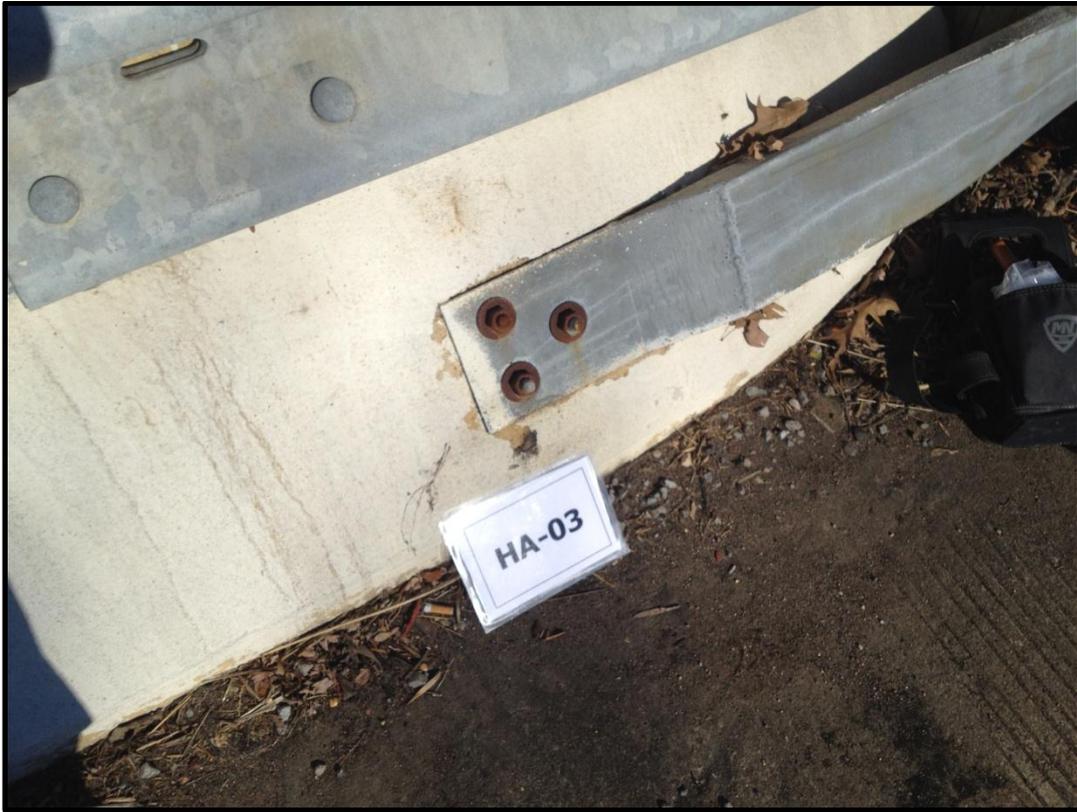
There were concrete parapets extending the length of both sides of the bridge. Both were accessible on foot. Three samples were obtained of the cement (26HA4-A through 26HA4-C) and of what appeared to be a thin bridge coating (26HA3-A through 26HA3-C) of the parapet by using hammers, chisels, and scrapers.

Photo 1 HA-3 and HA-4– White asbestos skim coating on parapet wall.

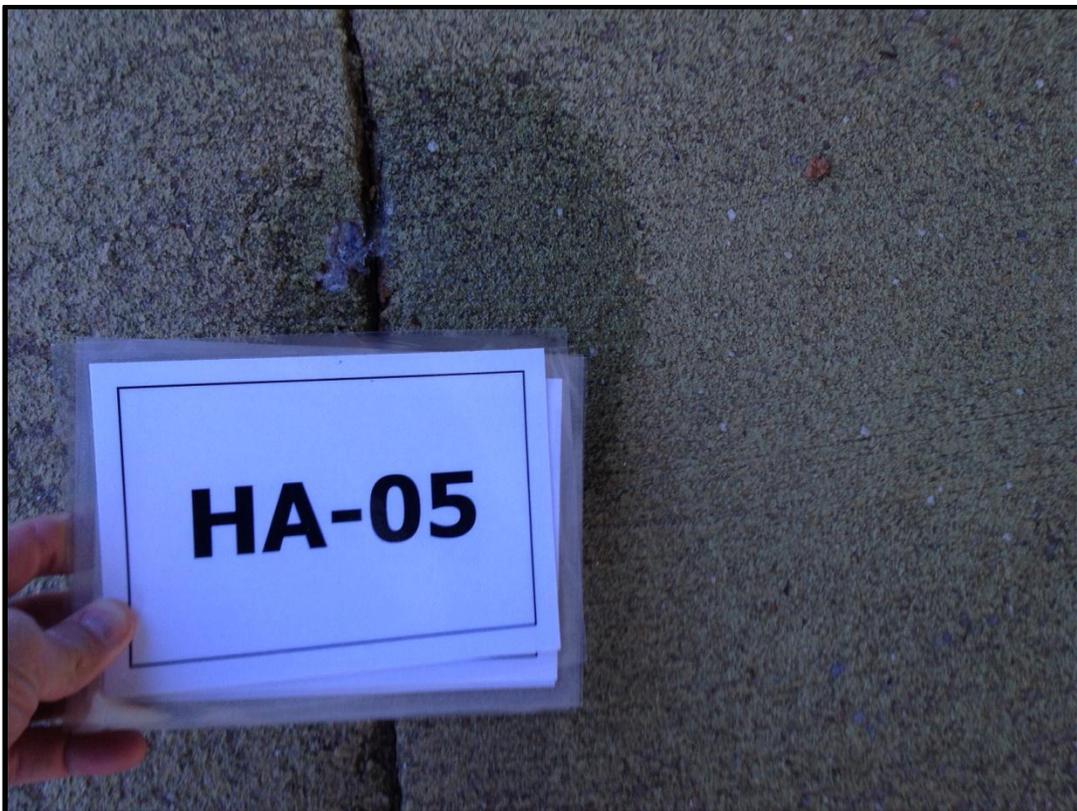
Photo 2: HA-5 – Asbestos coating on concrete slope.

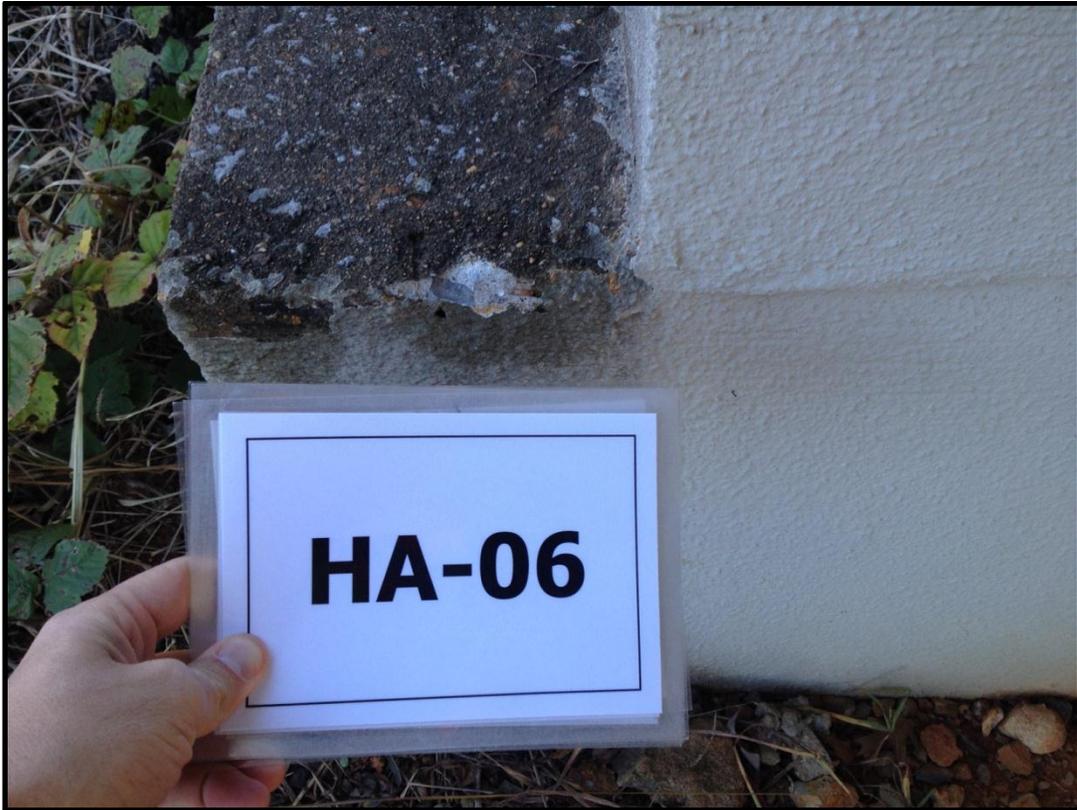
The abutments and abutment slopes on both sides of the bridge were accessed on foot. Samples were obtained using hammers and chisels. Samples 26HA6-A through 26HA6-C were obtained from the abutment. The abutment slope samples were labeled as 26HA5-A through 26HA5-C. Samples 26HA10-A through 26HA10-C were obtained from the pad located between the abutment and the abutment slope.

Photo 3: HA-6 – Asbestos skim coat on abutment.

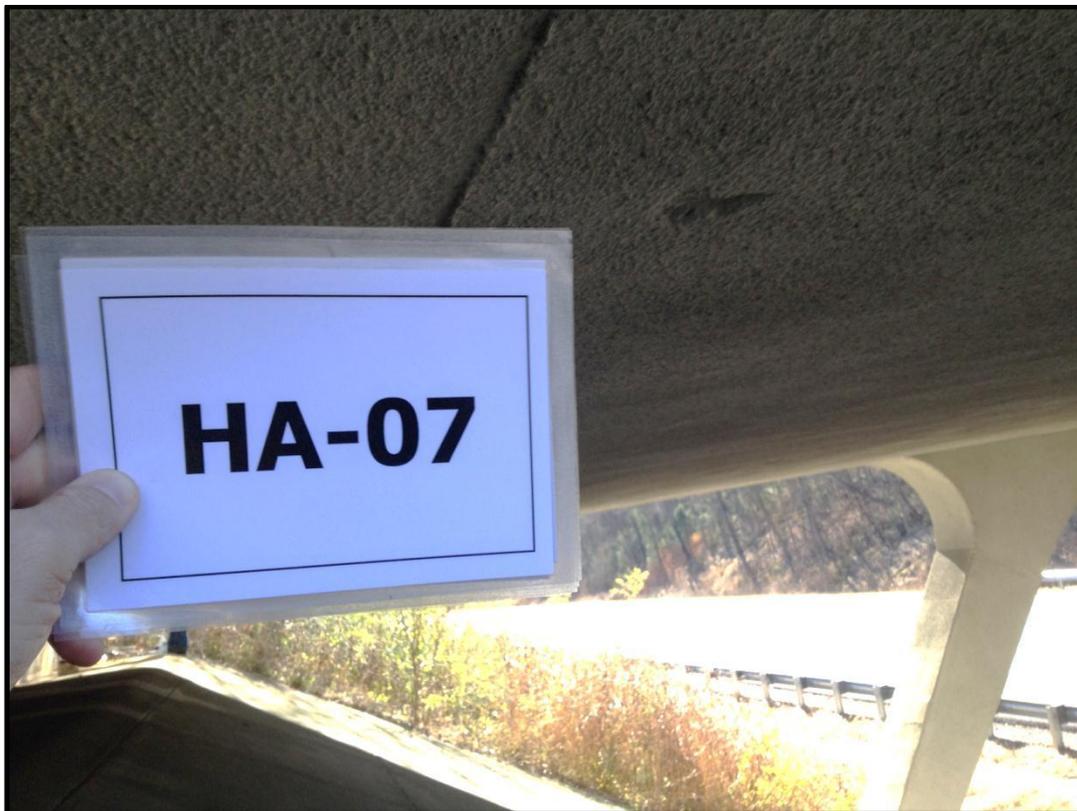
The underside of the bridge deck was accessed by foot. Samples were obtained using hammers and chisels. Samples 26HA7-A through 26HA7-C were obtained from the bottom of the bridge deck. Samples 26HA-8A through 26HA-8C were obtained from the bridge overhang.

Photo 4: HA-7 – Asbestos skim coat on underside of bridge deck.

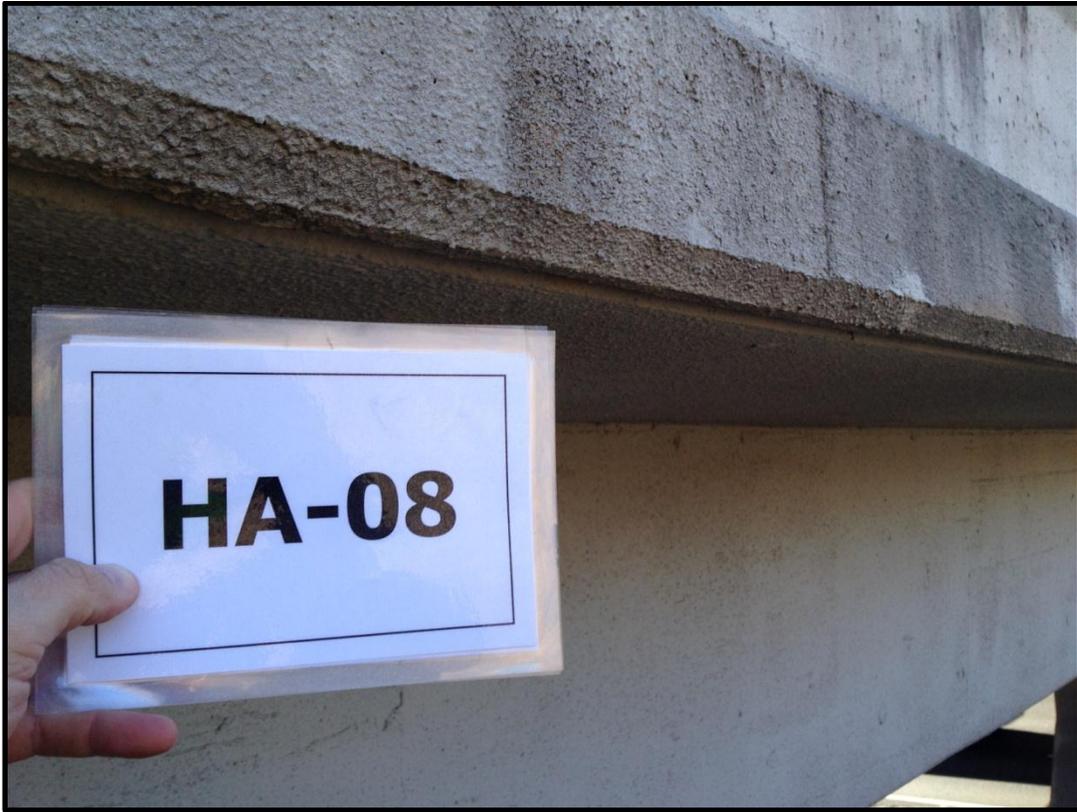
Photo 5: HA-8 – Asbestos skim coat on bridge overhang.

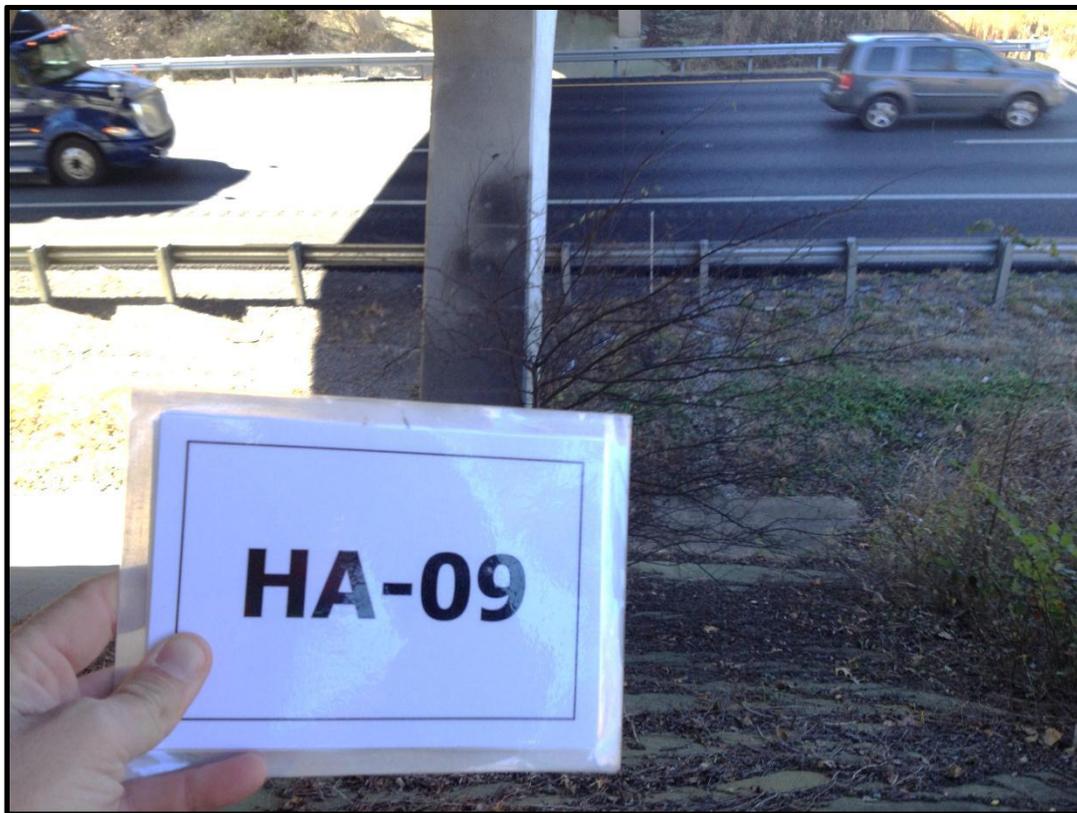
The bridge columns were accessed on foot. There were two columns supporting the bridge. Samples 26HA9-A through 26HA9-C were obtained from the pier columns. Samples 26HA11-A through 26HA11-C were obtained from the pad located between the base of the columns and the abutment slope.

Photo 6: HA-9 – Asbestos skim coat on bridge columns.

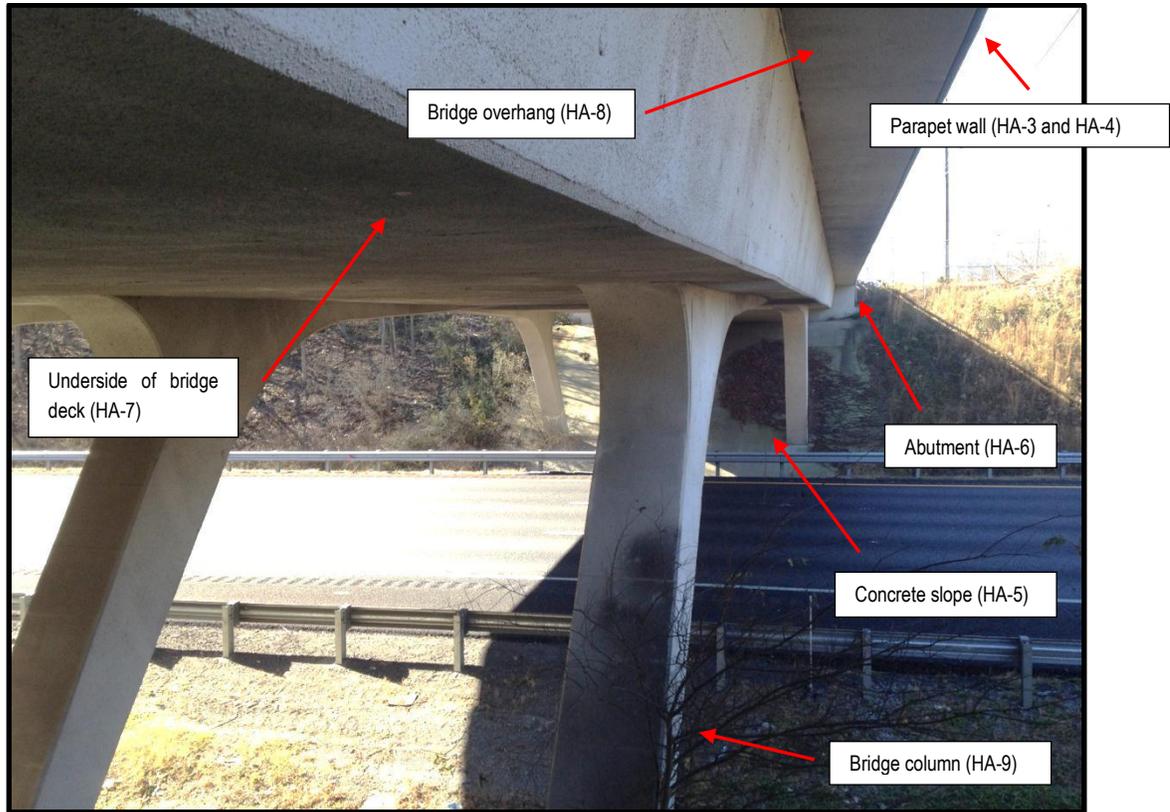
Photo 7: View of the asbestos-containing materials: parapet wall (HA-3), concrete slope (HA-5), abutment (HA-6), underside deck (HA-7), bridge overhang (HA-8), and bridge column (HA-9).
