951004000011
95-I40-7.43R
OVER
WILSON
CREEK

BRIDGE MAINTENANCE RECOMMENDATIONS

Field Report No. 19 Date 2/26/2010
Previous Report No. 18 Date 2/21/2008
Plans: YES

SUMMARY
95-I40-7.43 RT
2/26/2010

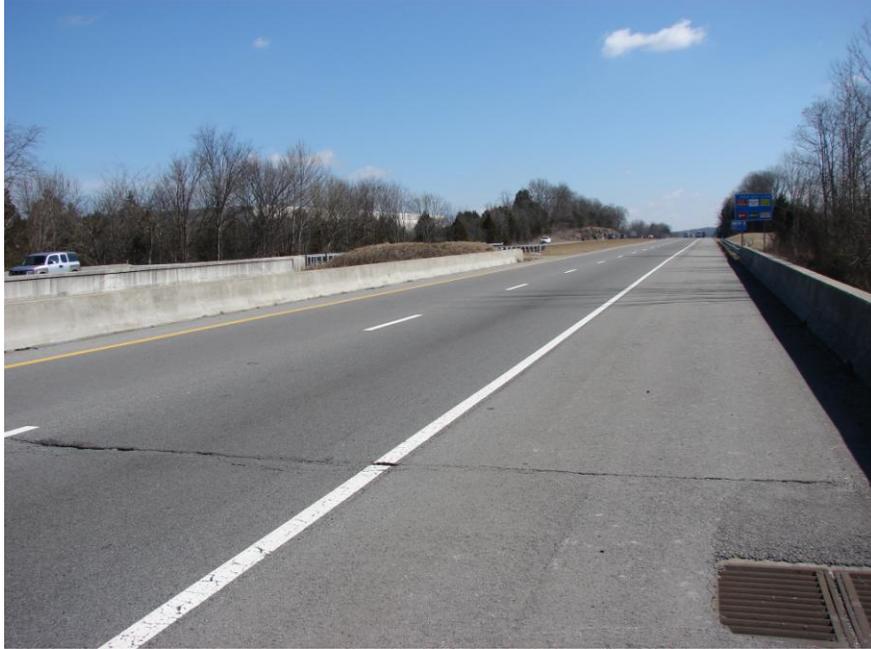
VIEW ACROSS DECK

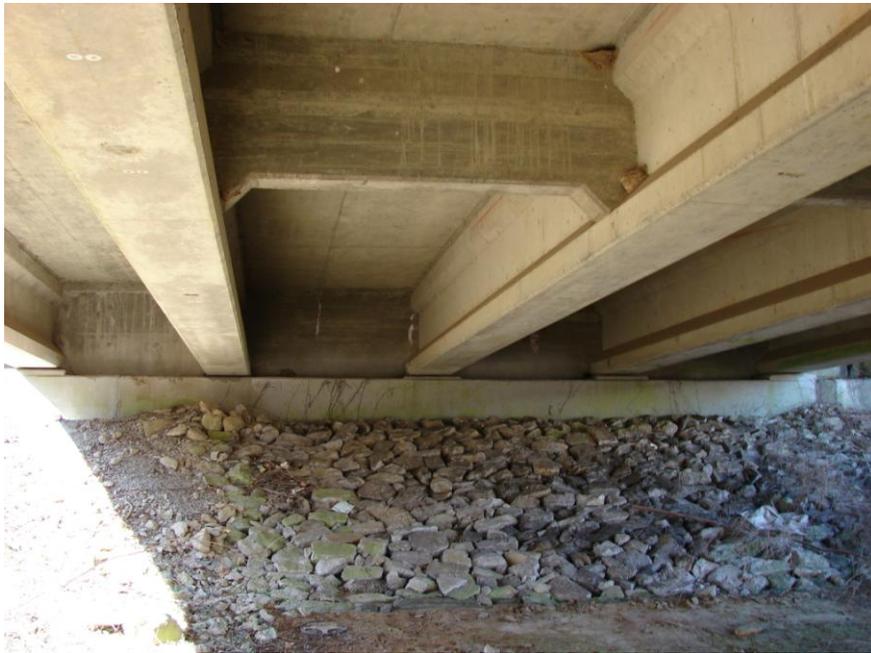
ABUTMENT TYPICAL

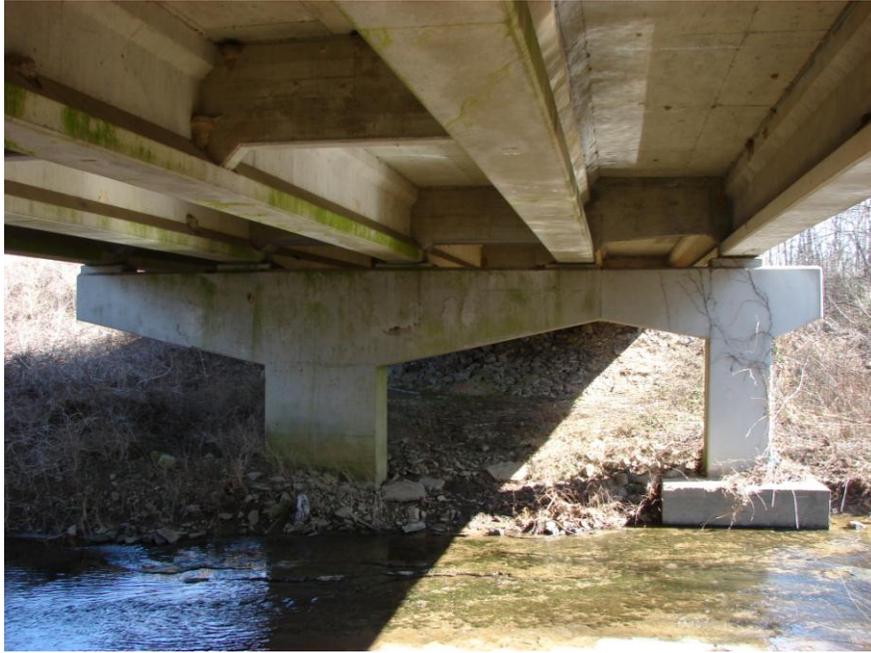
BENT TYPICAL

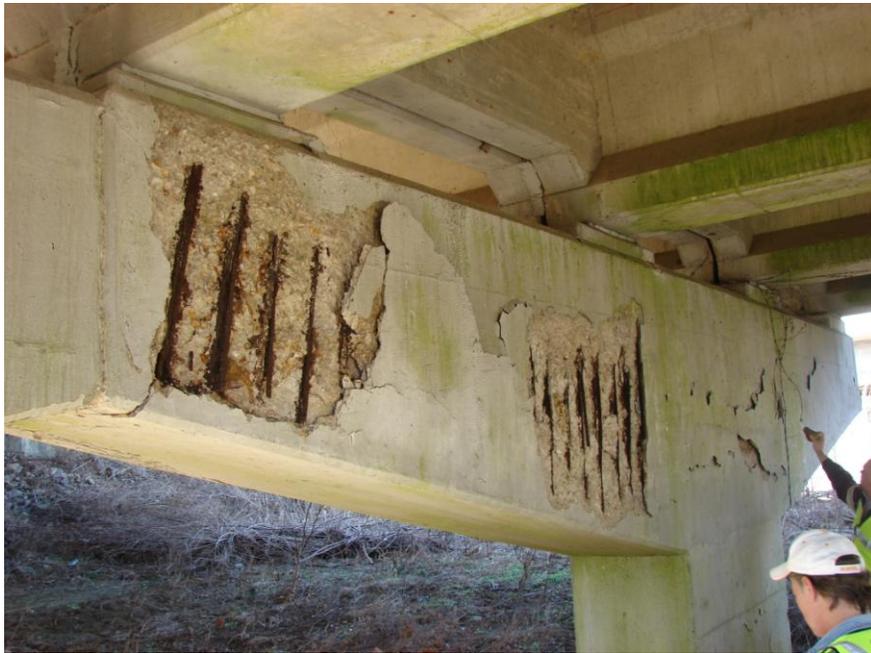
SPALLS W/EXP REBAR BACKSIDE OF CAP BENT-1

Caps	FAIR	2" DEEP SPALLS WITH HEAVILY RUSTED REBAR
Columns	GOOD	
Plumb	GOOD	
Footings	GOOD	
Piles	NA	
Bearing Surface	GOOD

The concrete wearing surface is in good condition. There are deck drains which are open and good, and the joint leakage is good. The superstructure elements and substructure units are in good condition. The caps are fair due to 2" spalls and ¼" cracks with moderate delamination. The channel appears adequate, and there was no scour detected at time of inspection.

No.	RECOMMENDATIONS	REPAIR DATE	REPAIRED BY
1.	REPAIR BENT CAPS

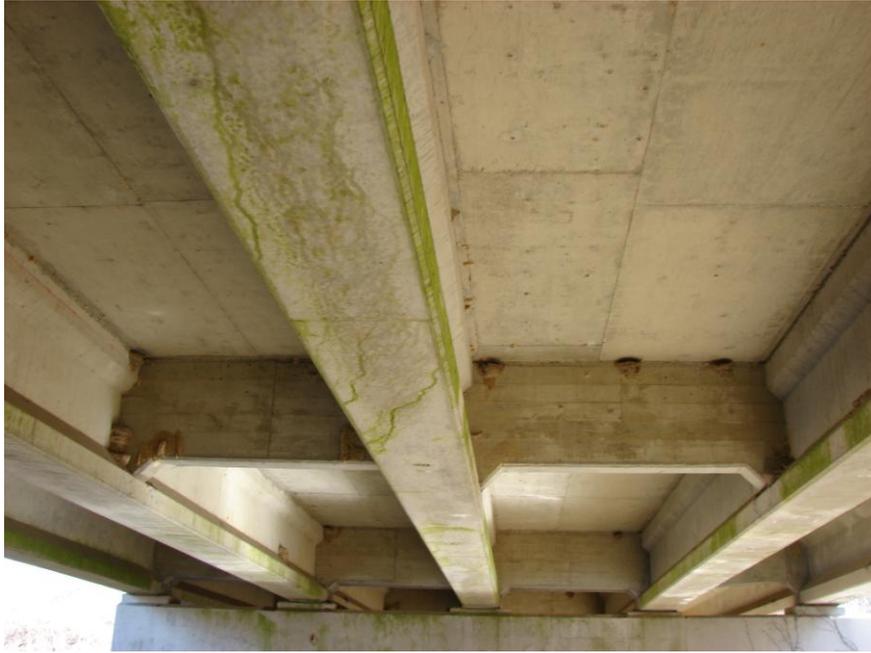
BOTTOM DECK VIEW TYPICAL

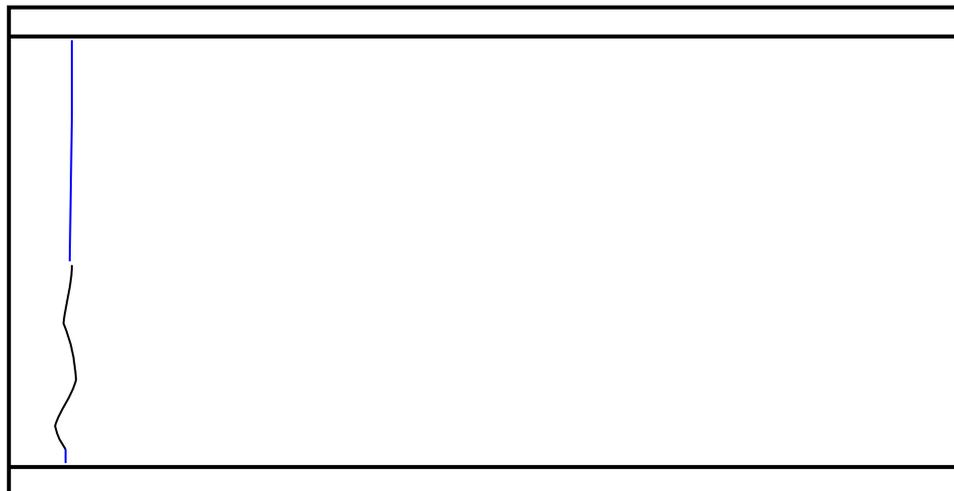
Top of Deck Span No. 1

DECK	NV	SEPARATION CRACK AT JOINT
PARAPET	GOOD	
DRAINS	GOOD

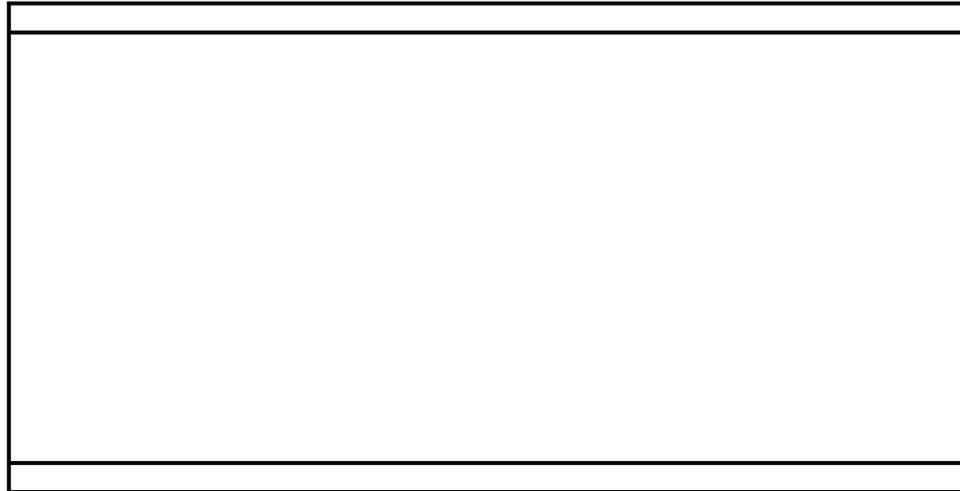
Top of Deck Span No. 2

DECK	NV	
PARAPET	GOOD	
DRAINS	GOOD

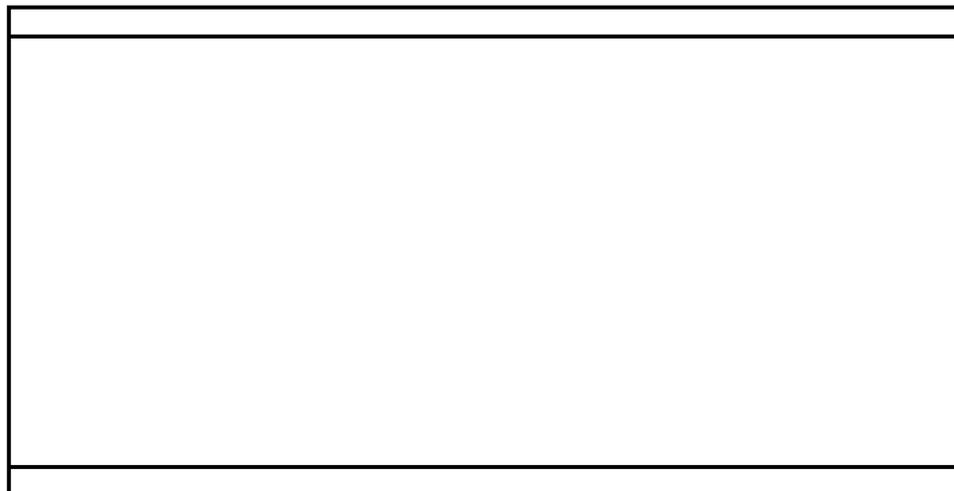
Top of Deck Span No. 3

DECK	NV	SEPARATION CRACK AT JOINT
PARAPET	GOOD	
DRAINS	GOOD

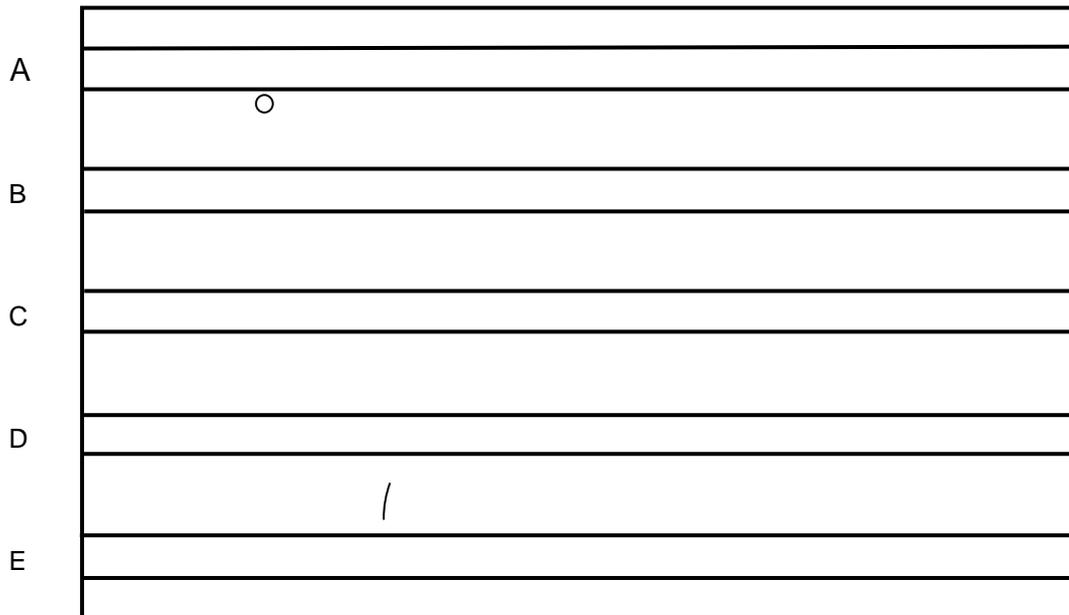
Bottom of Slab Span No. 3

DECK	GOOD	DRILL HOLE BREAKOUT. HC W/LEACH
DIAPHRAGMS	GOOD	
BEAMS	GOOD

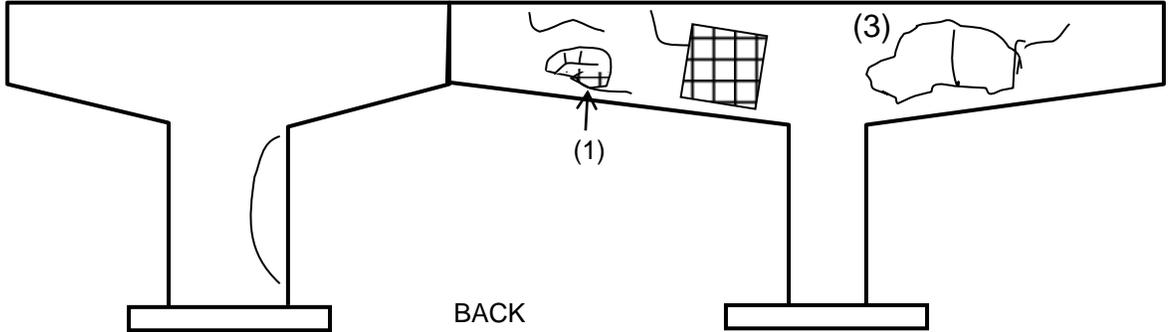
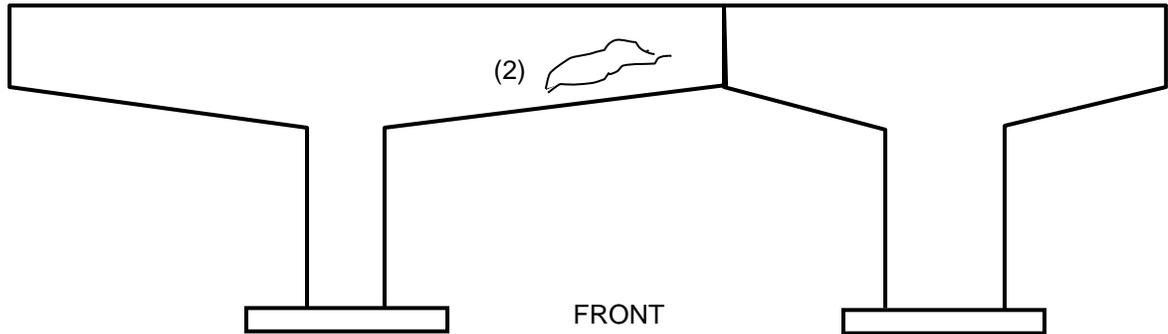
BENT # 1

CAP	FAIR	RAMDOM CRACKS, (1) 3' DIAMETER SPALLS UP TO 3" DEEP
		(2) IN PLACE SPALL 3' LONG 2' HIGH
		(3) SPALL 6" L X UP TO 18" H X UP TO 2" DEEP
COLUMN	GOOD	
FOOTING	NV	
BEARING	GOOD

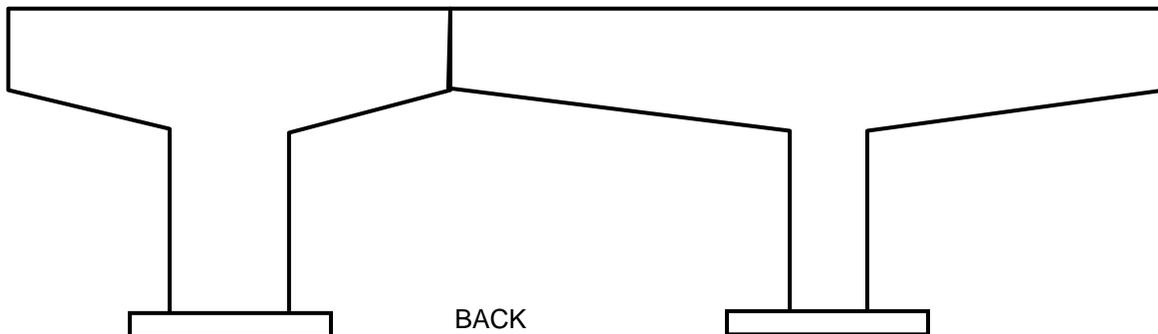
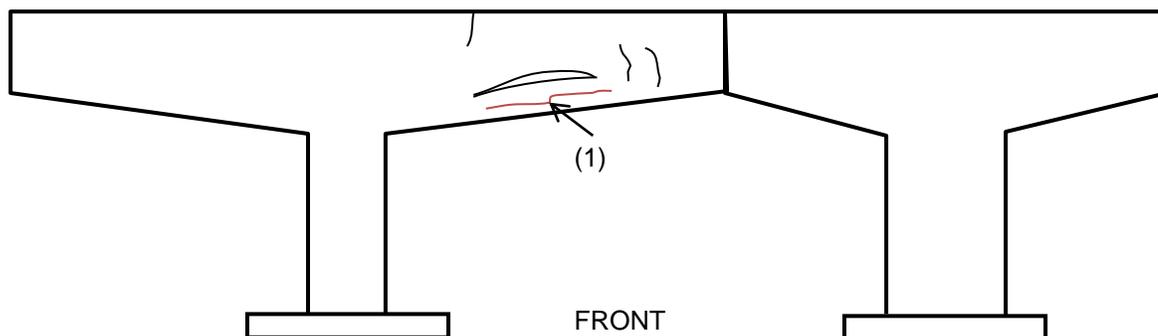
BENT # 2

CAP	FAIR	RAMDOM CRACKS, 1' DIAMETER SPALLS UP TO 1" DEEP
		(1) 1/16" HORIZONTAL CRACK 2.5' LONG
COLUMN	GOOD	
FOOTING	GOOD	
BEARING	GOOD
