Re: Asbestos Inspection Report
Shelby County; SR-14 Overflow Bridge
Bridge #: 79SR0140031 (LM 26.28)
TDOT Project # 79024-4298-04, PIN 116134.00
TDOT Contract: E1647; Work Order: 06

TENNESSEE DEPARTMENT OF TRANSPORTATION ASBESTOS INSPECTION REPORT

Overflow Bridge
Bridge No. 79SR0140031 (LM 26.28)
State Route 14
Bartlett, Shelby County

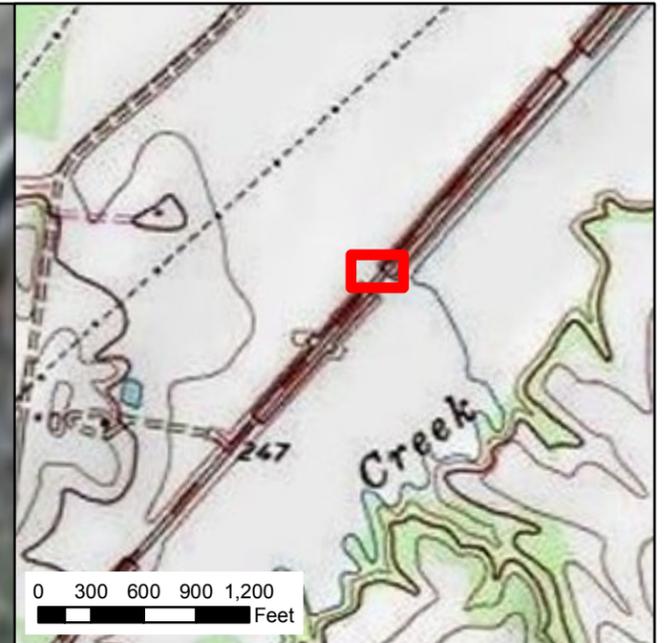
Figure – 2: Asbestos-Containing Pipe Wrap Sample Locations

Drainage from the bridge is through piping cored through the bridge deck on the northwest side of the bridge. The piping appeared to be metal and was coated with a hard wrapping. The pipe wrap was sampled as 31HA-12A through 31HA-12C.

Sample No.	HA/Material Description	Location (Bridge Component)	Approx Qty.	Friable (Y/N)	Type Asbestos and Content
1213990PLM_34-31HA-12A	HA-12 Pipe Wrap	Drainage Pipes	17 LF	N	15% Chrysotile
1213990PLM_35-31HA-12B *	HA-12 Pipe Wrap	Drainage Pipes	17 LF	N	assumed 15% Chrysotile -not analyzed
1213990PLM_36-31HA-12C *	HA-12 Pipe Wrap	Drainage Pipes	17 LF	N	assumed 15% Chrysotile -not analyzed

● 31HA-12A
 ● 31HA-12B
 ● 31HA-12C

● Sampled Drain Pipe Wrap Location. Approximately seventeen 4-inch diameter drains total, with an estimated 17 linear feet of ACM for all 17 drains.

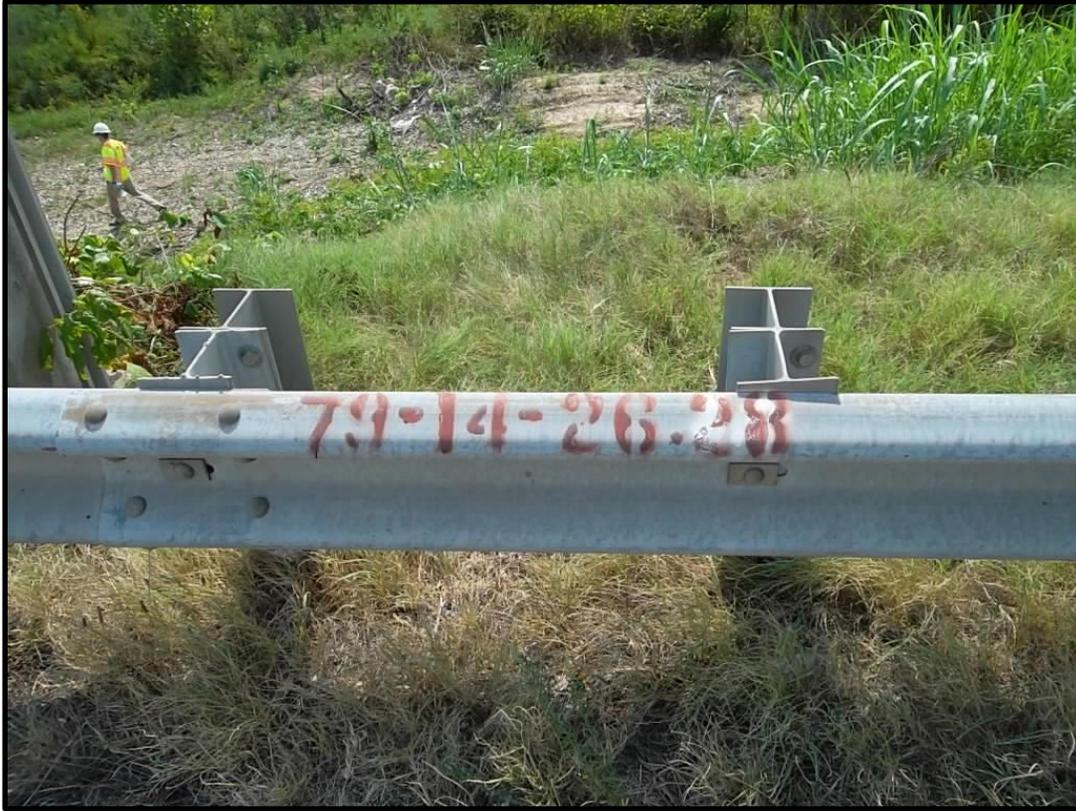
Photo 1: Bridge Identification photograph.

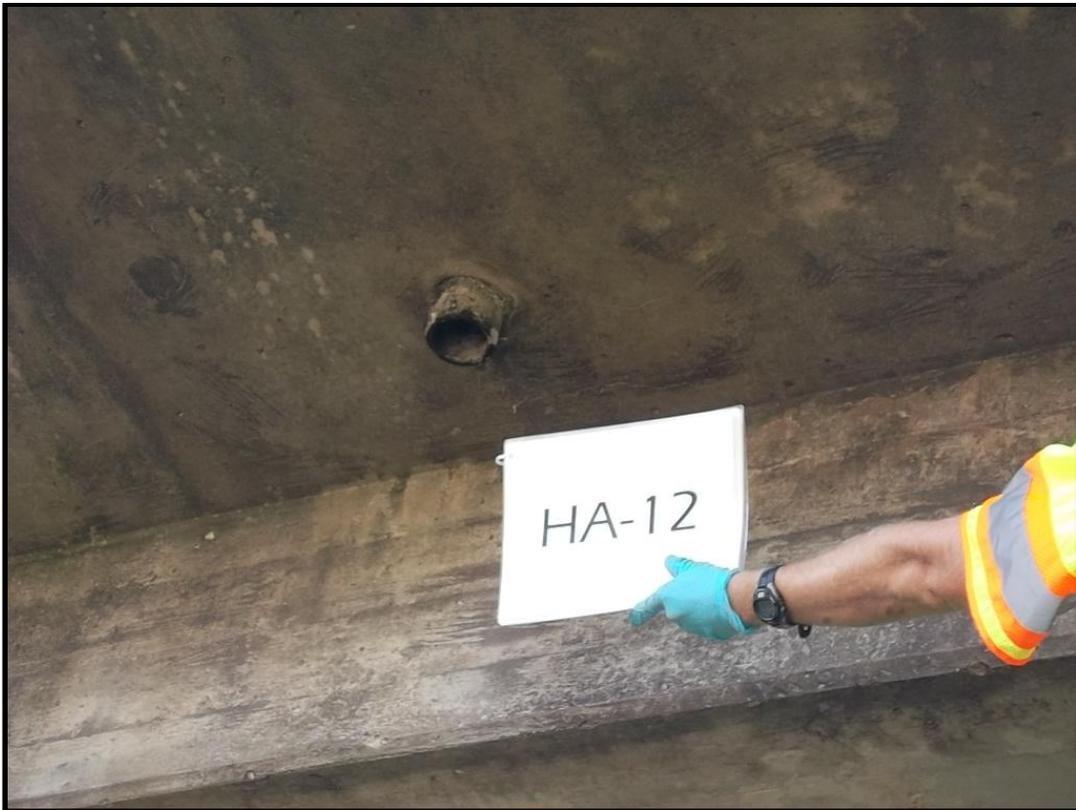
Enclosed is the asbestos inspection report for the above-referenced bridge. A total of 42 samples were obtained during the inspection. Asbestos was detected in the wrap around the drain pipes that penetrate the decking. There were 17 drains located, but based on the condition of the drains, it was not possible to determine if the entire drain pipe is wrapped in this material or if it is only the portions that extend below the bridge deck. Most likely it is the entire drain.

In its current condition this ACM was determined to be non-friable, that is, it could not be pulverized using hand pressure alone. Accordingly, it is classified under EPA NESHAP rules (40 CFR 61) as a Category II non-friable ACM in its current condition. Depending upon the type of bridge maintenance required, there could be potential for the material to become pulverized and thereby become friable, at that time it would be considered a "Regulated Asbestos-Containing Material" (RACM).

Photo 2: Asbestos-containing sample of wrapping located around the drain pipes.

OSHA would consider the abatement of RACM to be a Class II activity, which would require trained workers and a competent person to oversee the work (an asbestos supervisor). Additionally, State of Tennessee asbestos accreditation requirements (TCA 1200-01-20) mandate that such work be performed by an accredited firm (contractor) using accredited abatement workers and supervisors.
