Re: Asbestos Inspection Report
Shelby County; SR-14 Overflow Bridge
Bridge #: 79SR0140035 (LM 26.74)
TDOT Project # 79024-4298-04, PIN 116134.00
TDOT Contract: E1647; Work Order: 06

TENNESSEE DEPARTMENT OF TRANSPORTATION ASBESTOS INSPECTION REPORT

Overflow Bridge
Bridge No. 79SR0140035 (LM 26.74)
State Route 14
Bartlett, Shelby County

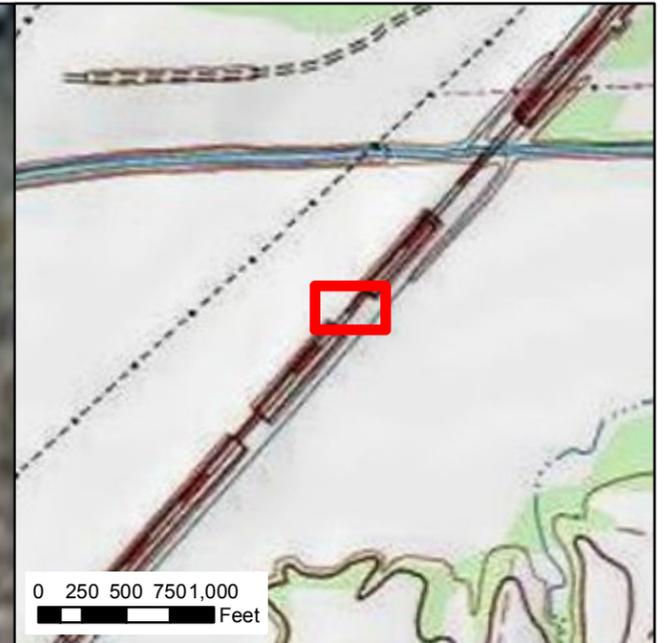
Figure – 2: Asbestos-Containing Pipe Wrap Sample Locations

Drainage from the bridge is through piping cored through the bridge deck on the northwest side of the bridge. The piping appeared to be metal and was coated with a hard wrapping. The pipe wrap was sampled as 35HA-12A through 35HA-12C.

| Sample No. | HA/Material Description | Location (Bridge Component) | Approx Qty. | Friable (Y/N) | Type Asbestos and Content |
|---|---|---|---|---|---|
| 1213990PLM_34-35HA-12A | HA-12 Pipe Wrap | Drainage Pipes | 35 LF | N | 20% Chrysotile |

● 35HA-12A
 ● 35HA-12B
 ● 35HA-12C

● Sampled Drain Pipe Wrap Locations. Approximately thirty five 4-inch diameter drains total, with an estimated 35 linear feet of ACM for all 35 drains.

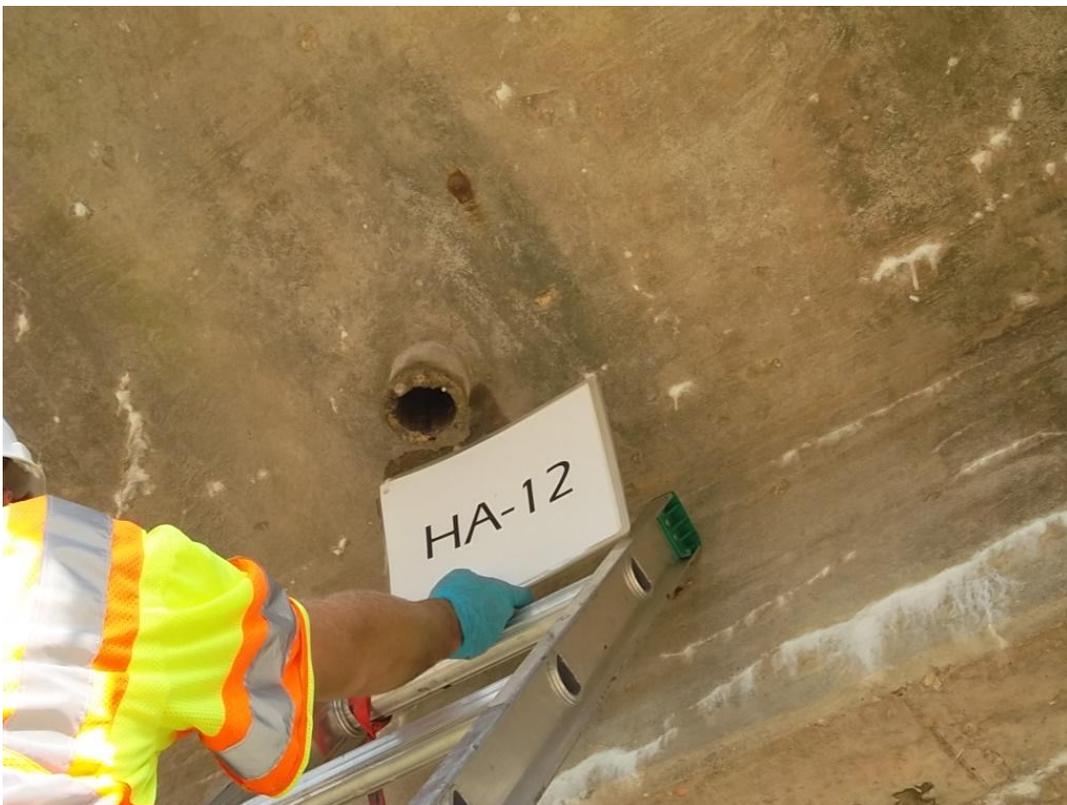
Enclosed is the asbestos inspection report for the above-referenced bridge. A total of 42 samples were obtained during the inspection. Asbestos was detected in the wrap around the drain pipes that penetrate the decking. There were 35 drains located, but based on the condition of the drains, it was not possible to determine if the entire drain pipe is wrapped in this material or if it is only the portions that extend below the bridge deck. Most likely it is the entire drain.

In its current condition this ACM was determined to be non-friable, that is, it could not be pulverized using hand pressure alone. Accordingly, it is classified under EPA NESHAP rules (40 CFR 61) as a Category II non-friable ACM in its current condition. Depending upon the type of bridge maintenance required, there could be potential for the material to become pulverized and thereby become friable, at that time it would be considered a "Regulated Asbestos-Containing Material" (RACM).

Photo 2: Asbestos-containing sample of wrapping located around the drain pipes.

OSHA would consider the abatement of RACM to be a Class II activity, which would require trained workers and a competent person to oversee the work (an asbestos supervisor). Additionally, State of Tennessee asbestos accreditation requirements (TCA 1200-01-20) mandate that such work be performed by an accredited firm (contractor) using accredited abatement workers and supervisors.
