Re: Asbestos Inspection Report  
Shelby County; SR-14 Bridge over Loosahatchie River  
Bridge #: 79SR0140037 (LM 26.90)  
TDOT Project # 79024-4298-04, PIN 116134.00  
TDOT Contract: E1647; Work Order: 06

## TENNESSEE DEPARTMENT OF TRANSPORTATION ASBESTOS INSPECTION REPORT

Bridge over Loosahatchie River  
Bridge No. 79SR0140037 (LM 26.90)  
State Route 14  
Bartlett, Shelby County

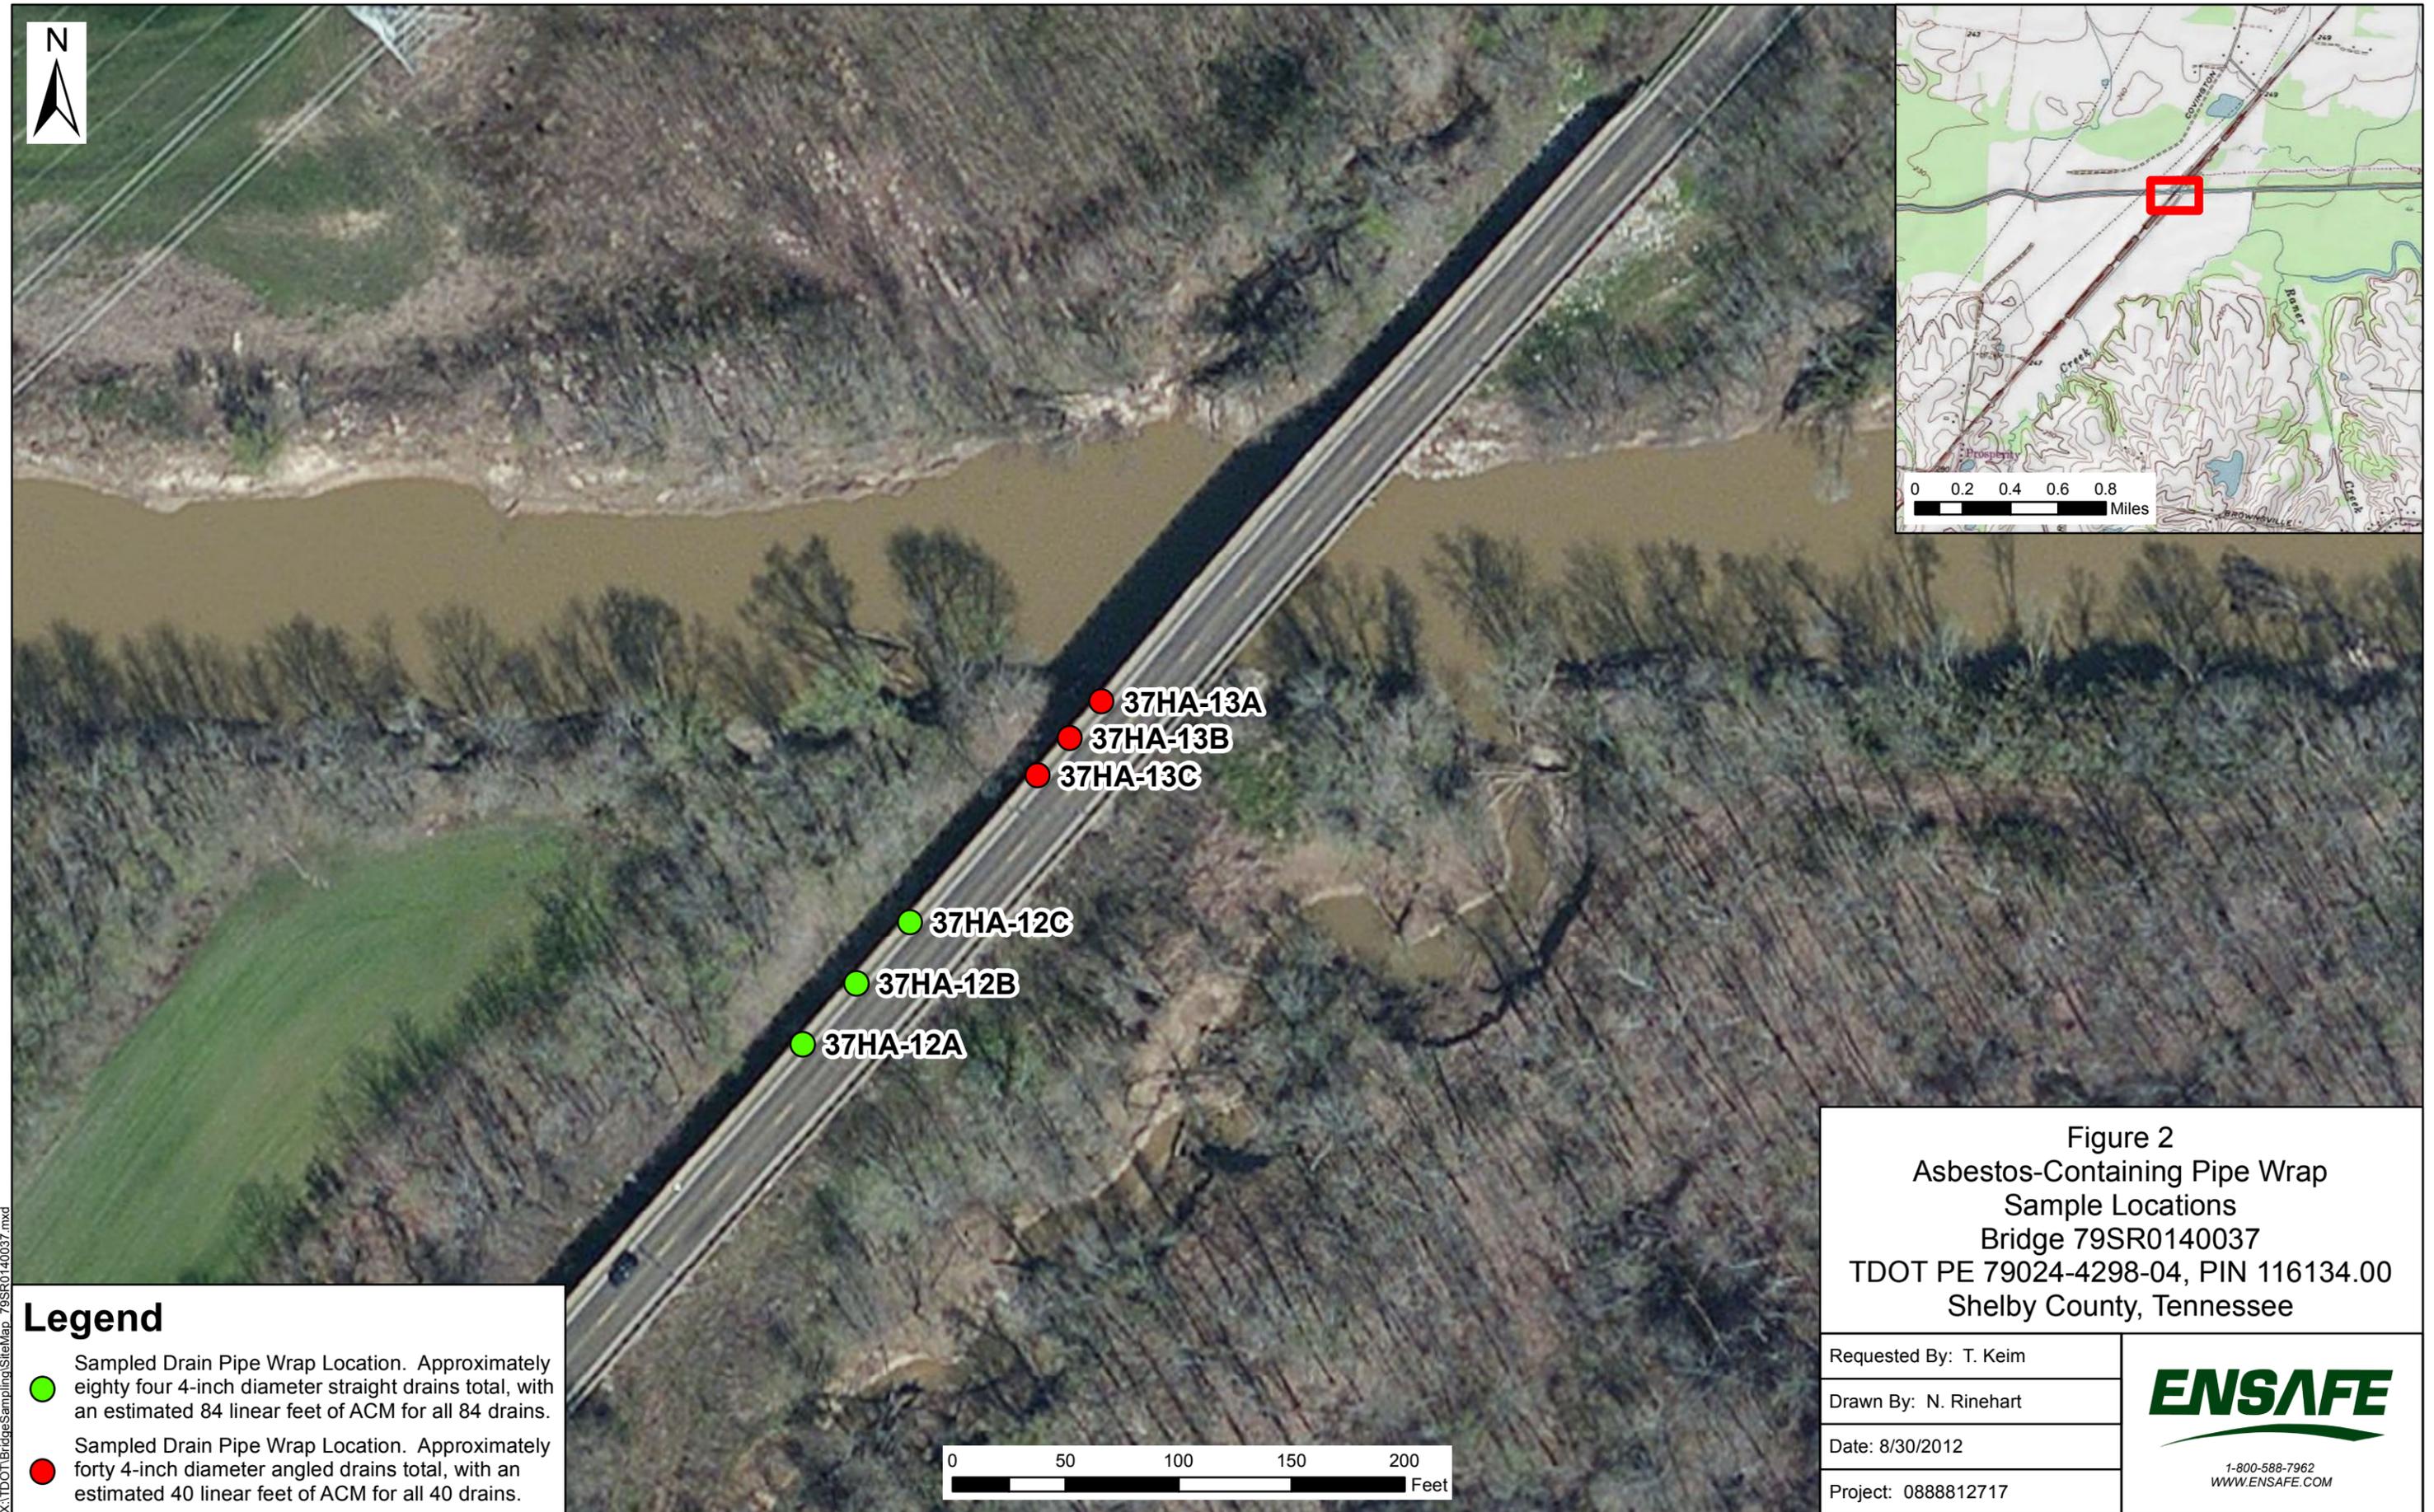
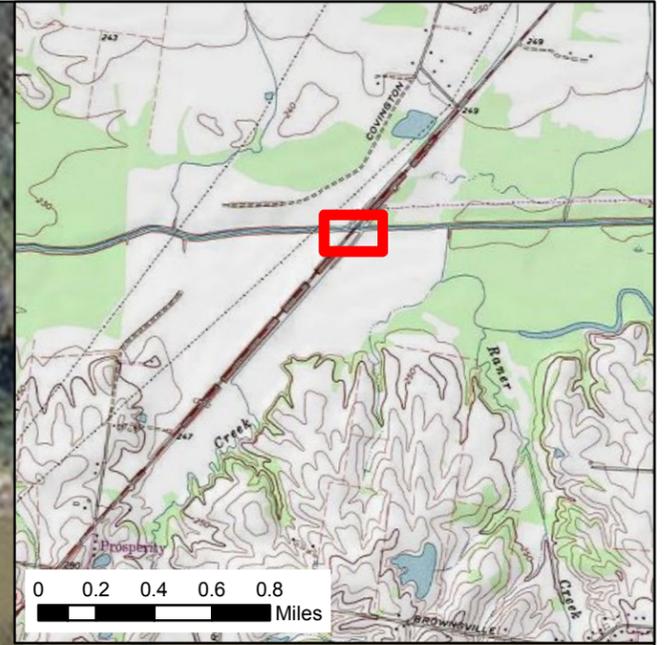
## **Figure – 2: Asbestos-Containing Pipe Wrap Sample Locations**

● 37HA-13A  
 ● 37HA-13B  
 ● 37HA-13C

● 37HA-12C  
 ● 37HA-12B  
 ● 37HA-12A

● Sampled Drain Pipe Wrap Location. Approximately eighty four 4-inch diameter straight drains total, with an estimated 84 linear feet of ACM for all 84 drains.

● Sampled Drain Pipe Wrap Location. Approximately forty 4-inch diameter angled drains total, with an estimated 40 linear feet of ACM for all 40 drains.

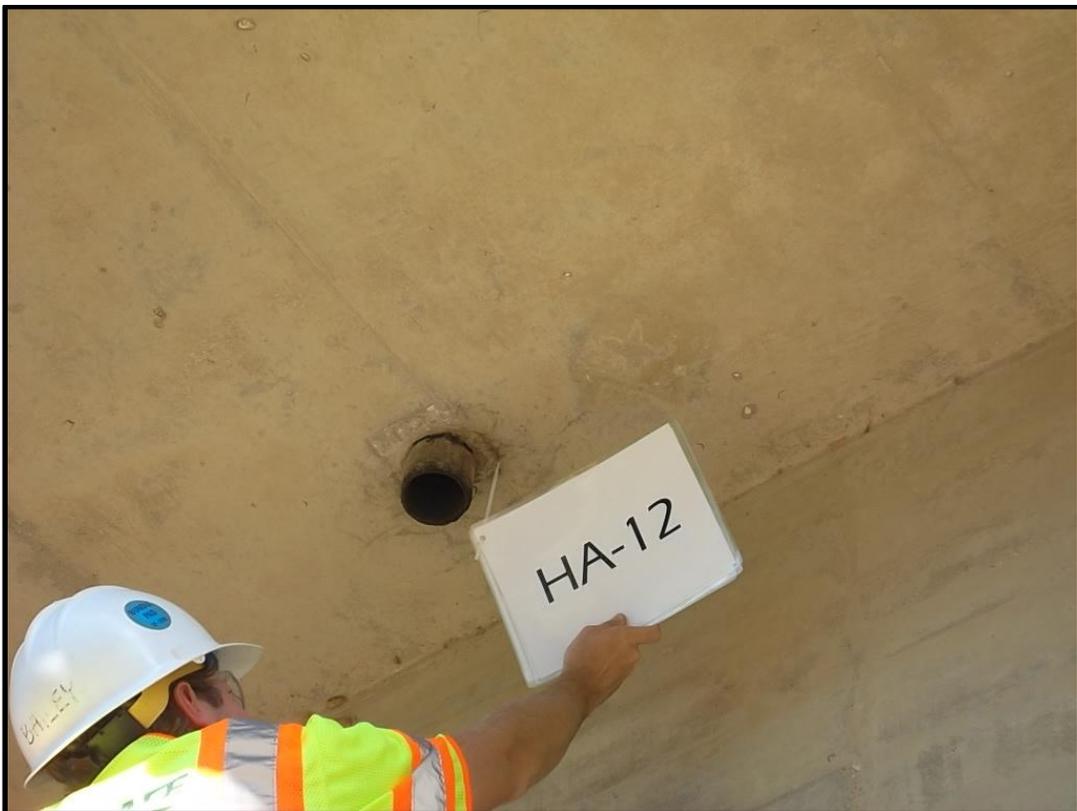
Enclosed is the asbestos inspection report for the above-referenced bridge. A total of 60 samples were obtained during the inspection. Asbestos was detected in the wrap around the drain pipes that penetrate the decking. There were 124 drains located, but based on the condition of the drains, it was not possible to determine if the entire drain pipe is wrapped in this material or if it is only the portions that extend below the bridge deck. Most likely it is the entire drain.

In its current condition this ACM was determined to be non-friable, that is, it could not be pulverized using hand pressure alone. Accordingly, it is classified under EPA NESHAP rules (40 CFR 61) as a Category II non-friable ACM in its current condition. Depending upon the type of bridge maintenance required, there could be potential for the material to become pulverized and thereby become friable, at that time it would be considered a "Regulated Asbestos-Containing Material" (RACM).

Photo 2: Asbestos-containing sample of wrapping located around the straight drain pipes.

OSHA would consider the abatement of RACM to be a Class II activity, which would require trained workers and a competent person to oversee the work (an asbestos supervisor). Additionally, State of Tennessee asbestos accreditation requirements (TCA 1200-01-20) mandate that such work be performed by an accredited firm (contractor) using accredited abatement workers and supervisors.

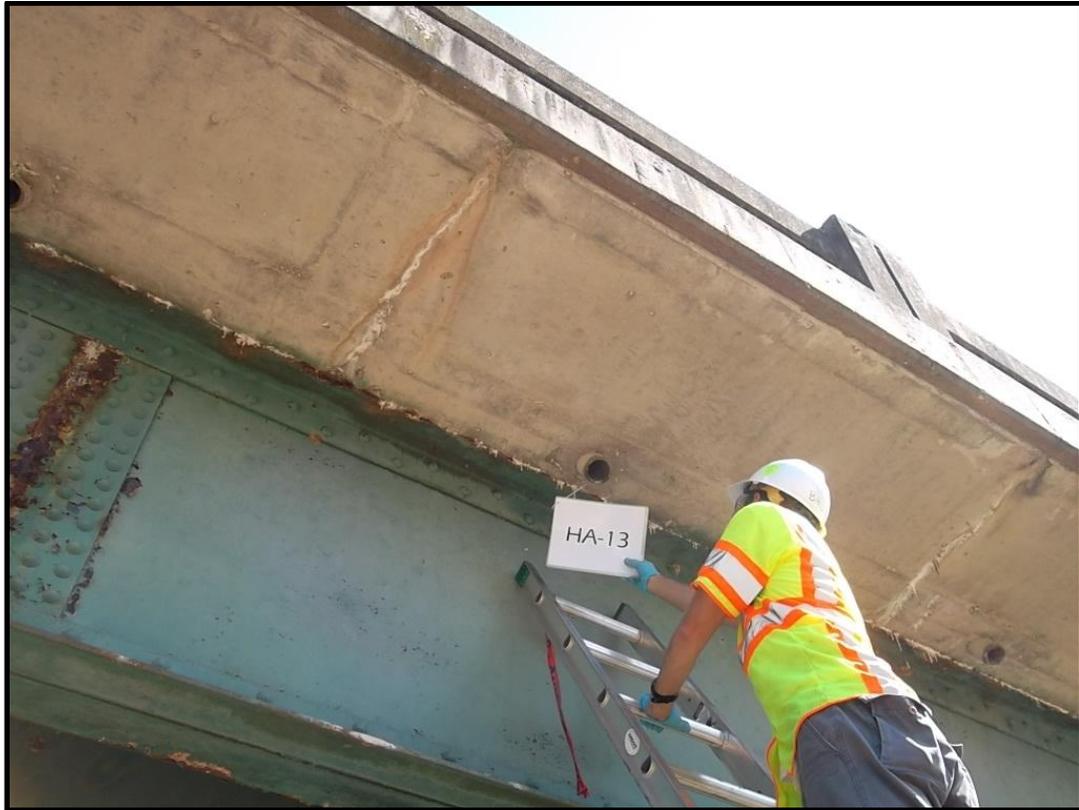
Drainage from the bridge is through piping cored through the bridge deck on the northwest side. Some of this piping was straight and some was angled. The angled drains were observed in the portion of the bridge deck that extends over the river, while the straight drains were observed in the north and south approach. The piping appeared to be metal and was coated with a hard wrapping. The wrap on the straight drain pipes was sampled as 37HA-12A through 37HA-12C and the wrap on the angled drain pipes was sampled as 37HA-13A through 37HA-13C.

**Photo 3:** Asbestos-containing sample of wrapping located around the angled drain pipes.
