Re: Asbestos Inspection Report  
Shelby County; SR-14 Overflow Bridge  
Bridge #: 79SR0140039 (LM 27.25)  
TDOT Project # 79024-4298-04, PIN 116134.00  
TDOT Contract: E1647; Work Order: 06

## TENNESSEE DEPARTMENT OF TRANSPORTATION ASBESTOS INSPECTION REPORT

Overflow Bridge  
Bridge No. 79SR0140039 (LM 27.25)  
State Route 14  
Bartlett, Shelby County

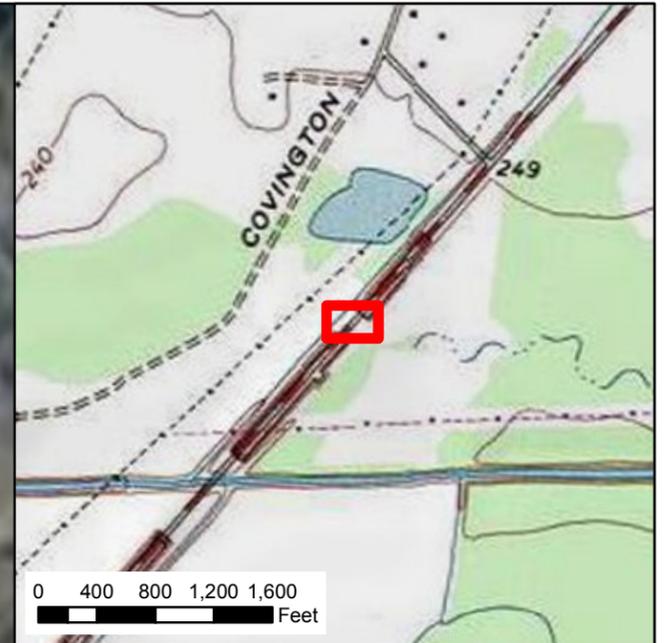
## **Figure – 2: Asbestos-Containing Pipe Wrap Sample Locations**

Drainage from the bridge is through piping cored through the bridge deck on the northwest side of the bridge. The piping appeared to be metal and was coated with a hard wrapping. The pipe wrap was sampled as 39HA-12A through 39HA-12C.

Sample No.	HA/Material Description	Location (Bridge Component)	Approx Qty.	Friable (Y/N)	Type Asbestos and Content
1213990PLM_34-39HA-12A	HA-12 Pipe Wrap	Drainage Pipes	27 LF	N	20% Chrysotile
1213990PLM_39-39HA-12B *	HA-12 Pipe Wrap	Drainage Pipes	27 LF	N	assumed 20% Chrysotile -not analyzed
1213990PLM_36-39HA-12C *	HA-12 Pipe Wrap	Drainage Pipes	27 LF	N	assumed 20% Chrysotile -not analyzed

- 39HA-12A
- 39HA-12B
- 39HA-12C

- Sampled Drain Pipe Wrap Location. Approximately twenty seven 4-inch diameter drains total, with an estimated 27 linear feet of ACM for all 27 drains.

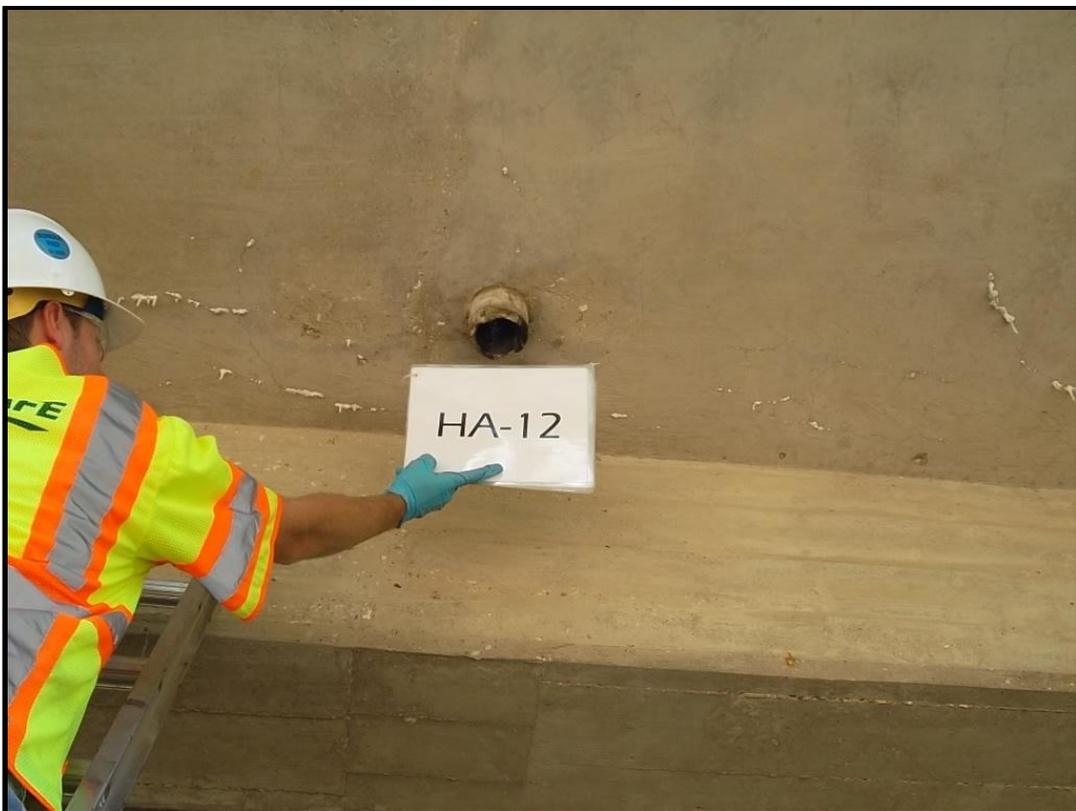
Enclosed is the asbestos inspection report for the above-referenced bridge. A total of 42 samples were obtained during the inspection. Asbestos was detected in the wrap around the drain pipes that penetrate the decking. There were 27 drains located, but based on the condition of the drains, it was not possible to determine if the entire drain pipe is wrapped in this material or if it is only the portions that extend below the bridge deck. Most likely it is the entire drain.

In its current condition this ACM was determined to be non-friable, that is, it could not be pulverized using hand pressure alone. Accordingly, it is classified under EPA NESHAP rules (40 CFR 61) as a Category II non-friable ACM in its current condition. Depending upon the type of bridge maintenance required, there could be potential for the material to become pulverized and thereby become friable, at that time it would be considered a "Regulated Asbestos-Containing Material" (RACM).

Photo 2: Asbestos-containing sample of wrapping located around the drain pipes.

OSHA would consider the abatement of RACM to be a Class II activity, which would require trained workers and a competent person to oversee the work (an asbestos supervisor). Additionally, State of Tennessee asbestos accreditation requirements (TCA 1200-01-20) mandate that such work be performed by an accredited firm (contractor) using accredited abatement workers and supervisors.
