HAMILTON COUNTY

33-03611-01.01
33I00240057 (I-24 LM 12.59)
Belvoir Avenue OVER I-24 EB & WB
4-SPAN

BRIDGE MAINTENANCE RECOMMENDATIONS

BRIDGE INSPECTION REPORT

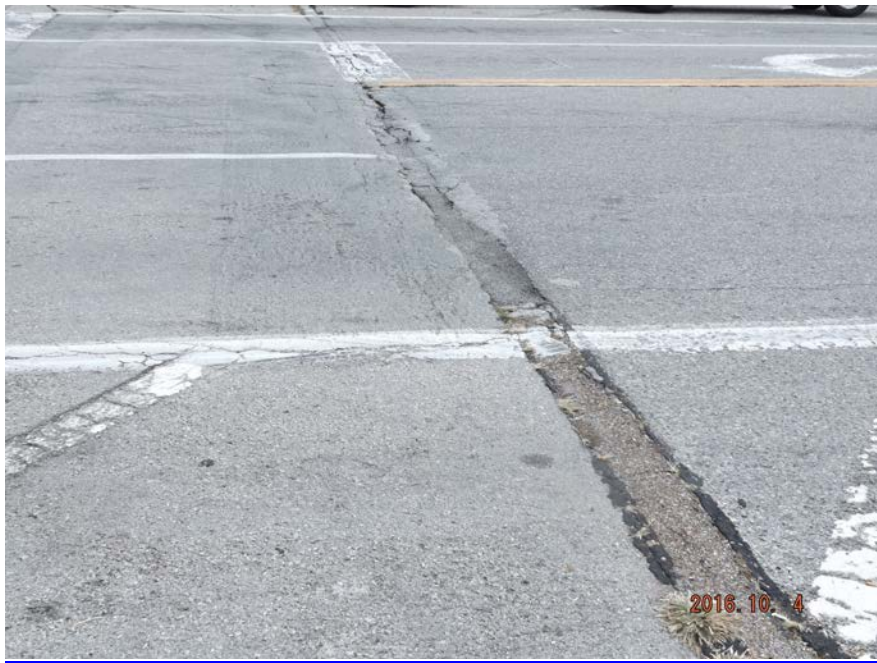
APPROACH 2 - BROKEN - UNEVEN

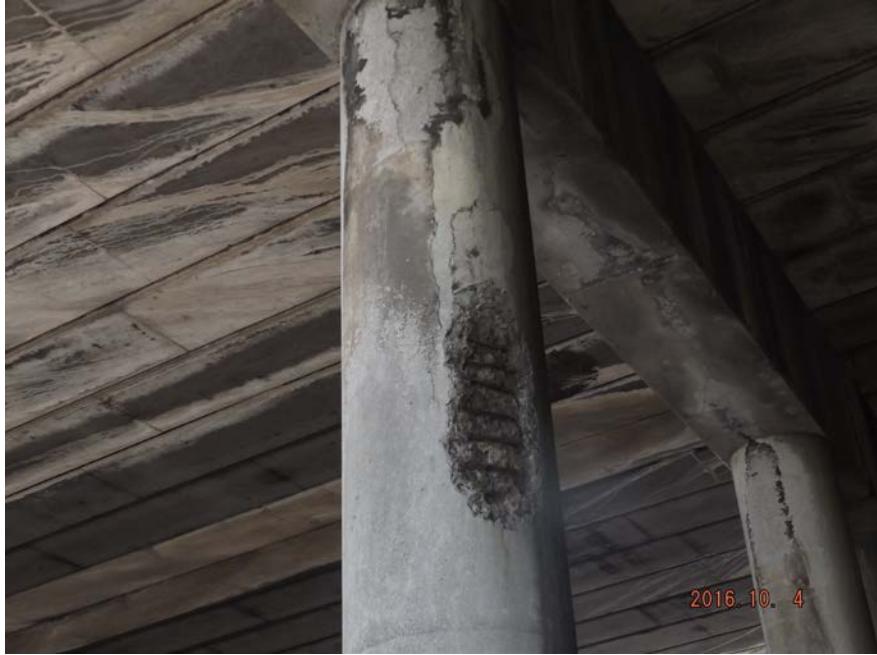
BENT 3 - COLUMN E - LARGE REBAR SPALL

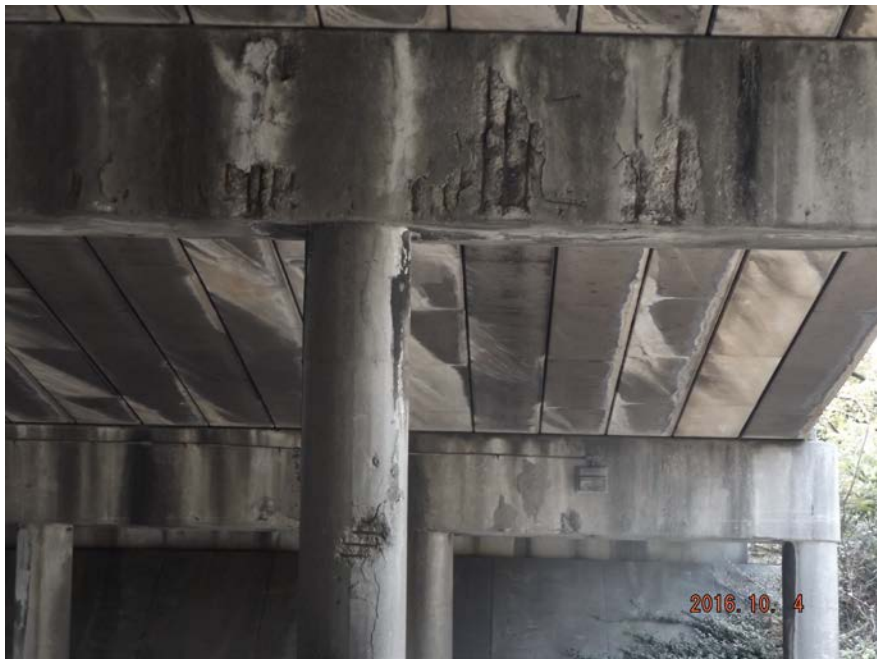
BENT 2 - CAP AND COLUMN B - REBAR SPLLS/DLAMS

Bridge Seat:	NV	<i>NO VISIBLE SIGNS OF STRUCTURAL ISSUES</i>
Caps	FAIR	<i>HL-SMALL CRACKS, DELAMS, SPALLS, PATCHES.</i>
Columns / Shaft	G-F	<i>DELAM S, SPALLS, PATCHES. BENT 2 - COLUMN B - SIGNIFICANT REBAR SPALL</i>
Pier / Crash Walls:		
Plumb	GOOD	
Footings	NV	
Piles	NV

SUGGESTED ROUTINE MAINTENANCE AND COMMENTS
Cut vegetation blocking sidewalk
PAINT PROTECT EXPOSED REBAR BENT 2
LEVEL THE WEARING SURFACE OVER THE COVERED JOINTS.
SEAL VOIDS IN DECK WEARING SURFACE AT CENTERLINE.

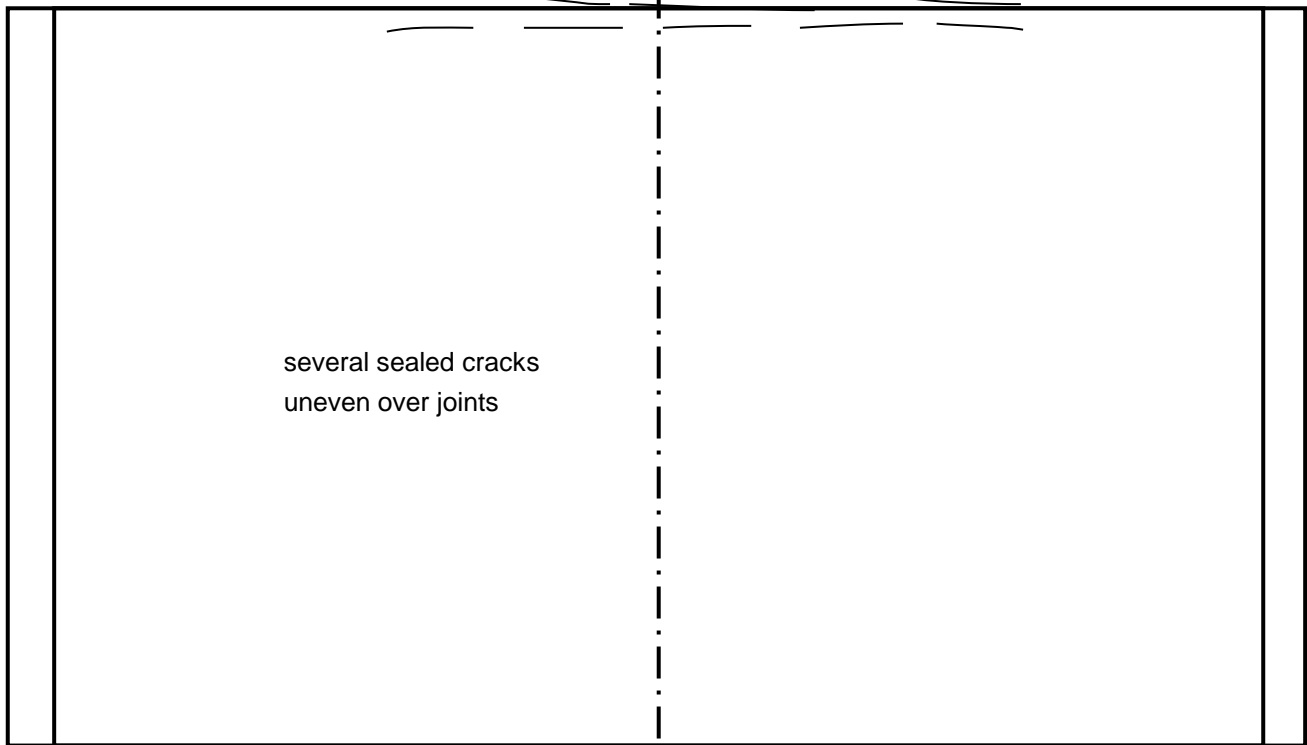
Top of Deck Span No. 1

App Pvmnt: F Uneven, cracks, rutting

Joints: P Cracks, uneven

CRACKING OVER JOINT ↑

several sealed cracks
uneven over joints

Patch - 12"x8"x2"

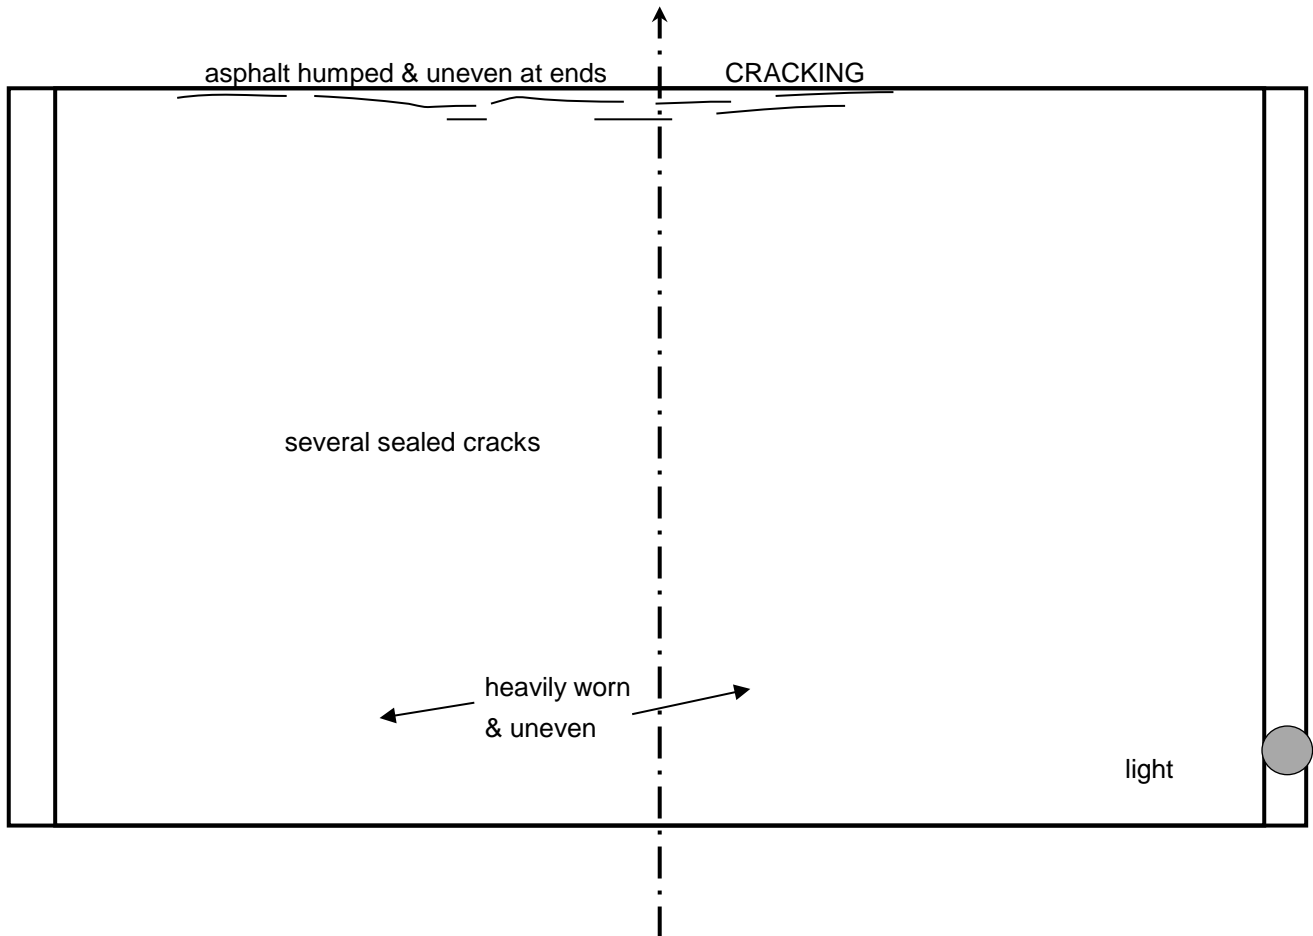
Top of Deck Span No. 2

Wearing Surface: F Cracks, rutting

Joints: P Cracks, uneven

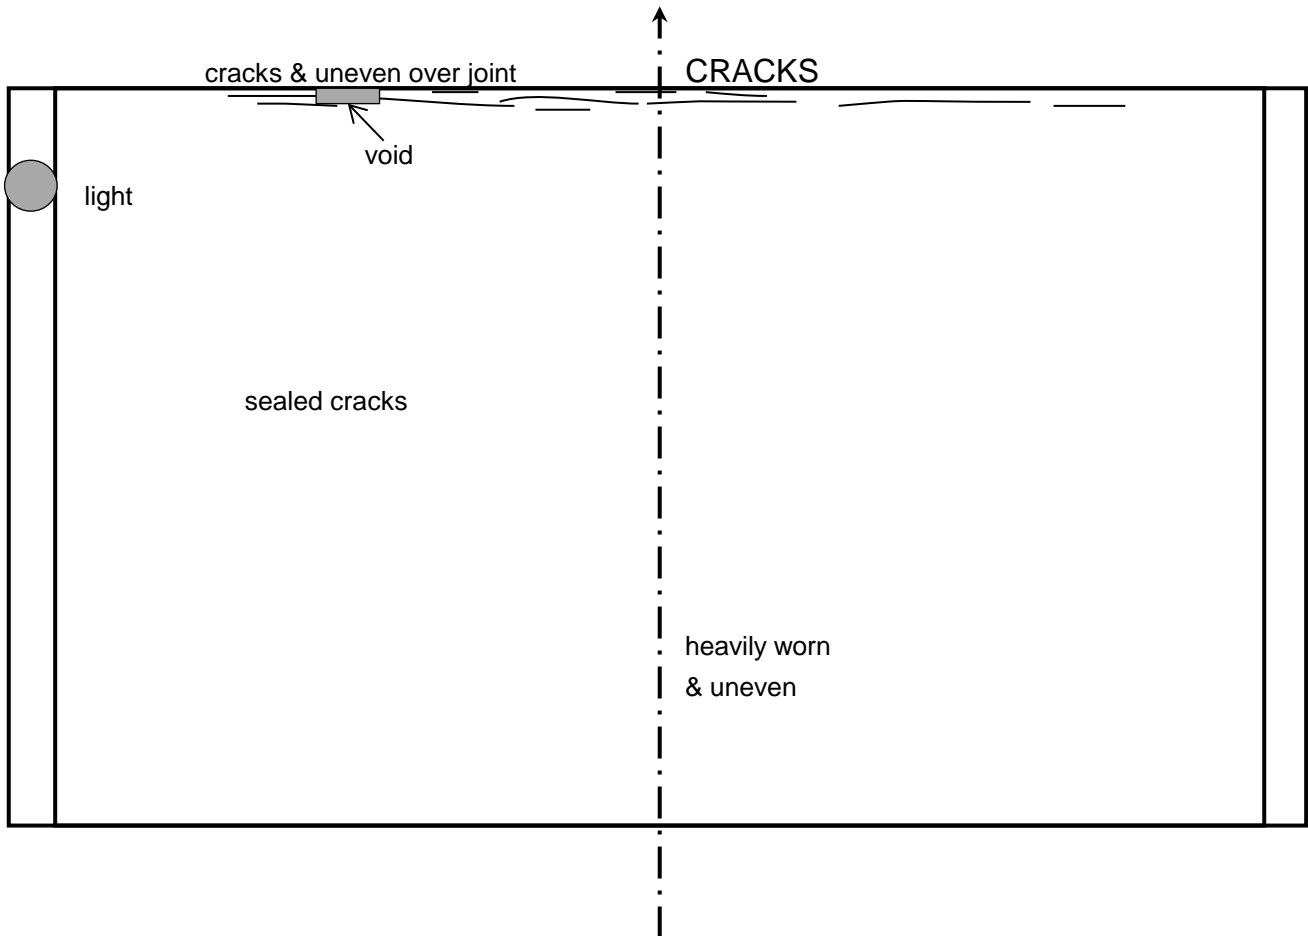
Top of Deck Span No. 3

Wearing Surface: F Cracks, rutting

Joints: P Cracks, uneven

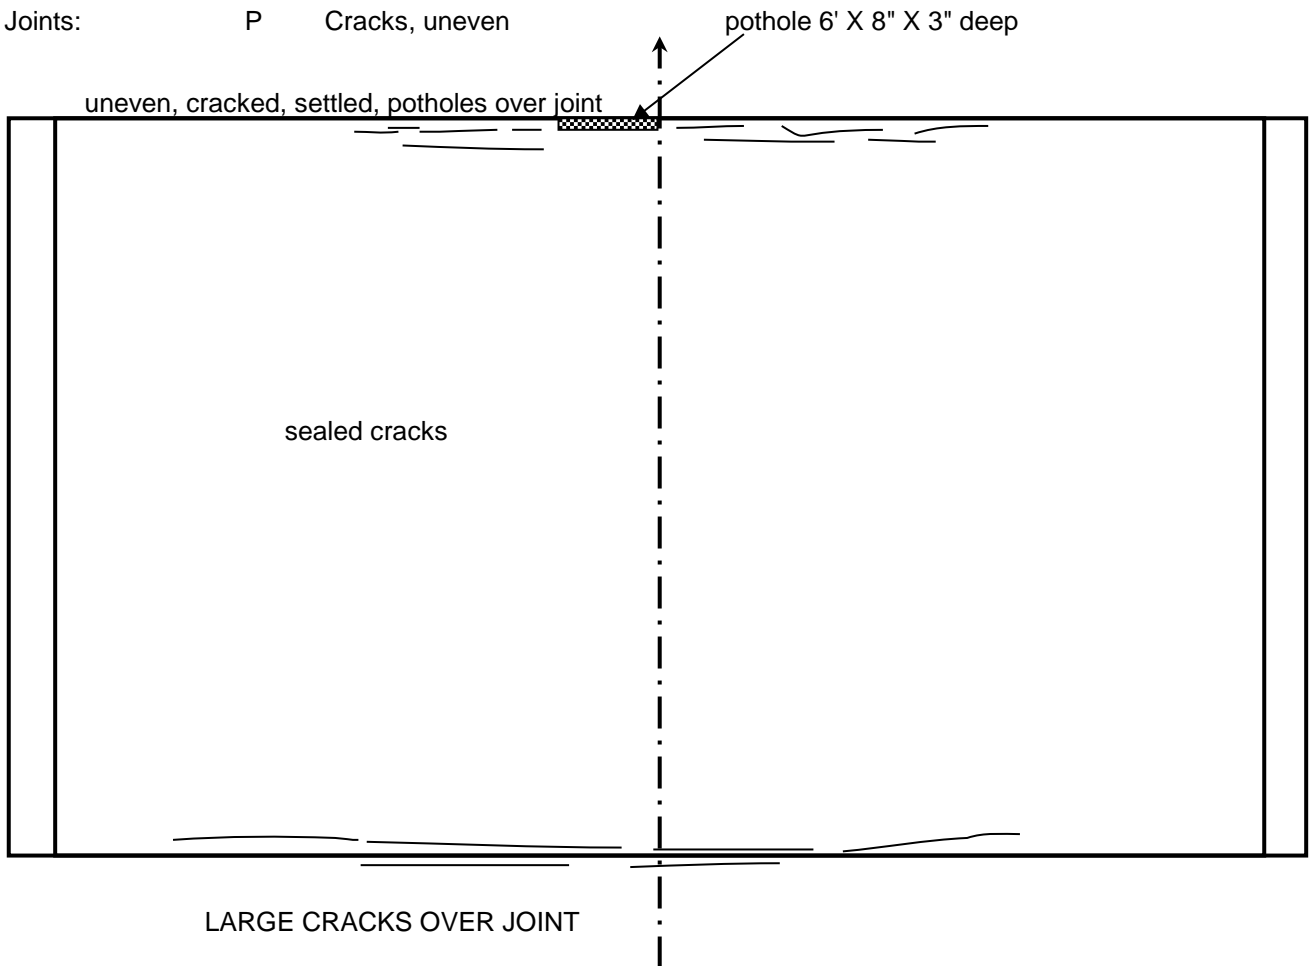
Top of Deck Span No. 4

Wearing surface: F Cracks, rutting

Joints: P Cracks, uneven

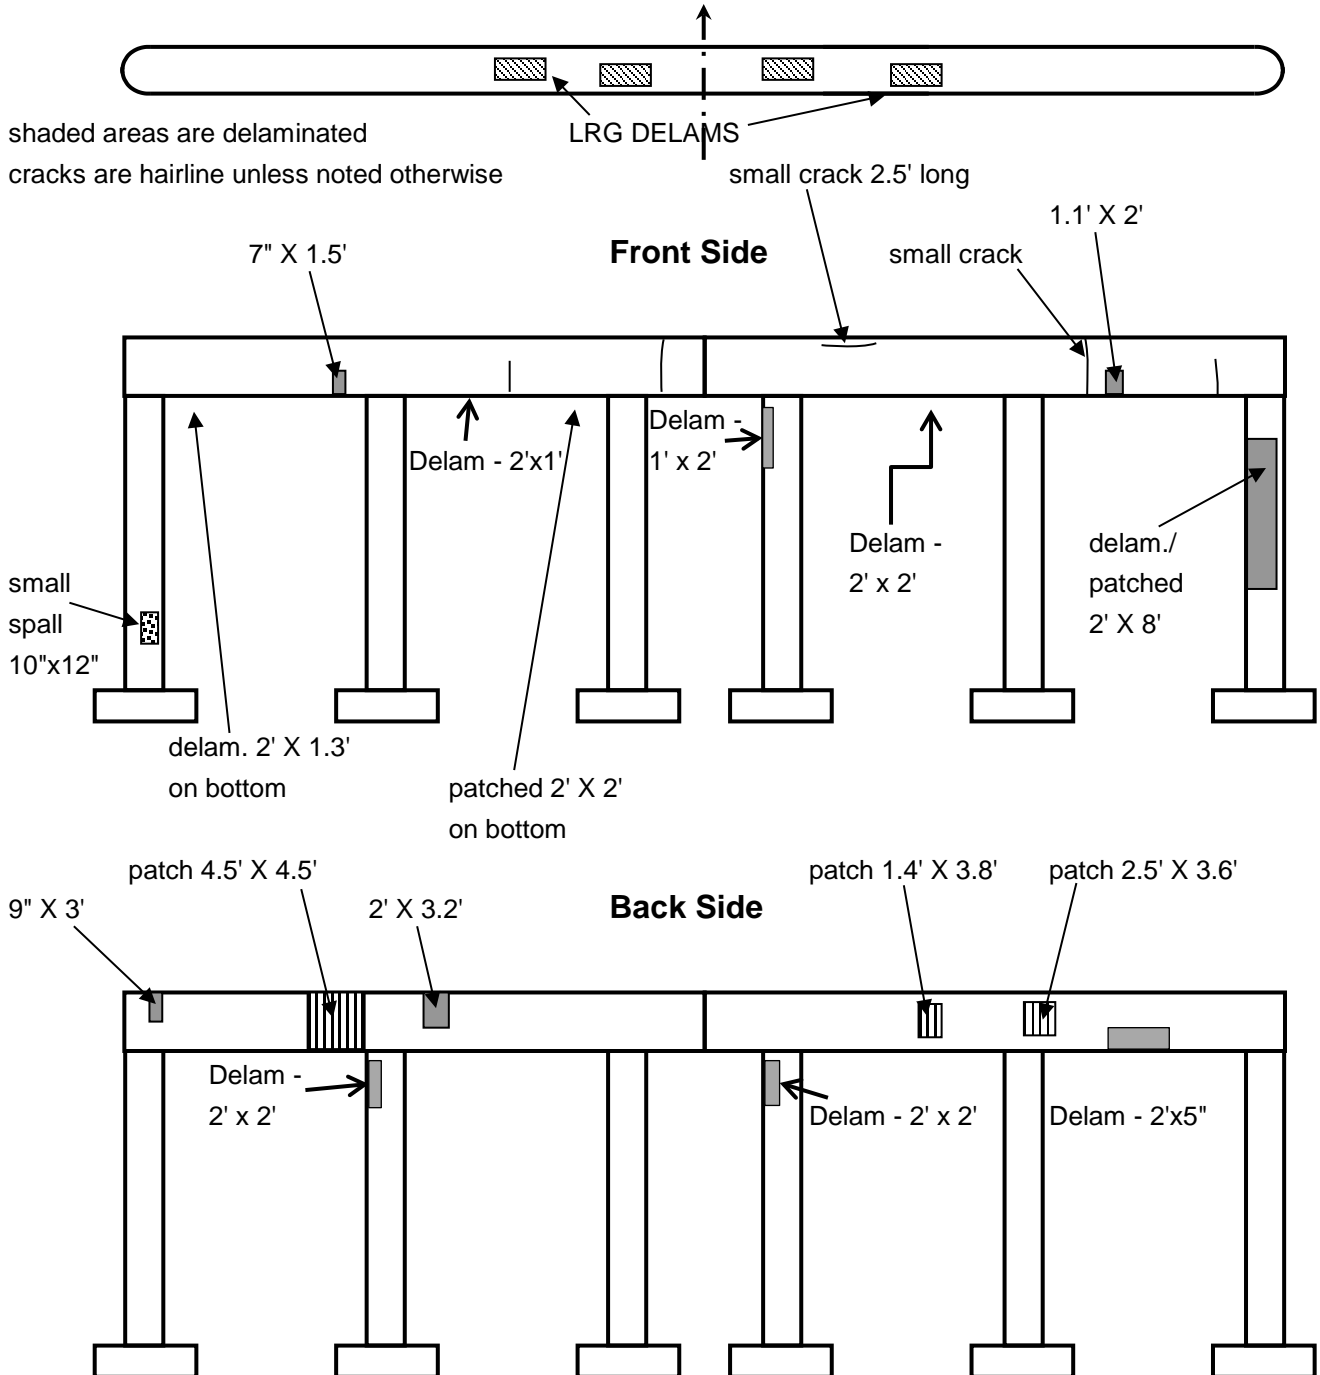
Bent No. 1

Columns: F

Cap: GF

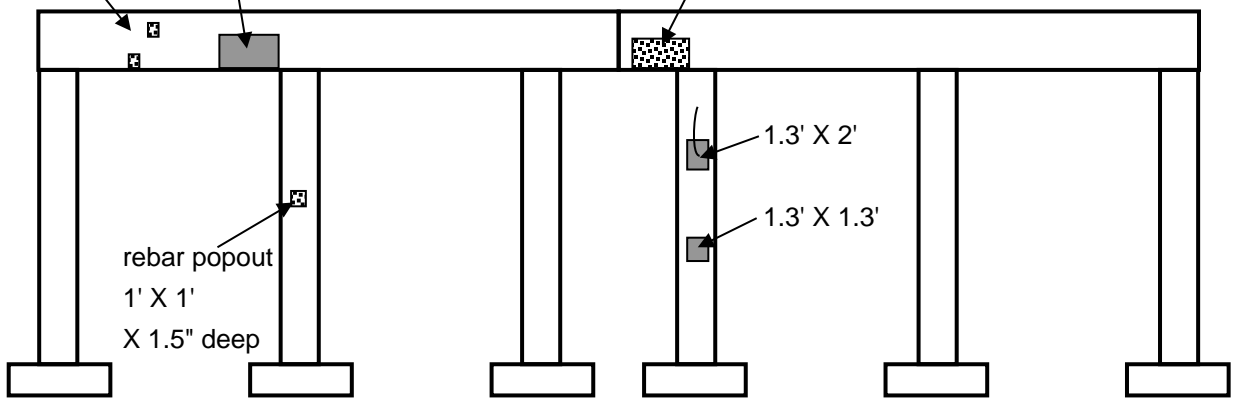
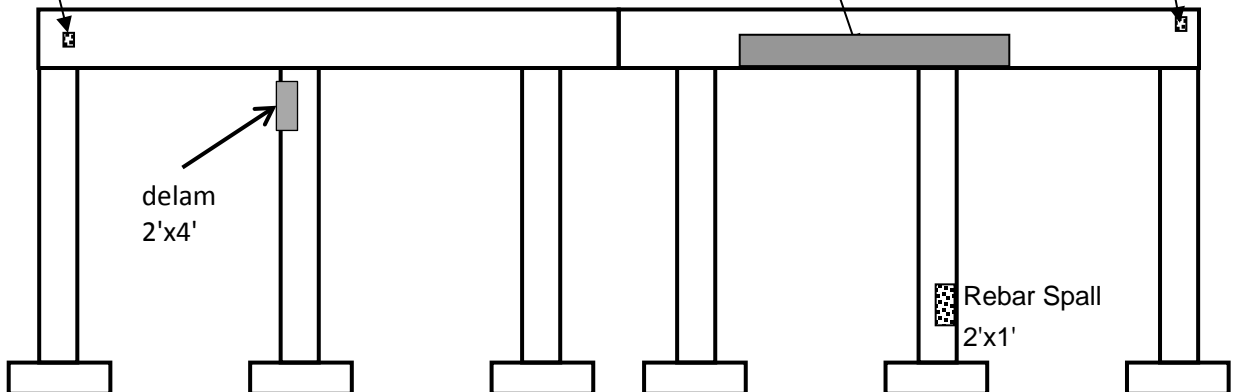
Bent No. 2

Columns: F

Cap: F

cracks are hairline unless noted otherwise
shaded areas are delaminated

rebar popouts 8" X 8" X 1" deep delam.with rebar popout 4.5' X 3.2'
Front Side Rebar Popout 3' x 3'

rebar popout 7" X 1' X 1" deep Delam/Spalled with rebar exposed 20' x 2' x 1" rebar popout 7" X 8" X 1" deep
Back Side

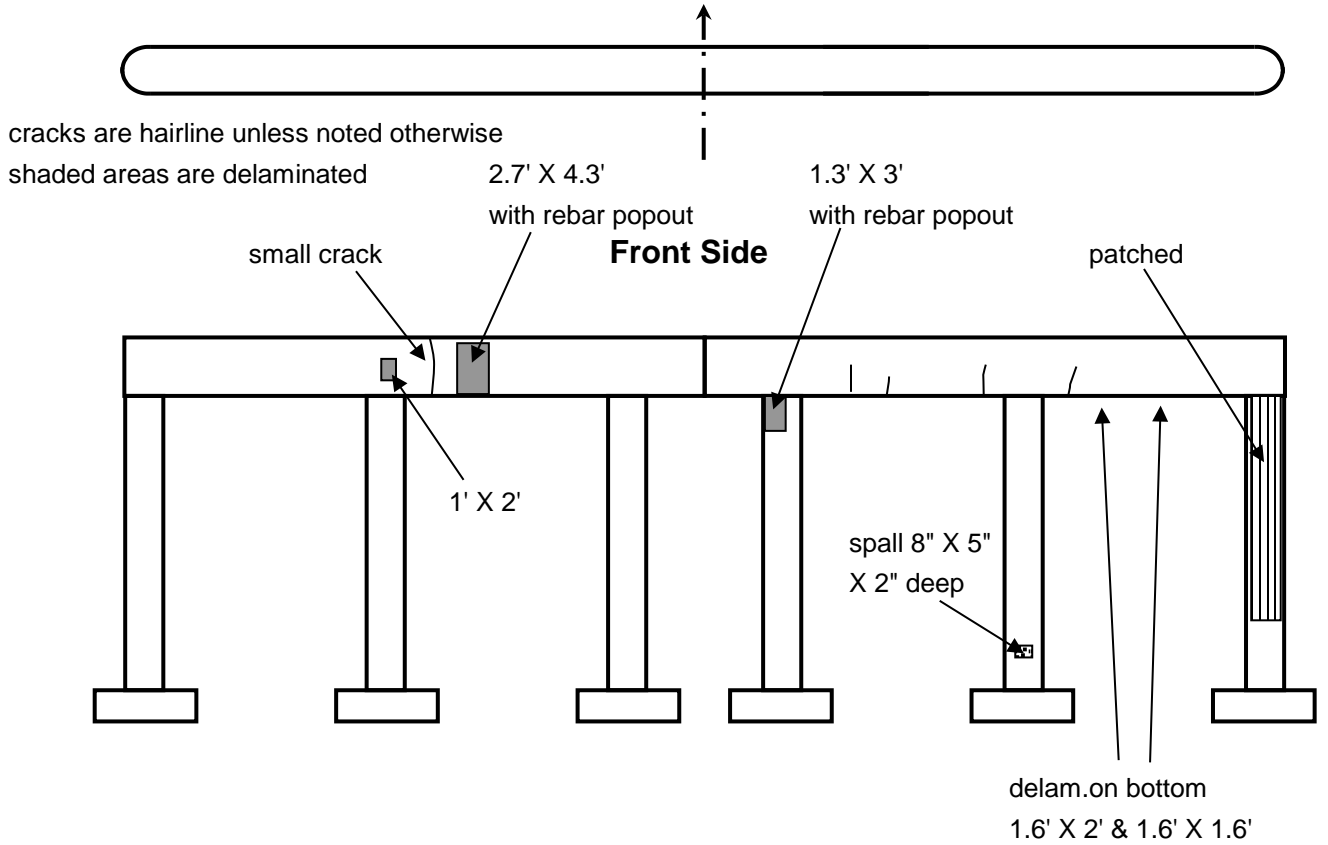
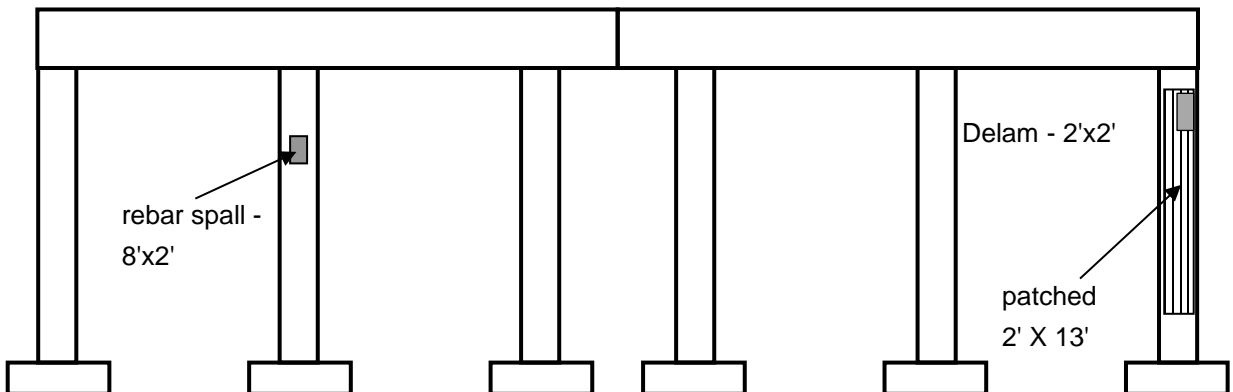
Bent No. 3

Columns: F

Cap: F

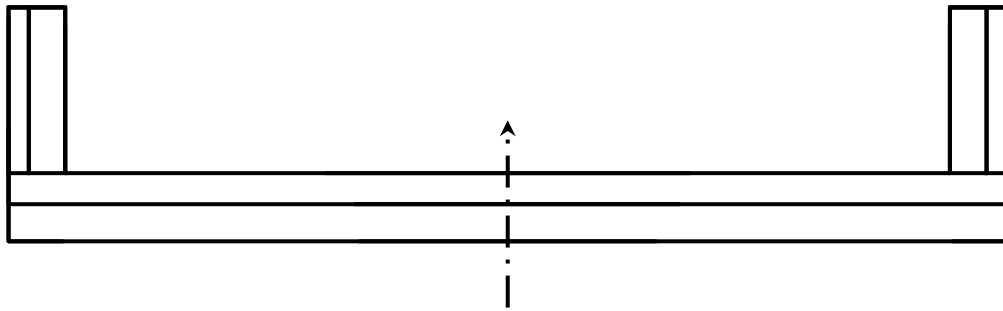
Abutment No. 2

cracks are hairline
