# HAMILTON COUNTY

**33-I0024-12.08**  
**33I00240055**  
**I-24 EB/WB OVER S. Germantown Road**  
**(FAU 3577 LM 0.90)**  
**4-SPAN**

# Photographs

# BRIDGE INSPECTION REPORT

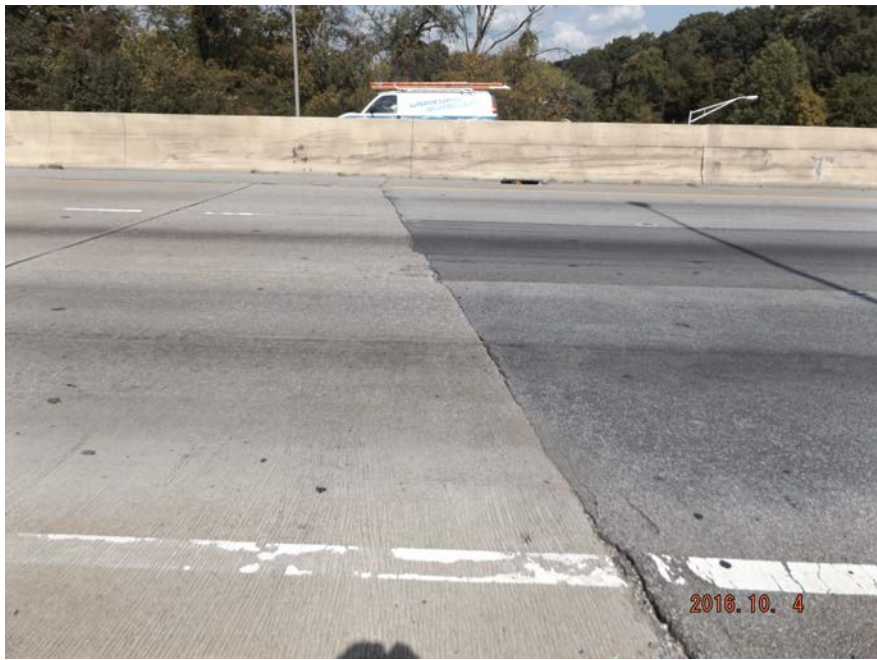
APPROACH 1

Rating	Comments
Alignment	GOOD	
Slab	NV	OVERLAYED
Joints	NV	OVERLAYED
Pavement	POOR	ASPHALT BREAKING UP, ROUGH
Slope	GOOD	
Drains	GOOD

<b>SUGGESTED ROUTINE MAINTENANCE AND COMMENTS</b>
LEVEL THE WEARING SURFACE
LEVEL THE WEARING SURFACE AT APPROACH NO. 1 & 2 - WESTBOUND

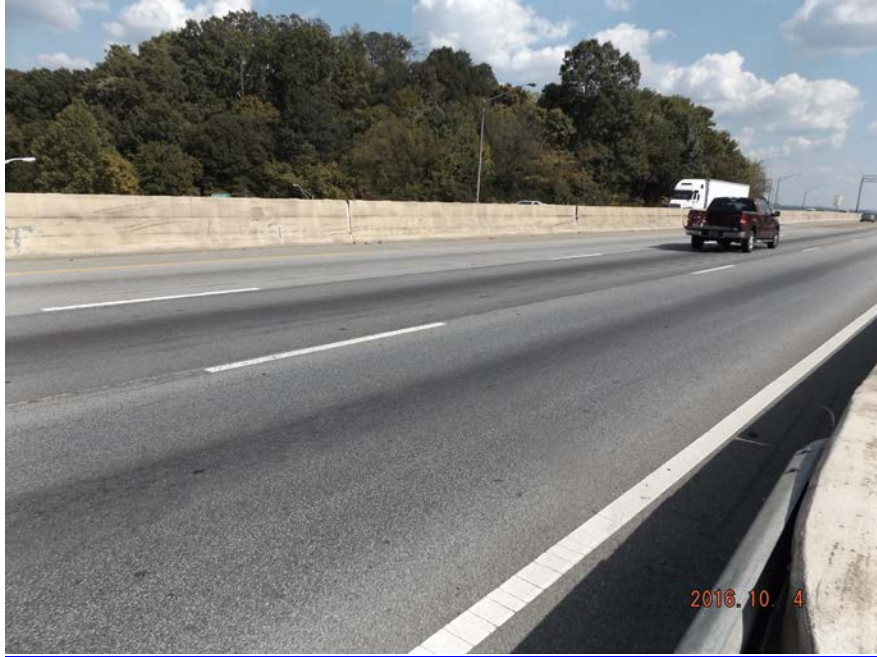
WEARING SURFACE

Rating	Comments
Wearing Surface	GOOD	<i>ROUGH, UNEVEN, ESPECIALLY WBL. MULTIPLE PATCHES</i>
Deck - TRIMS Item 58	5	
Deck - Structural Condition	FAIR	<i>HL CRACKS W/ EFF, PATCHES, DELAMS, SPALLS, HL MAP-CRACKING</i>
Curbs	NONE	
Median	GOOD	
Sidewalks	NONE	
Paint	NA	
Drains	G-P	<i>WBL ARE OPEN. EBL ARE COVERED.</i>
Lighting Standards	GOOD	
Utilities	NONE	
Joint Leakage	FAIR	<i>LEAKAGE ONTO BENT CAPS.</i>
Expansion Joints	NV	<i>OVERLAYED</i>

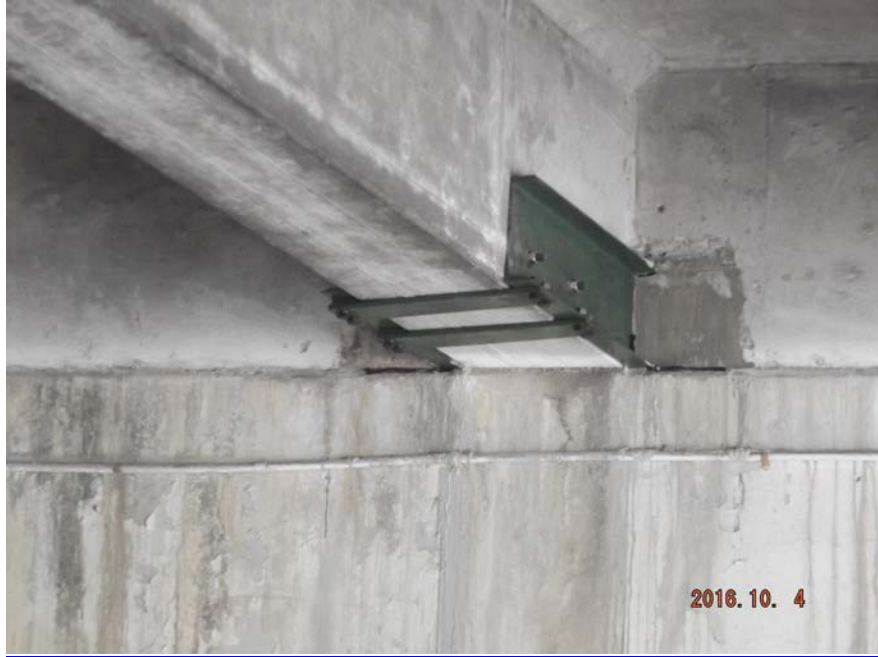
BENT 1 - NEW - REINFORCEMENTS - TYPICAL

Overall Bridge Rating:	GOOD
	Span 1 - Bent 1 - Cap - Steel reinforcement installed on beams
Approach Roadway Alignment: TRIMS Item 72

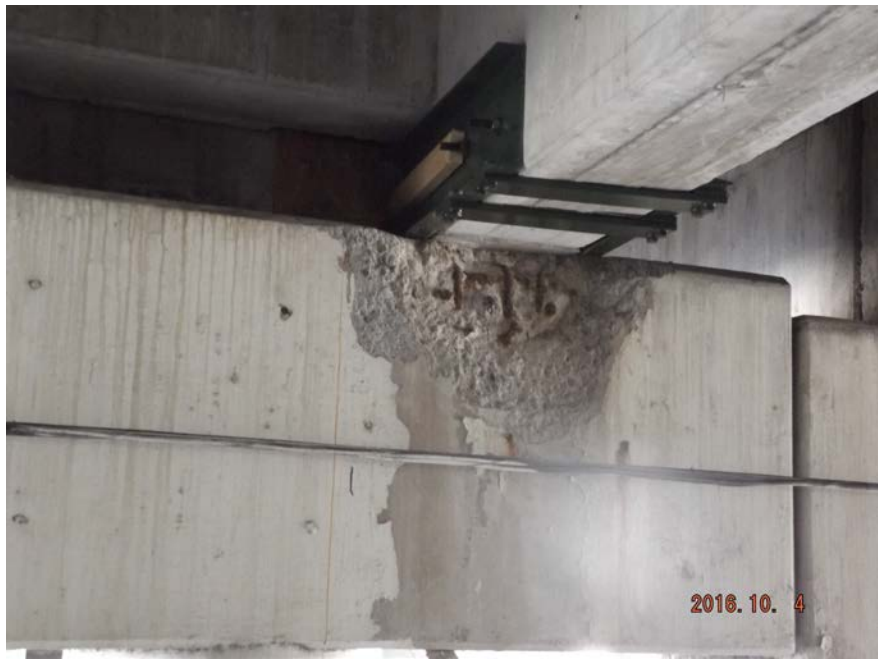
BENT 1 - SPALL - REBAR

Bridge Seat:	POOR	<i>SPAN 1 - BENT 1 - SIGNIFICANT LOSS OF ORIGINAL BEARING AREA</i>
Caps	POOR	<i>SPAN 1 - BENT 1 - SIGNIFICANT REBAR SPALLS</i>
Columns / Shaft	FAIR	<i>SPALLS, DELAMS</i>
Pier / Crash Walls:		
Plumb	GOOD	
Footings	NV	
Piles	NV

Although all loose concrete was removed by bridge inspection crews, potential exists for future loosed concrete to fall at Spane 1 - Bent 1.

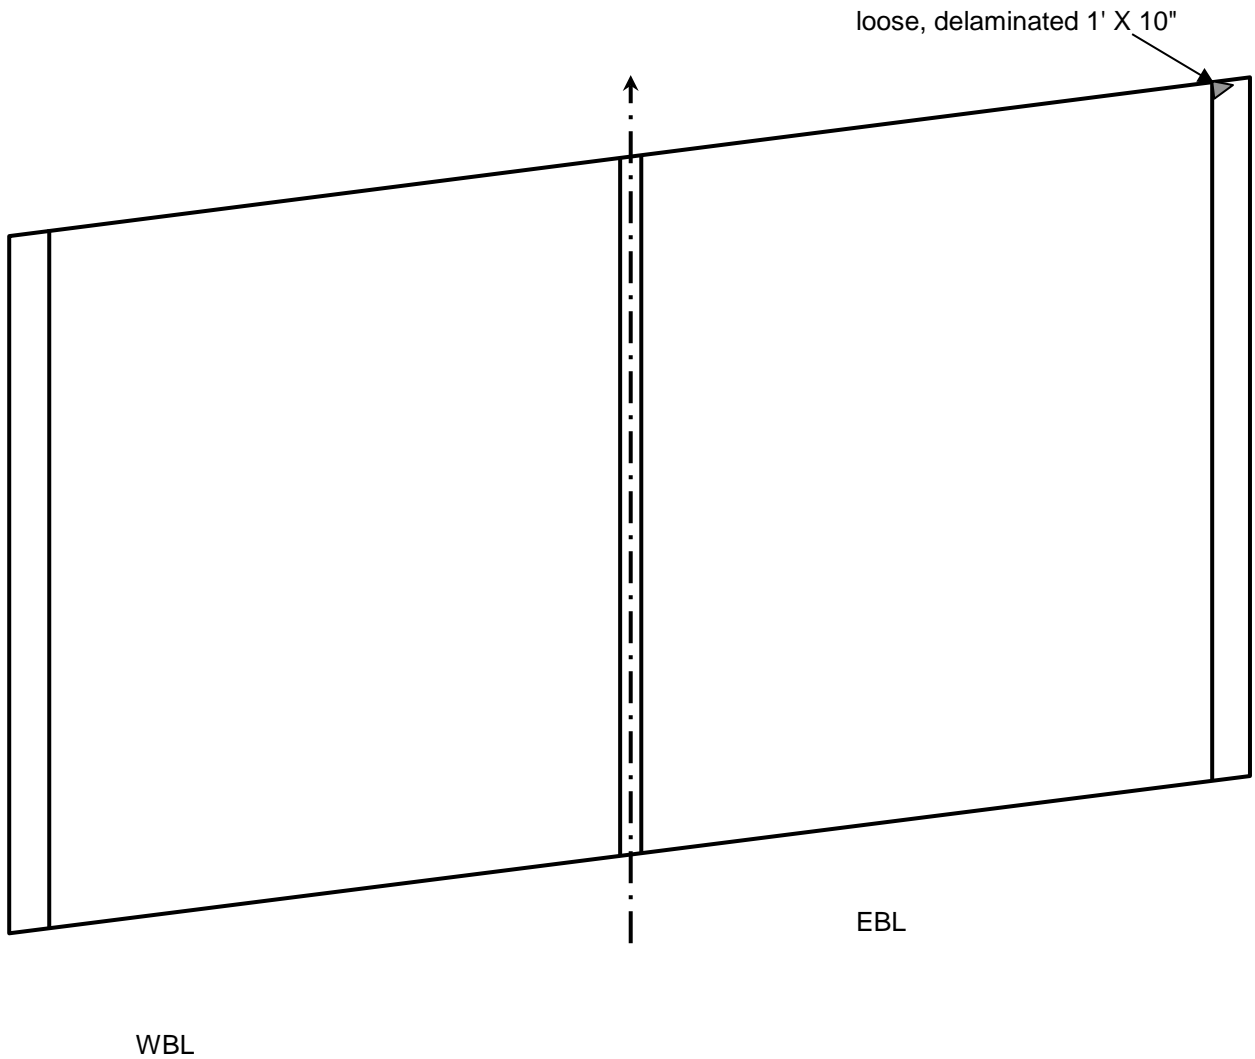
Top of Deck Span No. 3

Wearing Surface: P

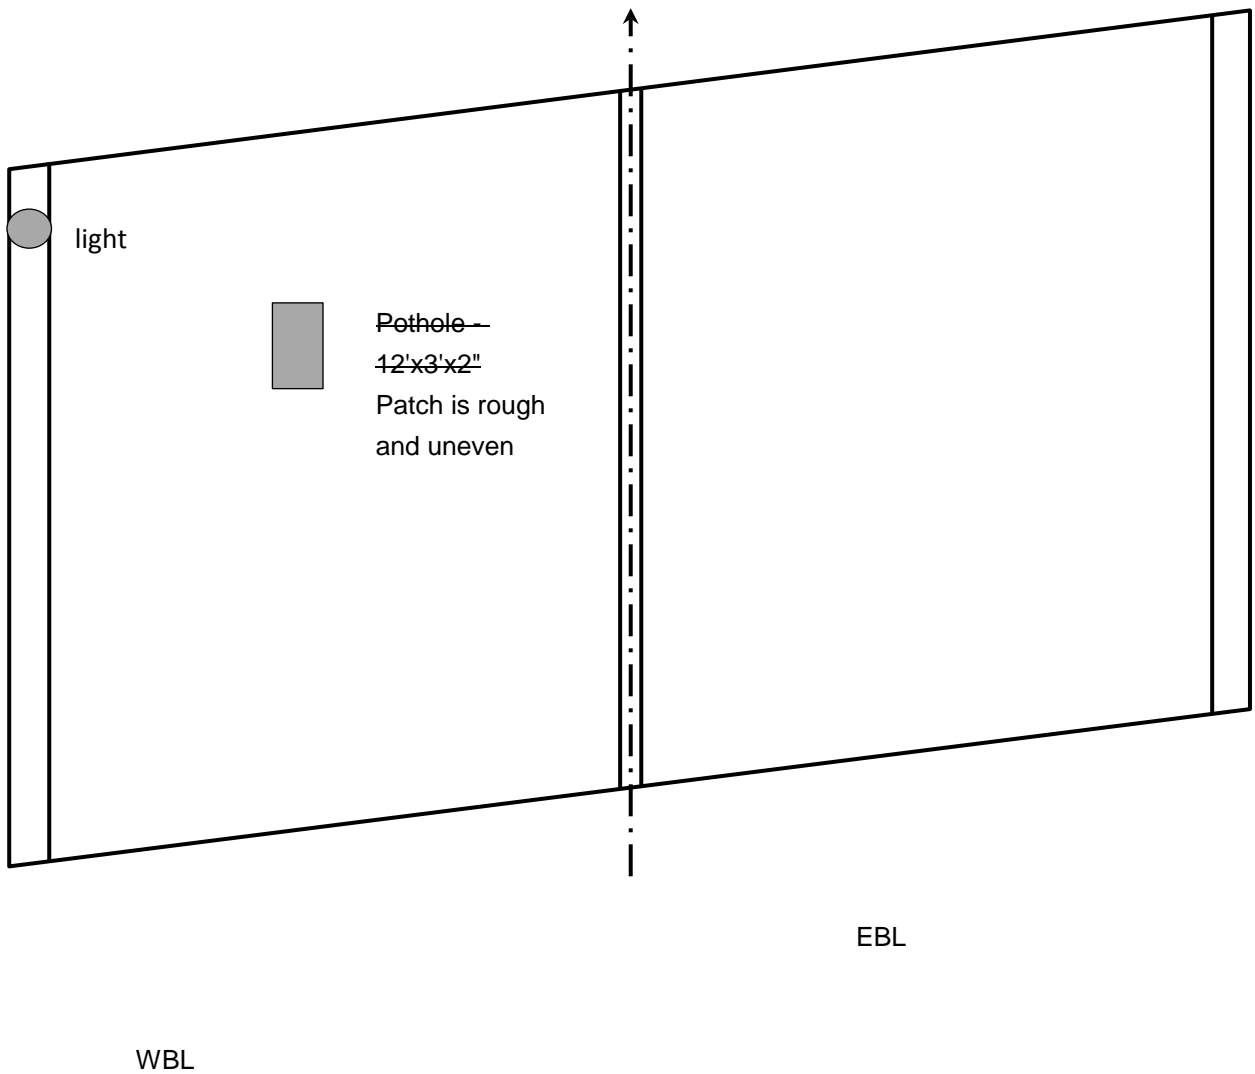
Top of Deck Span No. 4

Wearing surface: P

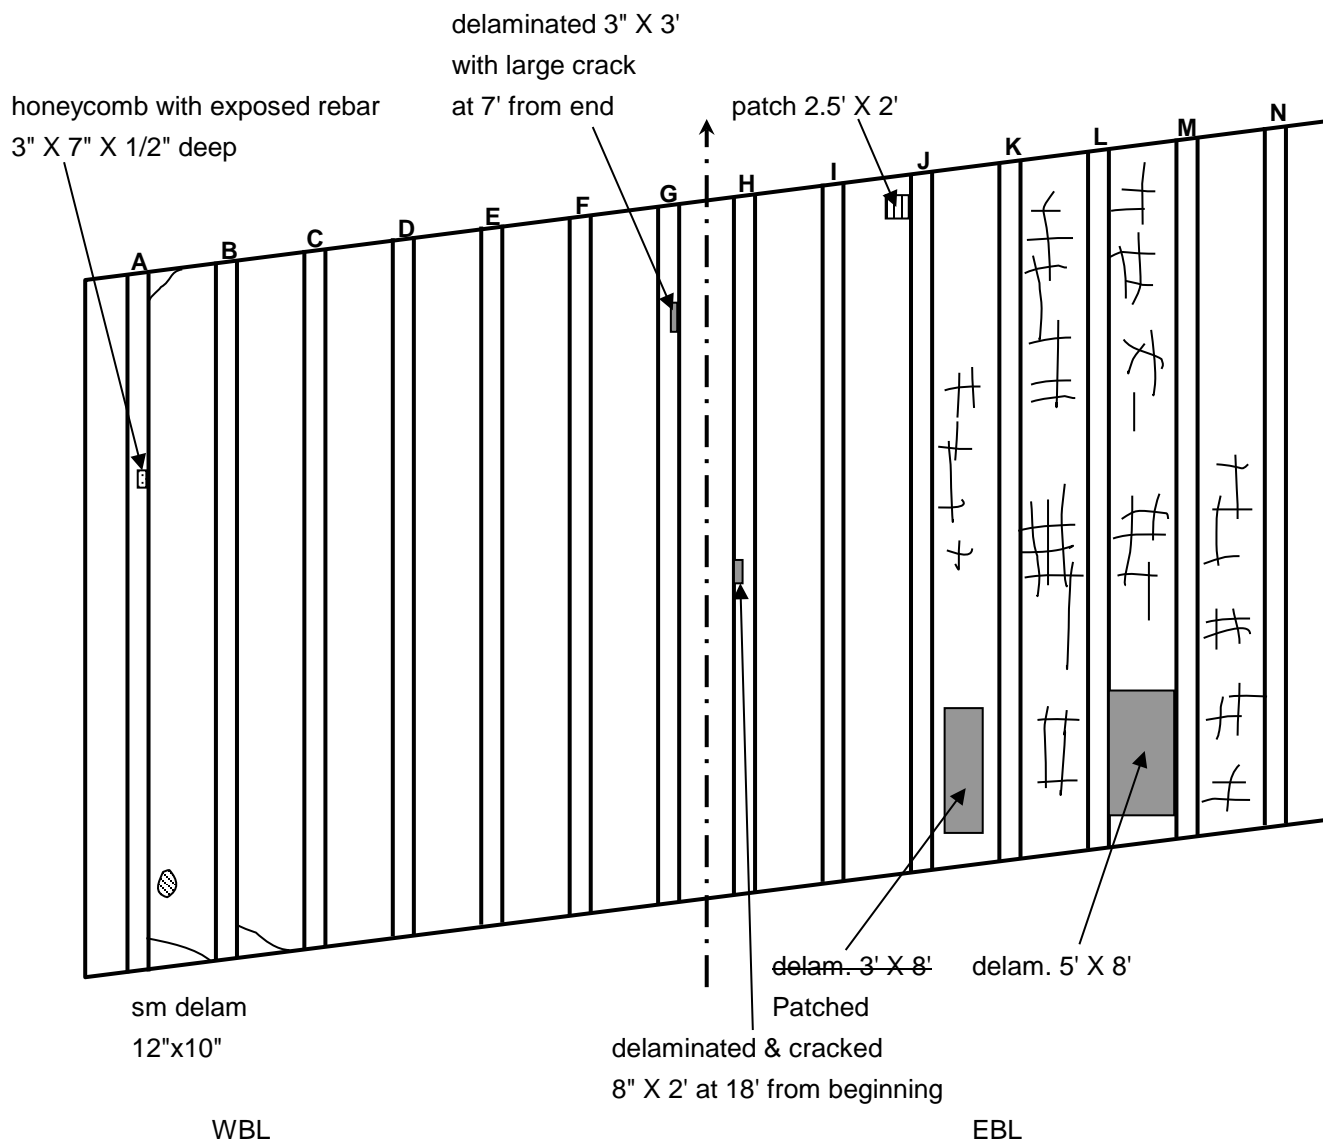
# Bottom of Deck Span No. 1

Beams: GF beams A-G have steel reinforcement repairs at bent 1

cracks are hairline, some with efflorescence

surface cracks on sides of beams in e.b.l.

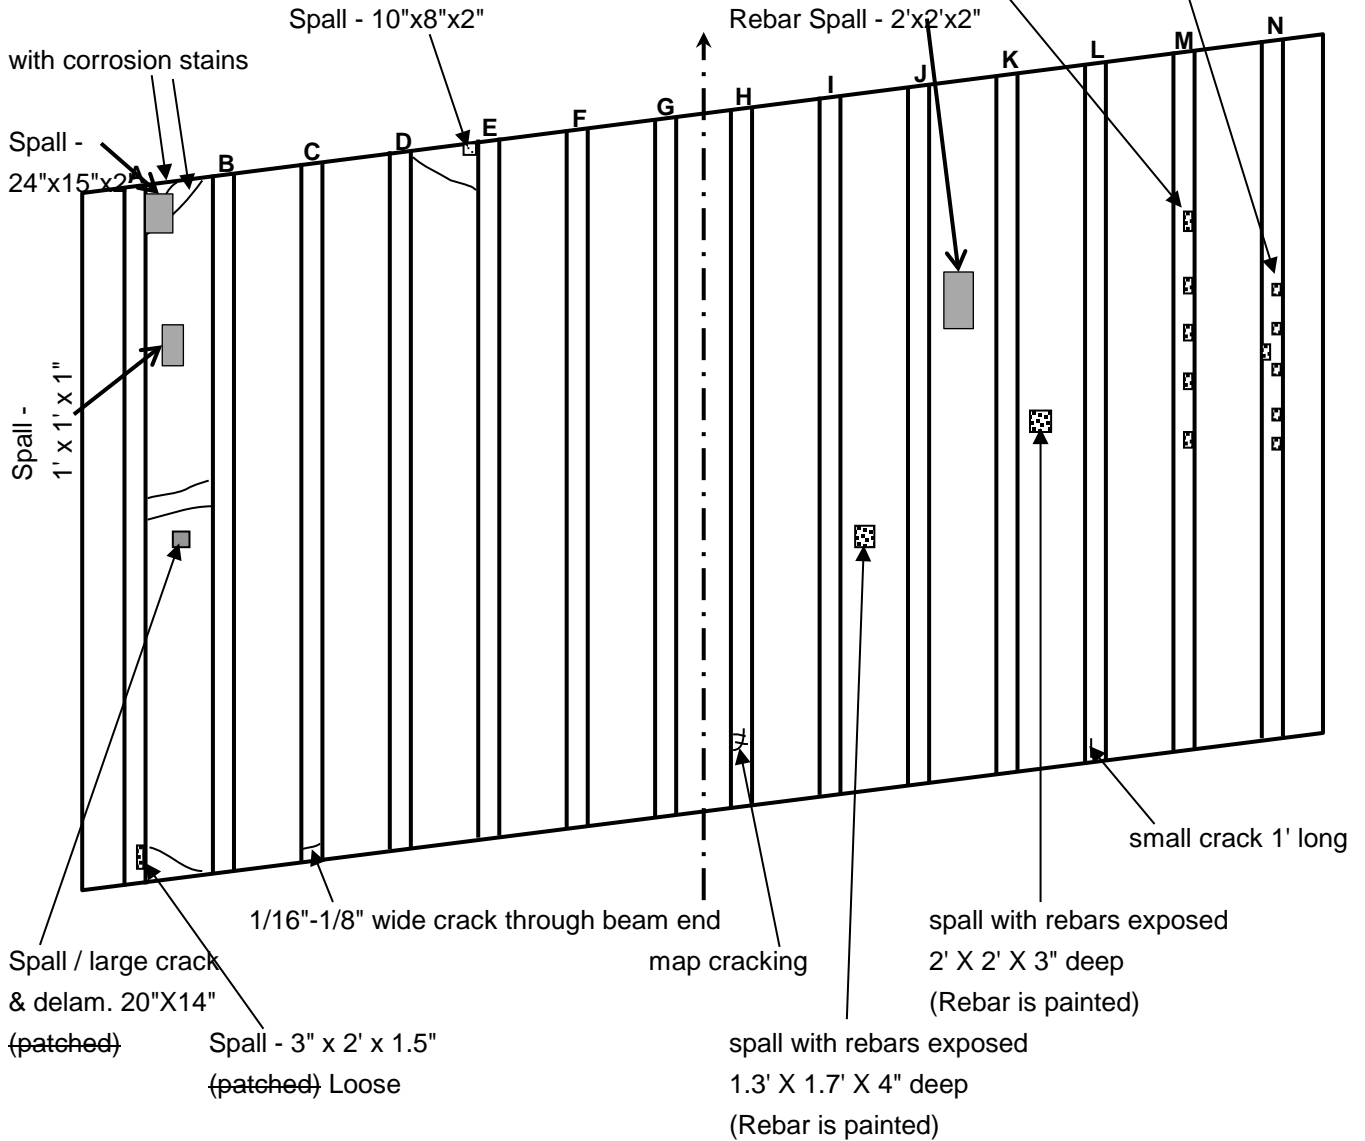
# Bottom of Deck Span No. 3

cracks are hairline  
 unless noted otherwise  
 some with efflorescence

spalls along edge of beam M  
 3" X 1' X 1" deep, 4" X 6" X 2" deep,  
 4" X 5" X 1" deep, 6" X 7" X 1" deep  
 & 6" X 8" X 1" deep

spalls in beam N  
 2" X 3"-9"

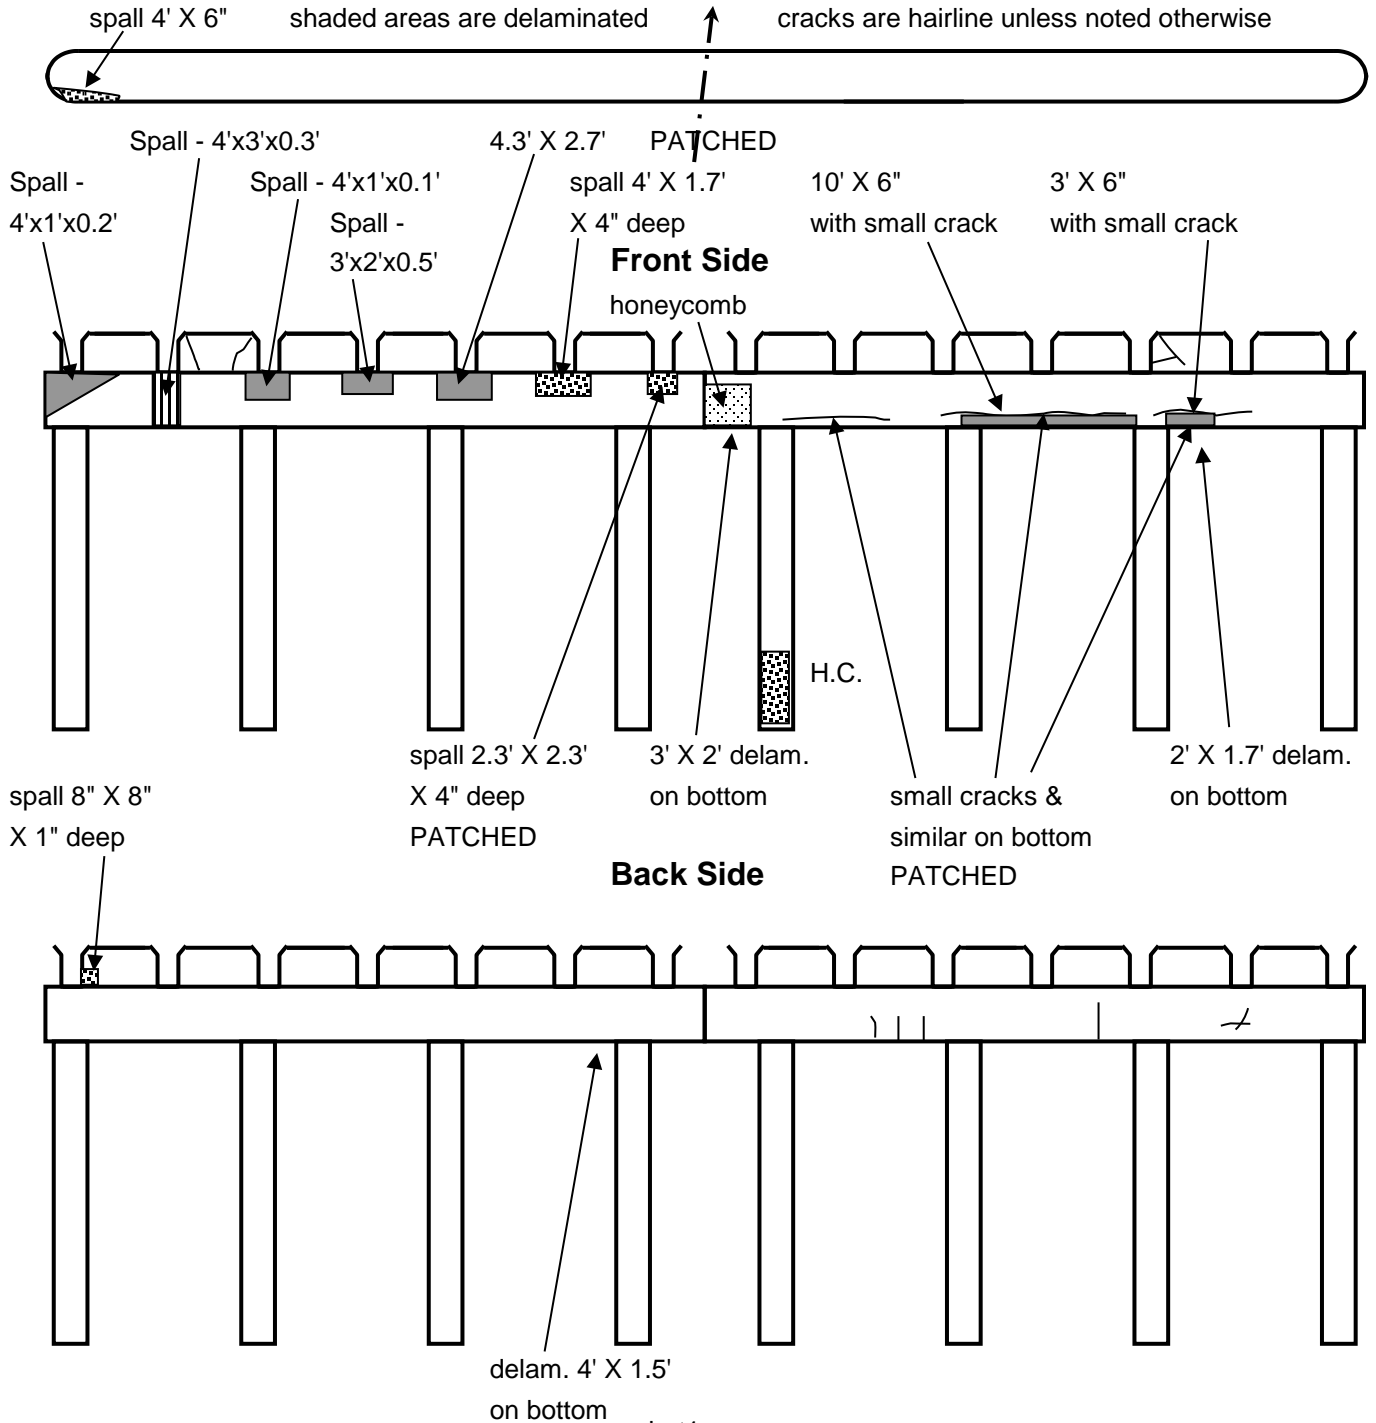
# Bent No. 1

Columns: F

Cap: P Span 1 face - Rebar spalls

Bearings: P Cap rebar spalls have significantly reduced original bearing area

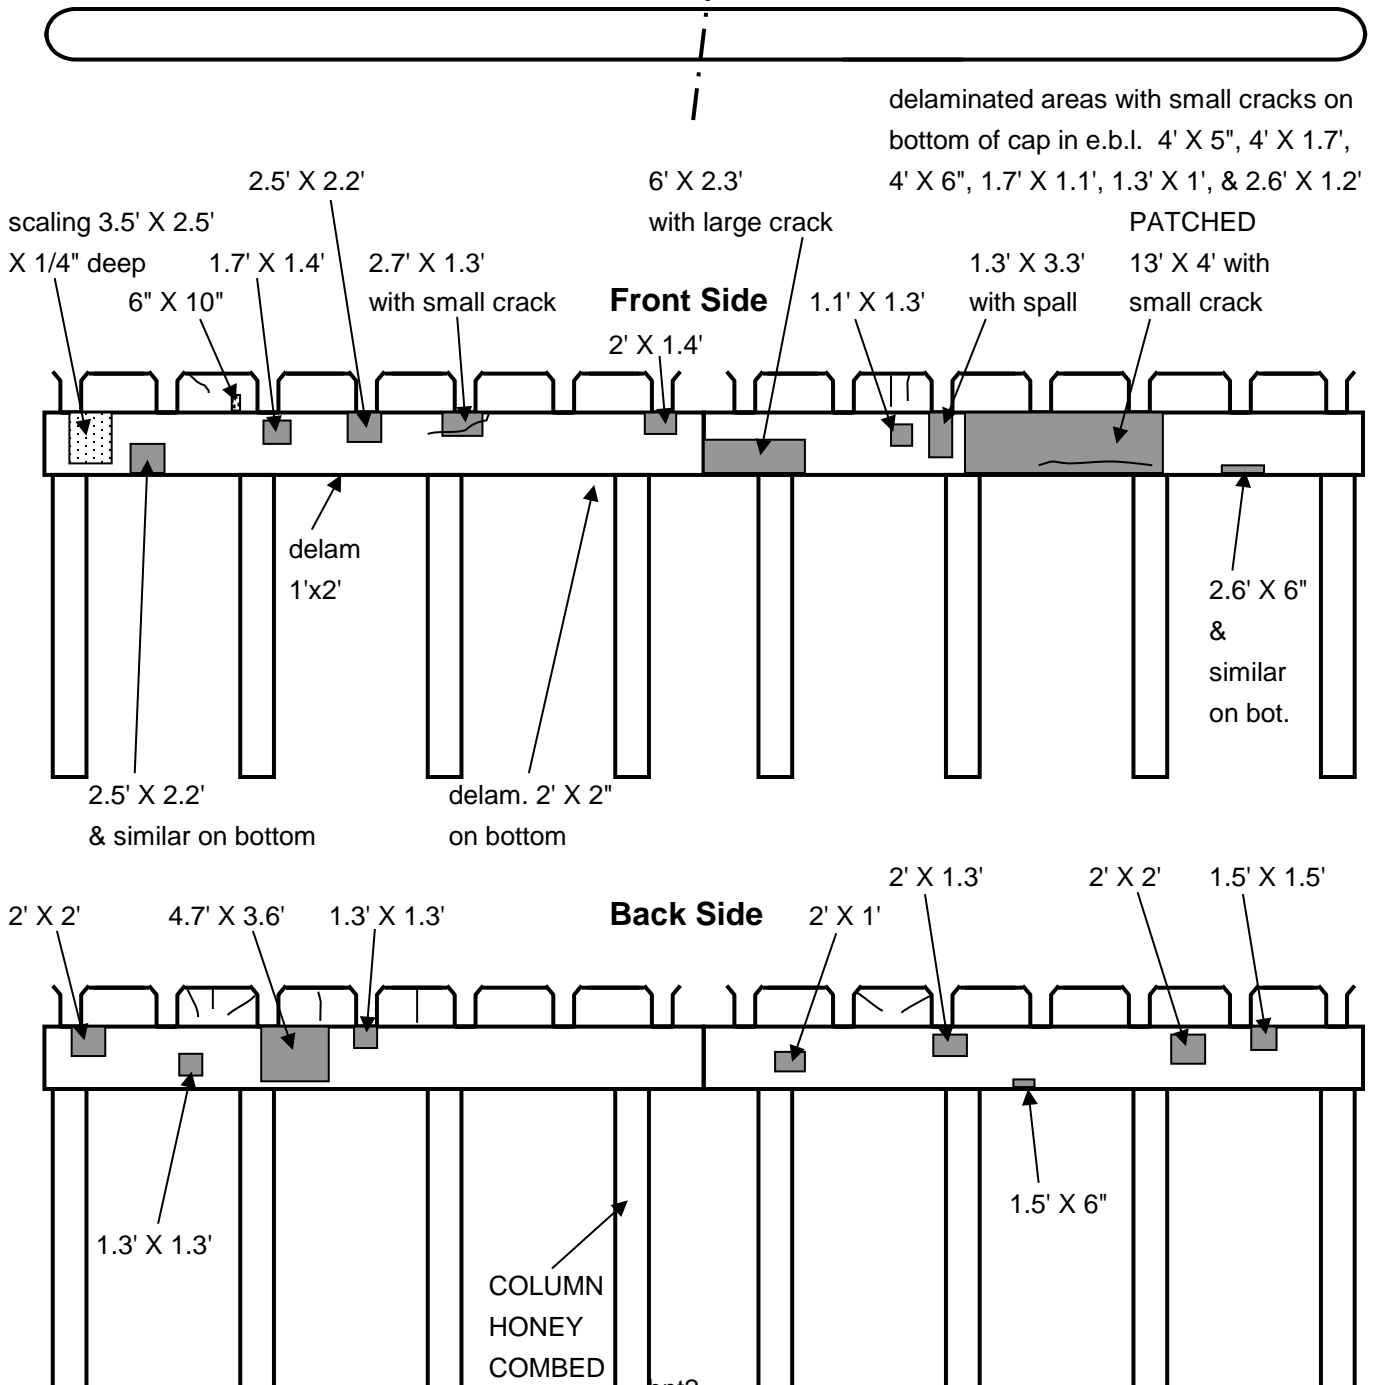
Bent No. 2

shaded areas are delaminated

cracks are hairline unless noted otherwise

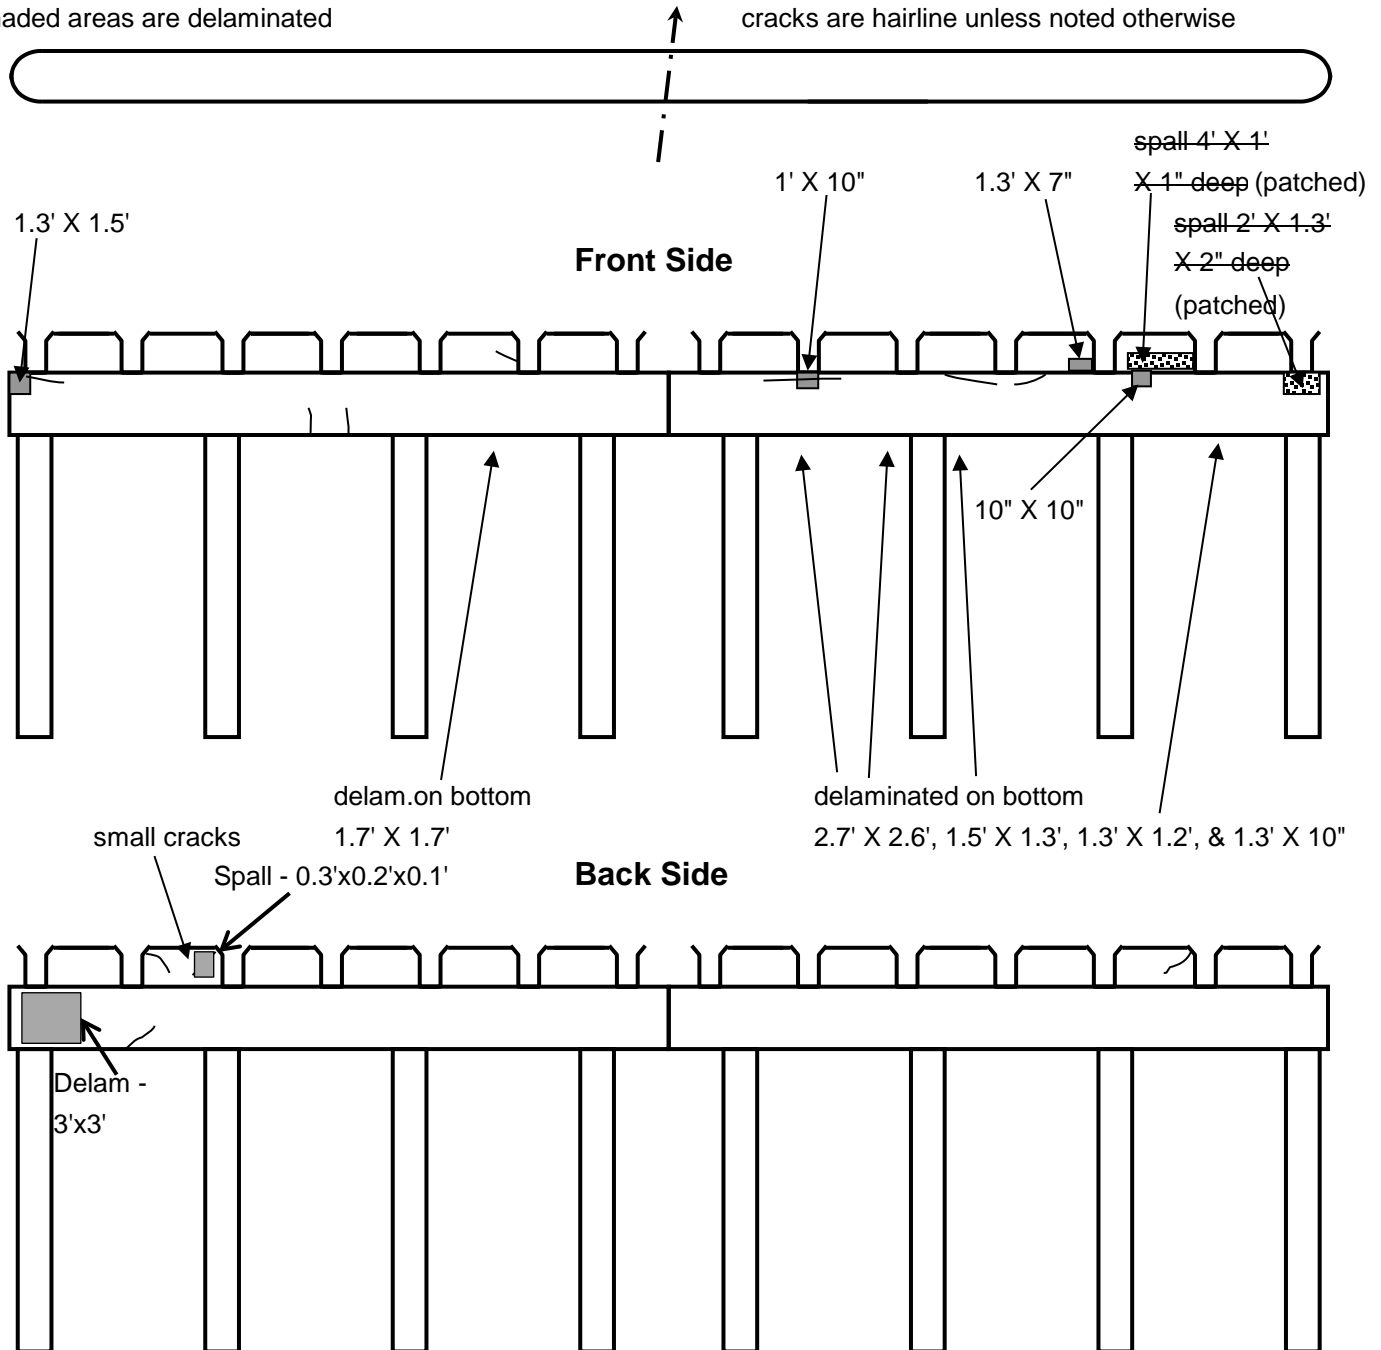
Bent No. 3

shaded areas are delaminated

cracks are hairline unless noted otherwise

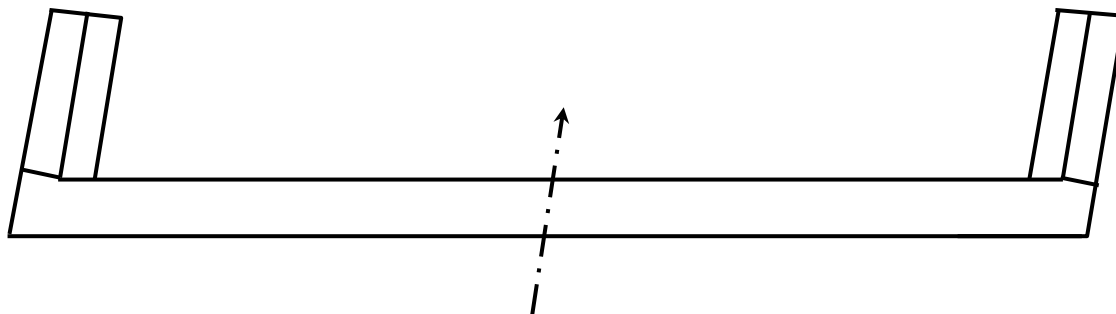
Abutment No. 2

Delam - 0.7'x0.6'

Delam - 8"x1'
