IDENTIFICATION	
(1) State Names	47 - Tennessee
(8) Structure Number	33035560003
(5) Inventory Route	1
(2) Highway Agency District	Region 2
(3) County Code	33 - Hamilton

(4) Place Code	14000
(6) Features Intersected	CSX & NS RAILROAD
(7) Facility Carried	FAU 3556 350045W
(9) Location	WILCOX BLVD / RR YARDS
(11) Mile Point	0.150 mi

Inspection Team's Summary

This is a 17-span steel girder bridge. It was inspected by a Chattanooga bridge inspection team from Region 2 and found to be in overall "POOR" condition. The bridge rails, transitions, approach guardrails, and approach guardrail terminals do not meet current safety standards. The wearing surface has wide cracks at both approaches. The bridge rails are damaged on the right side. The left side has a curb with separates this structure from the adjacent structure.

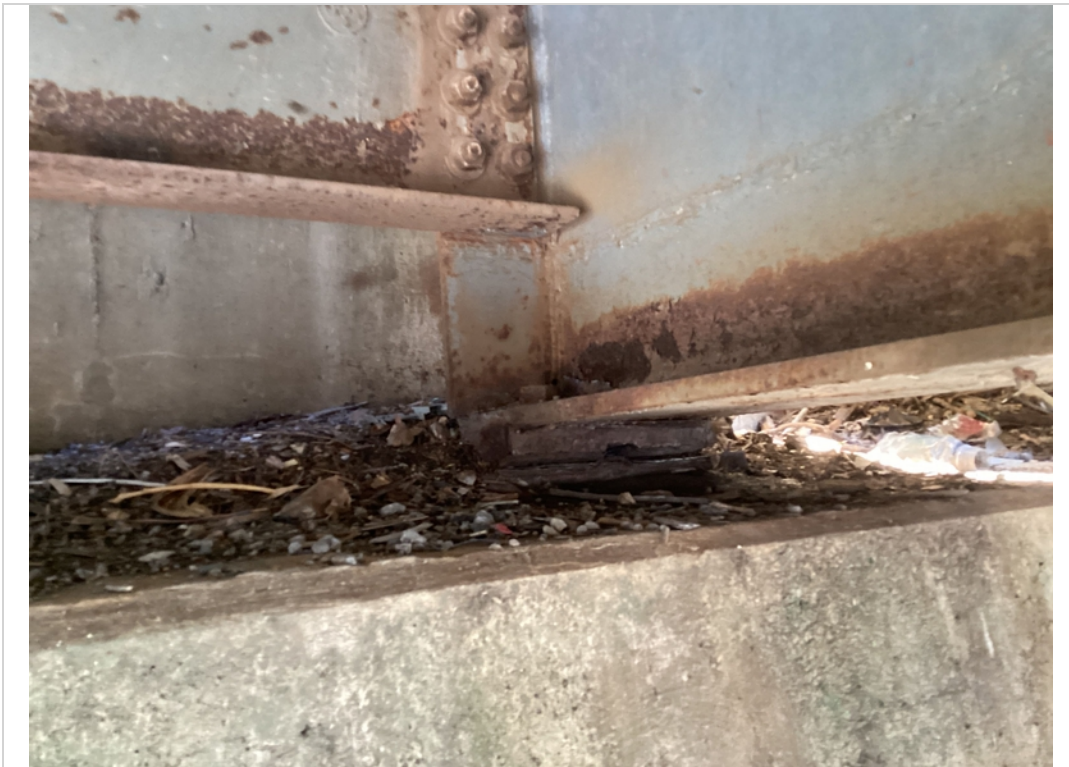
Abutment 1, Bearing "A" - corrosion/section loss

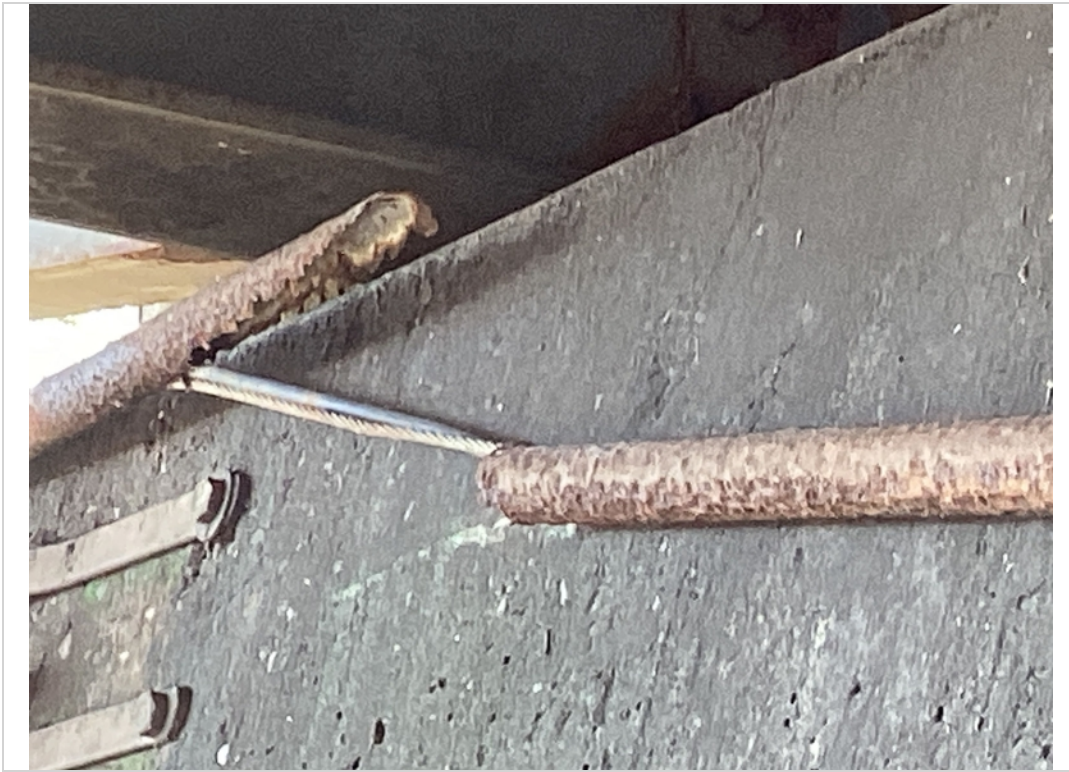
Utility pipe broken with exposed wires - abutment 1

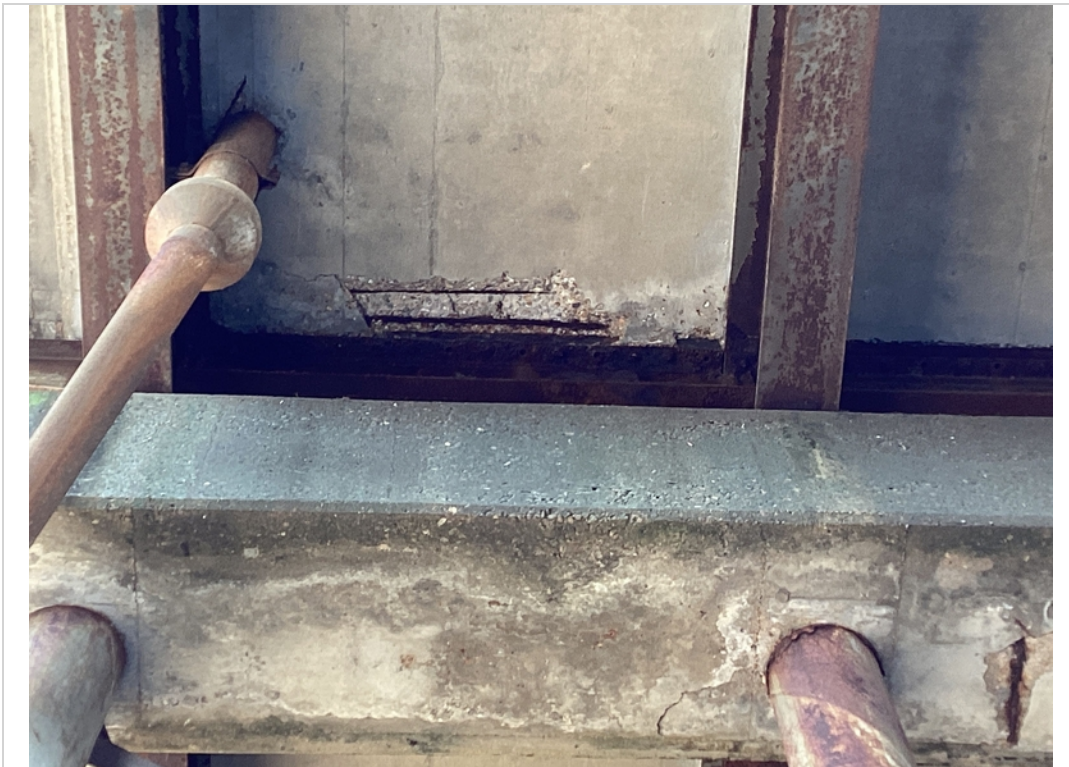
Rebar spall - bay C, span 2, near Bent #1

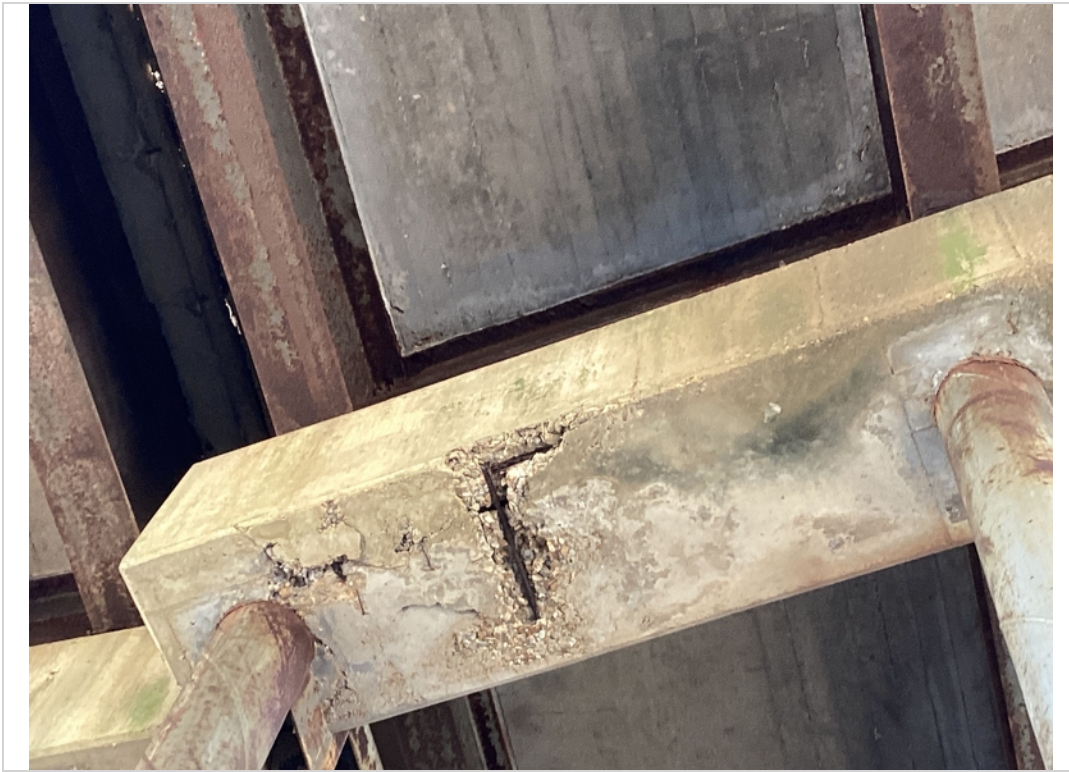
Rebar spall - bent 2, between Beams "A" and "B"

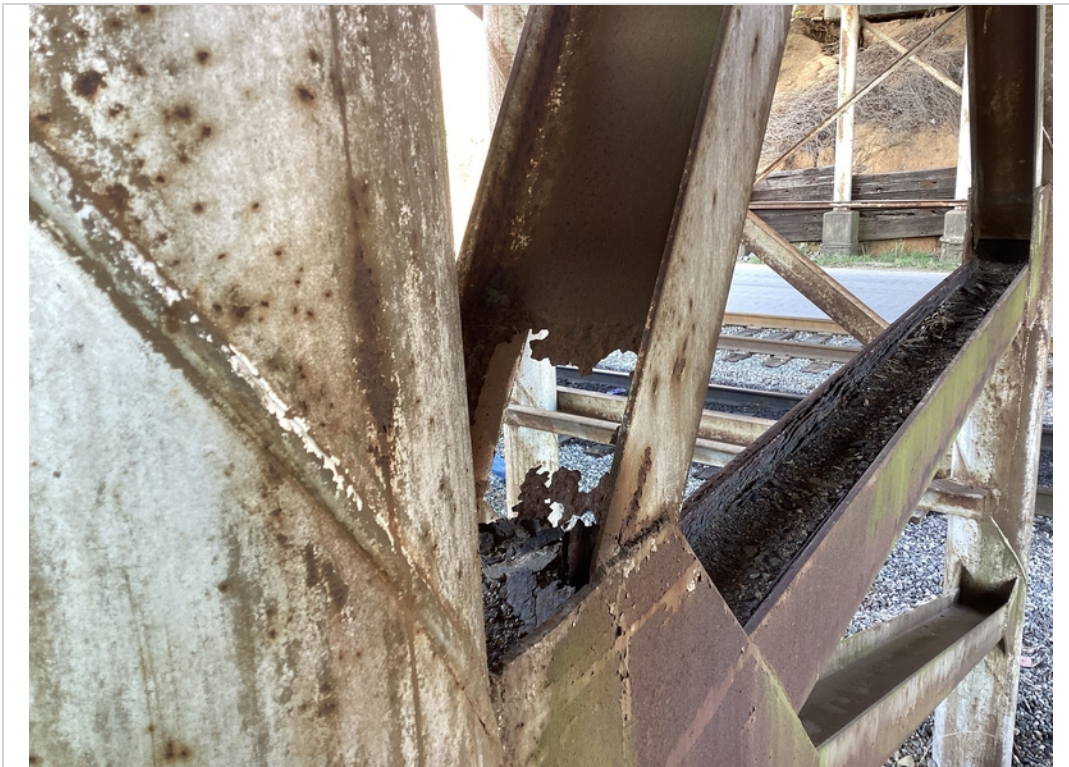
Bent 3, column A - hole through on cross brace, 2-3 left side

03/30/2021	REPAIR BENT NO. 2-3 CROSS BRACING (HOLE IN WEB AND FLANGE)	5
03/30/2021	REPAIR BENT NO. 10-11 CROSS BRACING (HOLES IN WEB AND FLANGE)	5
03/30/2021	REPAIR BENT NO. 16 COLUMN "C" COLLAR (UNDERCUTTING/EROSION)	5

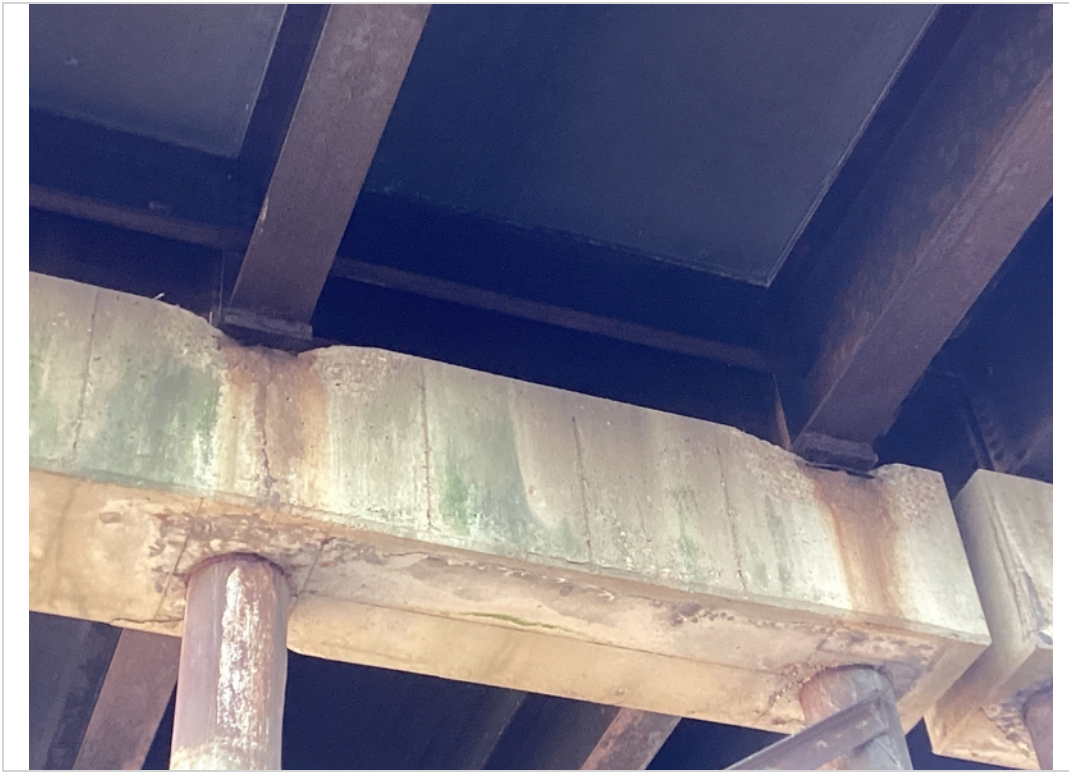
Bent 4, columns A and B, looking back on cap - spalling

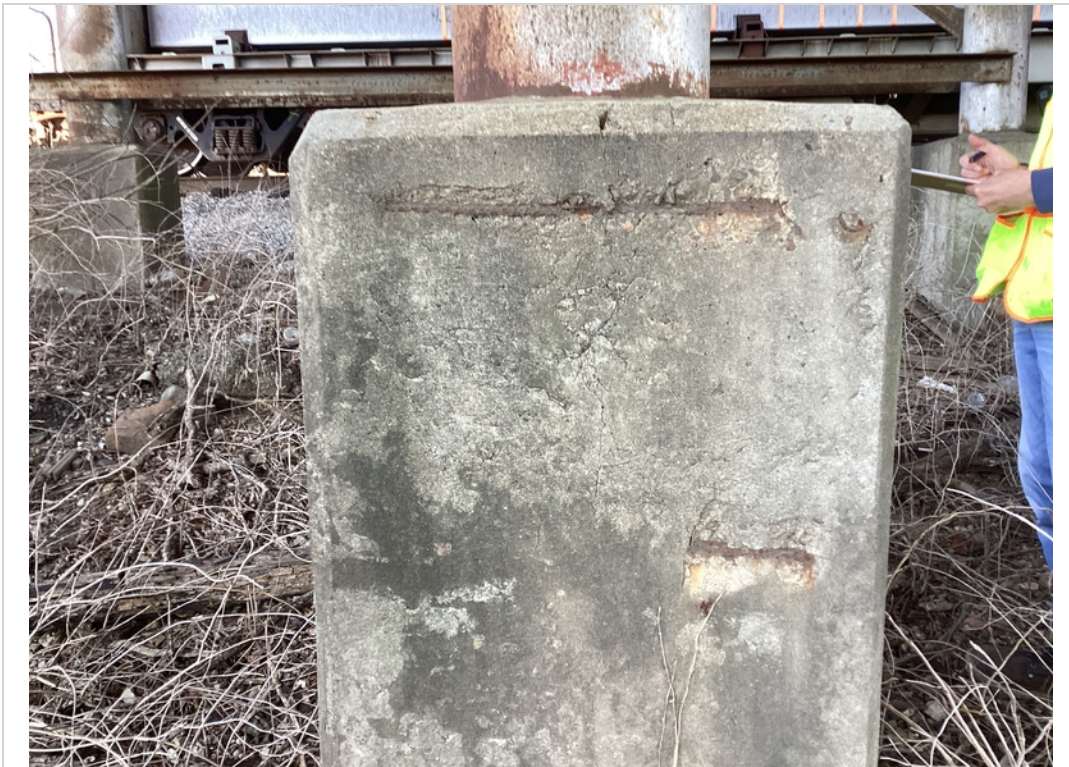
Bent 8, column B, looking back on concrete collar - rebar spalls

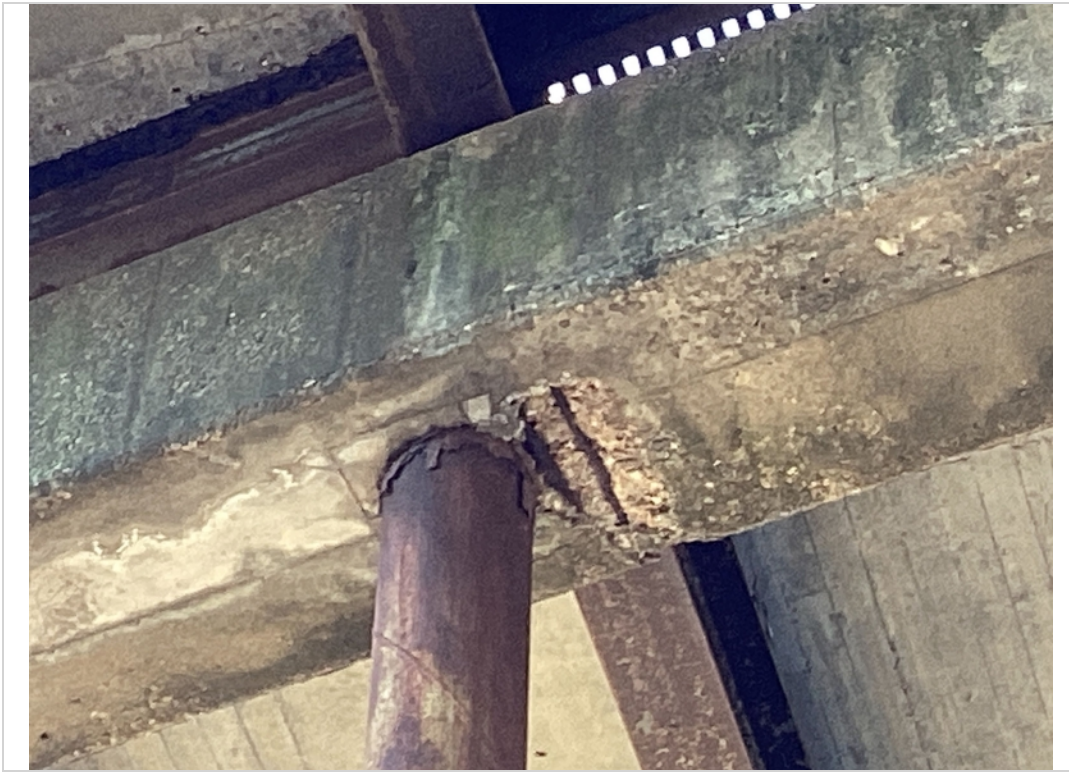
Rebar spall, rust, corrosion - bent 9, column C, looking back

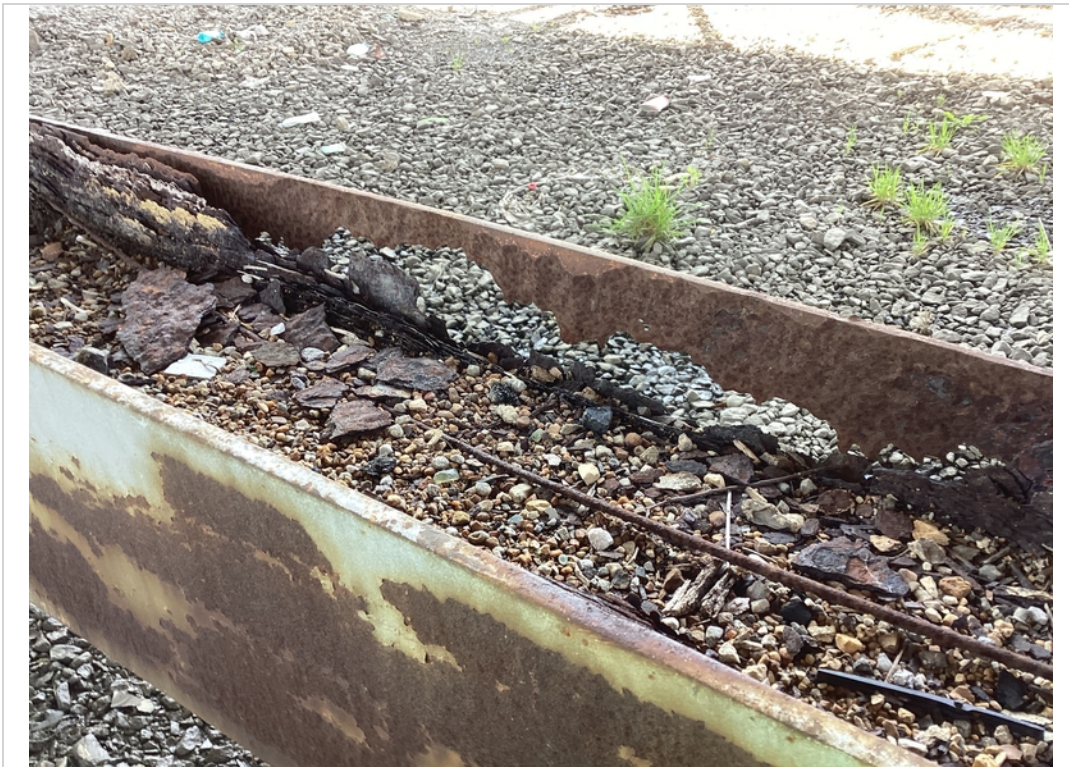
Cross bracing 10-11, left - longitudinal brace has hole through on flange

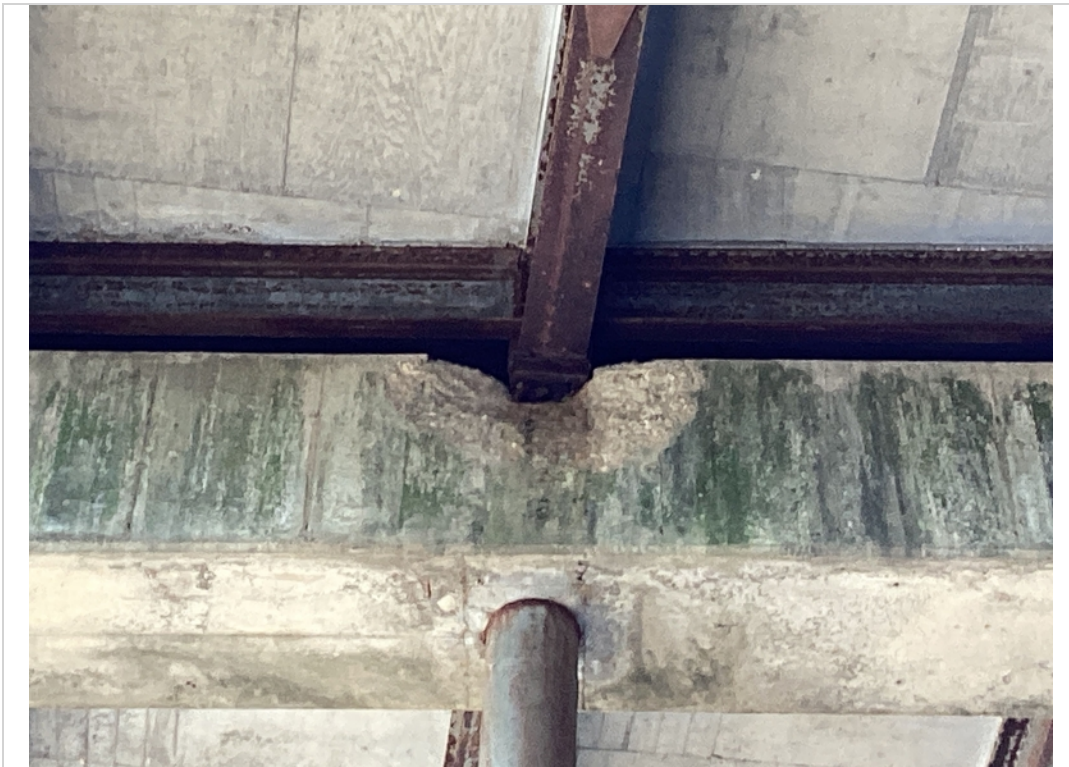
Bent 11, looking back, column B - spalling, loss of bearing area

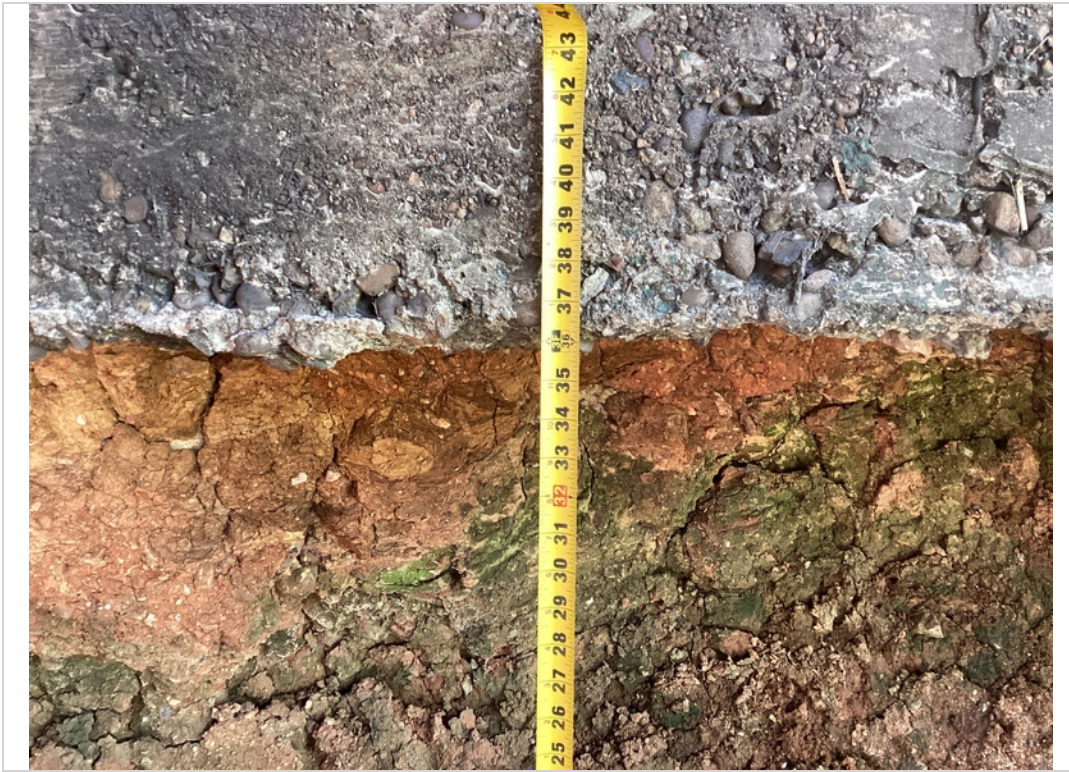
Erosion height at abutment 2

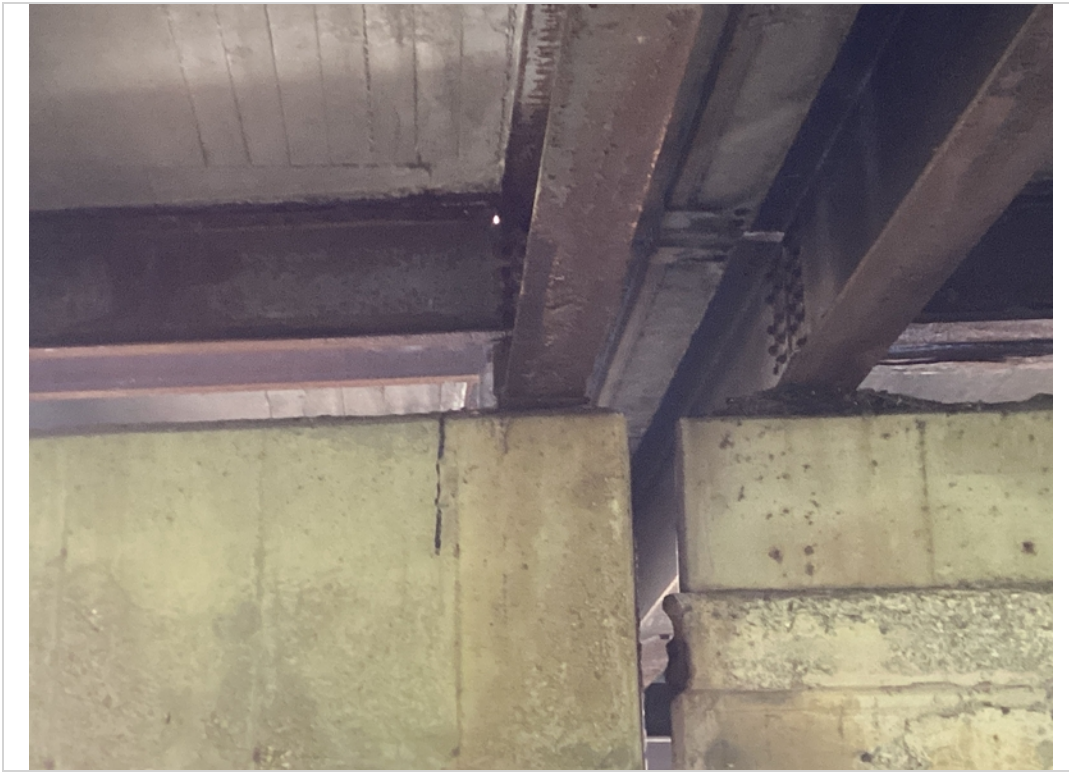
Bent 16, bearing A - missing nuts and bolts on the plate

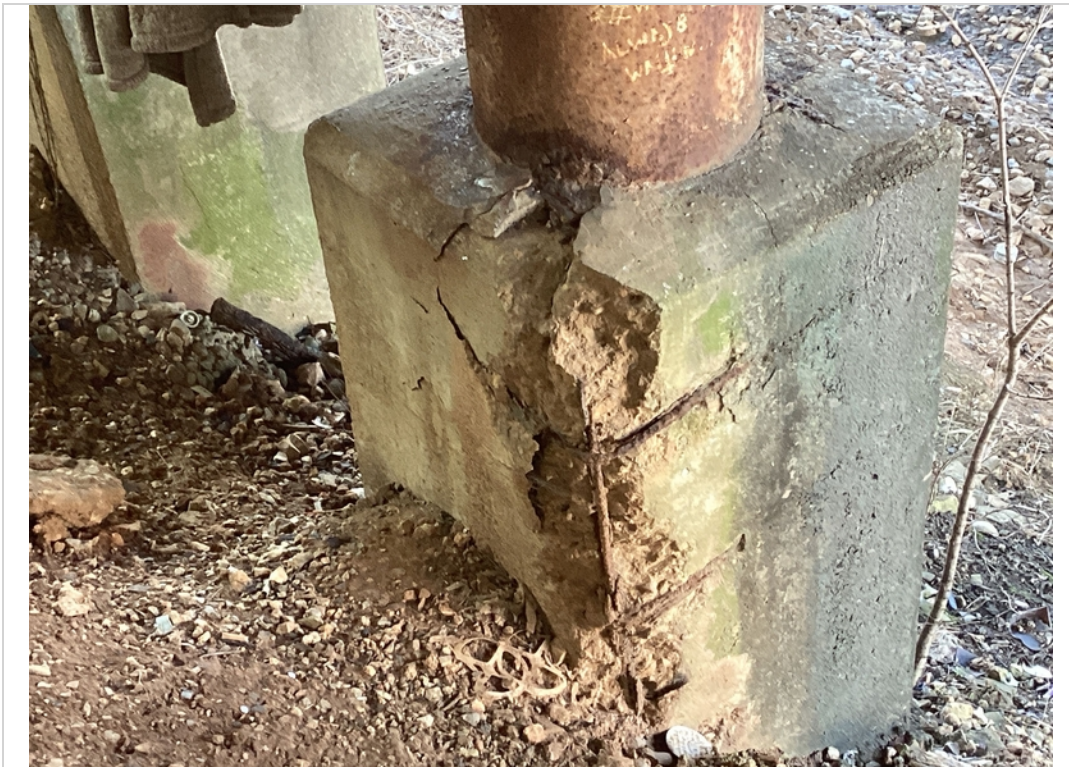
rebar spall - Bent 16, column A, looking back

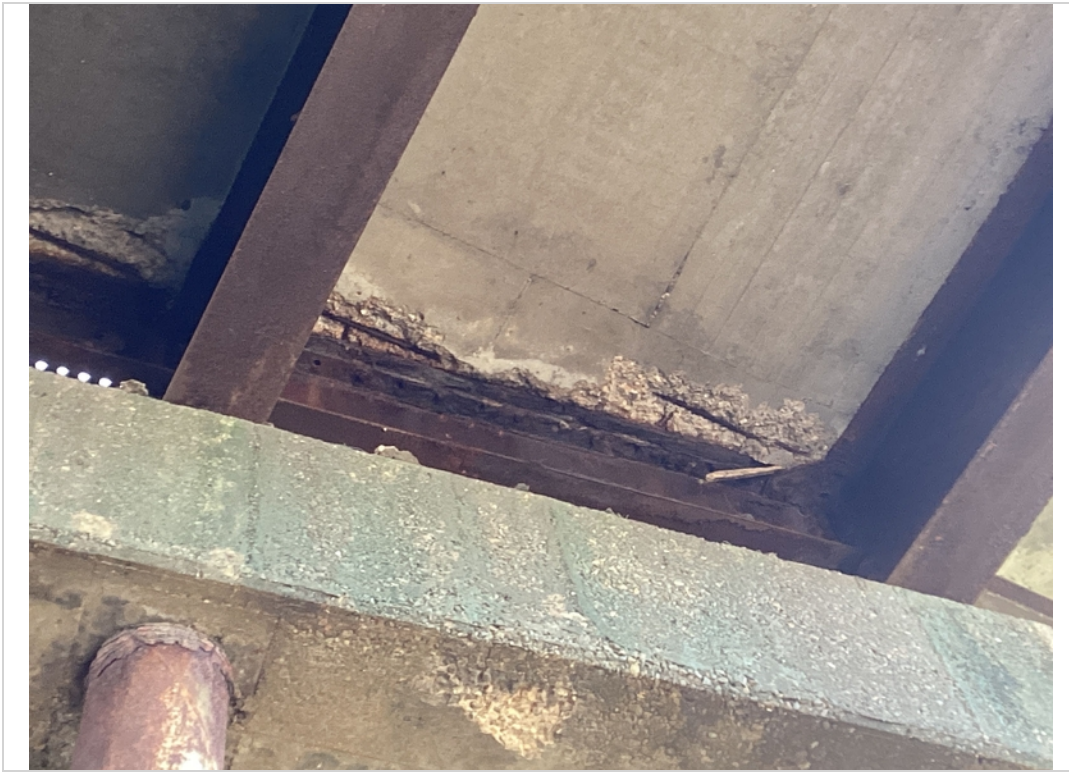
Span 16, bent 16, bay C - rebar spalls

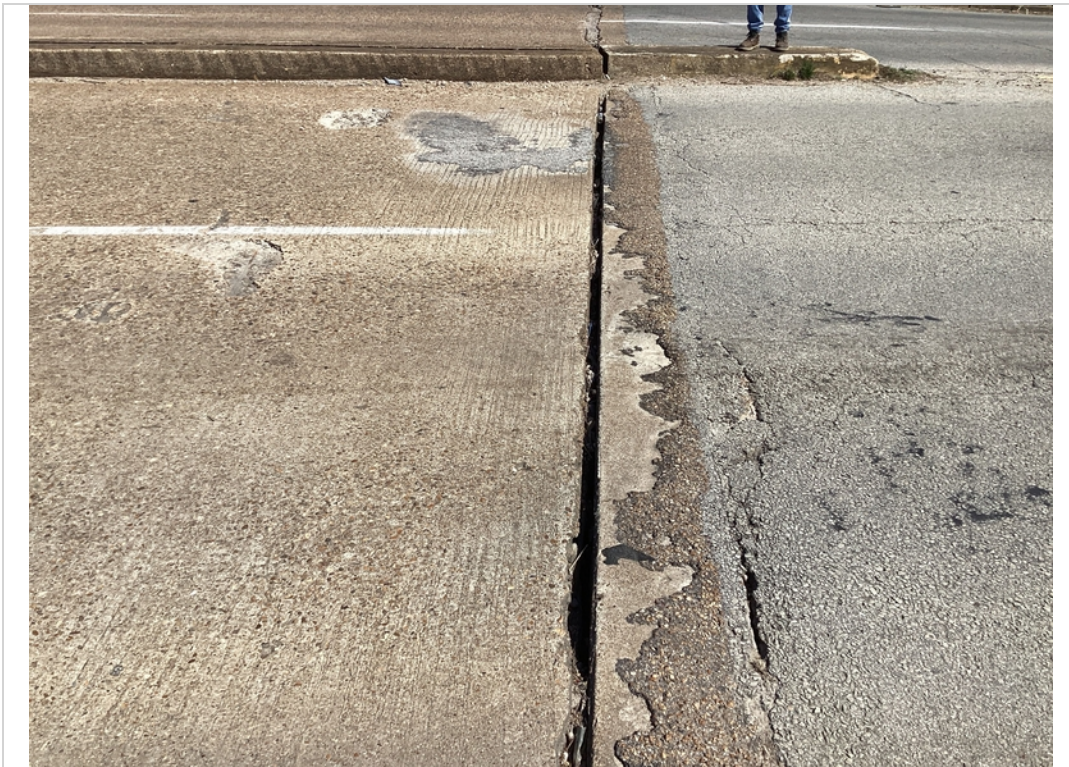
Joint, approach 2 - missing filler

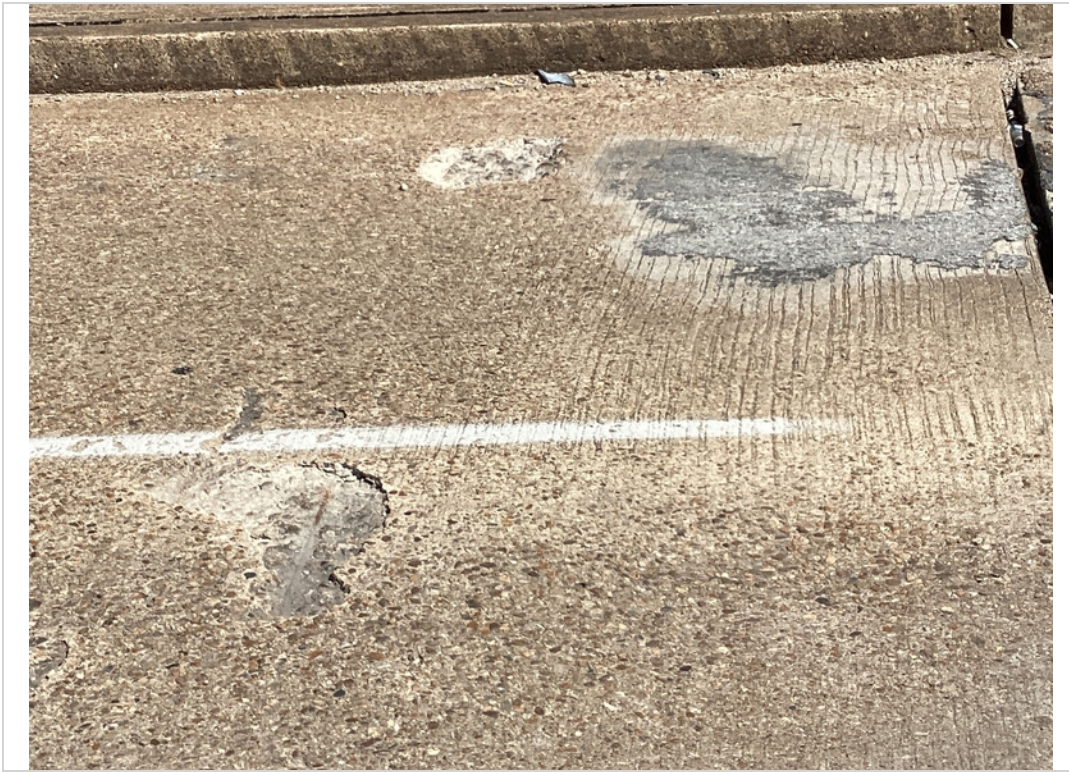
Span 17, wearing surface - potholes, patches

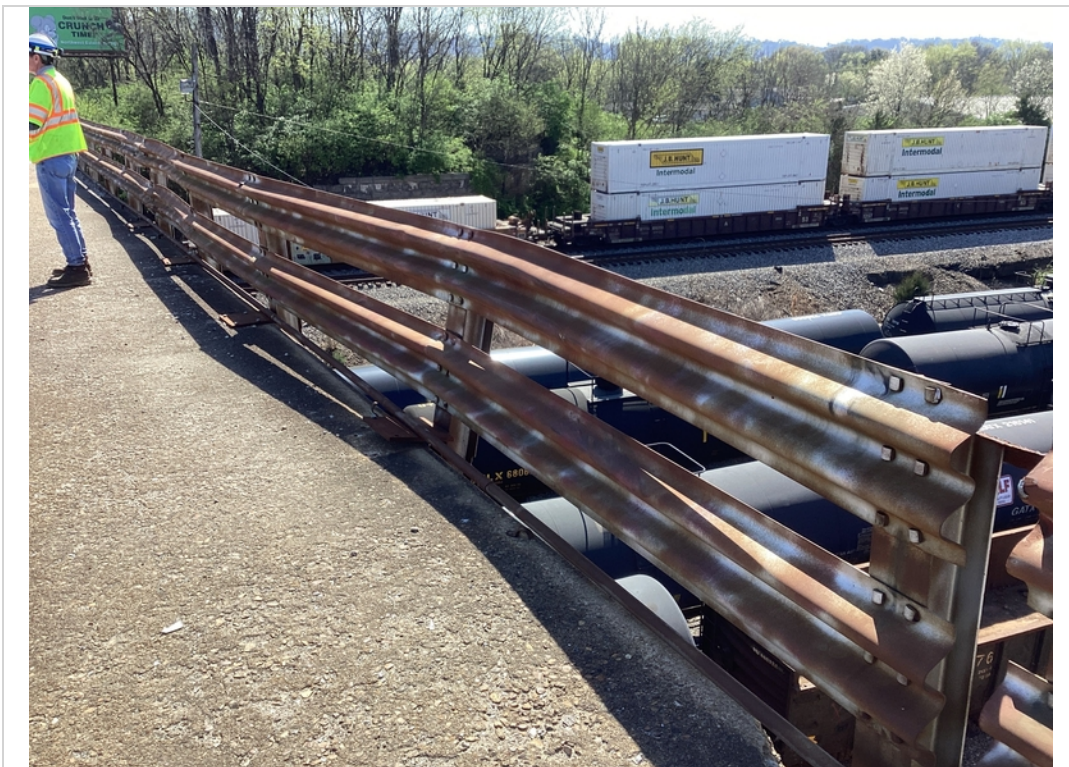
Span 13 - guardrail damage

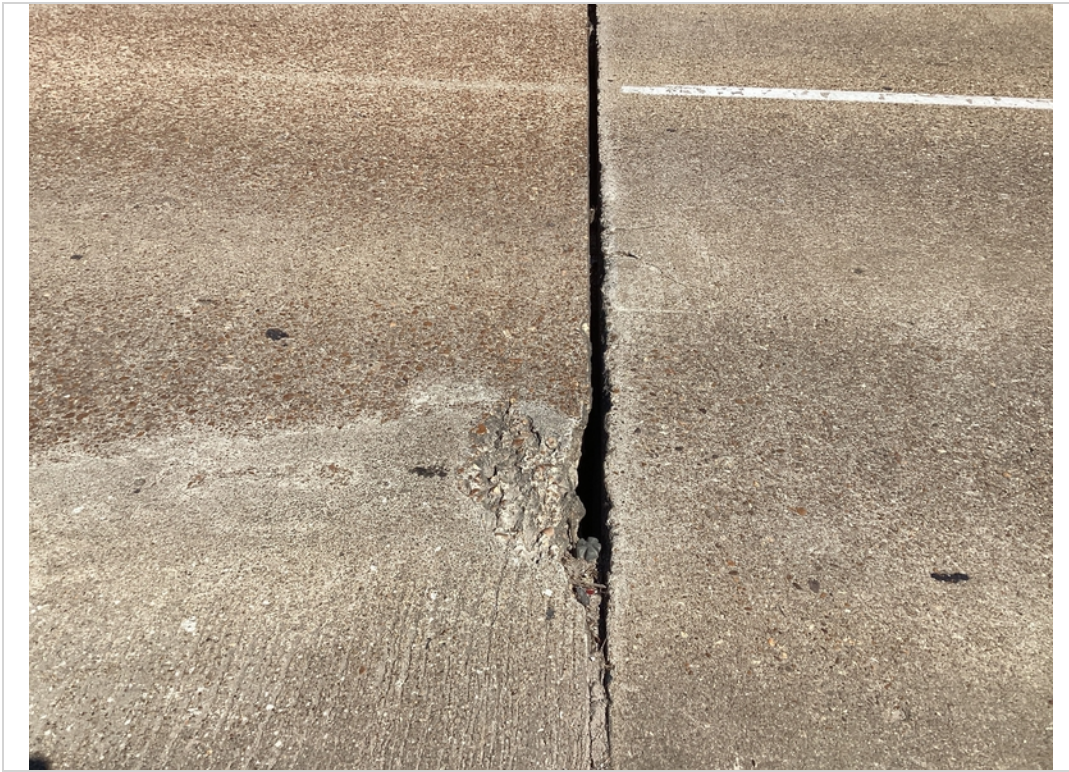
Start of span 8 - joint missing filler, spalling, hole through

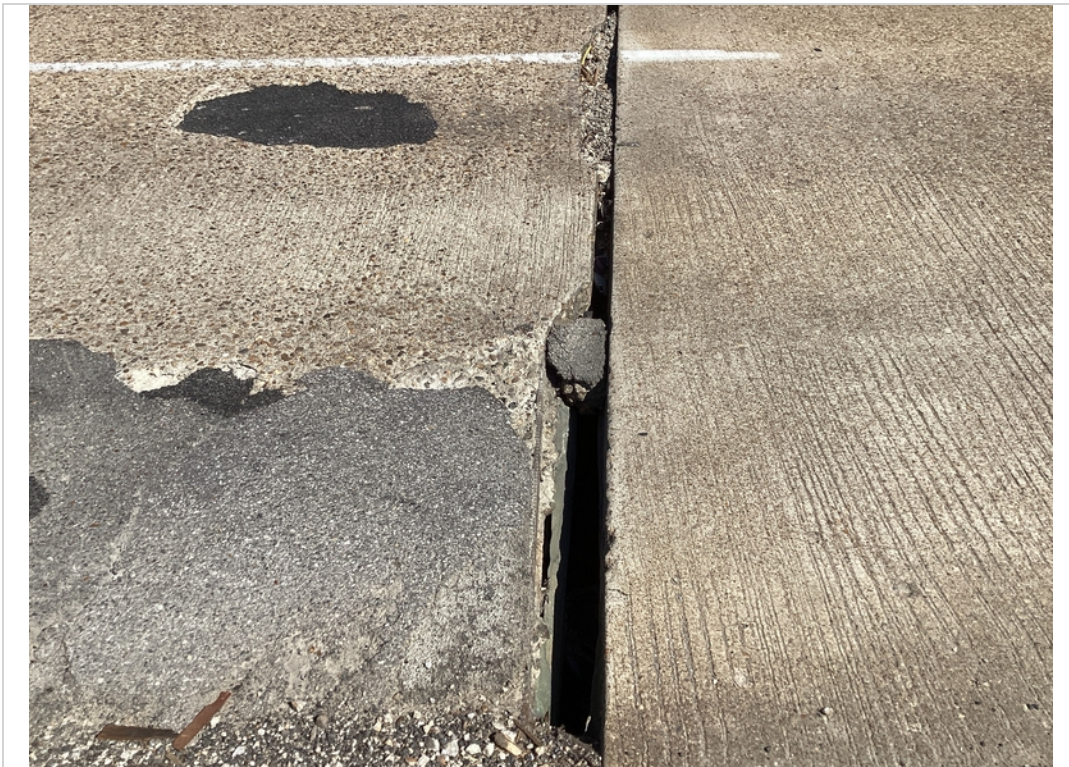
Joint at end of span 11 - rebar spall, breaking up, hole through

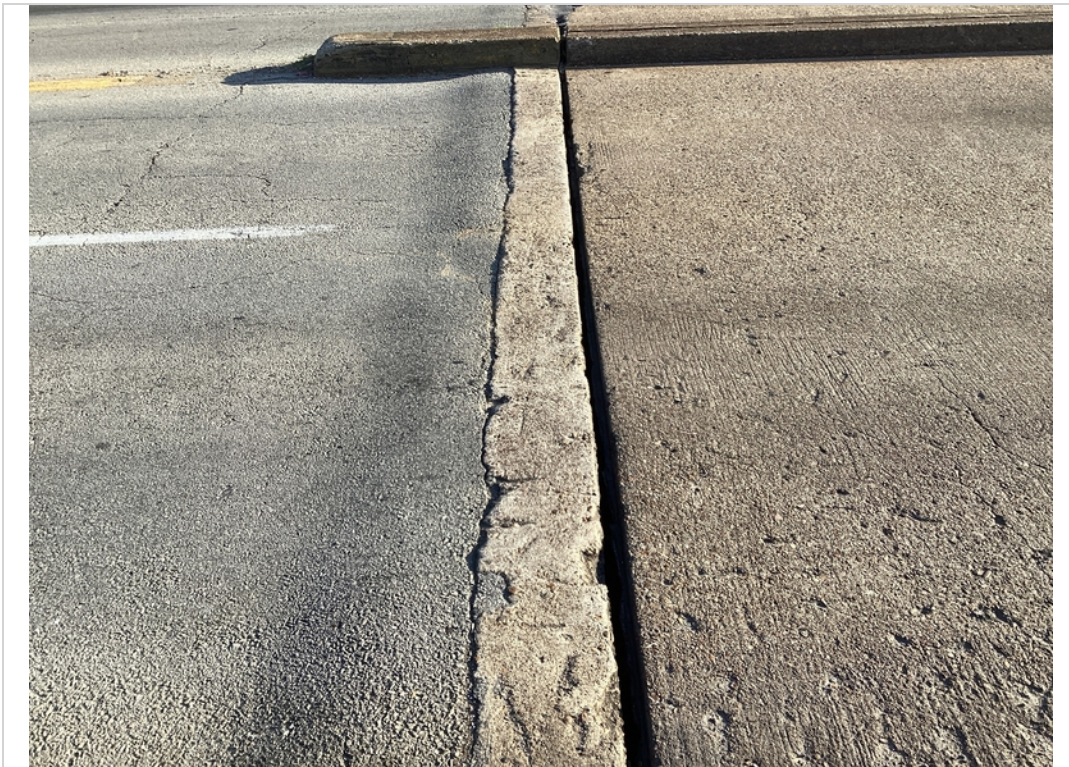
Joint - Approach #1 - Missing Filler

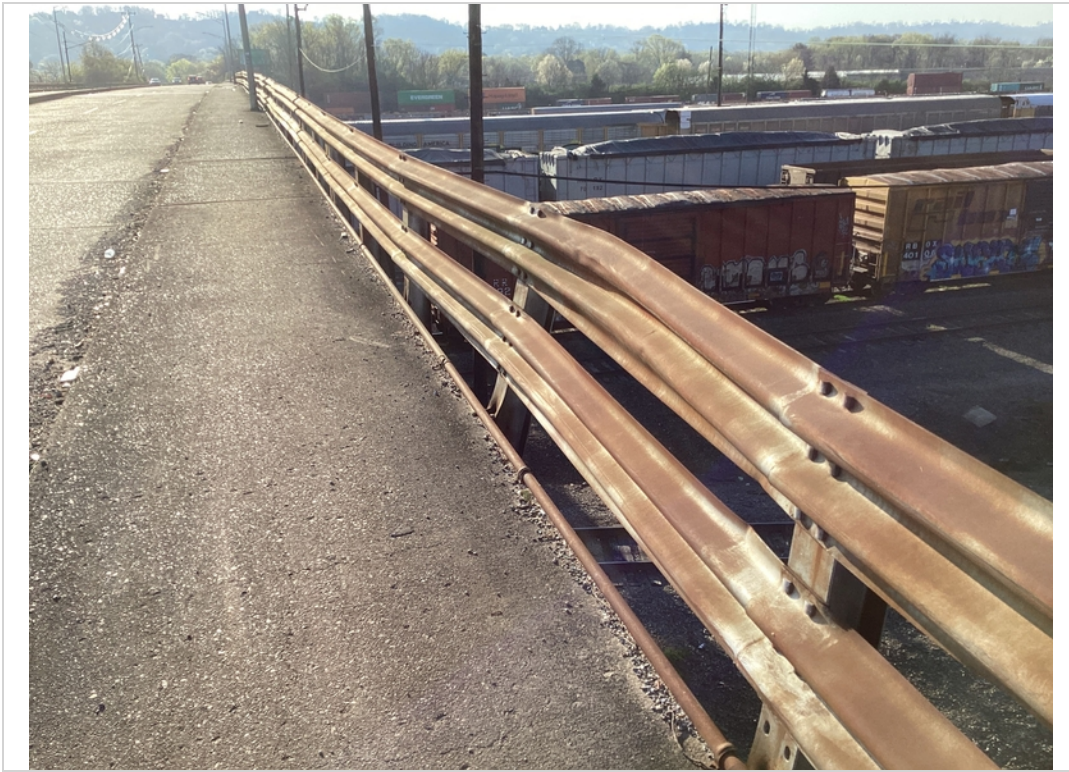
Bridgerail Damage - Span #2 - Right

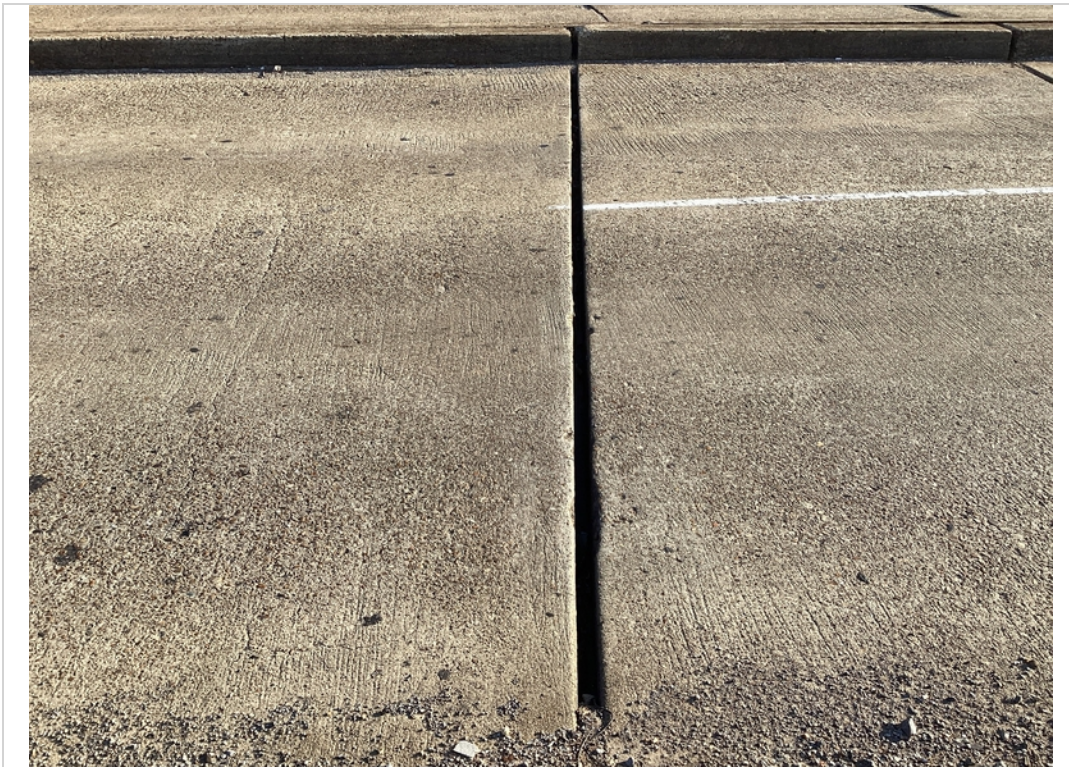
Filler Missing - open Joint - End of Span #2

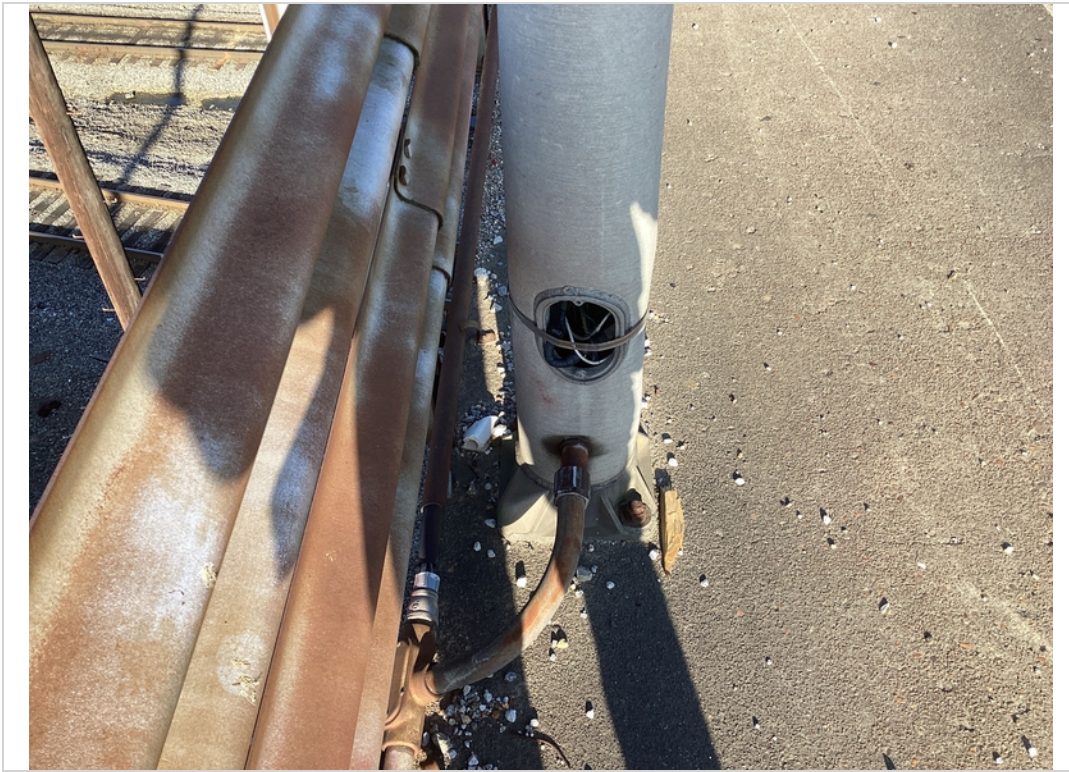
Exposed Wiring - Light Post - Span #4 - Right

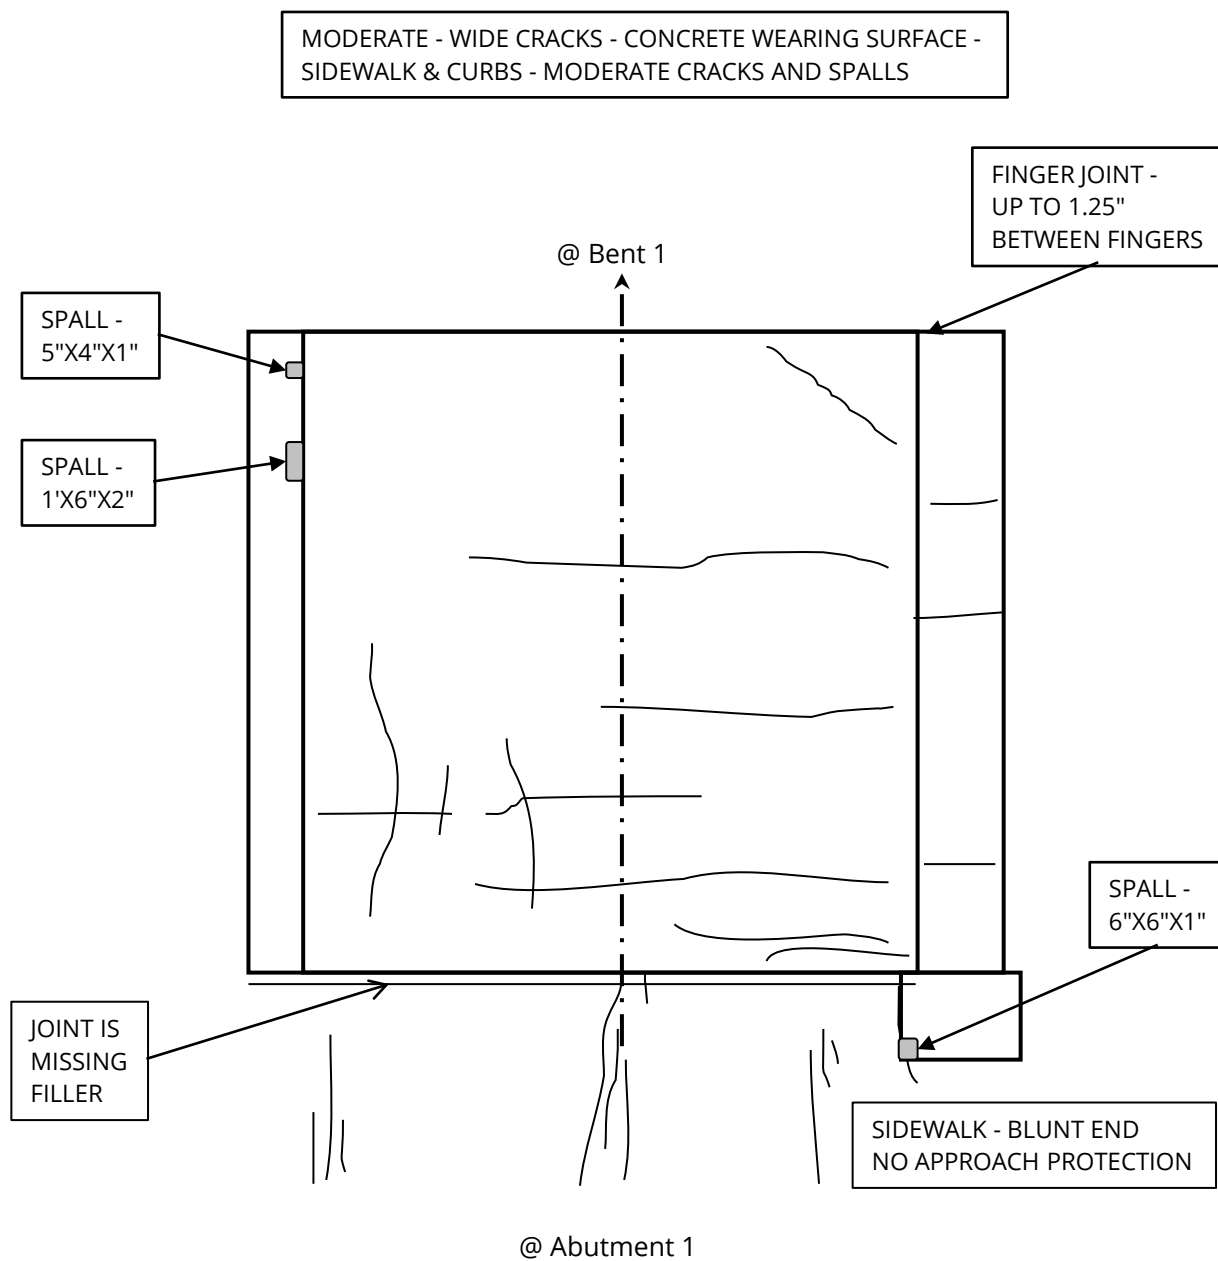
MODERATE - WIDE CRACKS - CONCRETE WEARING SURFACE -
SIDEWALK & CURBS - MODERATE CRACKS AND SPALLS

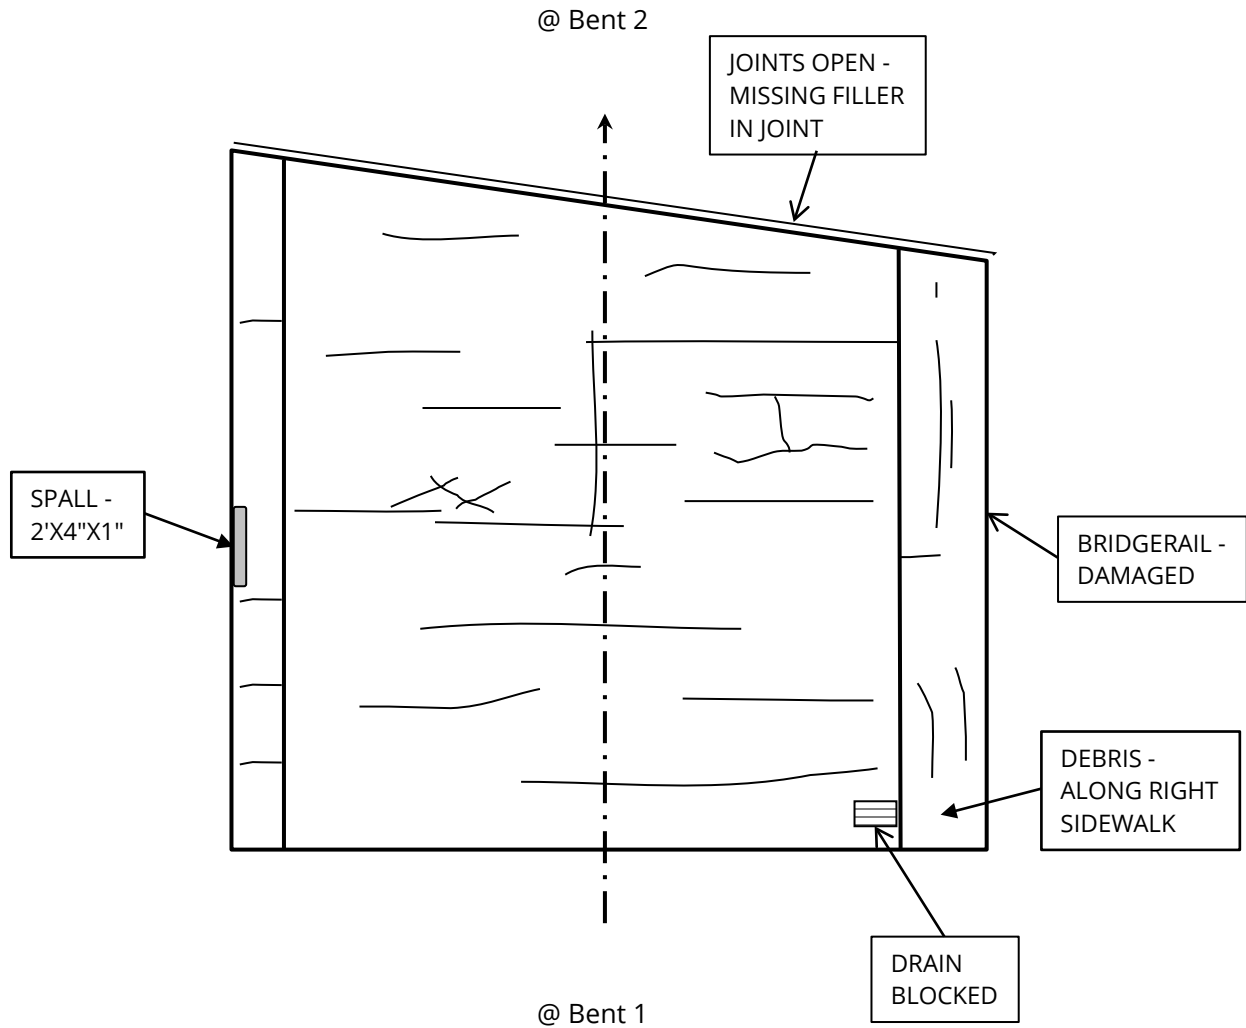
MODERATE - WIDE CRACKS - CONCRETE WEARING SURFACE -
DEBRIS ALONG RIGHT SIDEWALK
