140 RL / 8TH AVE (SR 6)

IDENTIFICATION	
(1) State Names	47 - Tennessee
(8) Structure Number	19I00400079
(5) Inventory Route	1
(2) Highway Agency District	Region 3
(3) County Code	19 - Davidson

INSPECTIONS *			
(90) Inspection Date	12/04/2023		
(91) Frequency	24		
(92) Critical Feature Inspection	Done	Freq. (Mon)	Date
A: Fracture Critical Detail	No		
B: Underwater Inspection	No		
C: Other Special Inspection	No		
<p>* The inspection date and frequency information in this box contains the current NBI date and frequency information. Please refer to the report header for the date this inspection was conducted.</p>

3 span Bridge / W.P.G.
I-40 EB / 8TH AVE (SR 6)

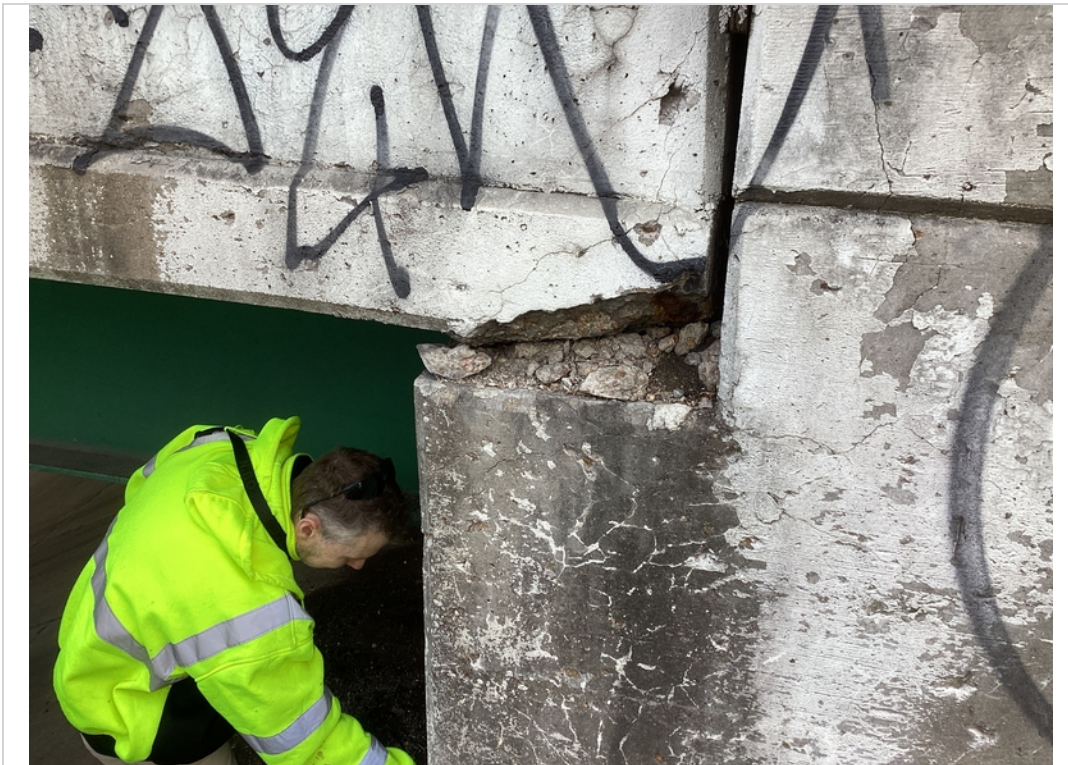
A approach bridge rail spall left

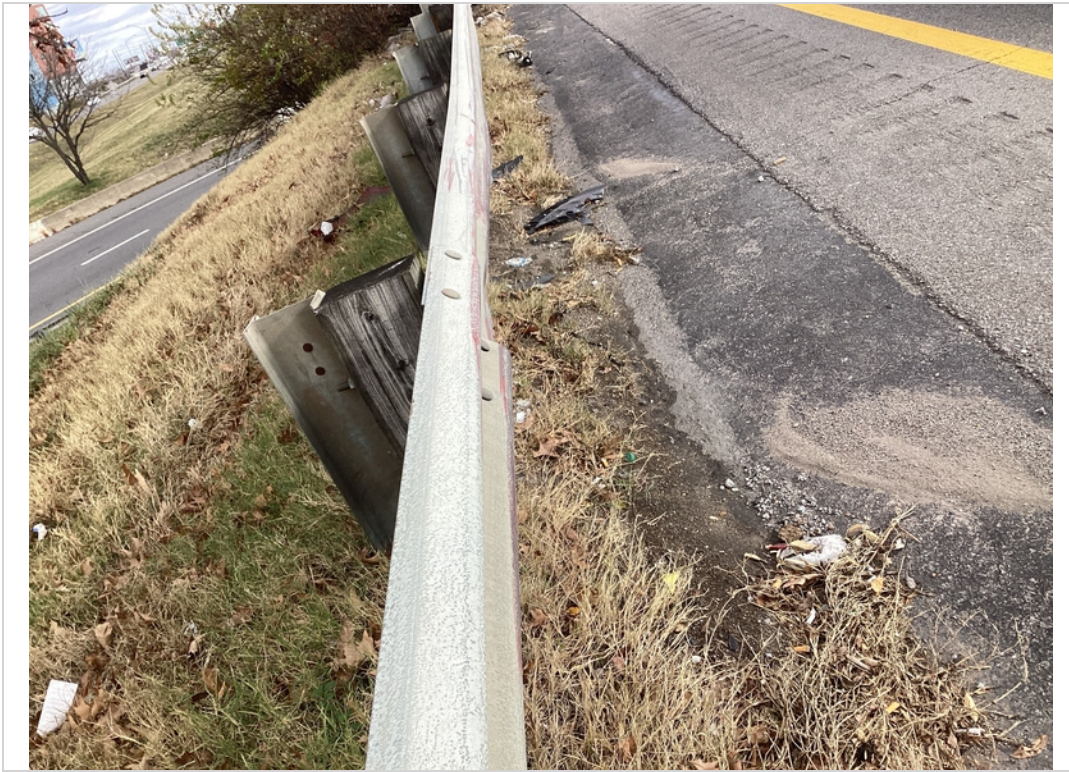
B approach guardrail impact damage

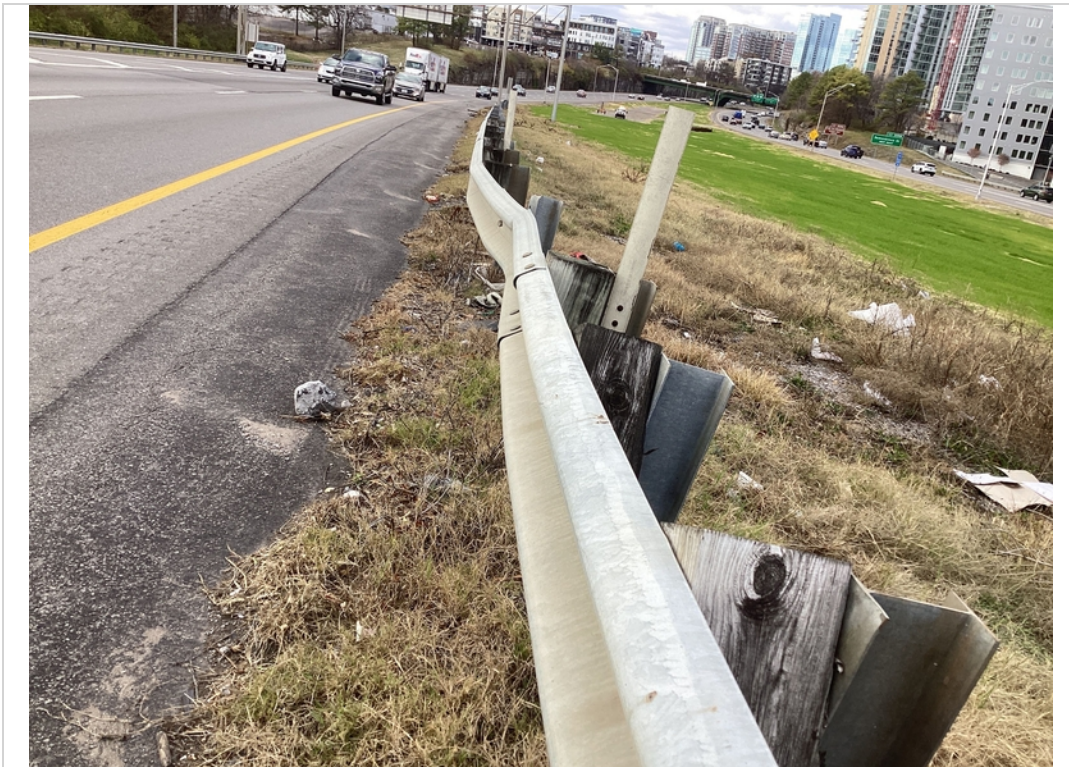
A approach guardrail impact damage

Date Added	Recommendation	Priority
09/08/2017	REPAIR BEARING "A", "C", & "D" AT ABUTMENT #1	2
12/02/2021	CLEAN DECK SHOULDERS	
01/04/2016	CLEAN AND PAINT ALL STRUCTURAL STEEL	2
01/04/2016	REPAIR APPROACH GUARDRAIL @ "A" END LT.	
01/04/2016	CLEAN EXPANSION JOINT @ "A" END	
01/04/2016	CLEAN DEBRIS FROM ABUTMENT CAPS	
01/04/2016	TEXTURE COAT BRIDGE RAIL	
01/04/2016	REPAIR UNDERPASS LIGHTING	
12/01/2017	REPAIR EROSION LEFT SIDE OF SLOPE PAVEMENT AT ABUTMENT #1

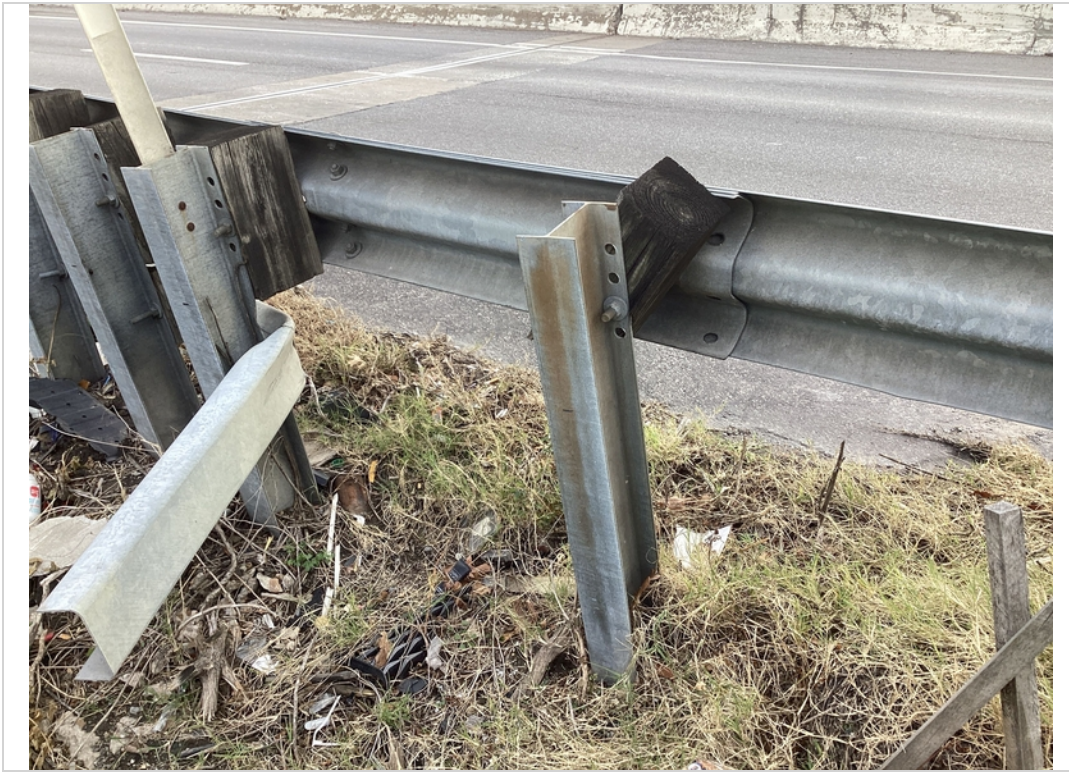
A approach guardrail impact damage

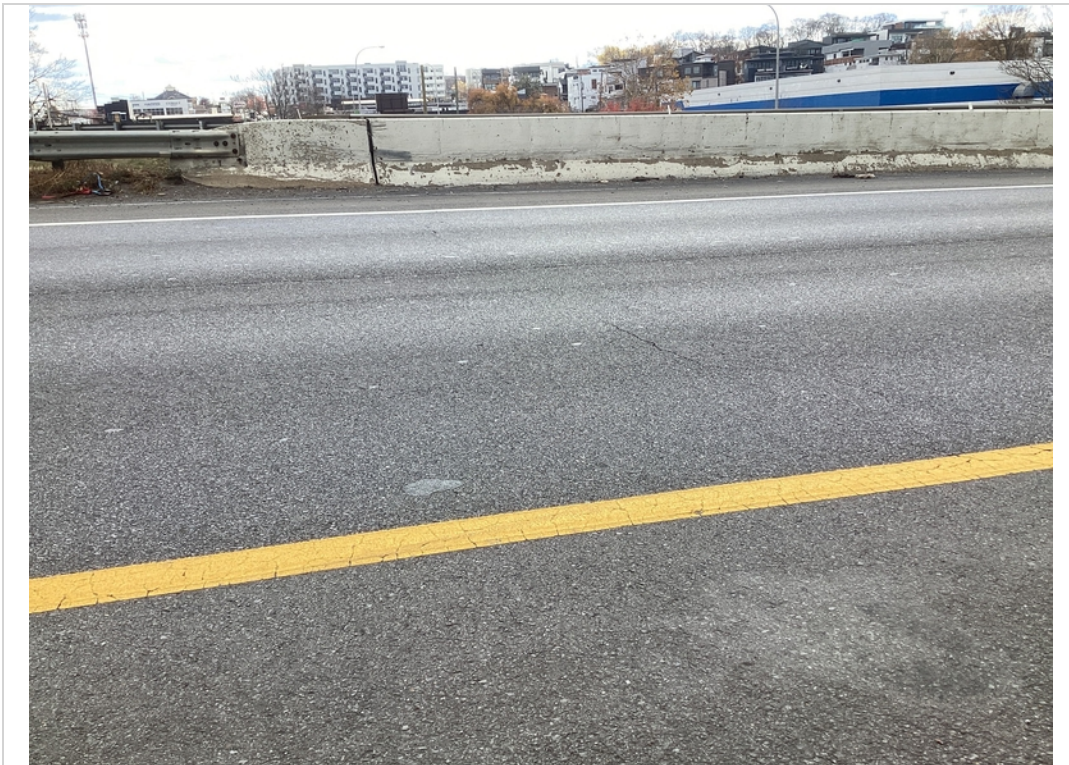
Span 3 transverse cracks

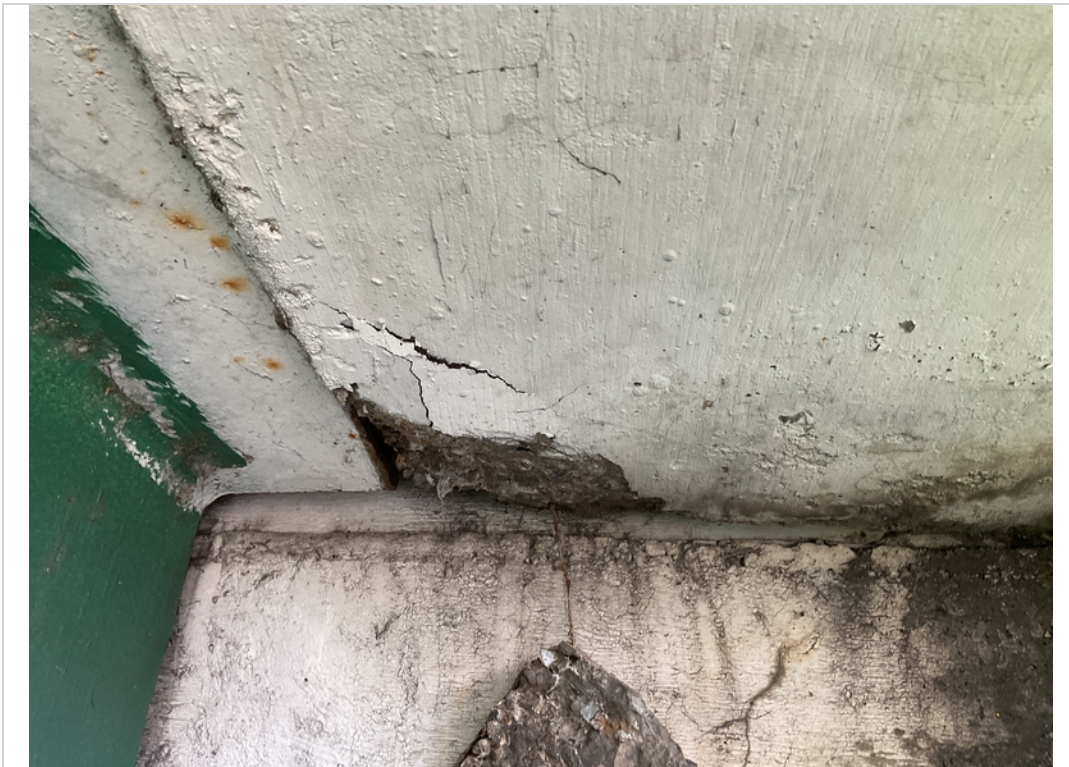
Overhang span 1 left side spall

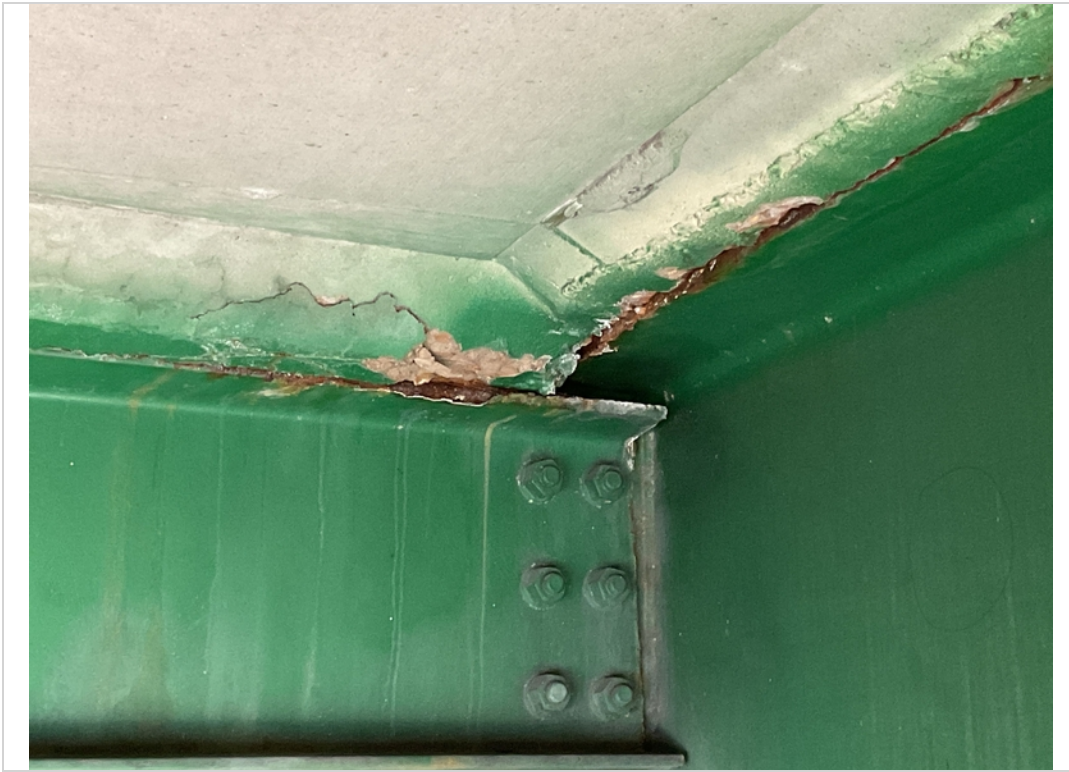
Span 3 bay C in place spall

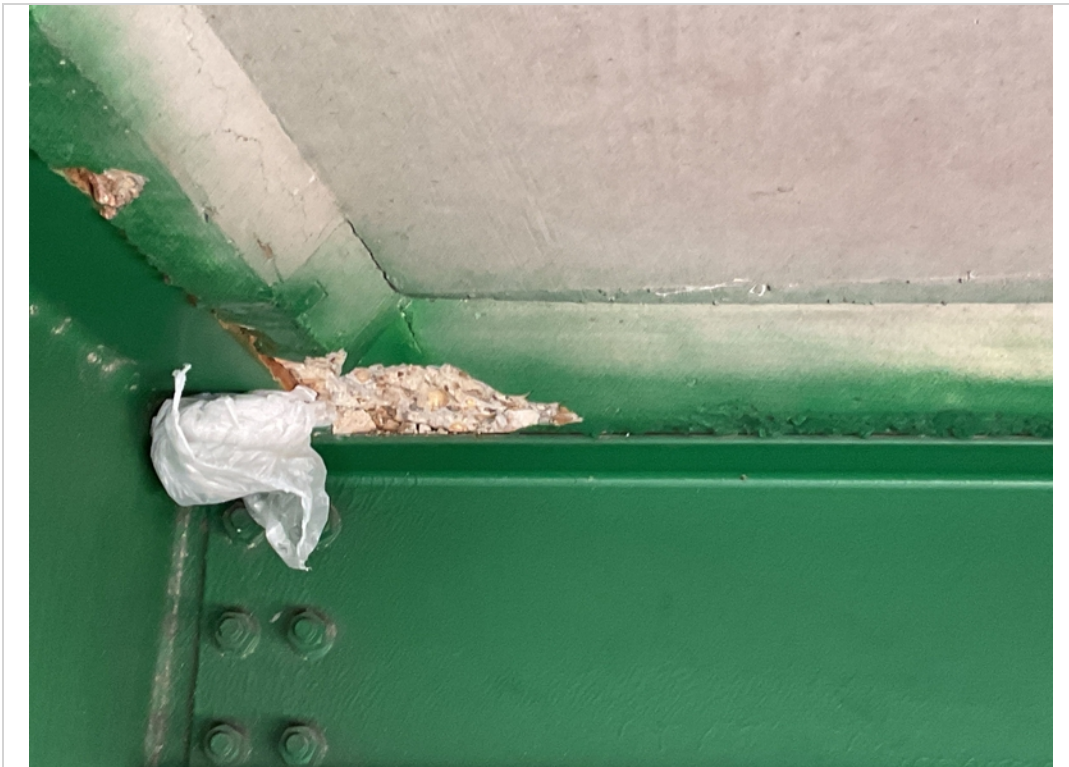
Span 3 bay B spall at abutment 2

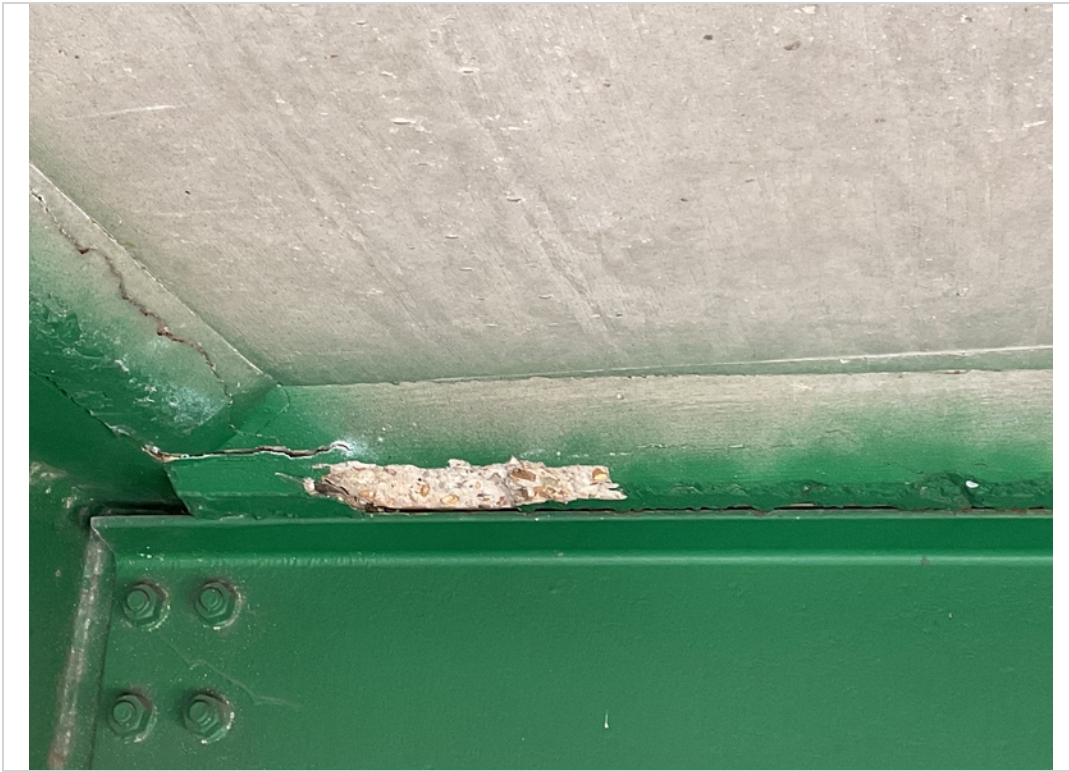
Span 3 bay A spall at abutment 2

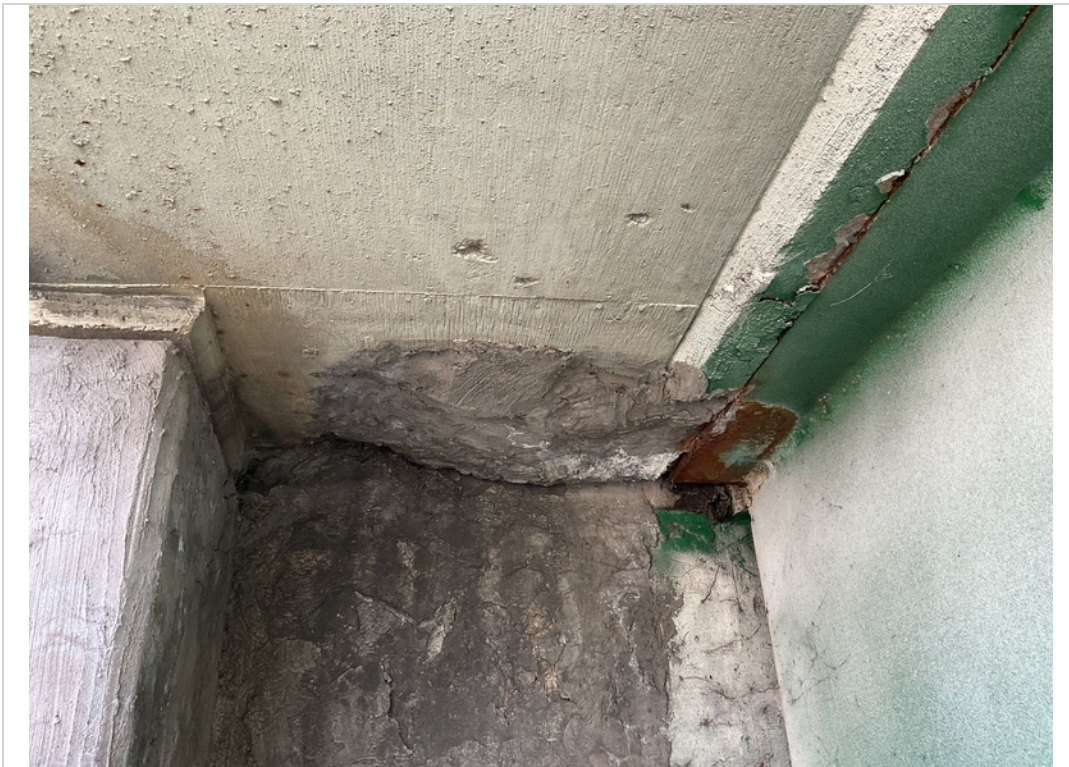
Overhang span 3 left side patch

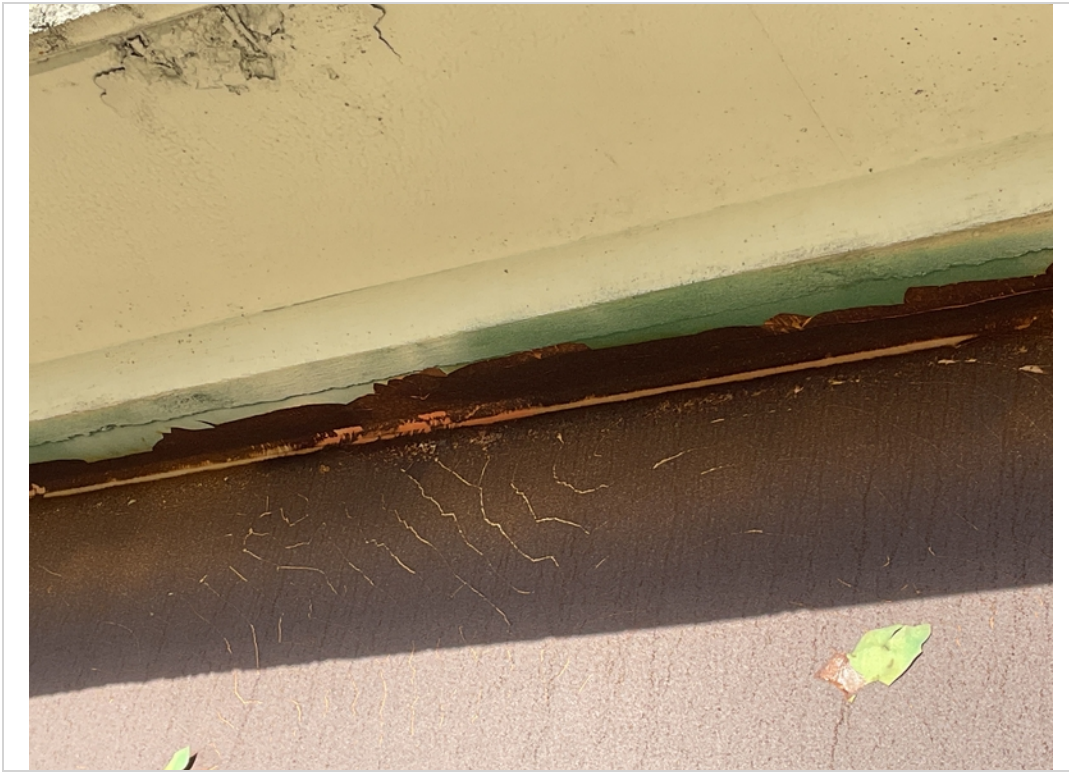
Overhang span 3 right side in place spall

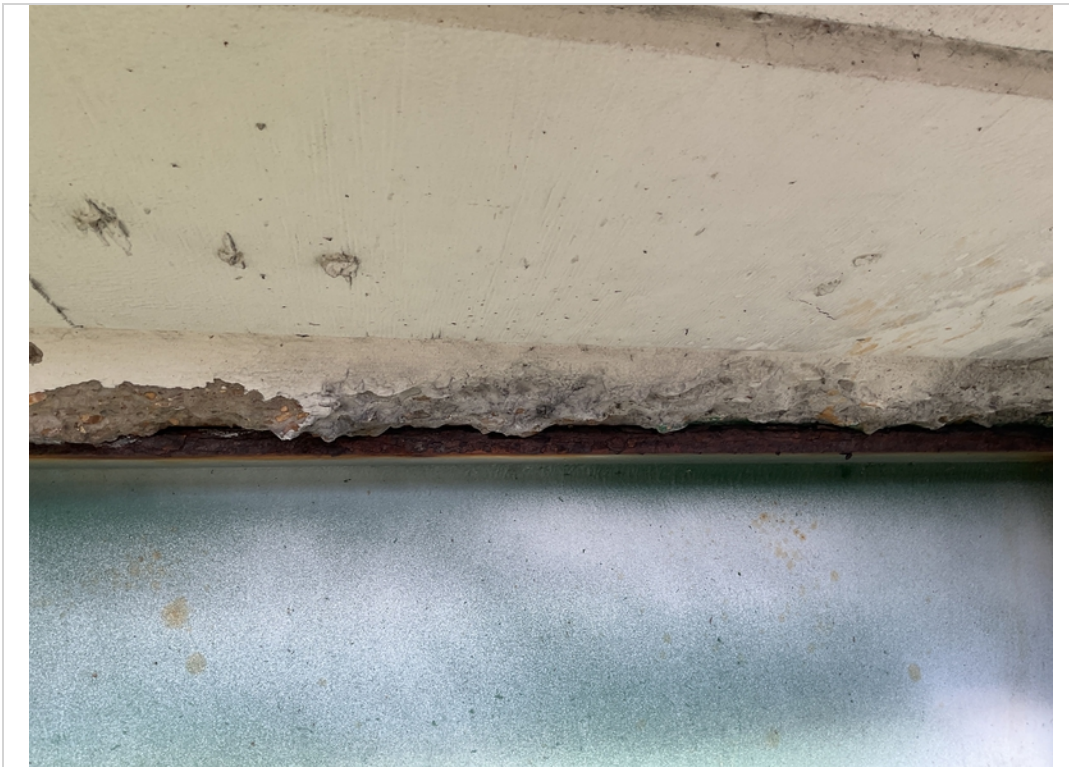
Overhang span 3 right side spall

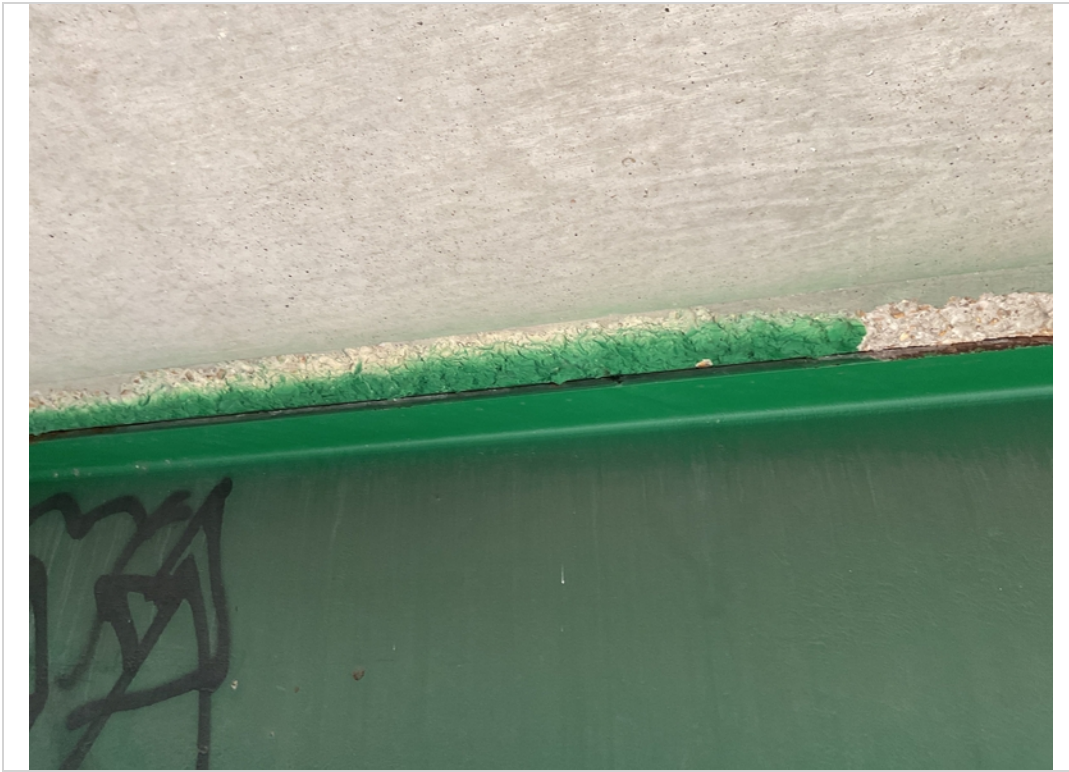
Span 3 bay D spall top flange beam E

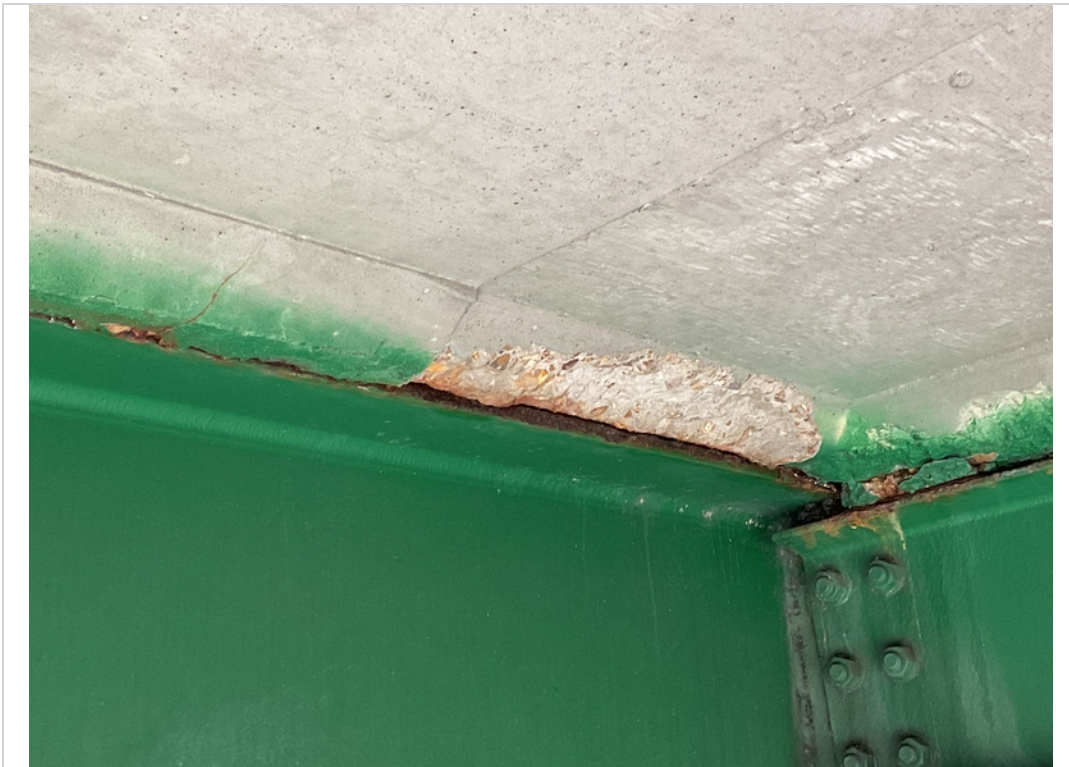
Span 3 bay D spall

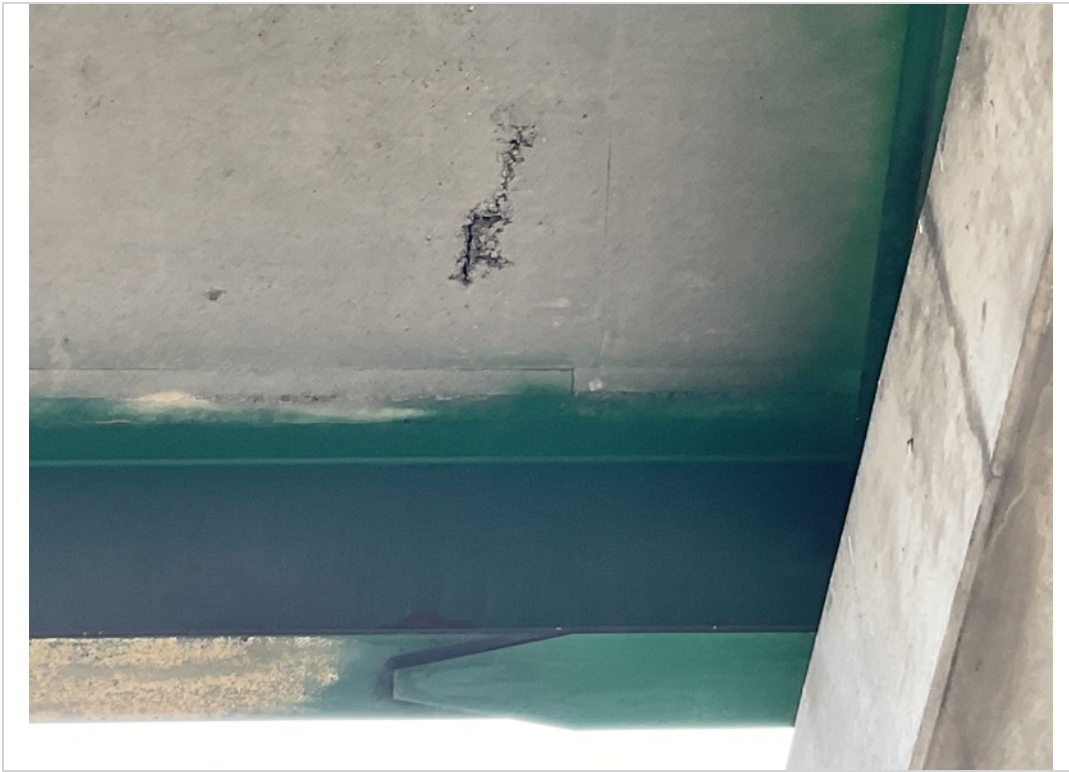
Span 2 bay A spall with exp steel

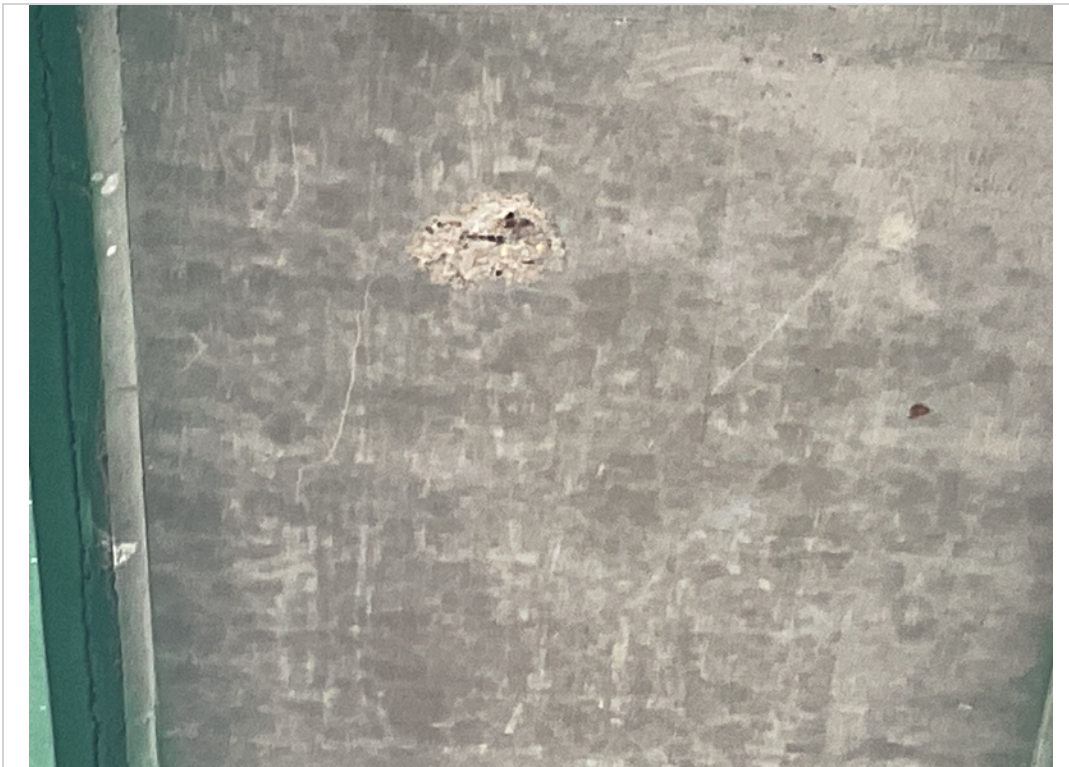
Span 2 bay C spall with exp steel

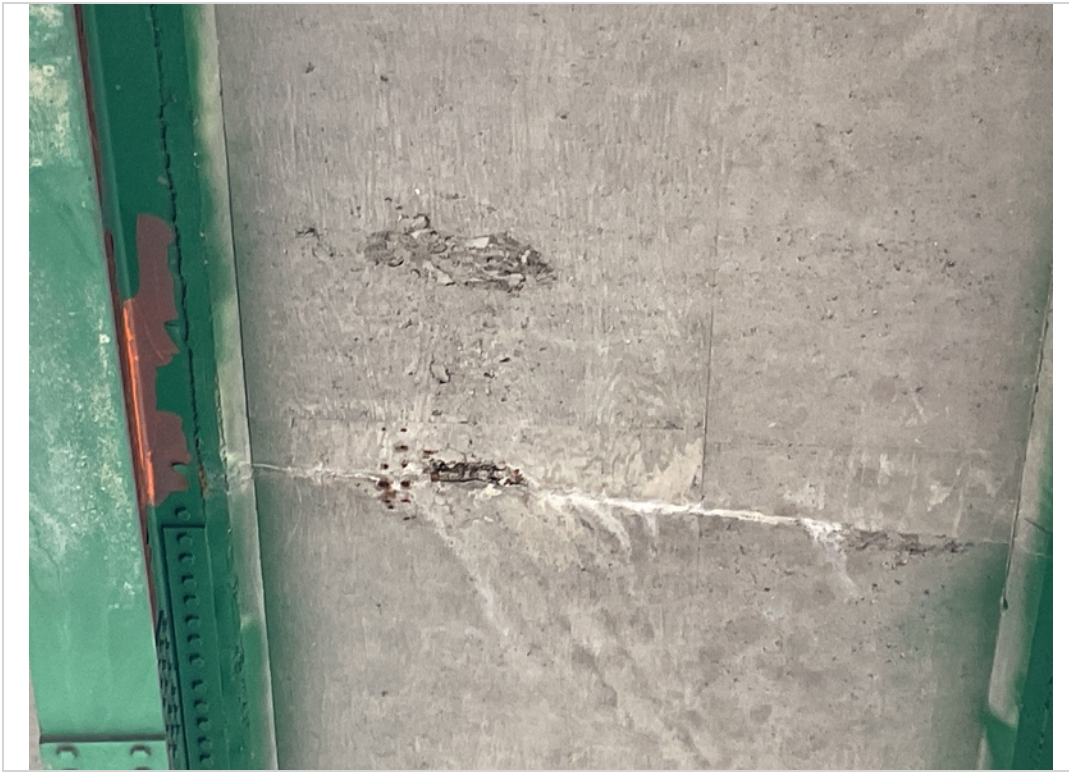
Span 2 bay B spall

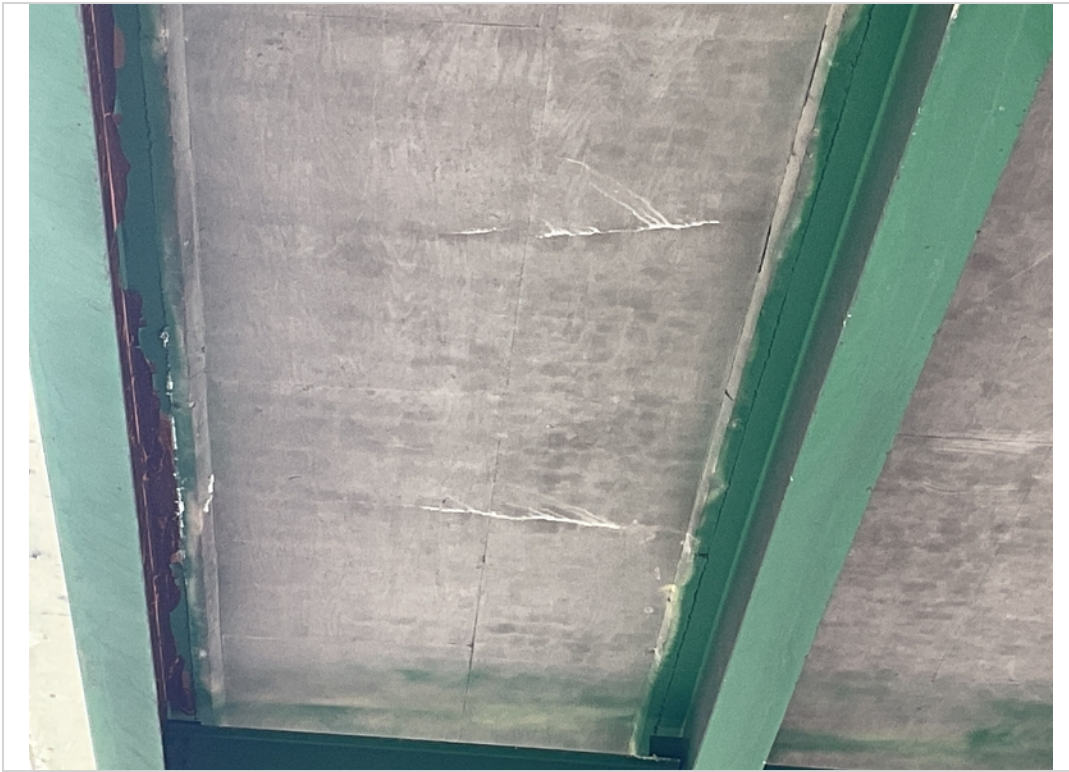
Span 2 bay A trans cracks with eff

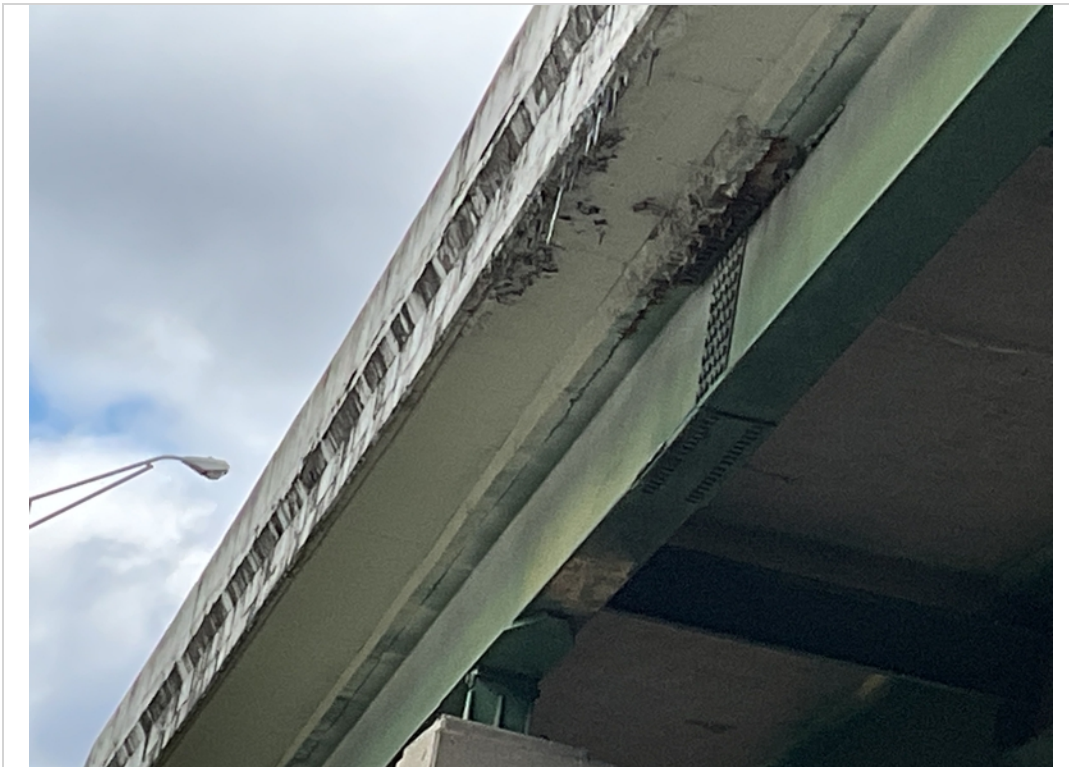
Overhang span 2 map cracks with eff left side

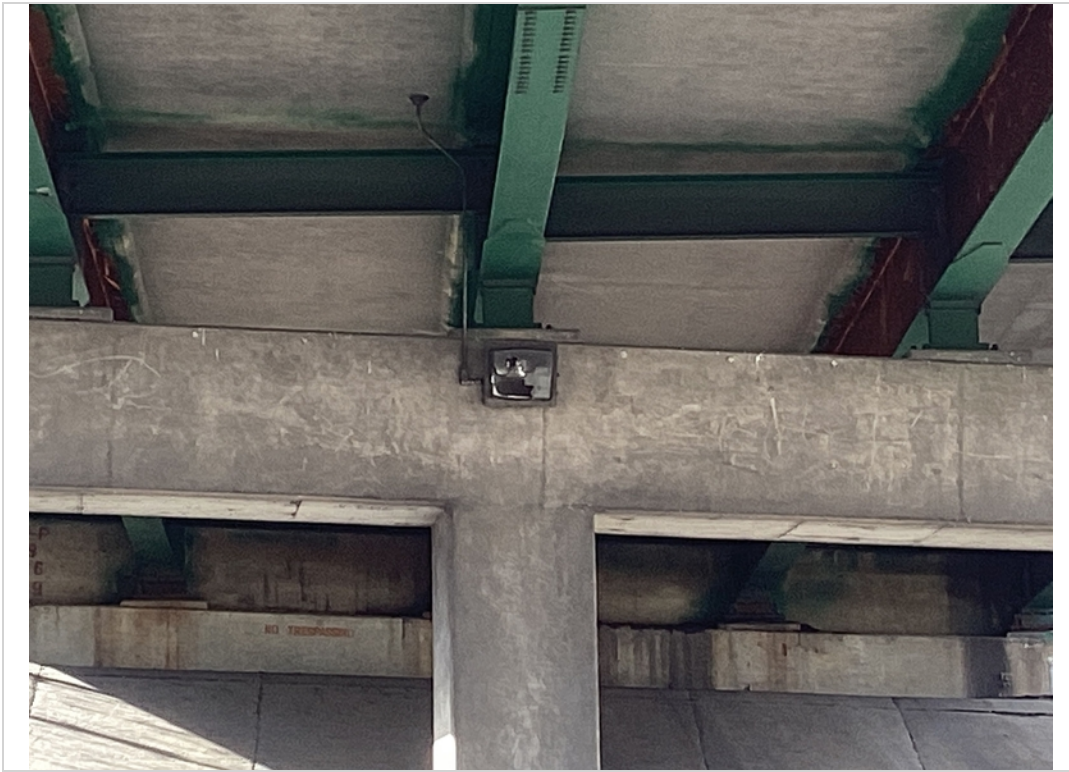
Bent 1 broken light case

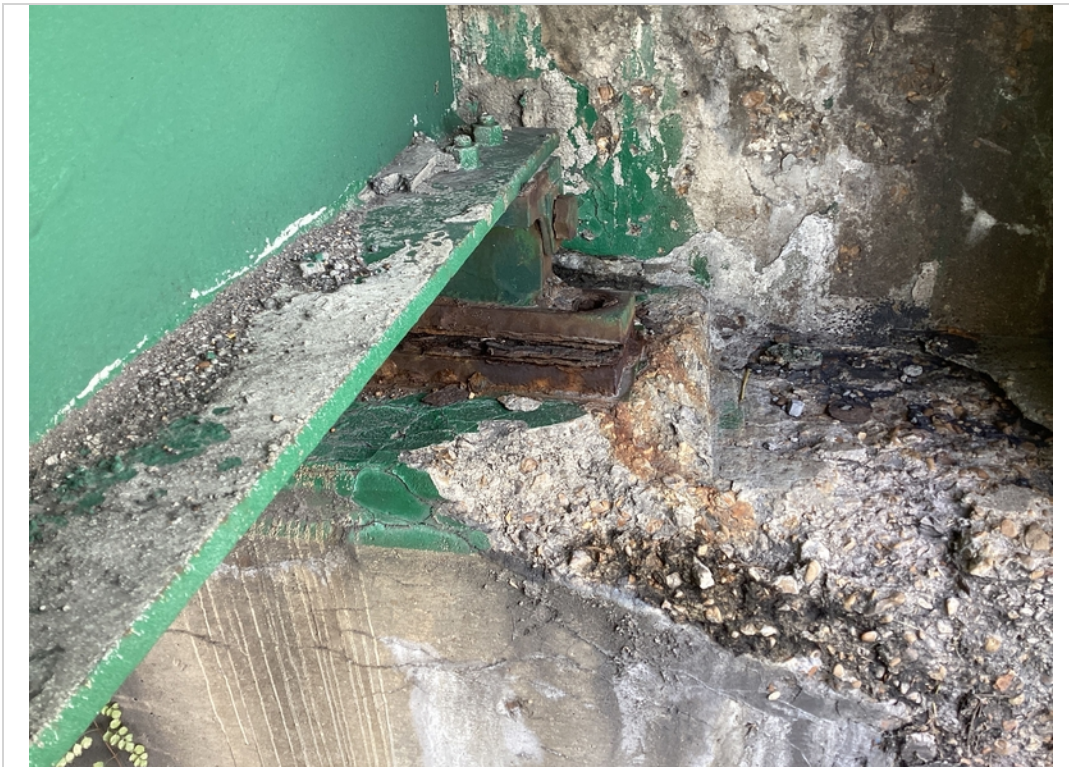
Girders are fair with heavy paint loss and surface corrosion. Girder "D" and "E" are fair with light-moderate corrosion and light section loss. Bearing devices are fair with light-moderate corrosion being painted over. However, bearings 'C' & 'D' at abutment #1 are poor with broken/missing bearing pins, and bearing 'A' abutment #1 is poor with a missing anchor bolt.

Abutment 1 missing anchor bolt bearing A riser A heavy scale

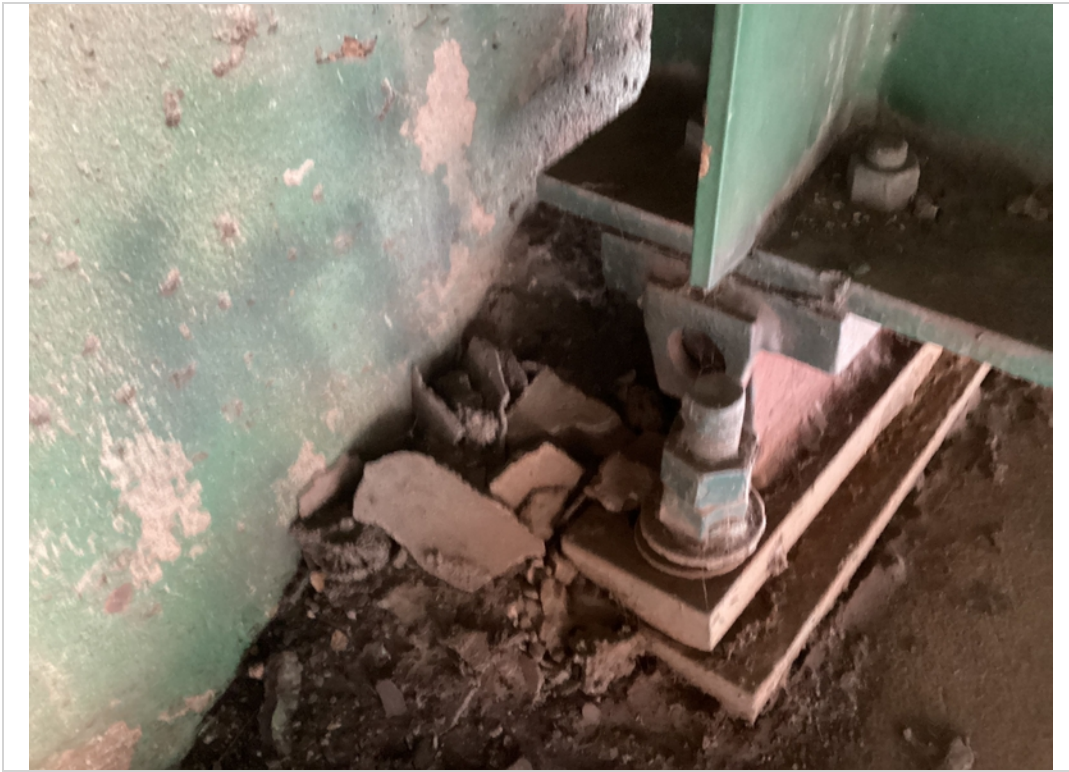
Abutment 1 bearing D missing pin

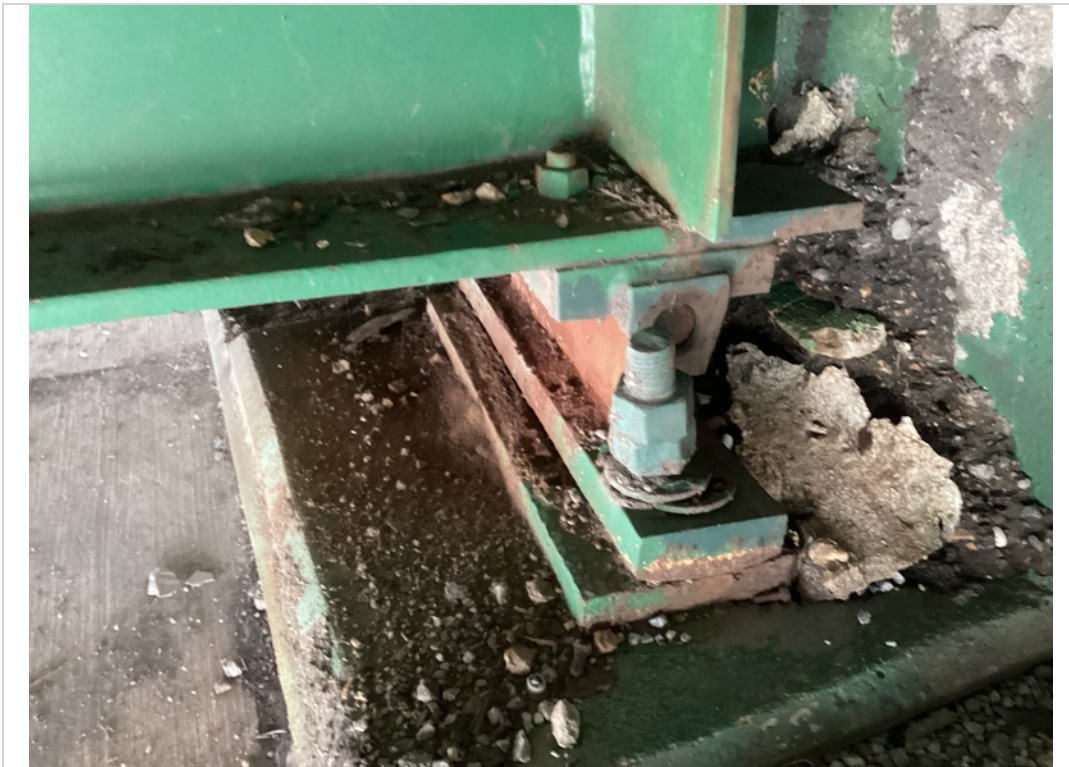
Abutment 1 bearing C missing pin

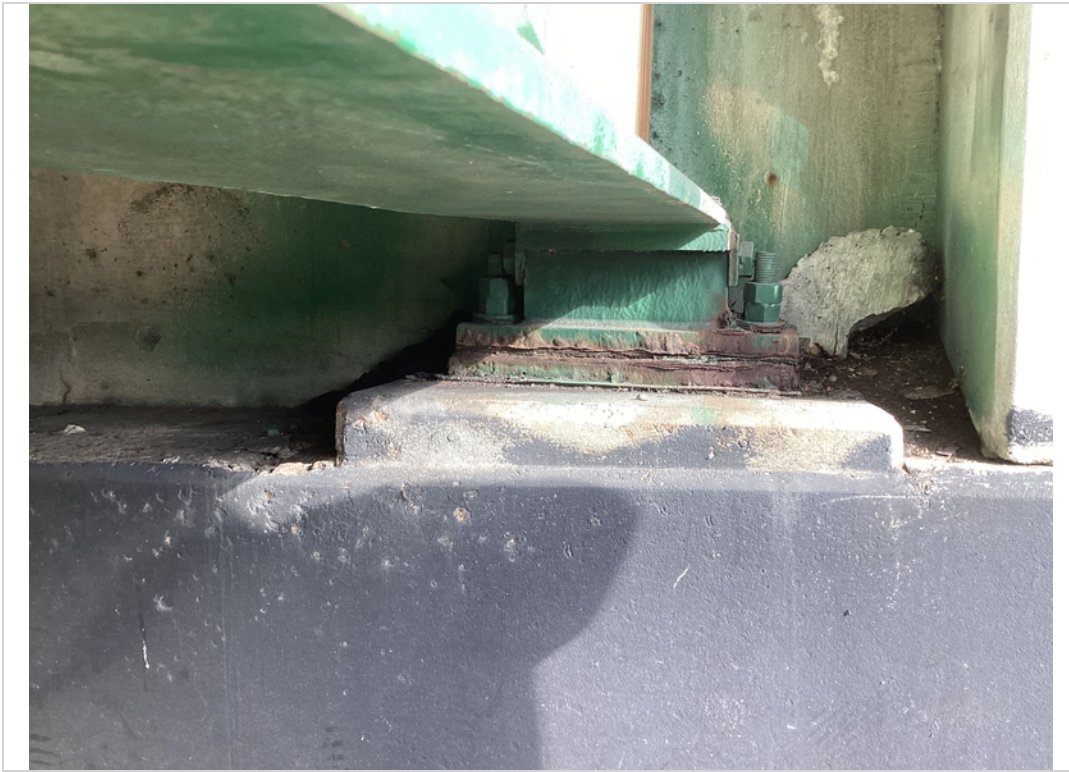
Abutment 2 bearing E light corrosion

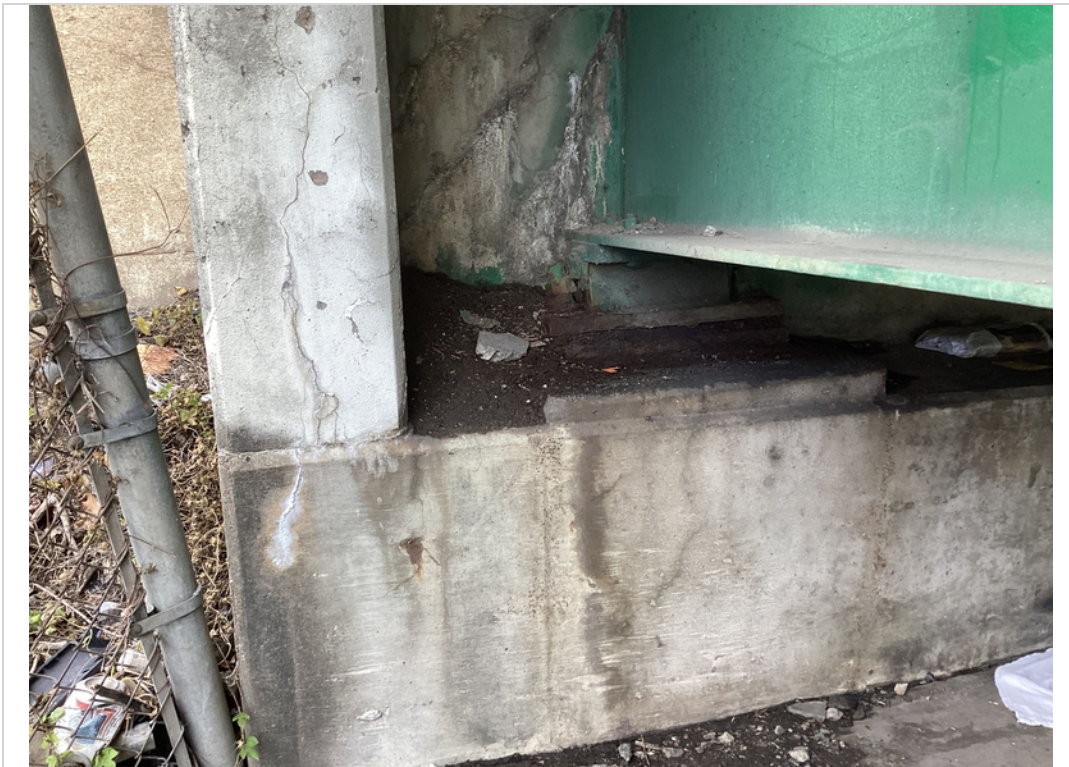
Abutment 1 bearing E rocked backstation

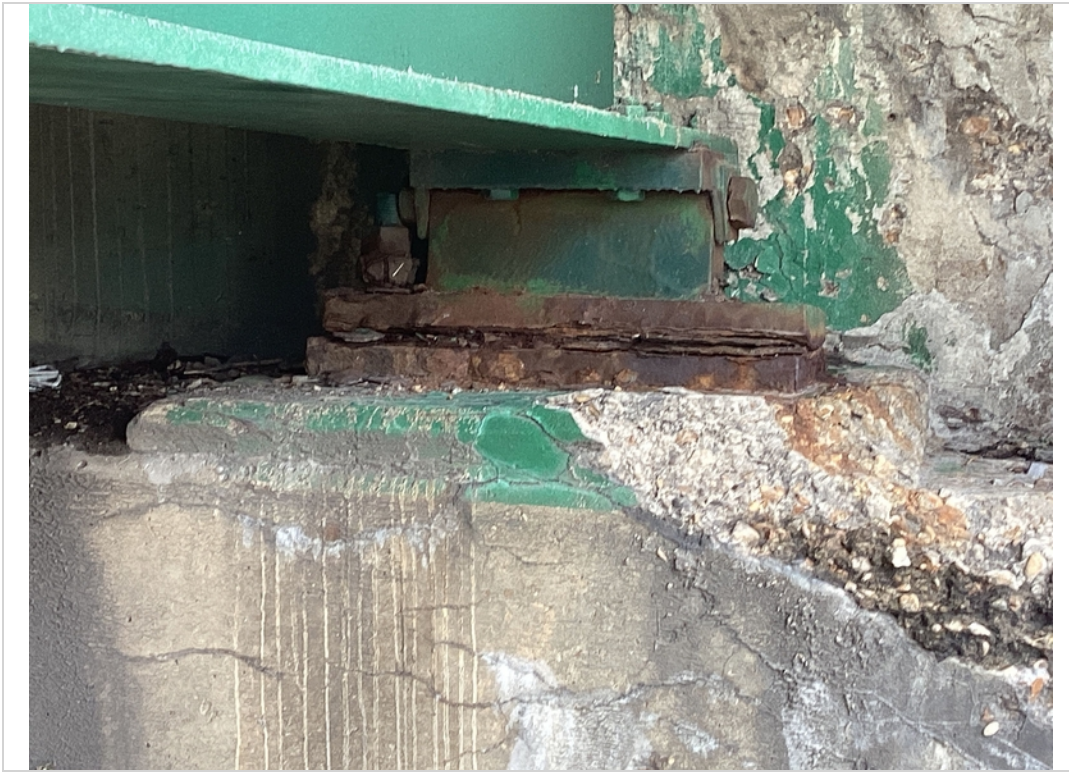
Abutment 1 bearing A heavy corrosion

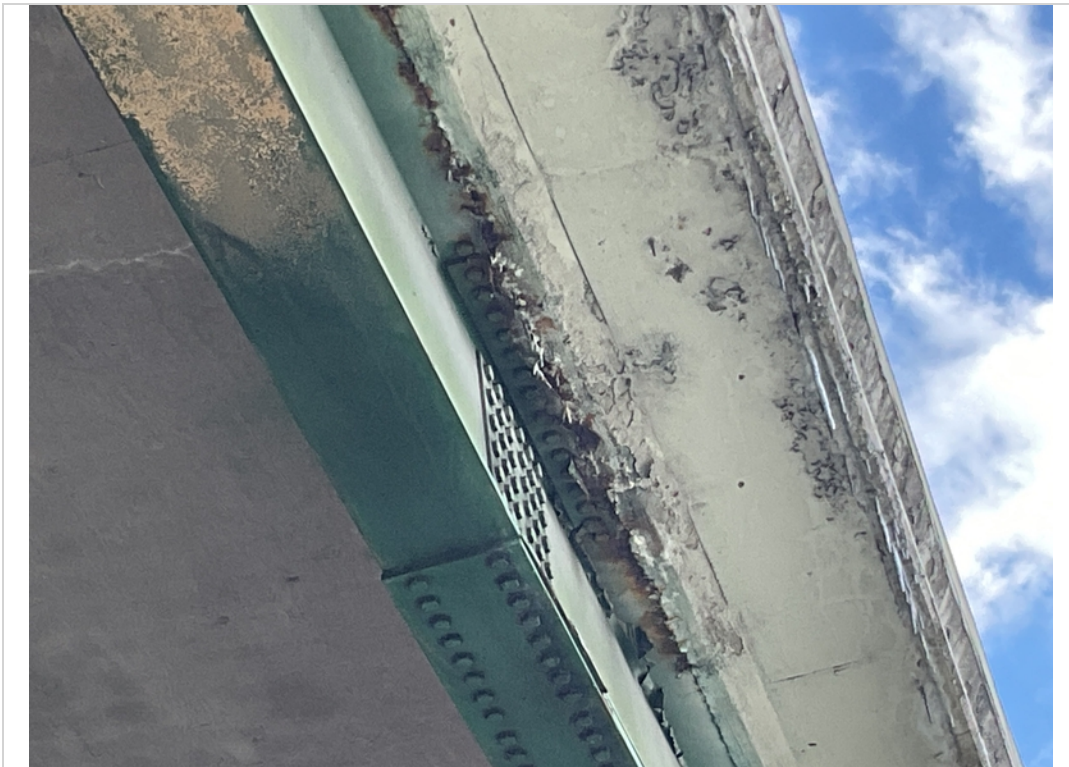
Span 2 Girder A top flange corrosion with eff
