140 RL / 8TH AVE (SR 6)

IDENTIFICATION	
(1) State Names	47 - Tennessee
(8) Structure Number	19I00400079
(5) Inventory Route	1
(2) Highway Agency District	Region 3
(3) County Code	19 - Davidson

INSPECTIONS *			
(90) Inspection Date	12/04/2023		
(91) Frequency	24		
(92) Critical Feature Inspection	Done	Freq. (Mon)	Date
A: Fracture Critical Detail	No		
B: Underwater Inspection	No		
C: Other Special Inspection	No		
<p>* The inspection date and frequency information in this box contains the current NBI date and frequency information. Please refer to the report header for the date this inspection was conducted.</p>

3 span Bridge / W.P.G.
I-40 EB / 8TH AVE (SR 6)

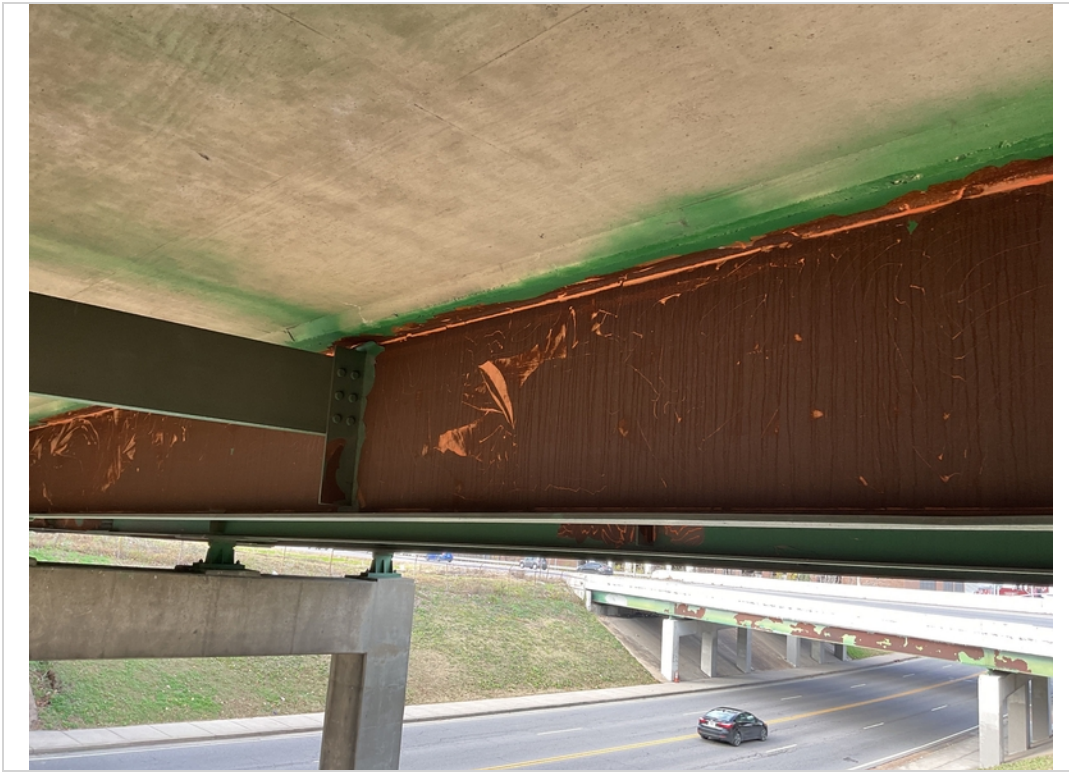
Span 3 Girder C corrosion

Date Added	Recommendation	Priority
09/08/2017	REPAIR BEARING "A", "C", & "D" AT ABUTMENT #1	2
12/02/2021	CLEAN DECK SHOULDERS	
01/04/2016	CLEAN AND PAINT ALL STRUCTURAL STEEL	2
01/04/2016	REPAIR APPROACH GUARDRAIL @ "A" END LT.	
01/04/2016	CLEAN EXPANSION JOINT @ "A" END	
01/04/2016	CLEAN DEBRIS FROM ABUTMENT CAPS	
01/04/2016	TEXTURE COAT BRIDGE RAIL	
01/04/2016	REPAIR UNDERPASS LIGHTING	
12/01/2017	REPAIR EROSION LEFT SIDE OF SLOPE PAVEMENT AT ABUTMENT #1

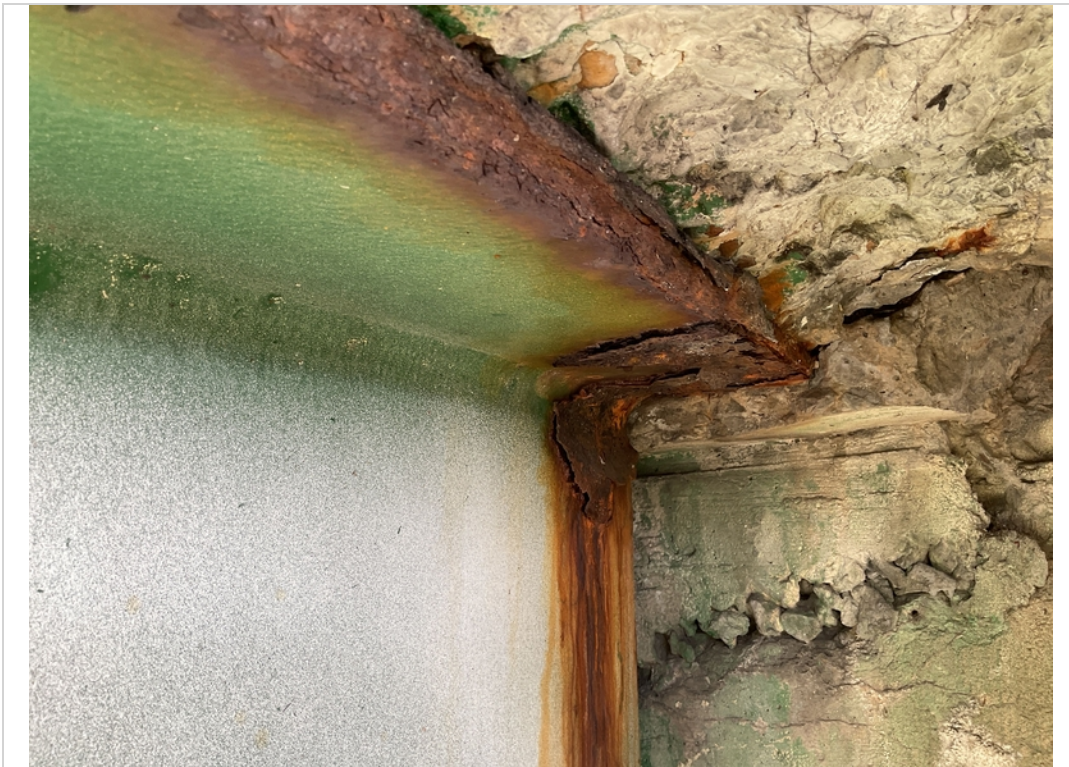
Span 3 Girder E top flange corrosion

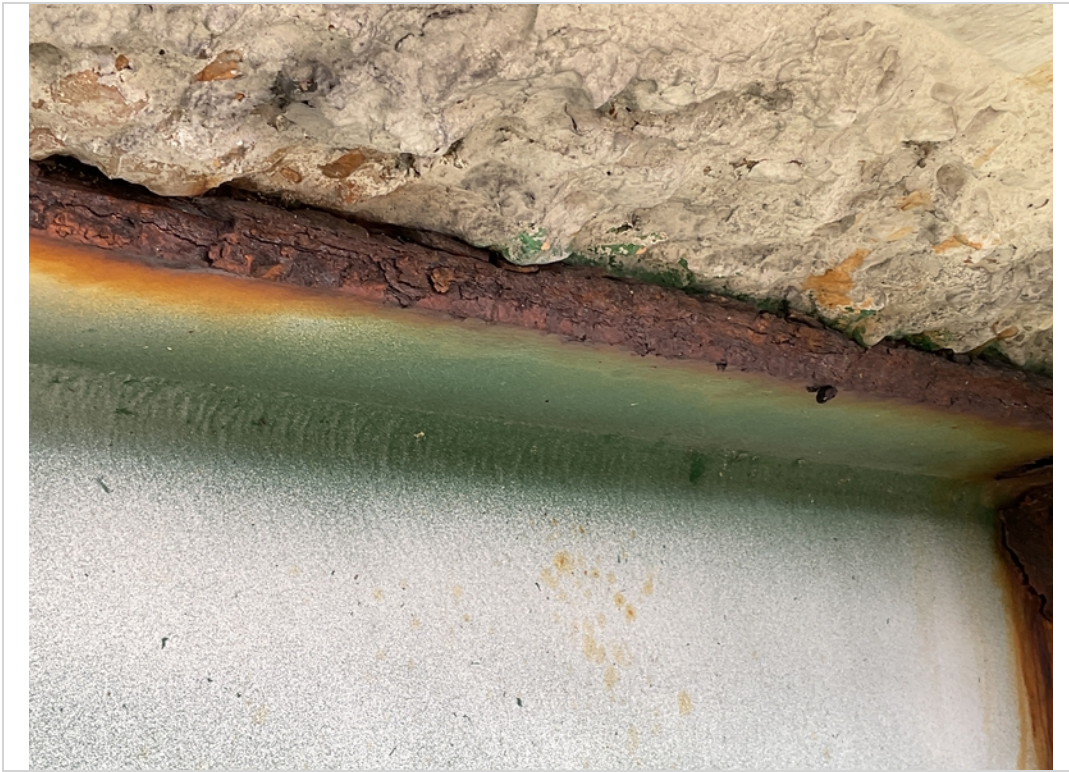
Span 3 Girder E top flange corrosion

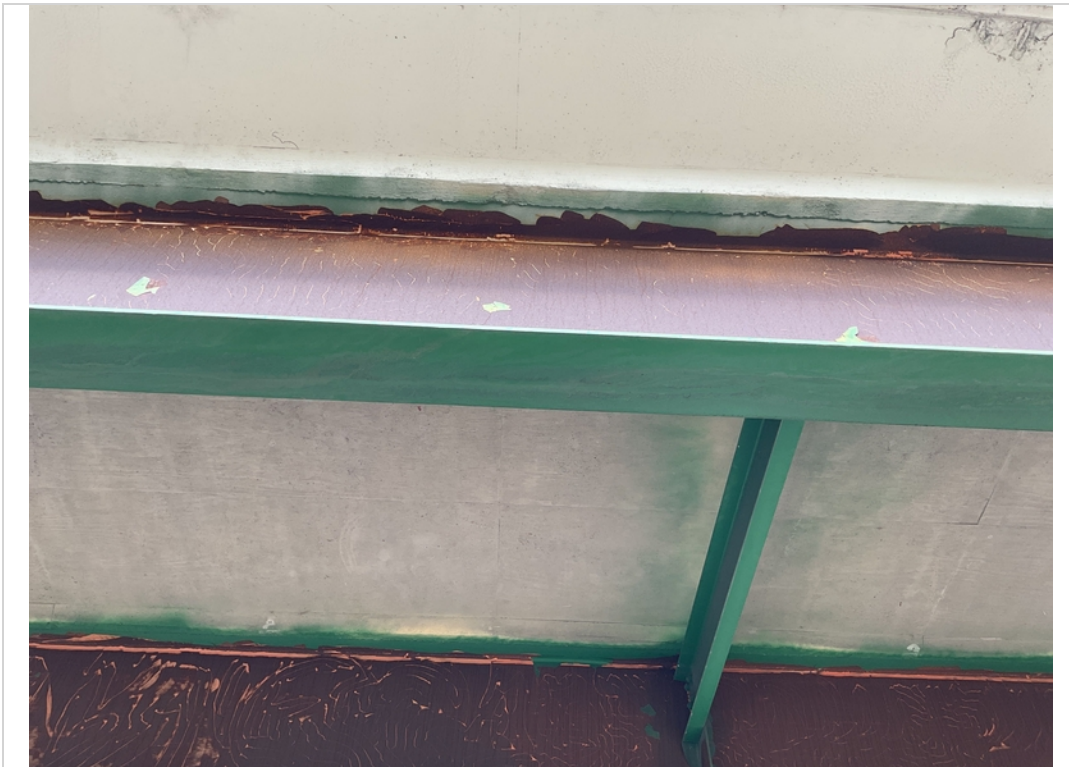
Span 3 Girder E corrosion

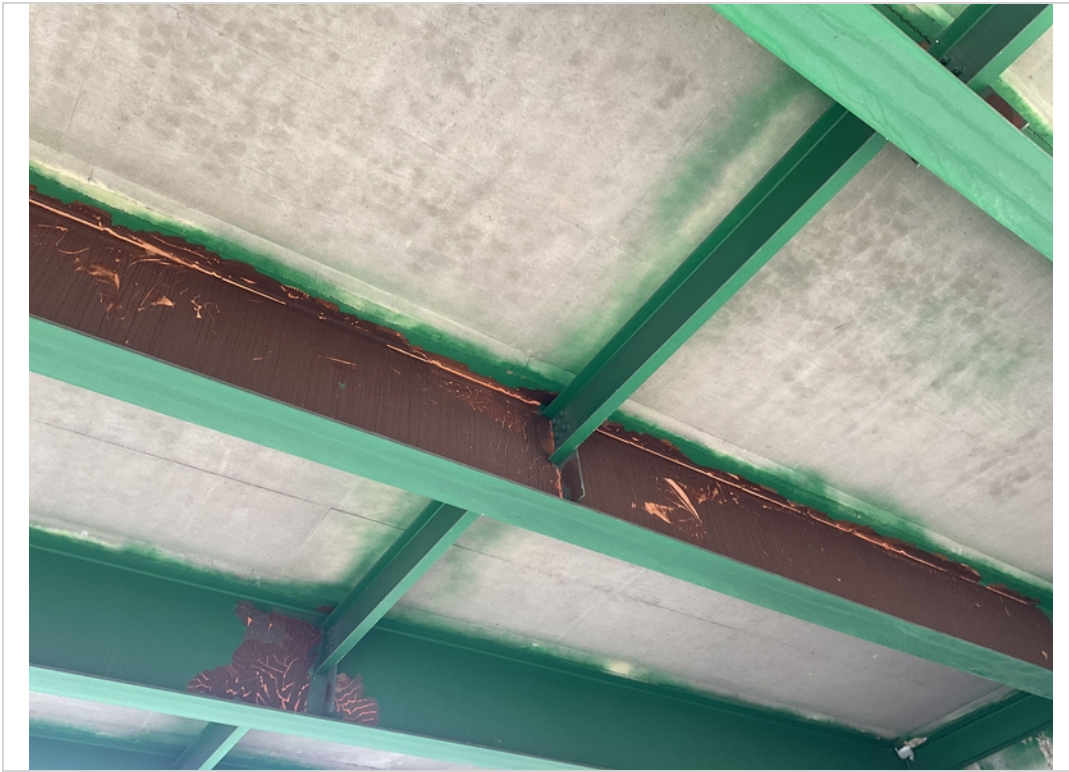
Span 3 Girder C corrosion

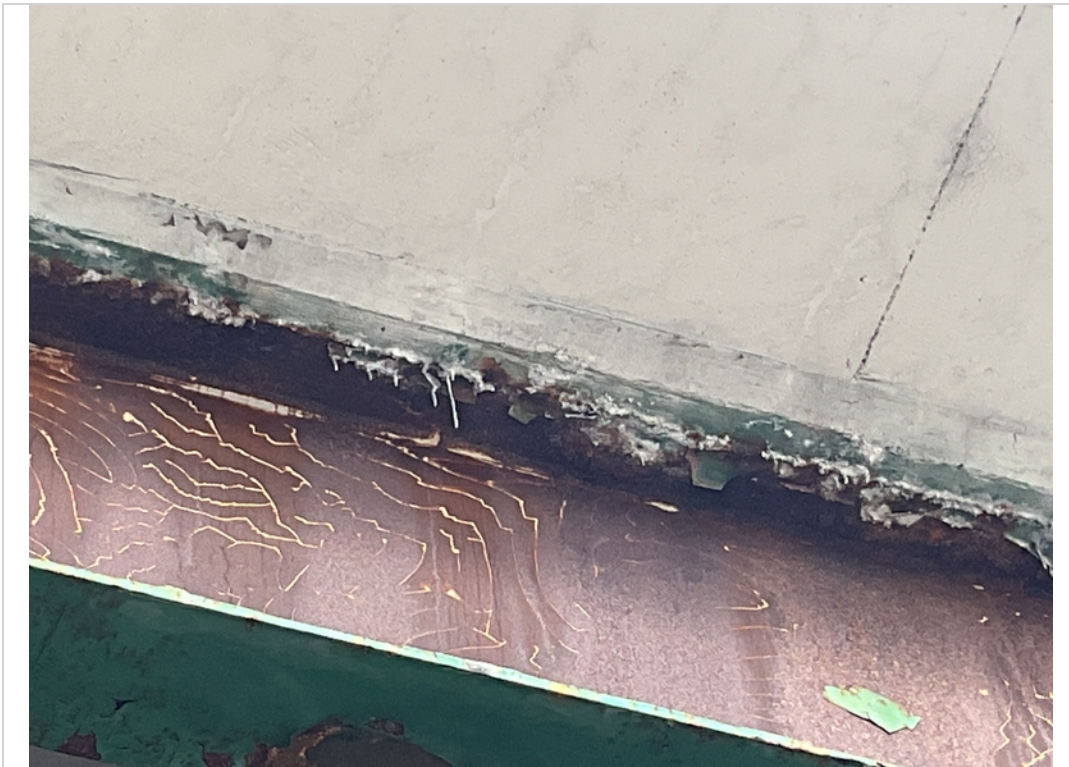
Span 2 Girder E top flange corrosion with eff

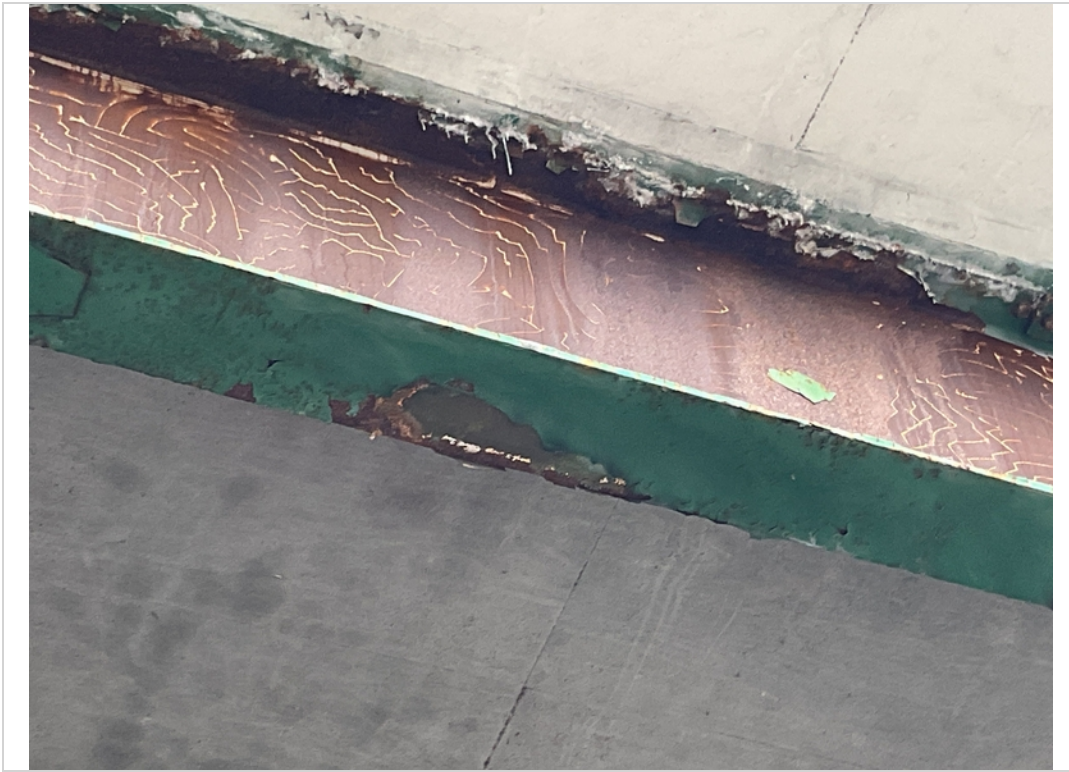
Span 2 Girder E bottom flange corrosion

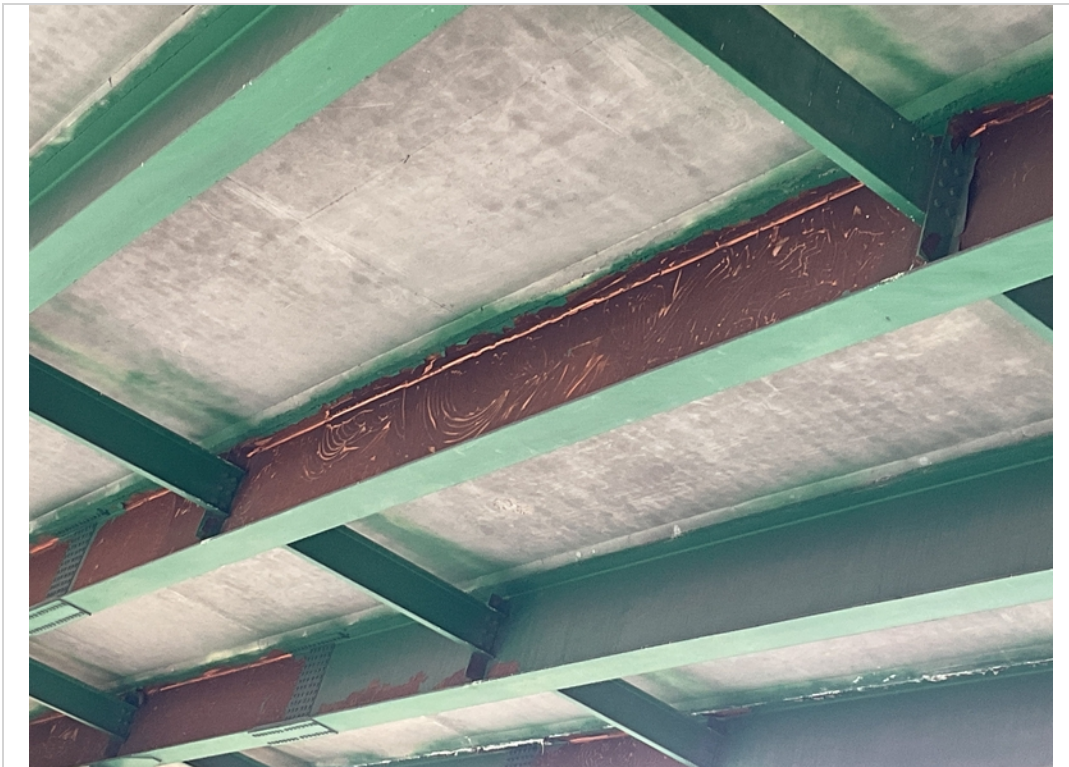
Span 2 Girder C corrosion

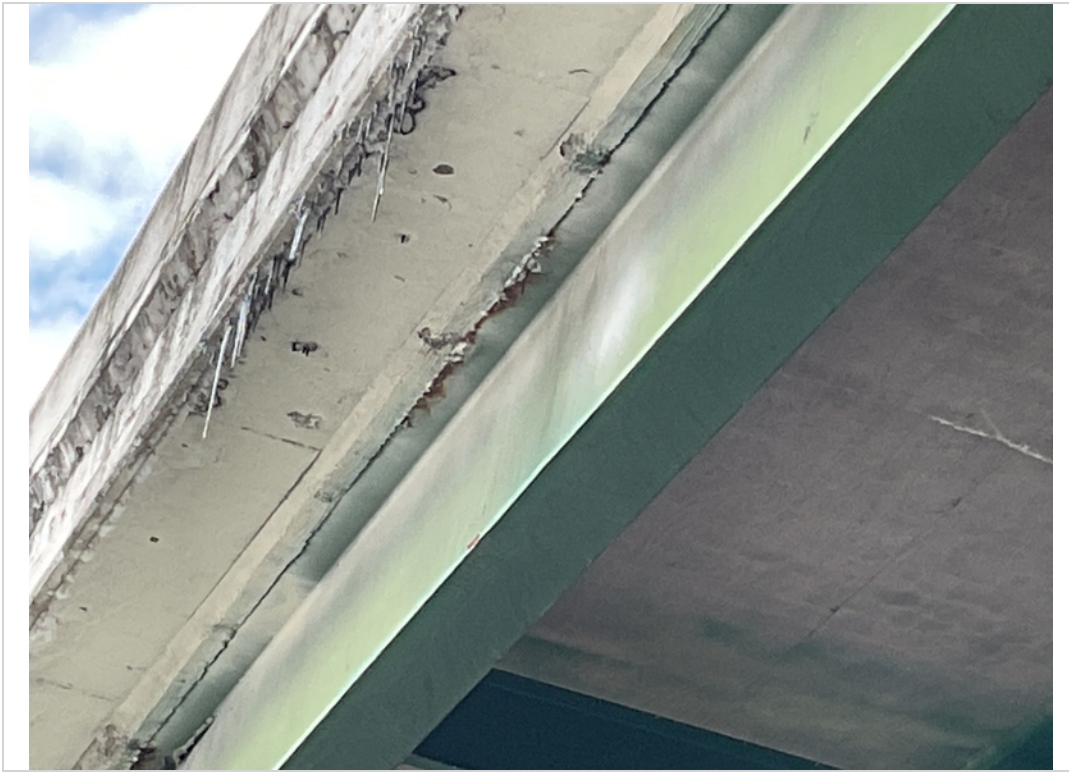
Span 2 Girder A top flange corrosion

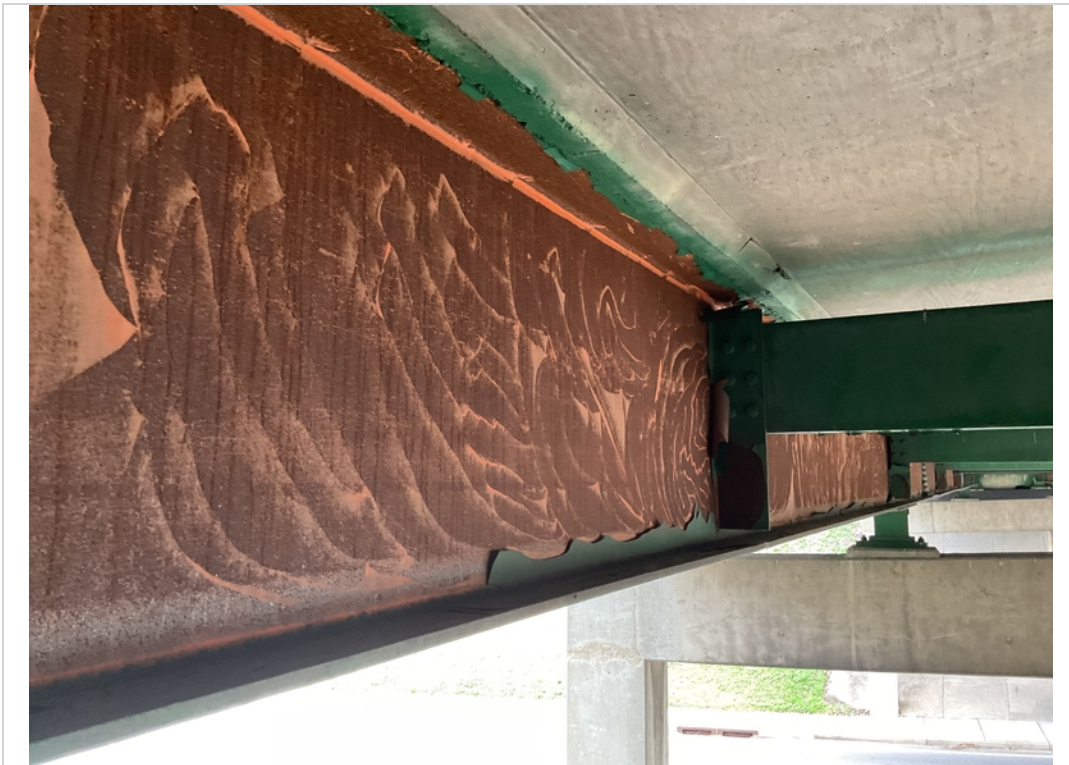
Span 1 Girder B corrosion

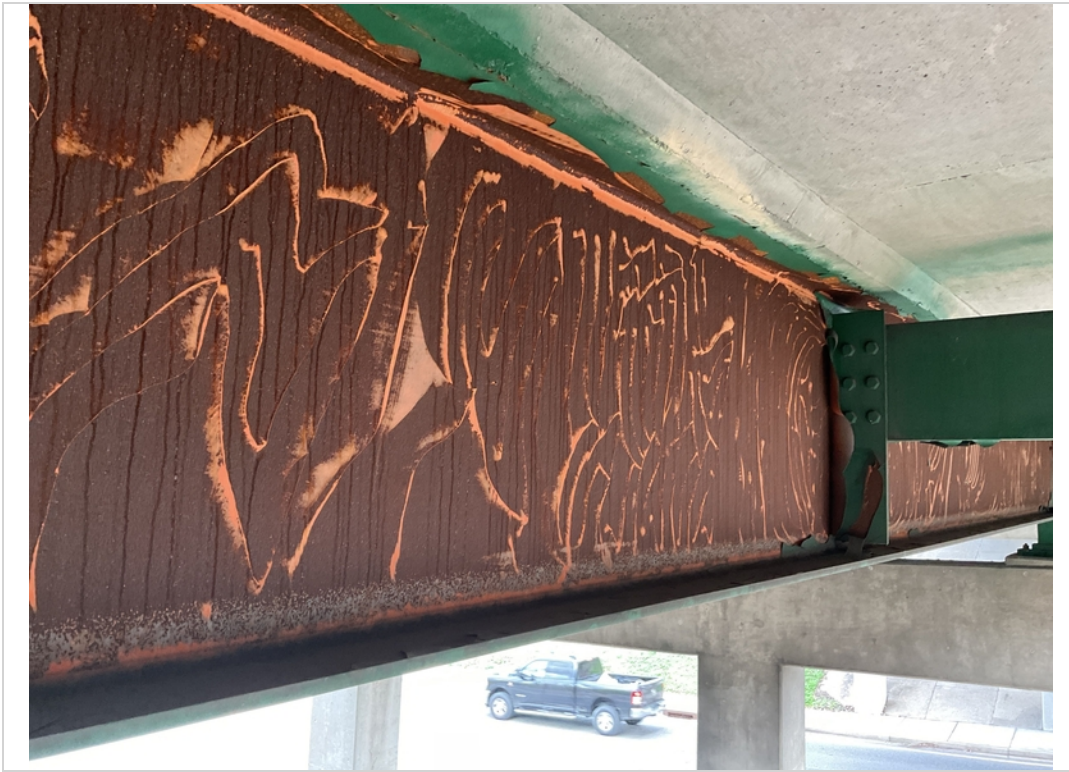
Span 1 Girder D corrosion

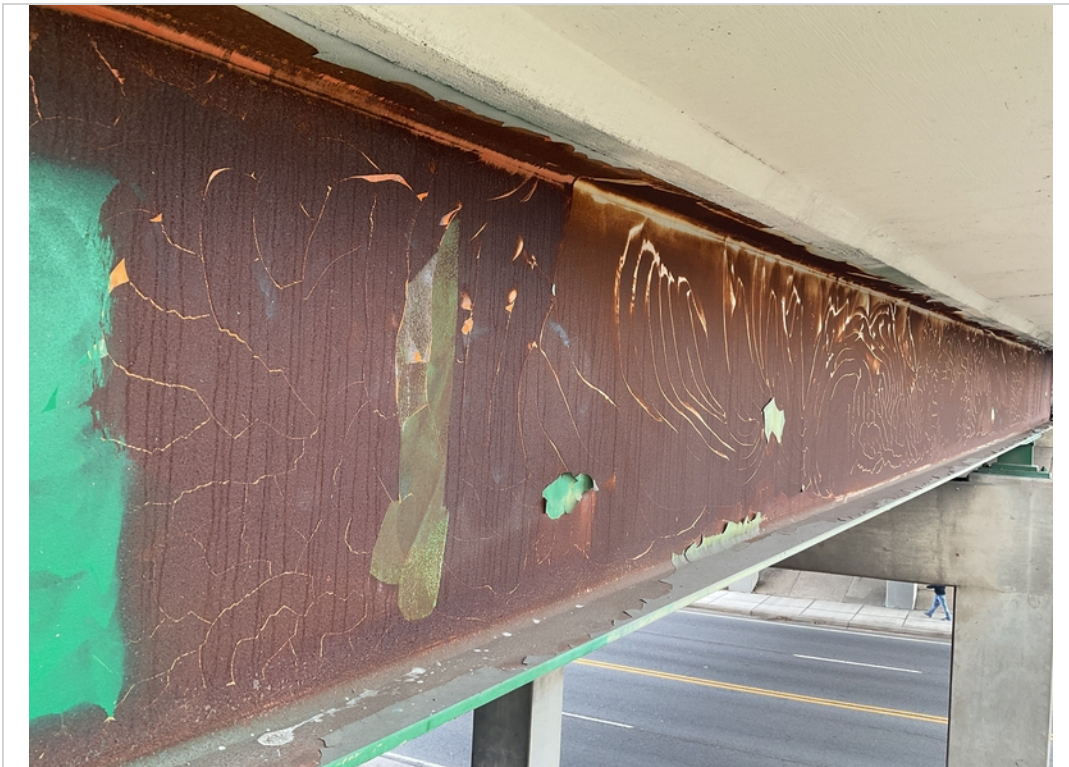
Span 1 Girder E corrosion

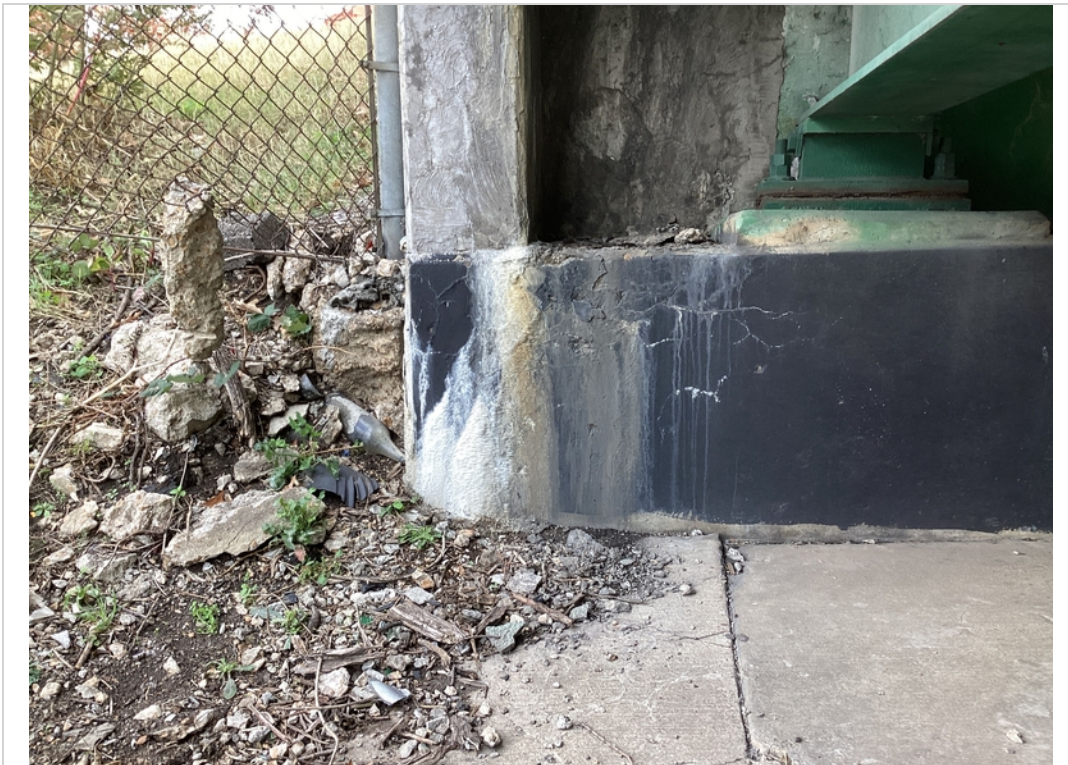
Abutment 2 cracks with eff

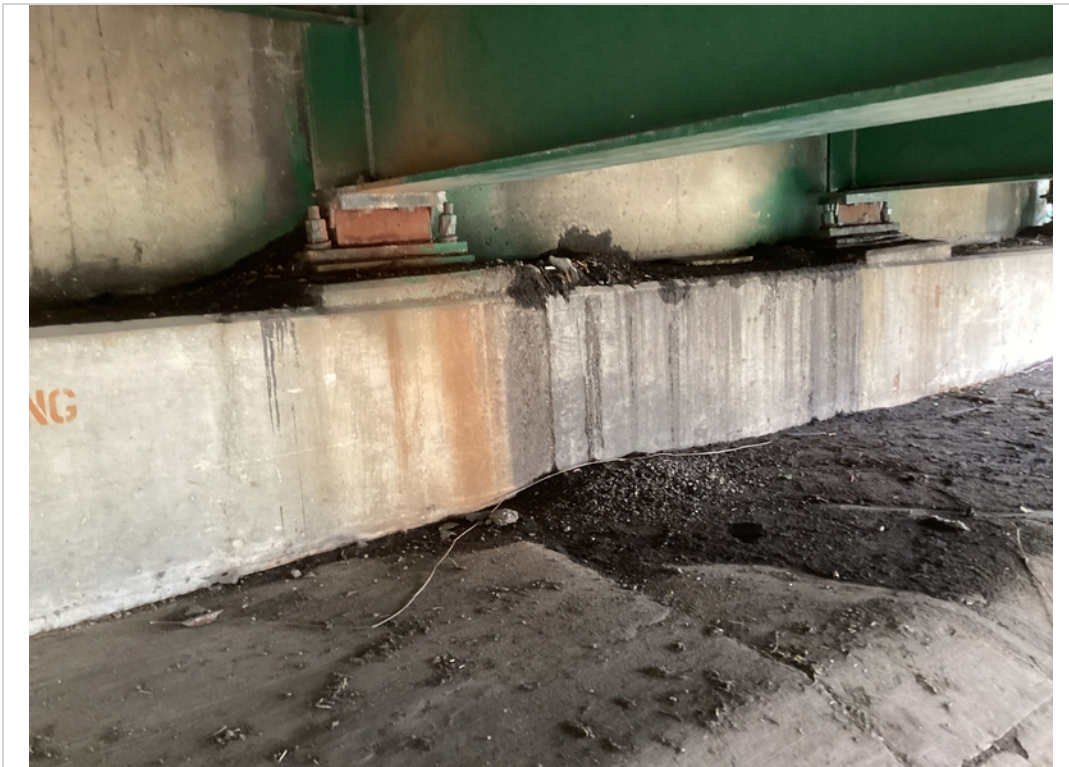
Abutment 1 water stains

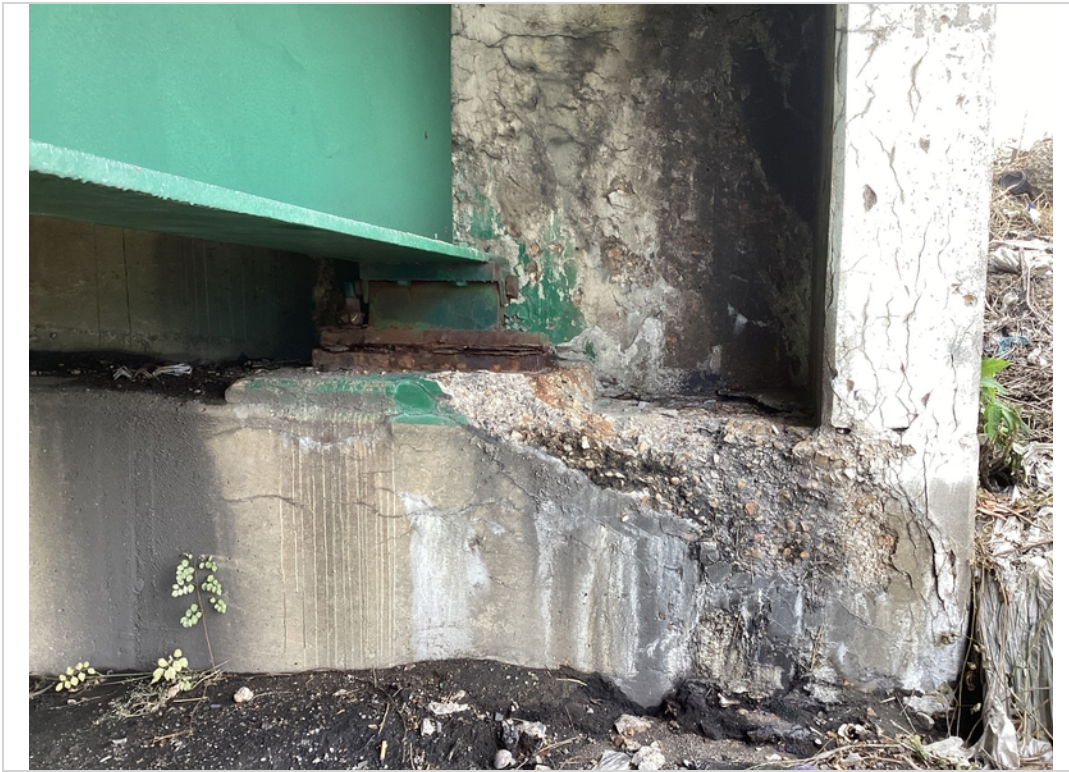
Abutment 1 cap and backwall scale map cracks

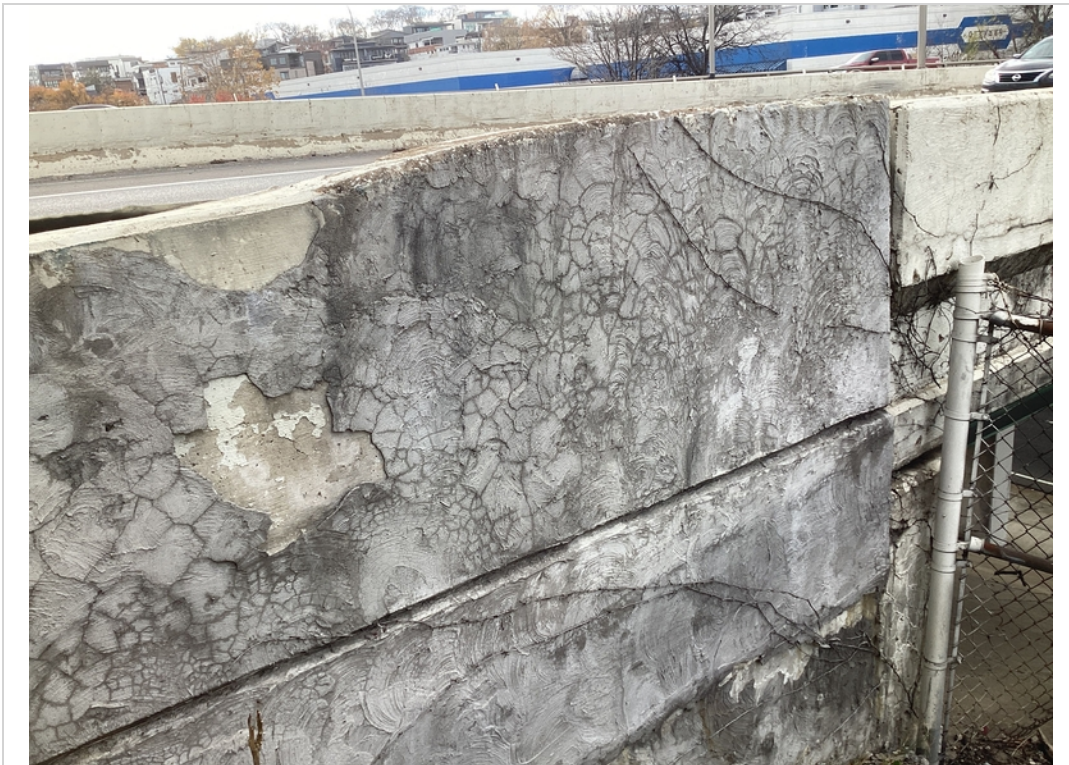
Abutment 2 left wing map cracks with eff

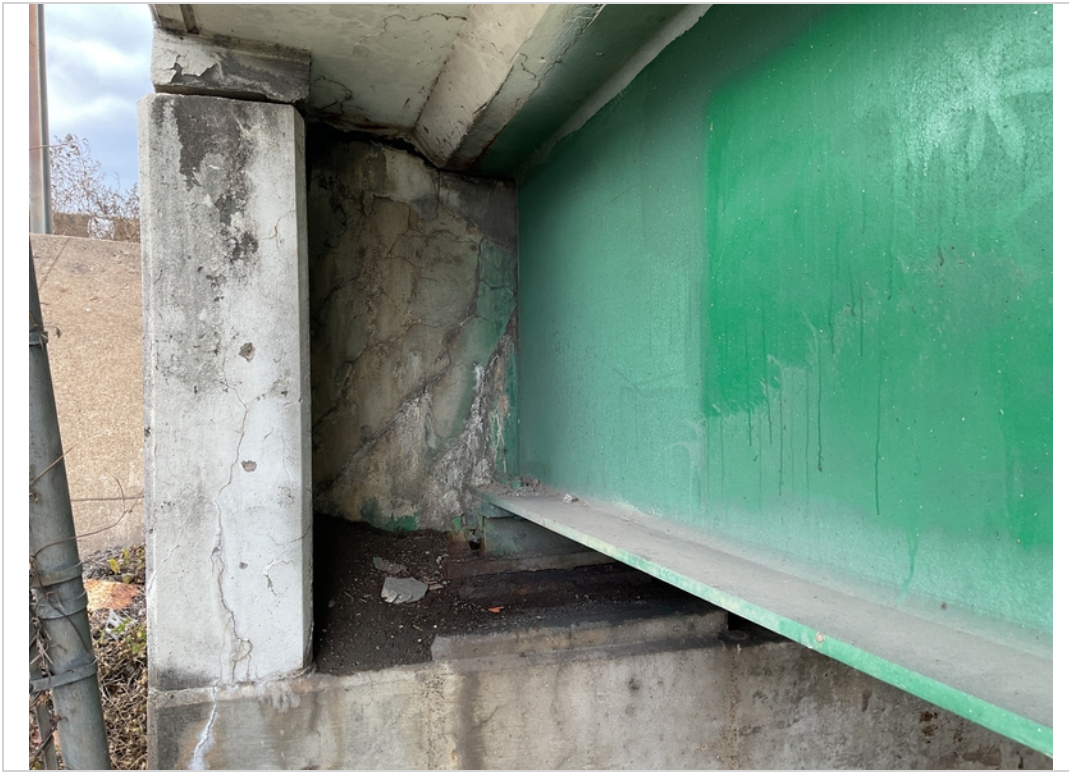
Abutment 1 back wall map cracks with eff

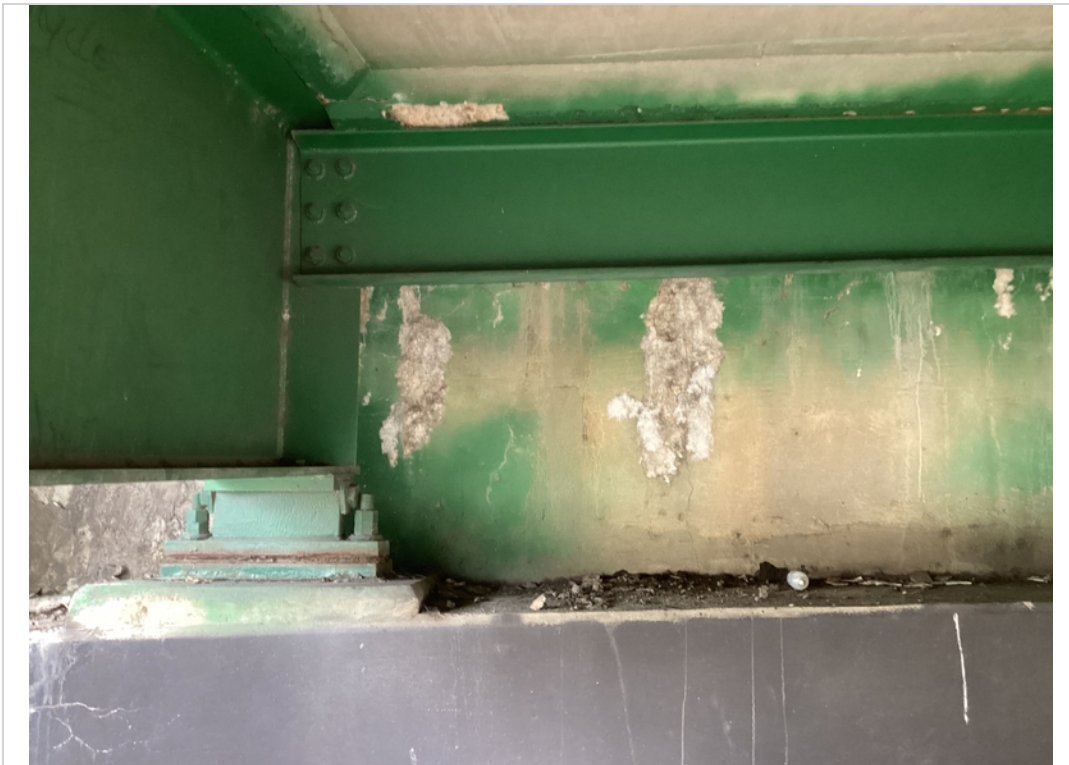
Abutment 2 backwall cracks with eff

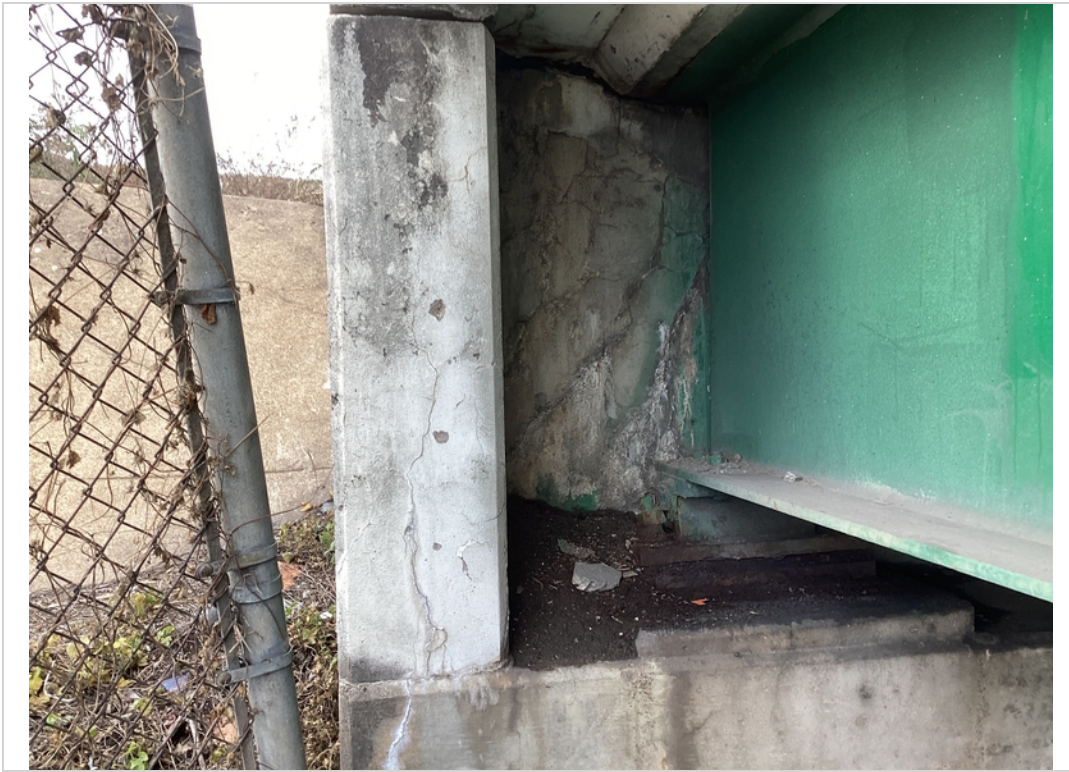
Abutment 1 backwall cracks with eff

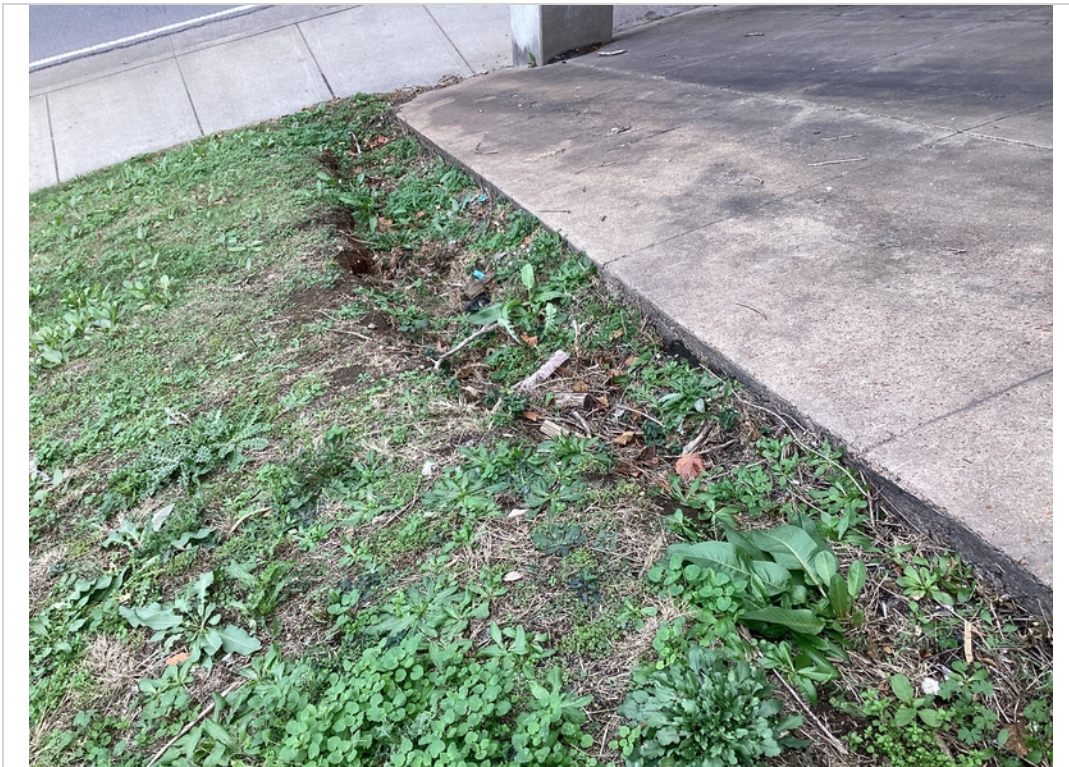
Abutment 1 erosion left side

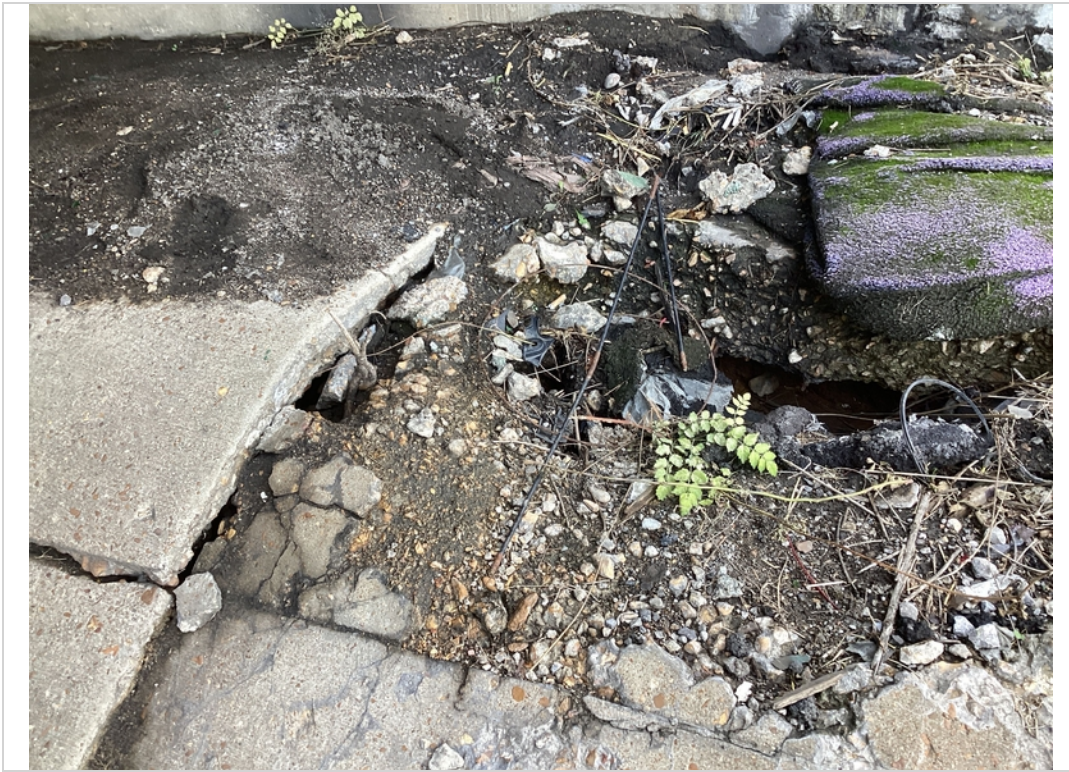
Abutment 1 slope pavement broken

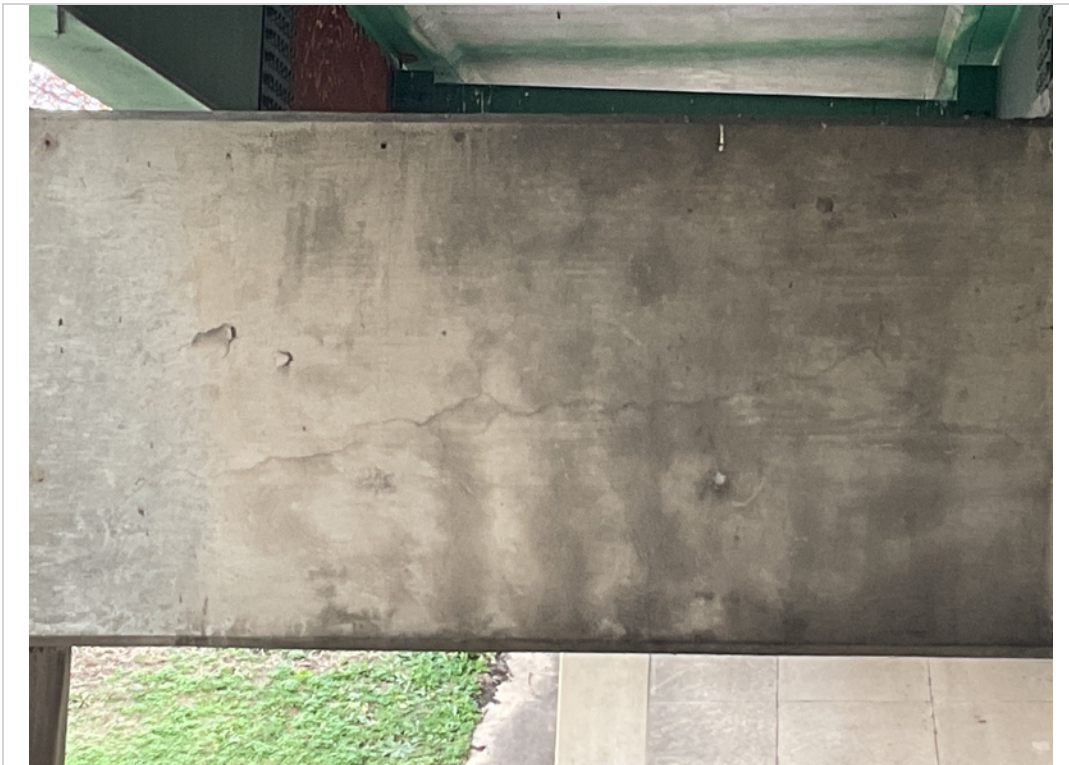
Bent 1 cap horizontal crack

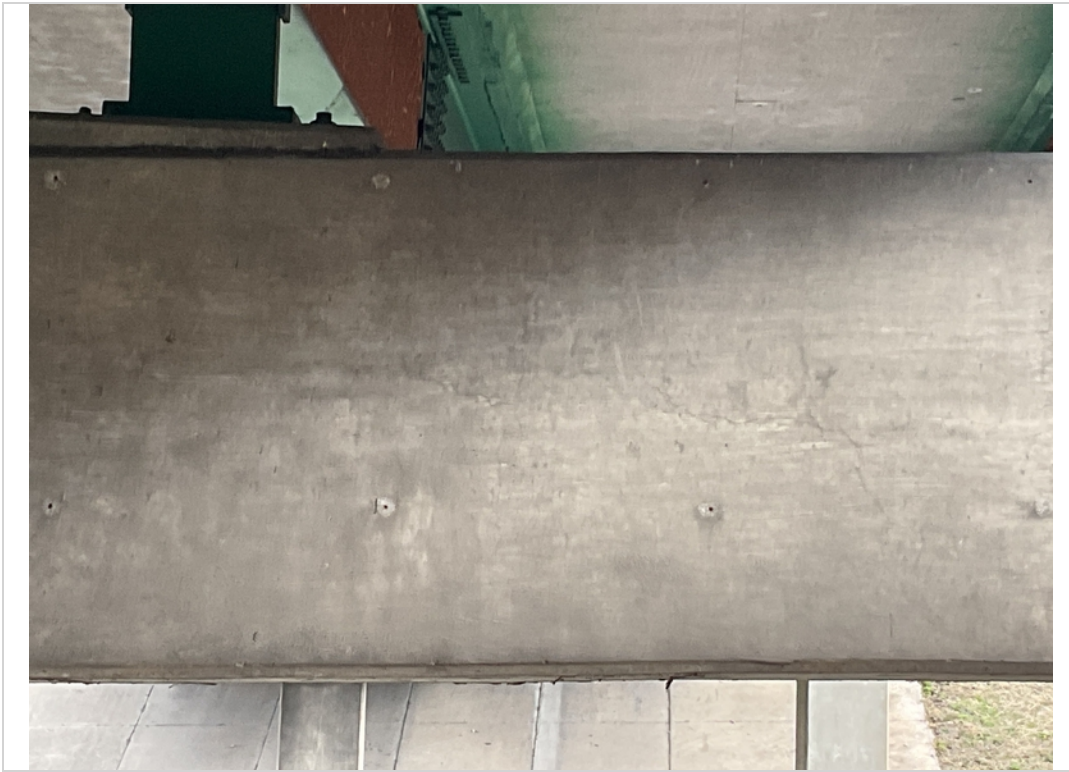
Bent 1 cap horizontal crack

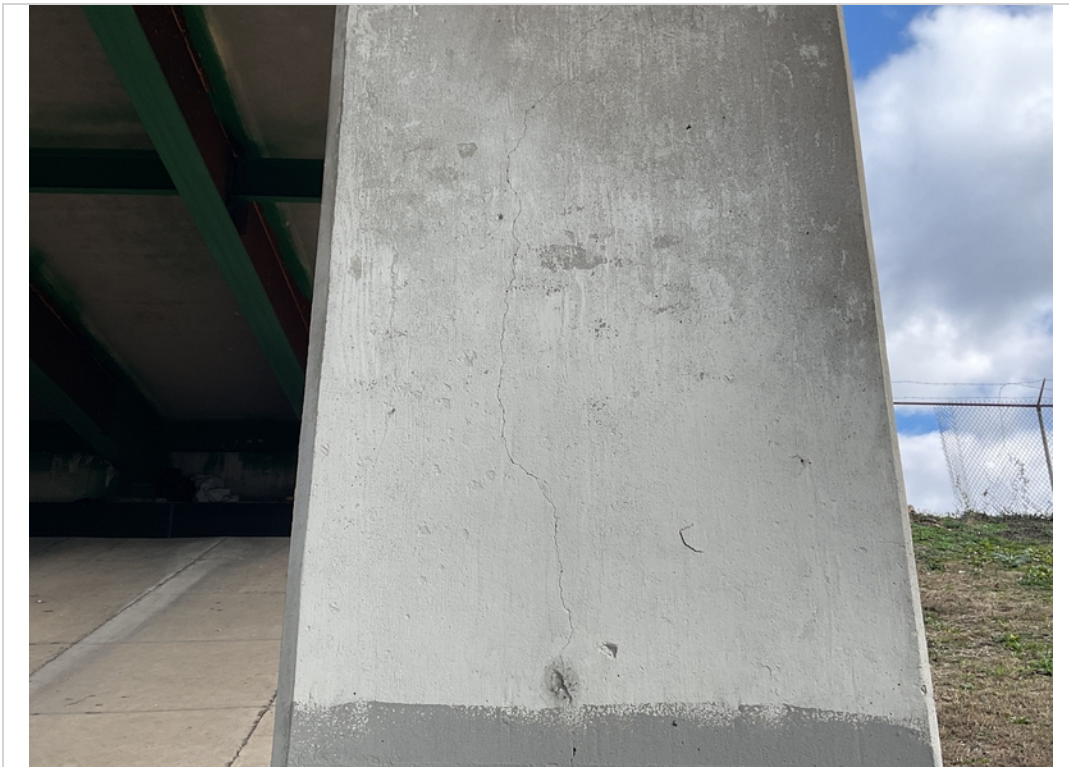
Bent 2 column C vertical crack

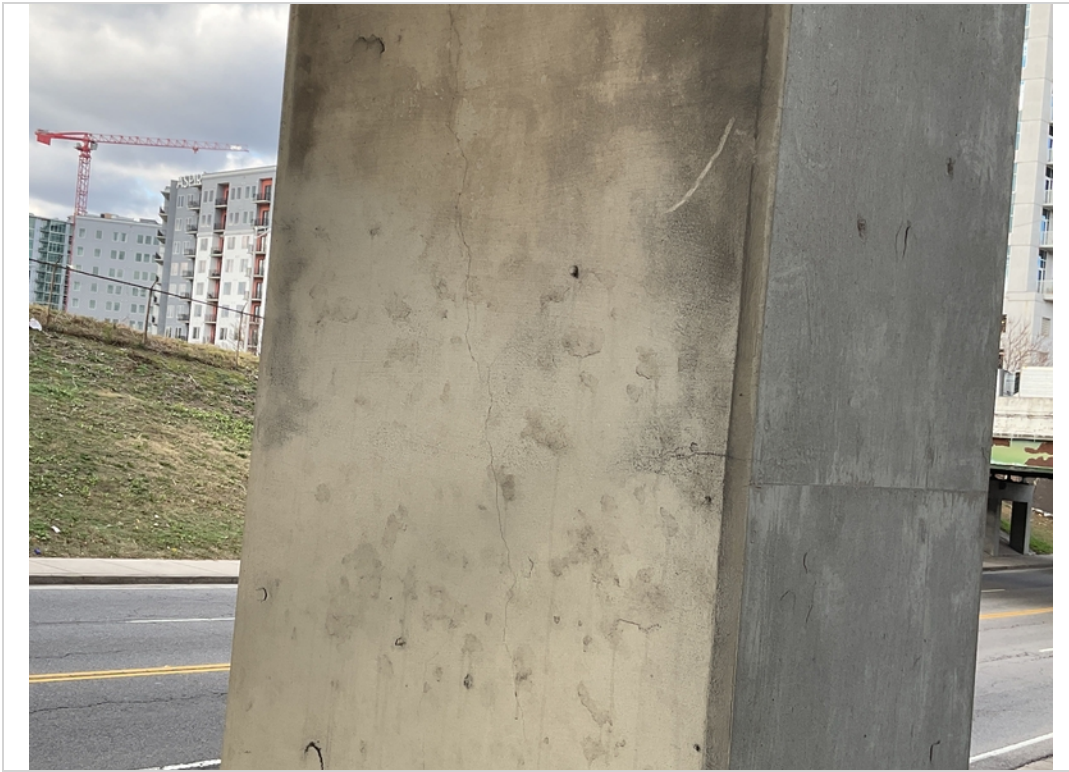
Bent 2 column A vertical crack

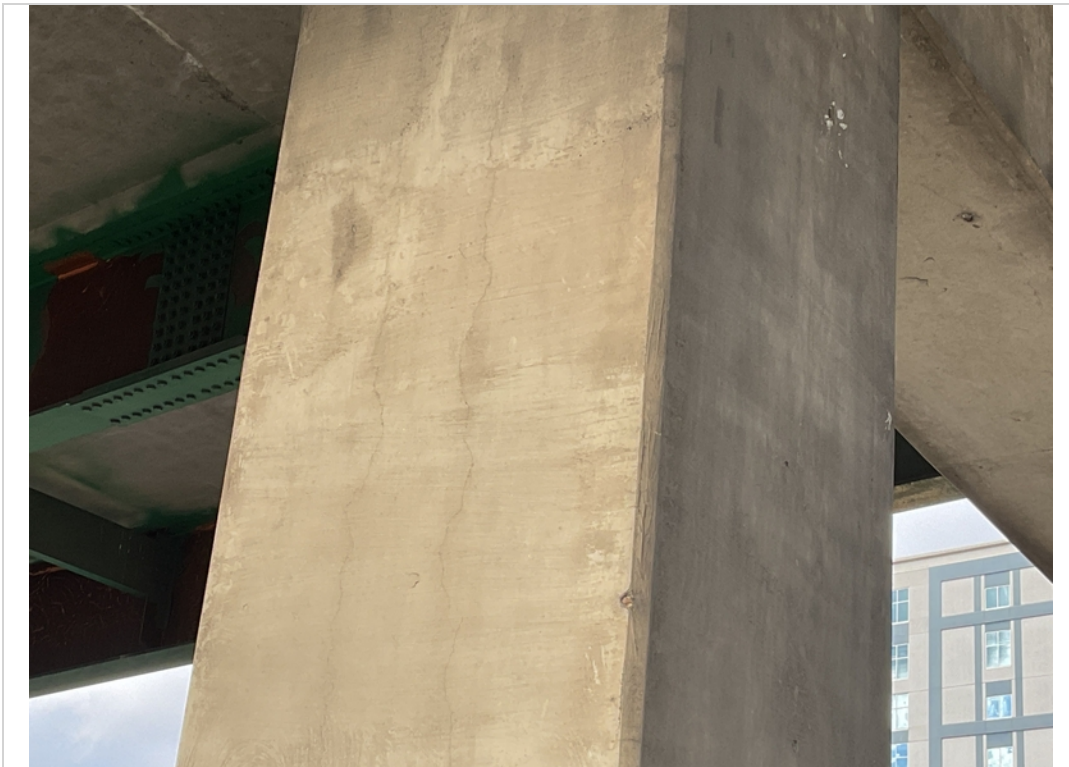
Bent 2 column B vertical crack

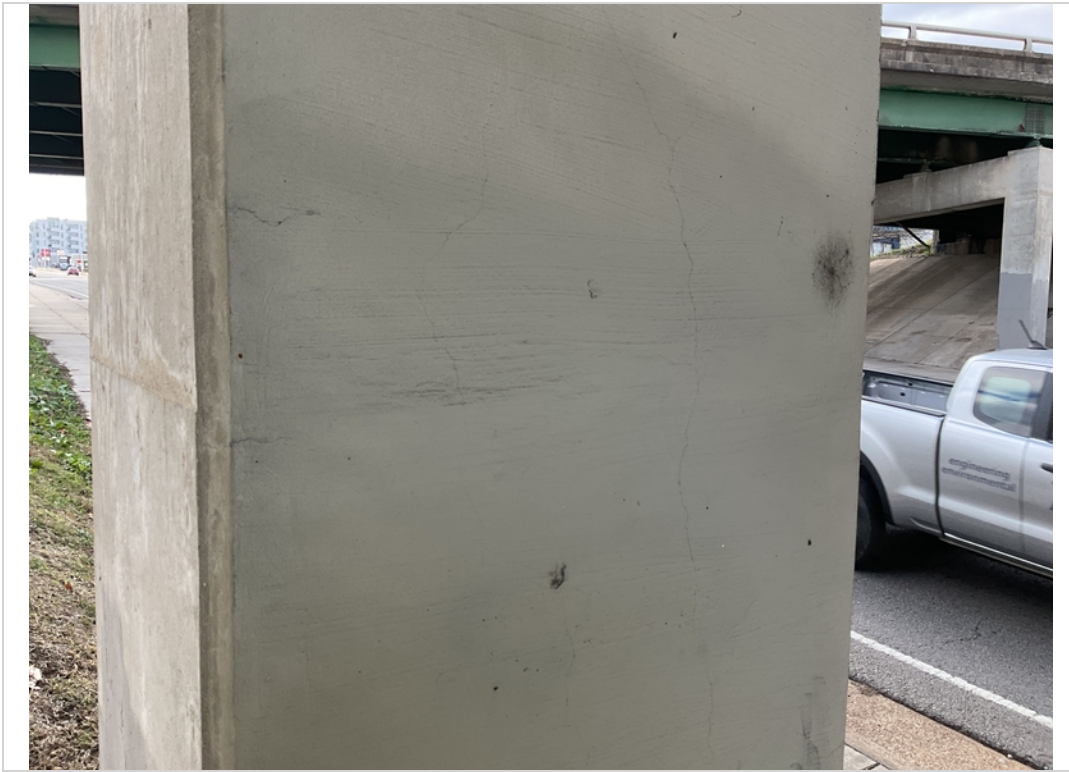
Bent 2 column C vertical crack
