140 RL / 8TH AVE (SR 6)

IDENTIFICATION	
(1) State Names	47 - Tennessee
(8) Structure Number	19I00400079
(5) Inventory Route	1
(2) Highway Agency District	Region 3
(3) County Code	19 - Davidson

INSPECTIONS *			
(90) Inspection Date	12/04/2023		
(91) Frequency	24		
(92) Critical Feature Inspection	Done	Freq. (Mon)	Date
A: Fracture Critical Detail	No		
B: Underwater Inspection	No		
C: Other Special Inspection	No		
<p>* The inspection date and frequency information in this box contains the current NBI date and frequency information. Please refer to the report header for the date this inspection was conducted.</p>

3 span Bridge / W.P.G.
I-40 EB / 8TH AVE (SR 6)

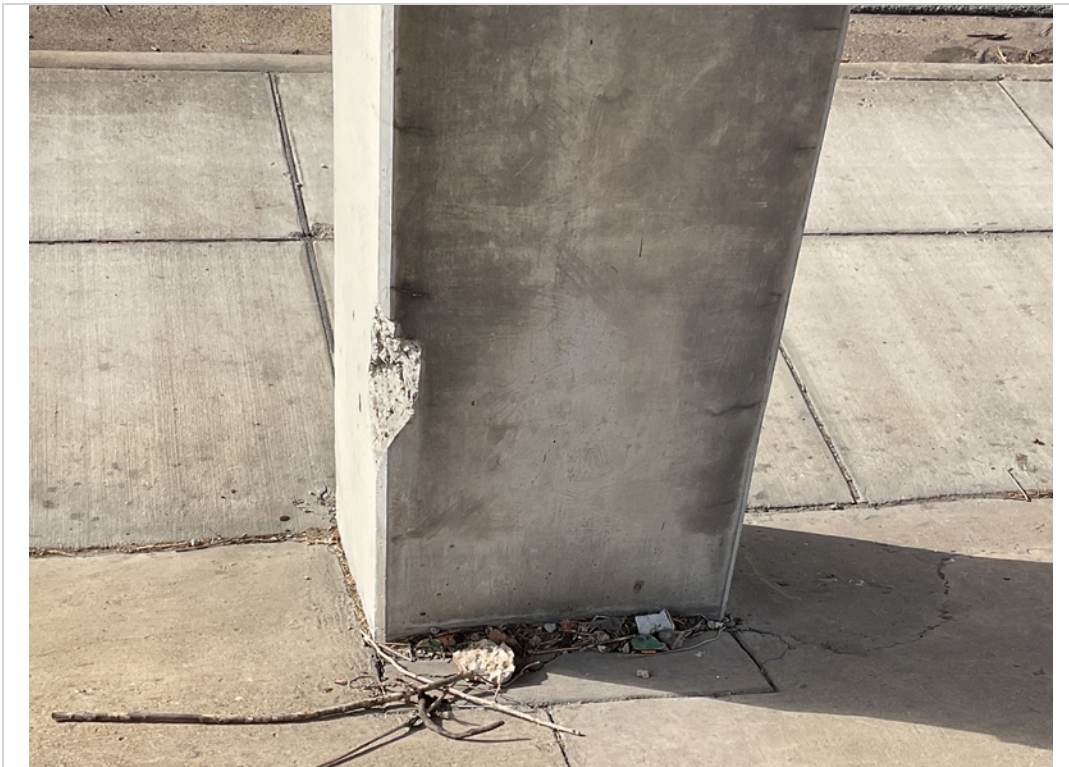
Bent 2 column B spall

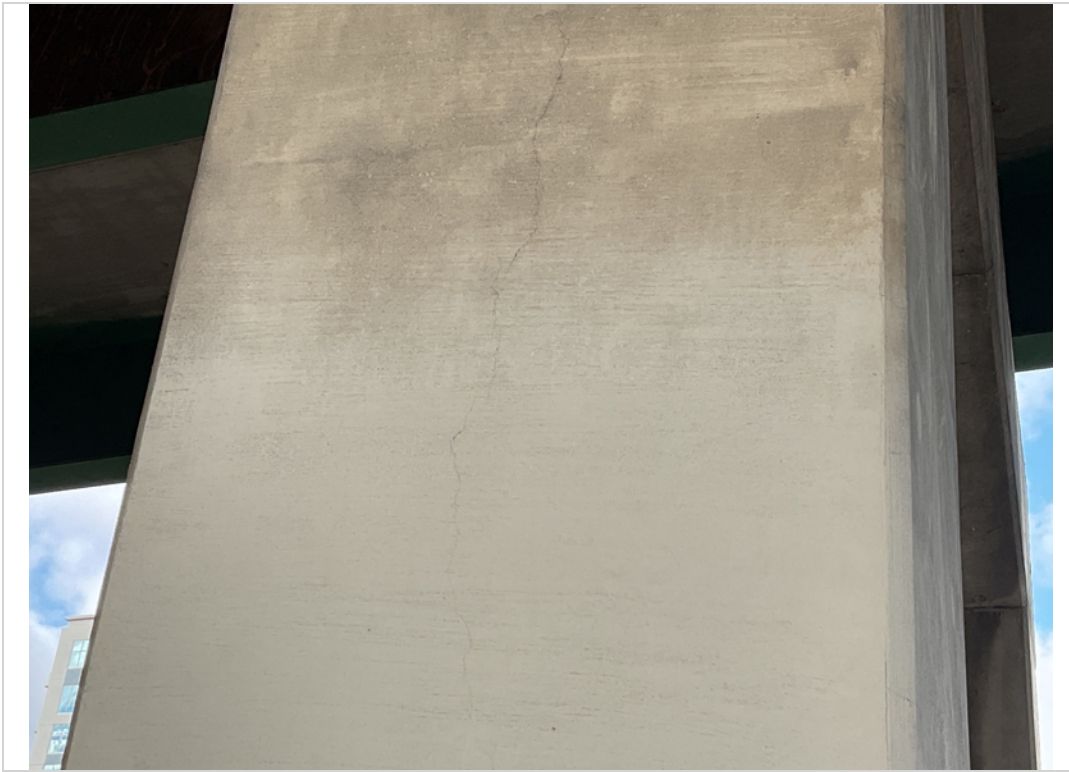
Bent 1 column B vertical crack

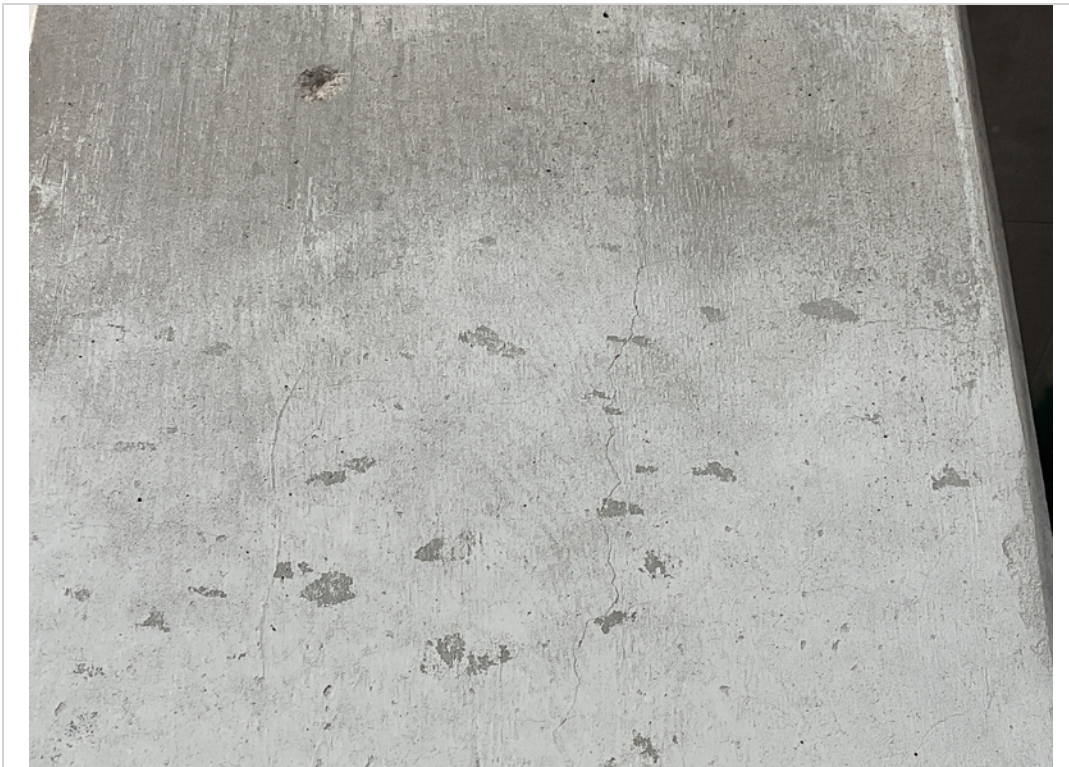
Bent 1 column C vertical crack

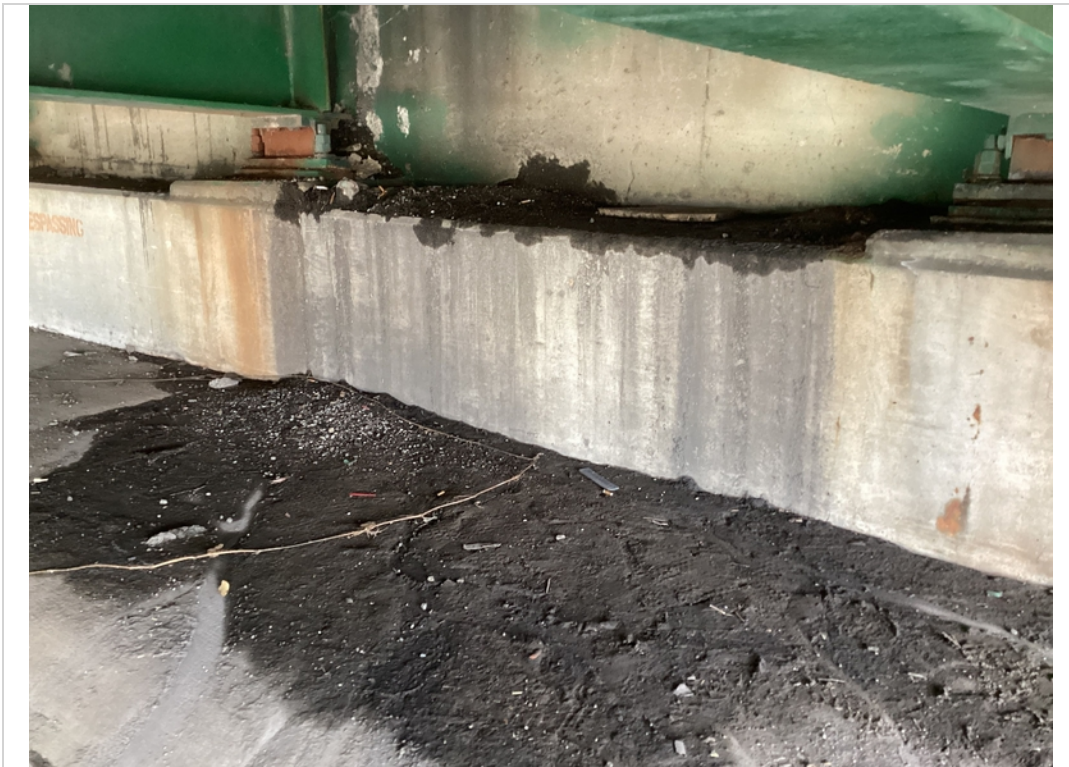
Abutment 1 debris on cap and slope pavement

Date Added	Recommendation	Priority
09/08/2017	REPAIR BEARING "A", "C", & "D" AT ABUTMENT #1	2
12/02/2021	CLEAN DECK SHOULDERS	
01/04/2016	CLEAN AND PAINT ALL STRUCTURAL STEEL	2
01/04/2016	REPAIR APPROACH GUARDRAIL @ "A" END LT.	
01/04/2016	CLEAN EXPANSION JOINT @ "A" END	
01/04/2016	CLEAN DEBRIS FROM ABUTMENT CAPS	
01/04/2016	TEXTURE COAT BRIDGE RAIL	
01/04/2016	REPAIR UNDERPASS LIGHTING	
12/01/2017	REPAIR EROSION LEFT SIDE OF SLOPE PAVEMENT AT ABUTMENT #1

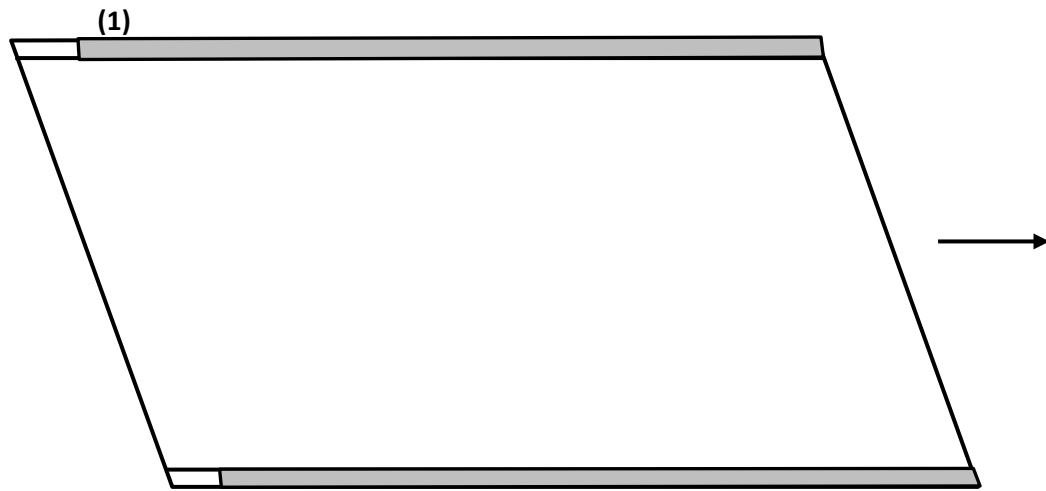
Approach 'B'

G.RAILS	GOOD	(1) LIGHT IMPACT DAMAGE
PAVEMENT	GOOD	
EMBANKS	GOOD	
PARAPETS	GOOD

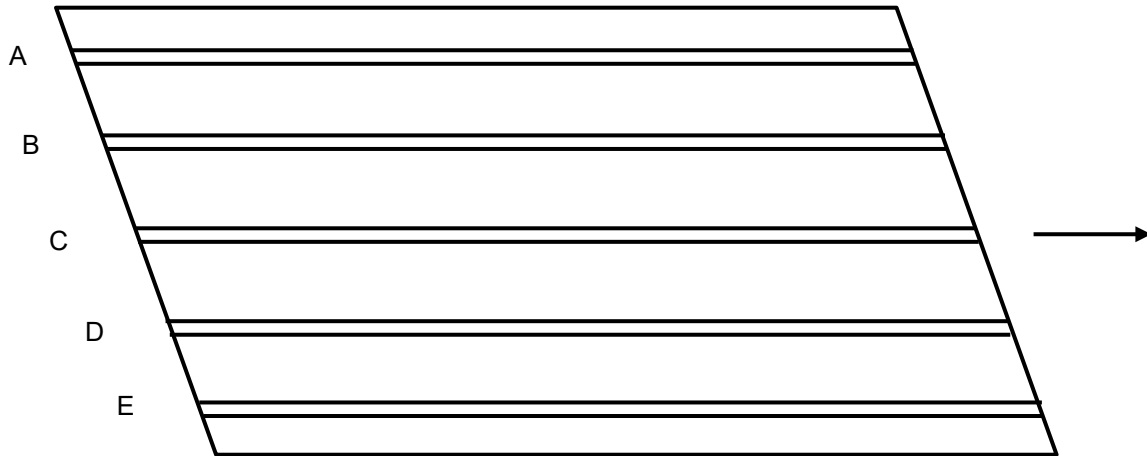
Bottom of Slab Span No. 1

DECK	GOOD	
DIAPHRAGMS	GOOD	LIGHT SURFACE RUST
BEAMS	FAIR	SURFACE RUST - ALL BEAMS
PAINT	POOR	LARGE AREAS OF PEELING BM'S B, C, D & E & DIAPHRAGMS
OVERHANGS	GOOD

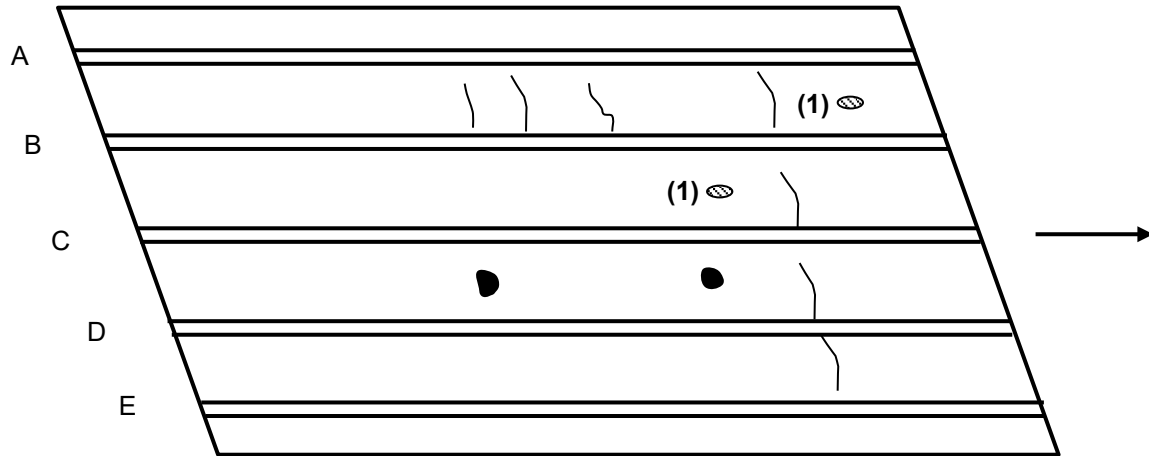
Bottom of Slab Span No. 2

DECK	FAIR	(1) SPALLS W/ EXP STL UPTO 1'D X 1"DP; LGT TRANS HCs W/EFF
		@ BAY "A"
DIAPHRAGMS	GOOD	
BEAMS	FAIR	SURFACE RUST- ALL BEAMS
OVERHANG	FAIR	EFF. & LEACHING
PAINT	POOR	AREAS OF COMPLETE PAINT LOSS, ALL BEAMS
OVERHANGS	GOOD

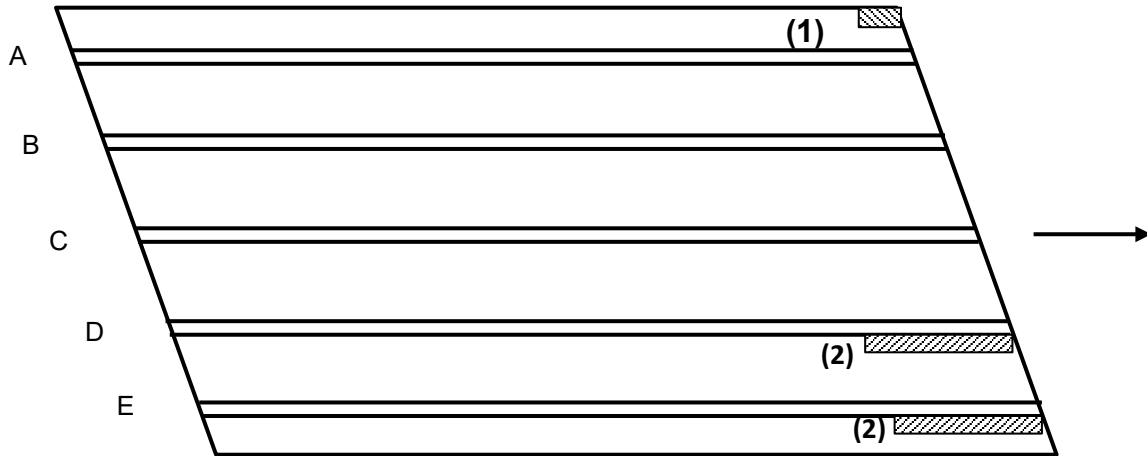
Bottom of Slab Span No. 3

DECK	GOOD	(1) PATCH; (2) SPALLS TOP FLANGE UPTO 10' LENGTH
DIAPHRAGMS	GOOD	
BEAMS	FAIR	AREAS OF HVY PAINT LOSS W/ SURFACE RUST
'D' & 'E'	FAIR	LGH-MOD CORR. 6' L FROM ABUT. W/ LGH SECT. LOSS - TOP
		FLANGE
PAINT	POOR	HVY LOSS AREAS
OVERHANGS	GOOD
