Region 03, 19 - Davidson County

I40 LL / 8TH AVE (SR 6)

| IDENTIFICATION | |
|---|---|
| (8) Structure Number | 19I00400080 |

3 span Bridge / W.P.G.
I-40 WB / 8th AVE (SR 6)

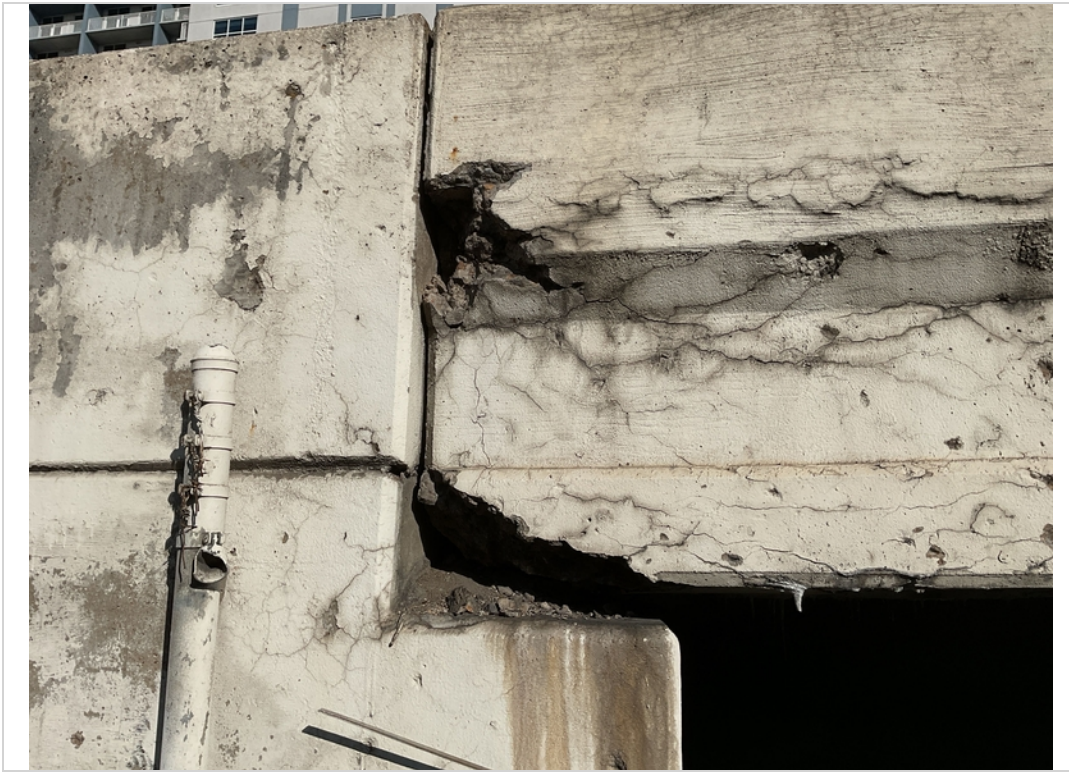
Bridge rail span 1 spall

| Date Added | Recommendation | Priority |
|---|--|---|
| 01/05/2016 | REPAIR PARAPET ALL SPANS | |

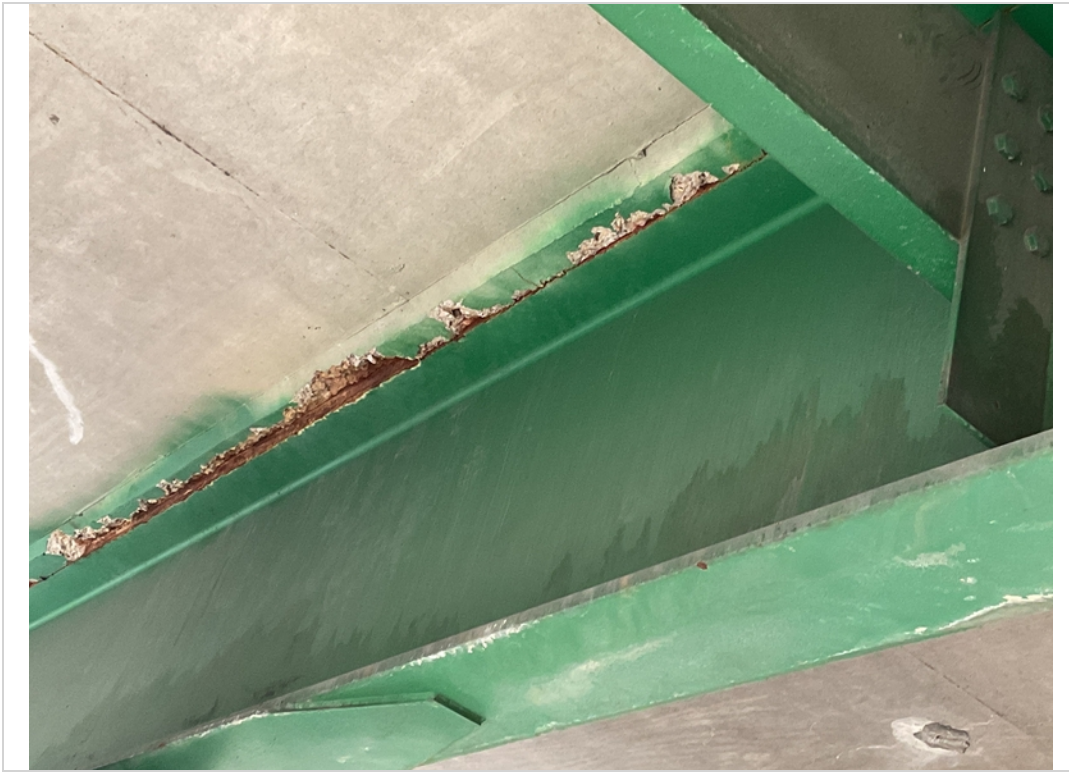
Span 3 bay D spalling at top flange of C

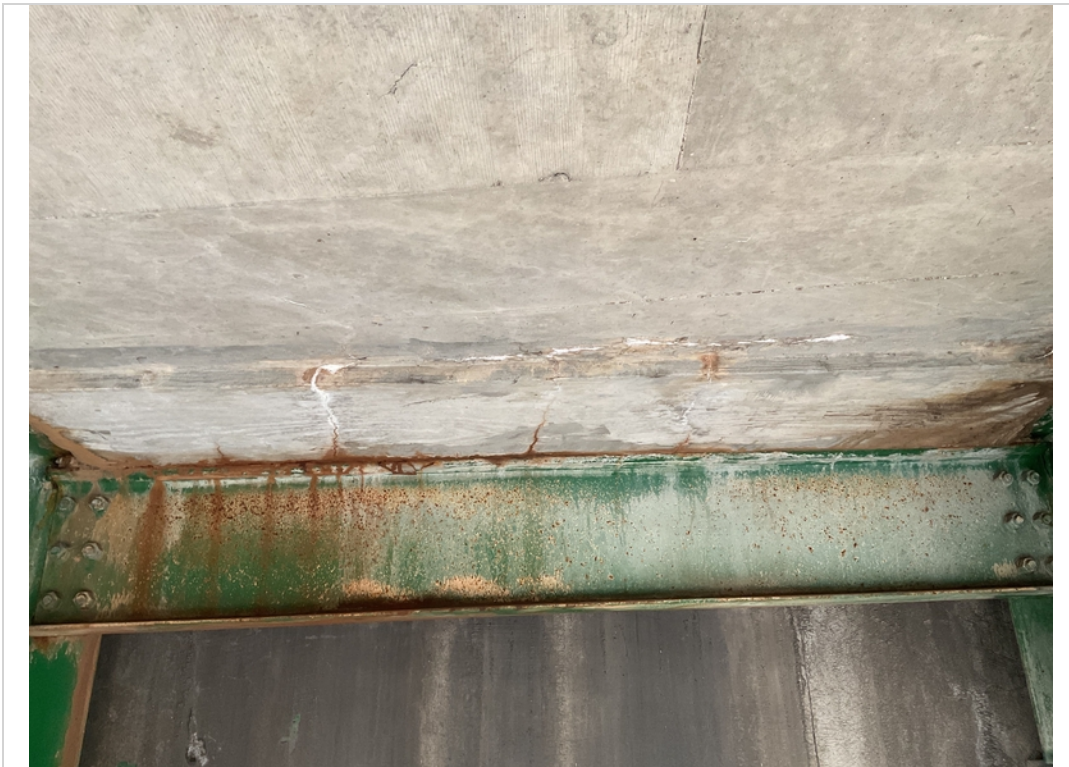
Span 3 bay D failing patch with eff

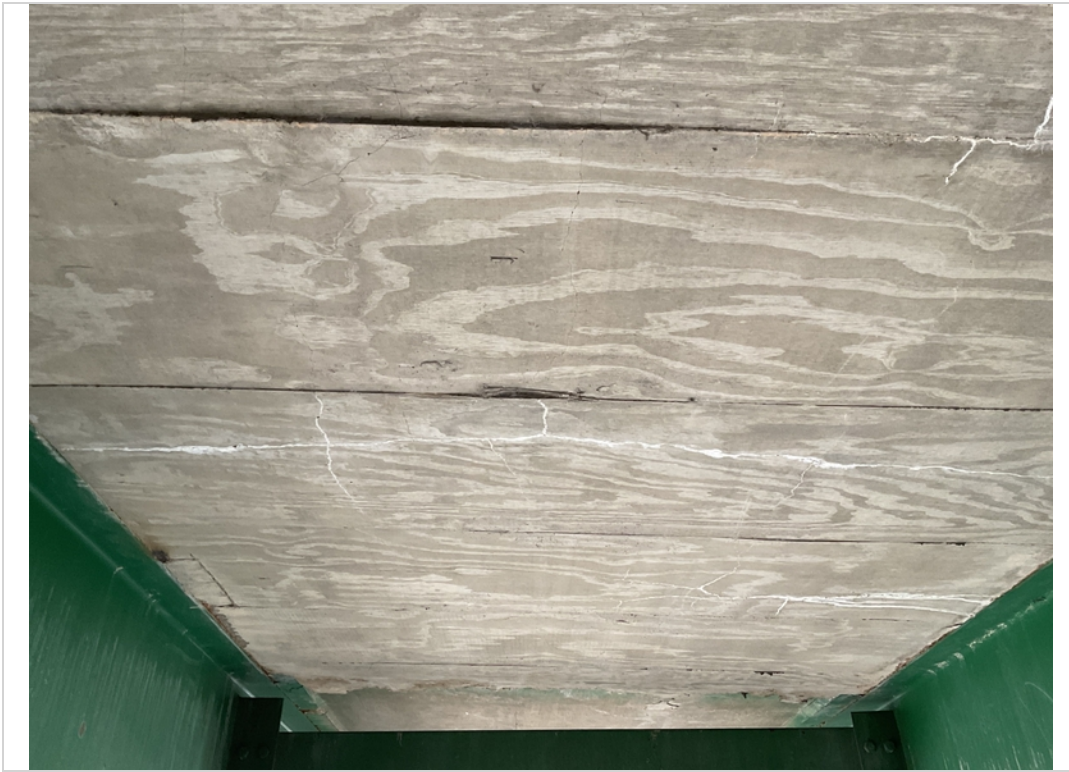
Span 3 bay C random map cracks with eff

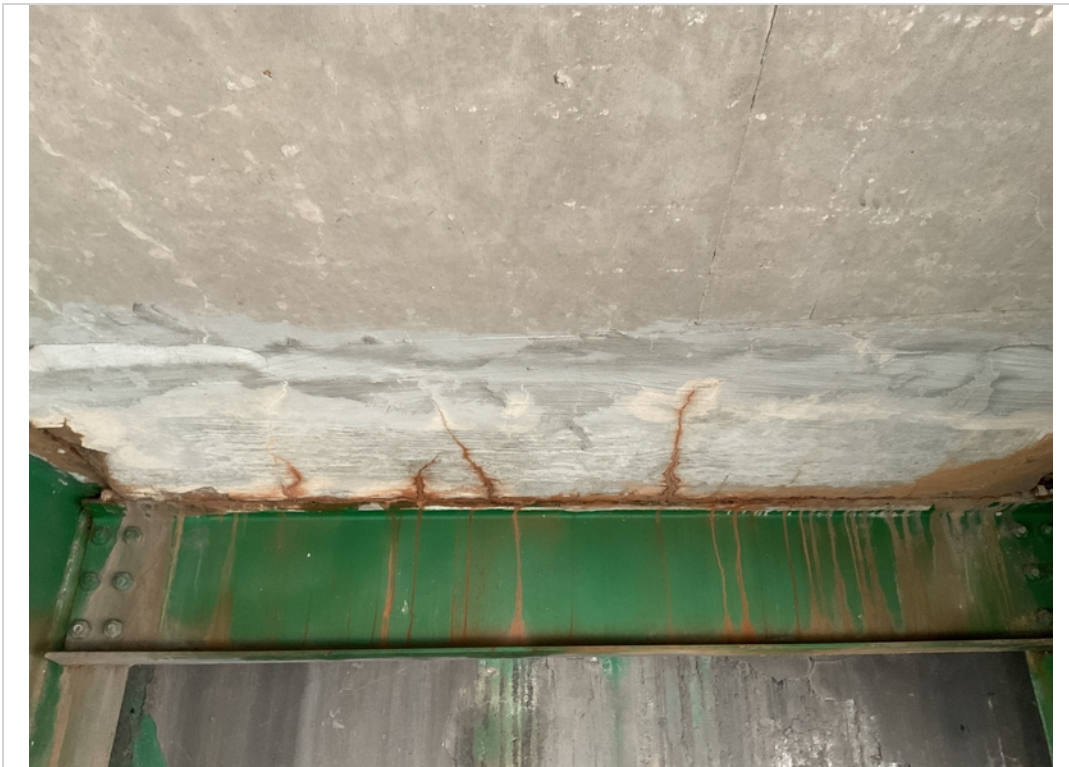
Span 3 bay C failing patch with eff

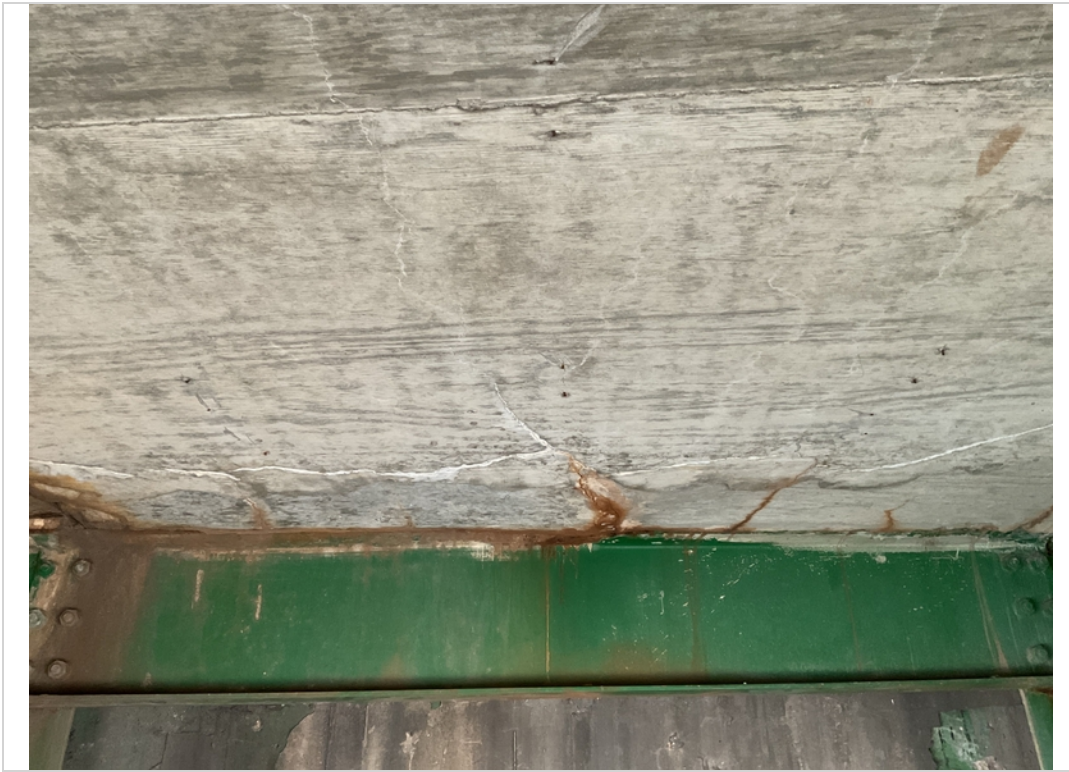
Span 3 bay B failing patch with eff

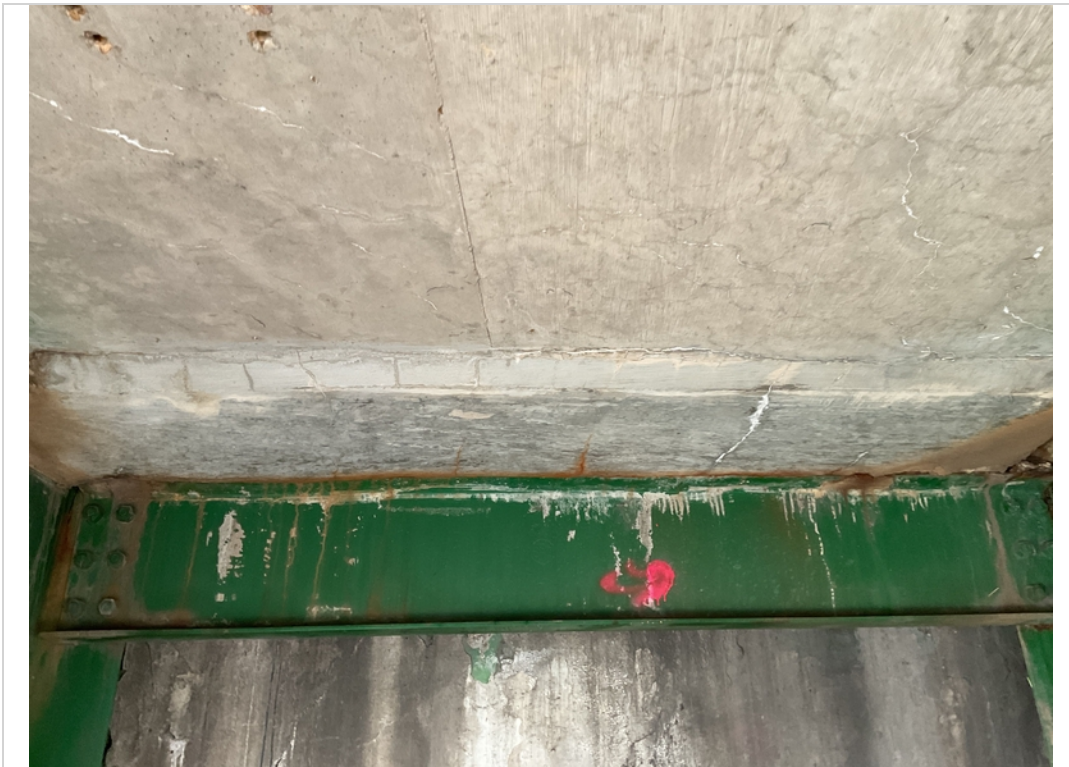
Span 3 bay A failing patch will eff

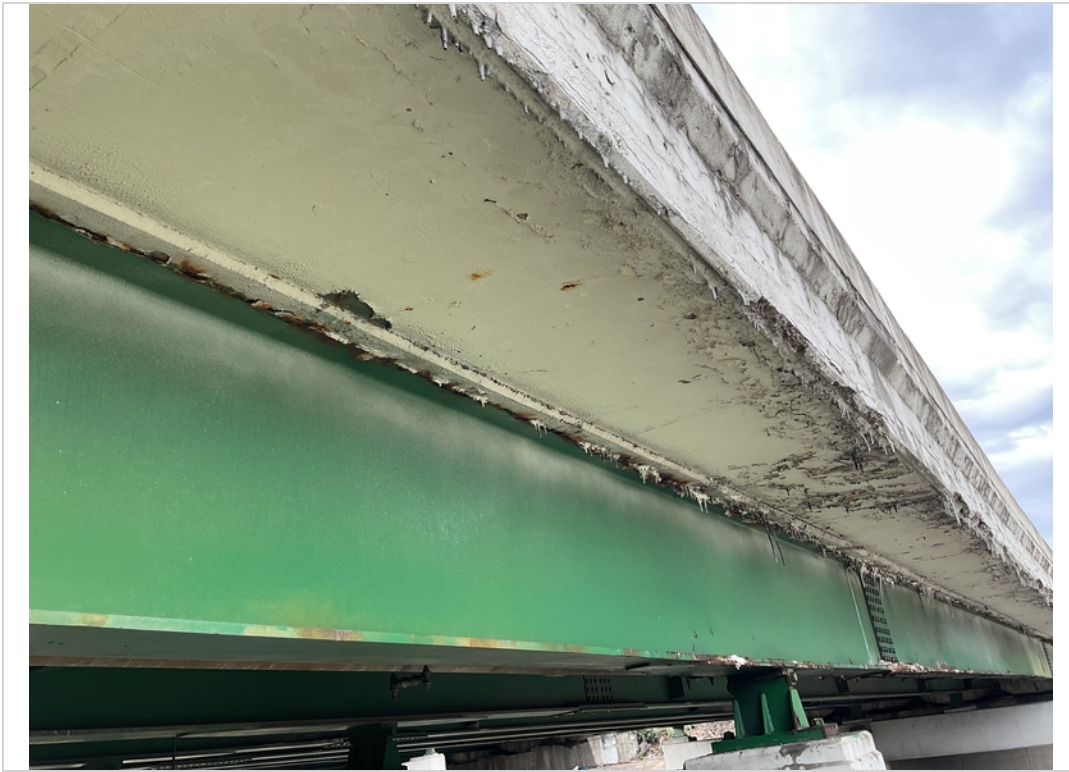
Overhang span 3 left side scale with eff

| Date Added | Recommendation | Priority |
|---|--|---|
| 01/05/2016 | REPAIR OVERHANGS ALL SPANS | 2 |

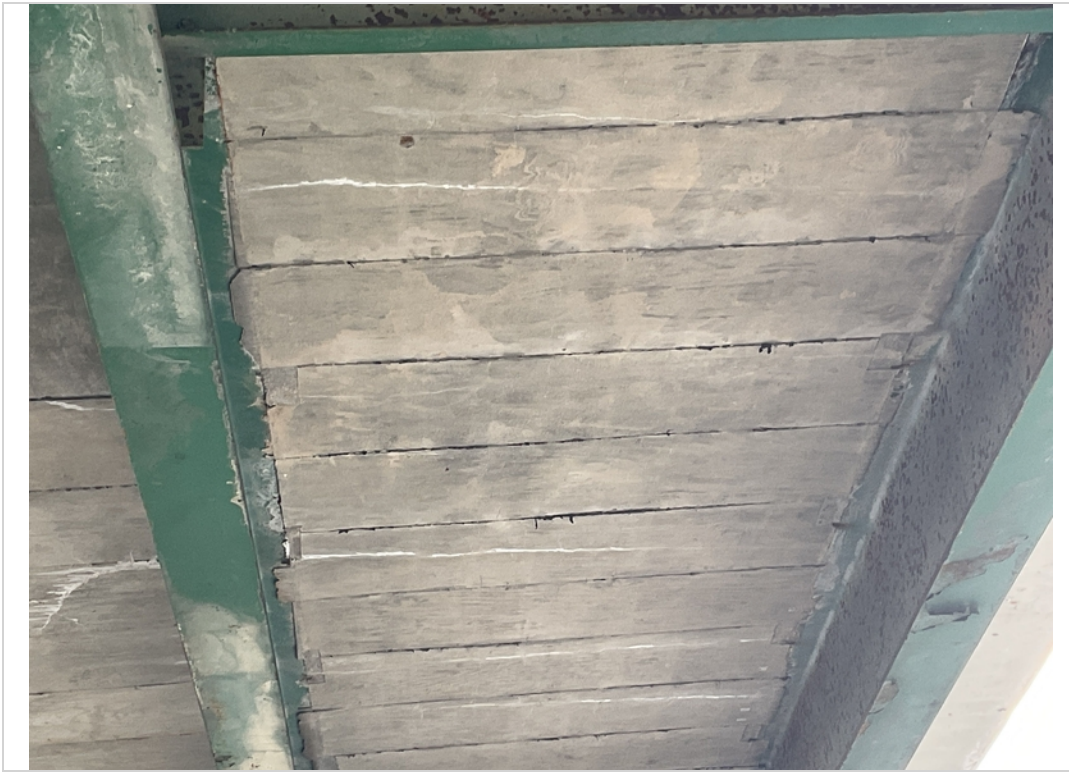
Span 2 bay D random trans cracks with eff

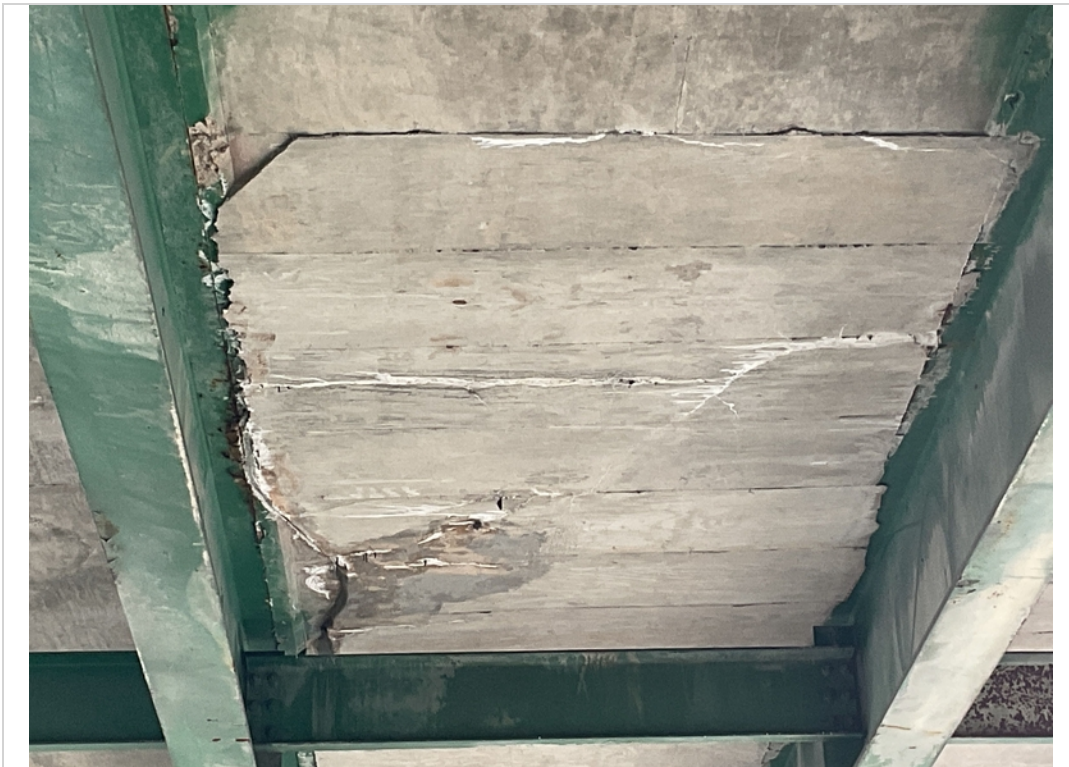
Span 2 bay C failing patch with eff

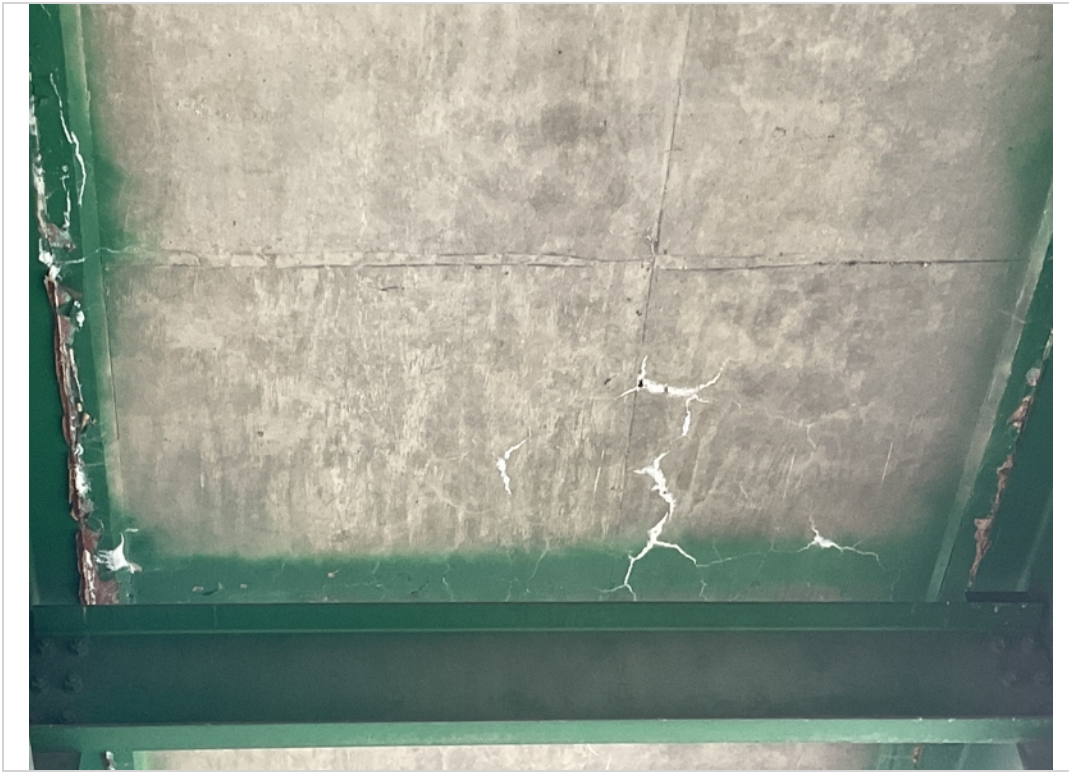
Span 2 bay C random map cracks with eff

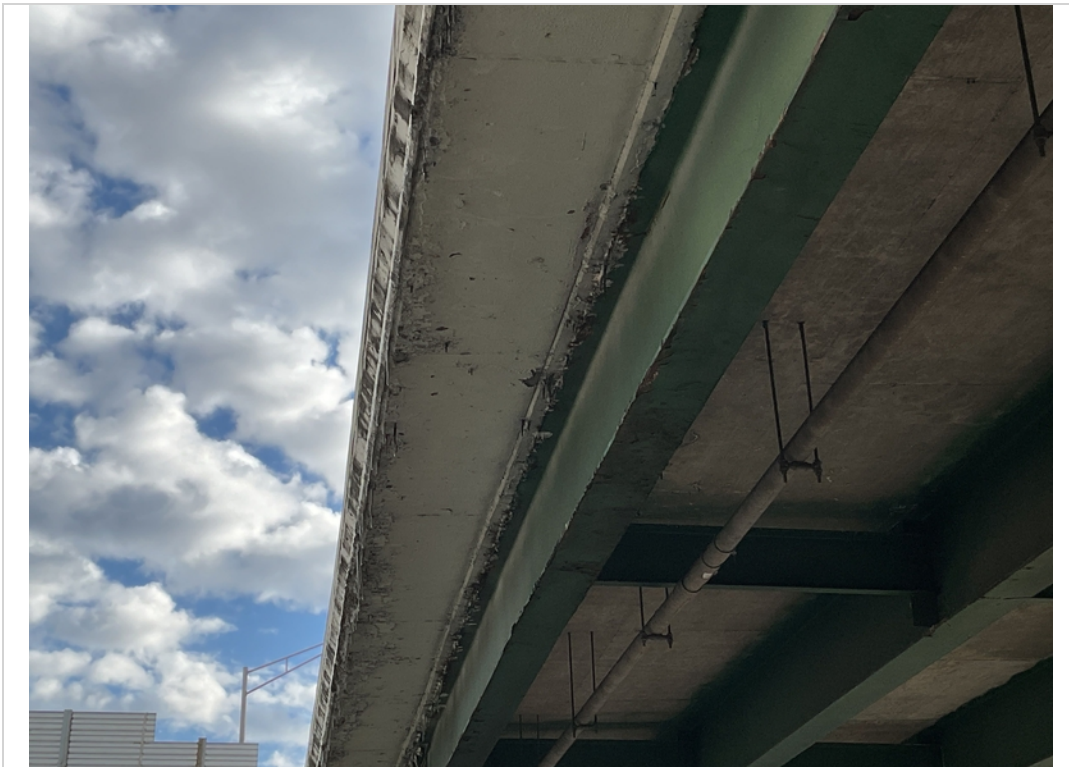
Overhang span 2 left side map cracks with eff

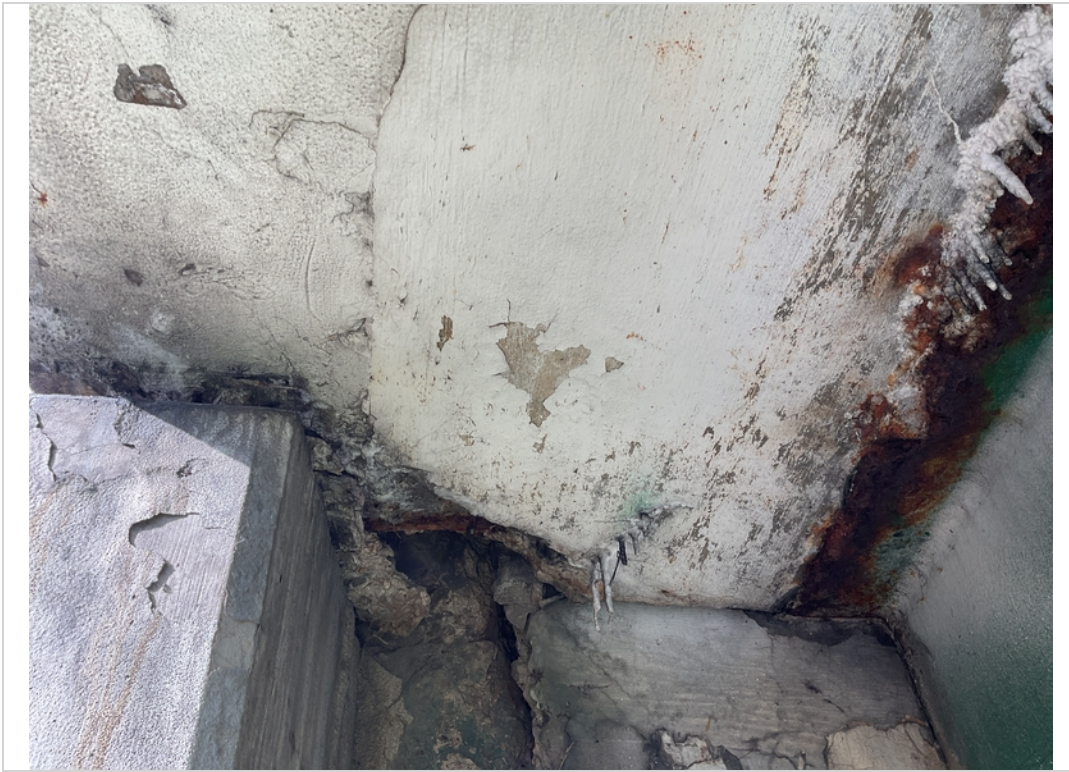
Overhang span 1 right side spall with exp steel

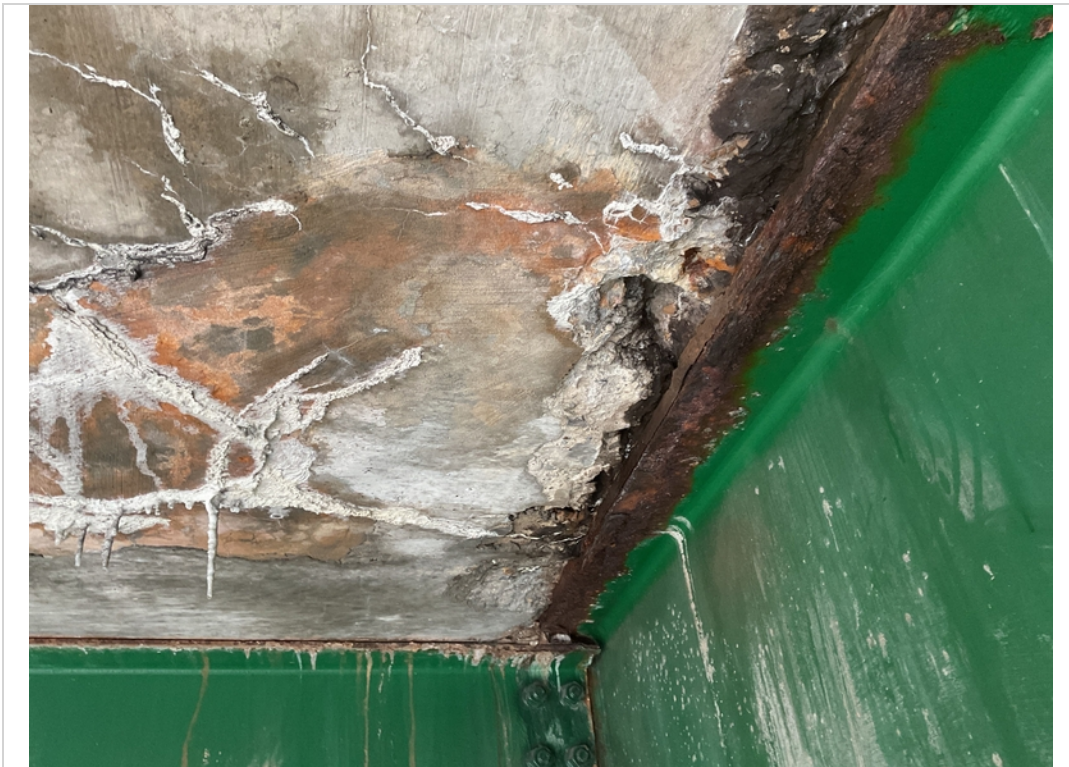
Span 1 bay D failing patch with spalling

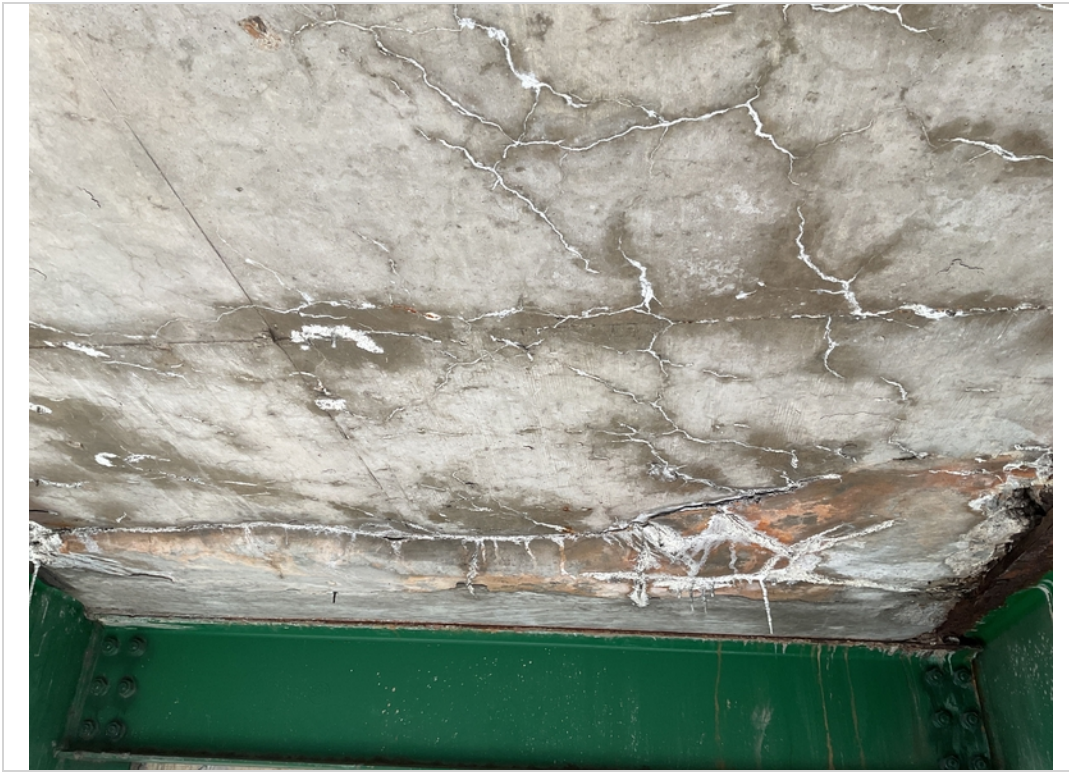
Span 1 bay D failing patch with eff

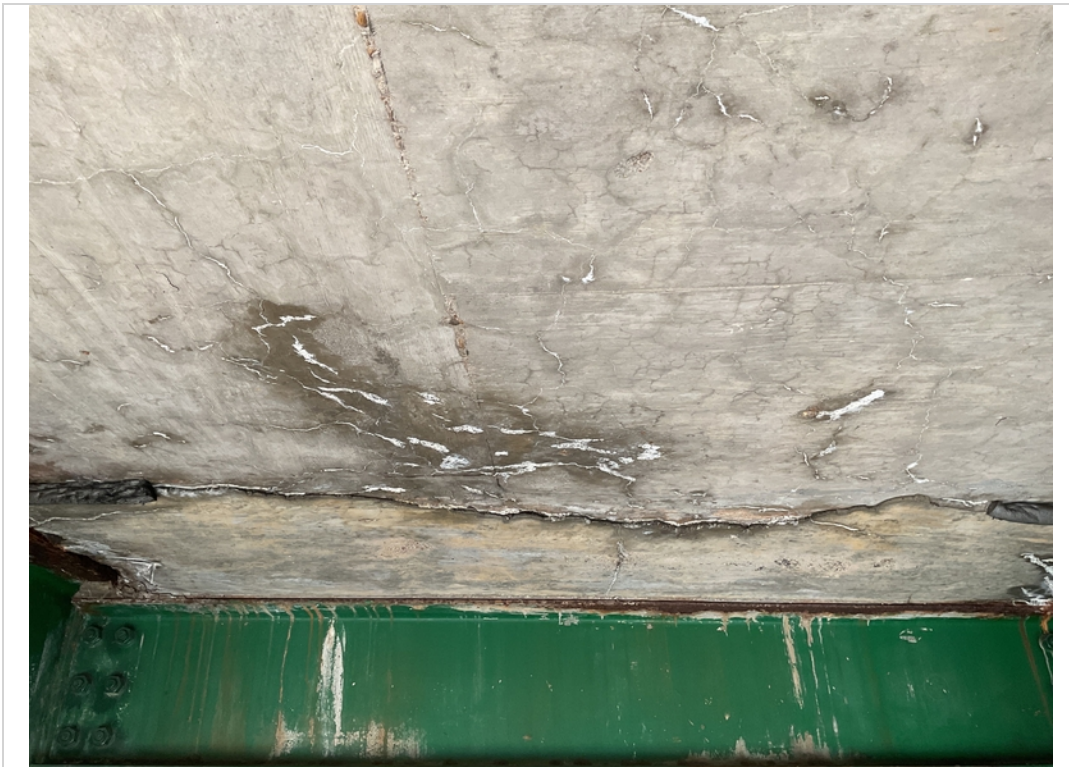
Span 1 bay C random map cracks with eff

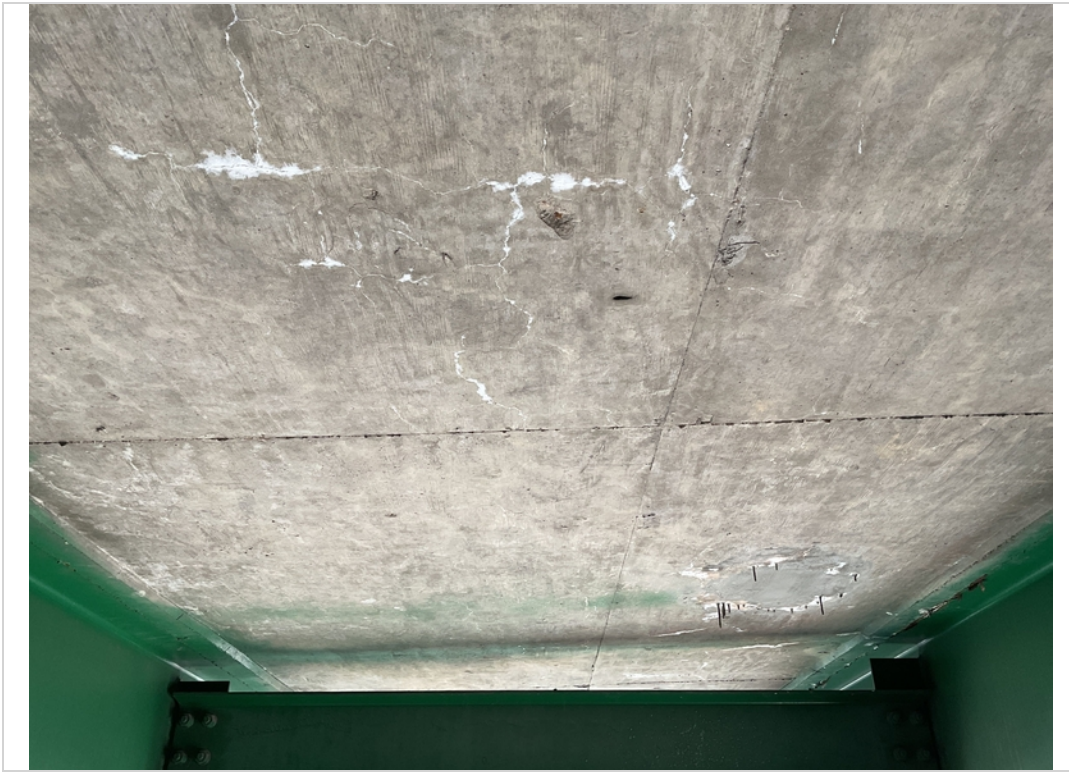
Span 1 bay B random map cracks with eff

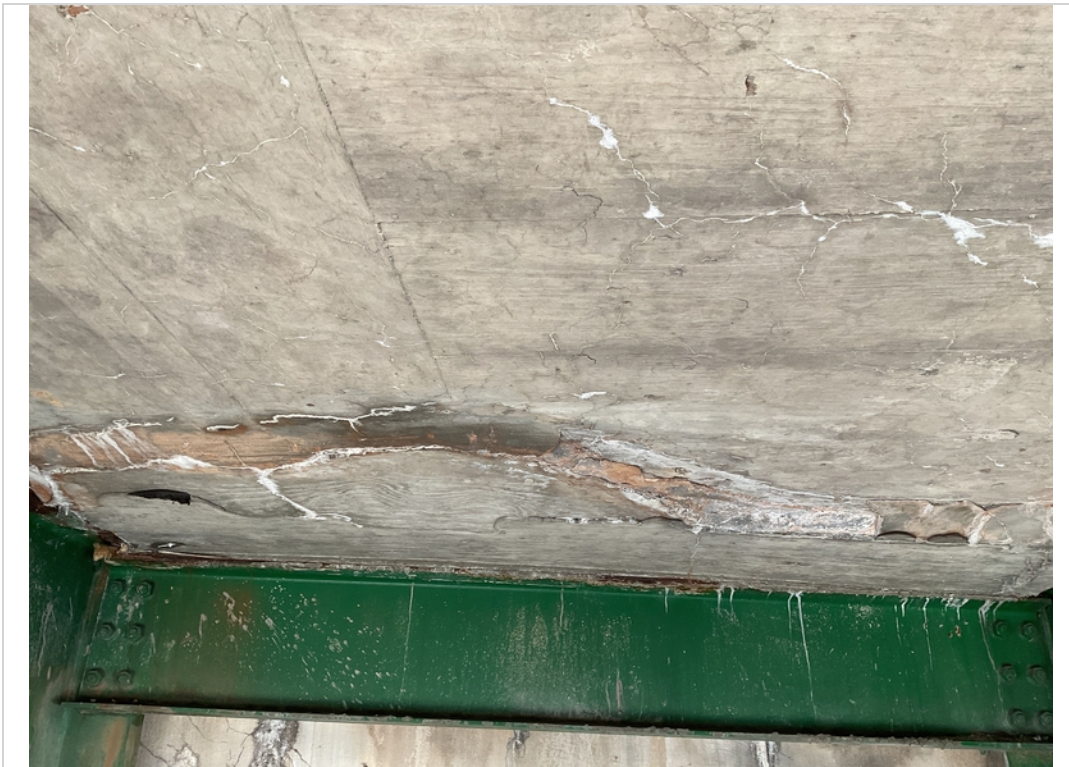
Span 1 bay B failing patch with eff

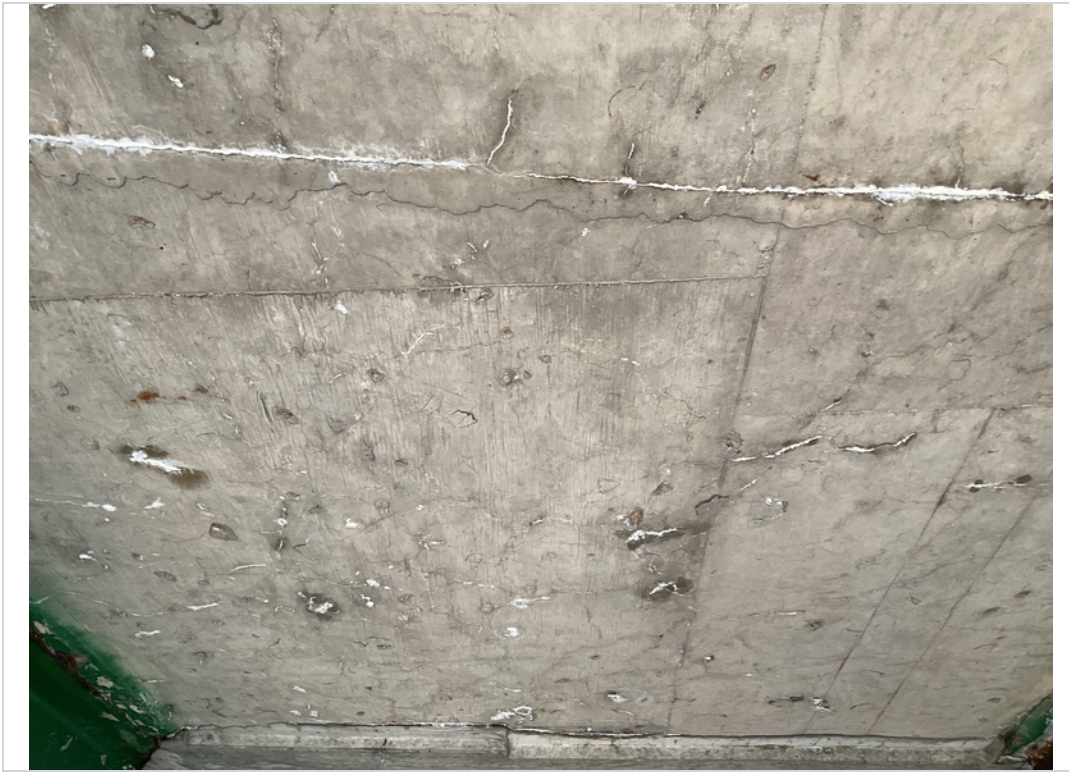
Span 1 bay A random map cracks with eff

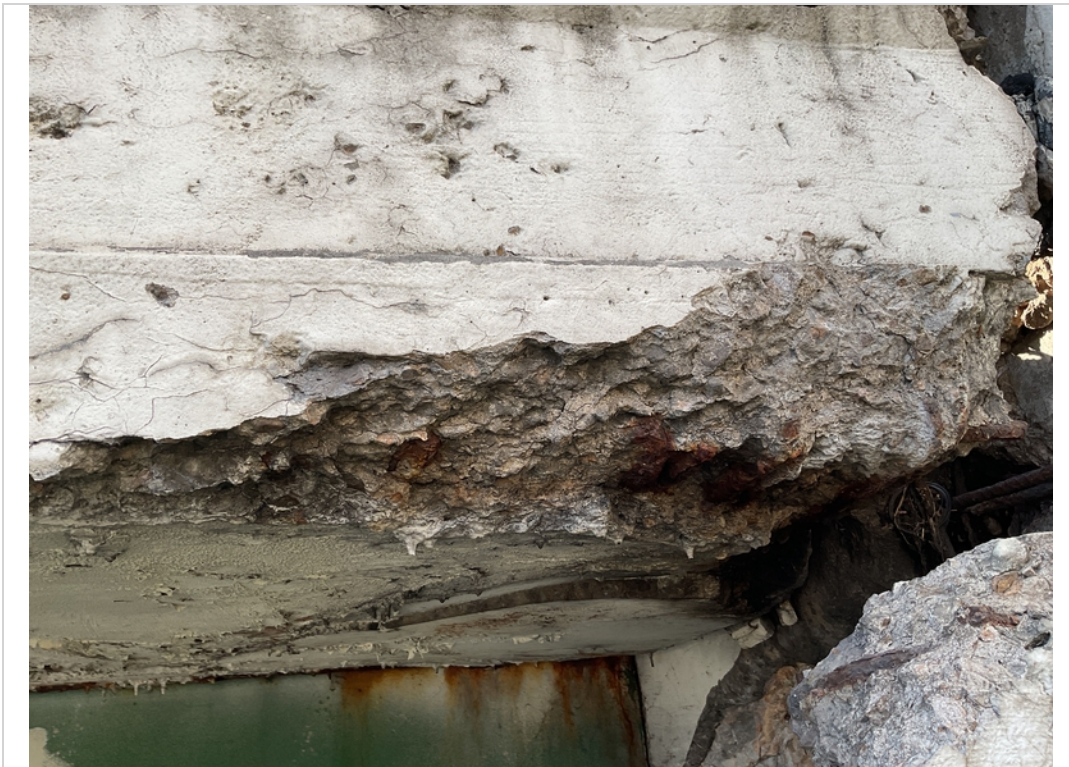
Overhang span 1 heavy scale with exp steel

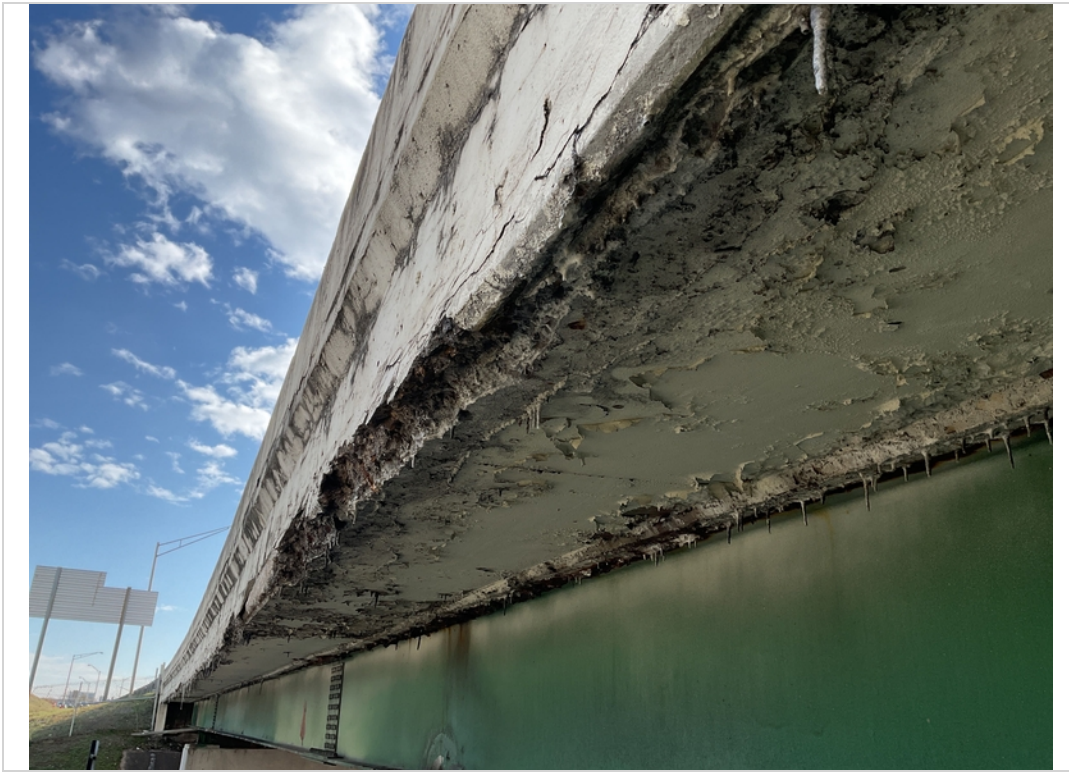
Overhang span 1 left side heavy scale with eff

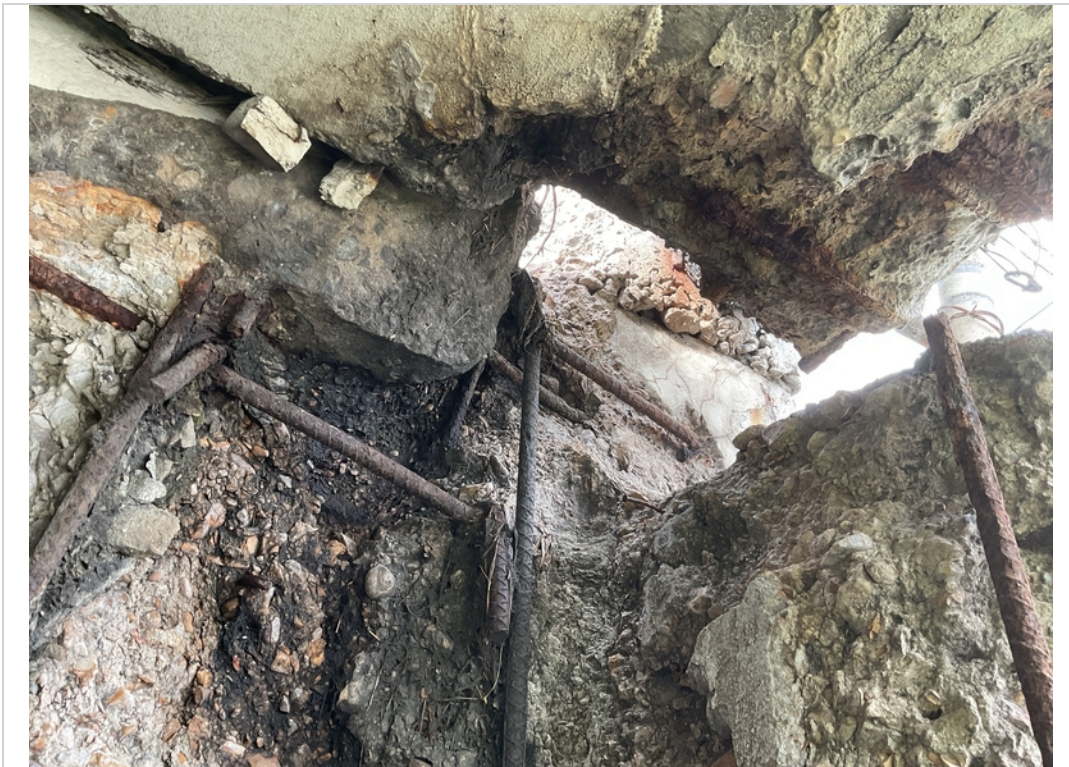
Overhang at Abut 1 left side and spall w/exp steel

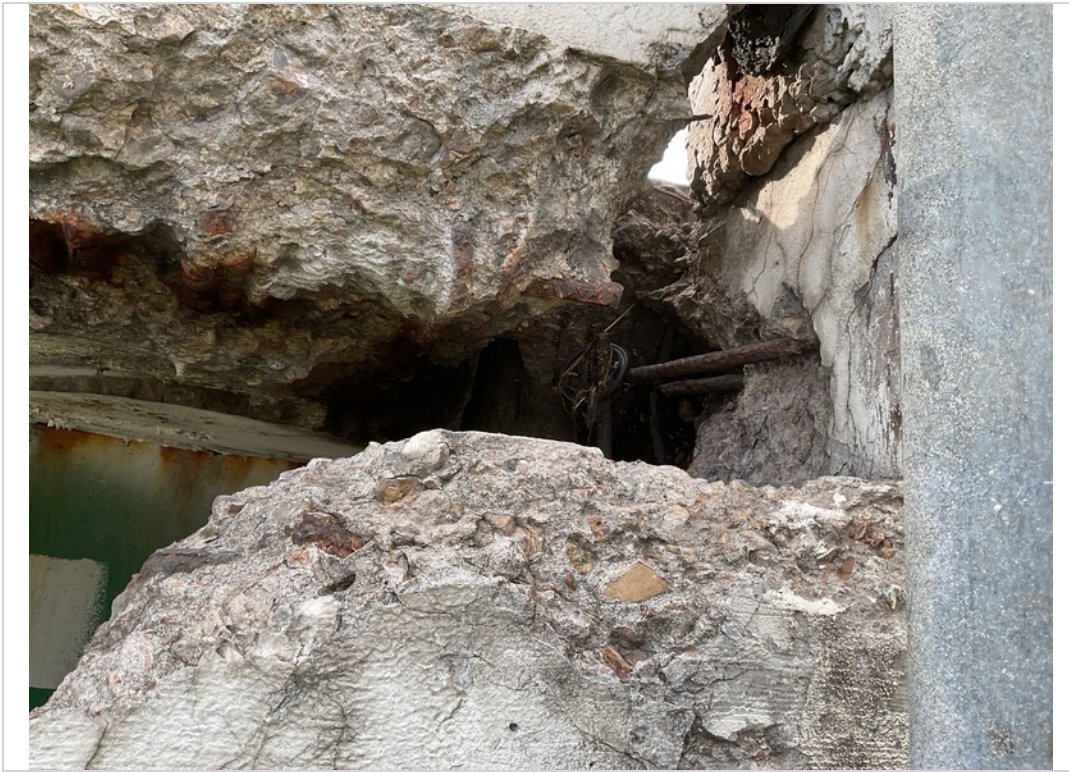
Abut 1 left overhang and back wall spalls w/exp steel and hvy scale

| Date Added | Recommendation | Priority |
|---|--|---|
| 01/05/2016 | REPAIR BACKWALLS AT ABUTMENTS | 2 |

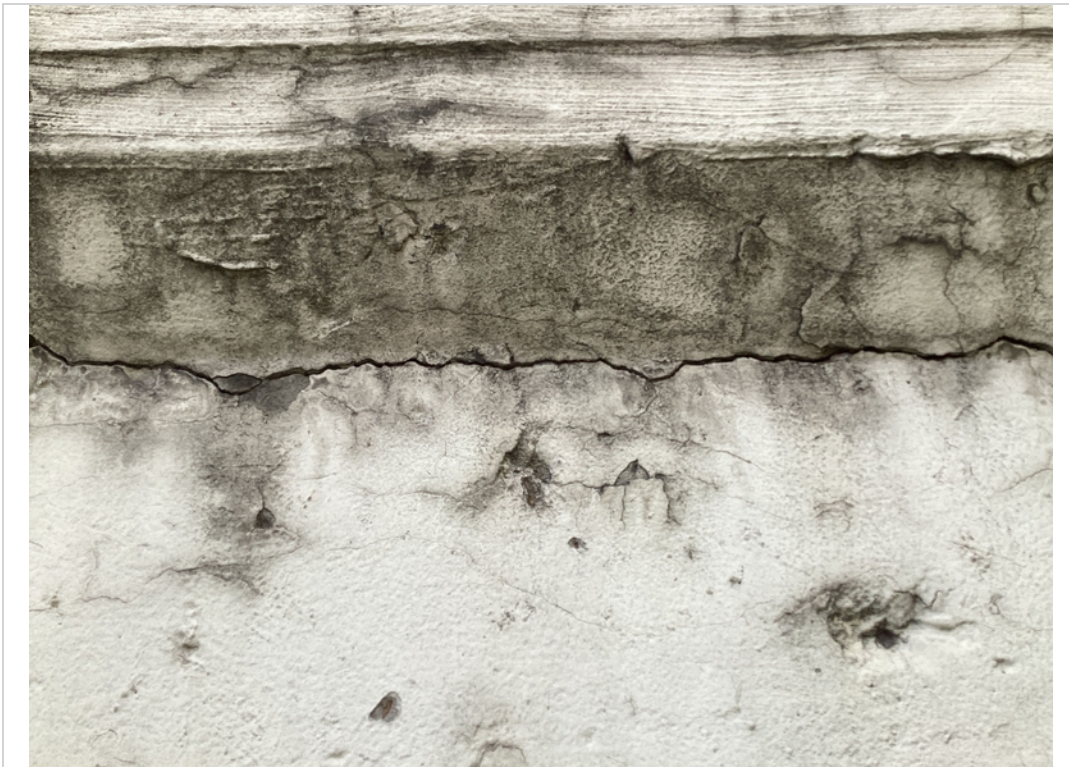
Parapet left cracks

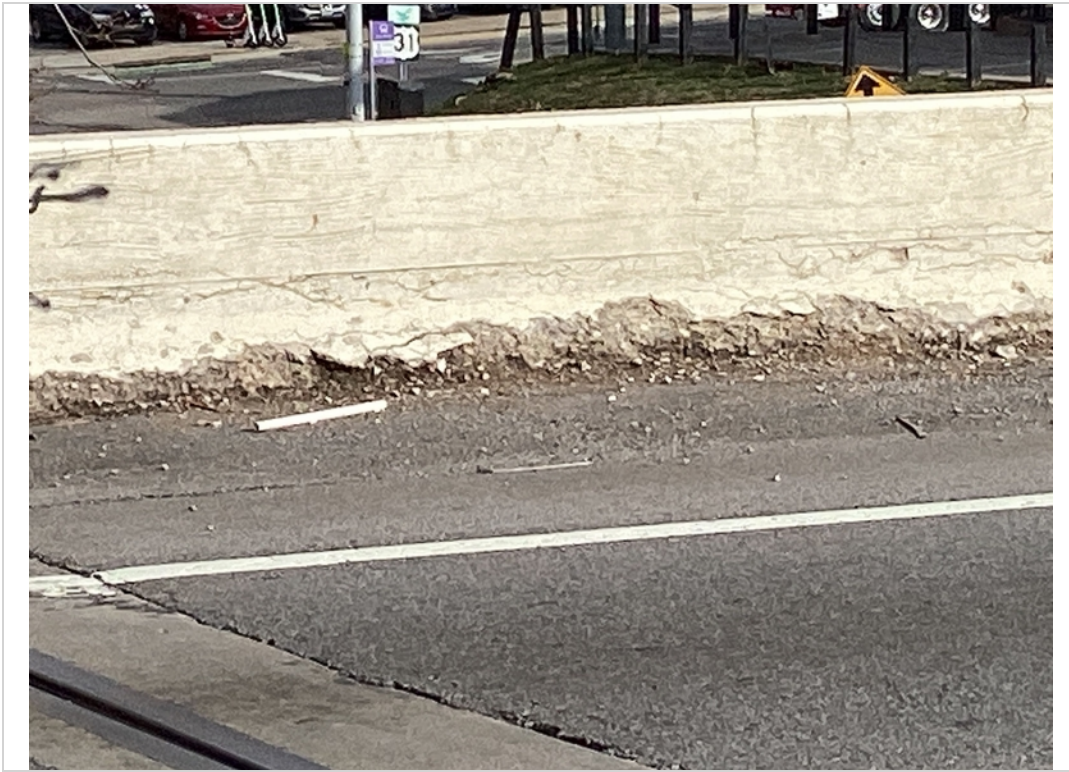
Span 1 and 2 parapet left heavy scale

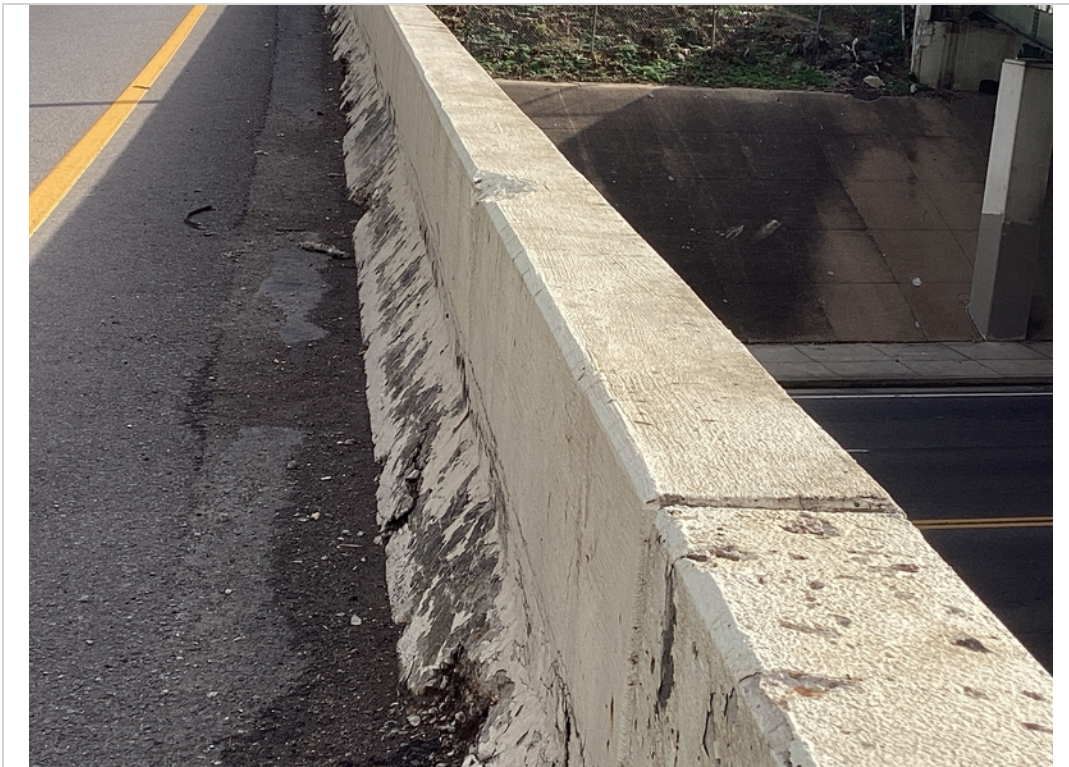
Span 1 parapet right spall

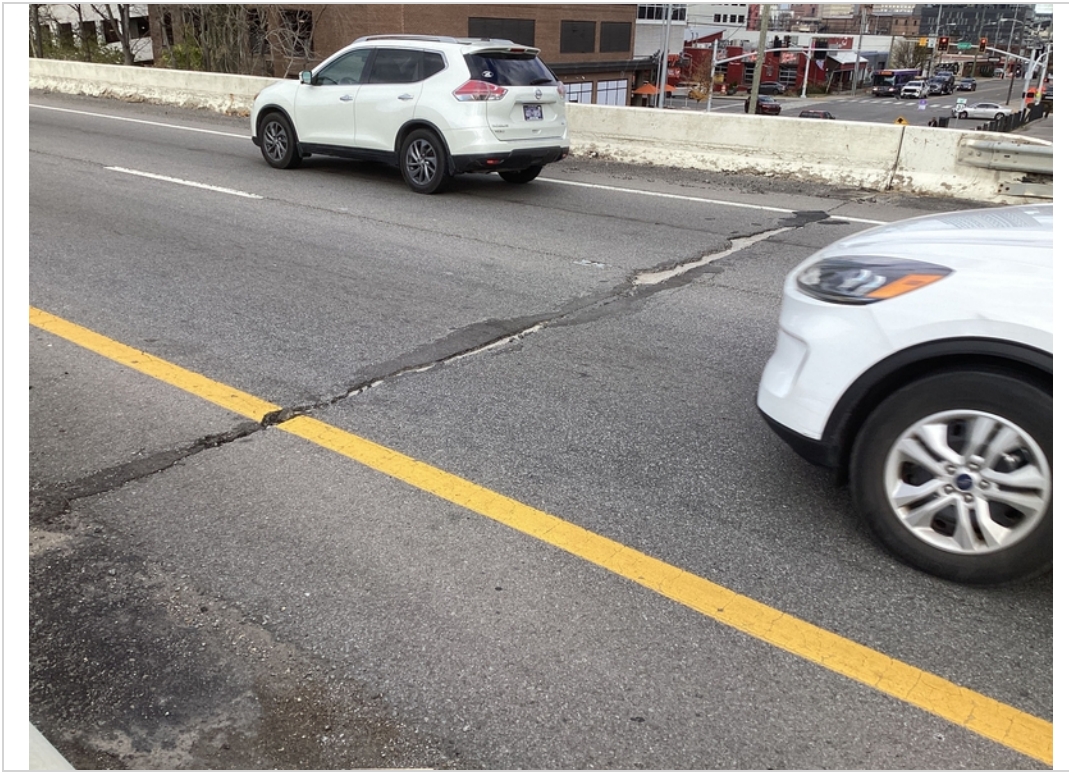
Span 3 joint paved over with light potholes

| Date Added | Recommendation | Priority |
|---|--|---|
| 01/05/2016 | REPAIR JOINT @ "B" END | |
