Region 03, 19 - Davidson County

I40 LL / 8TH AVE (SR 6)

| IDENTIFICATION | |
|---|---|
| (8) Structure Number | 19I00400080 |

3 span Bridge / W.P.G.
I-40 WB / 8th AVE (SR 6)

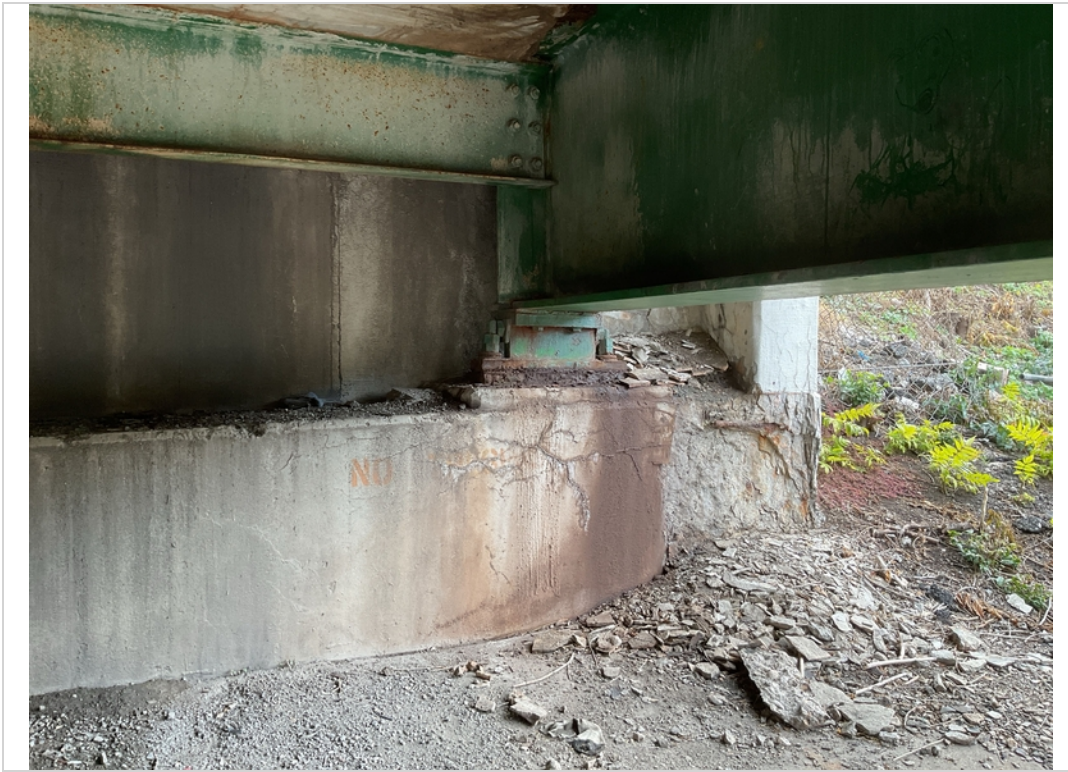
Abut 2 bearing A loose anchorage all bearings rocked rack w/
Hvy debris

| Date Added | Recommendation | Priority |
|---|--|---|
| 01/05/2016 | REPAIR BEARING 'A' - 'E' ABUT #2 | 1 |

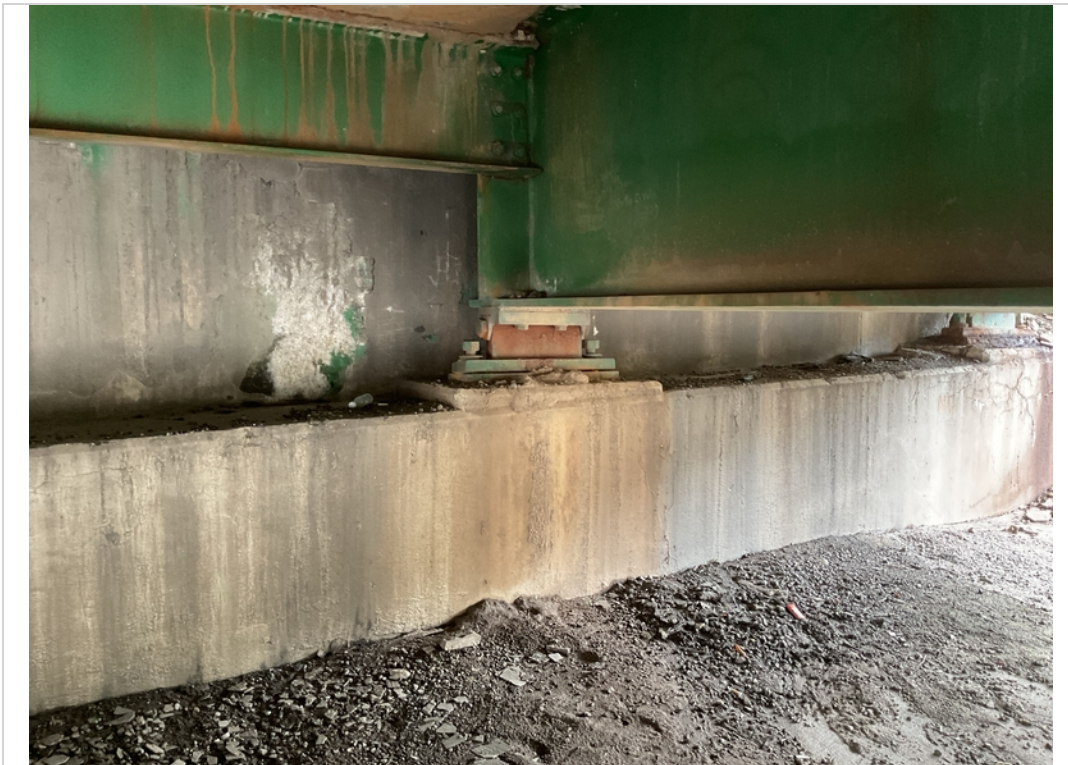
Abut 2 Bearing B corrosion loose anchorage

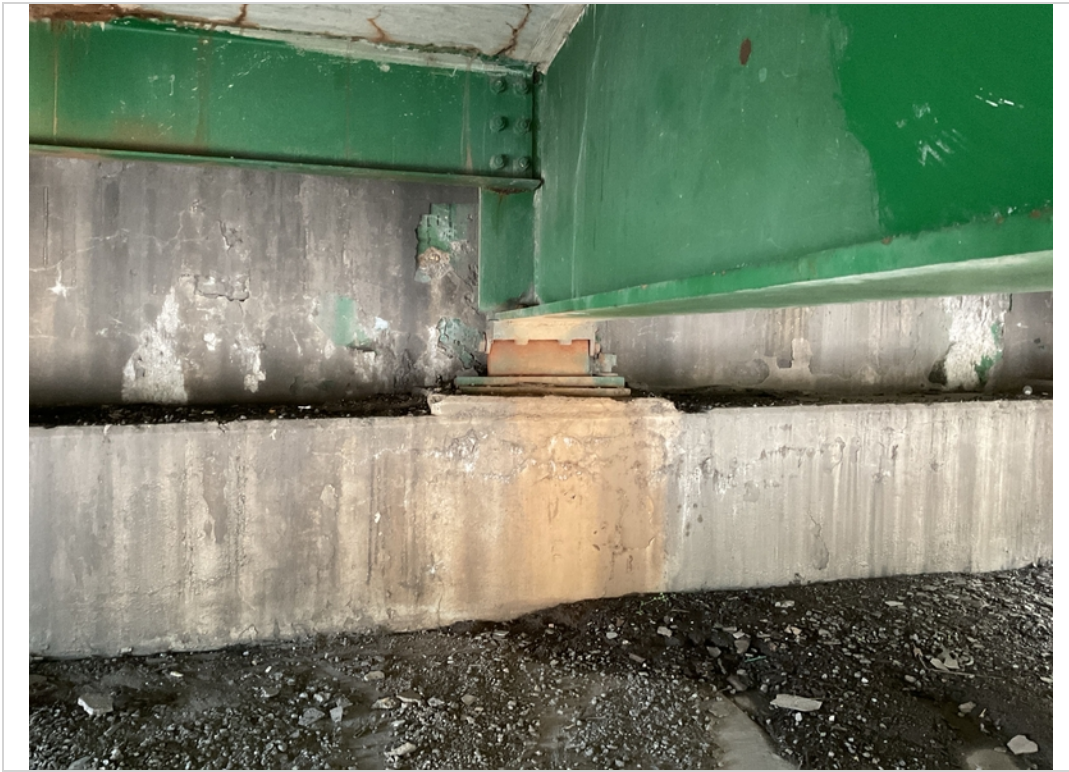
Abut 2 Bearing C missing bolt loose anchorage corrosion

| 'C' | CRITICAL | MISSING ANCHOR BOLT, LOOSE NUT, LOOSE/BROKEN PIN, |

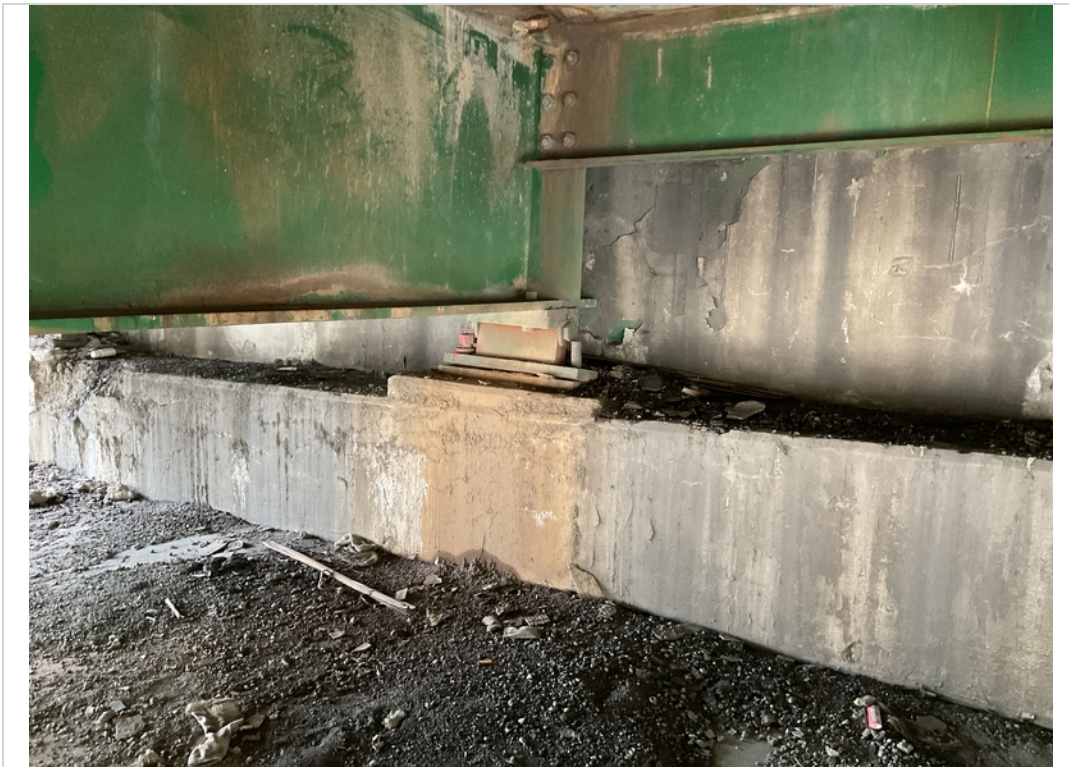
Abut 2 bearing B loose anchorage. Missing nut corrosion

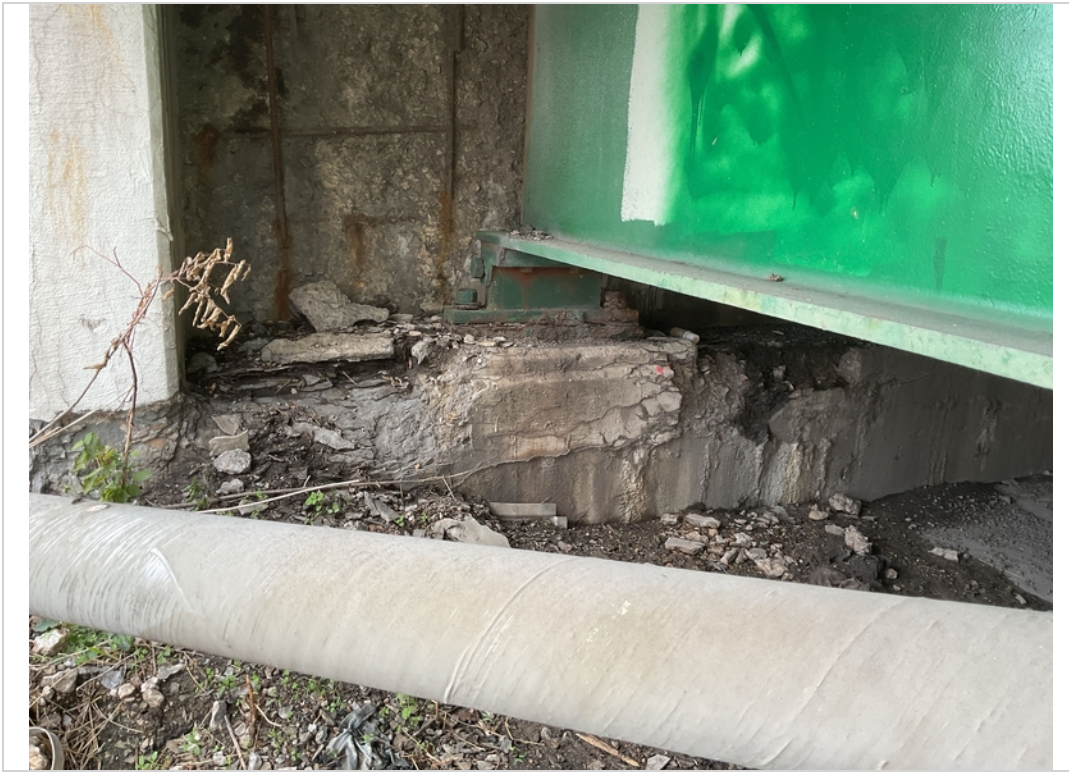
Abut 2 bearing A corrosion.

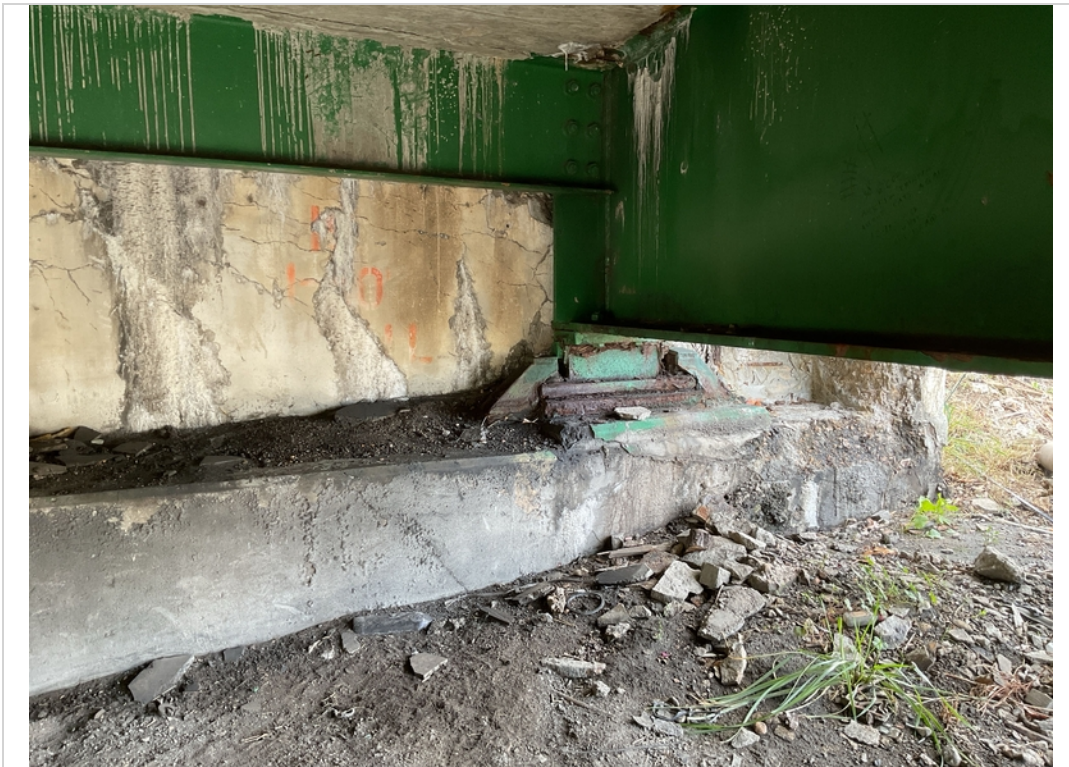
Abut 1 bearing A corrosion all bearing rocked back

| Date Added | Recommendation | Priority |
|---|--|---|
| 01/05/2016 | REPAIR BEARING 'A' @ ABUTMENT #1 | 1 |

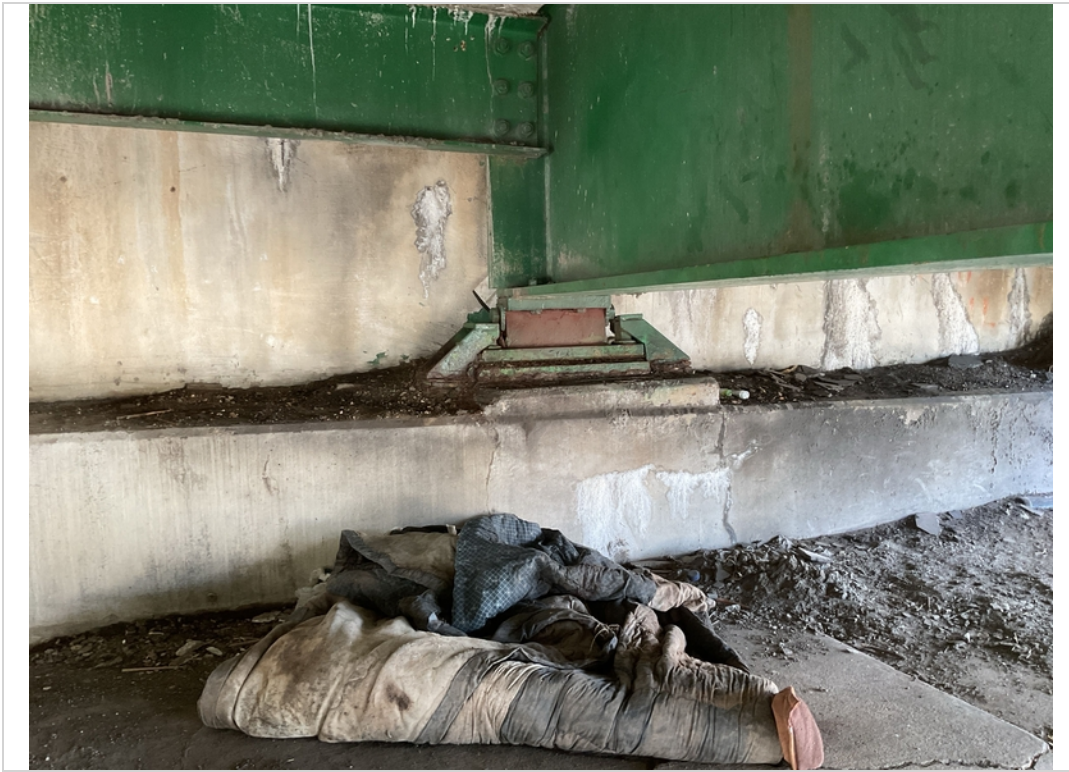
Abut 1 bearing B corrosion vert h.c horiz crack w/eff

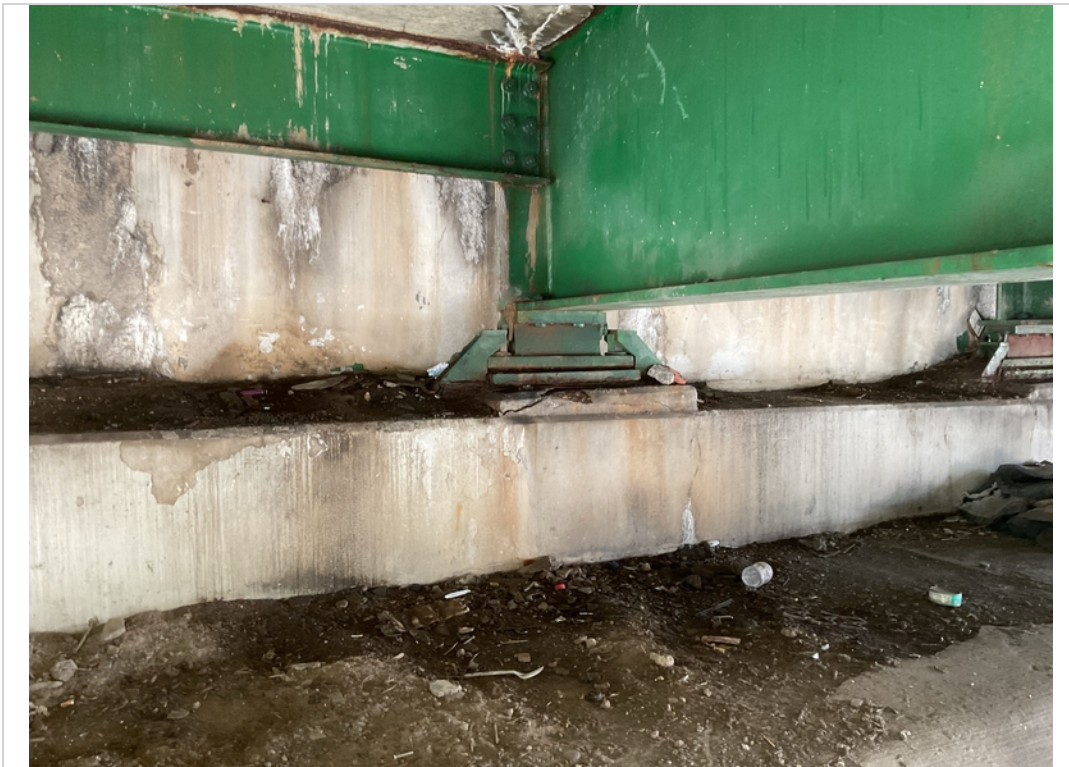
Abut 1 bearing C cracked riser and corrosion

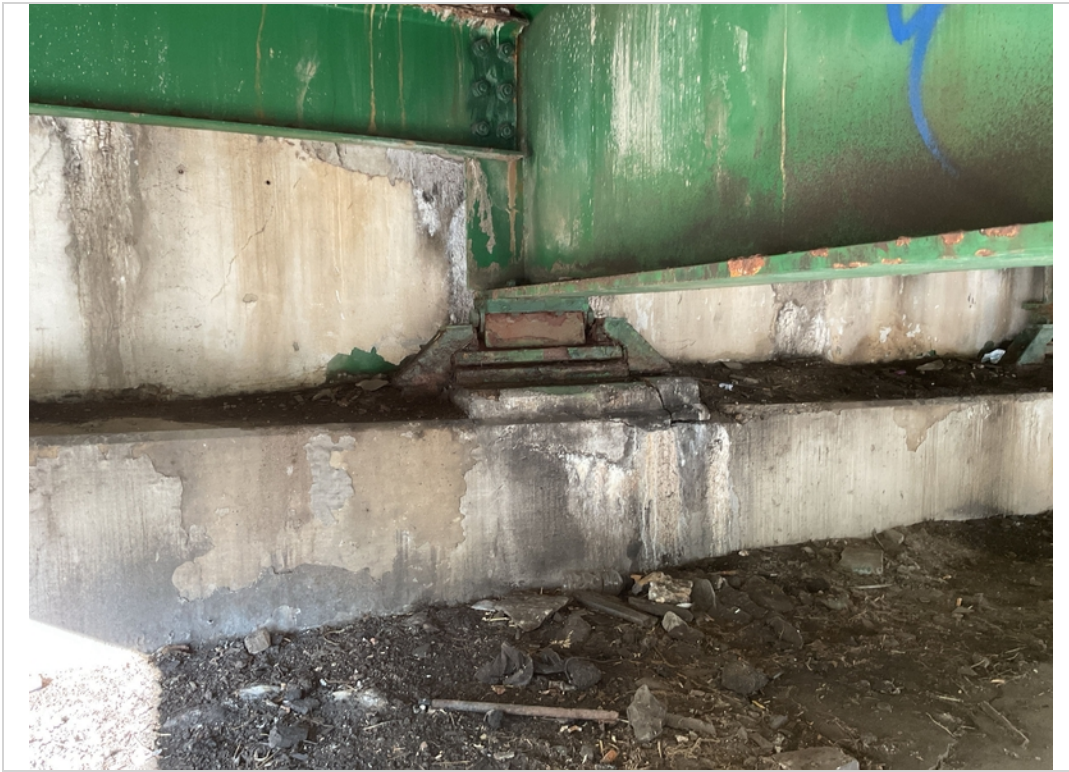
Abut 1 bearing D corrosion and cracked riser. W/eff

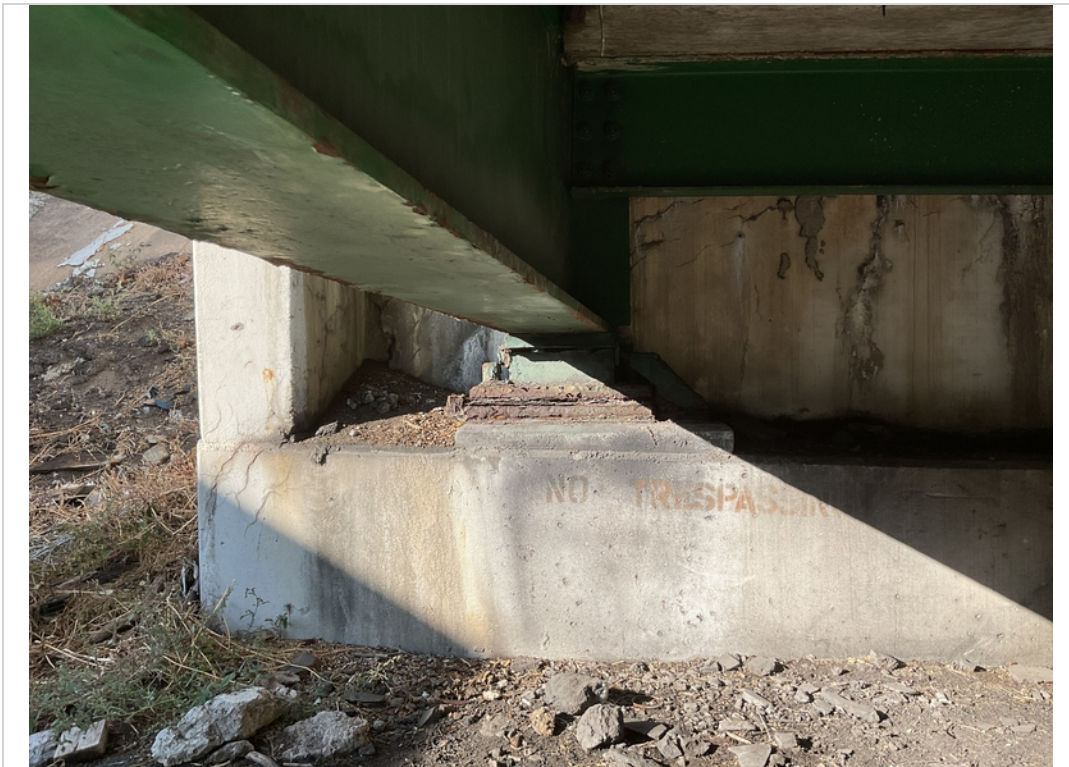
Abut 1 bearing E missing stabilizer arm

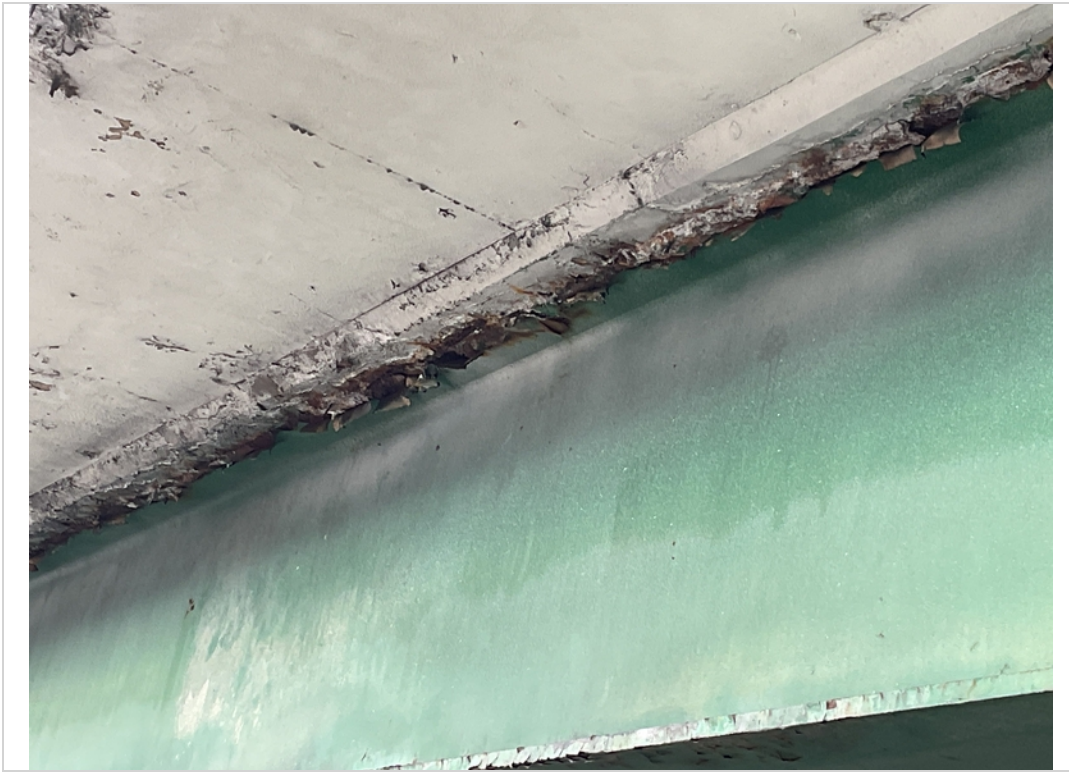
Span 3 Girder E top flange corrosion with eff

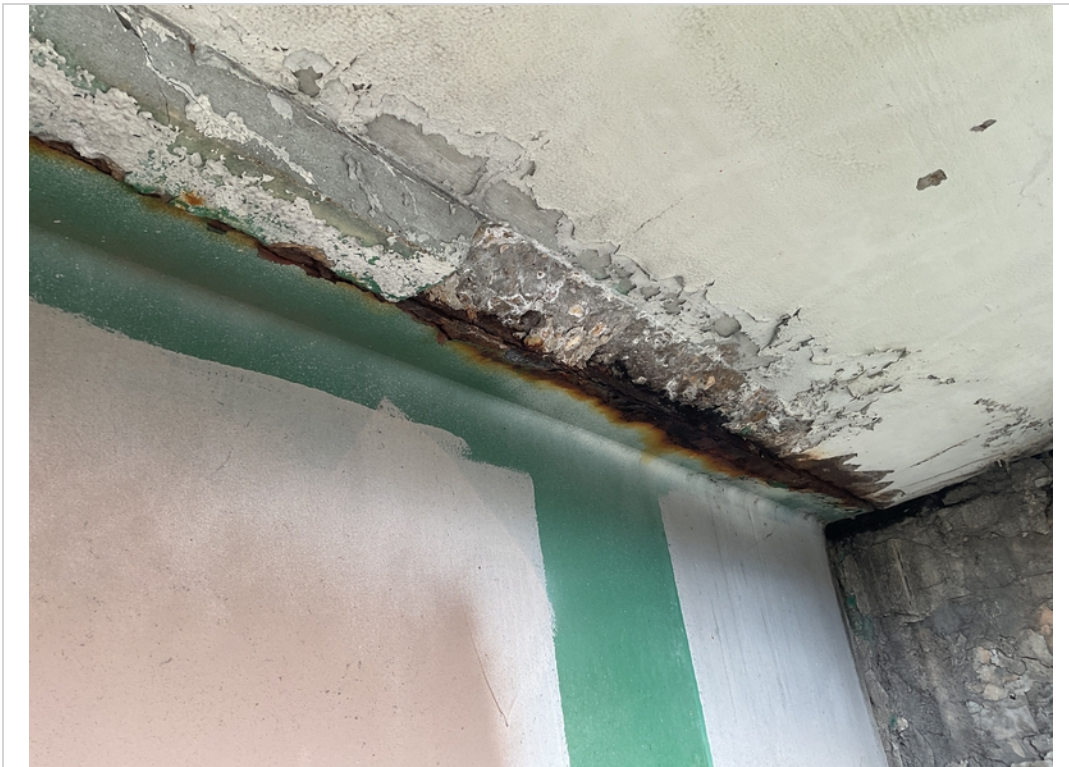
Span 3 Girder E top flange corrosion

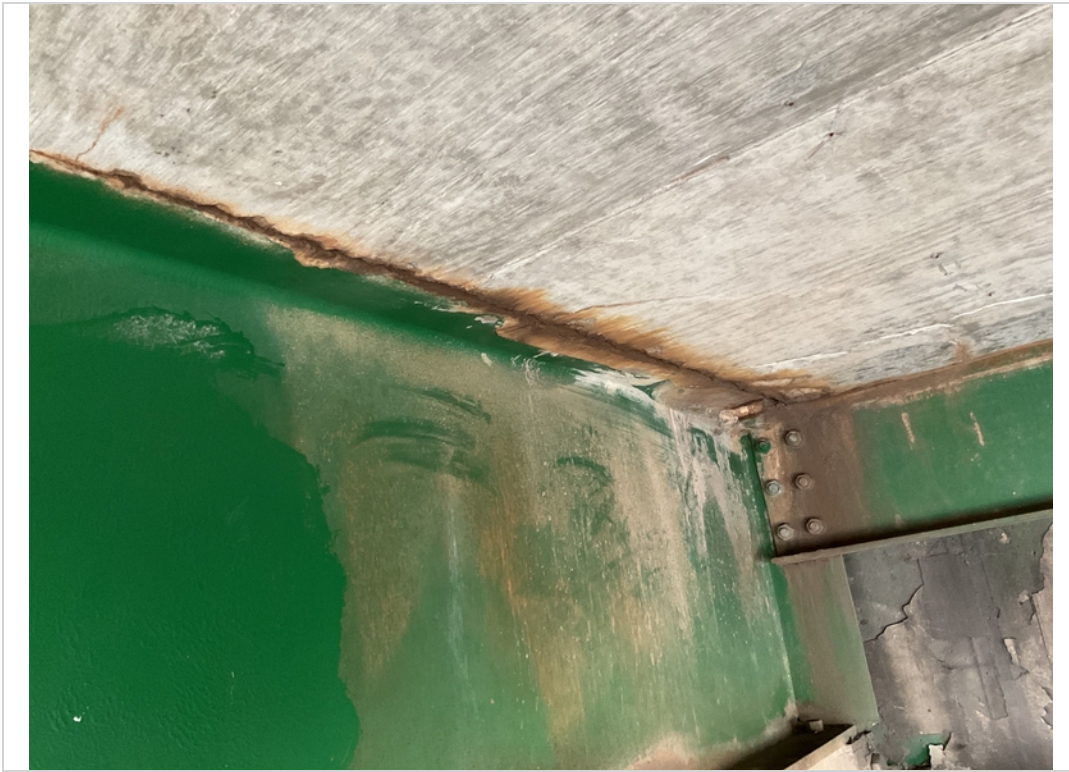
Span 3 Girder B top flange corrosion

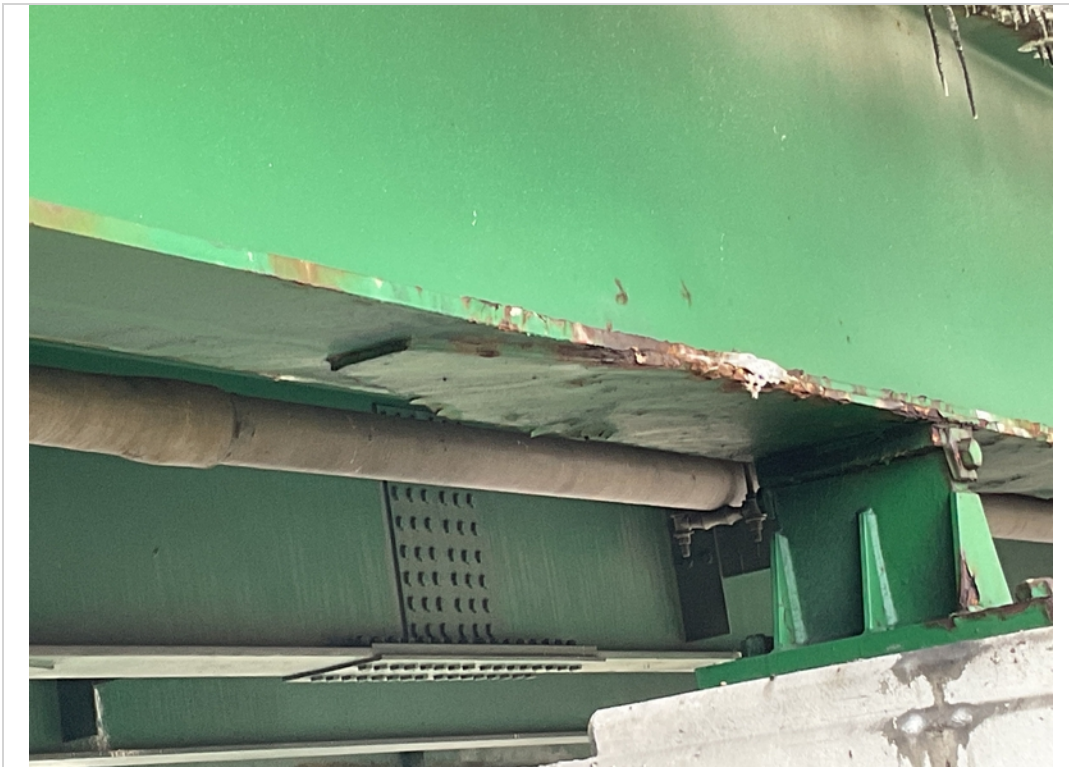
Span 3 Girder A bottom flange corrosion

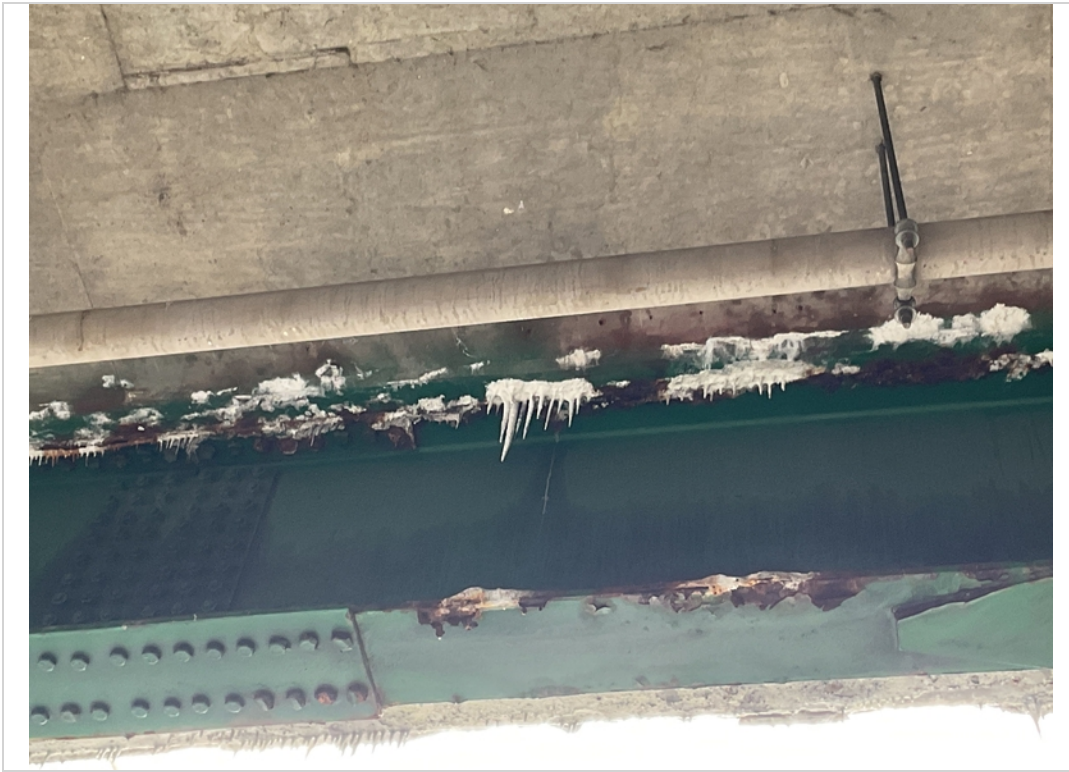
Span 2 Girder A top flange corrosion with eff

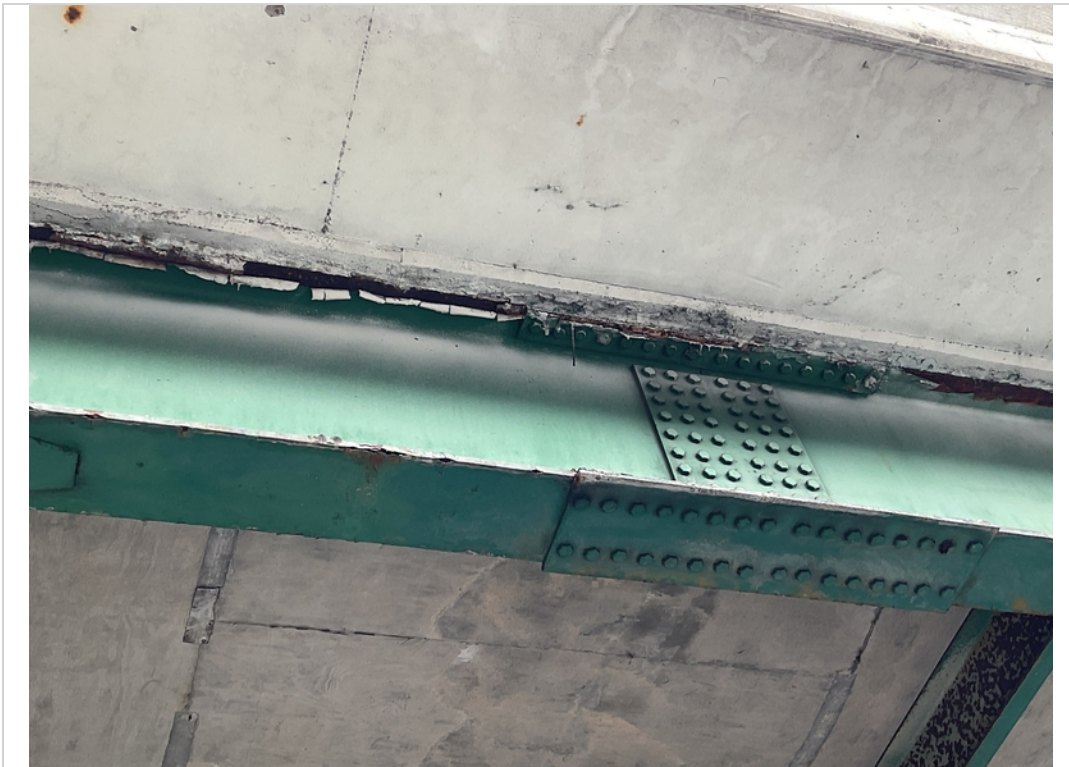
Span 2 Girder E top flange corrosion

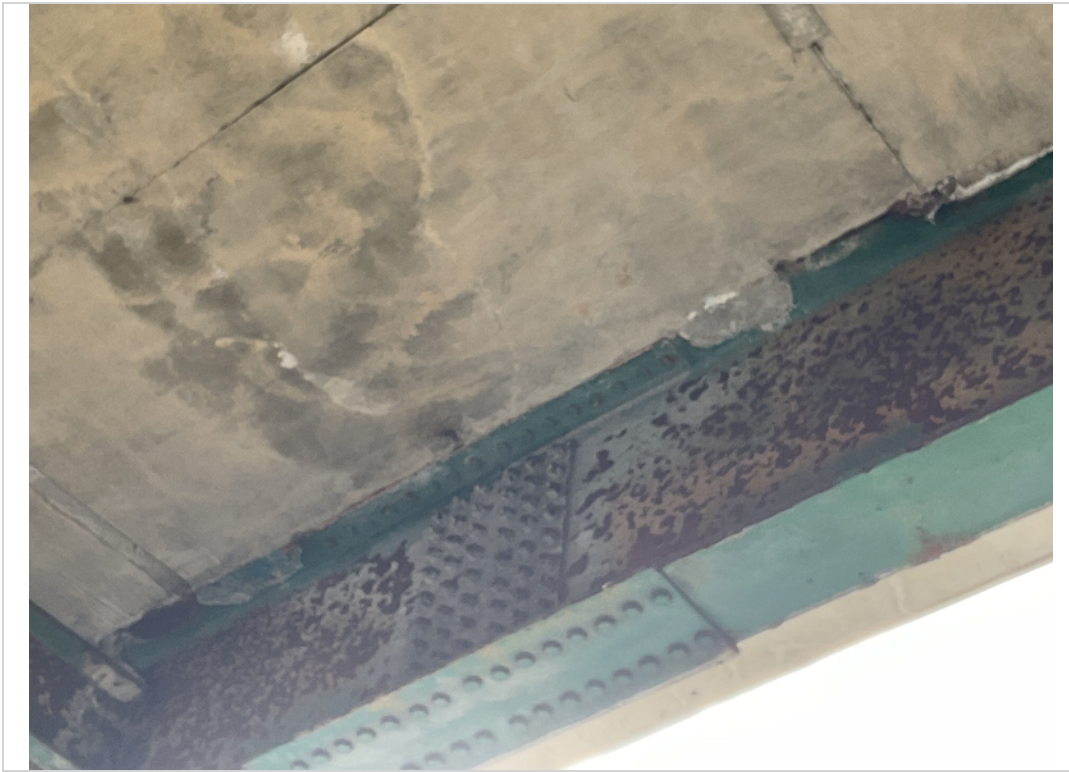
Span 2 Girder E corrosion

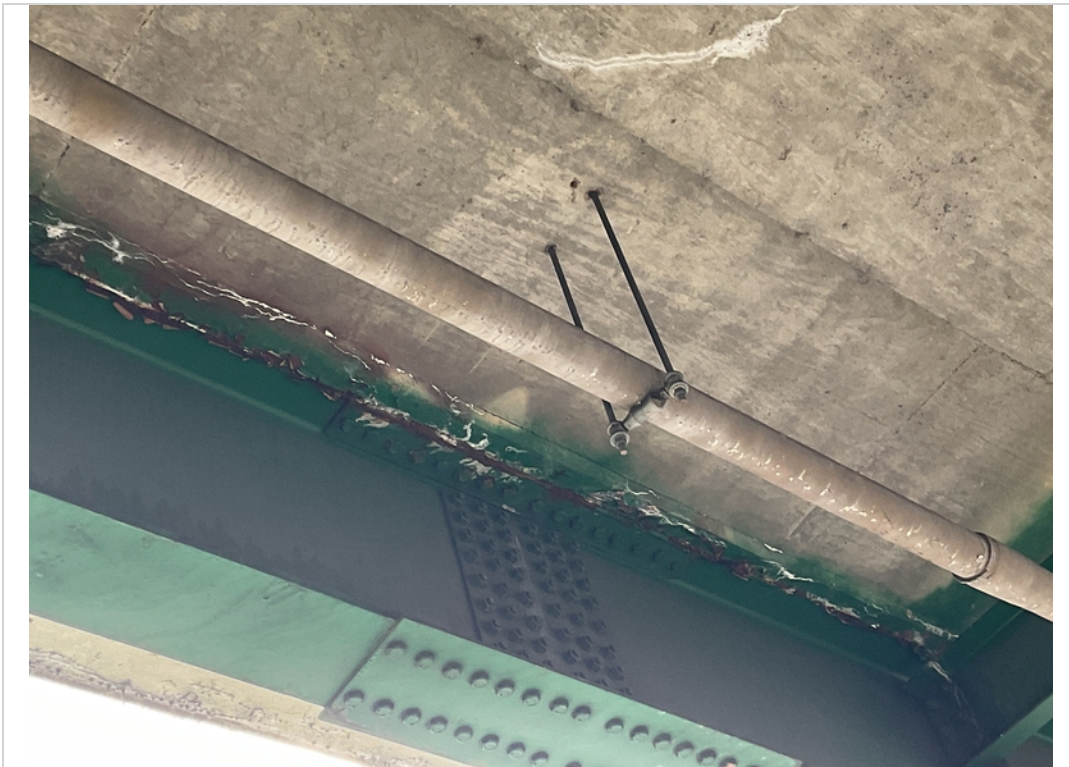
Span 2 Girder A top flange corrosion with eff

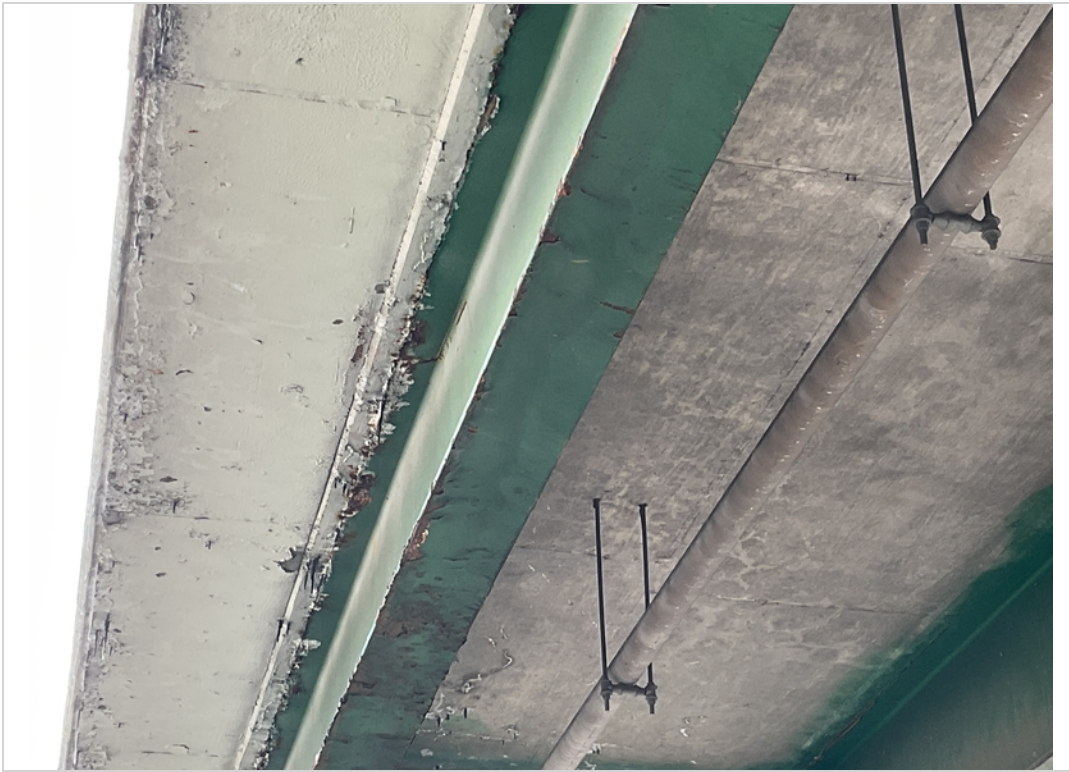
Span 2 Girder A impact scrapes

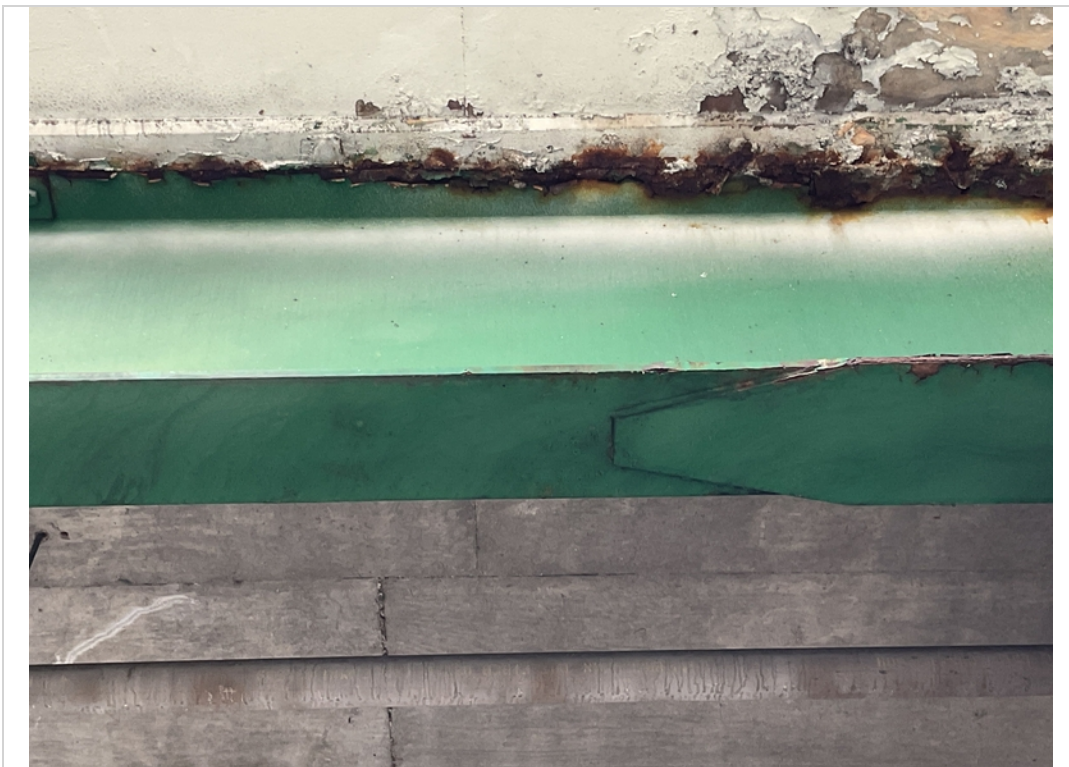
Span 2 Girder A top flange corrosion

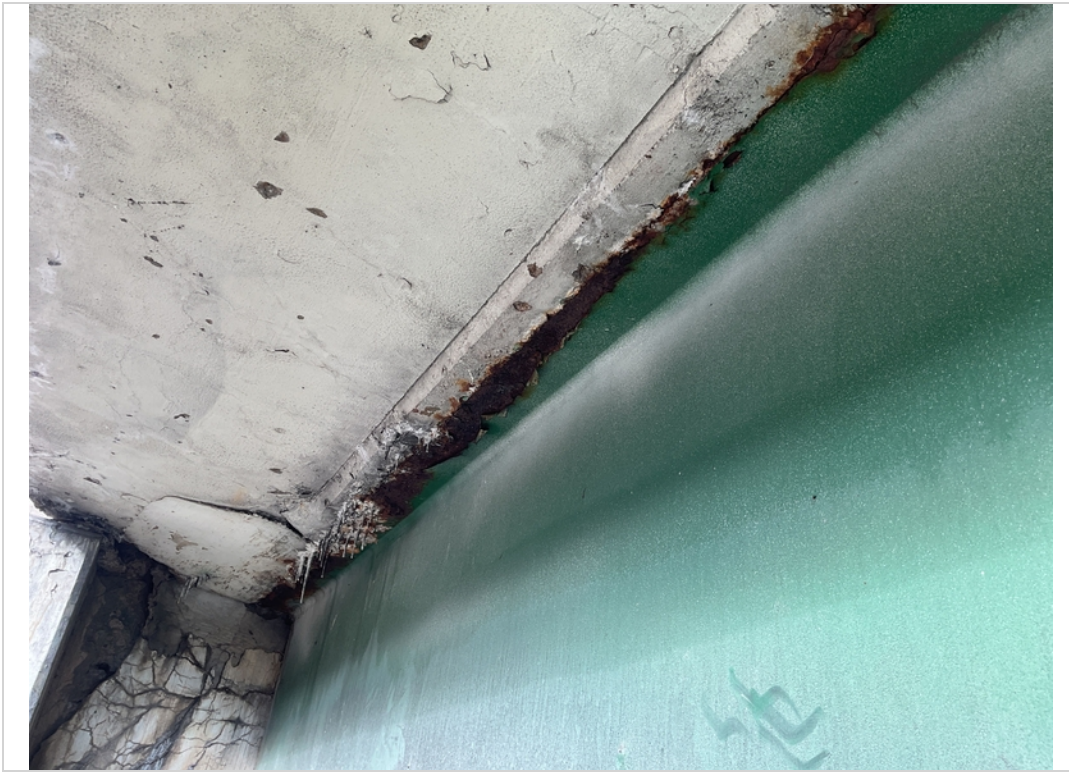
Span 1 Girder E top flange corrosion with eff

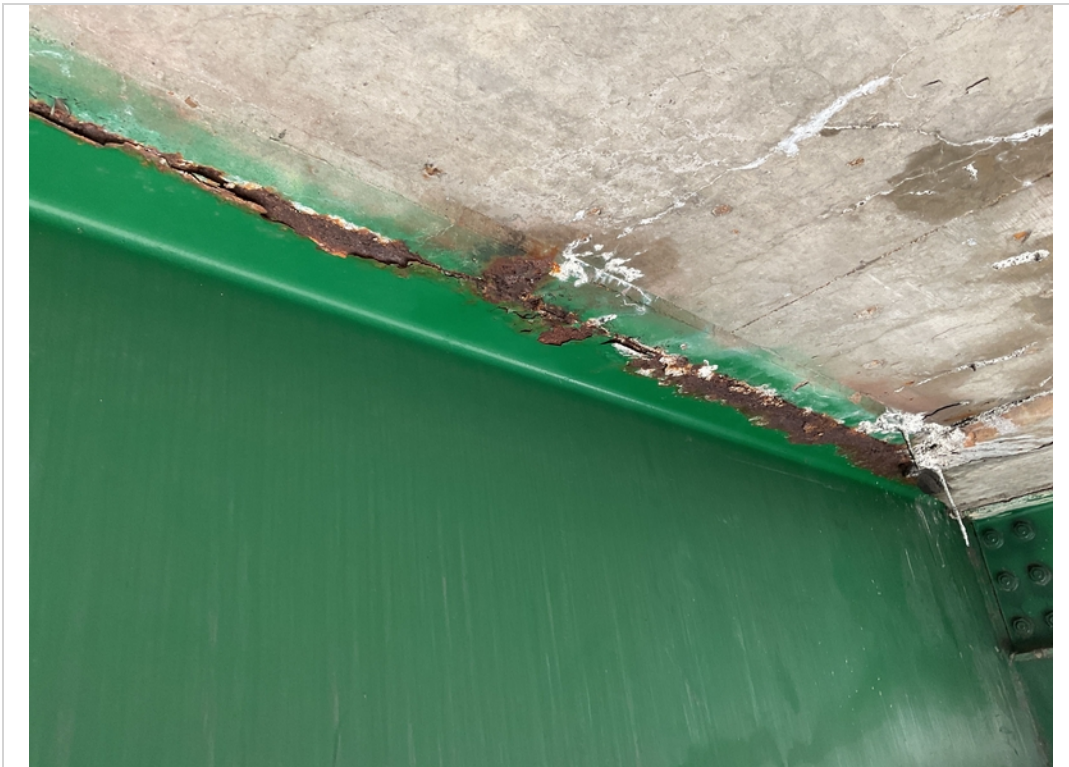
Span 1 Girder E top flange corrosion

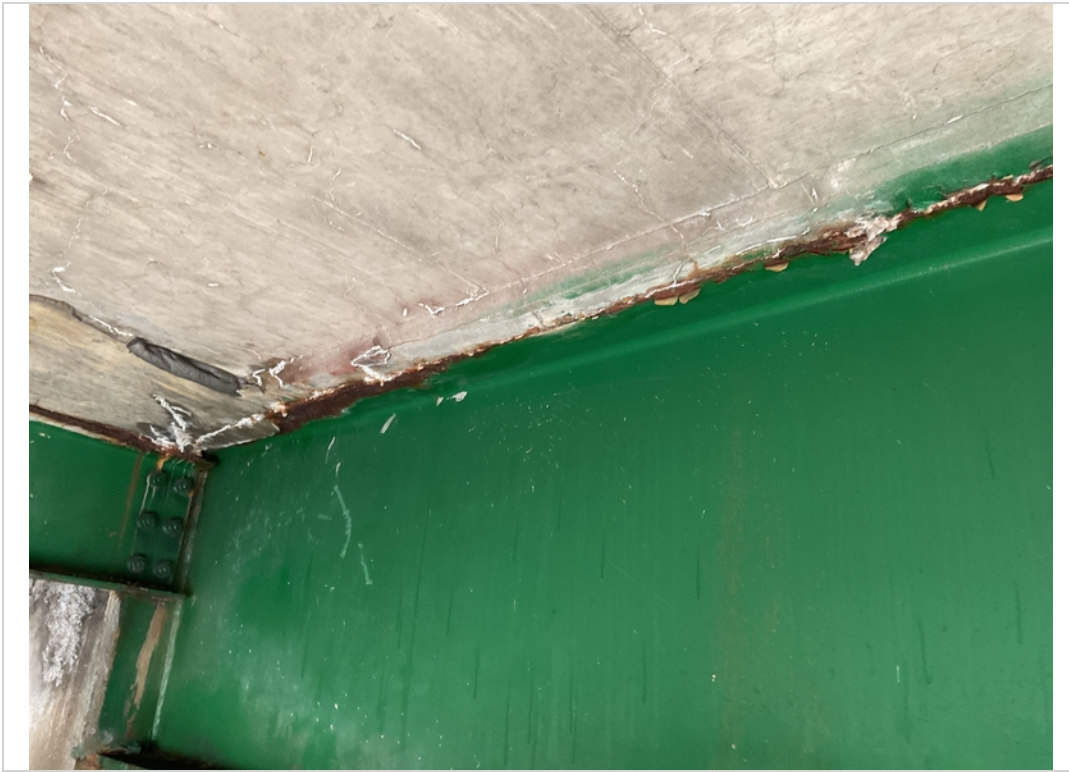
Span 1 Girder C top flange corrosion

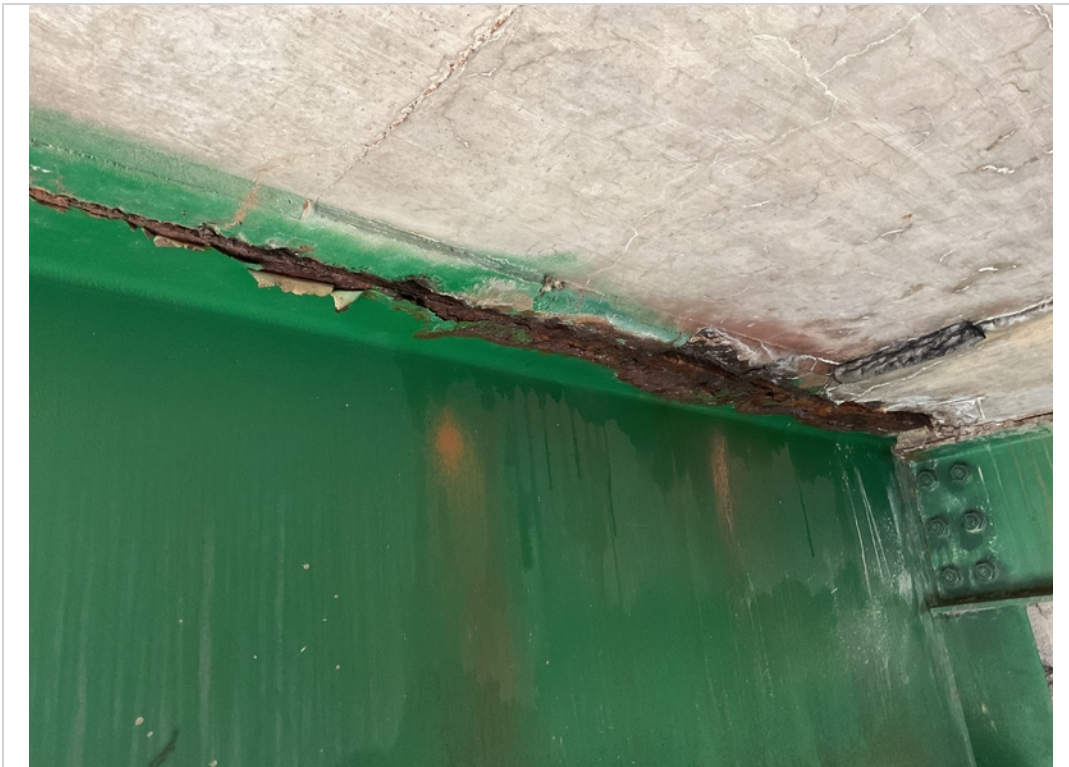
Span 1 Girder D top flange corrosion

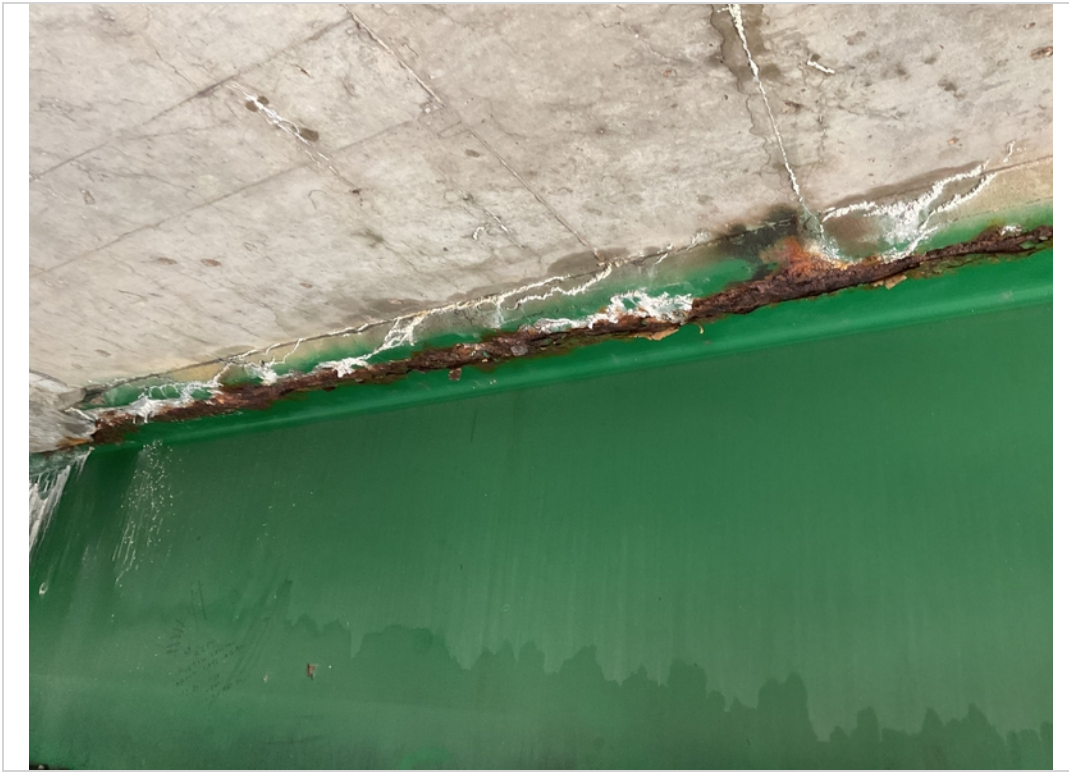
Span 1 Girder A top flange corrosion

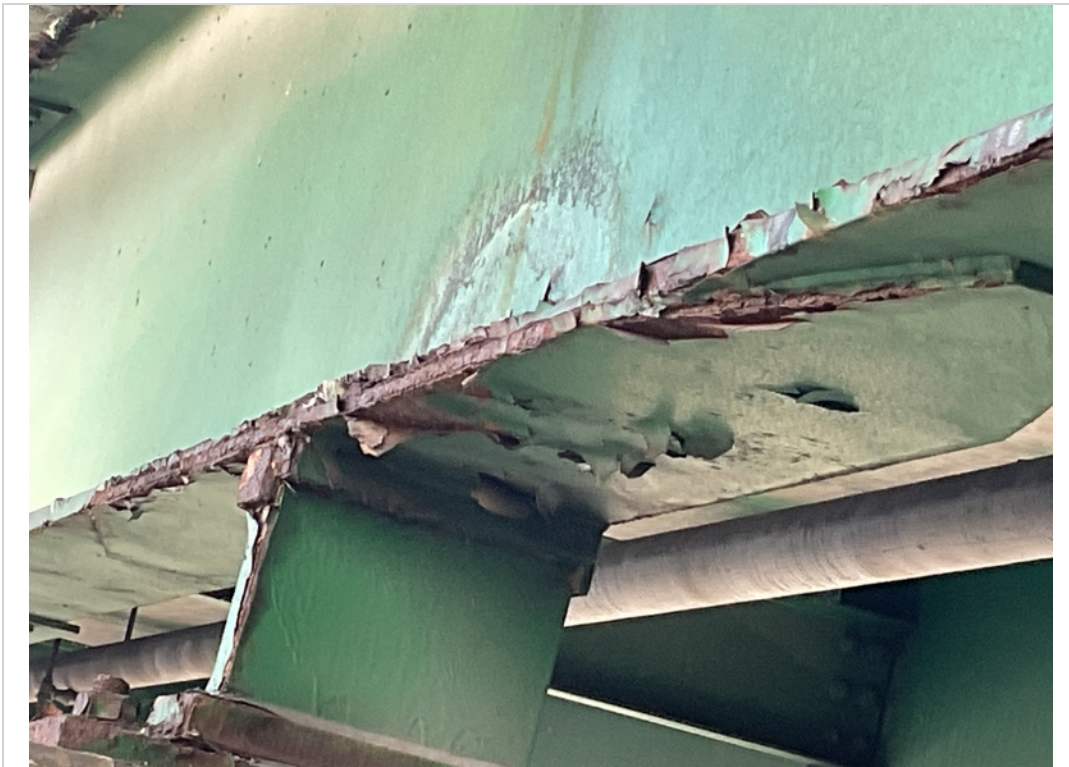
Span 1 Girder A bottom flange corrosion

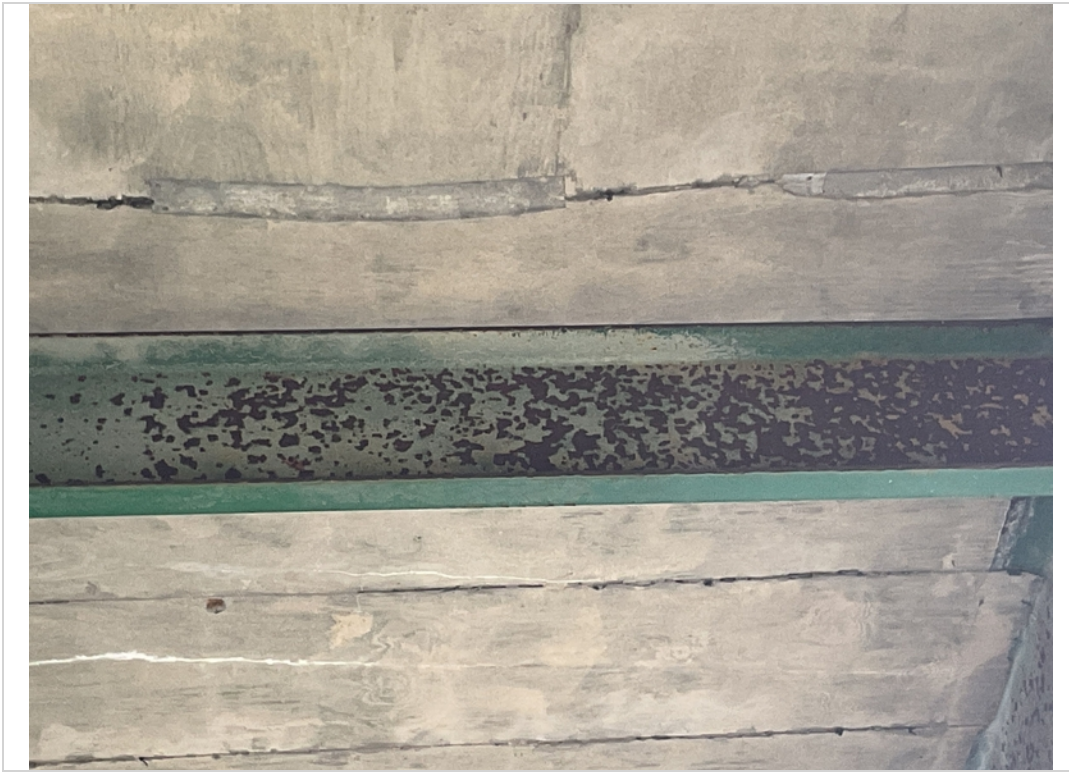
Span 2 diaphragm #2 corrosion
