Region 03, 19 - Davidson County

I40 LL / 8TH AVE (SR 6)

| IDENTIFICATION | |
|---|---|
| (8) Structure Number | 19I00400080 |

3 span Bridge / W.P.G.
I-40 WB / 8th AVE (SR 6)

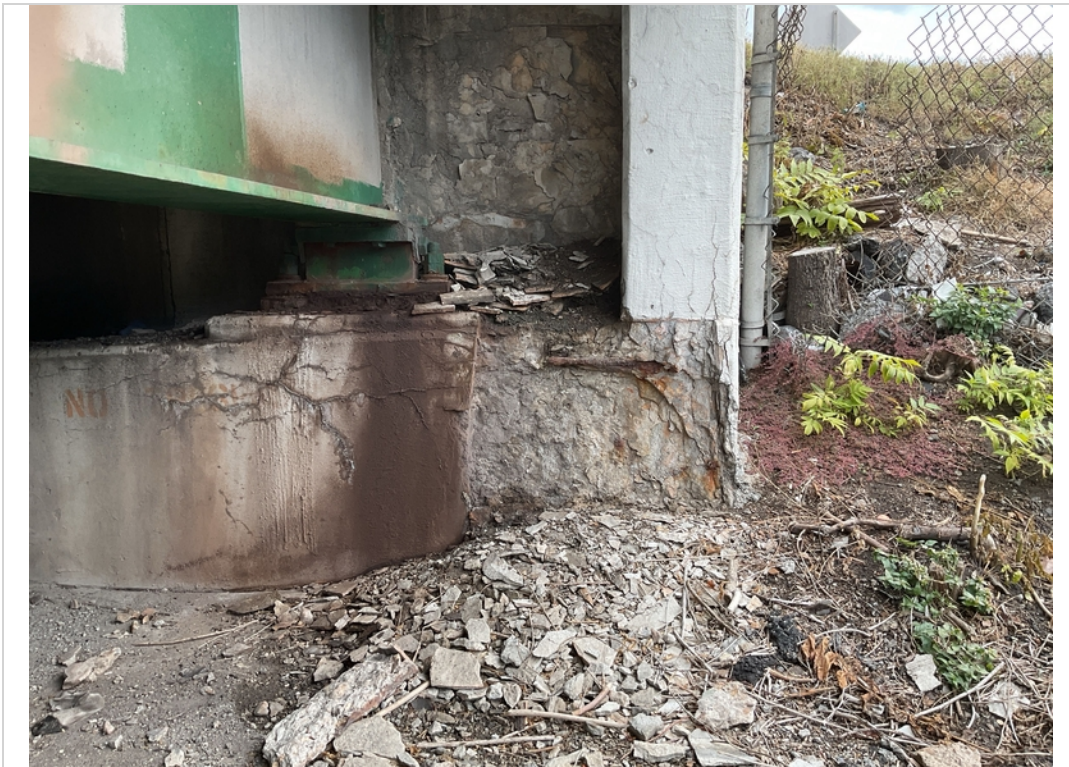
Abut 2 hvy scale w/ exp steel

| Date Added | Recommendation | Priority |
|---|--|---|
| 01/05/2016 | REPAIR BACKWALLS AT ABUTMENTS | 2 |

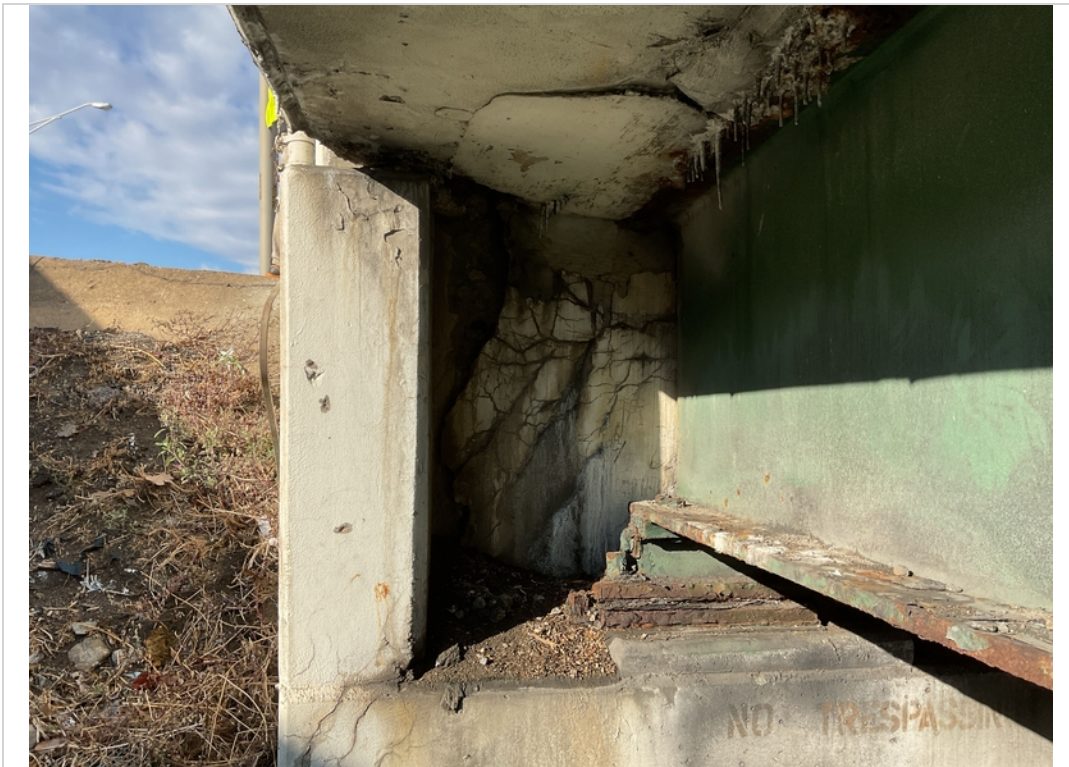
Abut 1 map cracks

| Date Added | Recommendation | Priority |
|---|--|---|
| 01/05/2016 | REPAIR LEFT WING ABUTMENT # 1 | 2 |

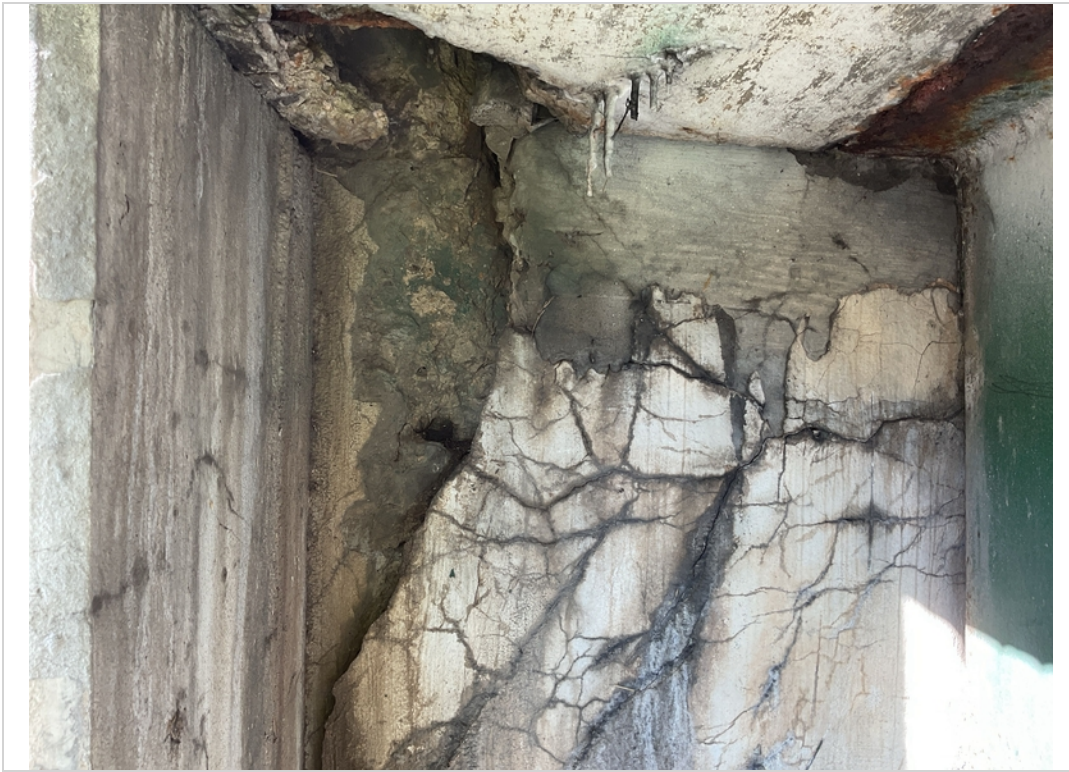
Abut 1 right spall

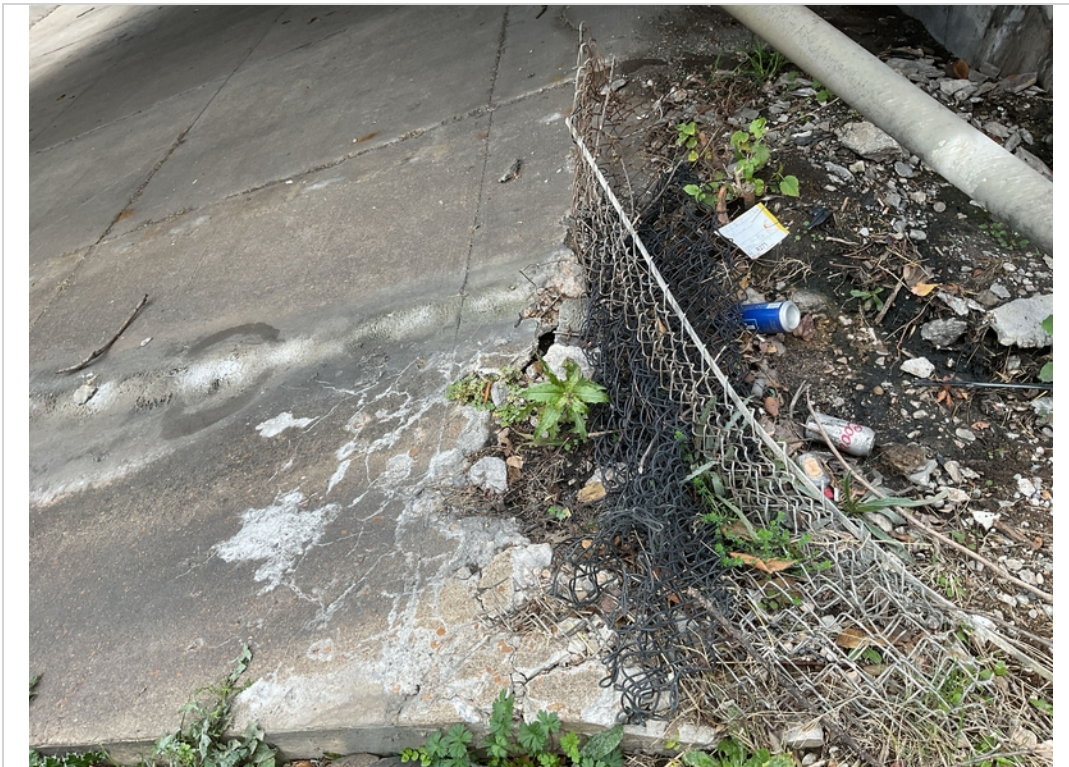
Abut 1 slope cracked w/erosion under slope.

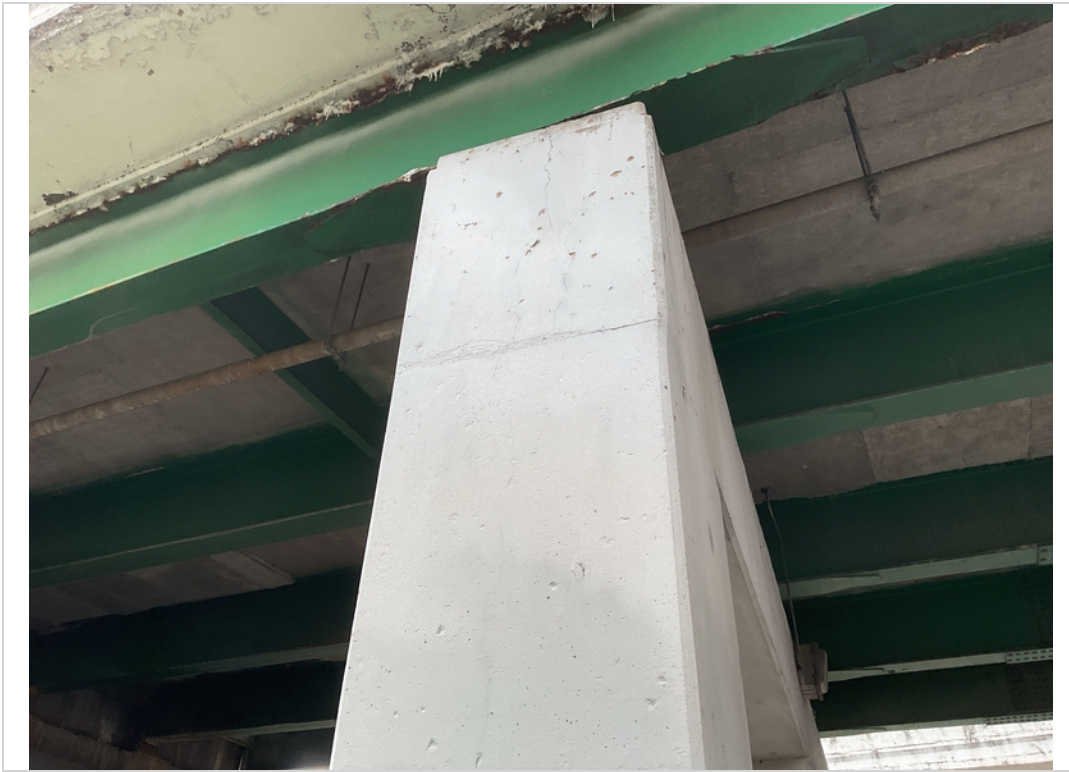
Bent 2 vert h.c.

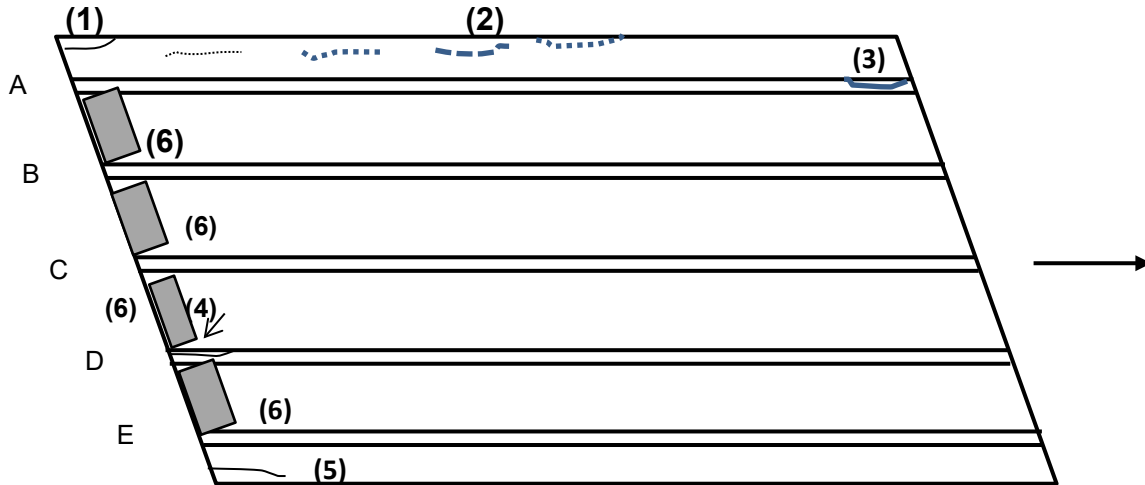
| DECK | FAIR | (6) PATCHES FULL WIDTH X 3' L ALL BAYS @ ABUT. # 1 W/ H.L MAP CRACKS & HVY. EFF; FAILING PATCHES W/ EFF AND SPALLING |
| DIAPHRAGMS | FAIR | LGT.-MOD CORROSION & PAINT FAILURE - TYP. |
| GIRDERS | FAIR | RANDOM LIGHT CORROSION |
| 'A' | FAIR | (3) CORROSION W/ LIGHT L.O.S < 1/16" TOP FLANGE FULL LENGTH |
| 'D' | FAIR | (4) CORRO. & L.O.S TOP FLANGE 8' L |

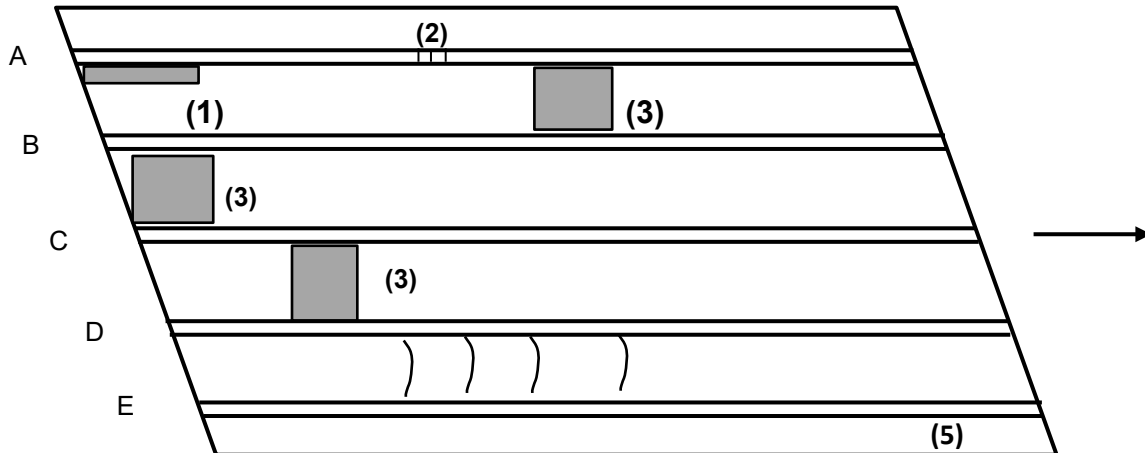
| DECK | FAIR | AREAS OF FULL DEPTH DECK REPAIR; |
| | | (3) H.L. CRACKS W/ EFF UPTO 6'L FULL WIDTH |
| | | RDM SPALLS UPTO 6" DIA. ALONG TOP FLANGE |
| | | (1) PATTERN HAIRLINE CRACKS W/EFF.; |
| DIAPHRAGMS | FAIR | LIGHT RUST & PITTING (RANDOM), & PAINT FAILURE |
| 'D' | FAIR | RANDOM LIGHT RUST & PITTING & PAINT FAILURE |
| 'E' | FAIR | HVY RUST PITTING ON WEB & PAINT FAILURE; |
| OVERHANGS | FAIR | MAP CRACKS W/ HVY. EFF UPTO 1/16" OPEN |

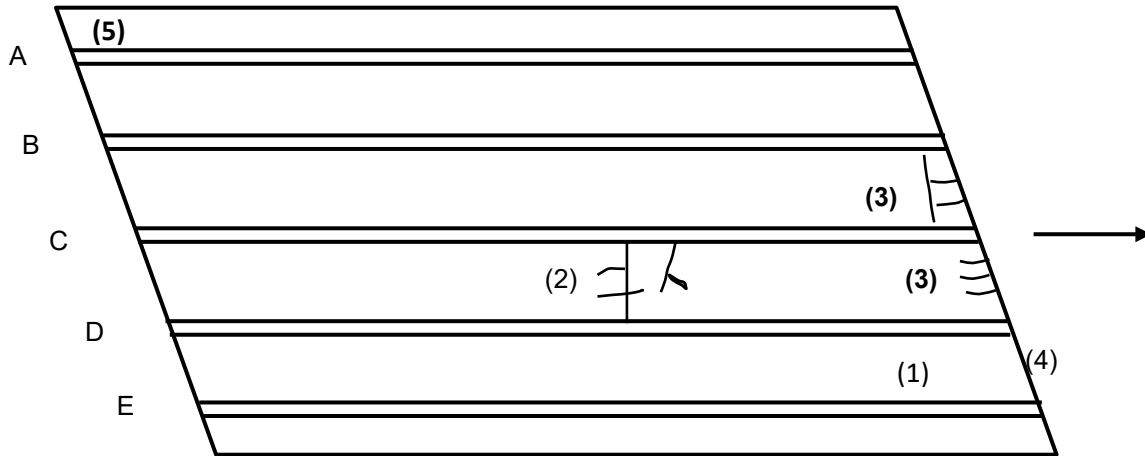
| DECK | GOOD | (1) SPALL W/ EXP. STL 1.5' DIA. X 2" DP, |
| | | (2) H.L. MAP CRACKS W/EFF FULL DEPTH REPAIRS W/ H.C'S & EFF |
| | | IN AND AROUND REPAIRED AREAS |
| | | (3) LONGIT H.L. CRACKS W/RUST STAINS |
| DIAPHRAGMS | GOOD | LIGHT RUST & PITTING @ ABUT |
| GIRDERS | GOOD | AREAS OF LIGHT CORROSION @ ABUT. # 2 UPTO 5' L |
| 'E' | POOR | (4) VERTICAL CRACK IN WELD @ VERT STIFFNER OVER BEARING |
| OVERHANGS | GOOD | SPALLING RIGHT SIDE 3'L |

| Date Added | Recommendation | Priority |
|---|--|---|
| 01/05/2016 | REPAIR CRACK AT DIAPHRAGM CONNECTION BEAM 'E' @ ABUTMENT # 2 | 2 |

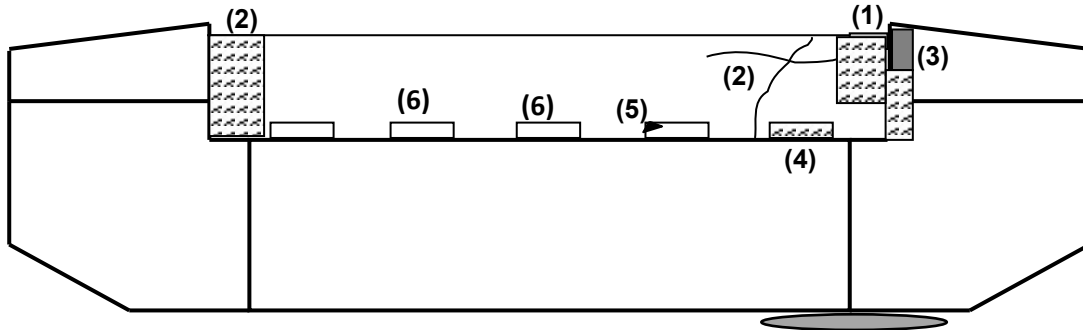
| BACKWALL | POOR | (1) SPALL W/ EXP. STL 3' X 3' X 6" DP; RDM H.C.'S W/EFF.; |
| | | (2) MAP CRACKS W/EF. & SPALLS UPTO FULL HEIGHT X 4"DP. |
| CAP | GOOD | MOD. DEBRIS BUILD-UP; H.L. CRACK W/EFF.; TEXTURE COAT |
| WINGS | POOR | (3) HVY. SCALE FULL HEIGHT X 2' L X 10" DP W/ MAP CRACKS W/ |
| RISERS | FAIR | (4) MAP CRACKING UP TO 1/4" OPEN ON RISER 'A'; |
| | | (6) CRACKS UP TO 1/8" OPEN; (5) SPALL 3" X 2"; |
| EMBKMENT | FAIR | CRACKS, SETTLEMENT W/VOID (LEFT SIDE) 3.5' X 2' X 8" DP |

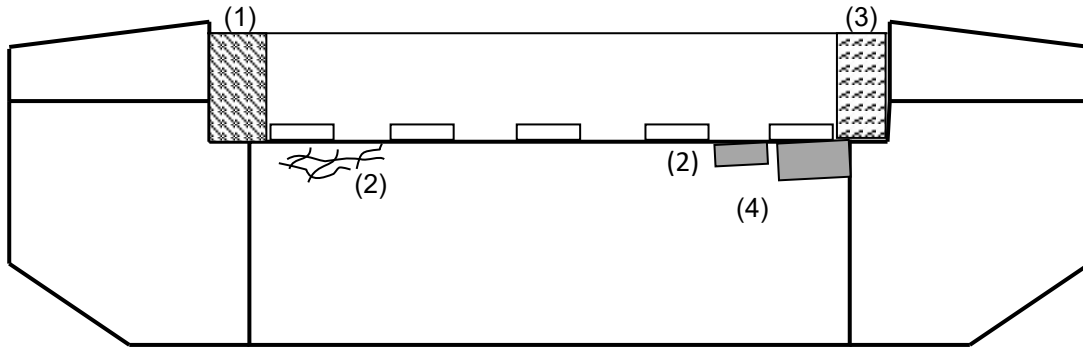
| BACKWALL | POOR | (1) SPALL W/ EXP STL FULL HEIGHT X 3' X 4"DP; (3) MAP CRACKS |
| | | RANDOM VERT. CRACKS W/ EFF. |
| CAP | FAIR | (2) MAP CRACKING UP TO 1/16" OPEN OVER 3' X 2' AREA; |
| 'B' | POOR | MISSING NUT & LOOSE NUTS |
| 'C' | CRITICAL | MISSING ANCHOR BOLT, LOOSE NUT, LOOSE/BROKEN PIN, |
| 'D' & 'E' | POOR | LOOSE NUTS |

| Date Added | Recommendation | Priority |
|---|--|---|
| 01/05/2016 | REPAIR BEARING 'A' - 'E' ABUT #2 | 1 |
