Latitude:36.14810, Longitude:-86.77920

Region 03, 19 - Davidson County

I40 RMP / 8TH AVE (SR 6)

3 span Bridge / W.P.G.  
I-40 Ramp / 8TH AVE (SR 6)

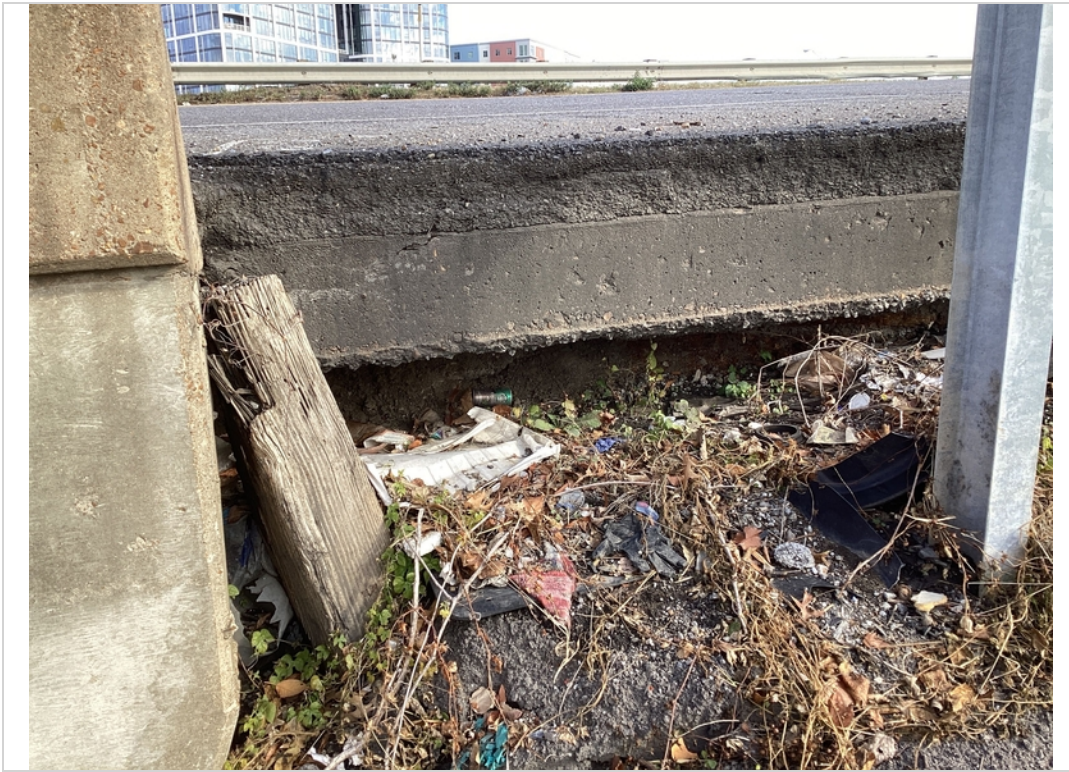
B approach heavy erosion

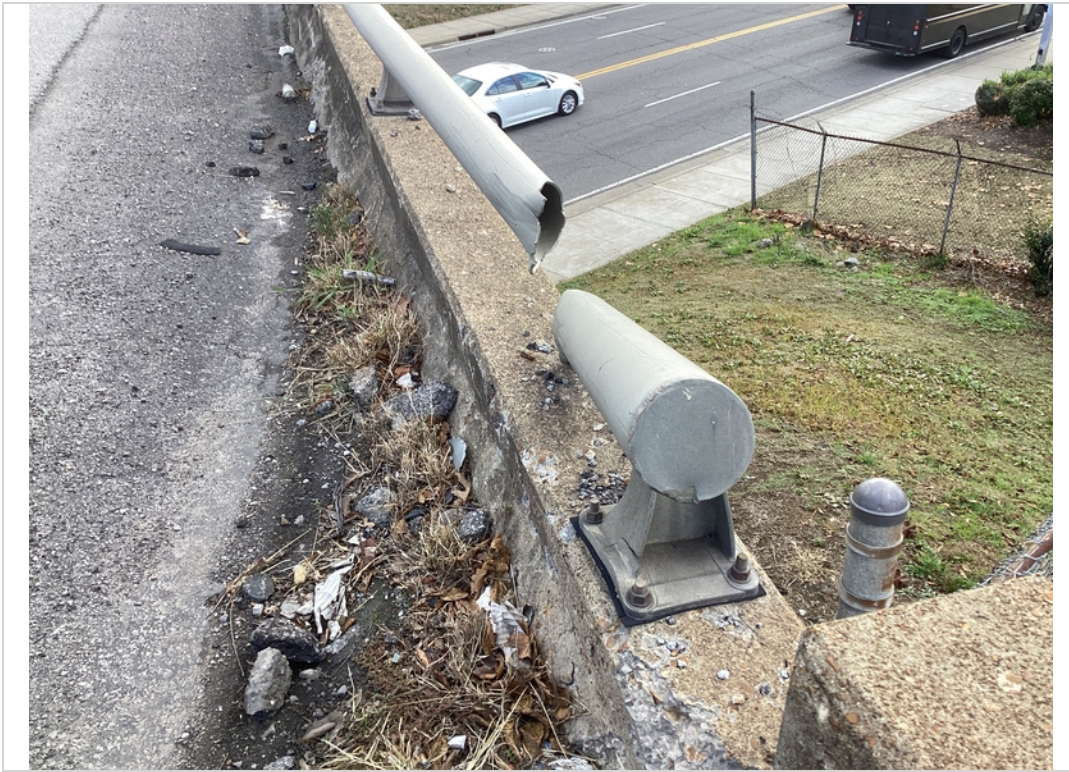
Span 1 tube rail broken

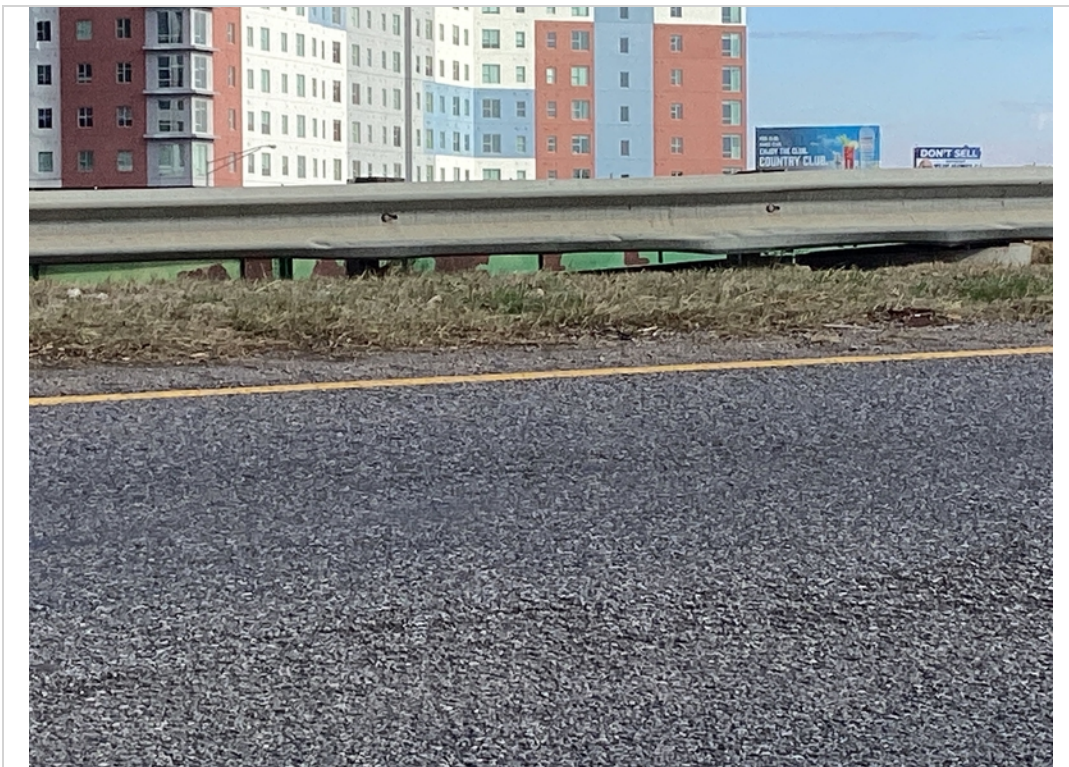
B approach left impact damage

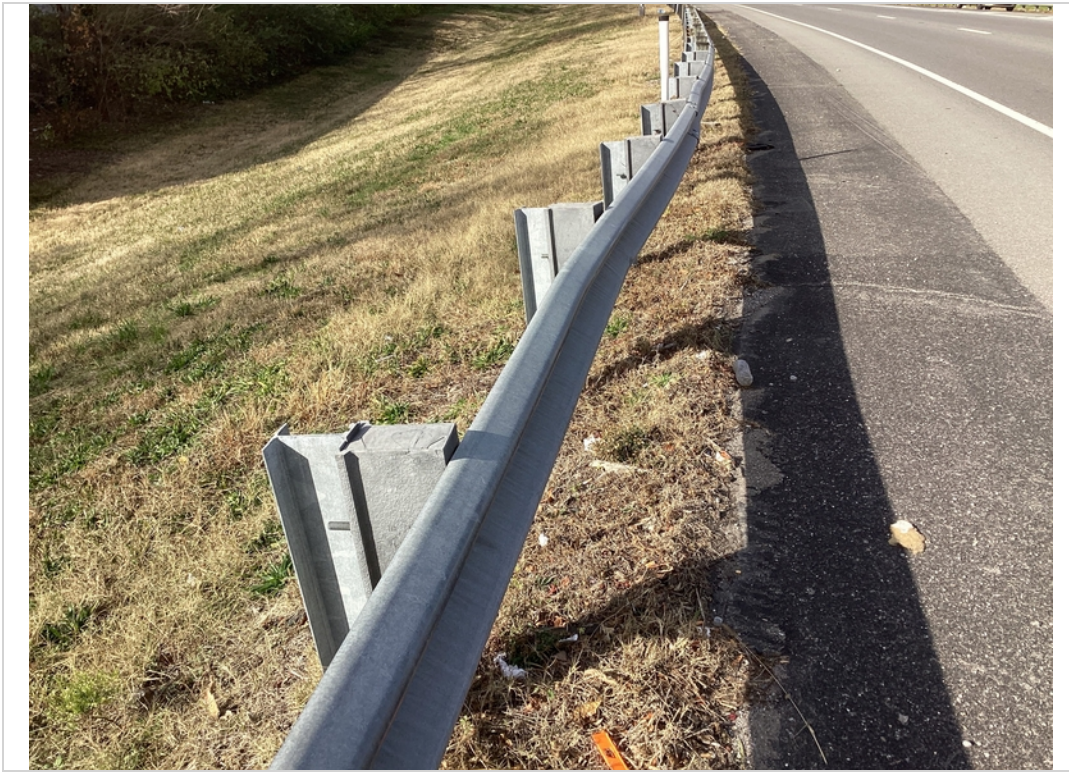
A approach guardrail impact damage

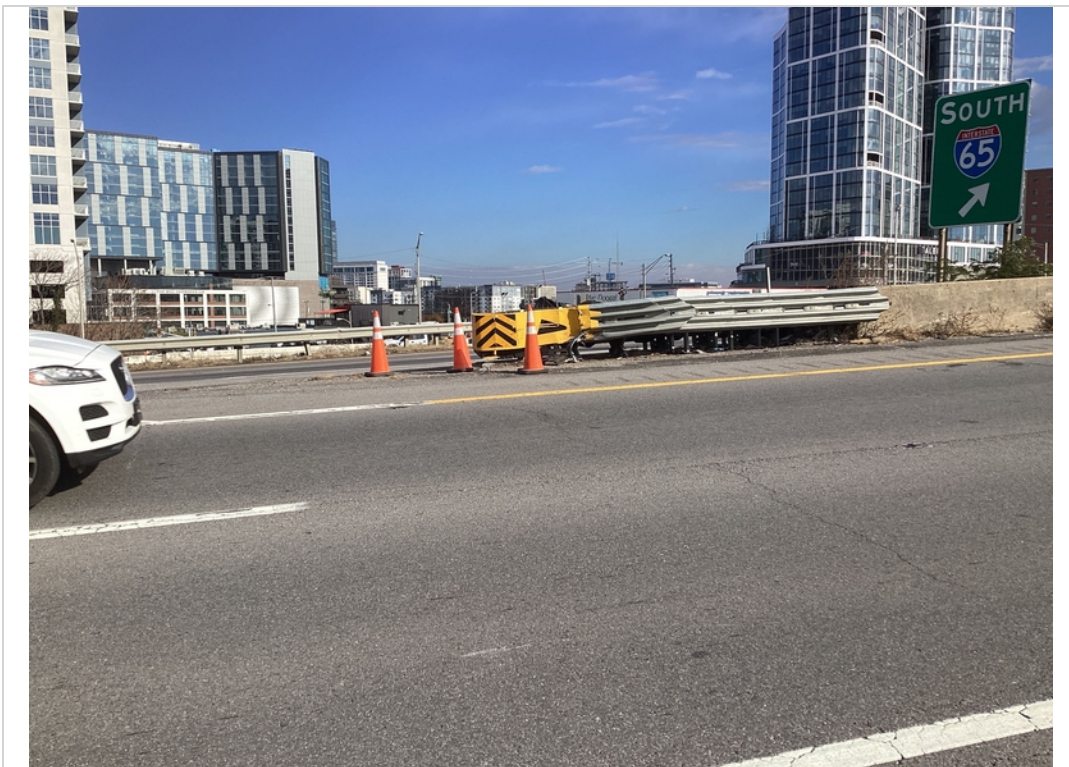
A approach end terminal impact damage

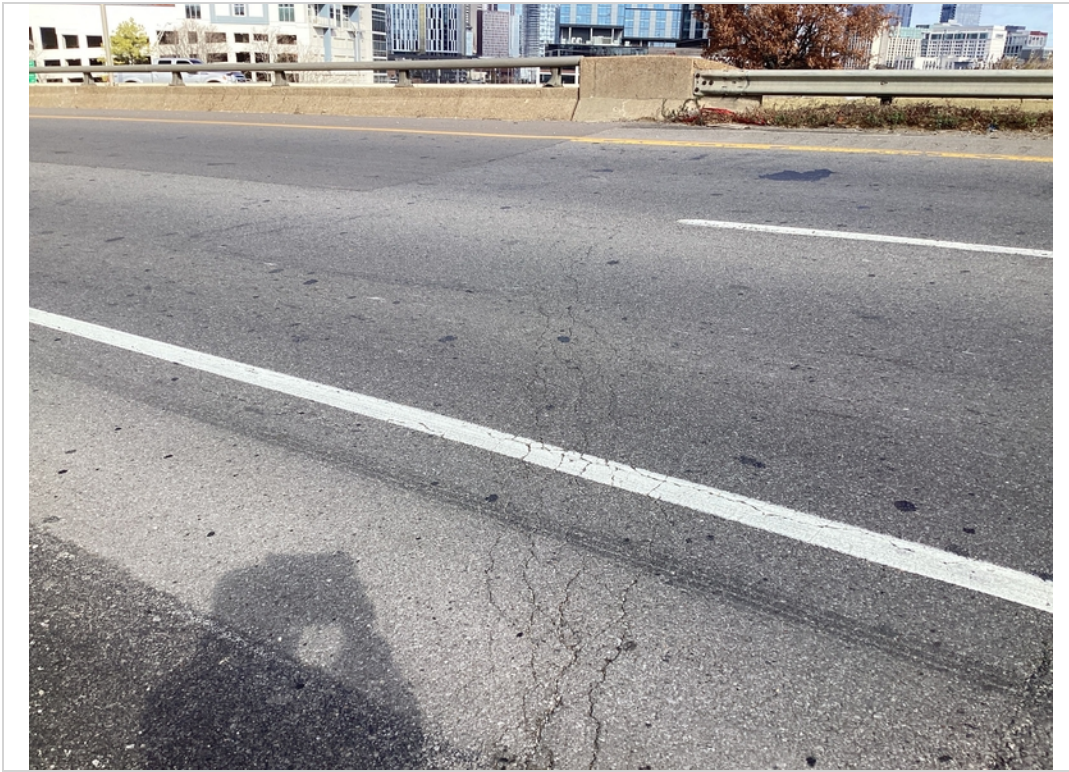
Span 3 map cracks

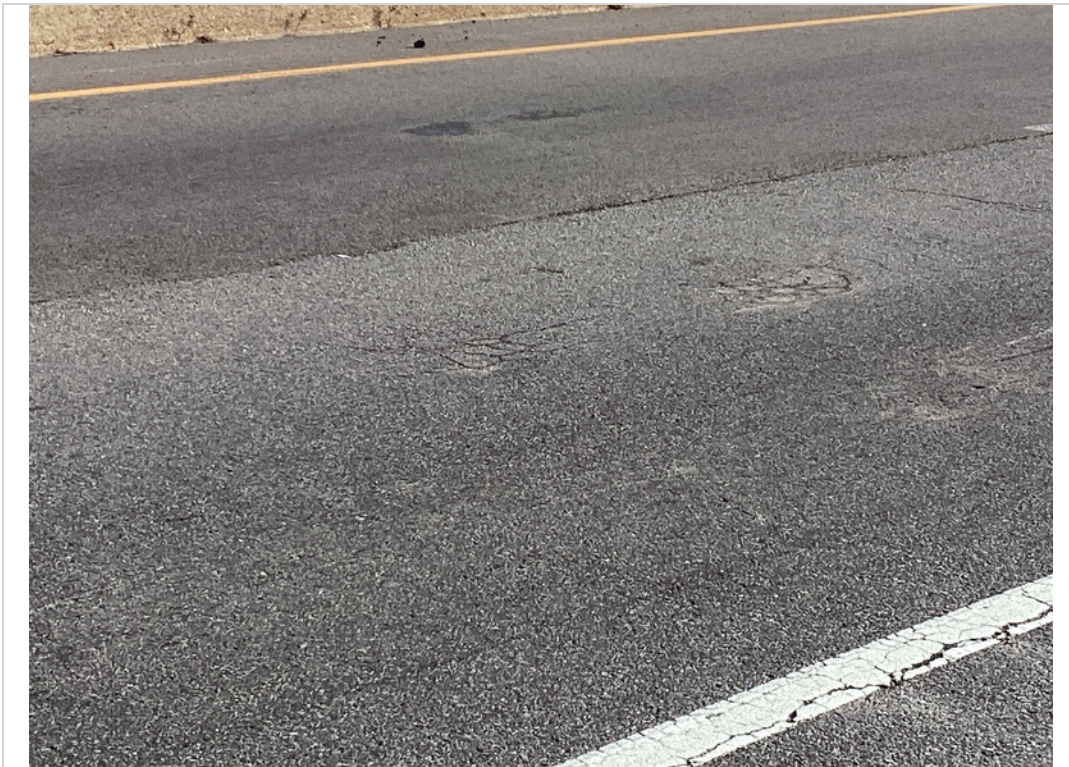
Span 1 depression with map cracks

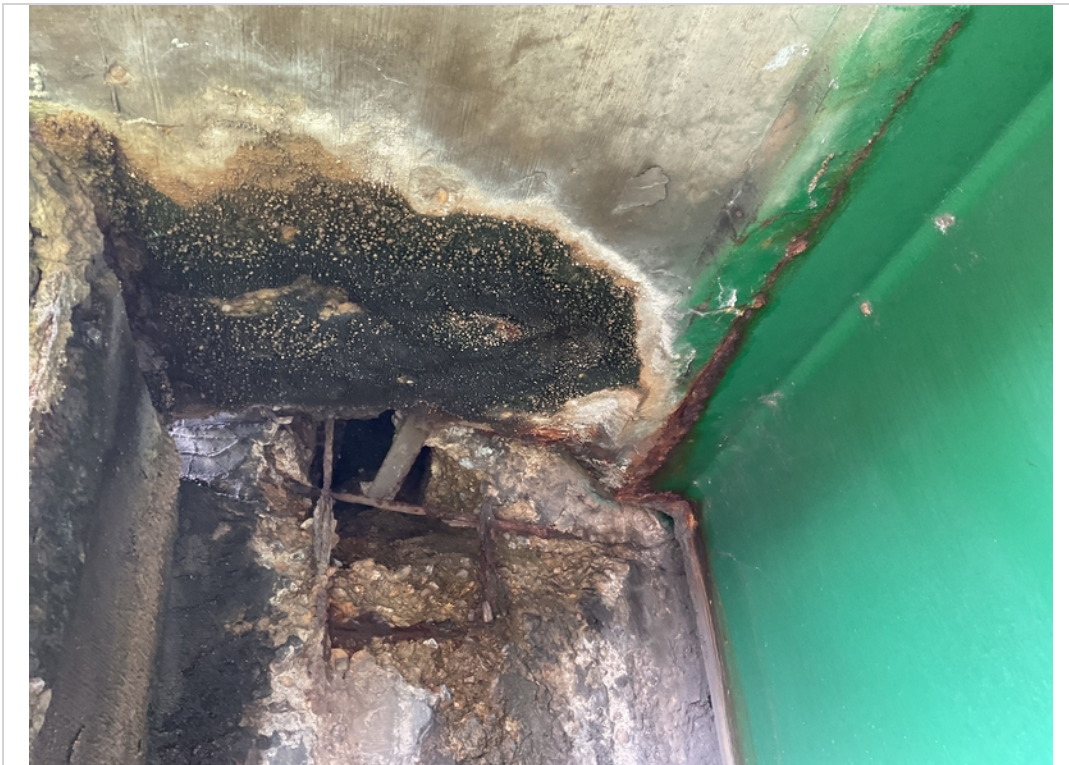
Overhang span 1 right side spall with eff

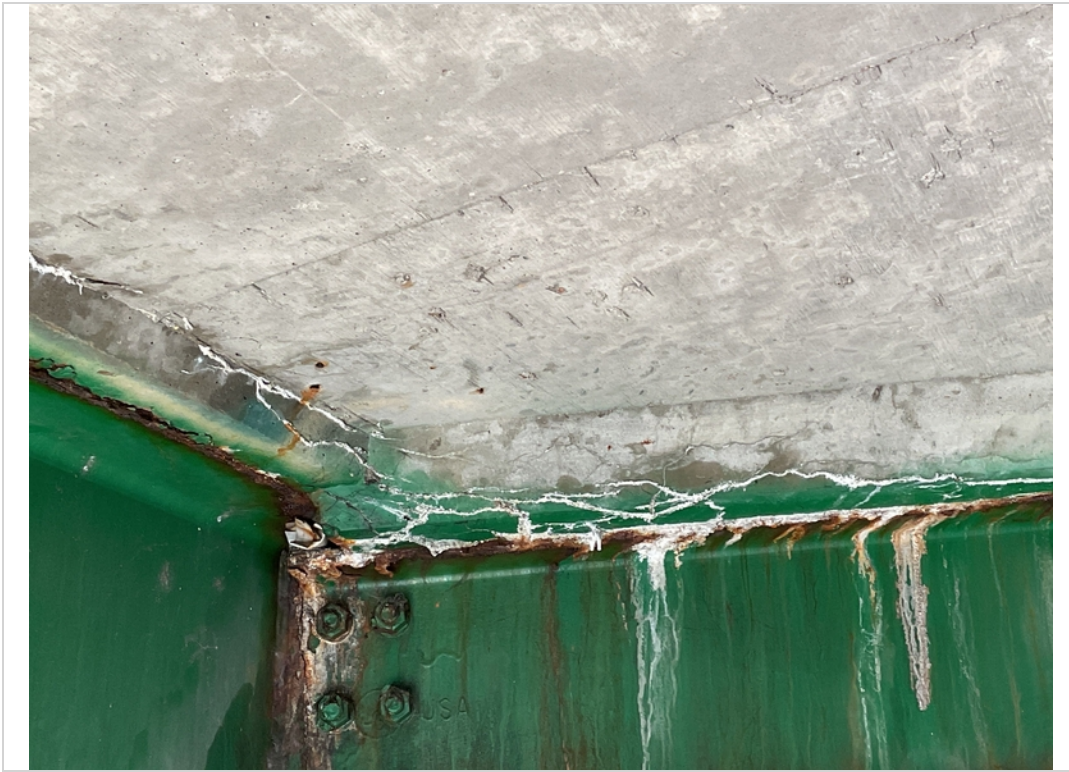
Span 1 bay D map cracks with eff

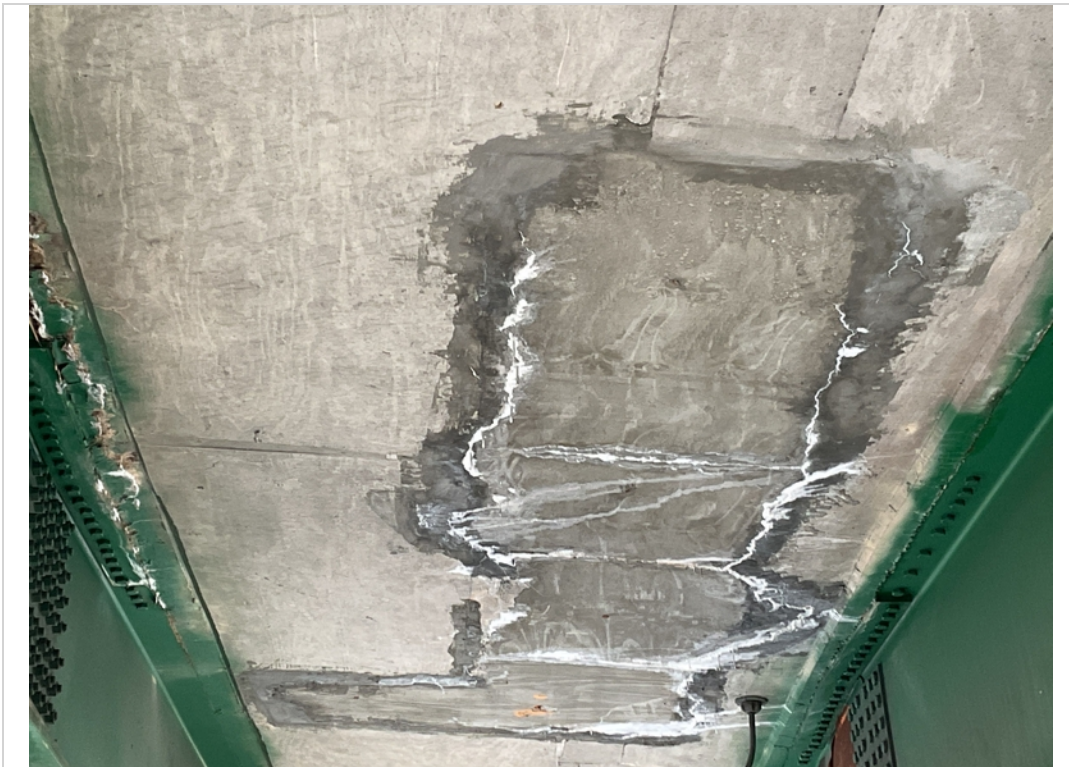
Span 1 bay B failing patch with eff

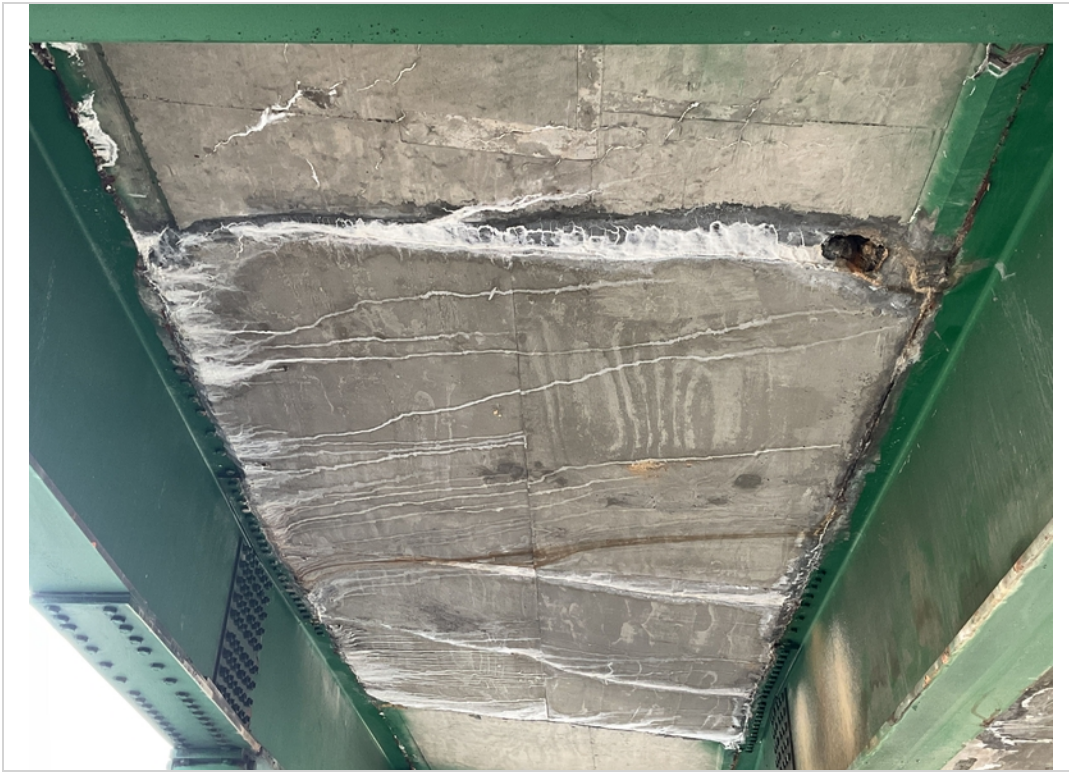
Span 1 bay A failing patch will eff

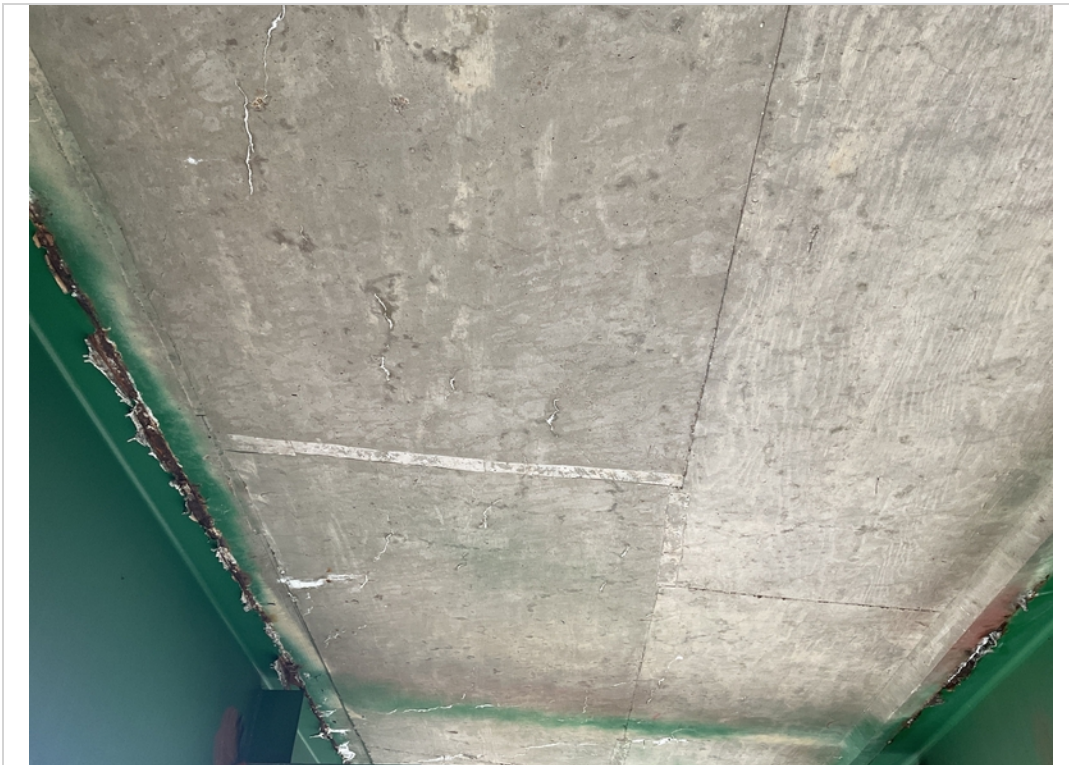
Span 1 bay A random map cracks with eff

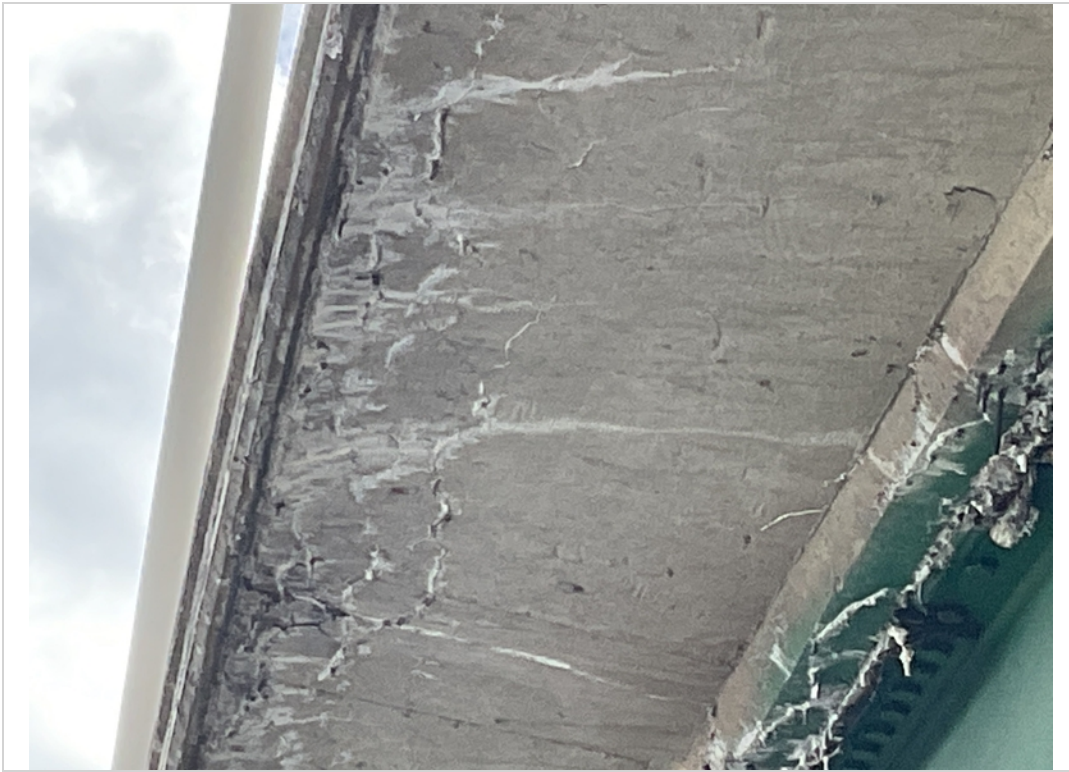
Overhang span 1 left side map cracks with eff

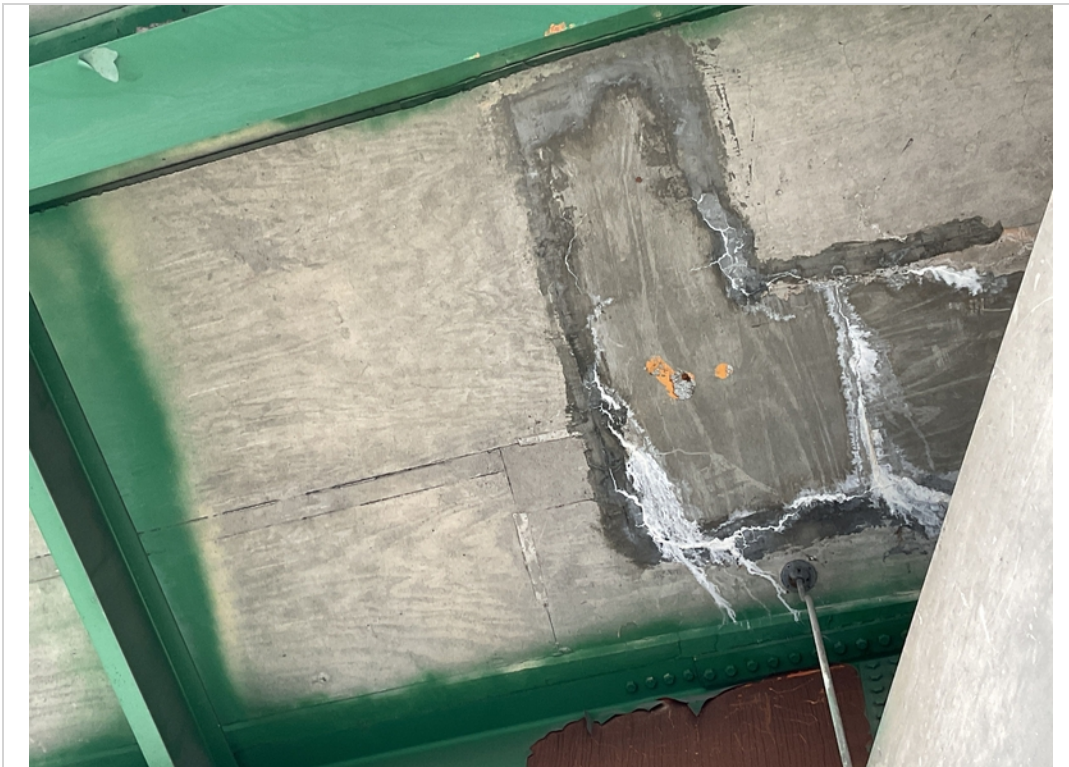
Span 2 bay B failing patch with eff

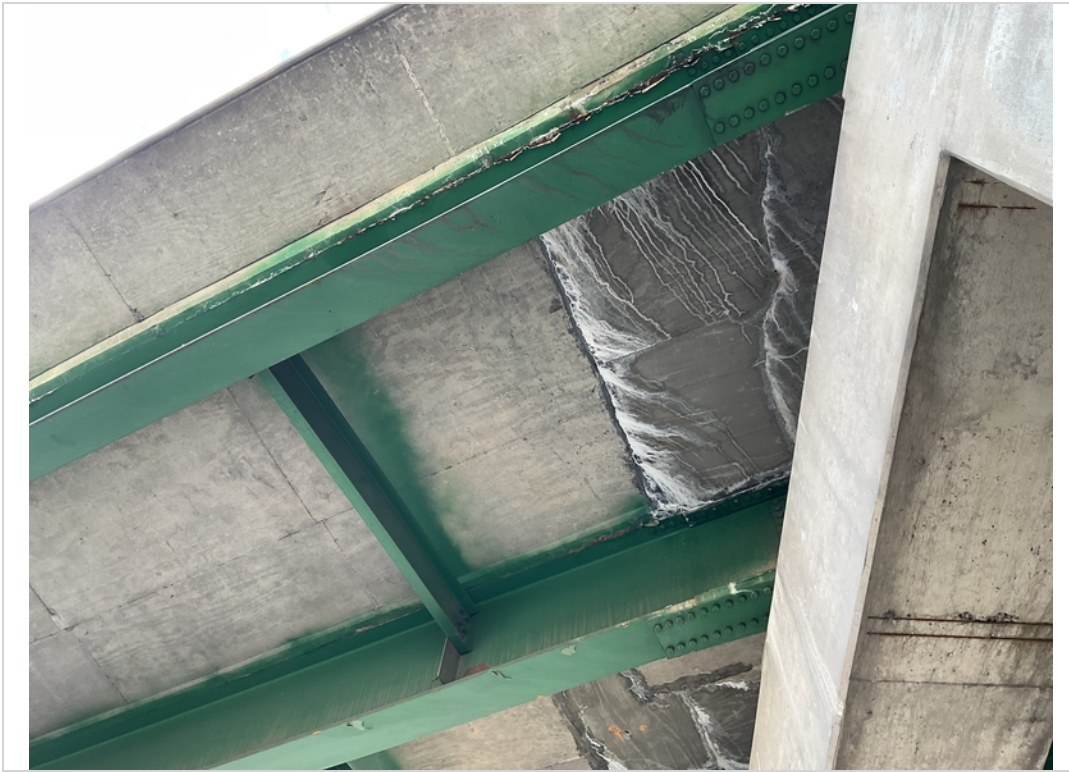
Span 2 bay A failing patch will eff

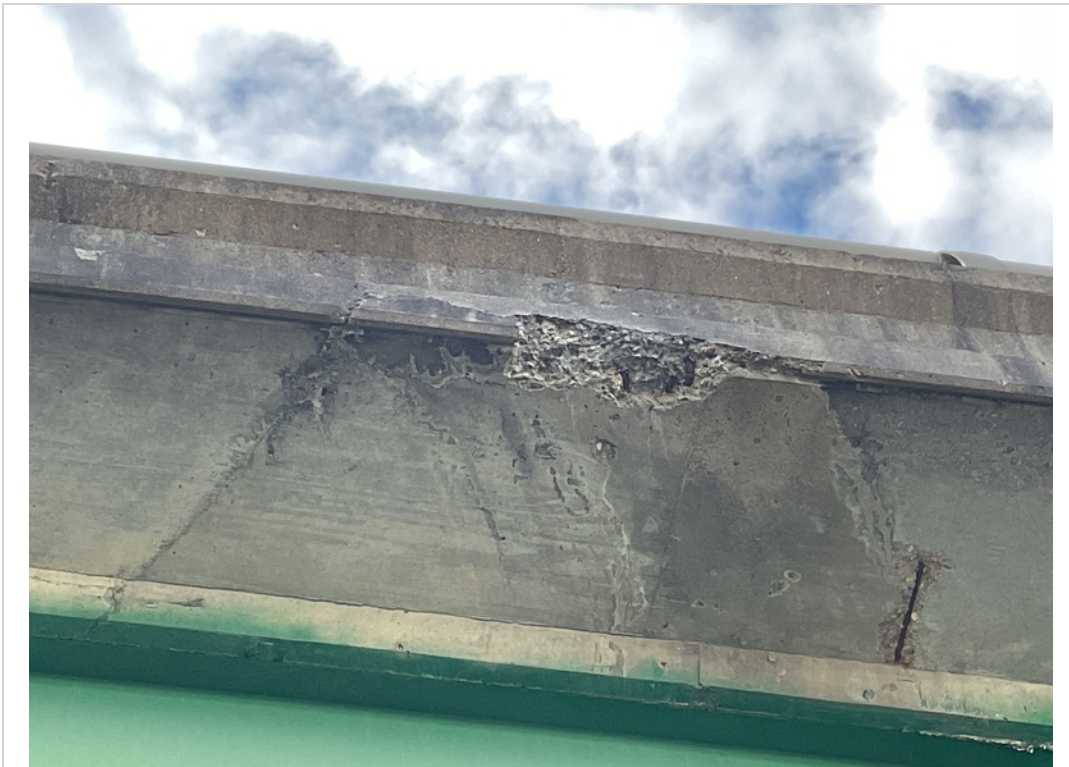
Overhang span 2 left side scale with exp steel

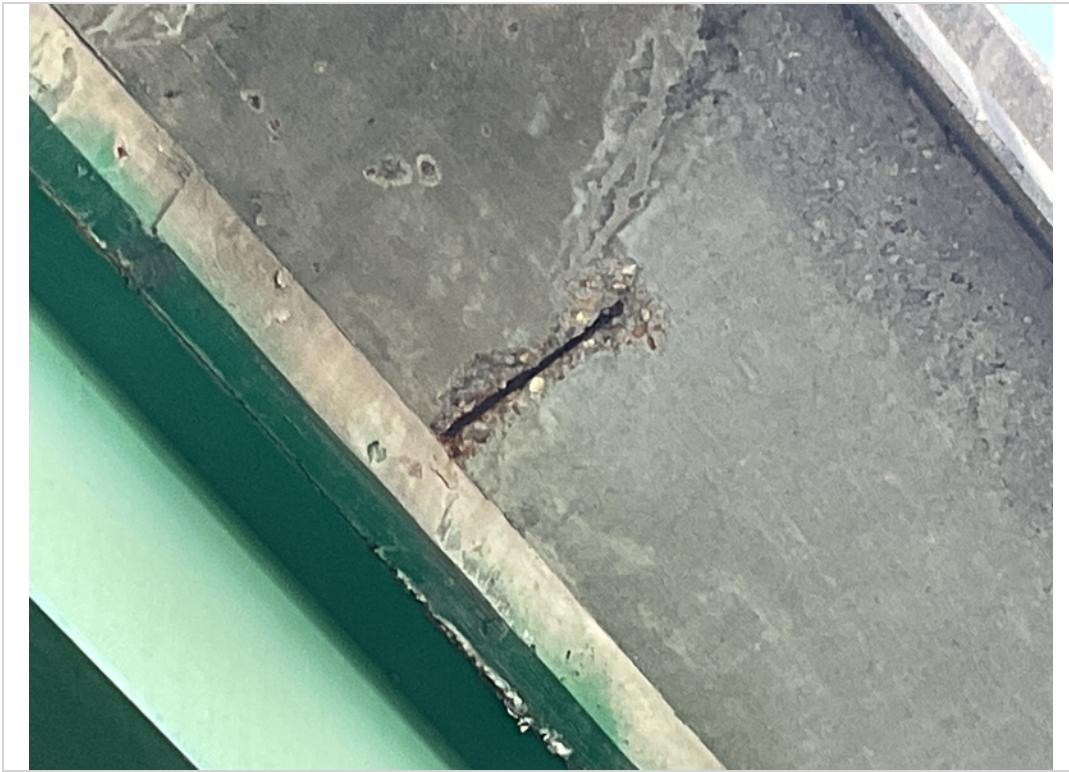
Overhang span 2 left side spall with exp steel

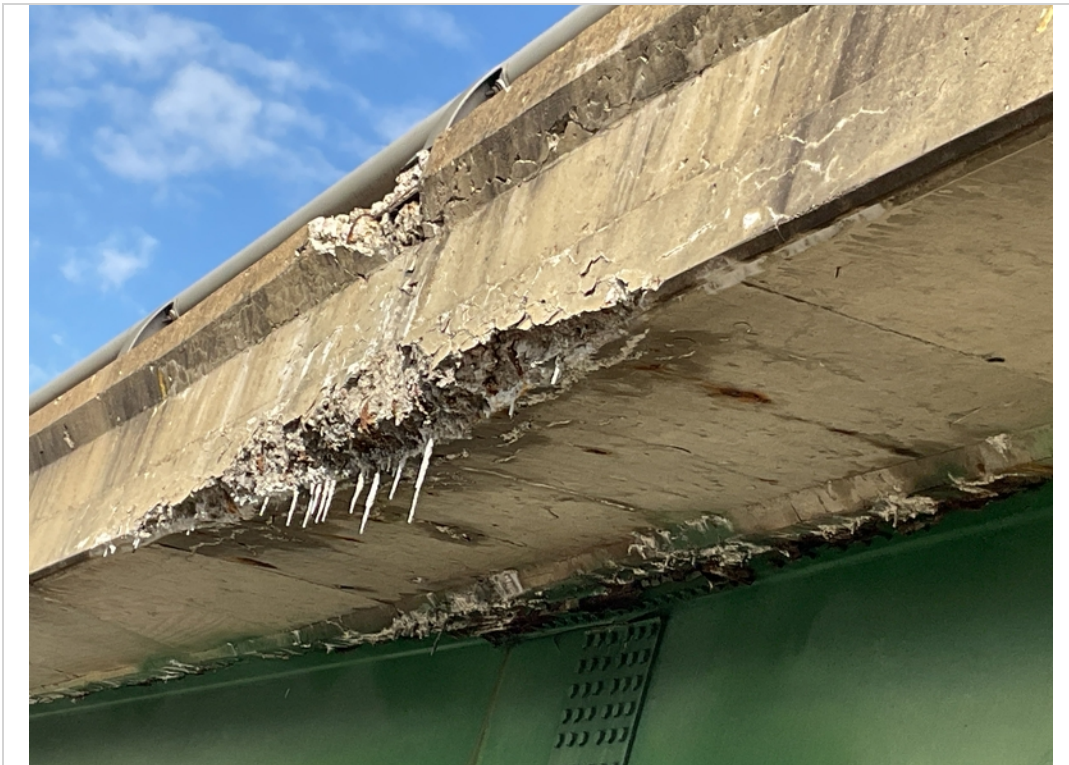
Overhang span 3 right side delam with eff

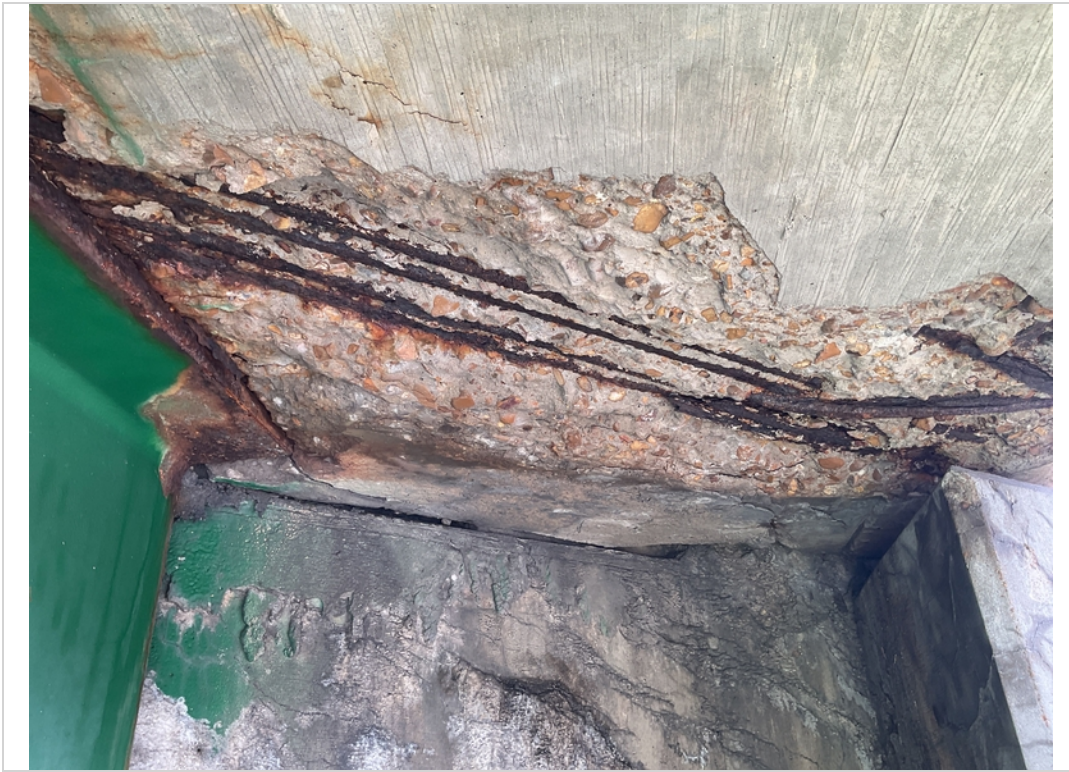
Overhang span 3 right side spall with exp steel

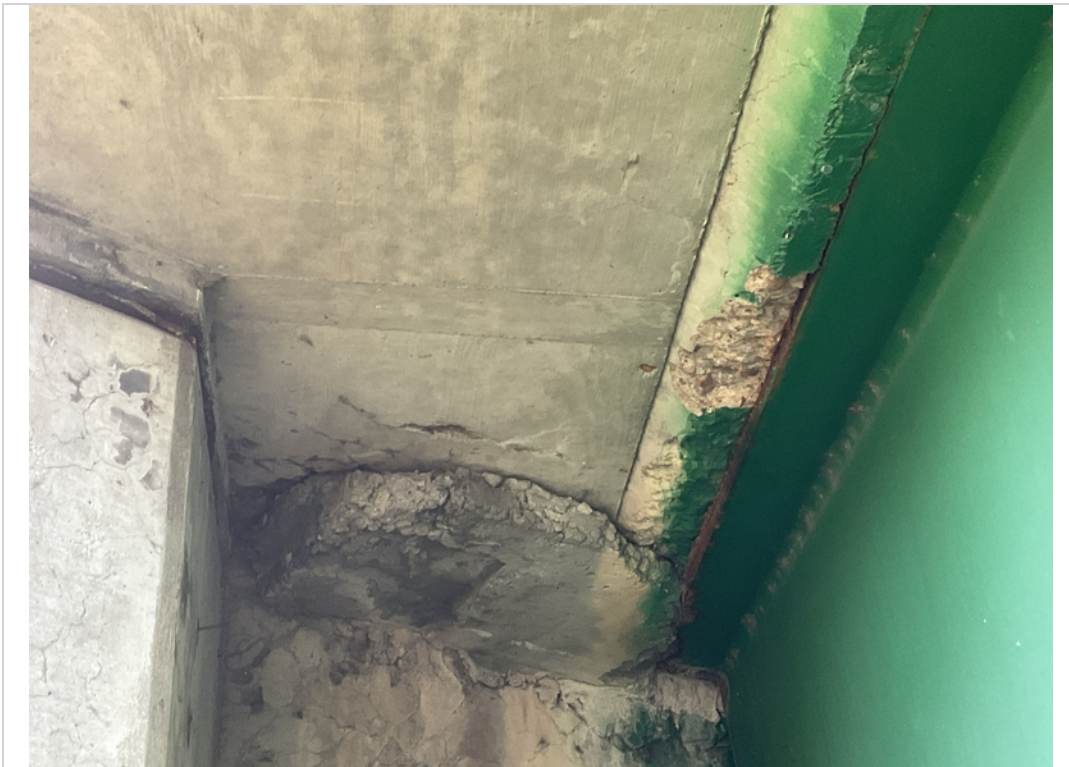
Overhang span 3 left side patch

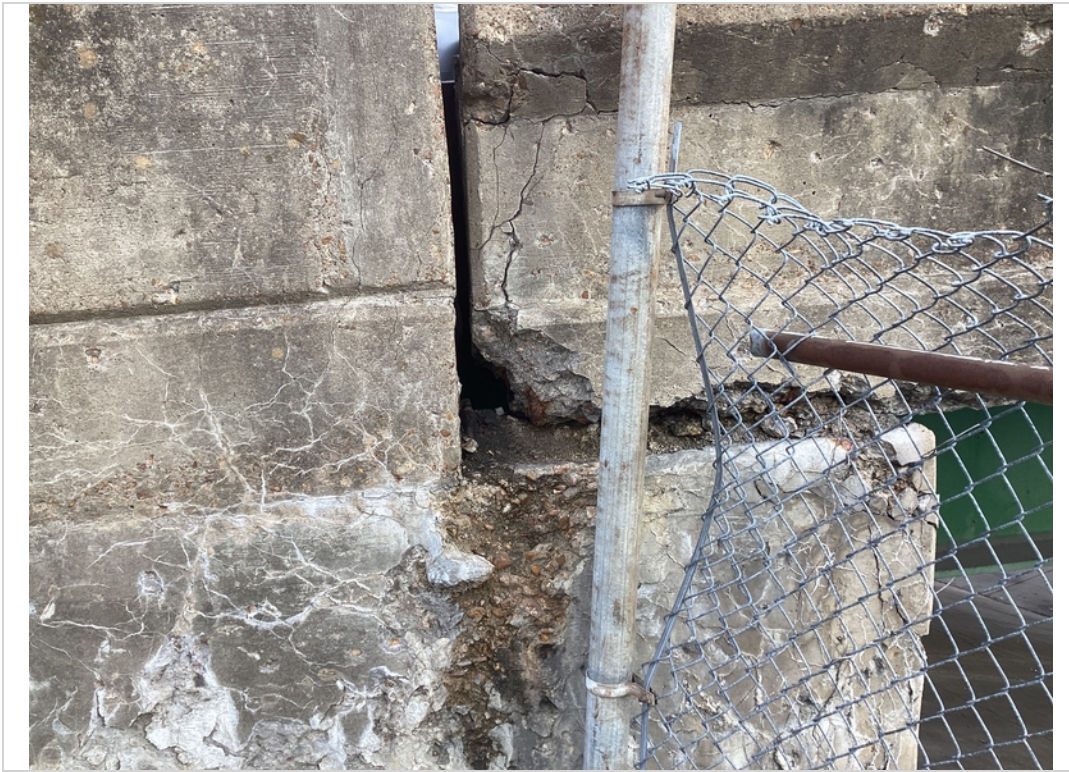
Span 1 parapet at right wing cracks spalls with exposed steel

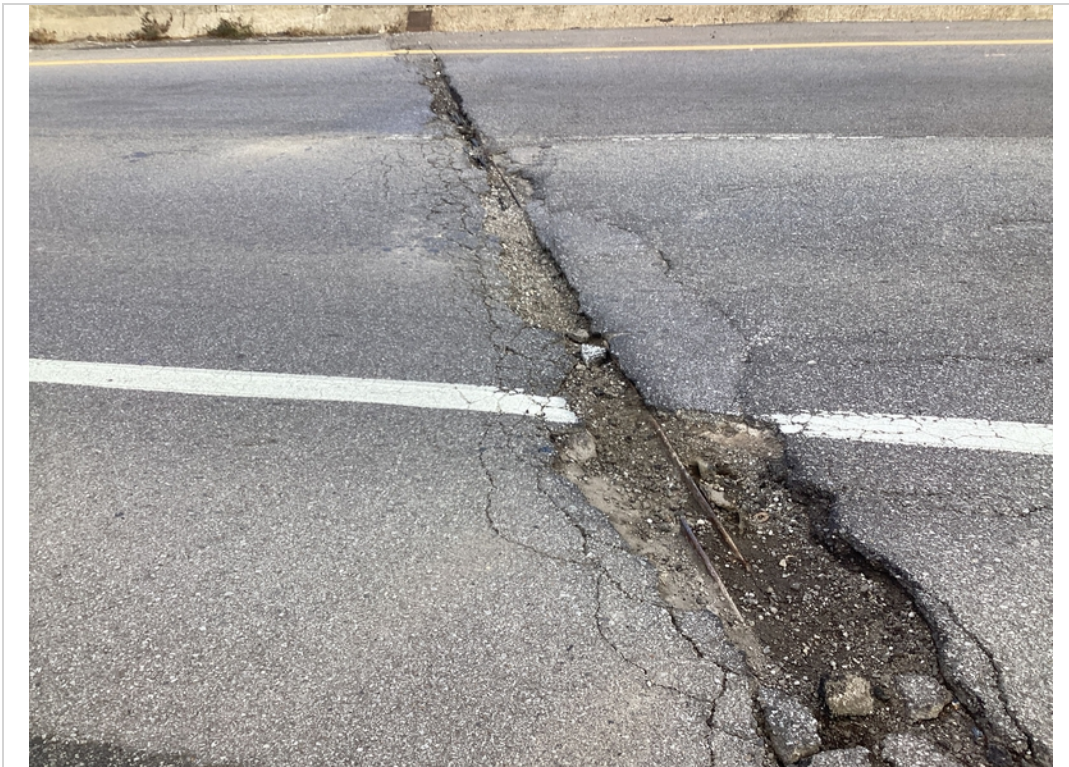
Span 1 joint paved over with potholes

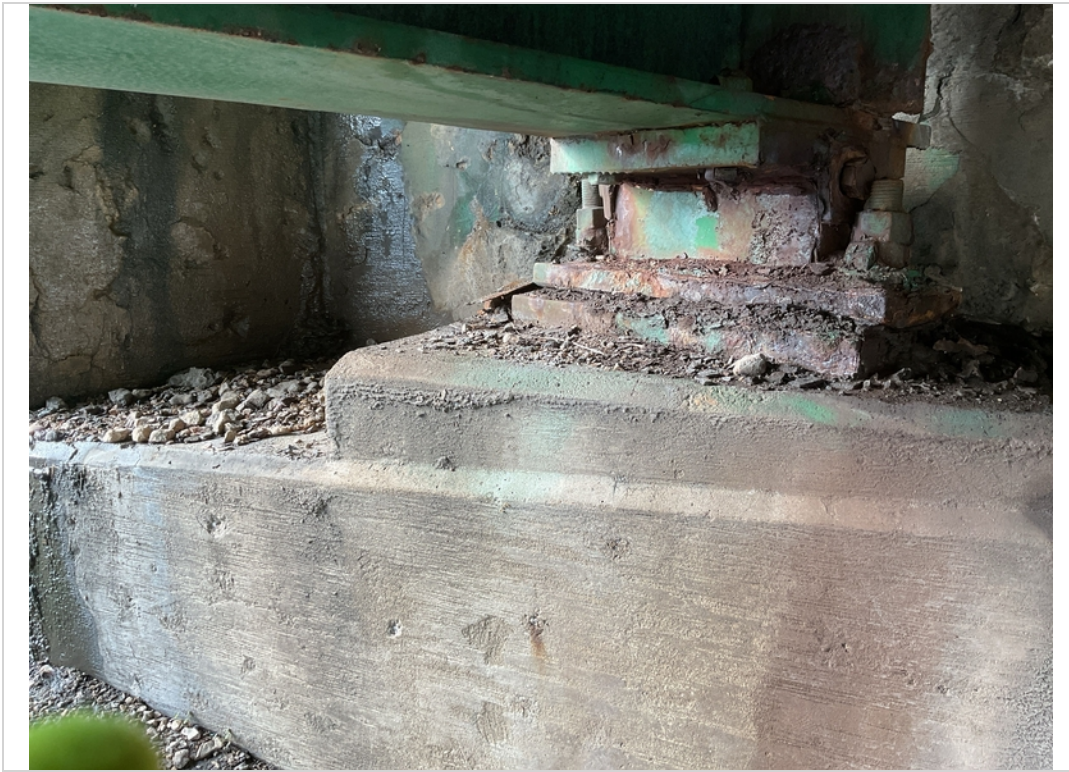
Abut 1 bearing E hvy corrosion loose or bent anchorage

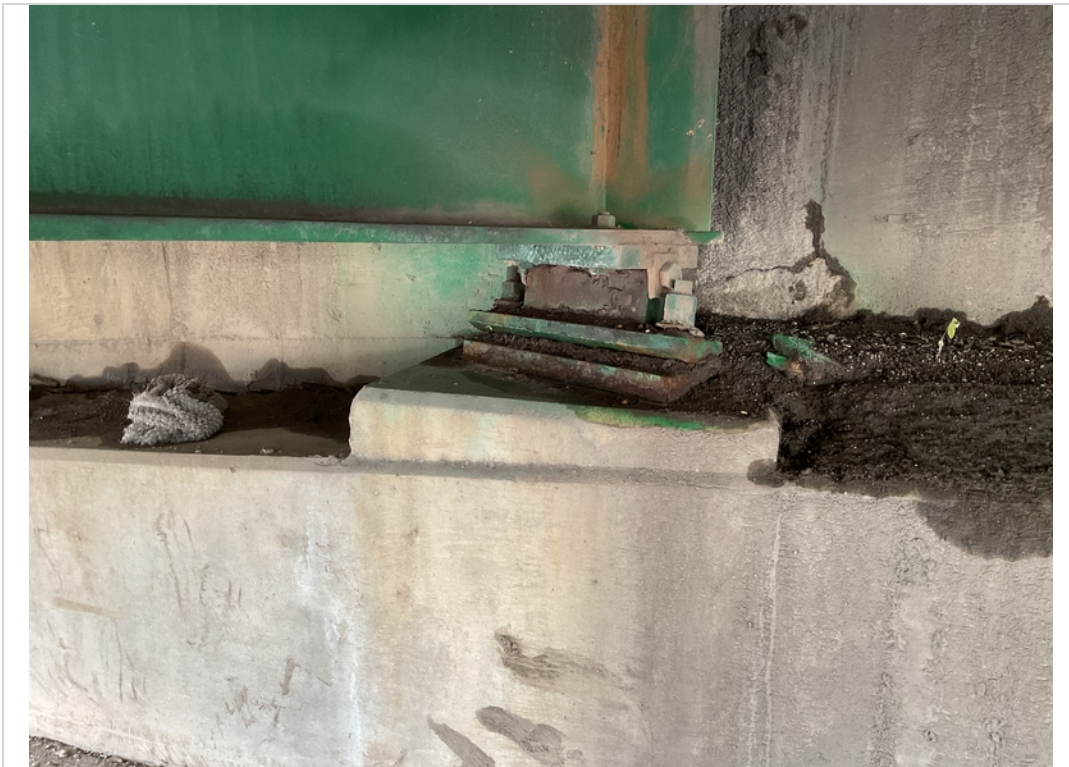
Abut 1 bearing D loose anchorage moderate corrosion

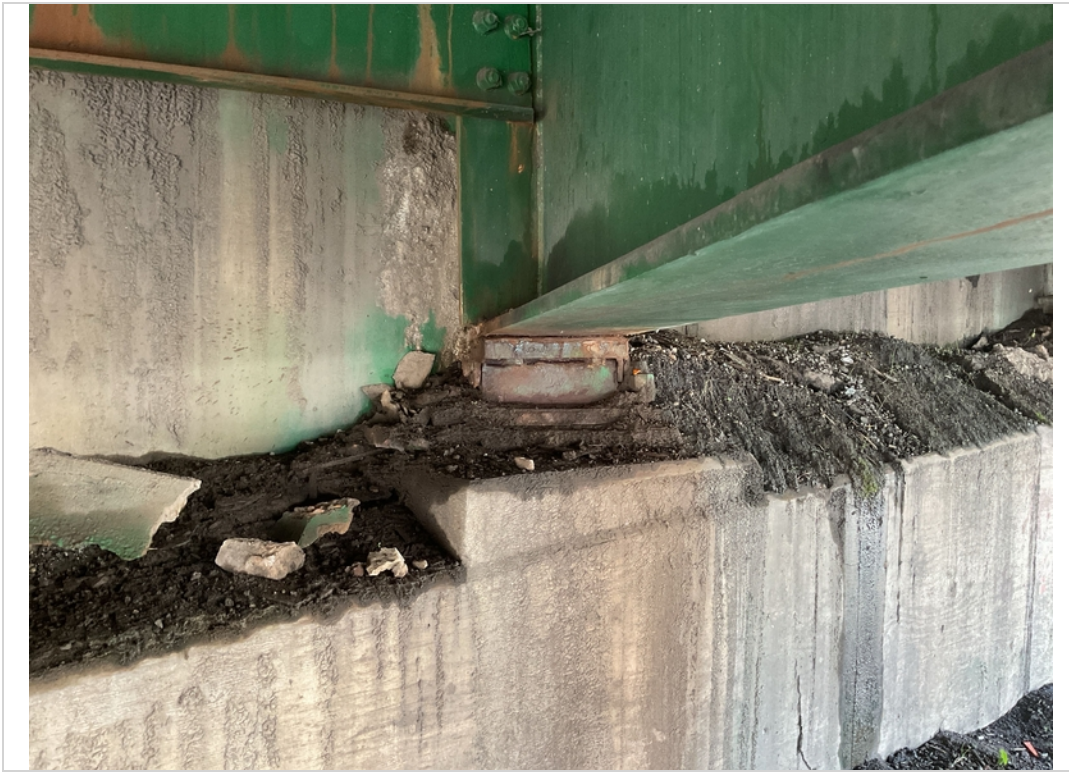
Abut 1 bearing C hvy corrosion loose or missing anchorage hvy build up

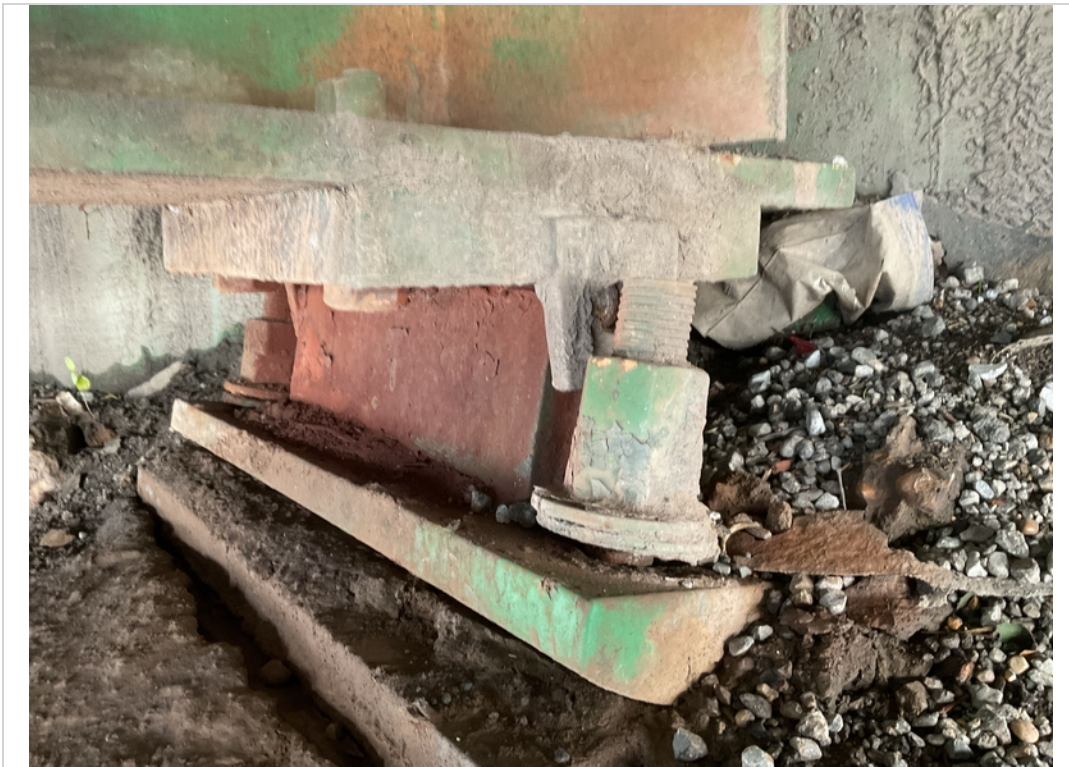
Abut 1 Bearing B broke pin loose anchorage

Date Added	Recommendation	Priority
01/05/2016	REPAIR BEARING 'A' AT ABUTMENT #1	1
01/05/2016	CLEAN AND PAINT STRUCTURAL STEEL	
12/04/2017	REPAIR EROSION 'B' END RIGHT SIDE	2
01/05/2016	REPAIR TUBULAR RAIL 'A' END RT SIDE AND 'B' END LT SPAN #3	2
12/07/2021	CLEAN DECK SHOULDERS	
12/04/2017	REPAIR APPROACH PAVEMENT @ 'A' END	2
01/05/2016	REPAIR SCALE/SPALLS ON PARAPET ALL SPANS	2
01/05/2016	REPAIR SPALLS ON BACKWALL ABUTMENT #1	2

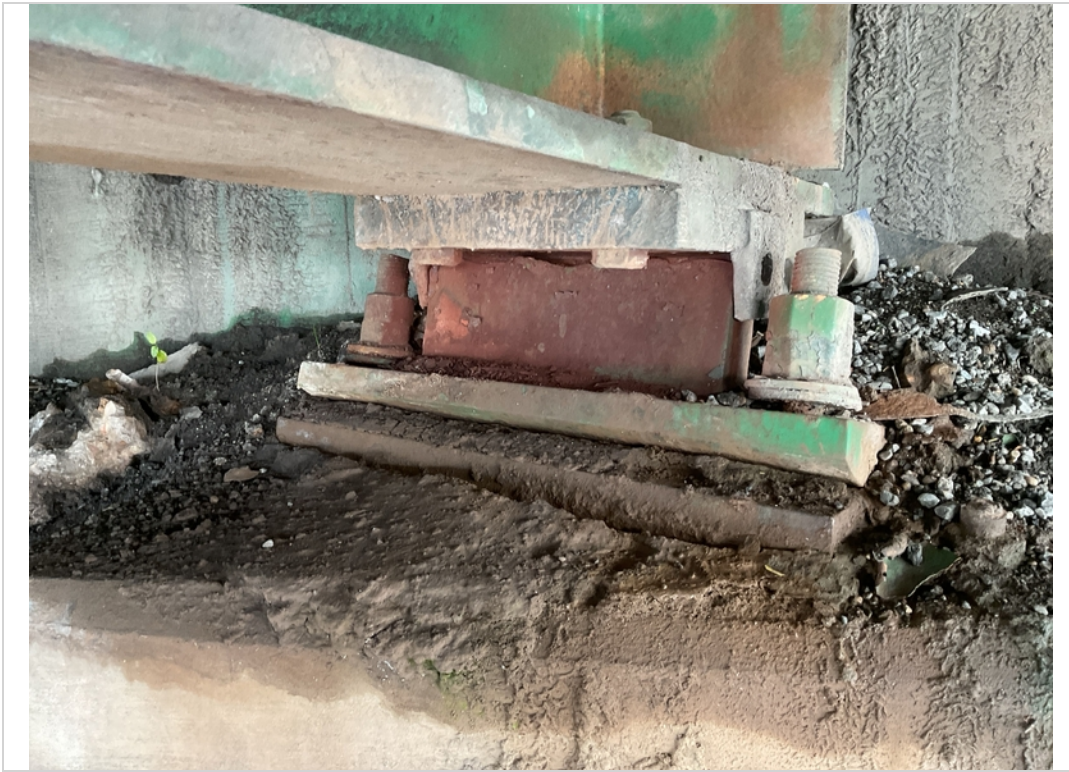
Abut 1 all bearings hvy corrosion w/ loose or missing anchorage
