Latitude:36.14810, Longitude:-86.77920

Region 03, 19 - Davidson County

I40 RMP / 8TH AVE (SR 6)

3 span Bridge / W.P.G.  
I-40 Ramp / 8TH AVE (SR 6)

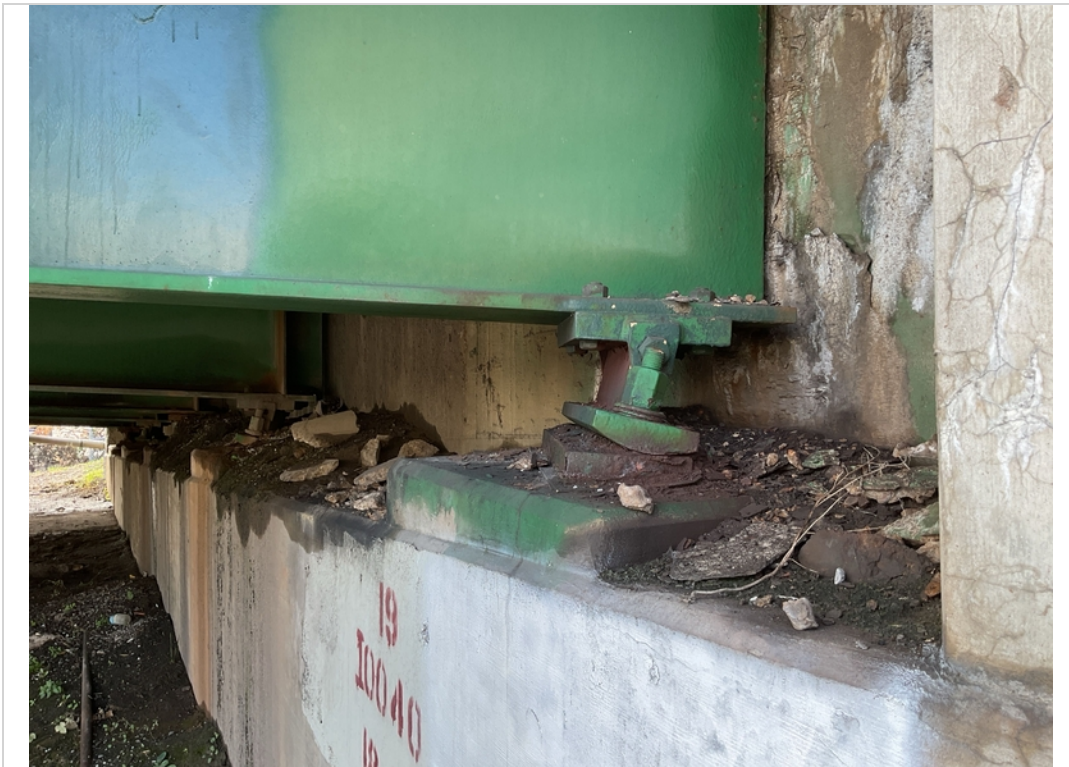
Abut 1 all bearings rocked back w/hvy debris build up.

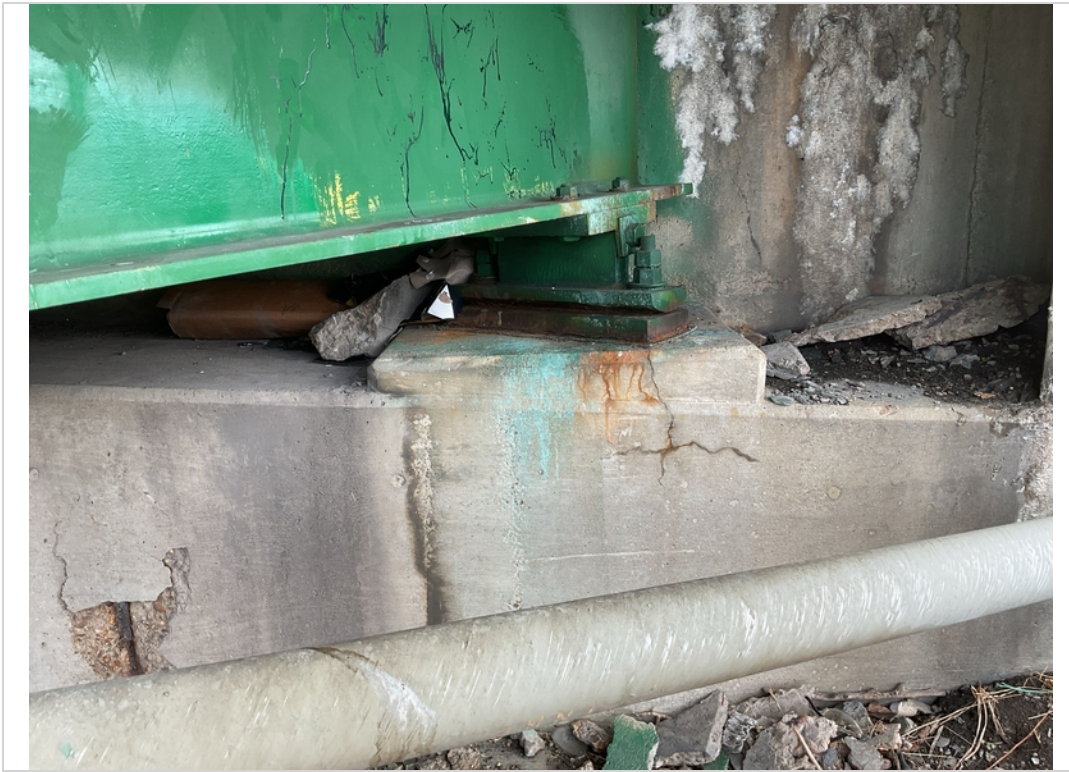
Abut 2 bearings moderate corrosion and debris

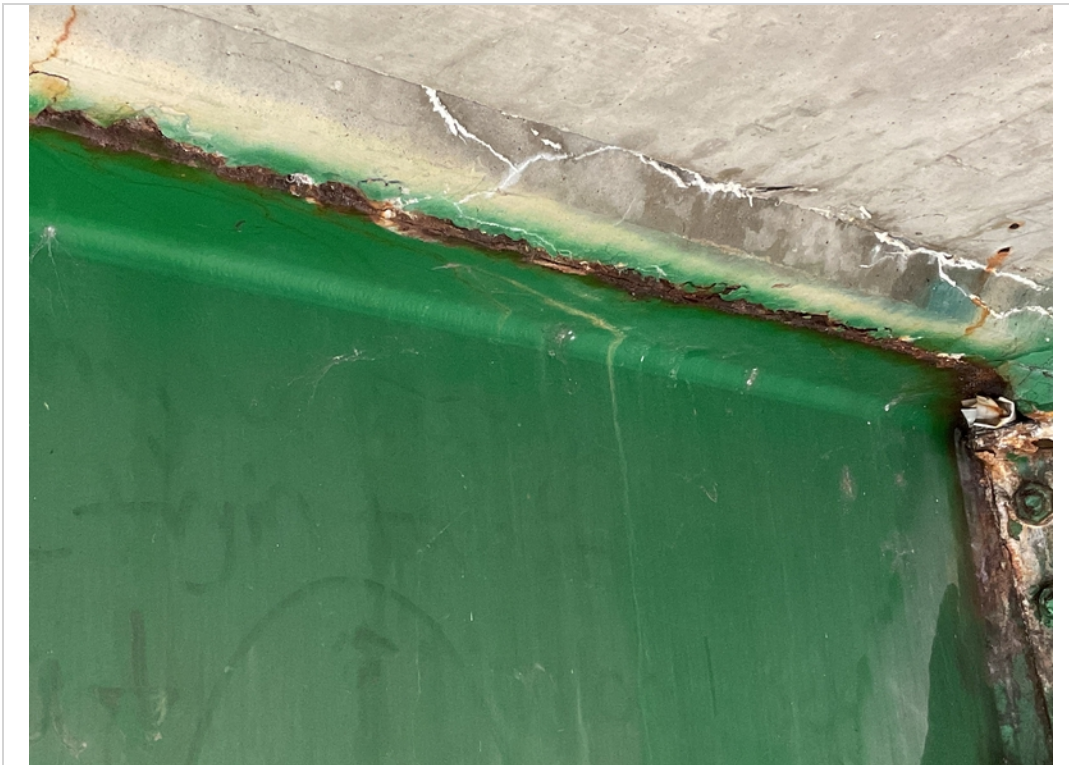
Span 1 Girder E top flange corrosion

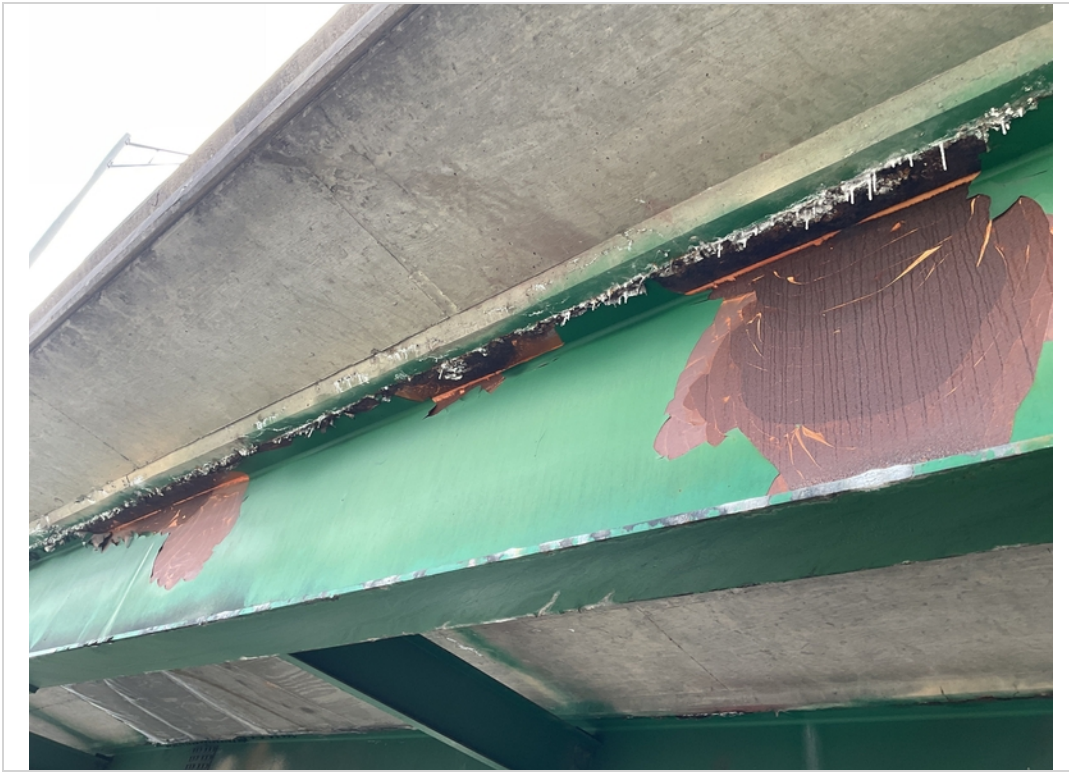
Span 1 Girder A top flange corrosion with eff

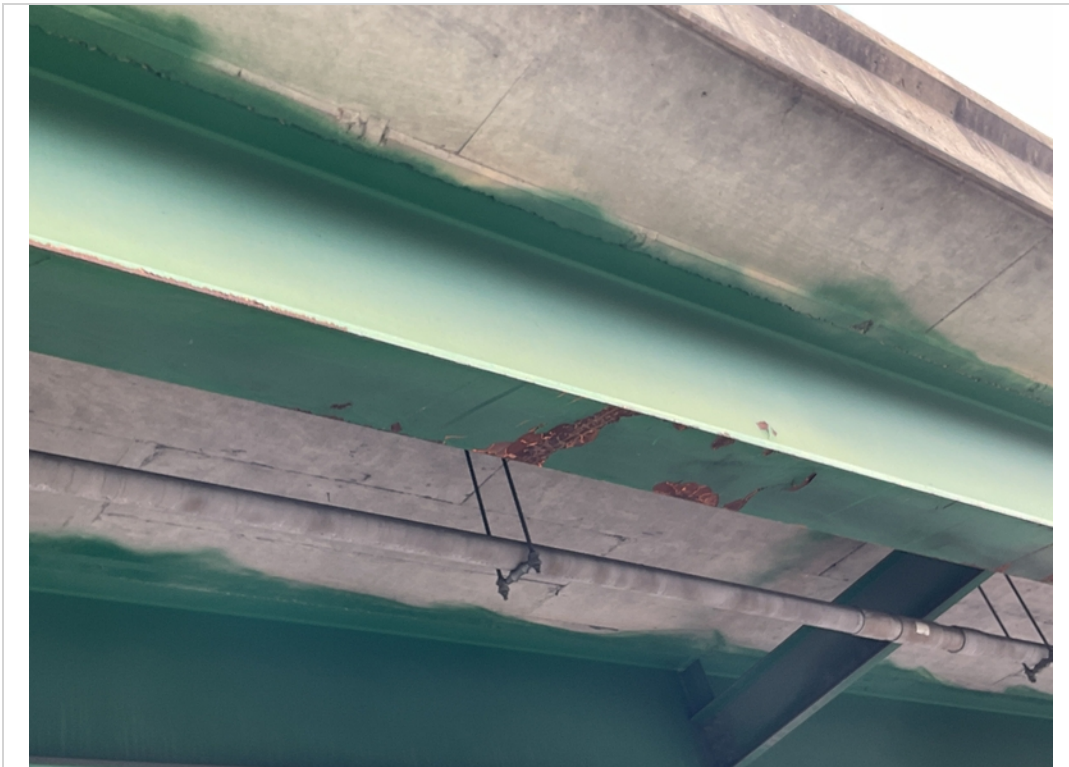
Span 2 Girder E impact scrapes

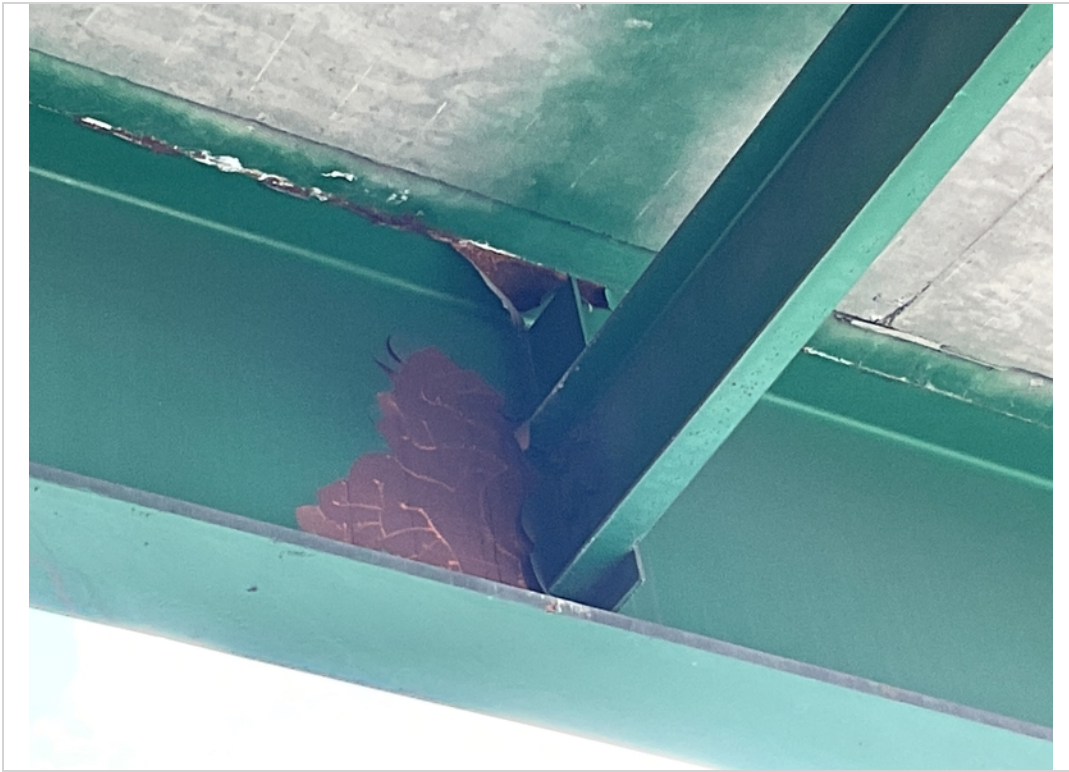
Span 2 Girder A corrosion

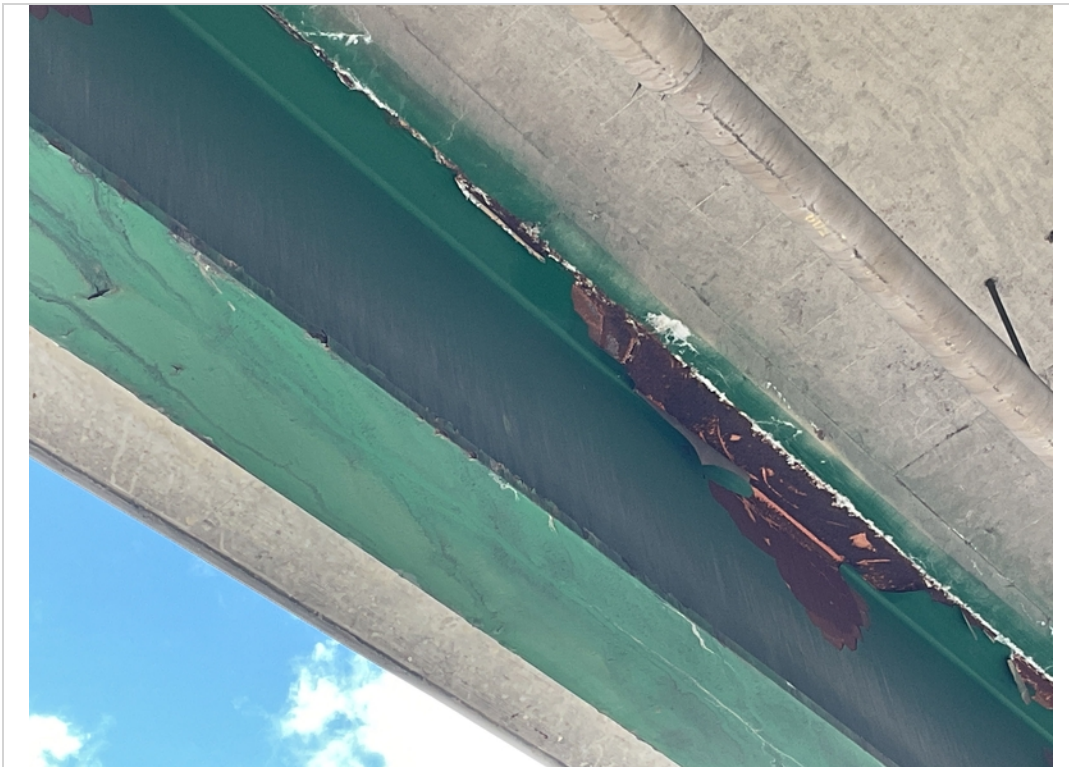
Span 2 Girder E top flange corrosion with eff

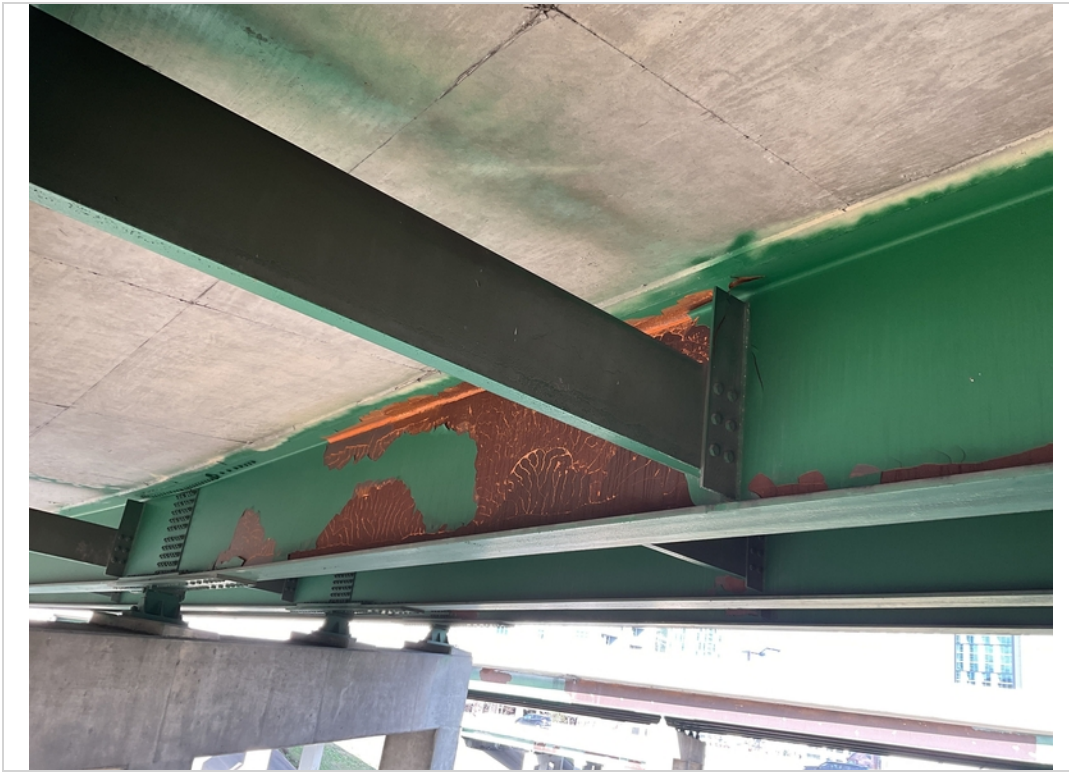
Span 3 Girder C corrosion

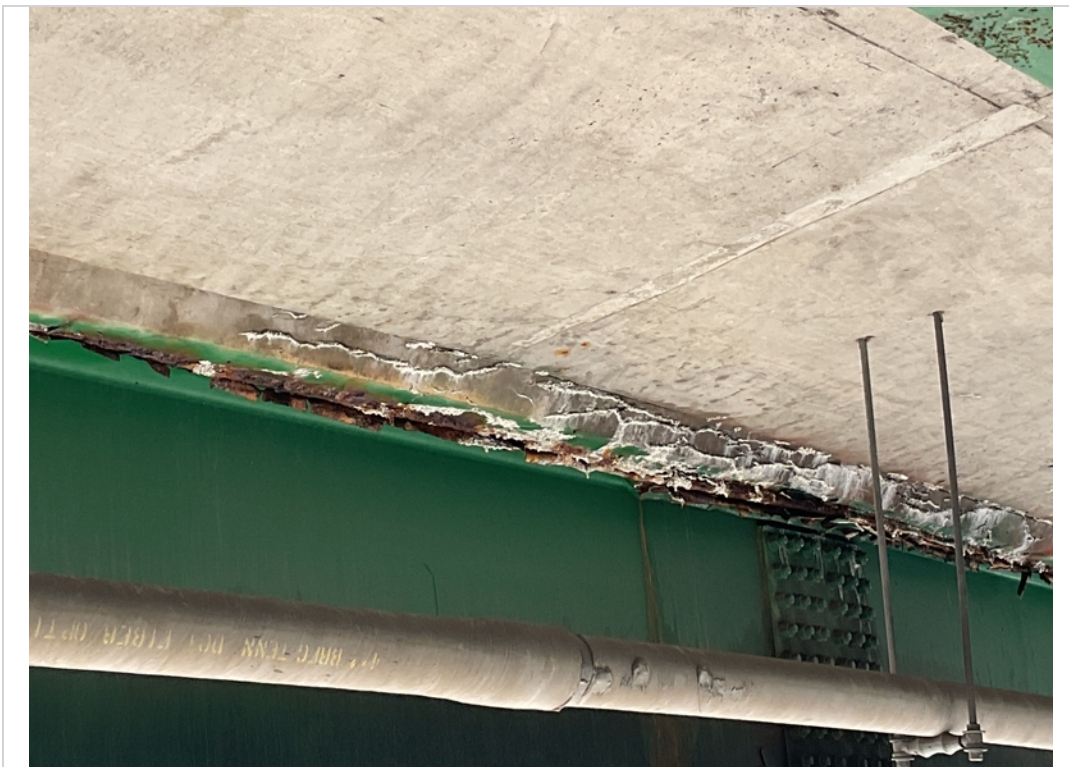
Span 3 Girder E top flange corrosion with eff

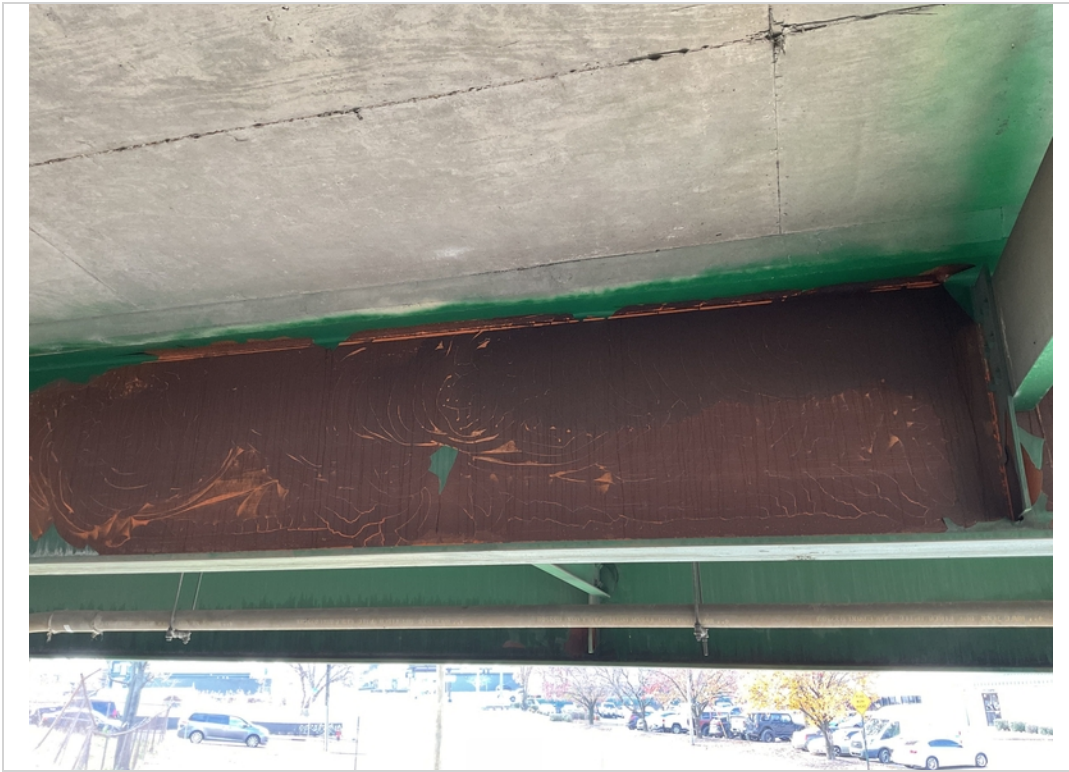
Span 3 Girder D corrosion

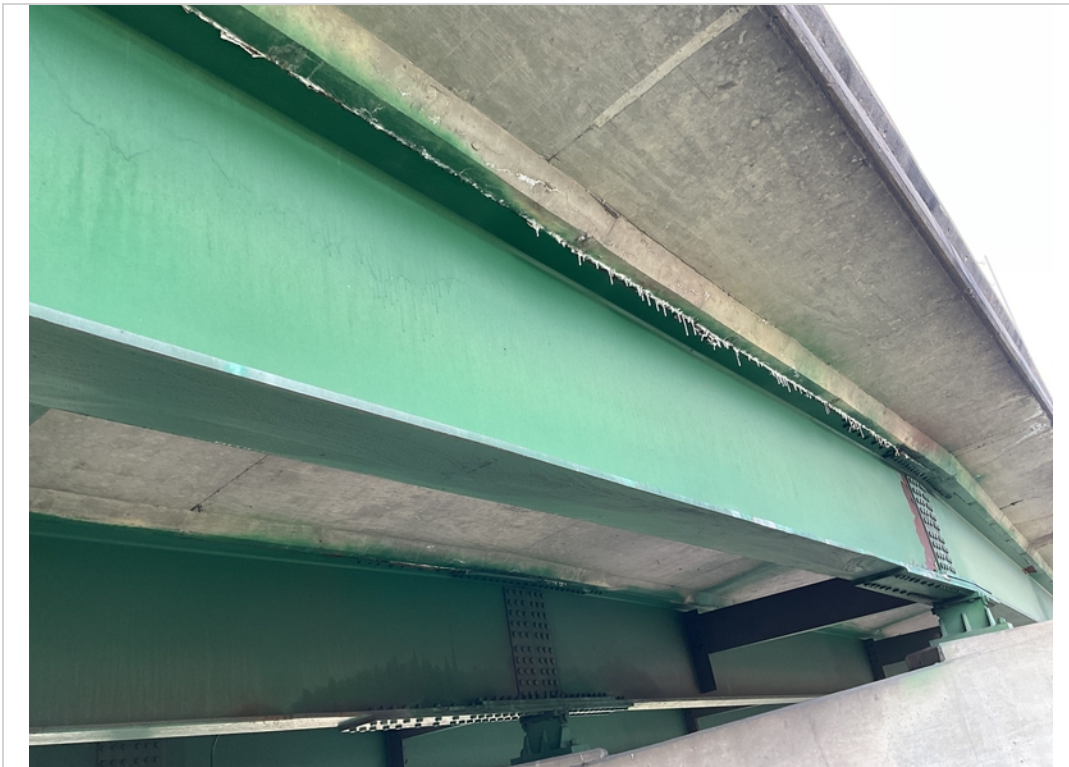
Span 3 Girder A top flange corrosion with eff

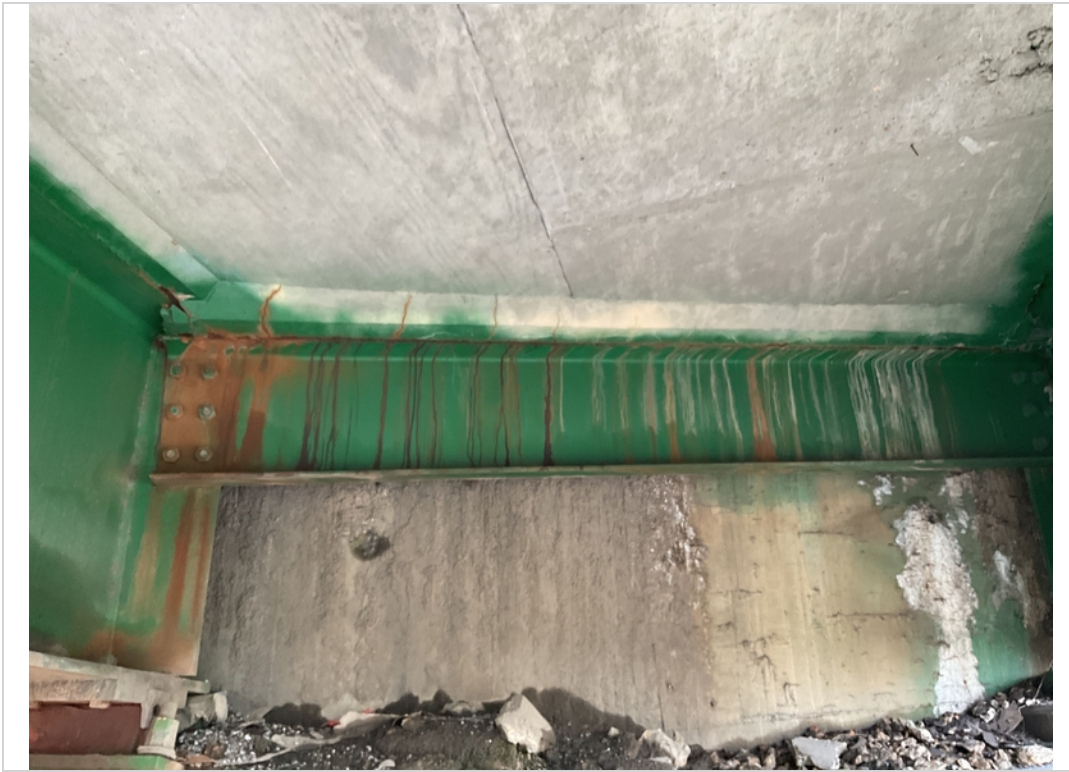
Span 1 diaphragm A corrosion

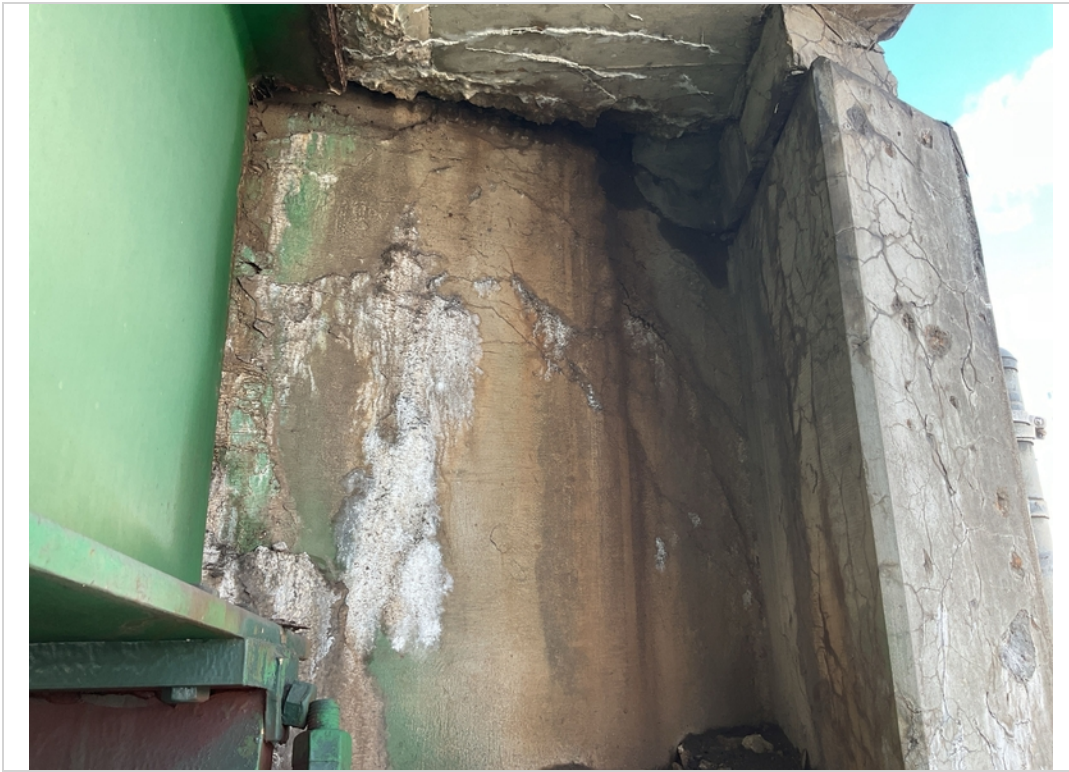
Abut 1 map cracks hvy eff

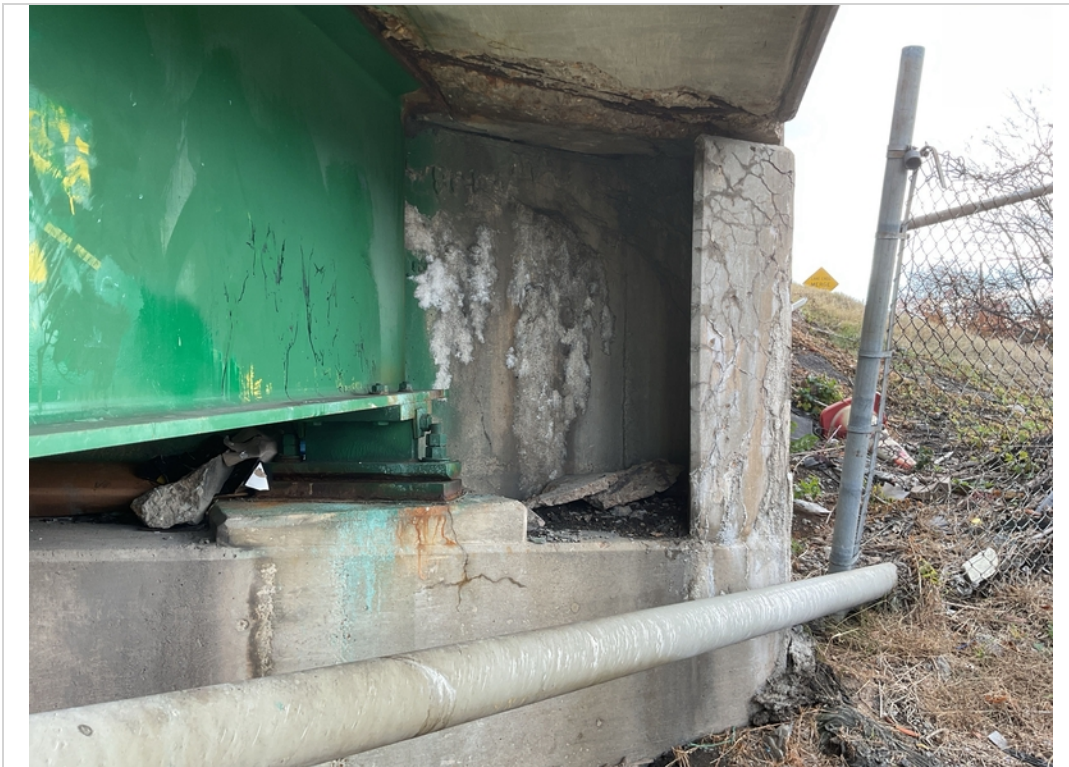
Abut 2 map cracks w/hvy eff

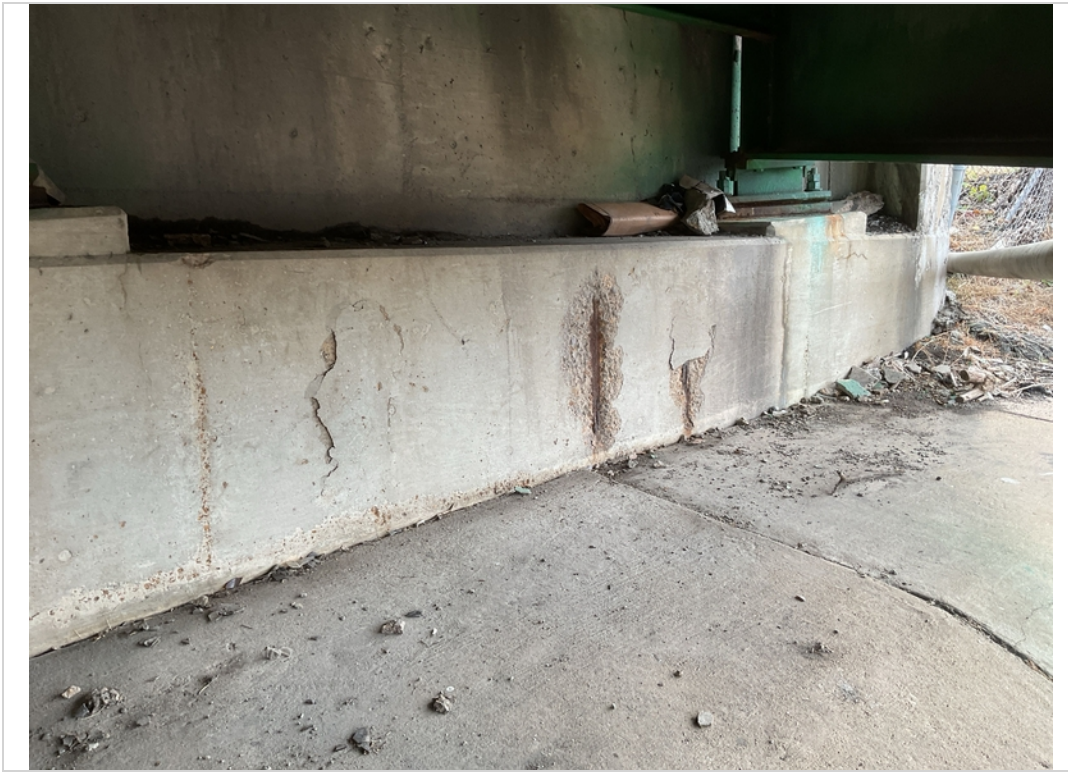
Abut 2 areas of delam w/exp steel

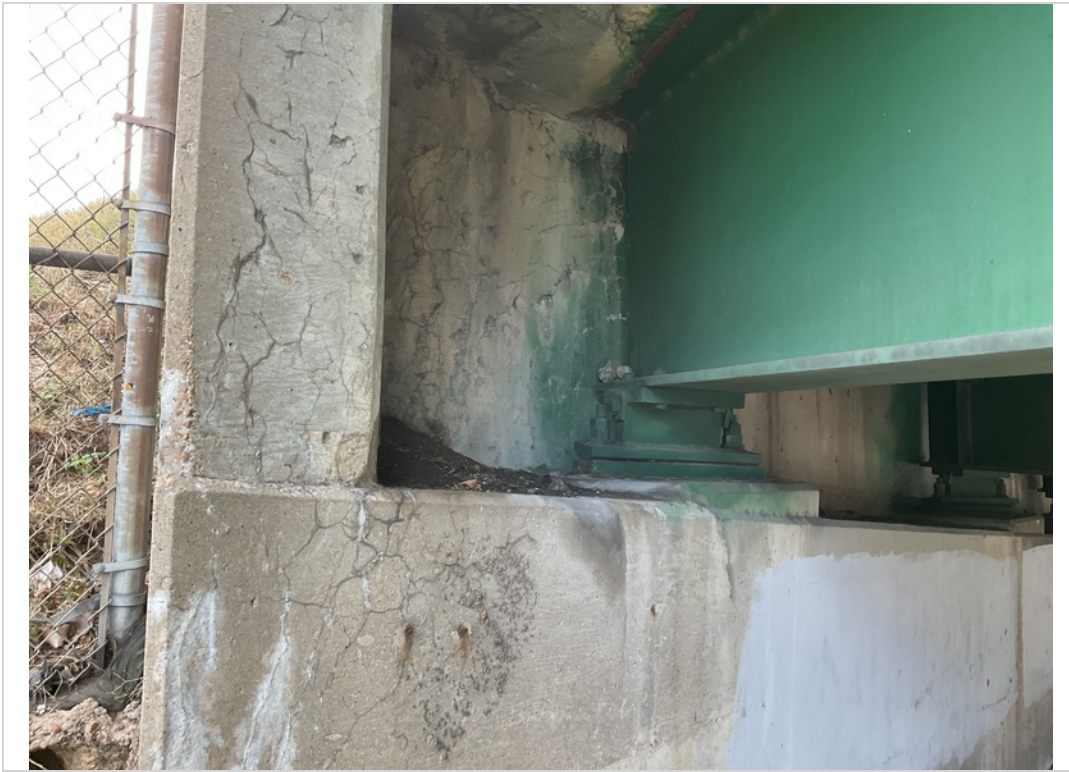
Abut 2 map cracks.

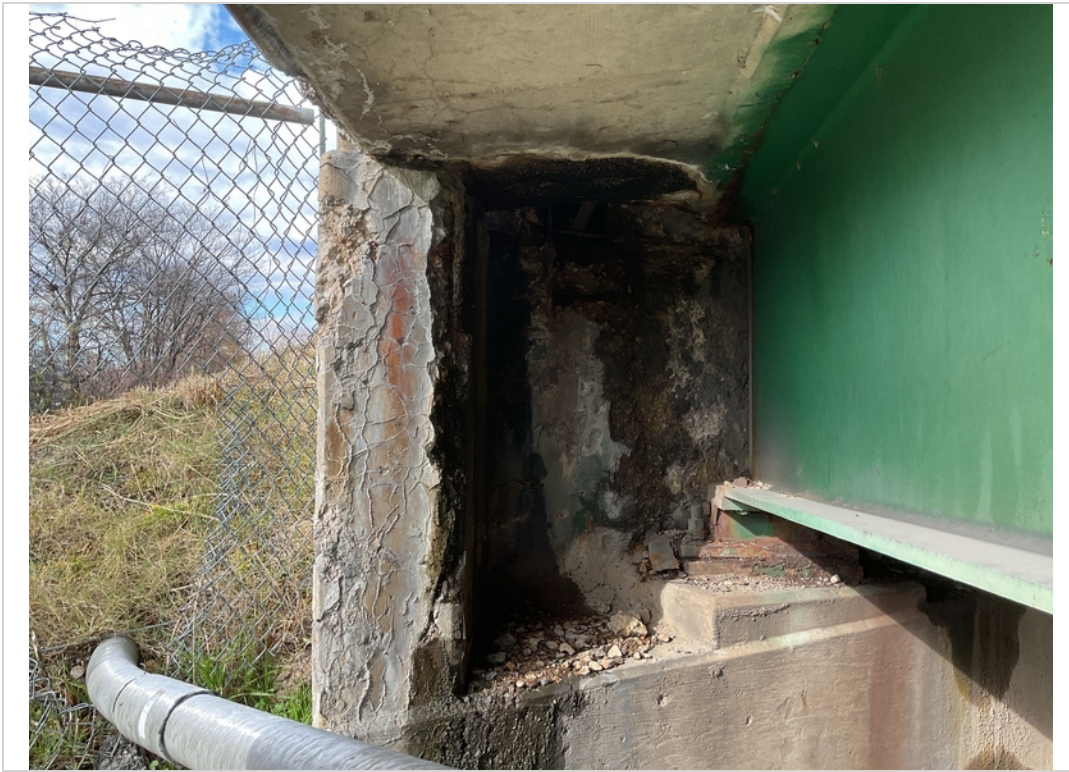
Abut 1 right wing map cracks

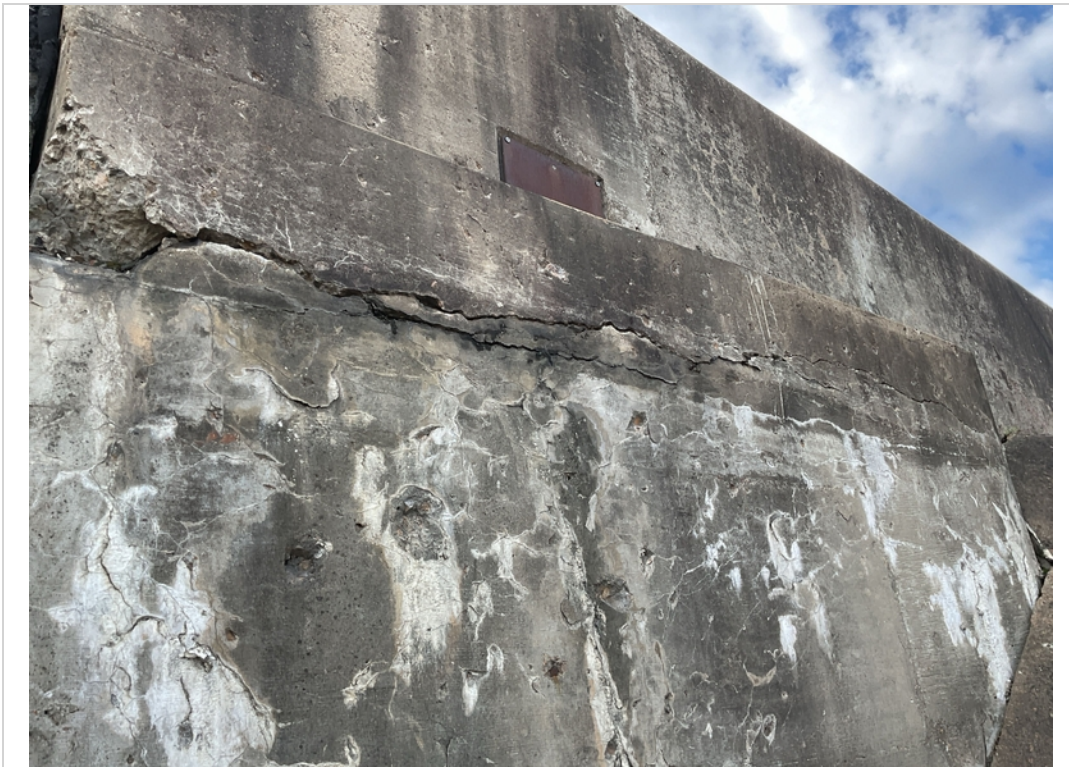
Abut 1 left wing open cracks hvy eff

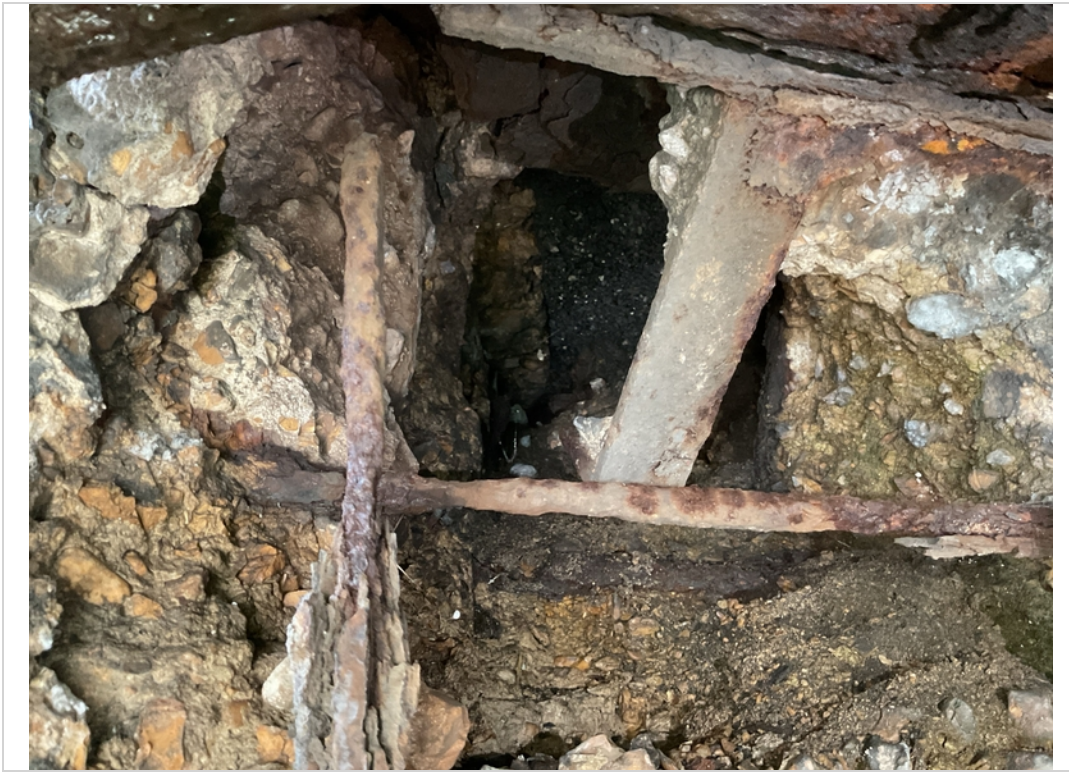
Abut 1 right back wall void w/exp steel exposing underside of wearing surface

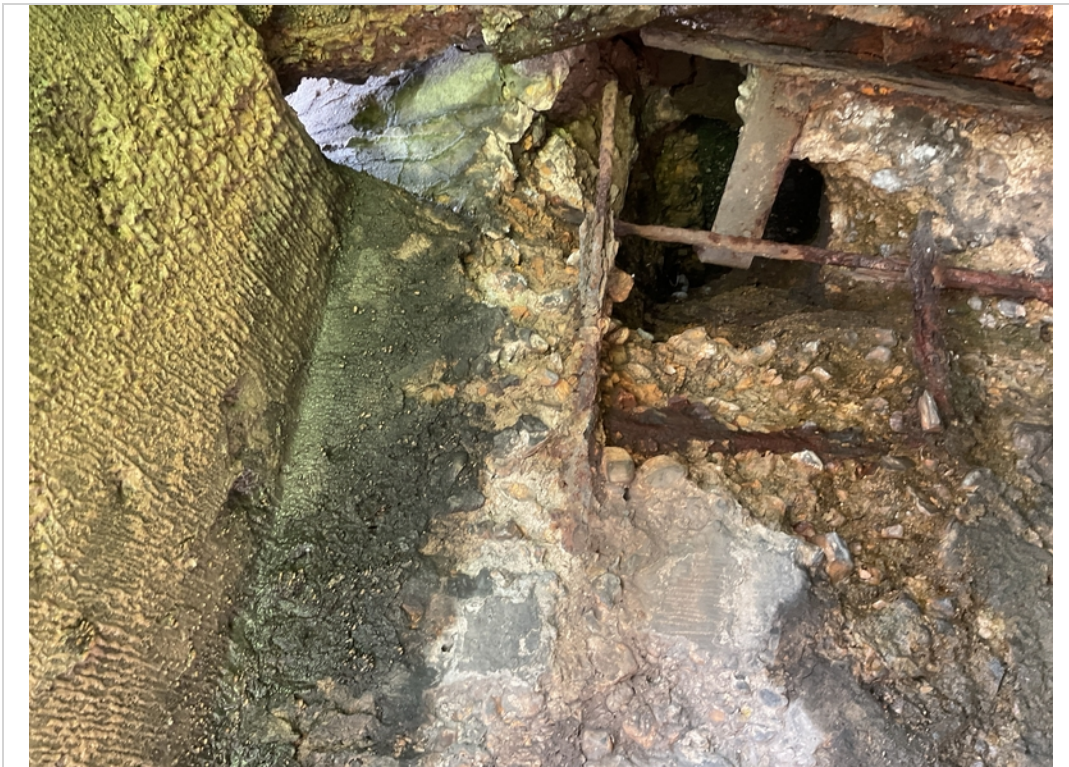
Abut 1 right spall w/exp steel

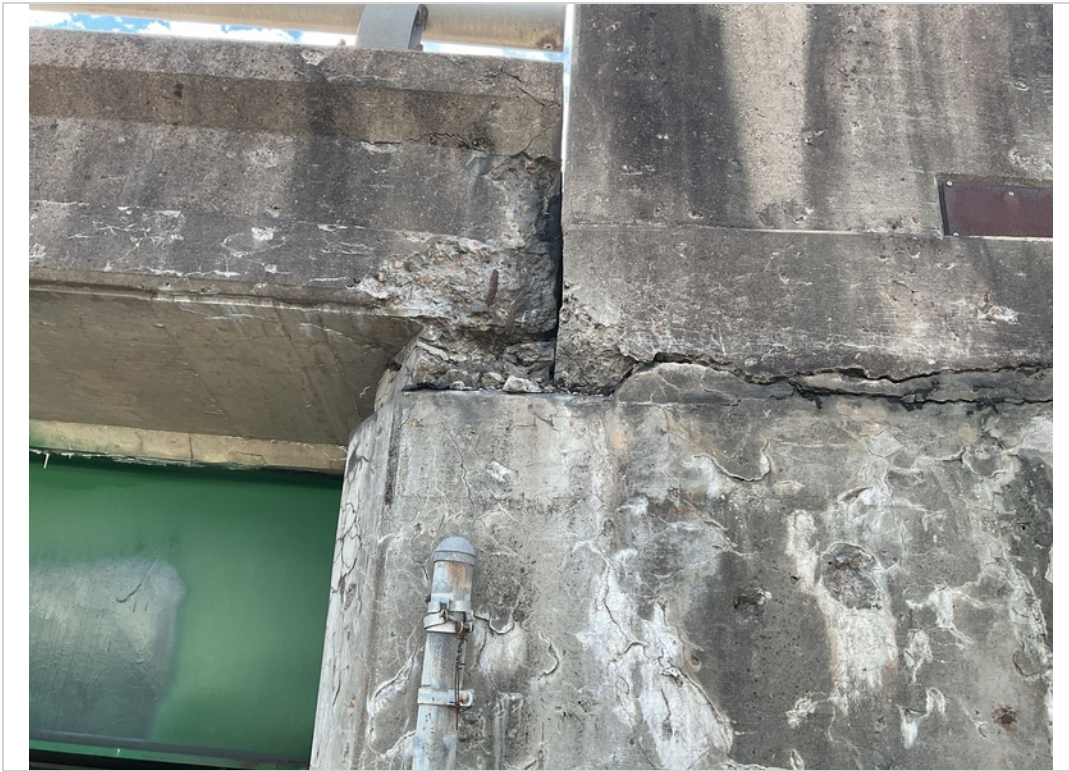
Abut 1 left spill w/exp steel on parapet

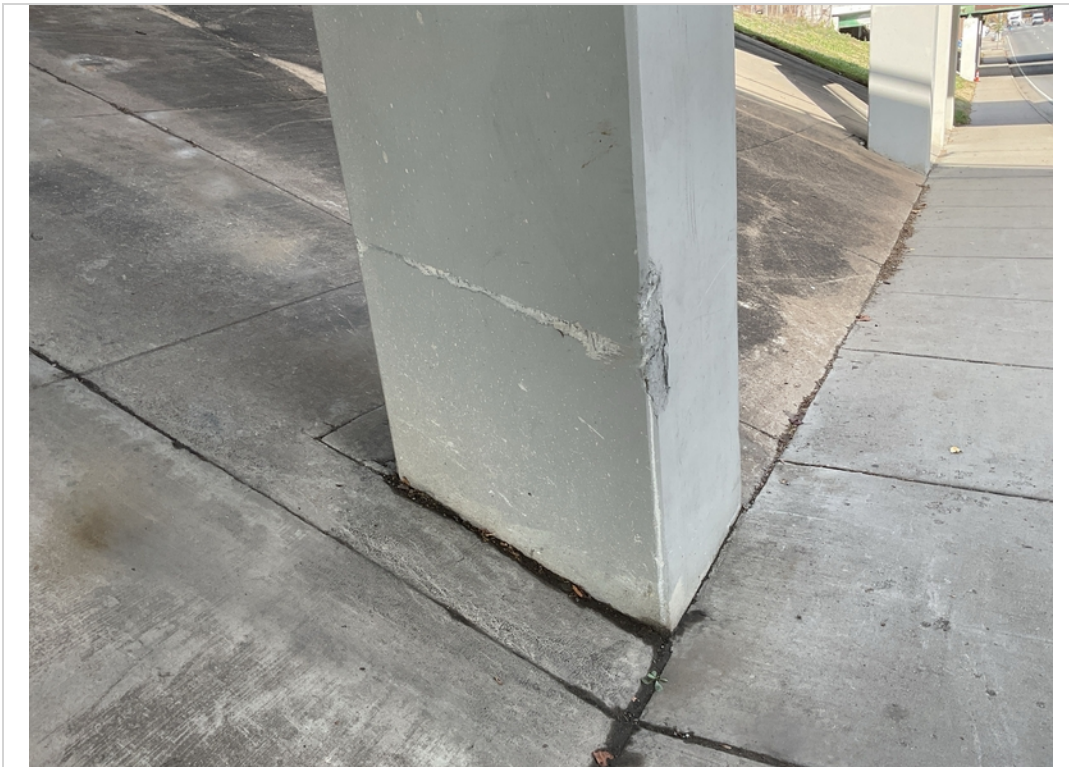
Pier 1 column A impact damage.

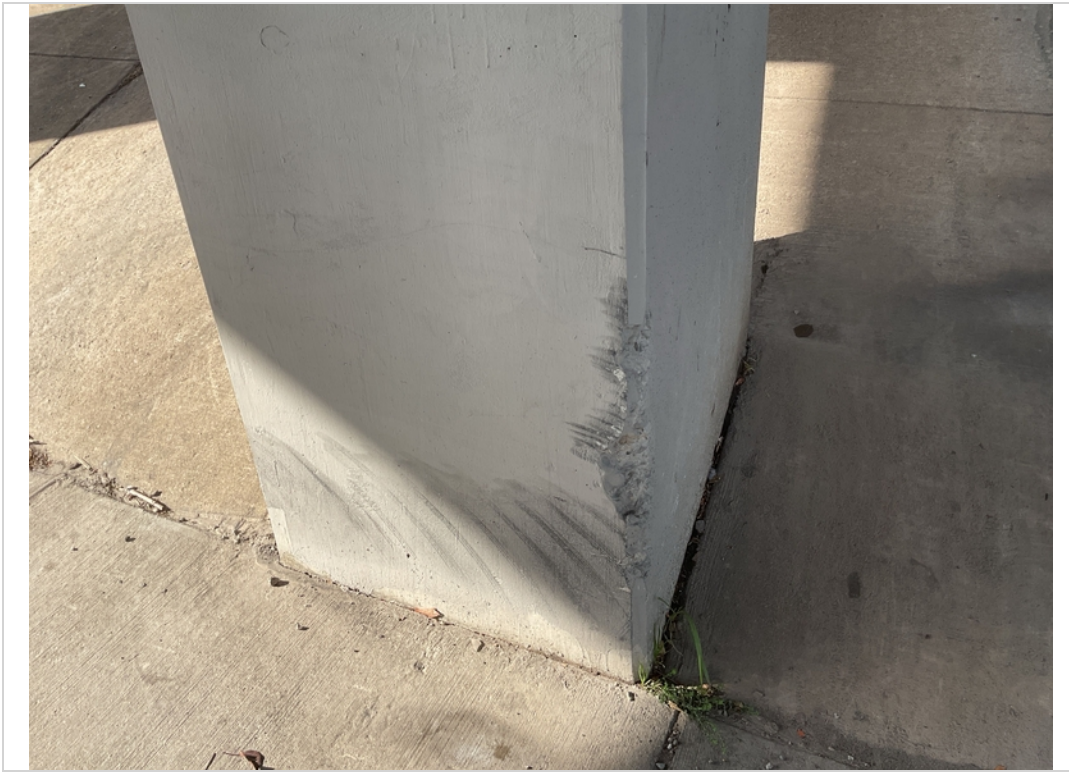
Pier 1 column B impact damage

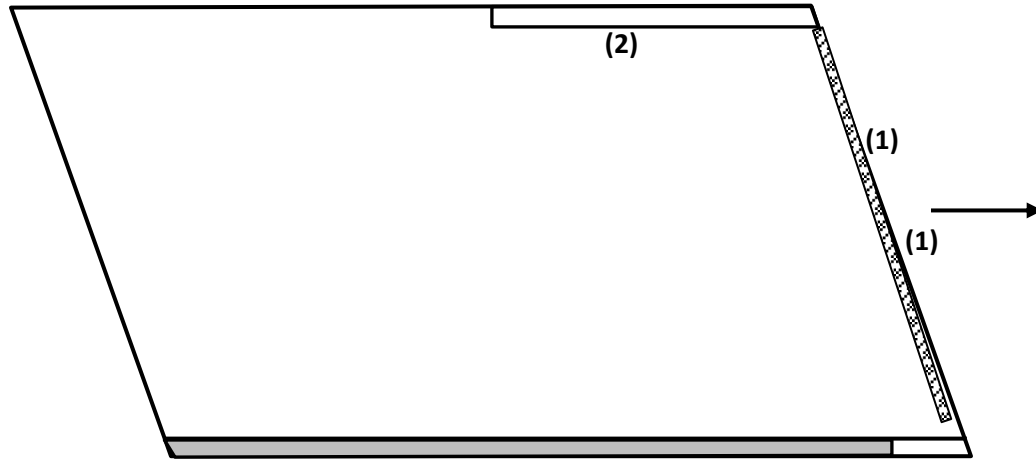
# Approach 'A'

PARAPETS	FAIR	(2) SPALLS W/EXP STL UP TO 1.5'L X 3'W; VERT CRACKS UP TO 1/4" OPEN
G-RAIL	GOOD	RT ONLY; LGT IMPACT DMG; END TERMINAL--MOD IMPACT DMG
PAVEMENT	POOR	(1) POTHOLES FULL WIDTH X 1'W X 2"DP
EMBANKS	GOOD	HVY EROSION 5'L X 5'W X 2'DP

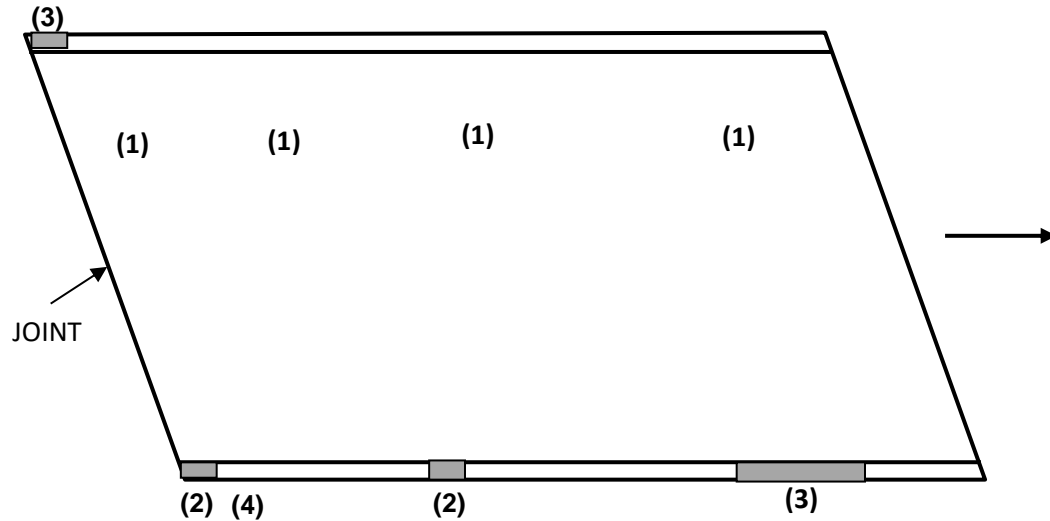
# Top of Deck Span No. 1

DECK	NV	AC OVERLAY -GOOD; (1) DEPRESSION AREAS
PARAPETS	POOR	(3) HVY SCALE UP TO 10' X FULL WIDTH X 2"DP;
		SPALLS W/EXP. STL. & MAP CRACKS UP TO 1/16" OPEN
JOINT	NV	PAVED OVER W/ POTHOLES
TUBE RAILS	POOR	(2) HVY IMPACT DMG. RT. SD. @ 1ST POST & 4TH POST AND 6TH
		POST LT SIDE; (4) TUBULAR RAIL BROKEN

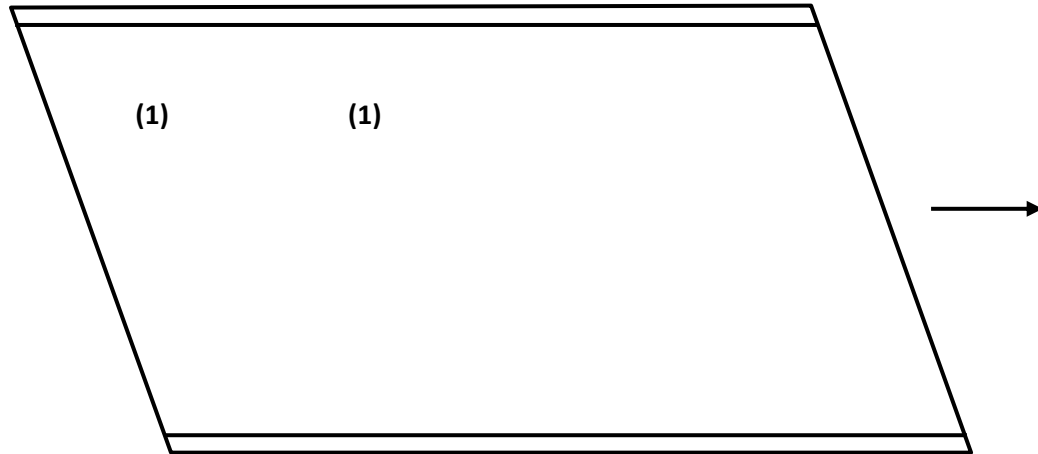
# Top of Deck Span No. 2

DECK	NV	AC OVERLAY - GOOD; <b>(1) DEPRESSION AREAS</b>
PARAPETS	FAIR	LIGHT SCALE & POP OUTS, RANDOM CRACKS UPTO 1/16" OPEN
TUBE RAILS	FAIR	LGT. IMPACT SCRAPES

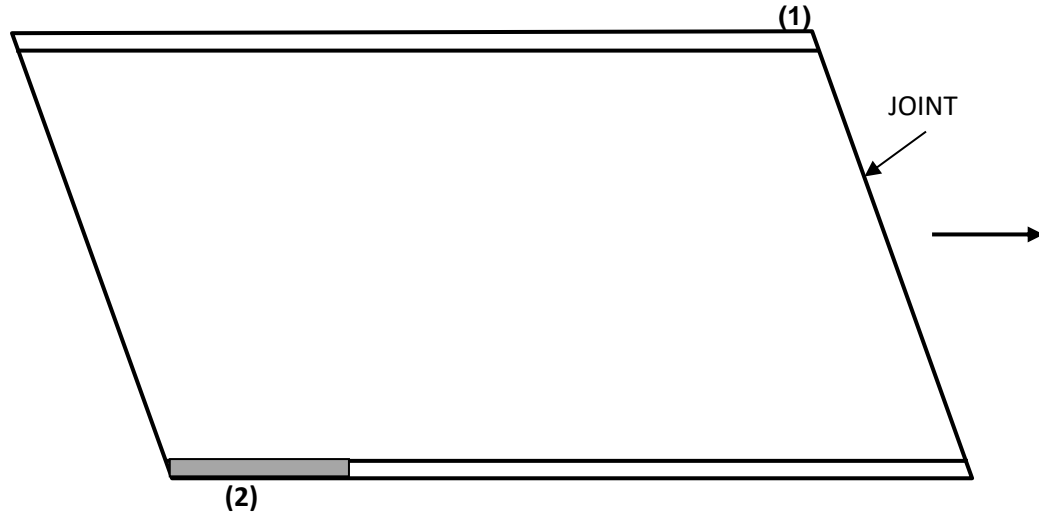
# Top of Deck Span No. 3

DECK	NV	AC OVERLAY - GOOD
PARAPETS	POOR	<b>(2) MOD SCALE, SPALLS W/ EXP. STL;</b>
		MAP CRACKS UP TO 1/16" OPEN 10'L X FULL WIDTH
JOINT	NV	PAVED OVER
TUBE RAILS	FAIR	<b>(1) MOD. IMPACT DMG. LAST POST LT. SD.</b>

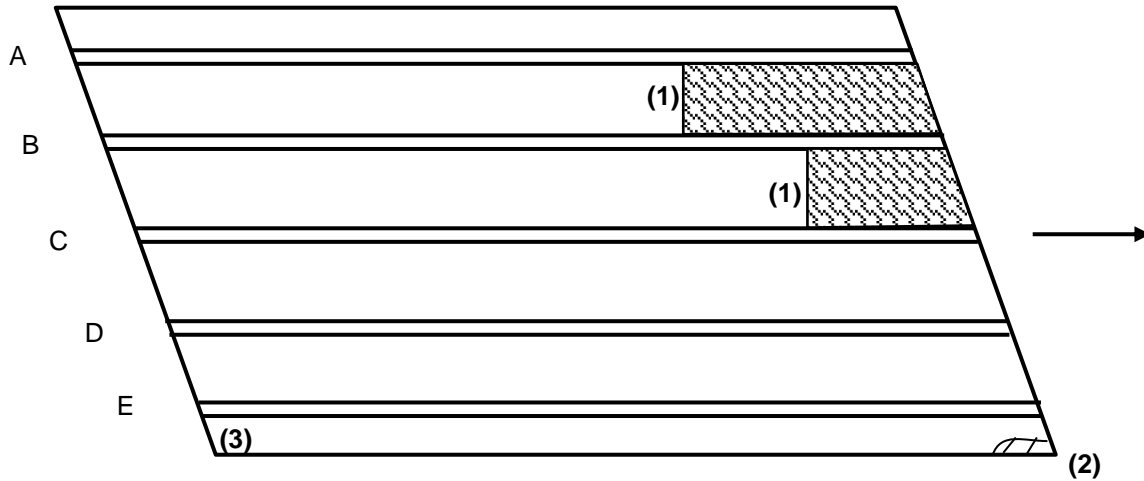
# Bottom of Slab Span No. 1

DECK	FAIR	<b>(1) PARTIAL &amp; FULL DEPTH REPAIRS</b>
		DIA X 8" DP BAY 'B'
DIAPHRAGMS	GOOD	LIGHT CORR. ALL BAYS
BEAMS	GOOD	
"A"	FAIR	MOD RUST TOP FLANGE FULL LENGTH W/EFF; HVY PEELING
"E"	FAIR	MOD RUST TOP FLANGE 8'L @ ABUT. #1
'B, D, C'	FAIR	VERT. MOVEMENT UPTO 1/4" UNDER LOADS @ BEARING
OVERHANGS	FAIR	<b>(2) SCALE OVER BENT #1 W/EFF. 10'L X 2'H X 4" DP</b>
		<b>(3) SPALL 2'W X 1'L AT ABUT 1 RT SIDE</b>
PAINT	FAIR	PEELING ON BM'S

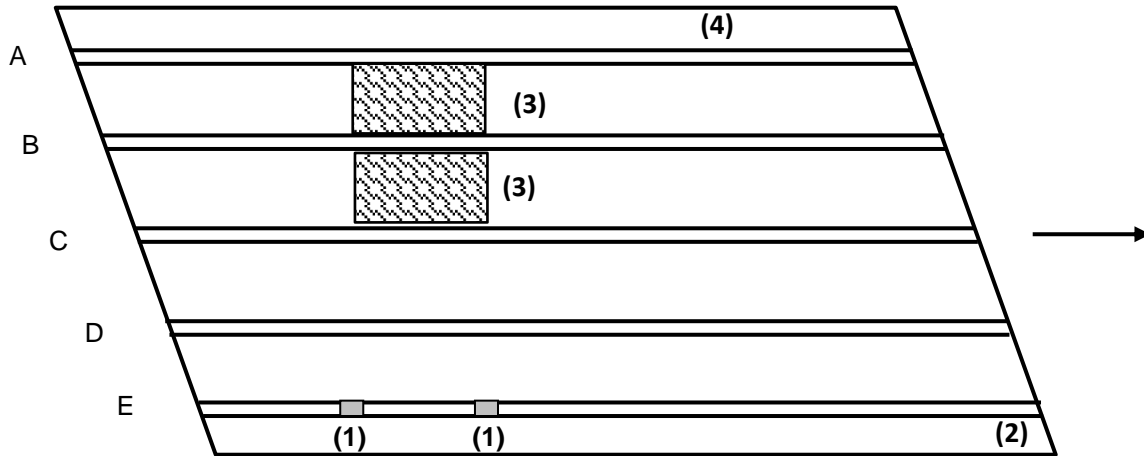
# Bottom of Slab Span No. 2

DECK	FAIR	MAP CRACKING W/EFF UP TO 3'L--BAY 'A';
		<b>(3) PARTIAL &amp; FULL DEPTH REPAIRS</b>
DIAPHRAGMS	GOOD	LIGHT CORROSION
BEAMS	GOOD	
"E"	GOOD	<b>(1) LIGHT SCRAPE BEAM 'E' W/RUST;</b>
		<b>(2) LGH CORR. TOP FLANGE 8' L FROM BENT #2,</b>
		MISSING BOLT ON GUSSET PLATE
PAINT	FAIR	FADING, MOD PEELING
OVERHANGS	GOOD	<b>(4) SPALL W/ EXP STL 1'L X 2"W; SCALE ON RT SIDE W/ EFF</b>
