Latitude:36.14810, Longitude:-86.77920

Region 03, 19 - Davidson County

I40 RMP / 8TH AVE (SR 6)

3 span Bridge / W.P.G.  
I-40 Ramp / 8TH AVE (SR 6)

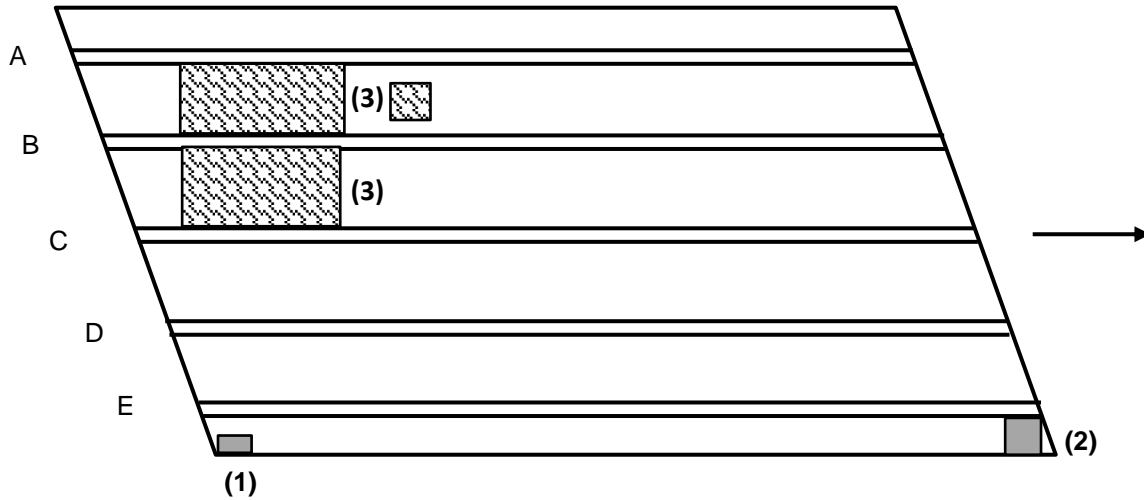
# Bottom of Slab Span No. 3

DECK	FAIR	EFF. W/ LEACHING @ BENT #2 TOP FLANGE BM 'E';
		<b>(3) PARTIAL DEPTH REPAIRS</b>
DIAPHRAGMS	GOOD	
BEAMS	GOOD	LIGHT CORR. @ BEAM ENDS @ ABUT.
"E"	POOR	M/H CORR & LEACH @ BENT 2 BM 'E' TOP FLANGE 12' L W/SEC LOSS
"D"		LGT CORR
"C"		LGT CORR
OVERHANGS	FAIR	<b>(1) DELAM OVER BENT #2 - 8' X 2' W/HVY EFF,</b>
		<b>(2) SPALL W/EXP STL 4' X 3' X 4" DP</b>
PAINT	FAIR	MOD PEELING BM'S C,D, & E

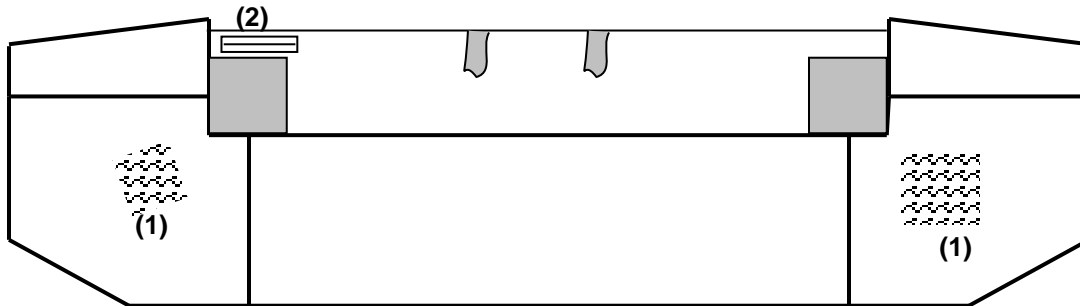
# Abutment No. 1

BACKWALL	POOR	(2) TOP OF DELAM AREA SPALL W/ EXP STL 3'H X 2'W X 2'D
		EXPOSING VOID THAT SHOWS UNDERSIDE OF WEARING SURFACE;
		HVY DELAM AREAS; HVY BLD-UP OF CONC
CAP	GOOD	HVY. DEBRIS BLD - UP; VERT. H.C.
WINGS	POOR	(1) HVY MAP CRACKING W/ POP-OUTS & EFF. (LEFT & RIGHT SIDE)
RISERS	GOOD	
'A'	GOOD	VERT. H.C.
BEARINGS	POOR	ALL BEARINGS ARE TILTED BACK 2", HVY CORR., HVY DEBRIS
'A'	POOR	BROKEN PIN
'B, C'	POOR	SEPARATED FROM PLATE 1/4", MISSING BOLTS
"D, E"	POOR	HVY CORR
SLOPE PVT.	GOOD	HVY SOIL BLD-UP

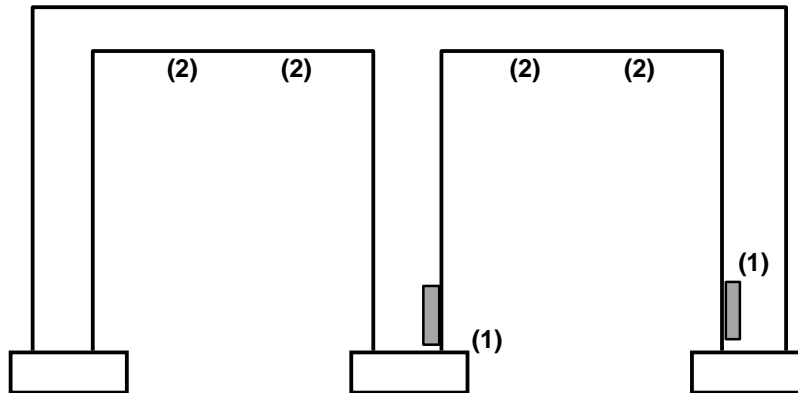
## BENT # 1

CAP	GOOD	RDM HCs W/ EFF; <b>(2) HIGH STEEL POPOUTS;</b>
		LGT HNYCMB BETWEEN COL. 'B' & 'C'
COLUMNS	GOOD	<b>(1) IMPACT DAMAGE 18" L X 6" W X 1/4" DP</b>
"B"	GOOD	TEXTURE COAT PEELING
'A'	GOOD	SPALL 1.5' X 6" X 1/4" DP
BAY 'B'		LGT HNYCMB
FOOTING	NV	
BEARINGS	GOOD

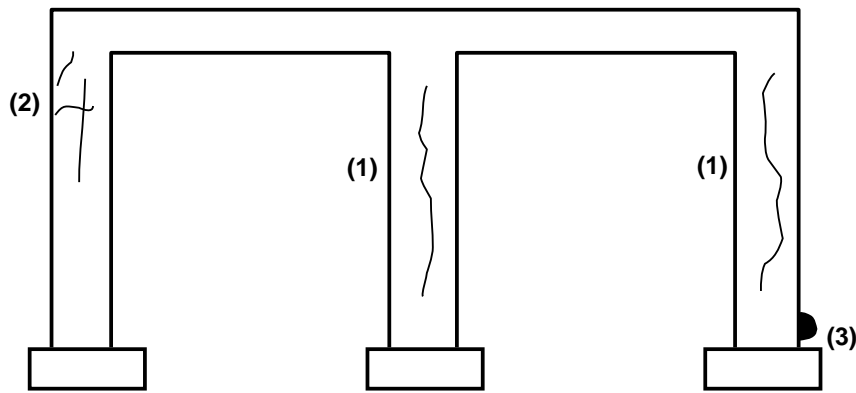
## BENT # 2

CAP	GOOD	RANDOM H.C.'S
COLUMNS	GOOD	(1) VERT. H.C.'S; (3) SPALL 7"L X 3"W X 1/2"DP COLUMN 'A';
		(2) MAP CRACKING
"C"	GOOD	TEXTURE COAT PEELING
"A"	GOOD	IMPACT DMG
FOOTING	NV	DIRT BLD-UP @ COLUMN 'A'
BEARINGS	GOOD

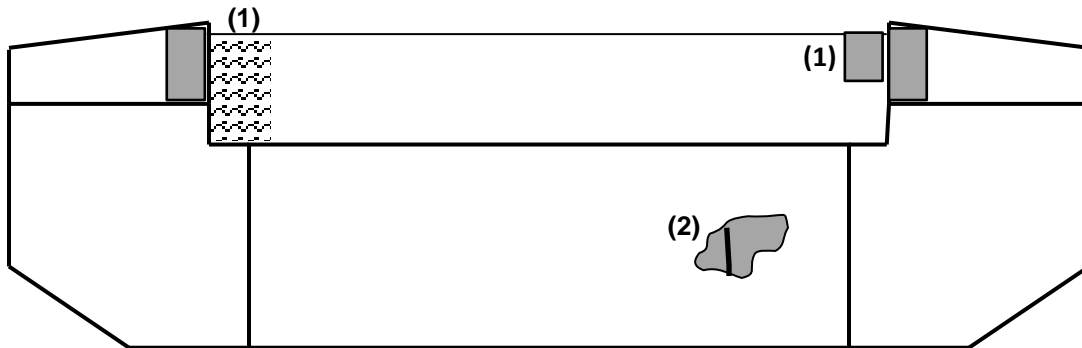
# Abutment No. 2

BACKWALL	FAIR	(1) MAP CRACKING W/ EFF. & POPOUTS
CAP	GOOD	(2) SPALLS UPTO 24" L X 16" W, UPTO 1.5" DP W/ EXP. STL;
		RANDOM VERT. H.C.'S W/ EFF; RANDOM MAP CRACKS; IN-PLACE
		SPALL 1' X 6"
WINGS	FAIR	
FOOTINGS	NV	
BEARINGS	GOOD	LIGHT CORROSION
