IDENTIFICATION	
(1) State Names	47 - Tennessee
(8) Structure Number	19I00400317
(5) Inventory Route	1
(2) Highway Agency District	Region 3
(3) County Code	19 - Davidson

(4) Place Code	52006
(6) Features Intersected	I40 RMP / 8TH AVE SR 6
(7) Facility Carried	I40
(9) Location	8TH AVE.SOUTH
(11) Mile Point	18.340 mi
(12) Base Highway Network	Yes

### Inspection Team's Summary

Partial and full depth repairs were made on the deck in all spans. Left lane was repaved.

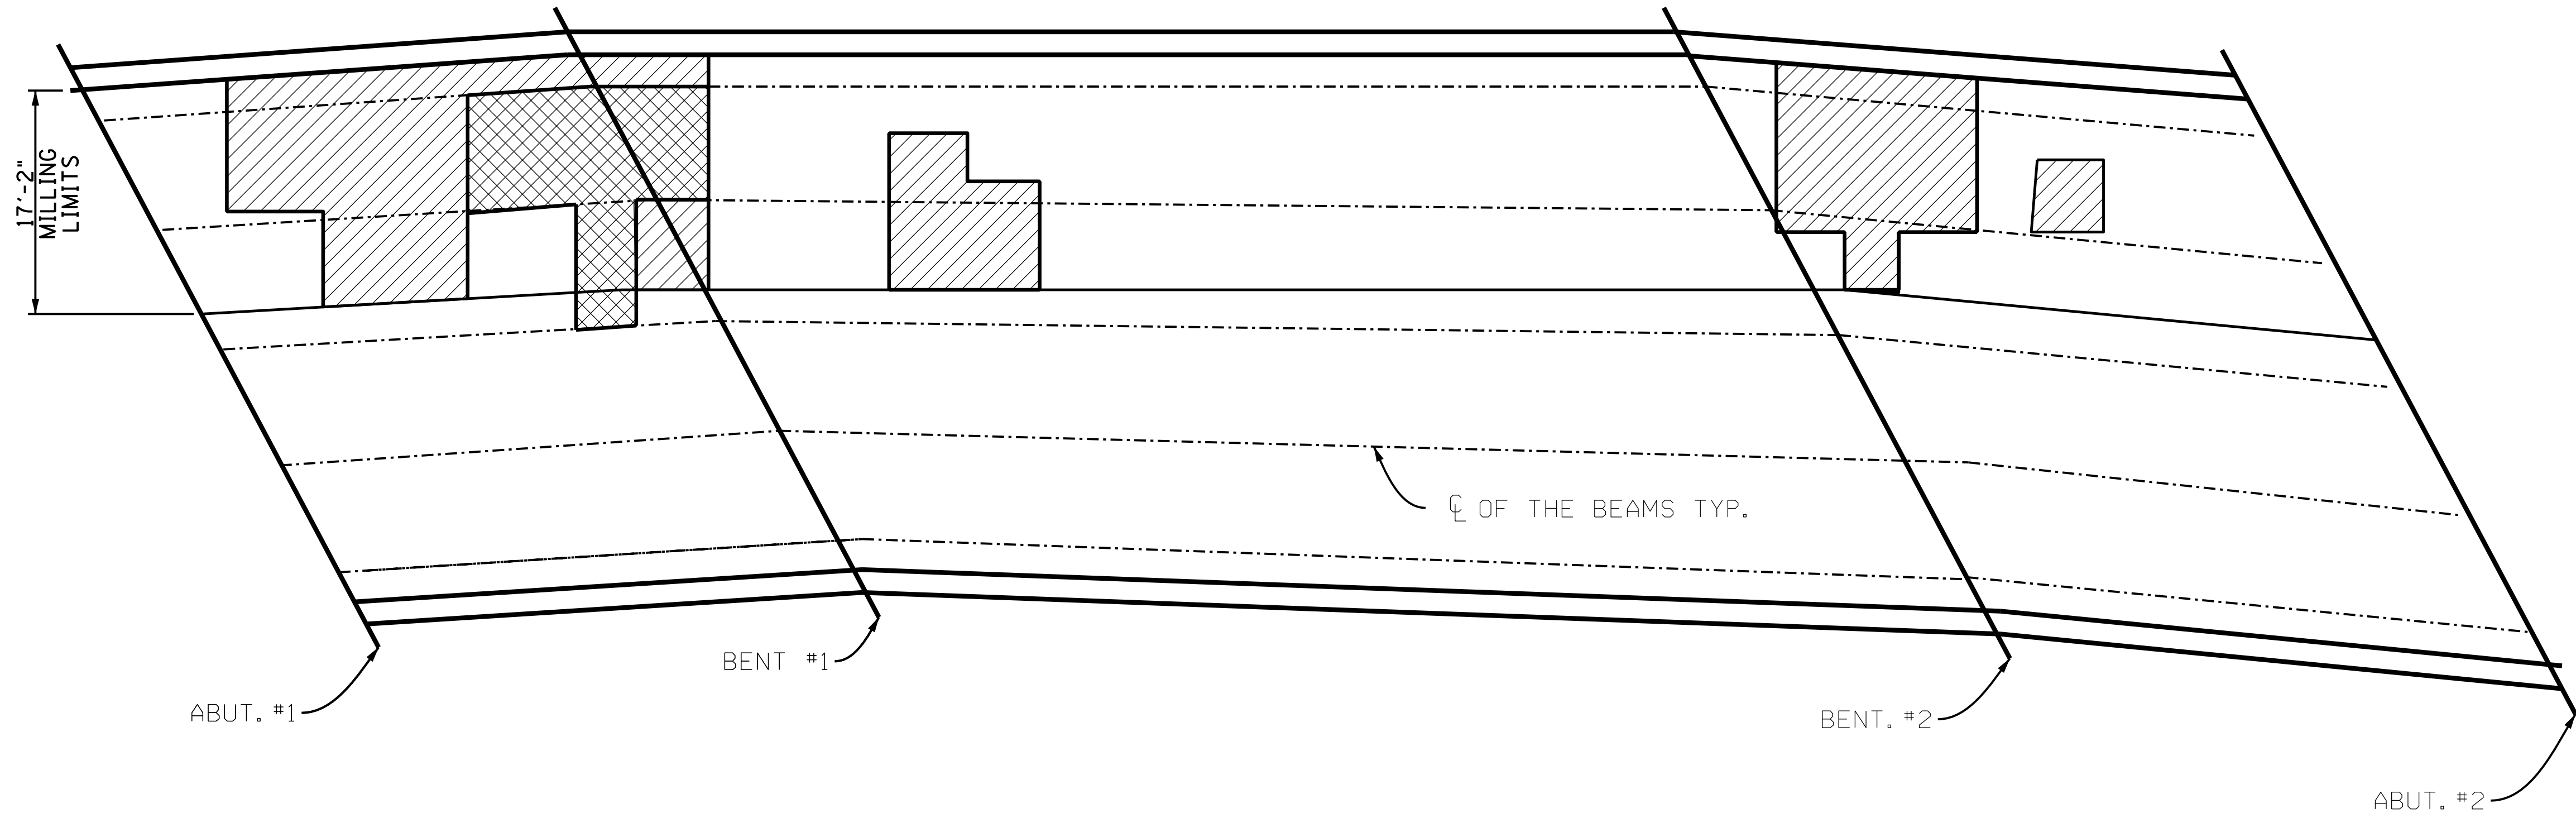
STATE OF TENNESSEE  
DEPARTMENT OF TRANSPORTATION  
REPAIRS LOCATIONS  
BRIDGE NO. 19-140-18.34  
FED. I.D. NO. 19I00400317  
OVER  
8TH AVENUE  
DAVIDSON CO.  
2/18/2023

-   FULL DEPTH REPAIRS LOCATIONS
-   PARTIAL DEPTH REPAIRS LOCATIONS

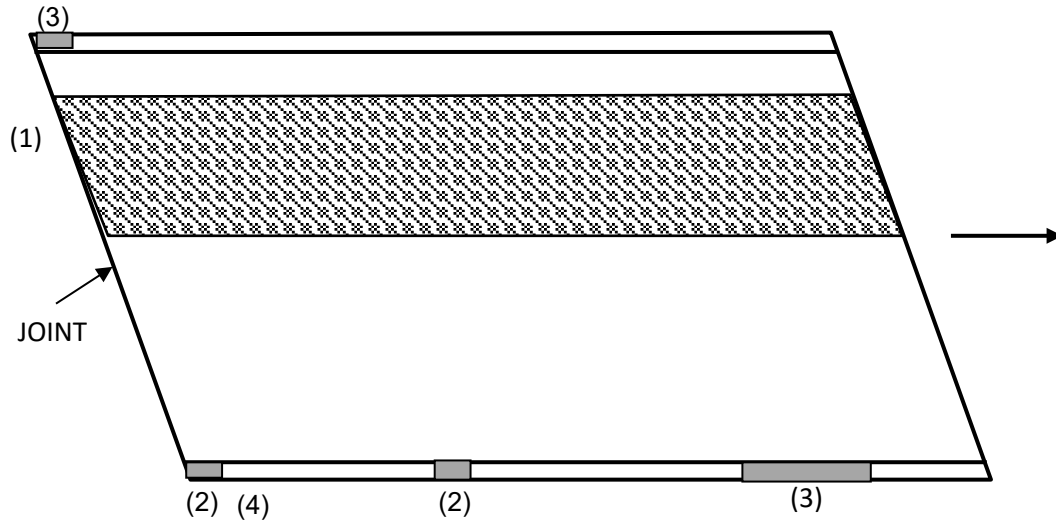
# Top of Deck Span No. 1

DECK	NV	AC OVERLAY -GOOD- (1) NEW A/C
PARAPETS	POOR	(3) HVY SCALE UP TO 10' X FULL WIDTH X 2"DP;
		SPALLS W/EXP. STL. & MAP CRACKS UP TO 1/16" OPEN
JOINT	NV	PAVED OVER W/ POTHOLES
TUBE RAILS	POOR	(2) HVY IMPACT DMG. RT. SD. @ 1ST POST & 4TH POST AND 6TH
		POST LT SIDE; (4) TUBULAR RAIL BROKEN

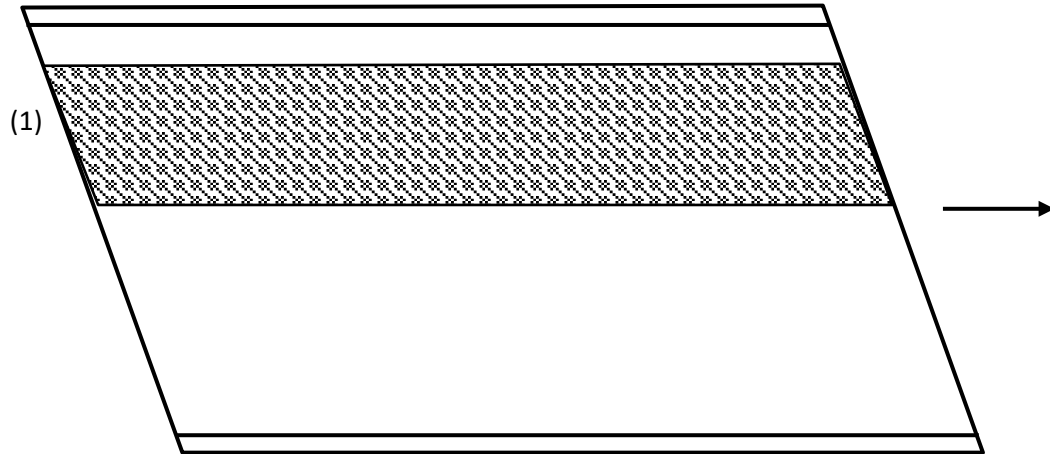
# Top of Deck Span No. 2

DECK	NV	AC OVERLAY - GOOD - (1) NEW A/C
PARAPETS	FAIR	LIGHT SCALE & POP OUTS, RANDOM CRACKS UPTO 1/16" OPEN
TUBE RAILS	FAIR	LGT. IMPACT SCRAPES

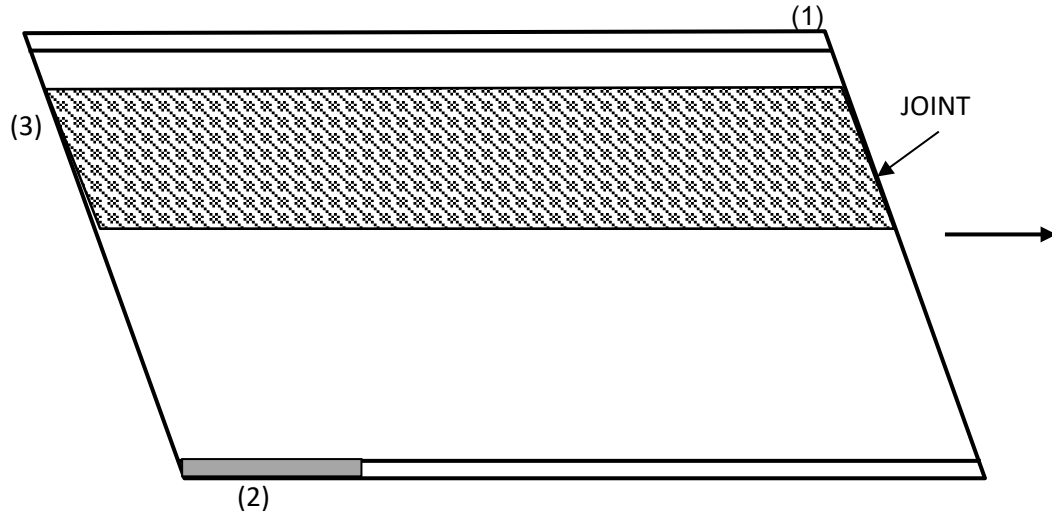
# Top of Deck Span No. 3

DECK	NV	AC OVERLAY - GOOD - (3) NEW A/C
PARAPETS	POOR	(2) MOD SCALE, SPALLS W/ EXP. STL., MAP CRACKS UP TO
		1/16" OPEN 10'L X FULL WIDTH
JOINT	NV	PAVED OVER
TUBE RAILS	FAIR	(1) MOD. IMPACT DMG. LAST POST LT. SD.

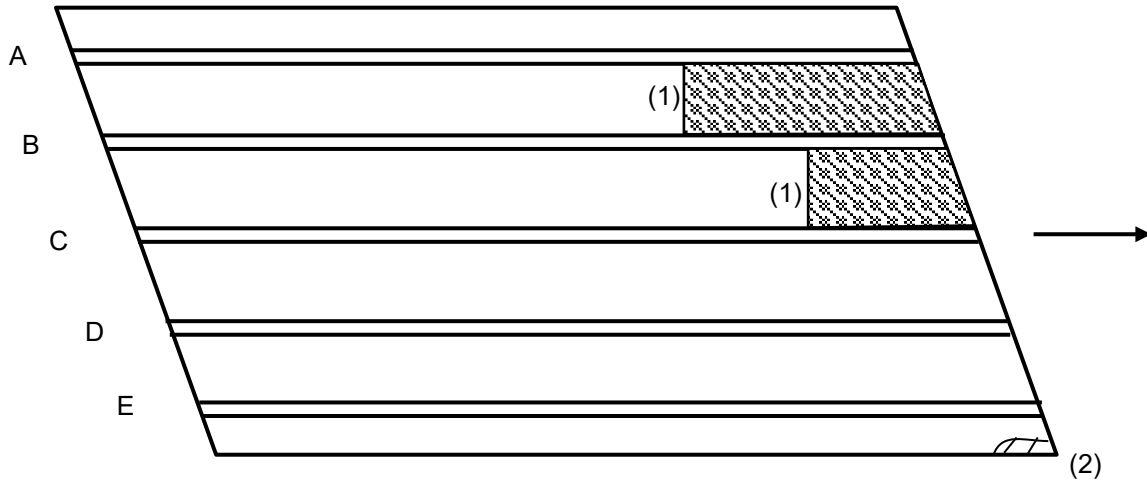
# Bottom of Slab Span No. 1

DECK	FAIR	(1) PARTIAL & FULL DEPTH REPAIRS
		DIA X 8" DP BAY 'B'
DIAPHRAGMS	GOOD	LIGHT CORR. ALL BAYS
BEAMS	GOOD	
"A"	FAIR	MOD RUST TOP FLANGE FULL LENGTH W/EFF; HVY PEELING
"E"	FAIR	MOD RUST TOP FLANGE 8'L @ ABUT. #1
'B, D, C'	FAIR	VERT. MOVEMENT UPTO 1/4" UNDER LOADS @ BEARING
OVERHANGS	FAIR	(2) SCALE OVER BENT #1 W/EFF. 10'L X 2'H X 4" DP
PAINT	FAIR	PEELING ON BM'S

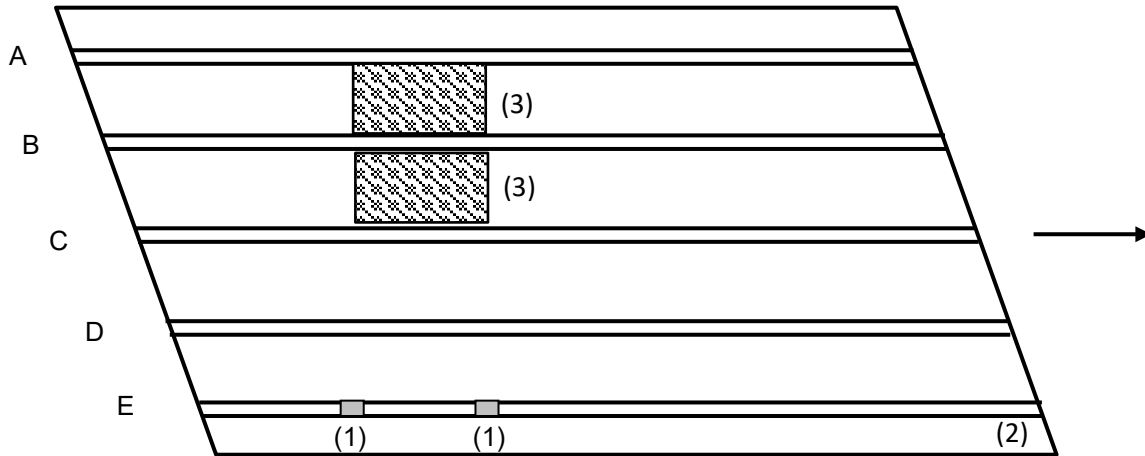
# Bottom of Slab Span No. 2

DECK	FAIR	MAP CRACKING W/EFF UP TO 3'L--BAY 'A'; (3) PARTIAL & FULL
		DEPTH REPAIRS
DIAPHRAGMS	GOOD	LIGHT CORROSION
BEAMS	GOOD	
"E"	GOOD	(1) LIGHT SCRAPE BEAM 'E' W/RUST; (2) LGH CORR. TOP FLANGE
		8' L FROM BENT #2, MISSING BOLT ON GUSSET PLATE
PAINT	FAIR	FADING, MOD PEELING
OVERHANGS	GOOD

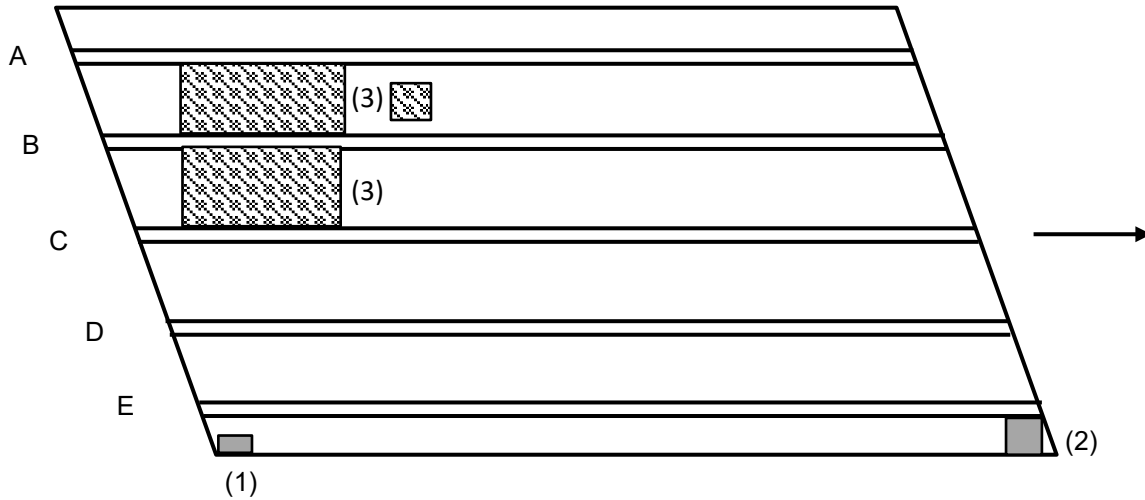
# Bottom of Slab Span No. 3

DECK	FAIR	EFF. W/ LEACHING @ BENT #2 TOP FLANGE BM 'E'; (3) PARTIAL DEPTH REPAIRS
DIAPHRAGMS	GOOD	
BEAMS	GOOD	LIGHT CORR. @ BEAM ENDS @ ABUT.
"E"	POOR	M/H CORR & LEACH @ BENT 2 BM 'E' TOP FLANGE 12' L W/SEC LOSS
OVERHANGS	FAIR	(1) DELAM OVER BENT #2 - 8' X 2' W/HVY EFF, (2) SPALL W/EXP STL 4' X 3' X 4" DP
PAINT	FAIR	MOD PEELING BM'S C,D, & E
