BRIDGE MAINTENANCE RECOMMENDATIONS

LOCATION: 79-I0240-15.43-

CROSSING: PARK AVE / I240

Inspection Team's Summary
Bridge Location No. 79 - I0240 - 15.43
Inspection Date 02-19-13
Bridge Rating FAIR

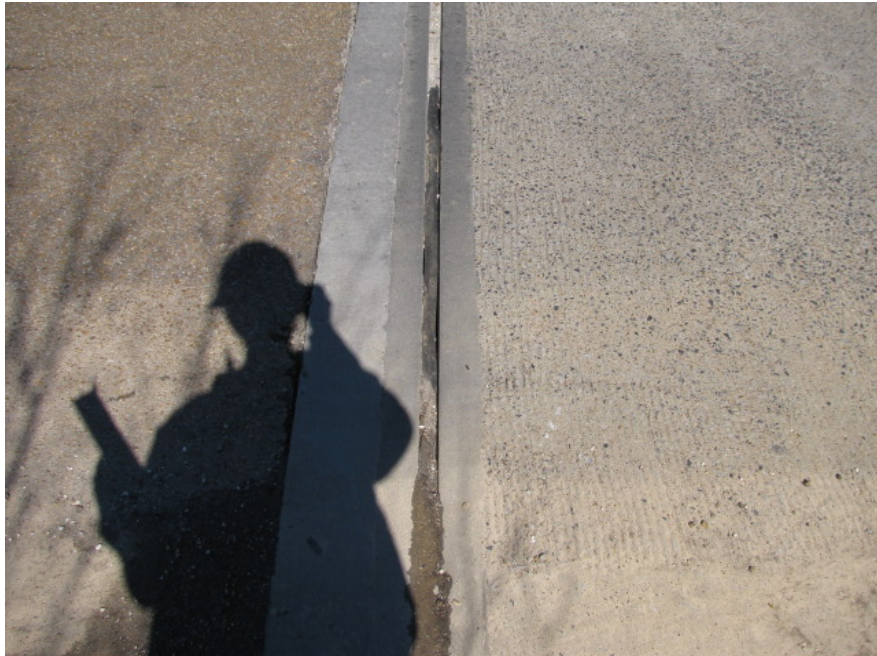
SPAN 1 JOINT MATERIAL PEELING(TYPICAL SPAN 5 JOINT)

SPANS 1&5 JOINT MATERIAL IS PEELING AND FILLED WITH DEBRIS.

CLEAN AND SEAL ROADWAY EXPANSION JOINTS.

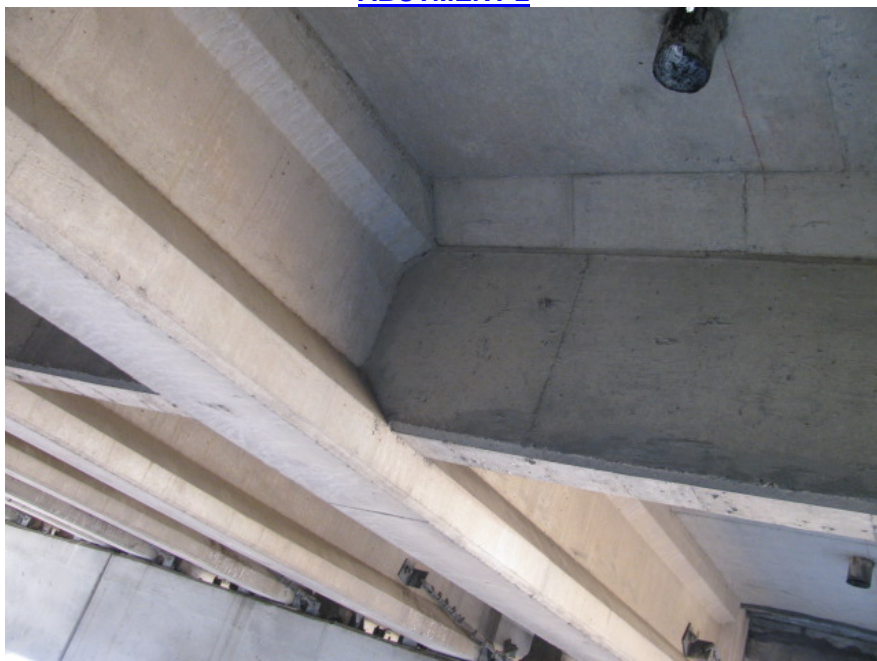
SPAN 5 BOTTOM

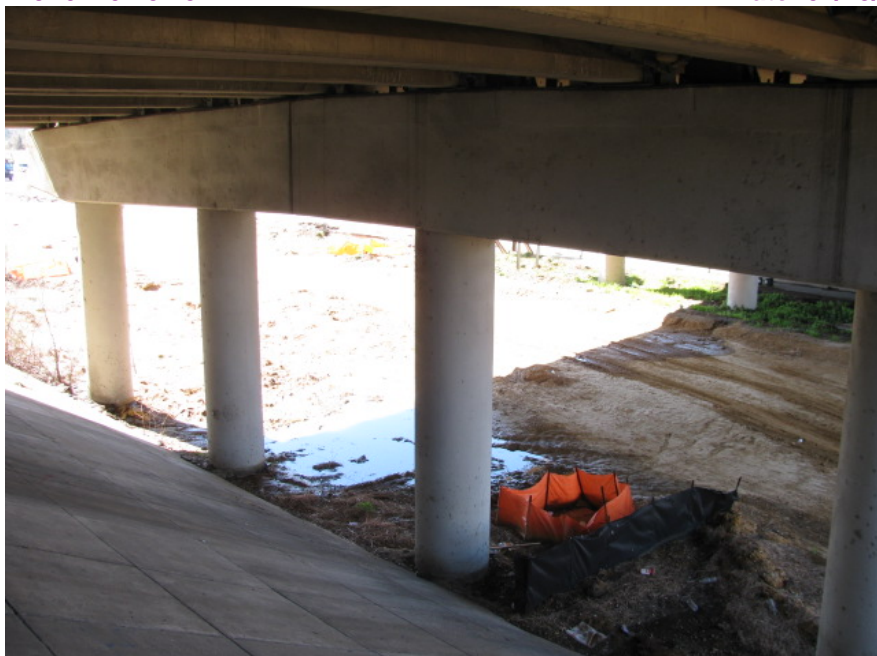
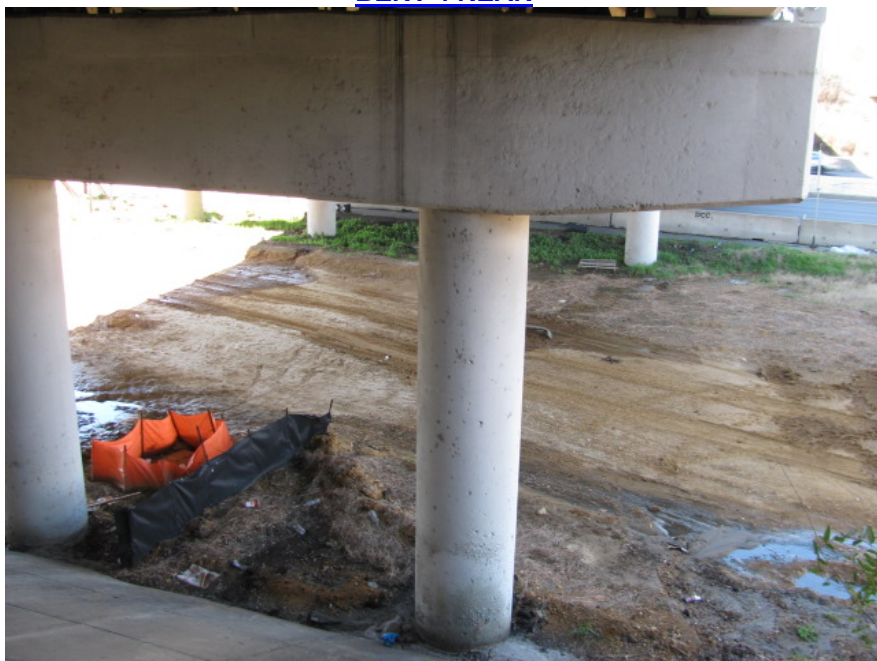
BENT 4 REAR

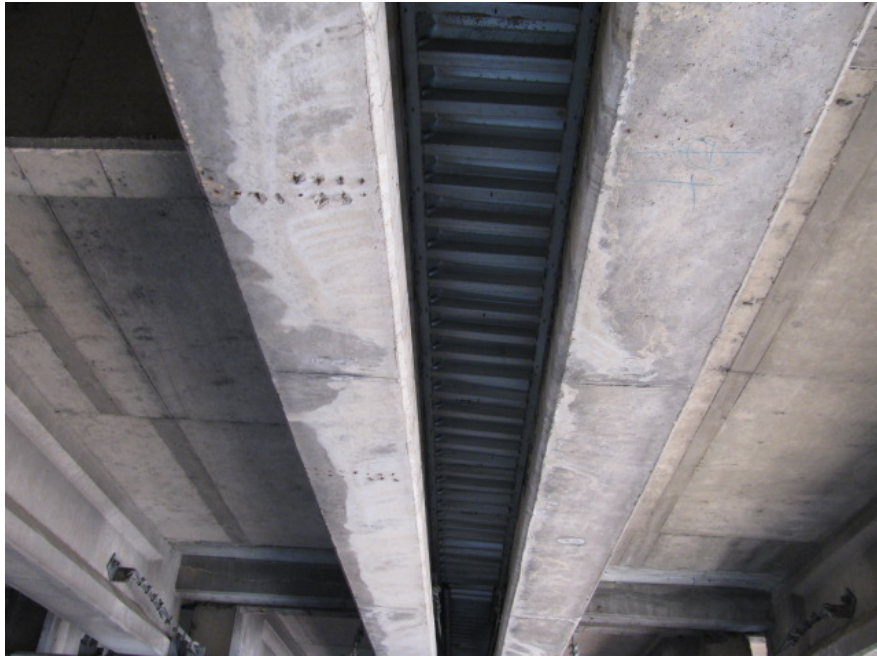
SPAN 1 BOTTOM

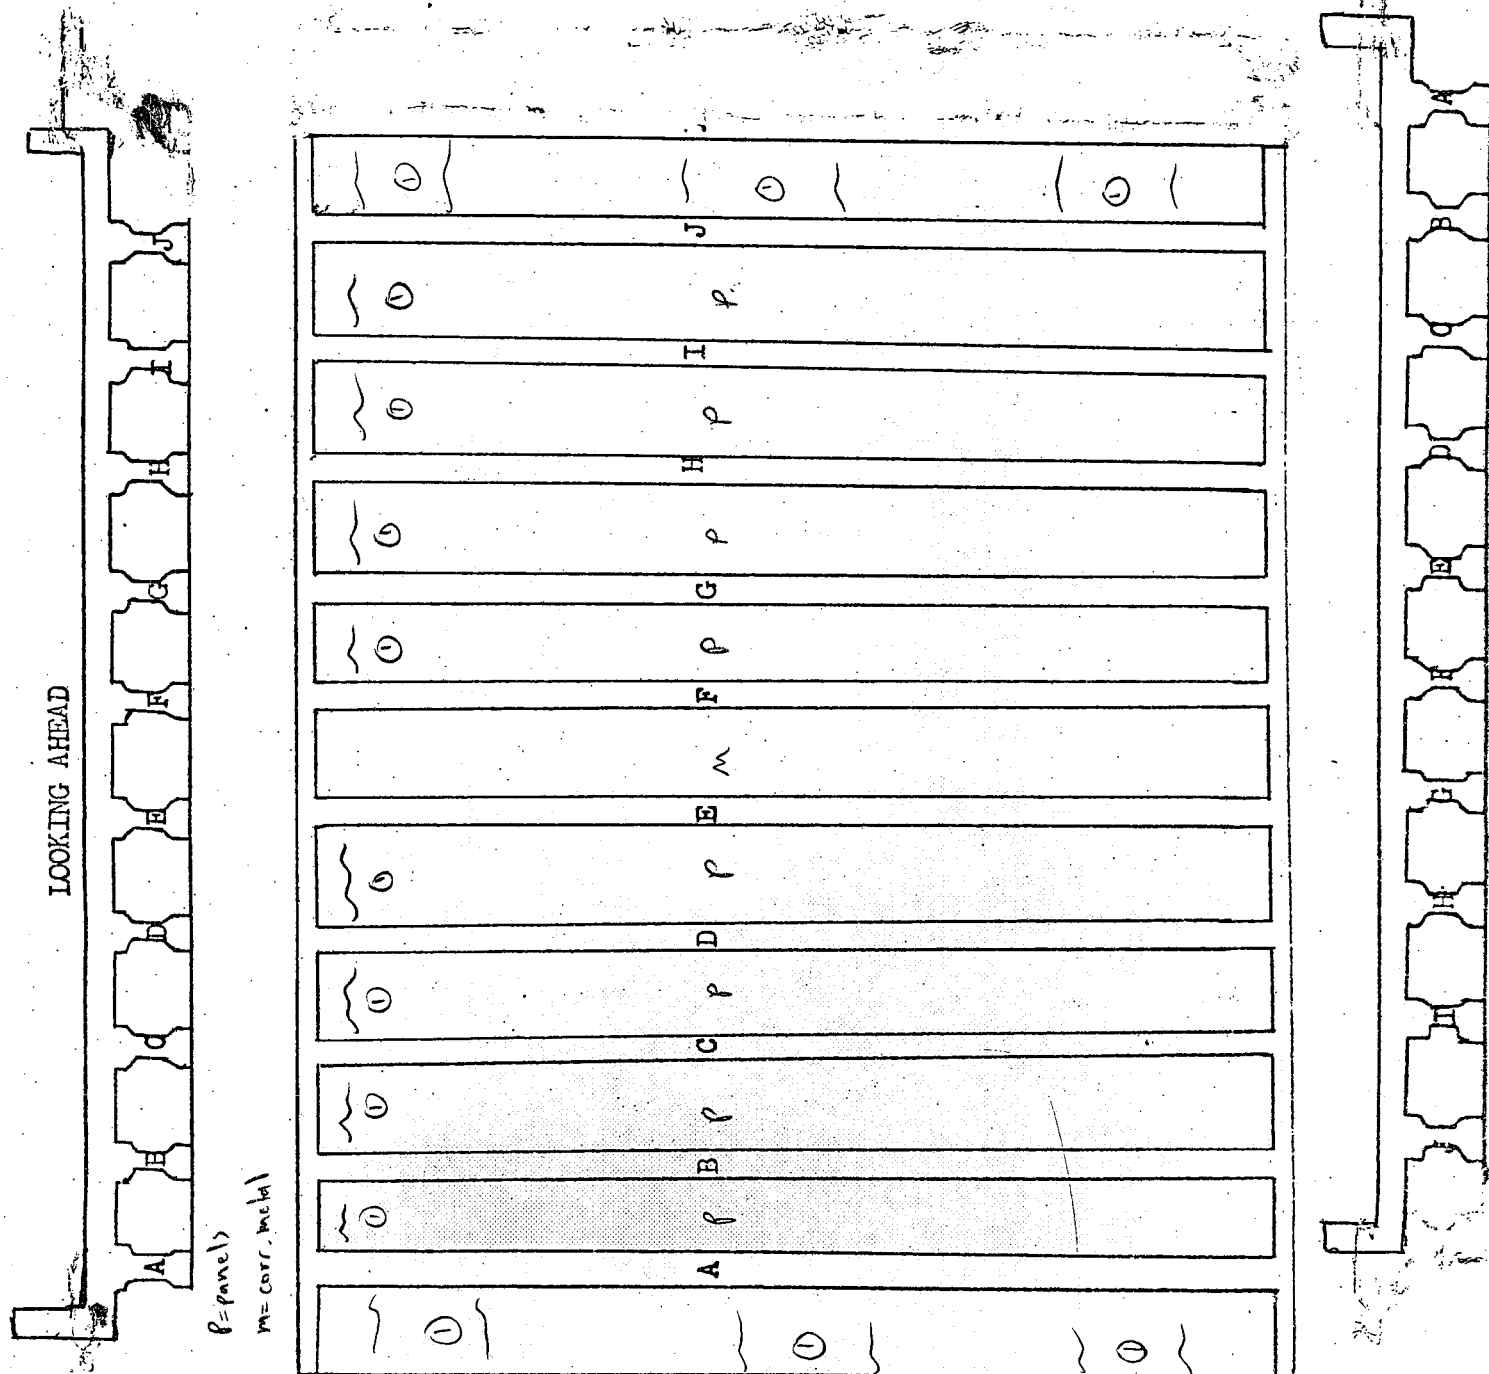
BR. NO. 29 J240 15.43 SK. LT. SPAN NO. 1

① fine cracks w/ left action

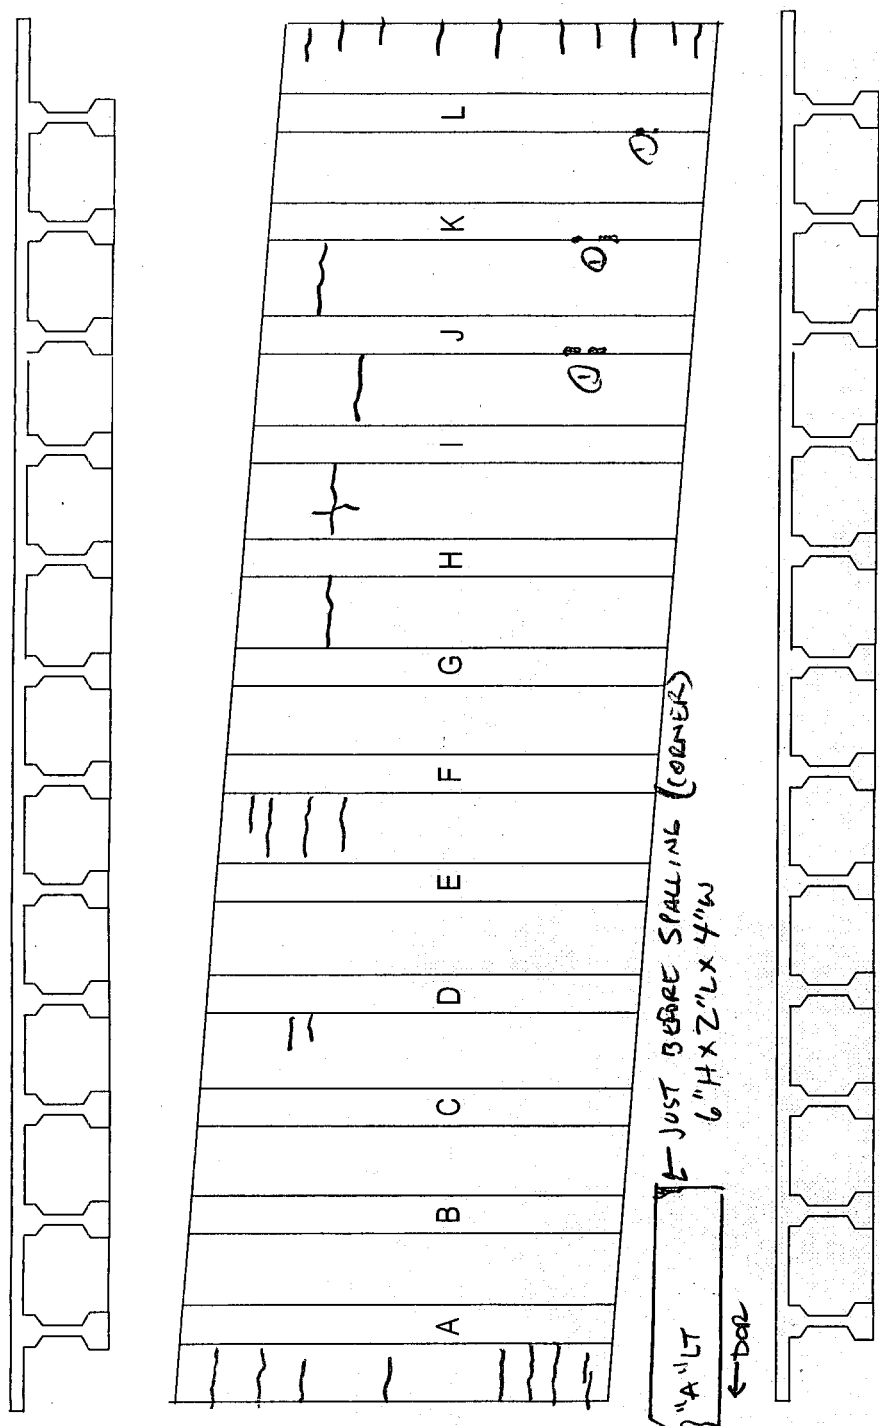
Span No. 2

ELEMENT	RATING	COMMENTS
BOTTOM DECK	G F P C	HAIRLINE CRACKS
CONC. I BEAM	G F P C	① LIGHT COLLISION DAMAGE 3'-12" L X 2" W X 1" D
A ---	G F P C	
B - I	G F P C	
J - L	G F P C	
E.Q.	G F P C	
DIA.	G F P C

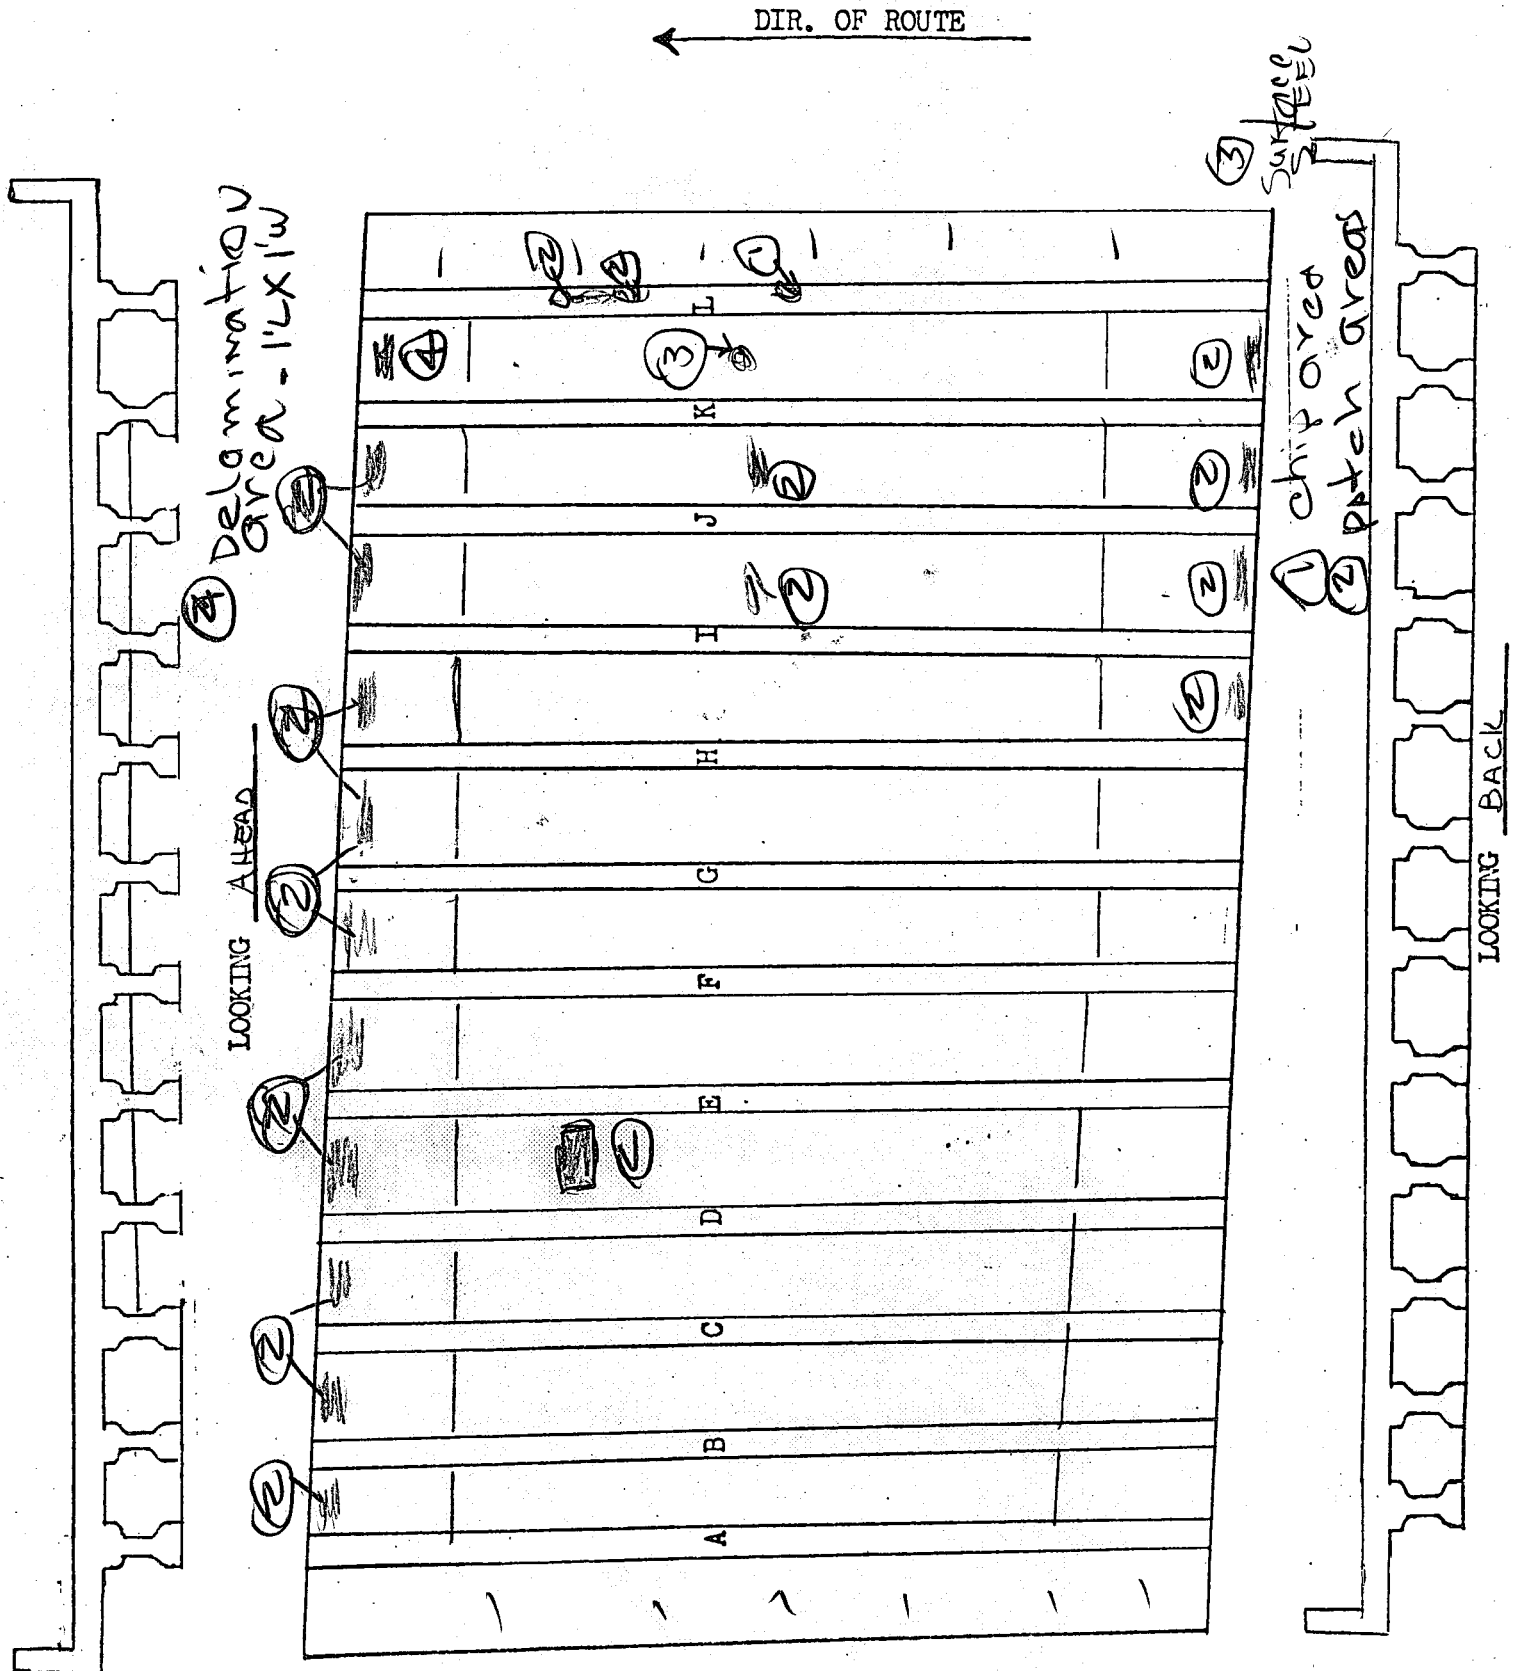
BRIDGE NO. 79 I-240 ~~1540~~ ^{15.43}BENT NO. _____ SPAN NO. 3 ABT. NO. _____ PIER NO. _____

ELEMENT	RATING	COMMENTS
BOTTOM DECK	G <u>F</u> P C	2-4 w/ fine cracks
CONC. I. BEAMS		
A B C	G <u>F</u> P C	
_____	G F P C	
D E F	G <u>F</u> P C	
_____	G F P C	
G H I	G <u>F</u> P C	
_____	G F P C	
J K	G <u>F</u>	
J K <u>L</u>	G <u>F</u> P C	see ① & ②
_____	G F P C	
	G F P C	
	G F P C	
	G F P C	
EQ BLACK TIES	G <u>F</u> P C	
DIA.	G <u>F</u> P C

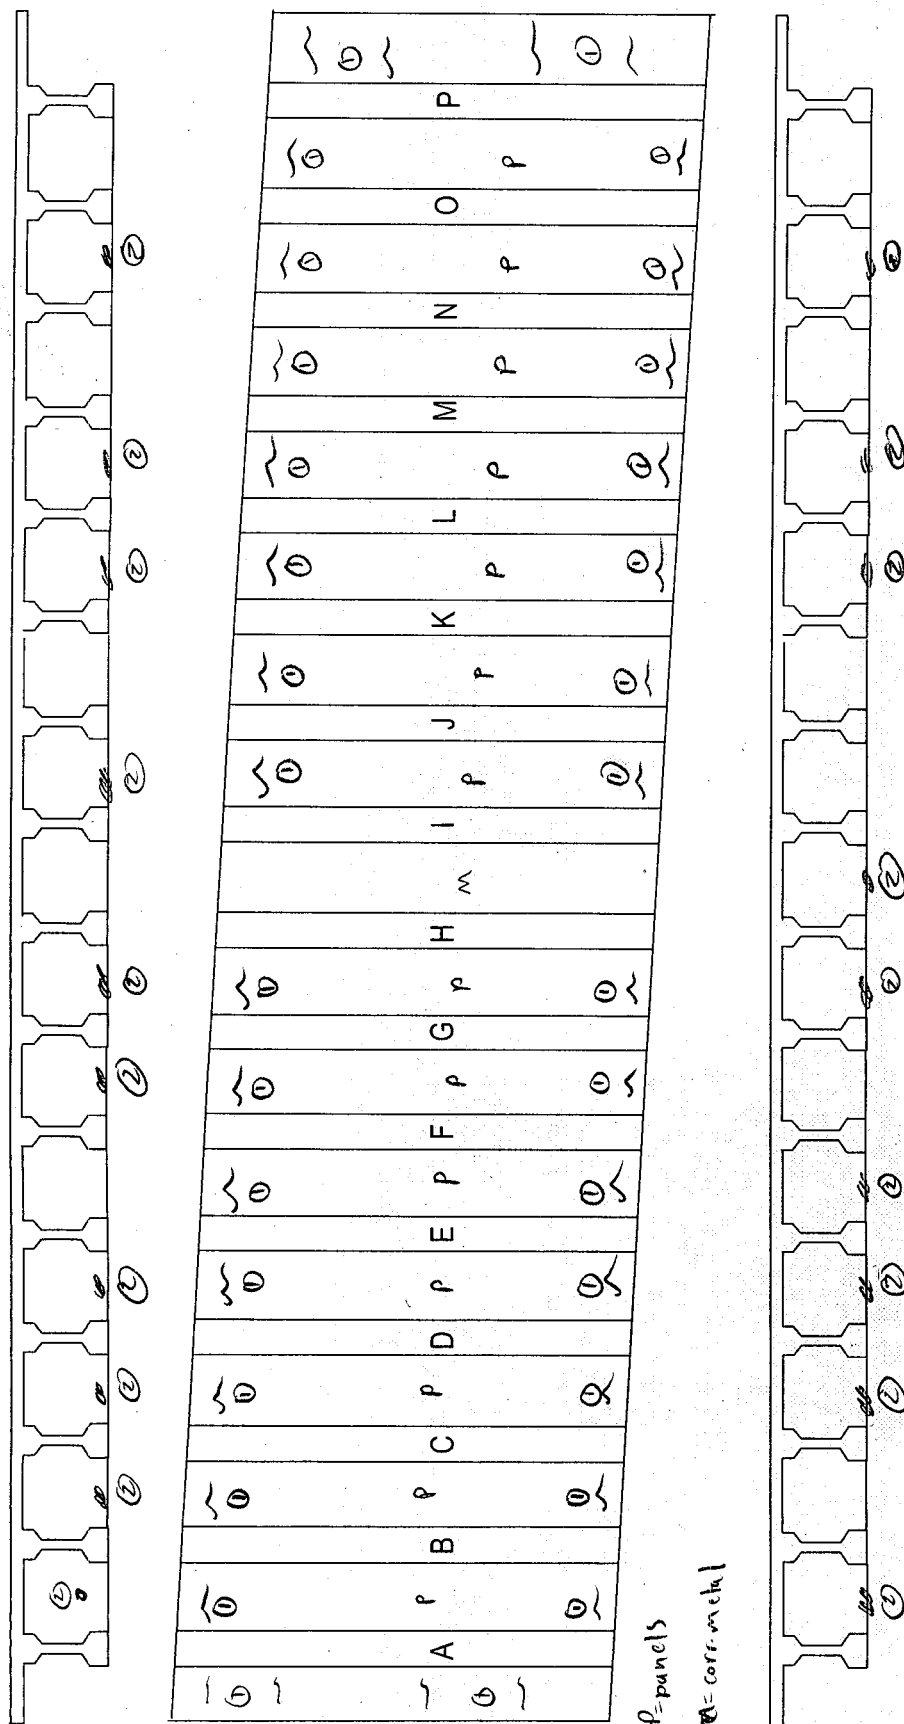
ELEMENT	RATING	COMMENTS
BOTTOM DECK	G \textcircled{F} P C	① fine cracks w/lett action
CONC. I BEAM		② chipped to steel areas
A --- ρ	G \textcircled{C} F P C	
	G F P C	
	G \textcircled{C} F P C	
BACKWALLS	G F P C	N/A
DIA.	G \textcircled{F} P C	②

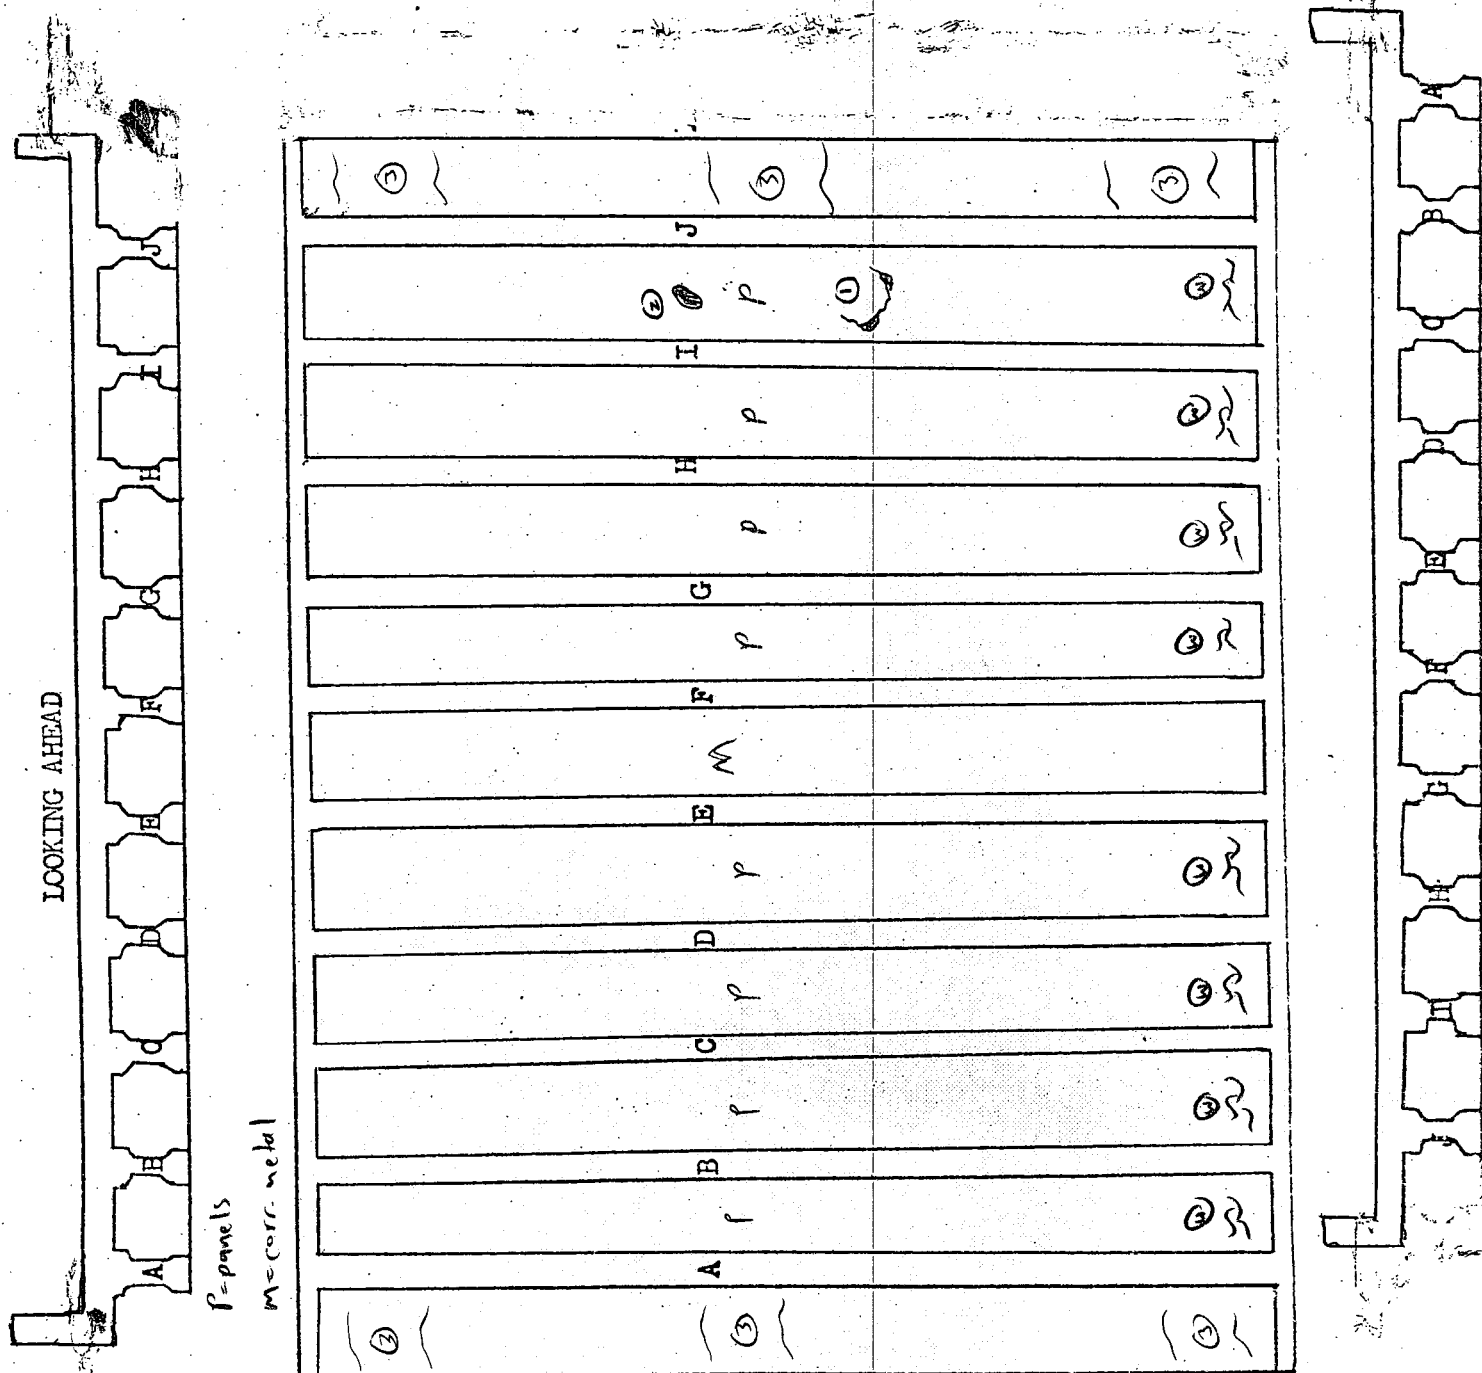
BR. NO. 79 - 7240-15.43 SK. 87 LT. SPAN NO. 5

- ① Area just before spalling
- ② chipped to steel area
- ③ fine cracks within section

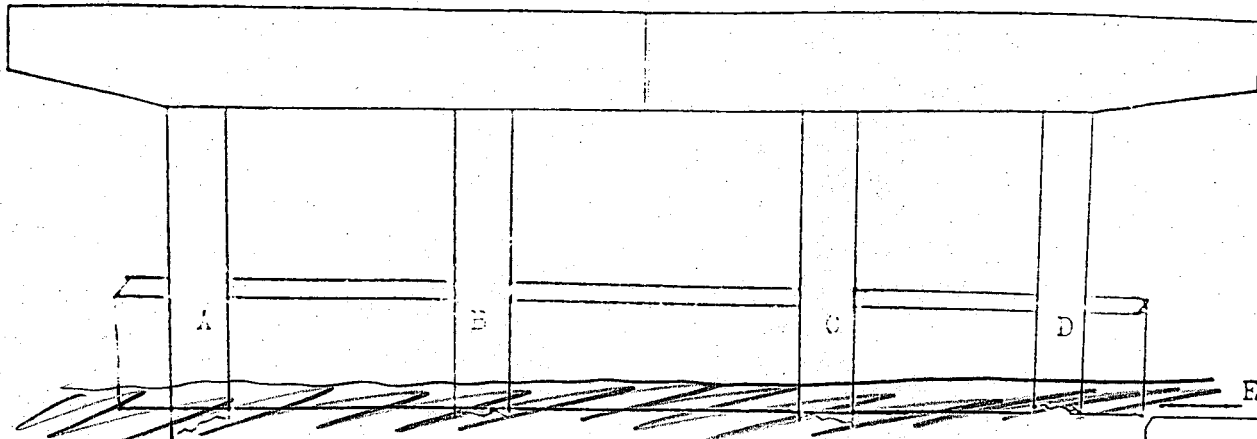
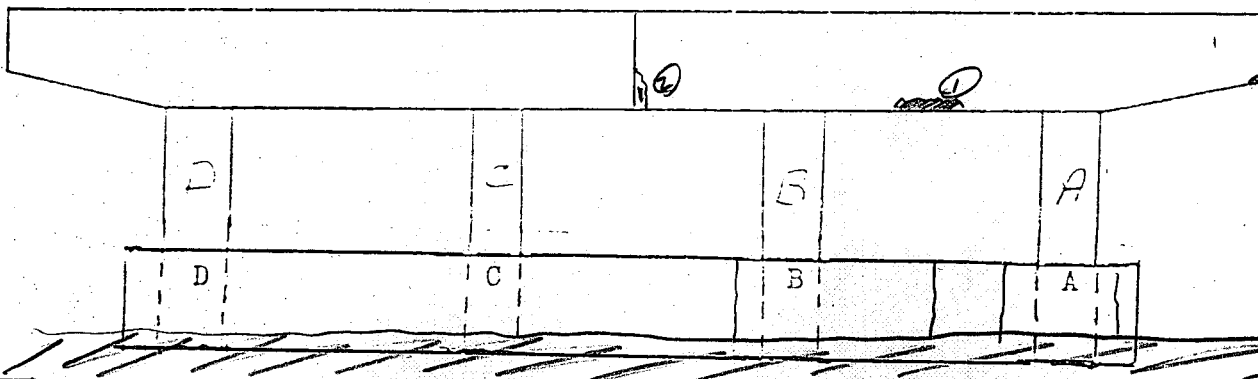
BENT NO.

③ CORNER
SPALL
12"W
2'-4"L
1'-3"H

HAIRLINE - 1/16" CRACKS

① JUST BEFORE SPALLING
24"W X 6"H X 3"D

② SPALLED TO STEEL
18"H X 6"W X 1'-3"D

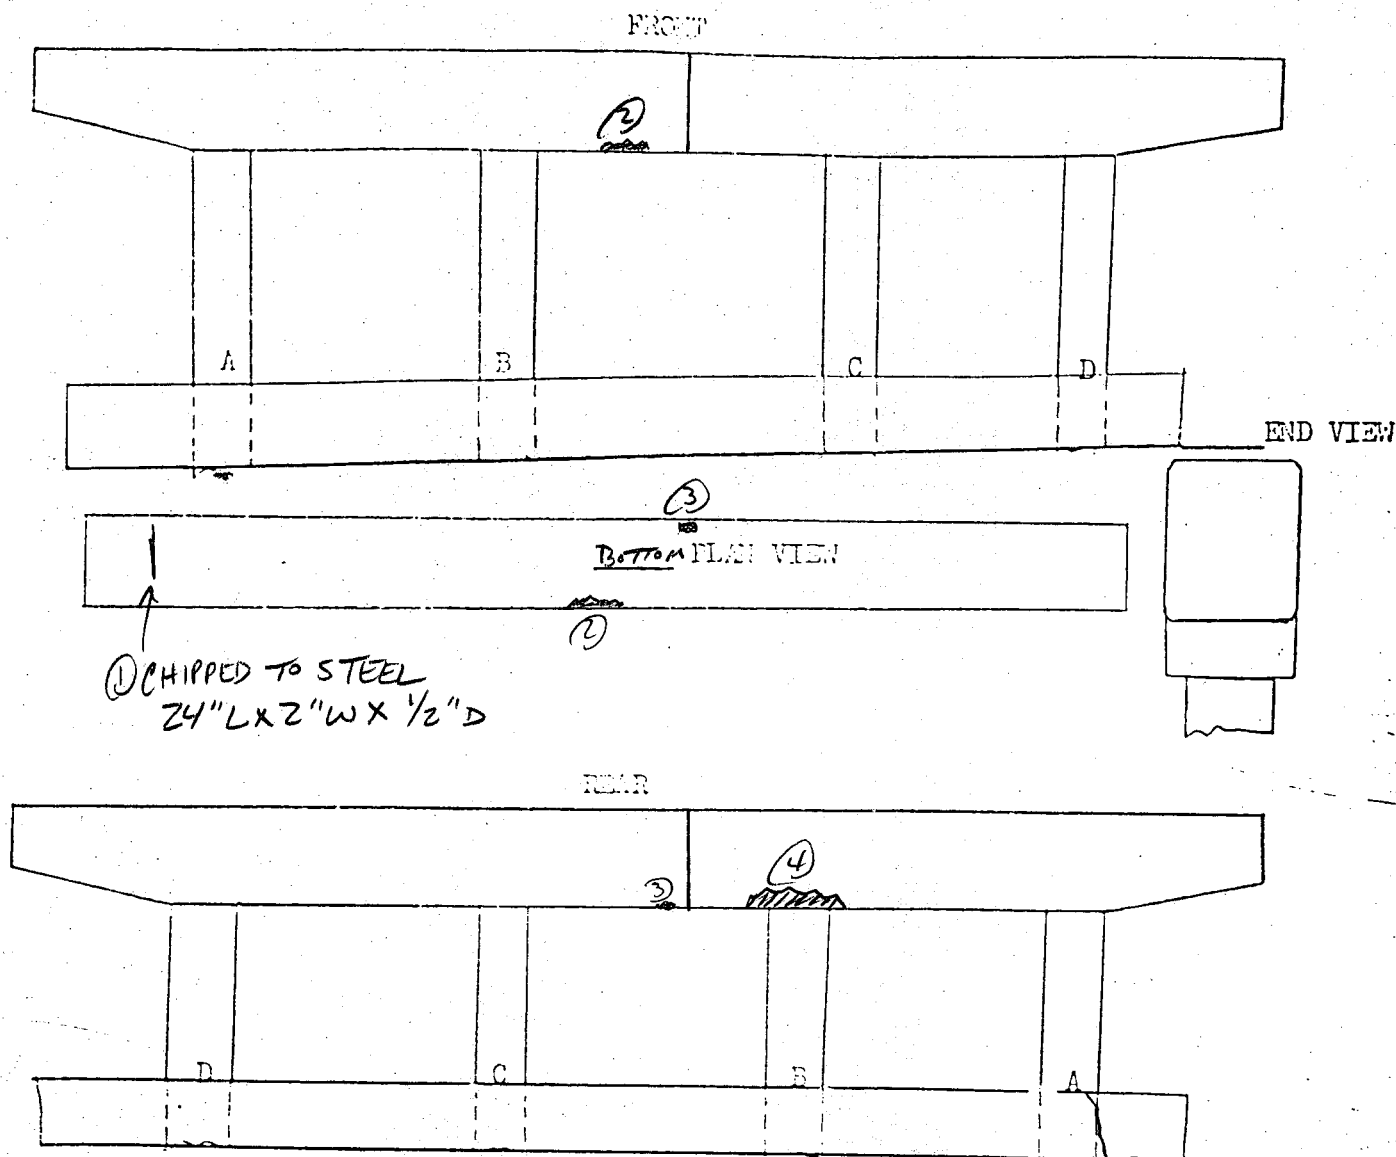
BENT NO. 2

ELEMENT	RATING	COMMENTS
BEARINGS	G F P C	
CAP	G F P C ① - ④	② JUST BEFORE SPALLING 18" W X 3" L X 3" H
COLUMNS A	G F P C	③ JUST BEFORE SPALLING 6" DIA X 1' H
B	G F P C	
C	G F P C	④ JUST BEFORE SPALLING 36" W X 10" H X 3" D
D	G F P C	
CRASHWALL	G F P C 1/16" CRACK	
E.Q.	G F P C

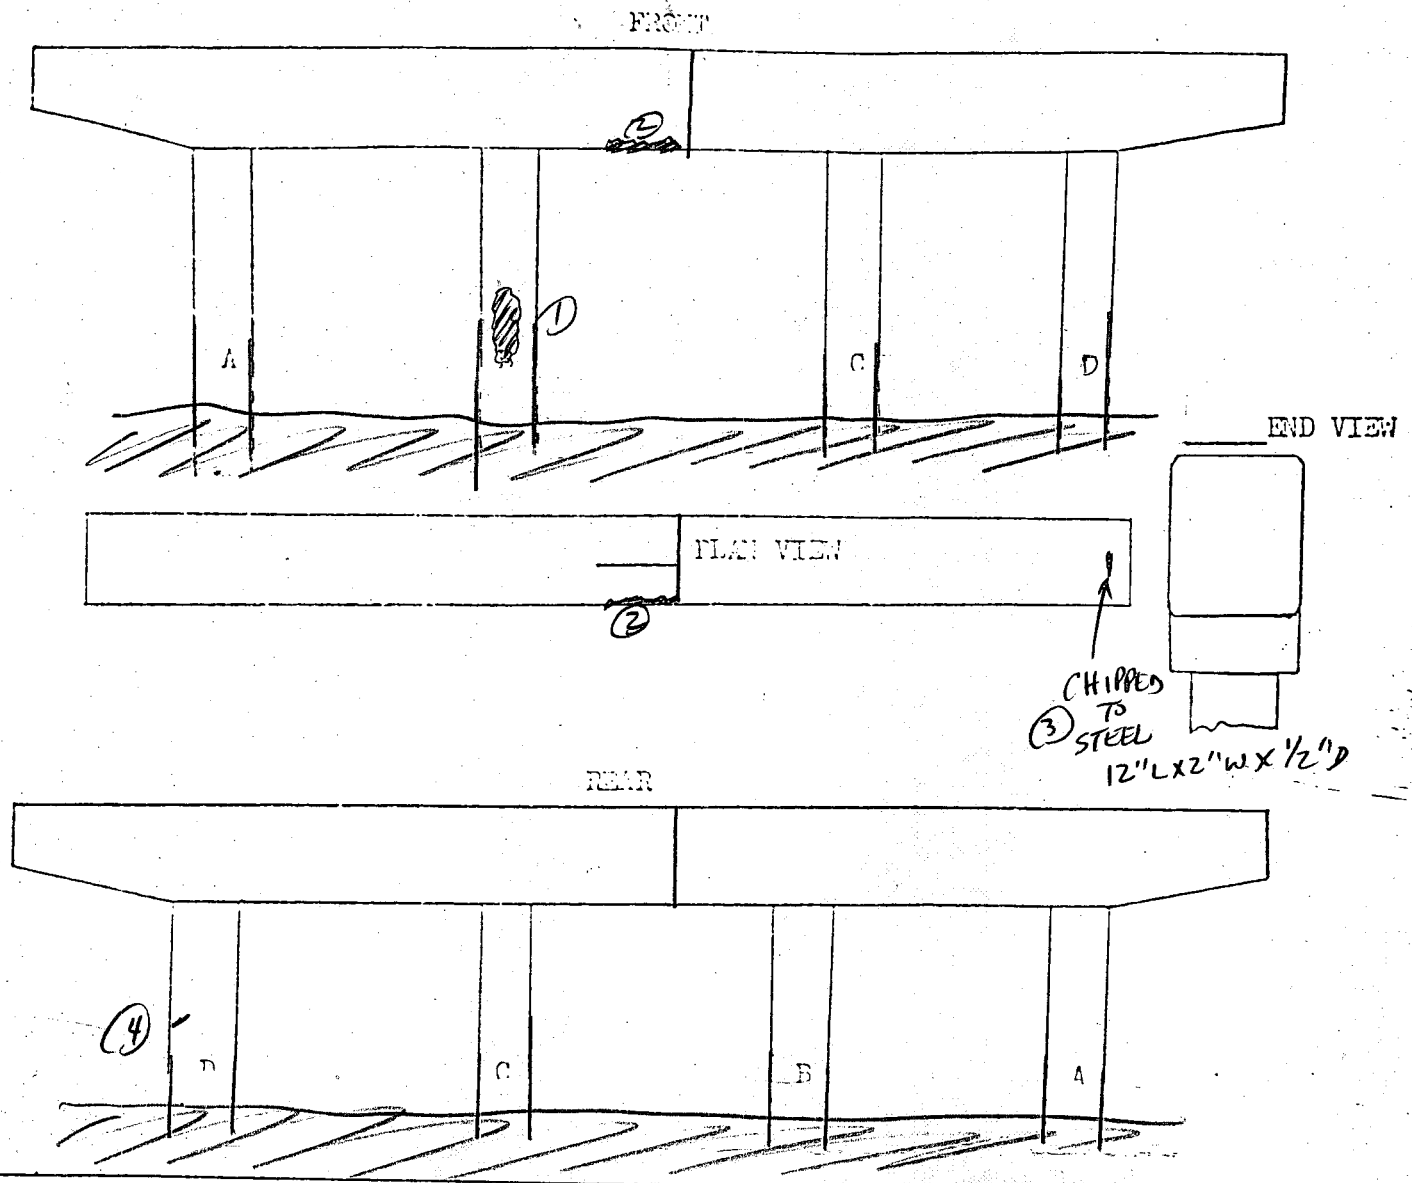
BENT NO. 3

ELEMENT	RATING	COMMENT
BEARINGS	(G) F P C	
CAP	G (F) P C (2) (3)	(1) JUST BEFORE SPALLING 42"H X 18"W X 1/2"D
COLUMNS A	(G) F P C	
B	G (F) P C (1)	(2) JUST BEFORE SPALLING 42"W X 4"H X 2"D
C	(G) F P C	
D	G (F) P C (4)	(4) SPALL 18"L X 4"H X 1"D
CRASHWALL	G F P C -	
E.Q.	(G) F P C	
LIGHT	(G)

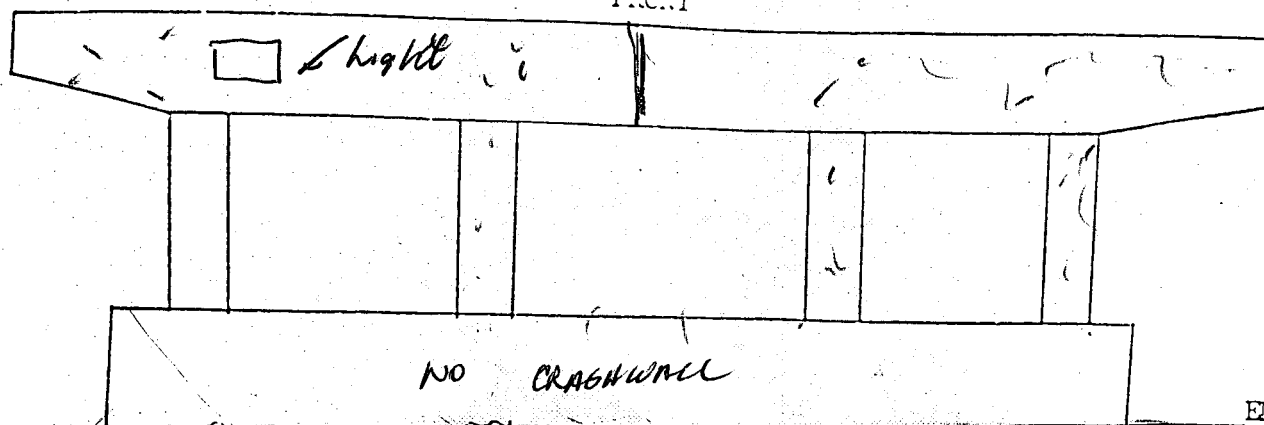
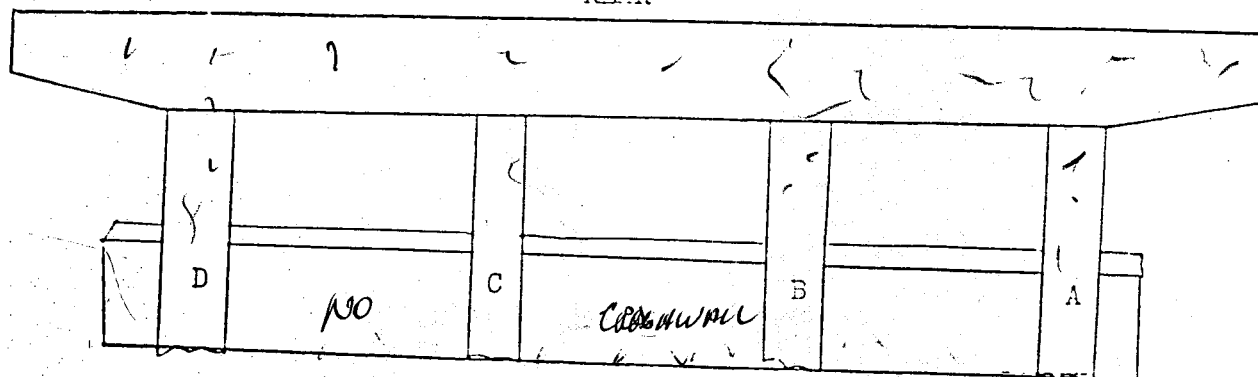
BR. NO. 79 1240 15.43 SK. 2 BENT NO. 4

Light Repairs

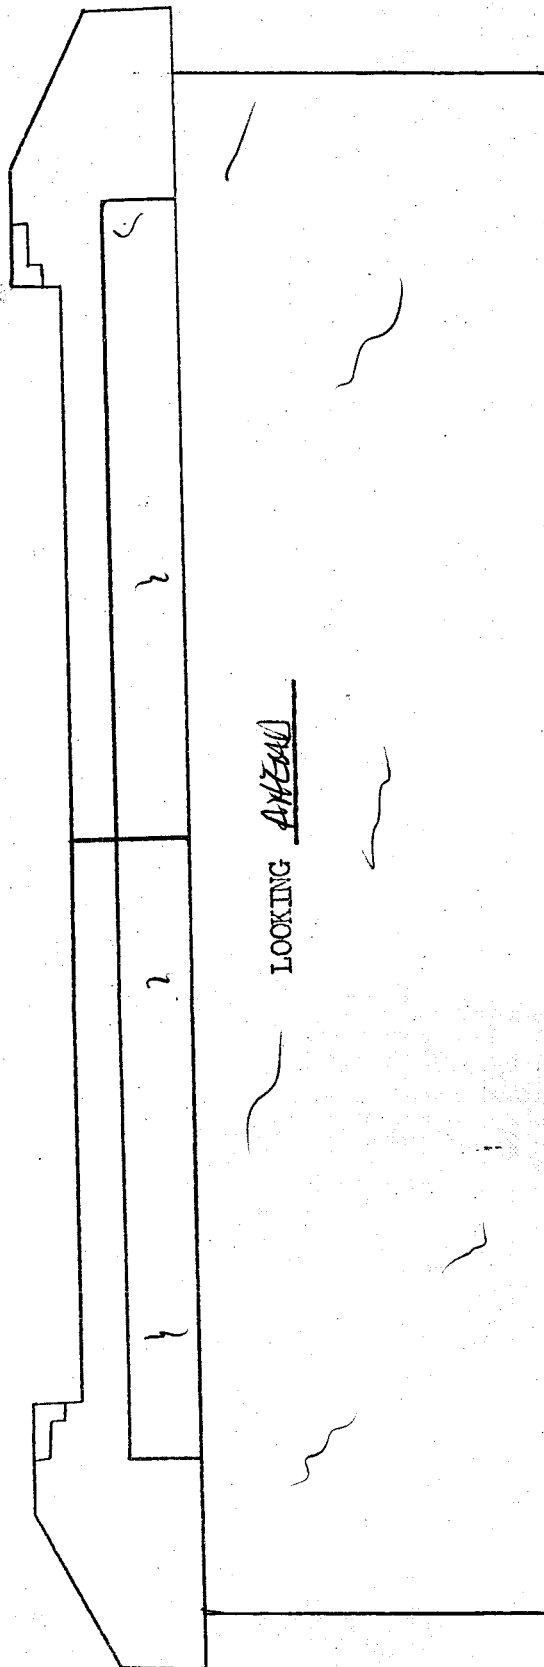
BR. NO. 79 I-240 1543 SK. 8704FEB 19 2013
ABUT. NO. 2

Fair cracks
NWFair cracks
Fair cracks
