SHELBY COUNTY

BRIDGE MAINTENANCE RECOMMENDATIONS

LOCATION: 79-SR057-08.18-R

BRIDGE INSPECTION REPORT

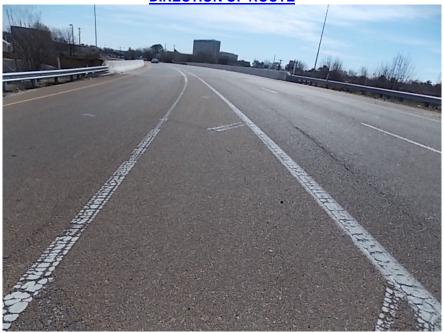
APPROACH 1 ASPHALT

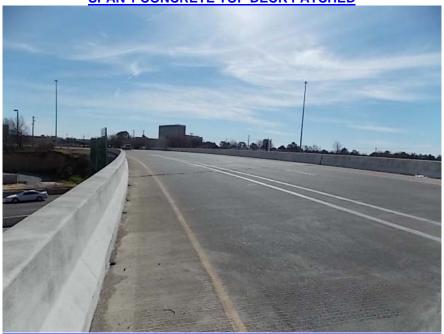
SPAN 1 CONCRETE TOP DECK PATCHED

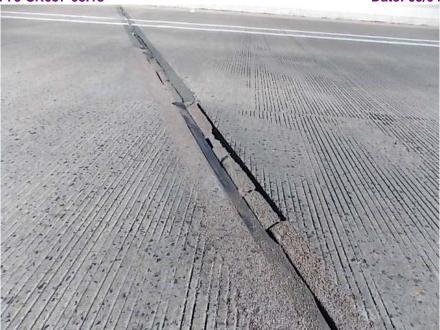
SPAN 1 JOINT SPALLING

THIS 4 SPAN CONCRETE I BEAM BRIDGE IS IN POOR CONDITION.
THE APPROACH PAVEMENT HAS FINE CRACKS AND A SPALL AREA.
THE CONCRETE WEARING SURFACE HAS FINE CRACKS.
THE JOINT HEADER ON SPAN 1 IS SPALLING AND MATERIAL TORN.
THE BOTTOM DECK HAS FINE CRACKS, PATCHED AREAS AND SPALL
TO STEEL AREAS.

SUGGESTED ROUTINE MAINTENANCE AND COMMENTS				
REPAIR CONCRETE BEAM "G" SPAN NO.1				
REPAIR DIAPHRAGMS IN SPAN NO.2				
REPLACE CONCRETE RISER BLOCKS AT BENT NO.1				
CLEAN AND SEAL ROADWAY EXPANSION JOINTS.

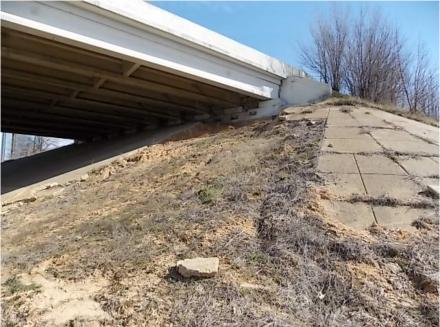
ABUTMENT 2 SLOPE PAVING MISSING

ABUTMENT 2 SECTION OF SLOPEPAVMENT MISSING DUE TO CONSTRUCTION, ABUTMENT 1 PLATE AND BOLT MISSING. ABUTMENT 1 EQ NOT CONNECTED.

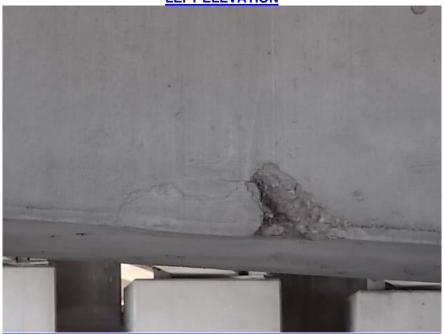
BENT 2 CAP SPALLING

BENT 2 CAP HAS SECTION BEGINNING TO SPALL THAT COULD FALL INTO ROADWAY.

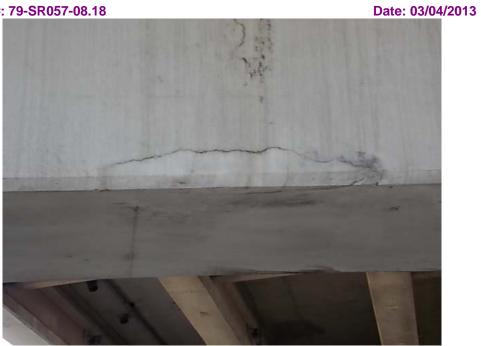
BENT 3 CAP BEGINNING TO SPALL

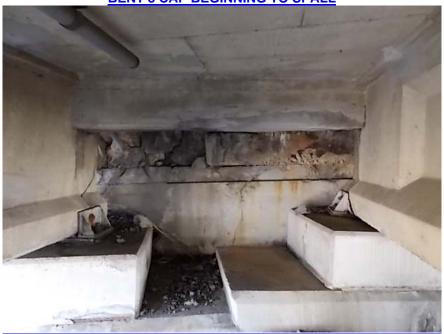
SPAN 4 BACKWALL SPALLING

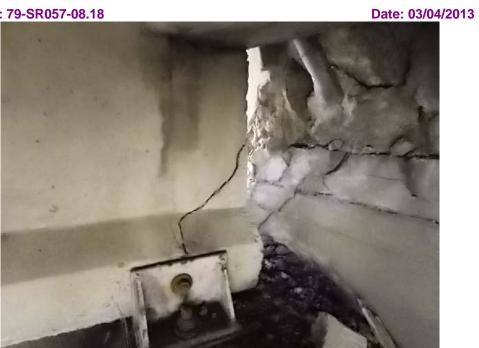
SPAN 4 BEAM A SPALLING

SPAN 4 CONCRETE I BEAM A-I AT END OF BEAMS ARE BEGINNING TO SPALL.

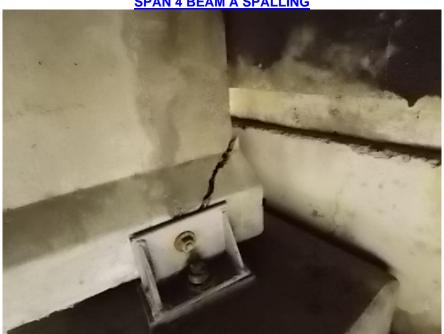
SPAN 4 BEAM B SPALLING

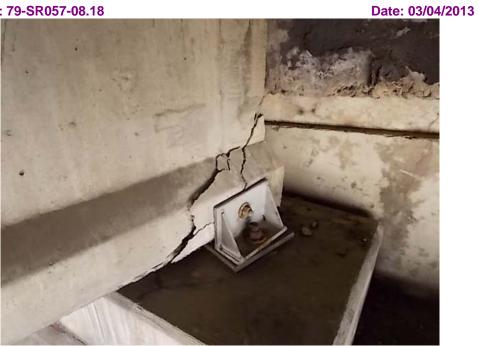
SPAN 4 BEAM C SPALLING

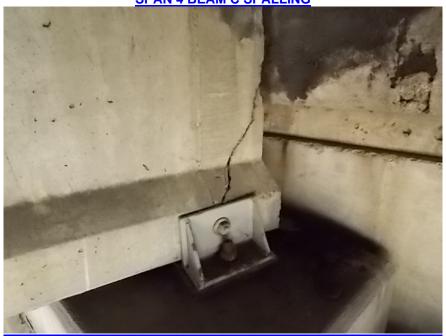
SPAN 4 BEAM D SPALLING

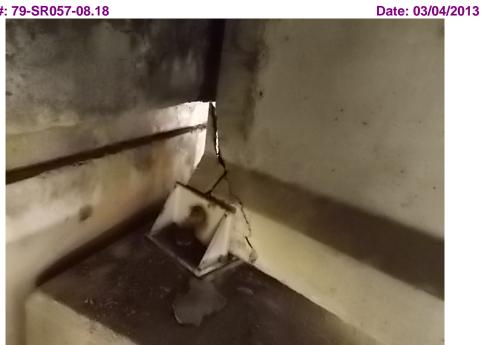
SPAN 4 BEAM E SPALLING

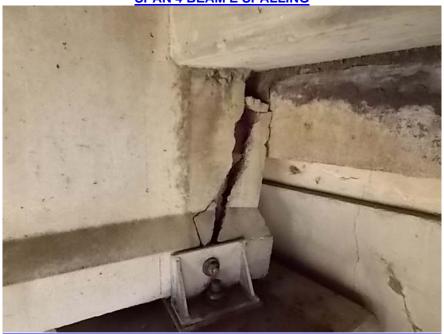
SPAN 4 BEAM F SPALLING

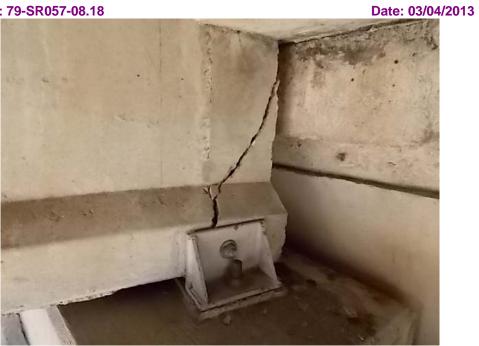
SPAN 4 BEAM G SPALLING

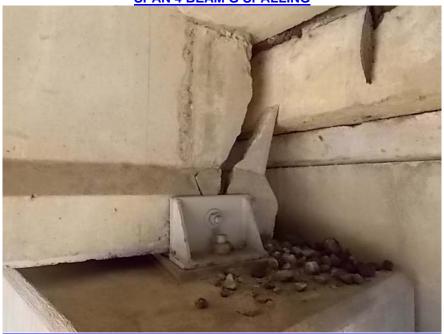
SPAN 4 BEAM H SPALLING

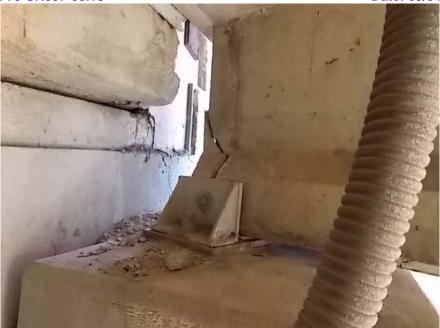
SPAN 4 BEAM I SPALLING

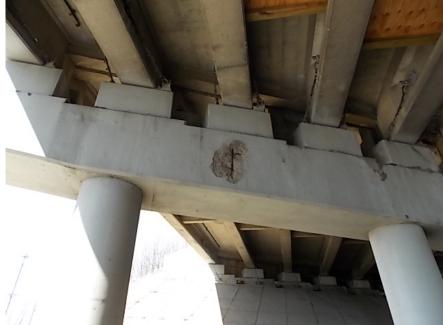
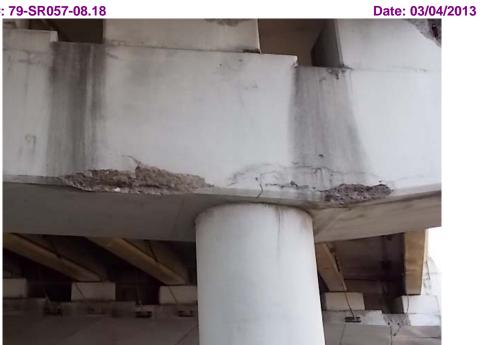
BENT 1 CAP SPALLING

THE CONCRETE SUBSTRUCTURE HAS FINE CRACKS, BEGINNING TO SPALL AND SPALL TO STEEL.

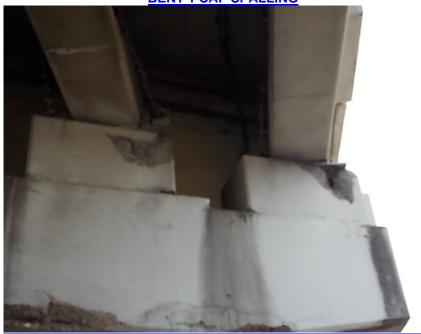
BENT 1 RISER BLOCKS SPALLING

BENT 1 RISER CLOCK SPALLING UNDER CONCRETE I BEAM A&B, THE VERTICAL CLEARANCE IS UNDER CONSTRUCTION.

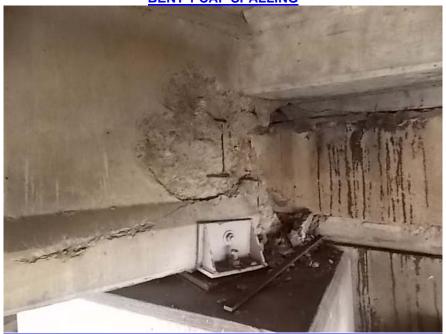
SPAN 1 BEAM G SPALLING

SPAN 1 CONCRETE I BEAM(G) IS SPALL TO STEEL.

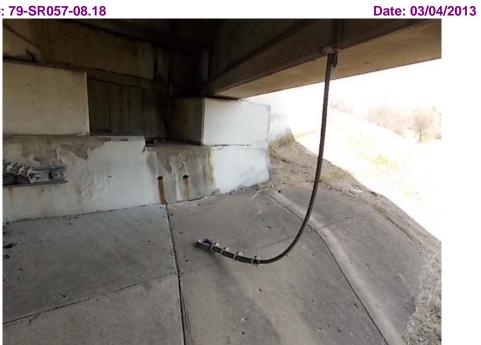
03-04-2013 UNDERPASS IS UNDER CONSTRUCTION. ABUTMENT # 1 EARTHQUAKE DEVICES NOT CONNECTED.

ABUTMENT 1 EQ PLATE MISSING

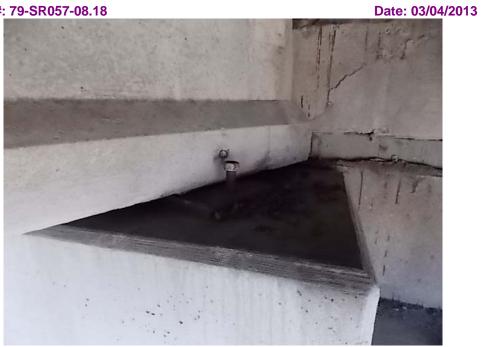
ABUTMENT 1 BEARING UNDER BEAM A PLATE MISSING

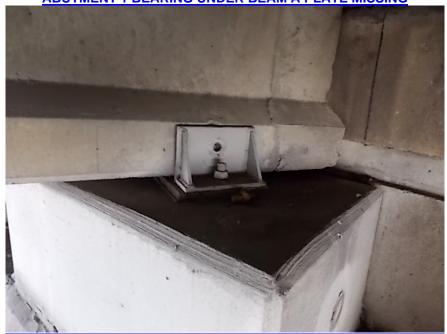
ABUTMENT 1 PLATE NOT BOLTED TO BEAM F,H,I TIP

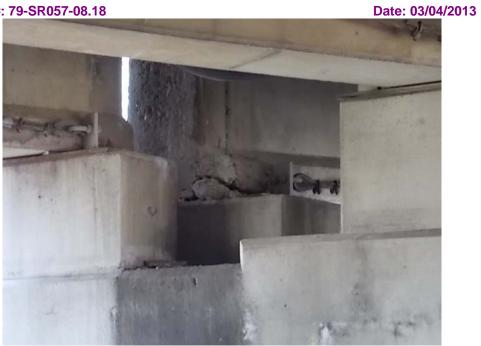
SPAN 2 BEAM A SPALLING

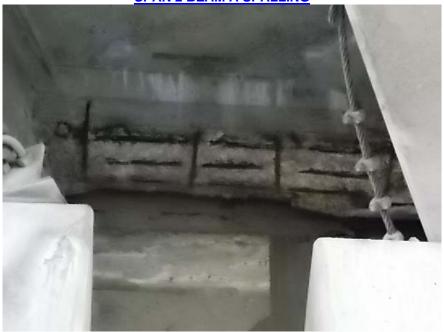
SPAN 2 DIAPHRAGM SPALLING

SPAN 2 DIAPHRAGM SPALL TO STEEL.

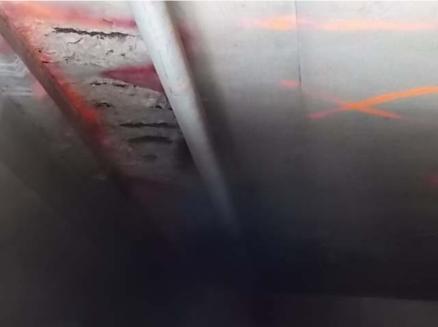
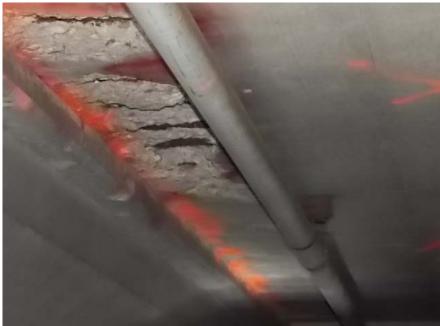
SPAN 2 BETWEEN CONCRETE I BEAM A&B SPALLED TO STEEL/DELAMINATED

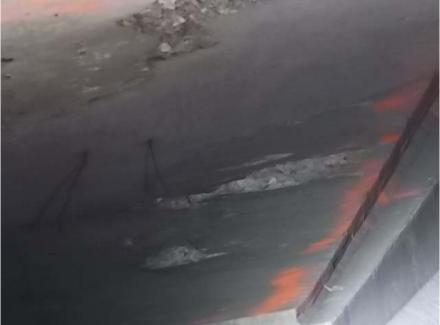
SPAN 2 BETWEEN CONCRETE I BEAM B&C SPALLING AND DELAMINATED

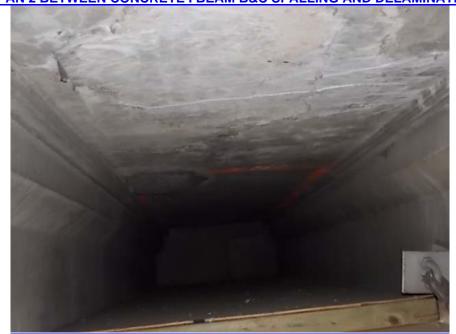
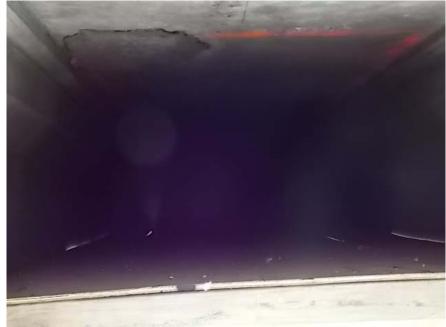
SPAN 2 BETWEEN CONCRETE I BEAM C&D RANDOM SPALLED AREAS

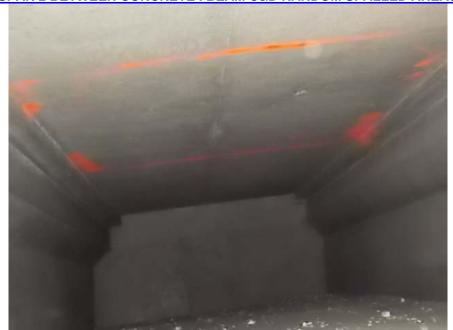
SPAN 2 BETWEEN CONCRETE I BEAM D&E DELAMINATED WITH NO SPALLING

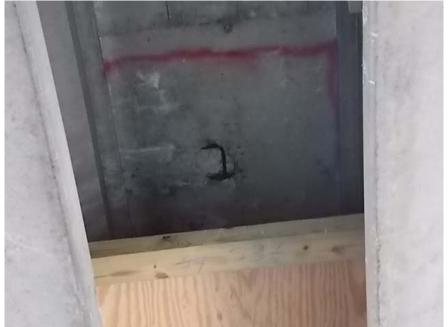
SPAN 2 BETWEEN CONCRETE I BEAM F&G SPALLED TO STEEL/DELAMINATED FIRST 1/3 OF SPAN

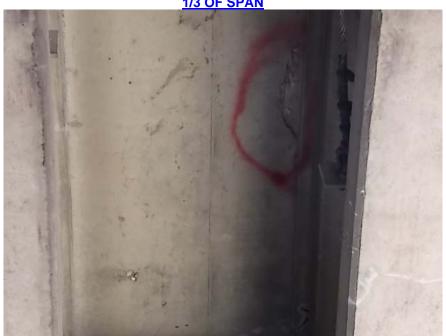
SPAN 2 BETWEEN CONCRETE I BEAM J&K SPALLED TO STEEL/DELAMINATED FIRST 1/3 OF SPAN

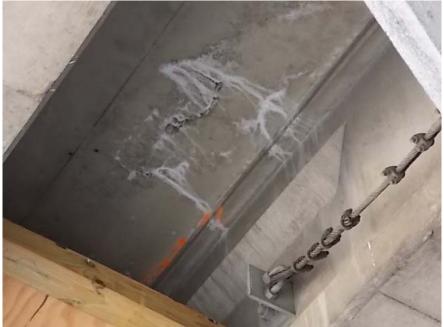
SPAN 2 LAST/3RD IF SPAN BETWEEN CONCRETE I BEAM H&I BEGINNING TO SPALL WITH EFFLORESCENCE

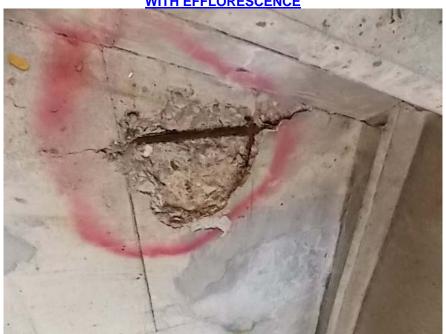
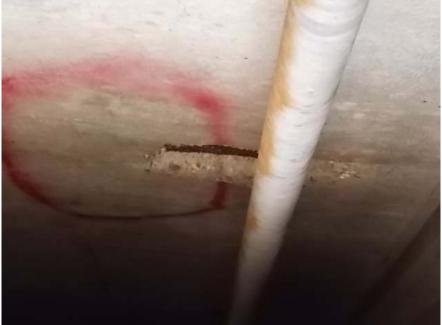
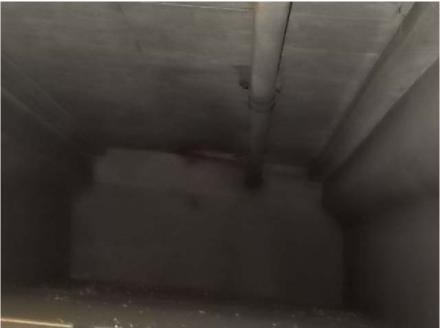
SPAN 3 LAST/3RD IF SPAN BETWEEN CONCRETE I BEAM A&B SPALLED TO STEEL/DELAMINATED

SPAN 3 LAST/3RD IF SPAN BETWEEN CONCRETE I BEAM A&B SPALLED TO STEEL AND DELAMINATED

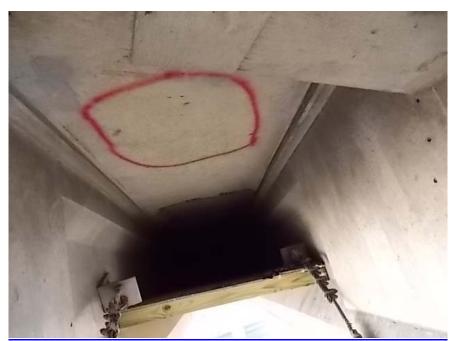
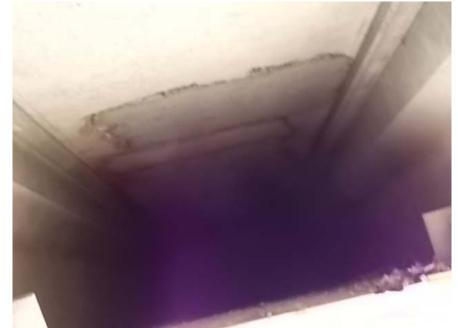
SPAN 3 BETWEEN CONCRETE I BEAM E&F BOTTOM DECK PAINTED FOR DELAMINATION

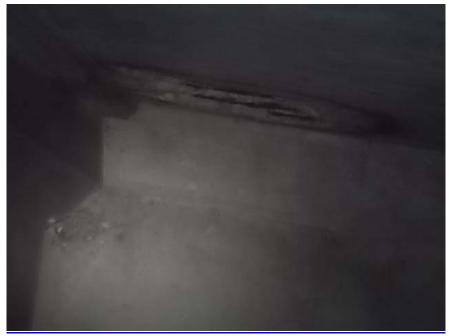
SPAN 3 BETWEEN CONCRETE I BEAM F&G BOTTOM DECK PAINTED FOR DELAMINATION
