BRIDGE MAINTENANCE RECOMMENDATIONS

COUNTY: SHELBY LOCATION: 79-SR057-08.09-L CO. SEQ.: 1 SPEC. CASE: 0

CROSSING: 1240 & 1240 EXIT RAMP
 REPAIR LIST NO.:
 2

BRIDGE INSPECTION REPORT

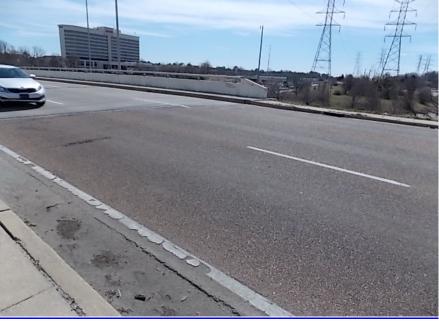
APPROACH 1 ASPHALT

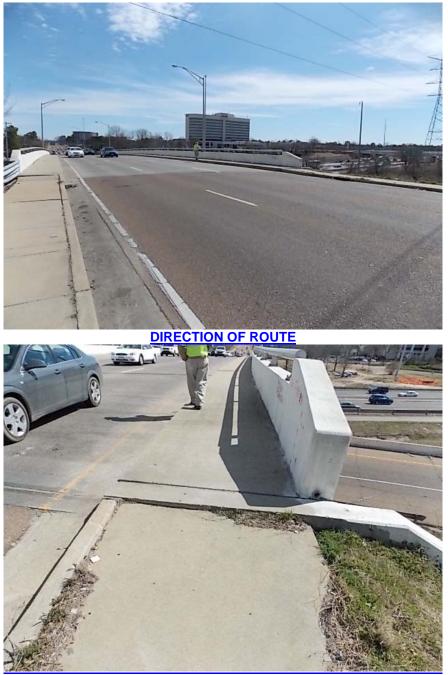
APPROACH 1 RIGHT SIDEWALK SETTLED

SUGGESTED ROUTINE MAINTENANCE AND COMMENTS
REPAIR CONCRETE BEAM "C & D" SPAN NO.5
PATCH BOTTOM OF DECK IN SPAN NO.3
CLEAN AND SEAL ROADWAY EXPANSION JOINTS.
REPAIR SIDEWALK AT APPROACH NO.1 RT & LT & 2 RT & LT
UNDERPASS SUBSTRUCTURE PROTECTION GUARDRAILS ARE SUBSTANDARD

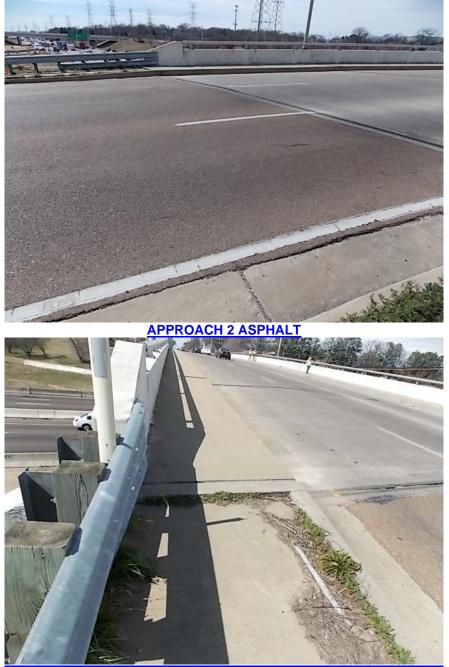
APPROACH 2 RIGHT SIDEWALK SETTLED

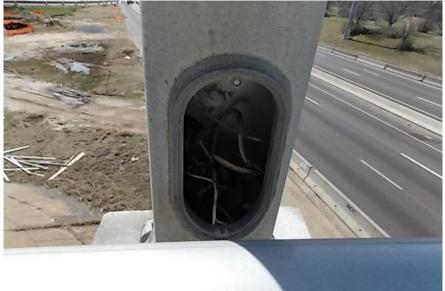
03-04-2013 I-240 MAINLINE OF UNDERPASS IS UNDER CONSTRUCTION. SPAN # 1, 2, & 3 LIGHTING COVER PLATE MISSING.

SPAN 5 COVER PLATE MISSING ON LIGHT

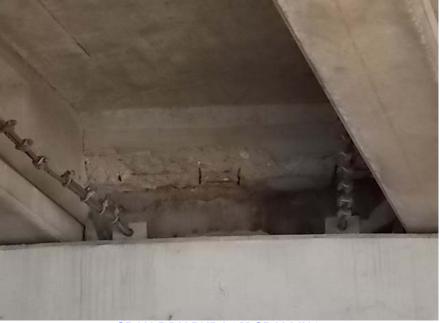
SPAN 5 DIAPHRAGM SPALLING

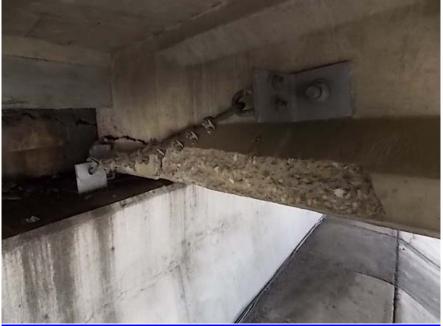
SPAN 5 BEAM D SPALLING

THIS 5 SPAN CONCRETE I BEAM BRIDGE IS IN POOR CONDITION. THE APPROACH PAVEMENT AND CONCRETE WEARING SURFACE HAVE FINE CRACKS. SPAN 1,3&5 COVER PLATES ARE MISSING FROM LIGHTS. SPAN 3 BOTTOM DECK HAS DELAMINATION AND SPALLING. SPAN 5 CONCRETE I BEAM(C&D) SPALLED TO STEEL AND BROKEN. THE CONCRETE SUBSTRUCTURE HAS FINE CRACKS AND BEGINNING TO SPALL. THE MAIN LANE VERTICAL CLEARANCE IS UNDER CONSTRUCTION. THE MINIMUM VERTICAL ON RAMP IS 16'5". NOTE: APPROACH 1&2 LEFT AND RIGHT SIDEWALK SETTLED. SPAN 5 JOINT MATERIAL TORN AND MISSING. THERE IS POTENTIAL FOR CONCRETE TO FALL IN ROADWAY SPAN 2 BOTTOM HAS DELAMINATION AND BENT 3 HAS BEGINNING TO SPAL THAT COULD FALL IN ROADWAY.

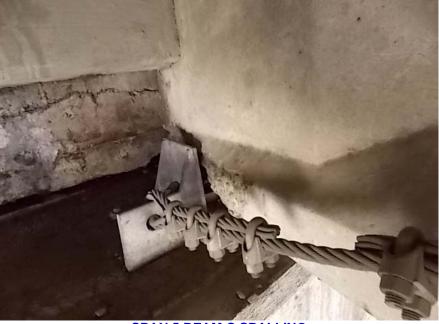
SPAN 5 BEAM C SPALLING

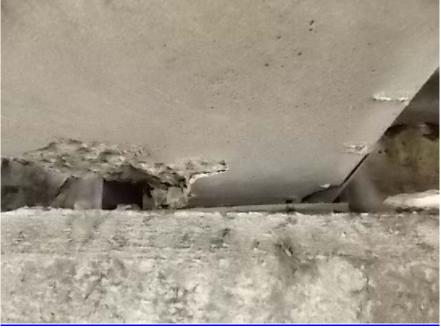
SPAN 5 BEAM C SPALLING

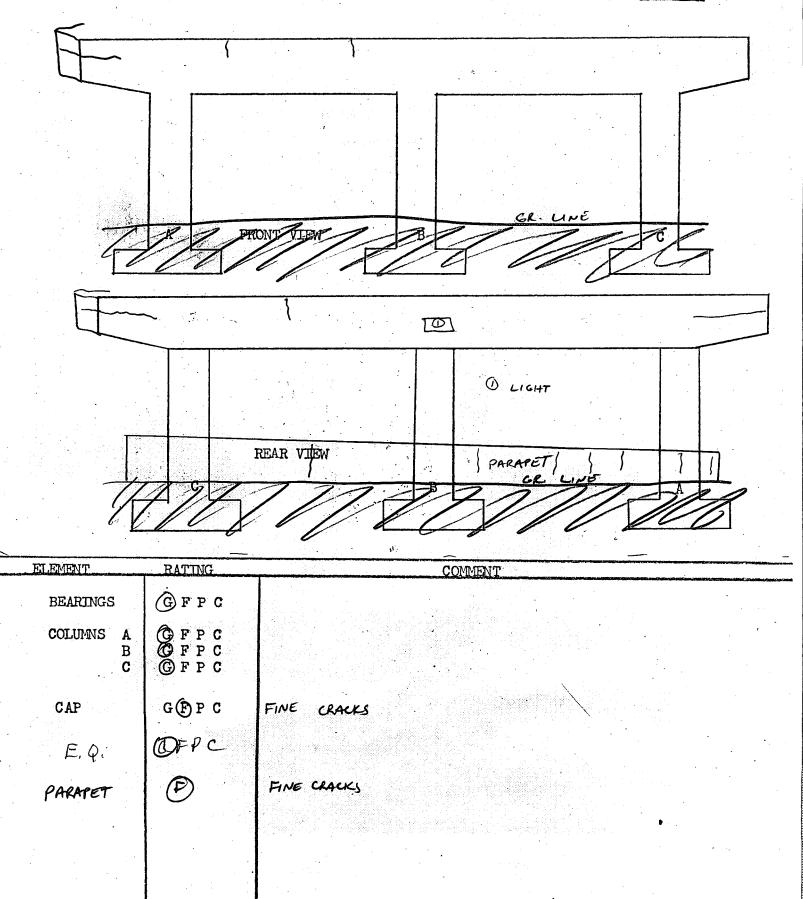
BENT NO. 3 MAR 0 4 2013

B C FRONT VIEW Α. с. Д. 3D -D Ż REAR VIEW C В A **s** -ELEMENT RATTNG COMMENT D Begin + 25 parl JuxiL GFPC BEARINGS COLUMNS A B G F P C G F P C G F P C C E CO, Fine Gracks GFP C CAP E.Q. OFPC fine cracks Parapet GEPC

Does Potential Exist Becau	se of Deteriorated Co	ndition or Failure of Major Me	ember YES()NO(
Comment on any Condition	s of Bridge that would	d Effect Roadway Beneath:	
SPAN # 2 BOTTOM ON	F DELK HAS	DELAMINATED SELTIONS	, ANS
BENT #3 CAP HA	S SECTIONS BE	TUNNING TO SPALL .	·
Note: If Underpass Route i	s Divided Highway, U	lse Two of These Forms, One	e for Each Roadway.
