**STATE OF TENNESSEE
DEPARTMENT OF TRANSPORTATION**

PROJECT MEMORANDUM

PROJECT: I-440 from I-40 to I-24
P.E. No. 19014-1169-04
Davidson County

SUBJECT: I-440 Rock Cut/Masonry Wall Assessment

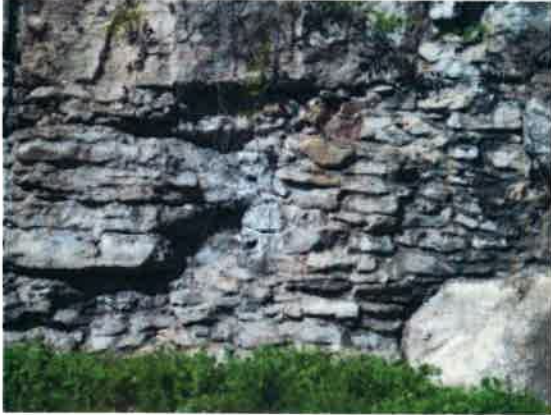
MM 1, Exit 1 to 1A

Masonry wall has some slight weathering and loss of cement.

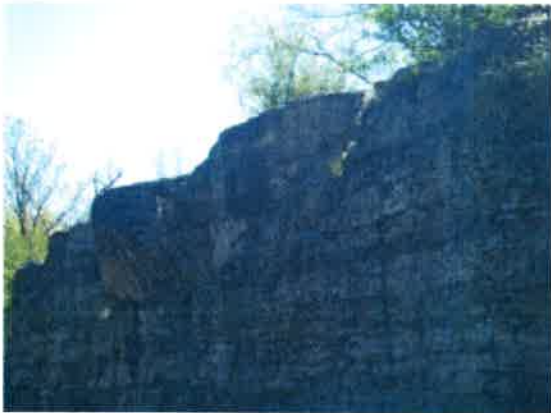
MM 3.6 to MM 3.8 (Granny White Pike)

Overhangs at top of rock cut require trim blasting.

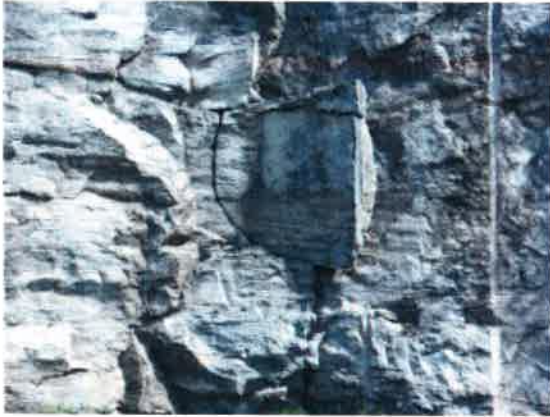
MM 4 to Belmont Blvd

Rock in the cut has slight fracturing resulting in loose blocks of material. The cut requires scaling.

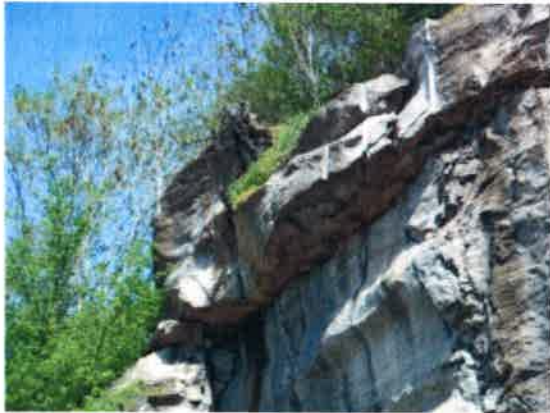
MM 3.8

Overhangs at top of rock cut require trim blasting.

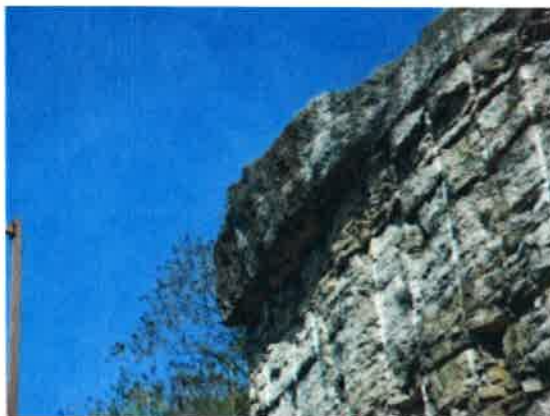
MM3.8 to MM 3.6

Overhangs at top of rock cut require trim blasting.

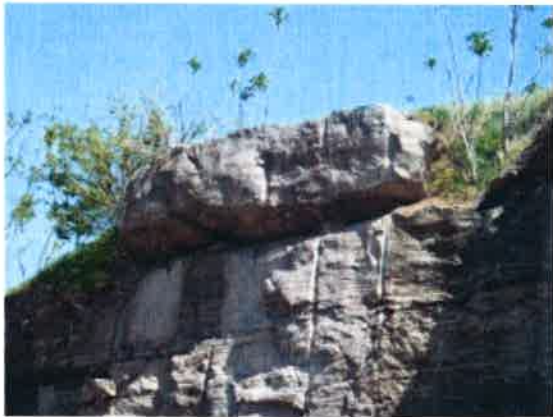
Ramp to Hillsboro Rd

Overhang at top of rock cut requires trim blasting.

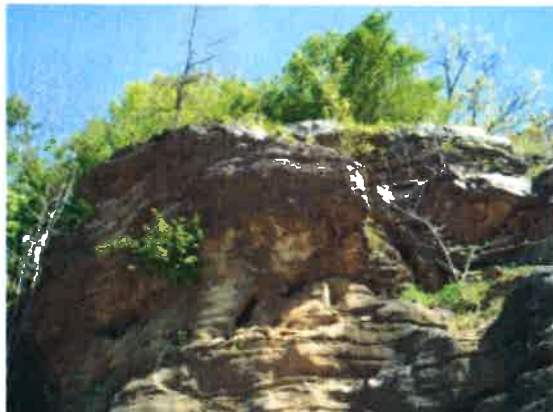
Hillsboro Rd to MM 2.4

Rock cut needs scaling and possible trim blasting.

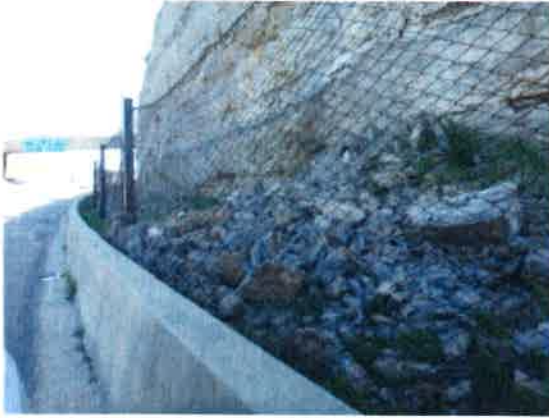
Murphy Rd On-ramp to I-440 WB

Rock cut may require trim blasting. Differential weathering is evident on slope.

Fallen rock debris needs to be cleaned out from behind fence and the fence panels are damaged at base and top. Fence needs repair.

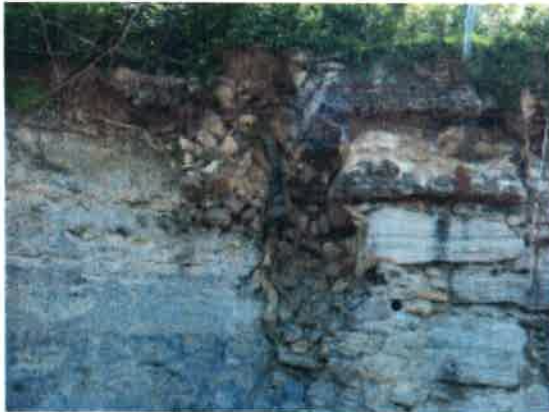
Acklen Park Drive overpass to MM 0.8

There is a failure in the masonry wall.

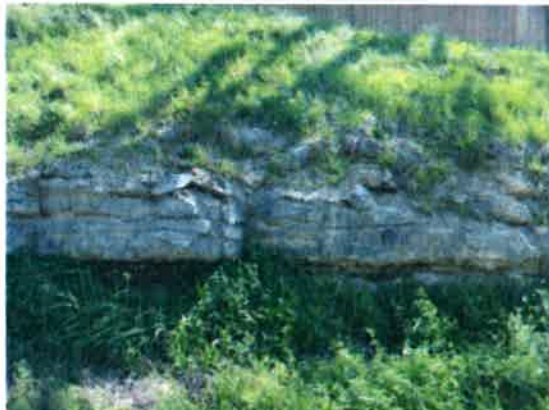
MM 0.8

Trim blasting is needed.
