19100650113
19-I0440-4.85 RT
L4-SN 167 RL/L3-SN 164 & 165

BRIDGE MAINTENANCE RECOMMENDATIONS

Tennessee Department
of Transportation

BRIDGE INSPECTION REPORT

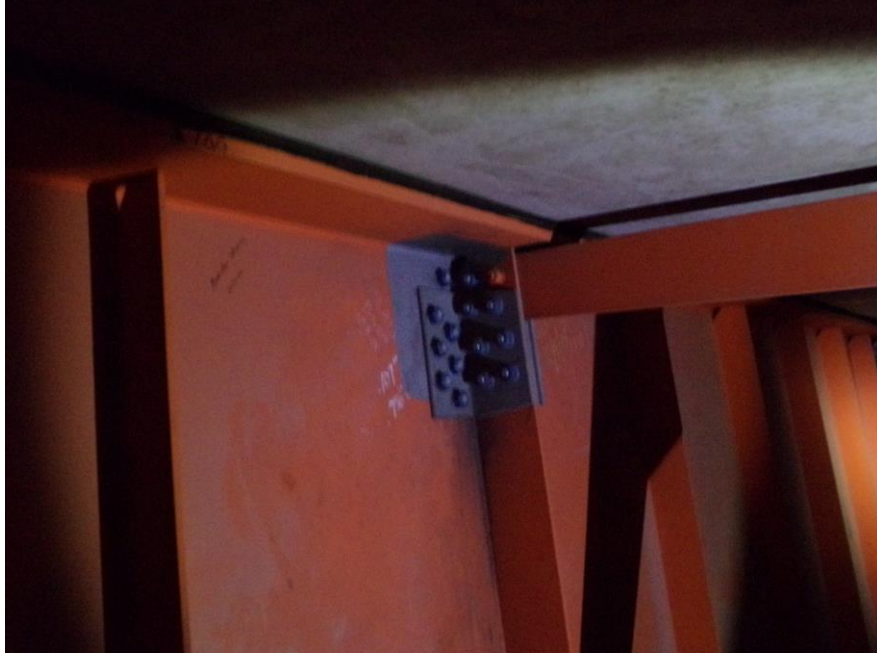
TUB "A" REPAIRS TYP.

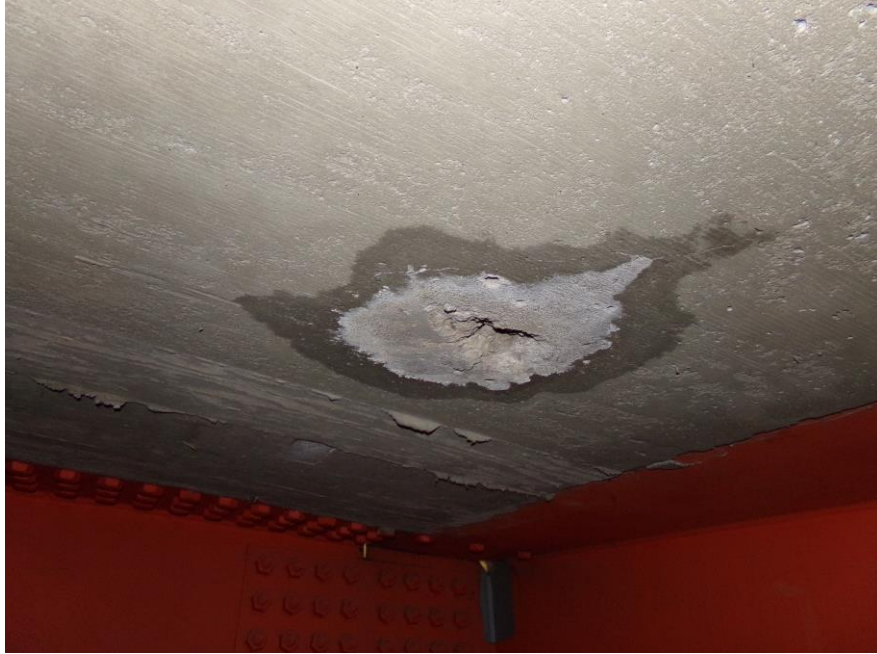
TUB "A" DIAPH.#3 SP.#1 DECK PANEL W/ SPALL

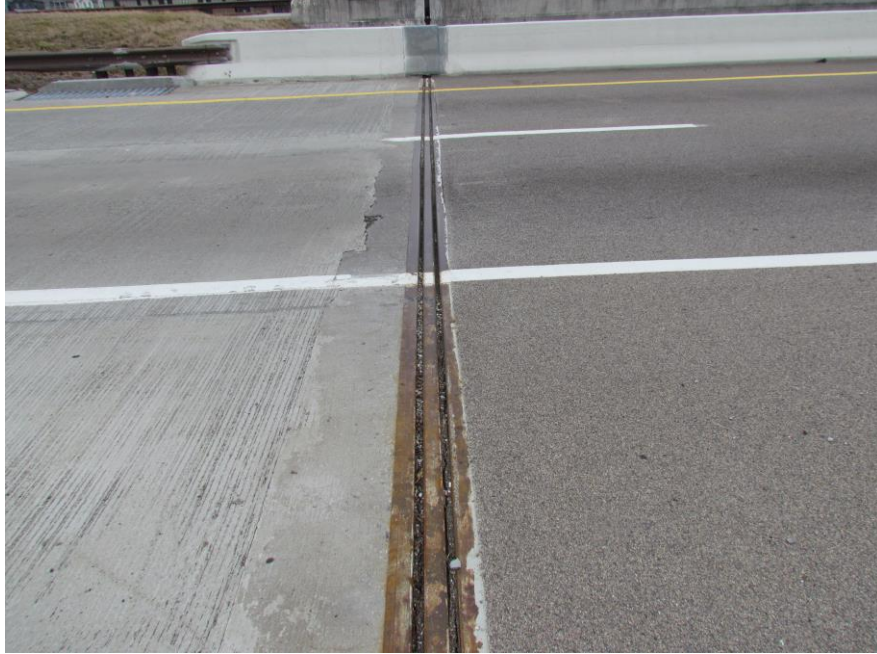
EXPANSION JOINT "A" W/ DEBRIS BLD-UP

SUGGESTED ROUTINE MAINTENANCE AND COMMENTS
CLEAN AND PAINT ALL STRUCTURAL STEEL
CLEAN AND REPAINT CORROSION INSIDE GIRDERS
REMOVE AND CONTROL MOSITURE ACCUMULATION INSIDE TUB "B" SP #4
CLEAN EXPANSION DEVICES
REPAIR APPROACH DRAIN LEFT SIDE "B" END

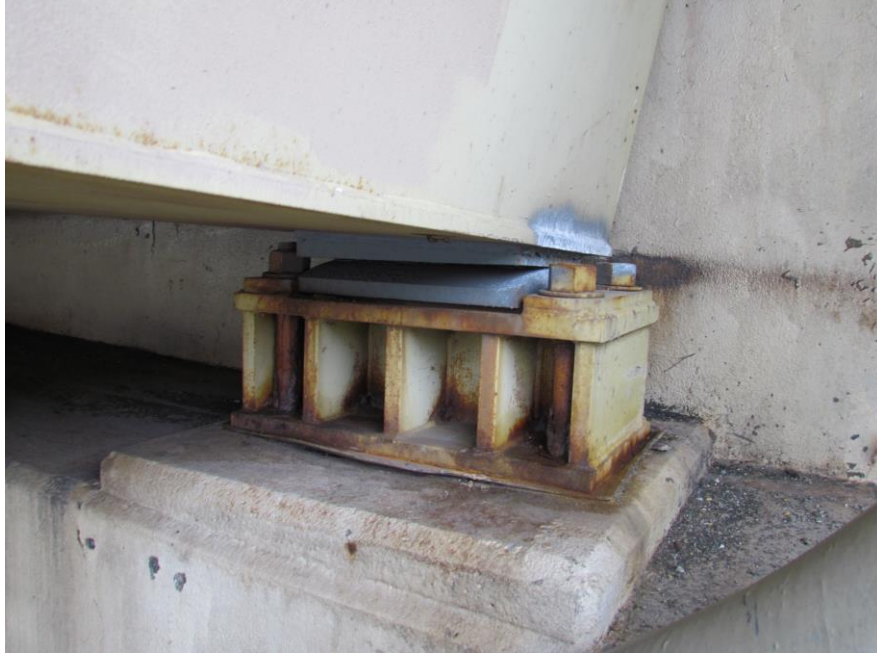
BEARING DEVICE W/ REPAIRS ABUT. #1

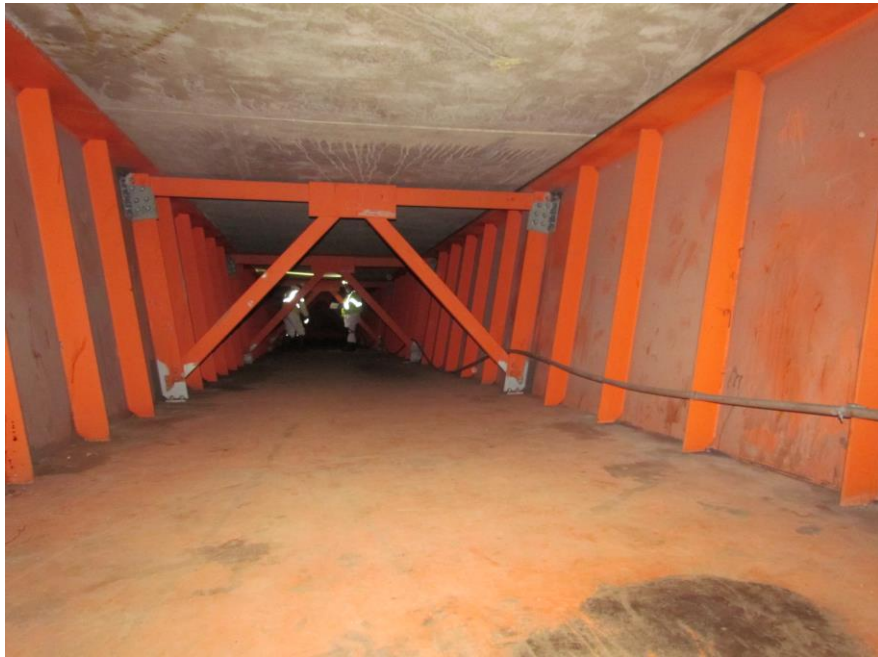
TUB "B" DIAPHRAGM #1 SP. #1 REPAIRS TYP

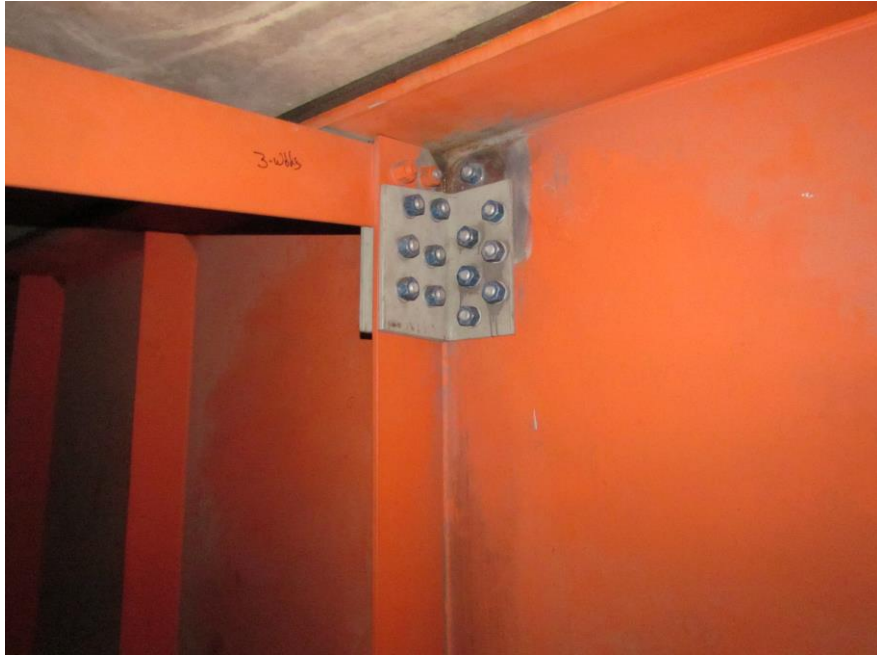
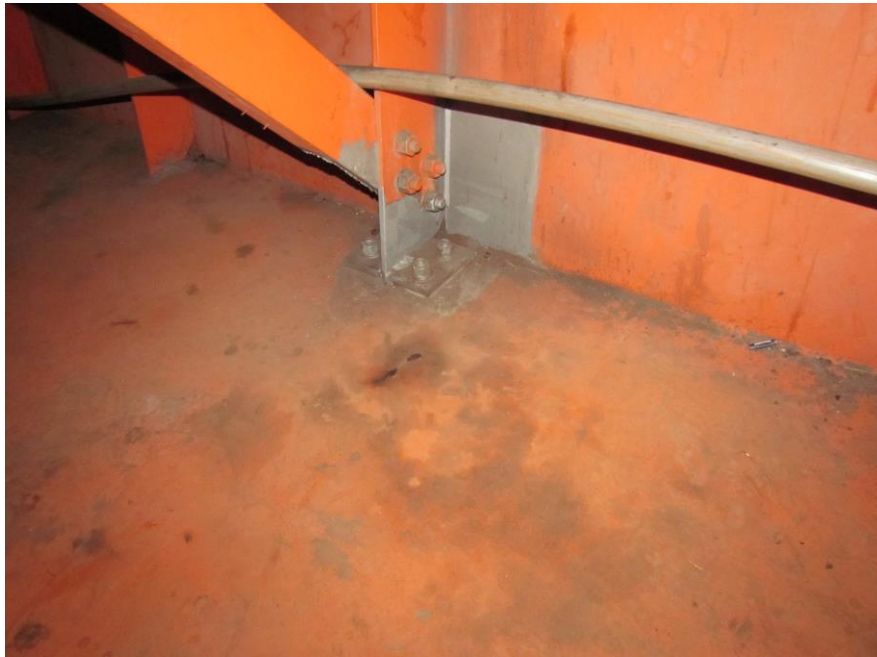
TUB "B" REPAIRS CLOSE-UP - TYP.

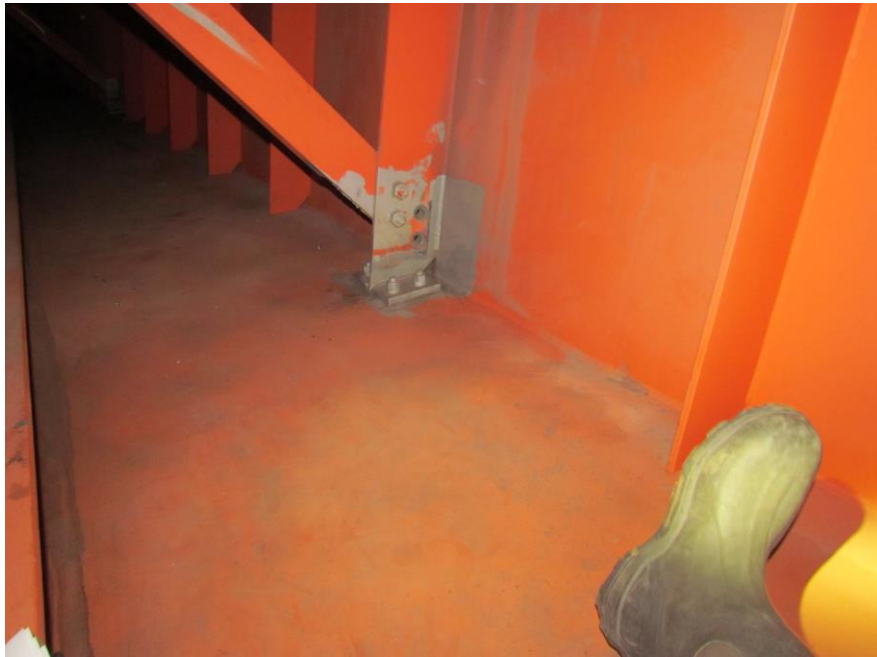
TUB "B" SP. #2 W/ 2 MISSING BOLTS DIAPH.#6

No.	RECOMMENDATIONS	REPAIR DATE	REPAIRED BY
1.	REPAIR CRACKS IN TUB GIRDERS "A" & "B"		
2.	REPLACE MISSING BOLTS (NUMEROUS) IN DIAPHRAGM TUB "B"		
3.	SEAL/REPAIR APPROACH PAVEMENT

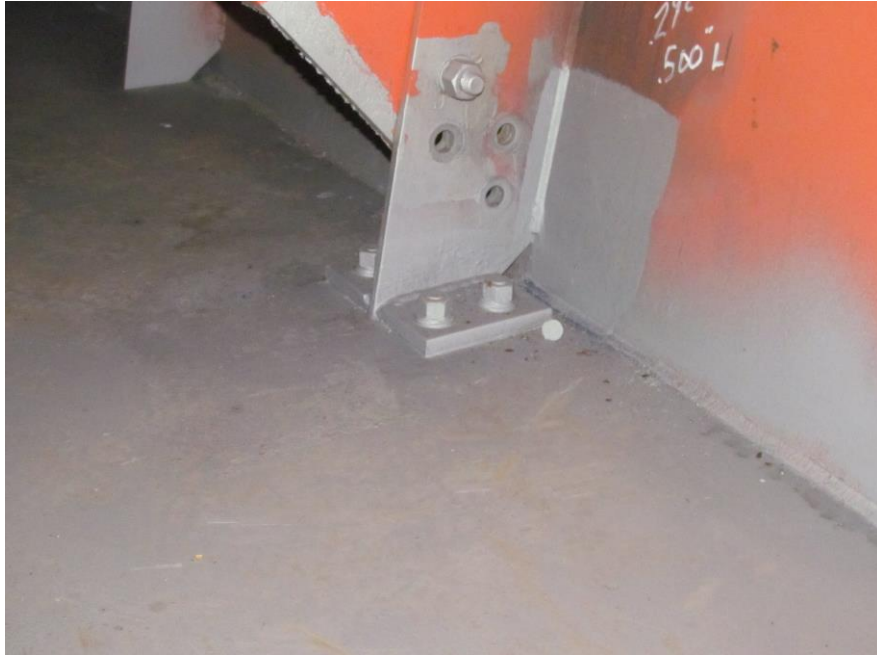
TUB "B" SP.#3 W/ 3 MISSING BOLTS DIAPH. #1

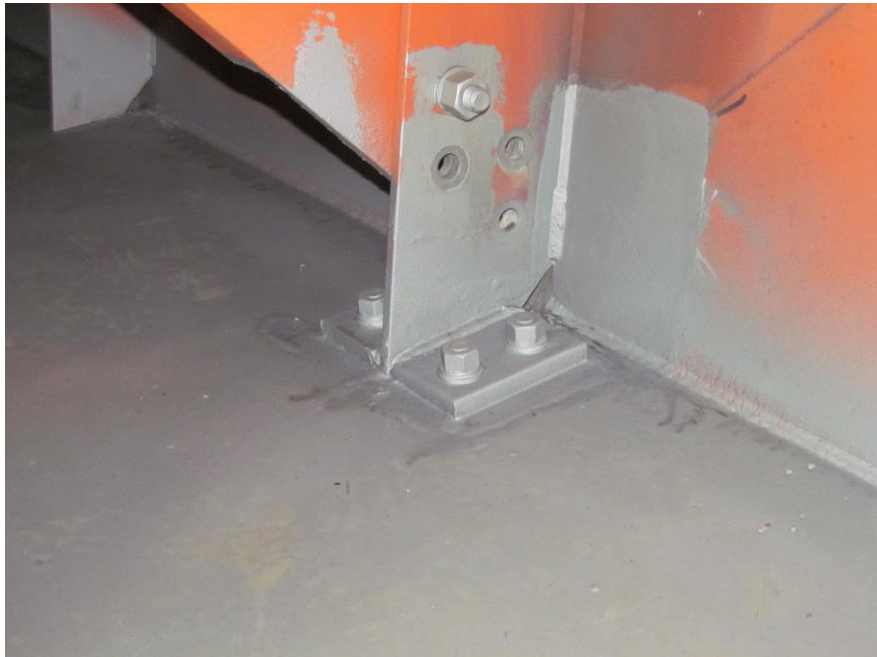
TUB "B" SP. #3 W/ 3 MISSING BOLTS DIAPH. #2

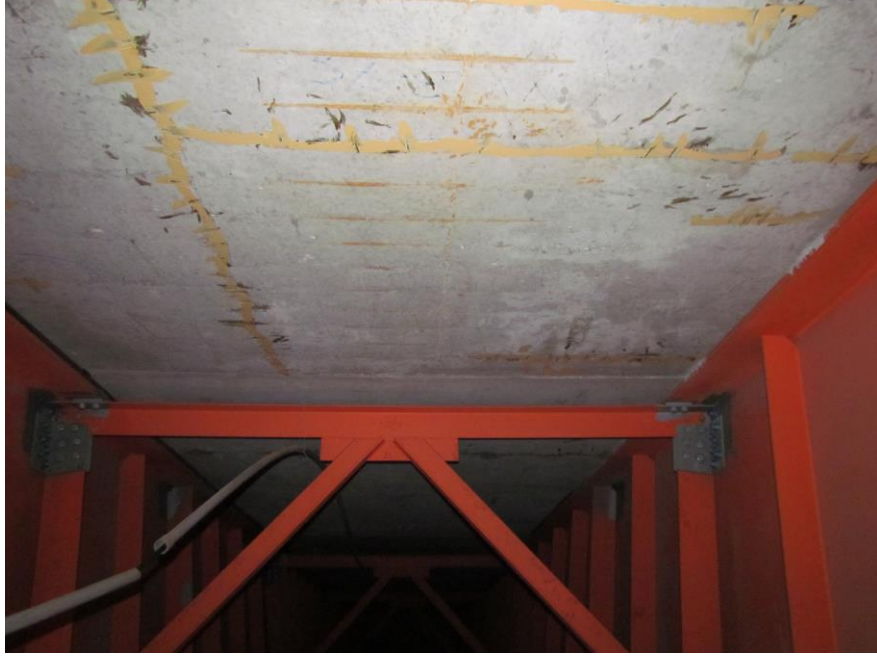
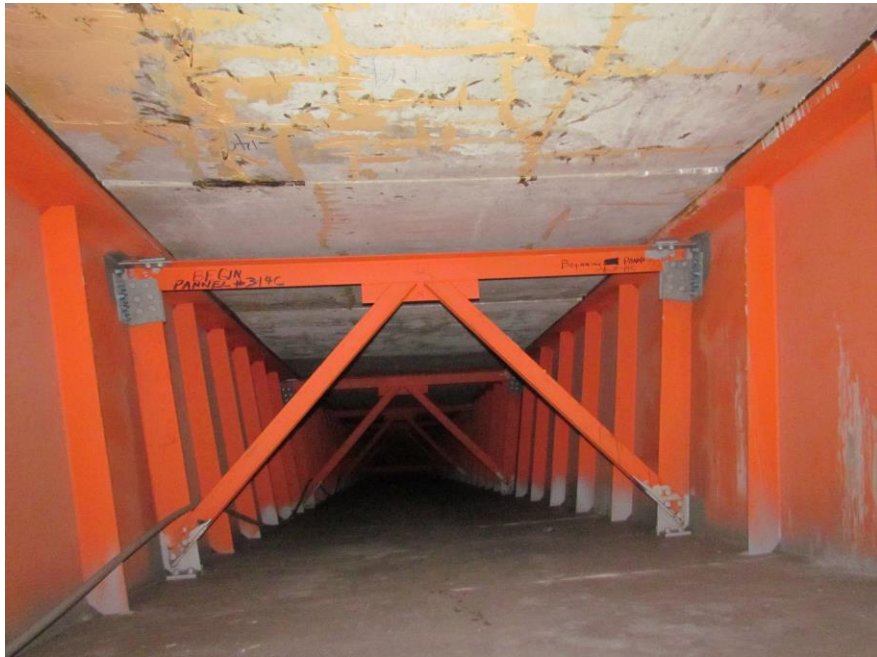
TUB "B" DECK PANELS SP. #3 W/ REPAIRS

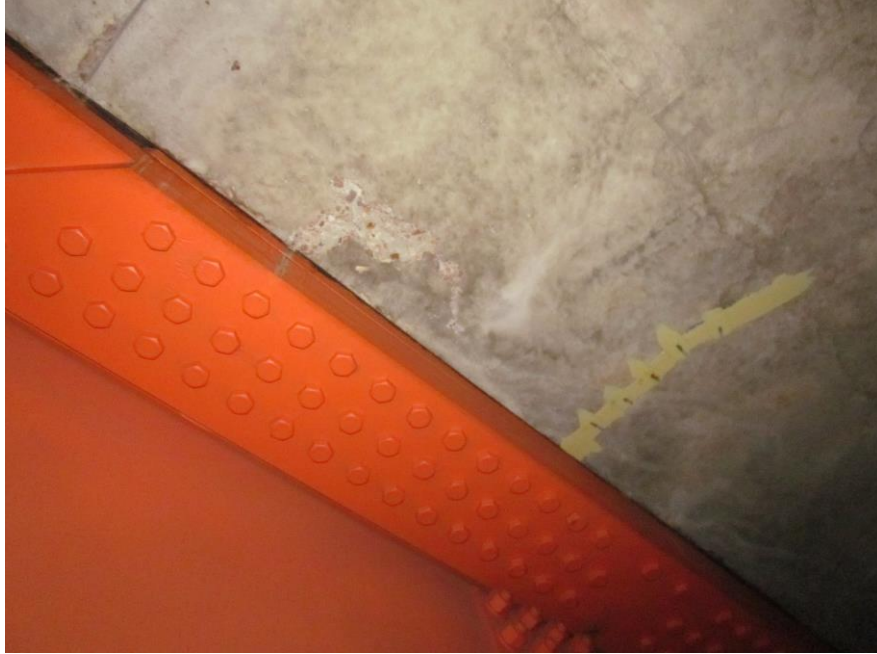
TUB "B" DECK PANEL SP. #3 W/ SPALL

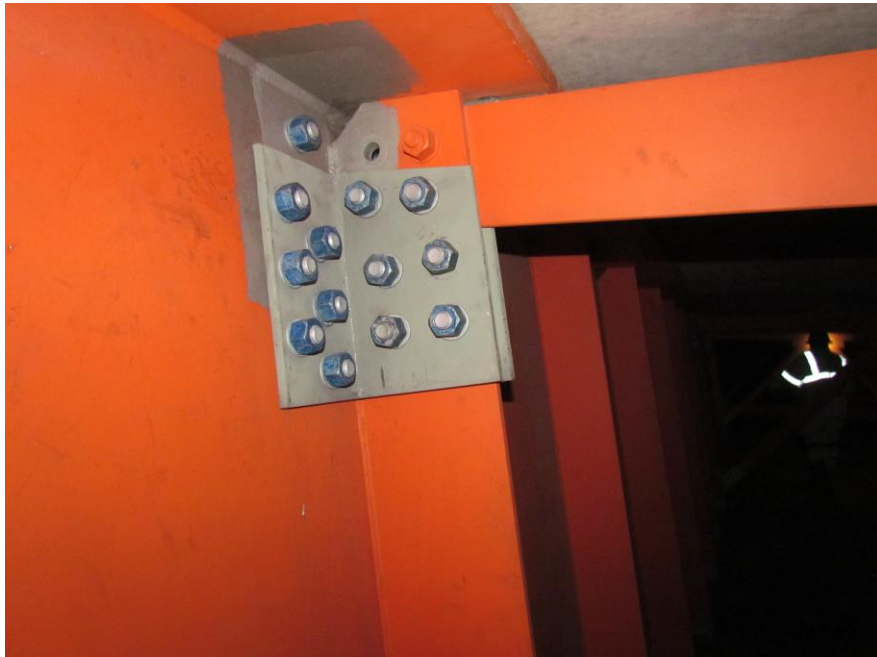
TUB "B" SP. #3 W/ 1 MISSING BOLT DIAPH. #10

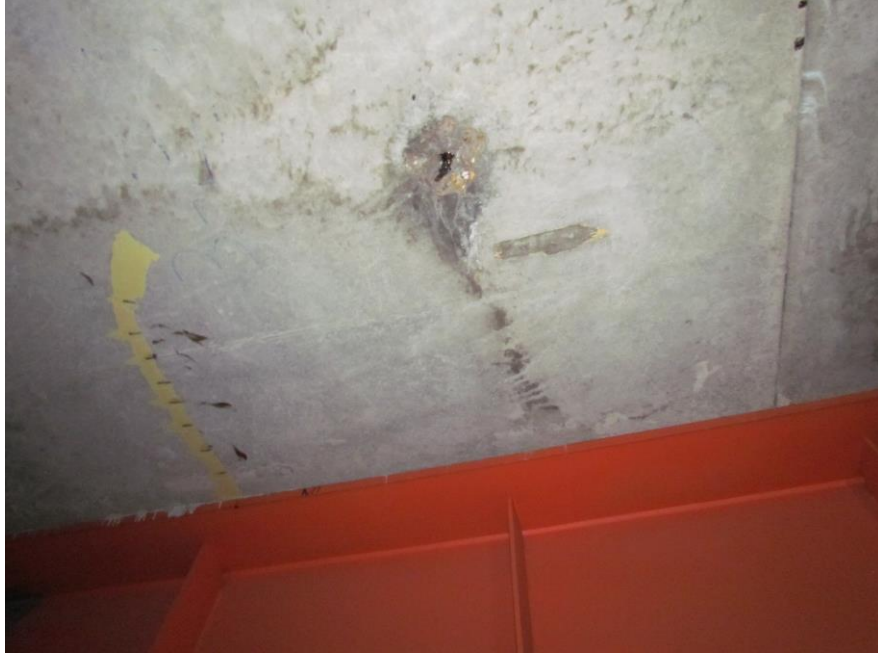
TUB "B" DECK PANEL SP. #3 W/ SPALL

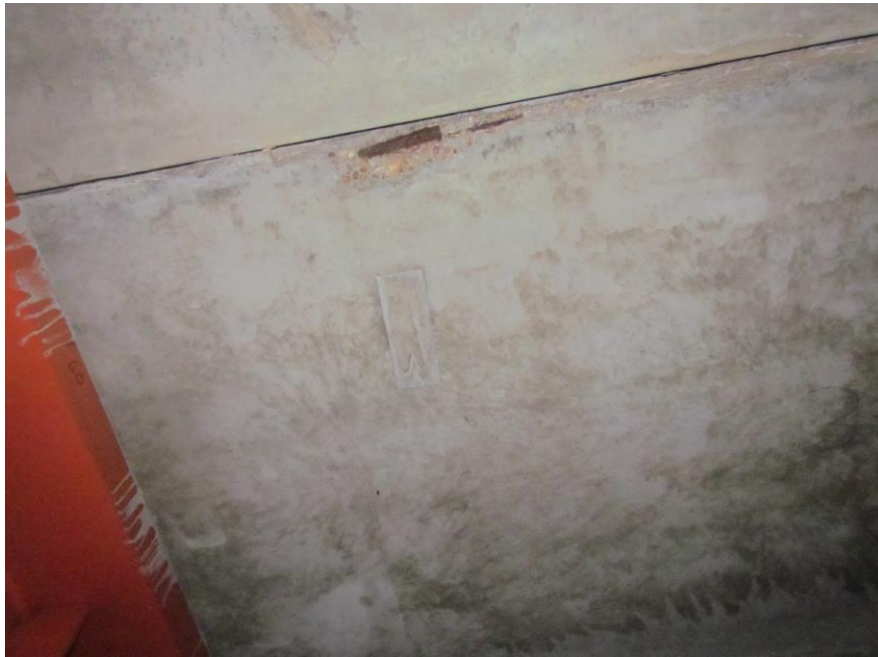
TUB "B" DECK PANEL#1 SP. #3 W/ SPALL & E.S

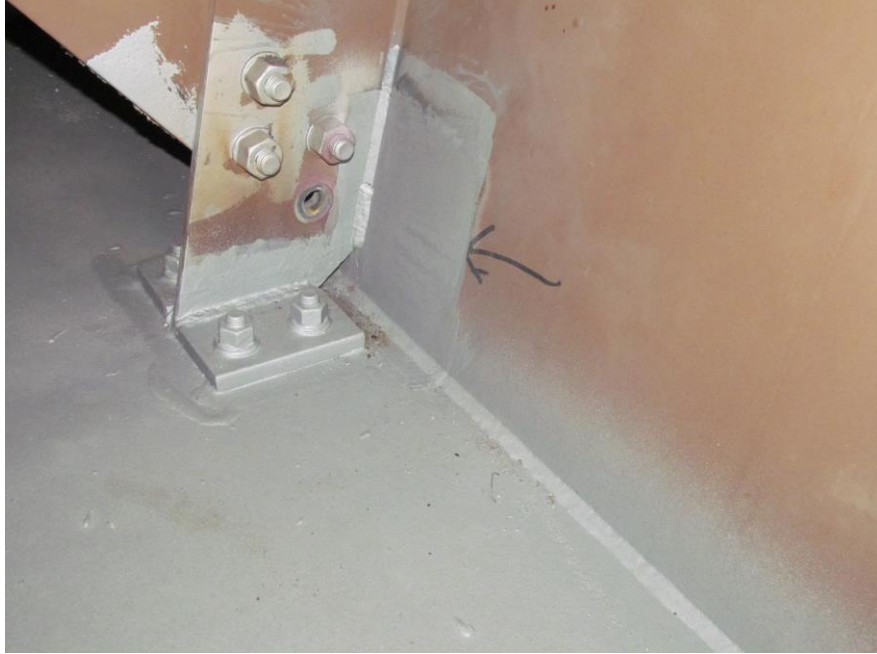
TUB "B" SP. #4 W/ 1 MISSING BOLT DIAPH. #6

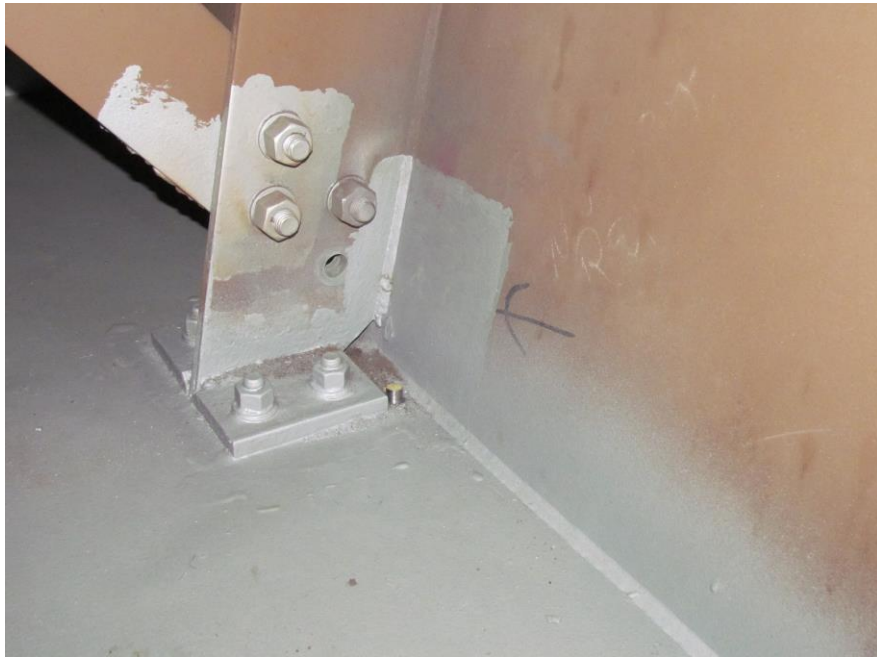
TUB "B" SP. #4 W/ 1 MISSING BOLT DIAPH. #8

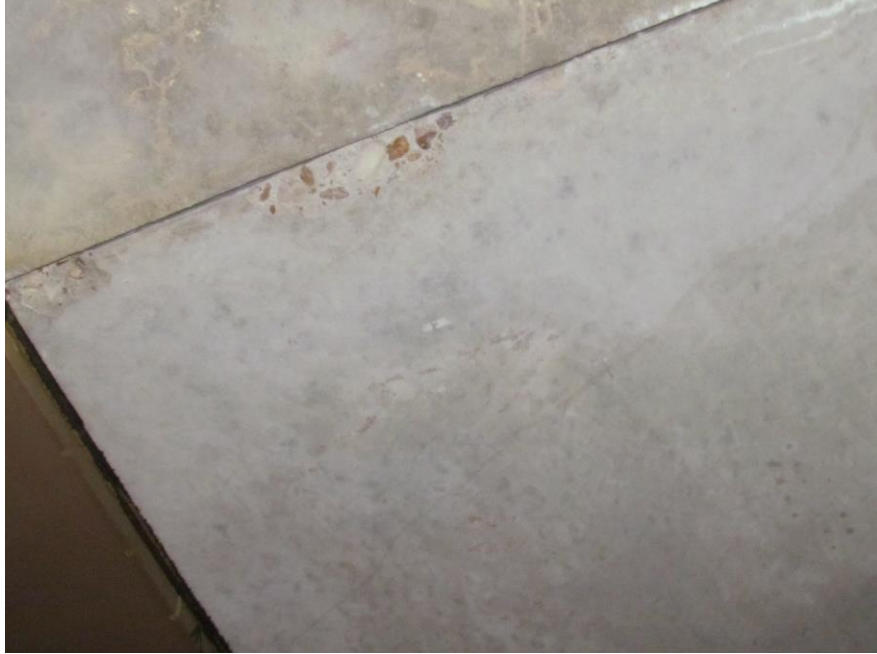
TUB "B" DECK PANEL SP. #4 W/ SPALL

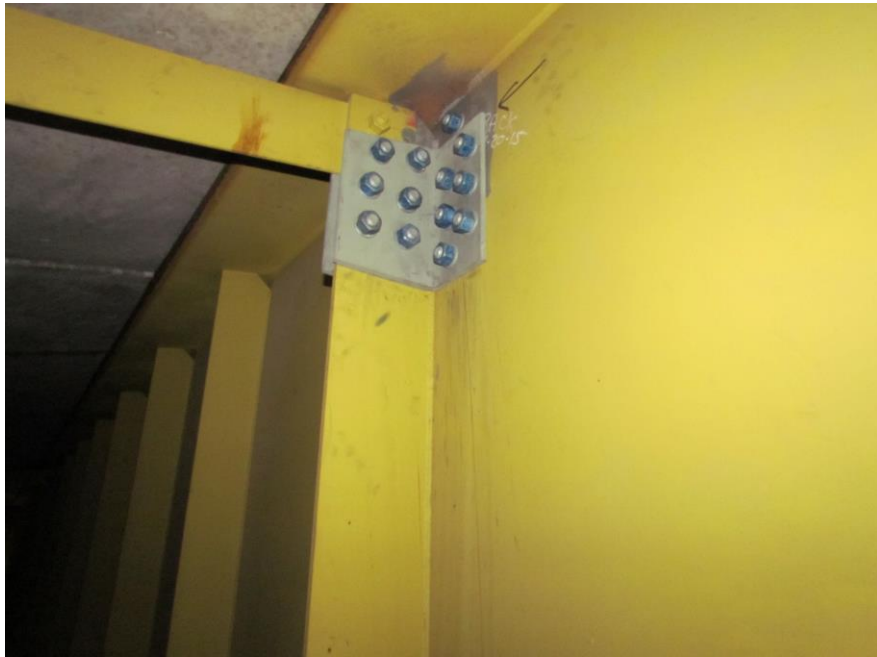
TUB "B" SP. #6 W/ 1 MISSING BOLT DIAPH.#11

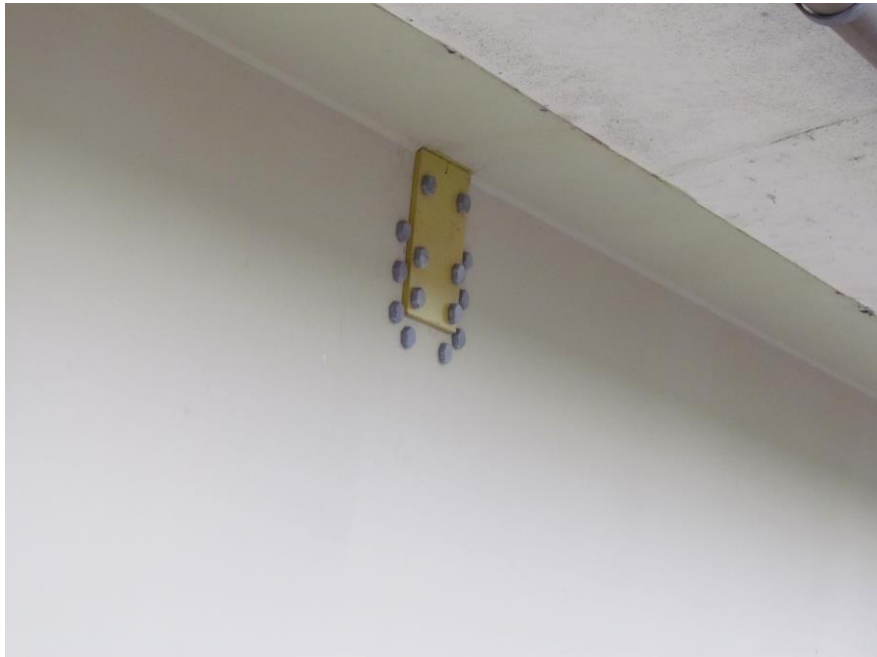
TUB "B" CLOSE-UP VIEW REPAIR PLATE OUTSIDE

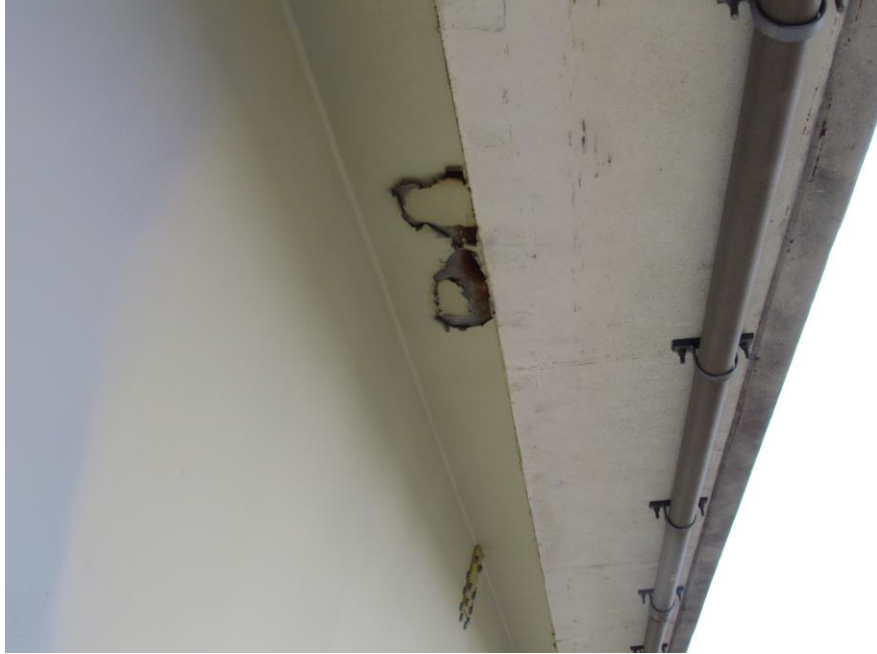
GIRDER W/ PAINT PEELING AT SPAN #6

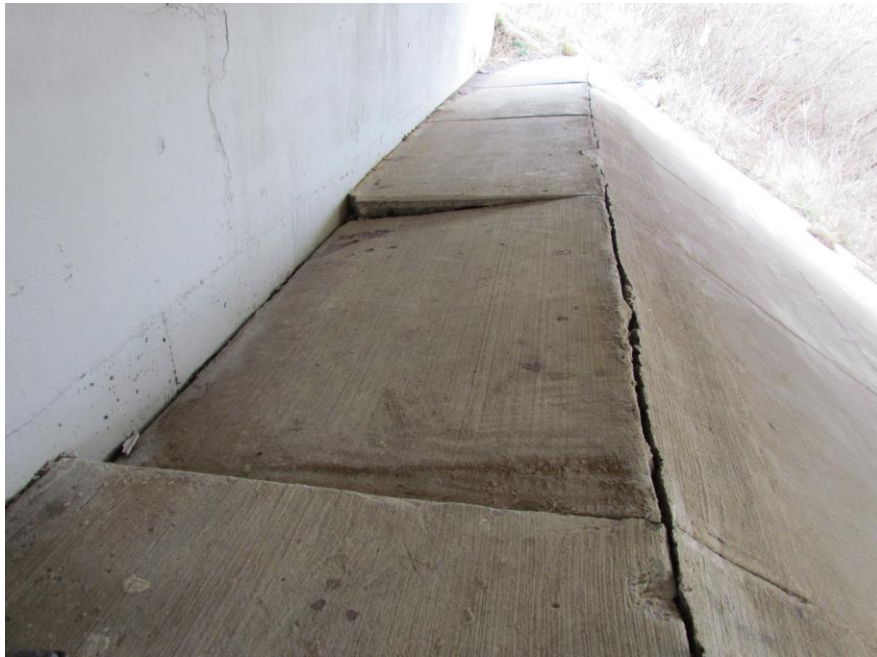
SLOPE PAVEMENT ABUTMENT #2 W/ SAG

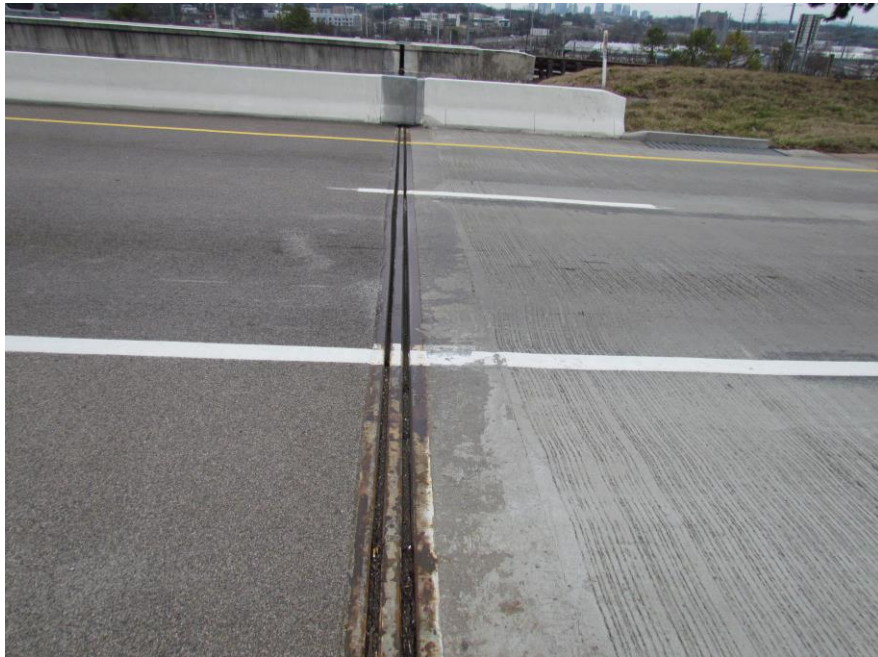
EXPANSION JOINT "B" W/ DEBRIS BLD-UP

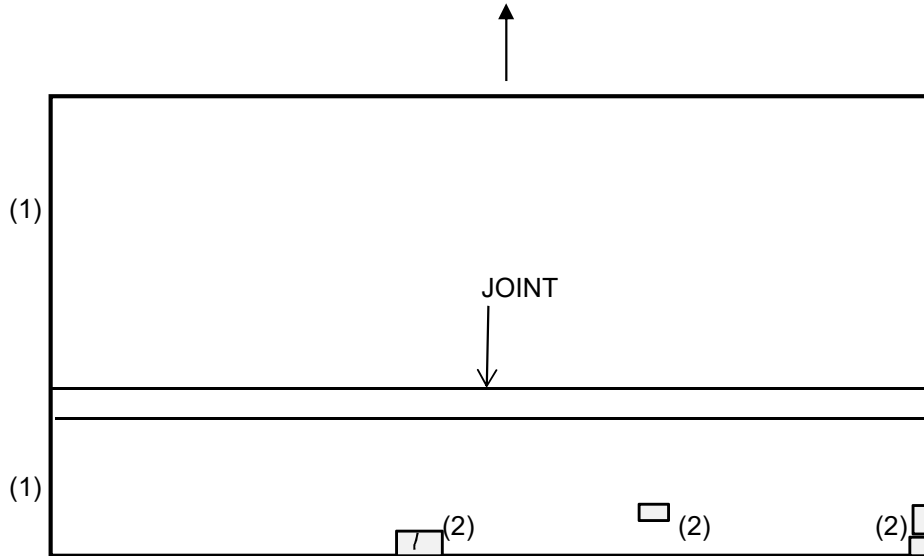
Approach 'A'

SLAB	GOOD	
JOINTS	GOOD	
PAVEMENT	FAIR	CONCRETE- (2) A/C PATCHES UP TO 3'L X 1.5'W W/BROKEN CONCRETE AROUND PATCHES
EMBANK	GOOD	
DRAINS	GOOD	
G-RAIL	GOOD	(1) LIGHT COLLISION DAMAGE

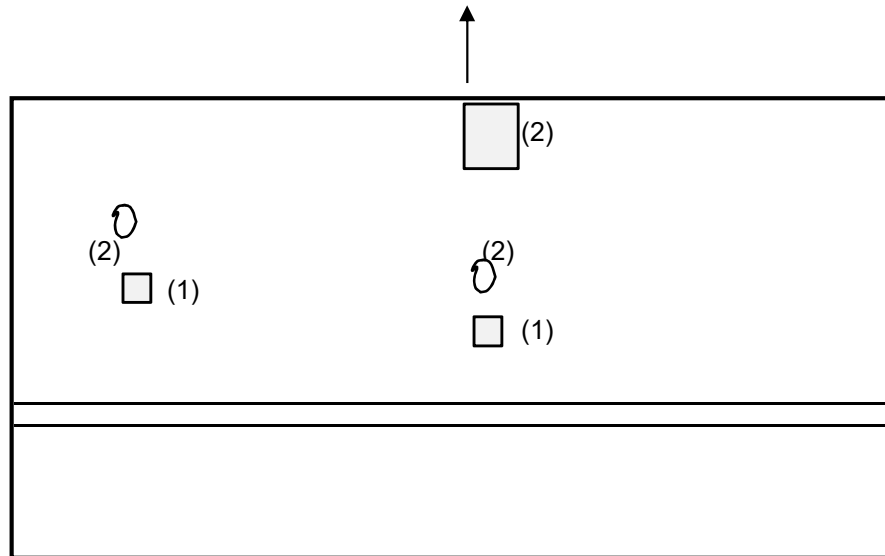
Approach 'B'

SLAB	GOOD	
JOINTS	FAIR	MISSING FILLER 10%
PAVEMENT	POOR	CONCRETE, (1) A/C PATCHES UP TO 6'L X 4'W, (2) POTHOLES UP TO 2'L X 1'W X 5"DP
EMBANK	GOOD	
DRAINS	GOOD	
G-RAIL	FAIR	MOD. RUST/CORROSION

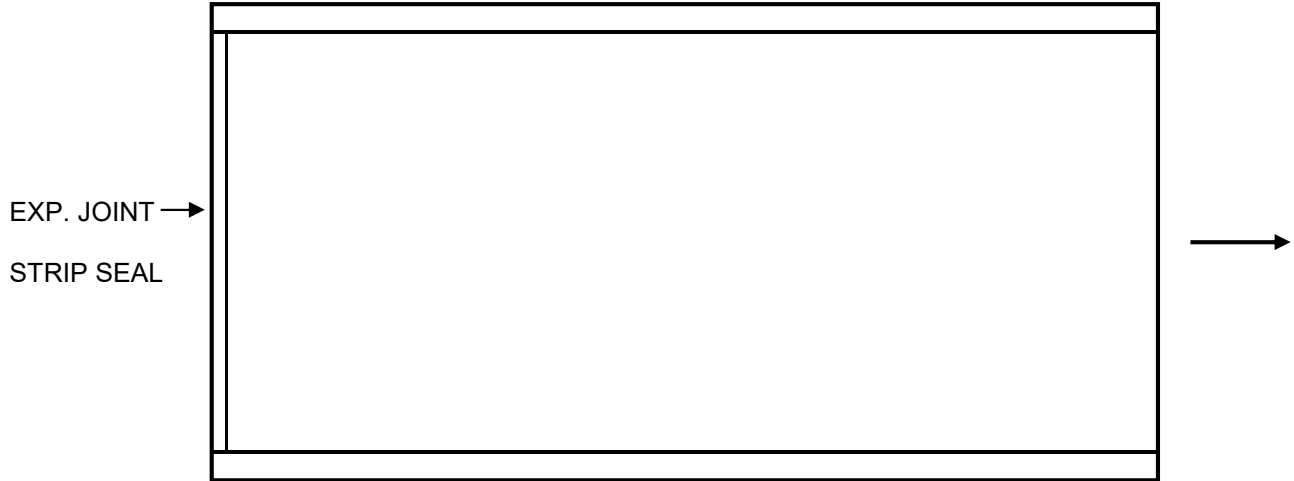
Top of Deck Span No. 1

DECK	GOOD	NEW THIN EPOXY OVERLAY (TYP)
PARAPET	GOOD	RANDOM VERT. H.C.'S W/EFF., NEW TEXTURE COAT 2017
JOINT	FAIR	LGH. DEBRIS BLD-UP

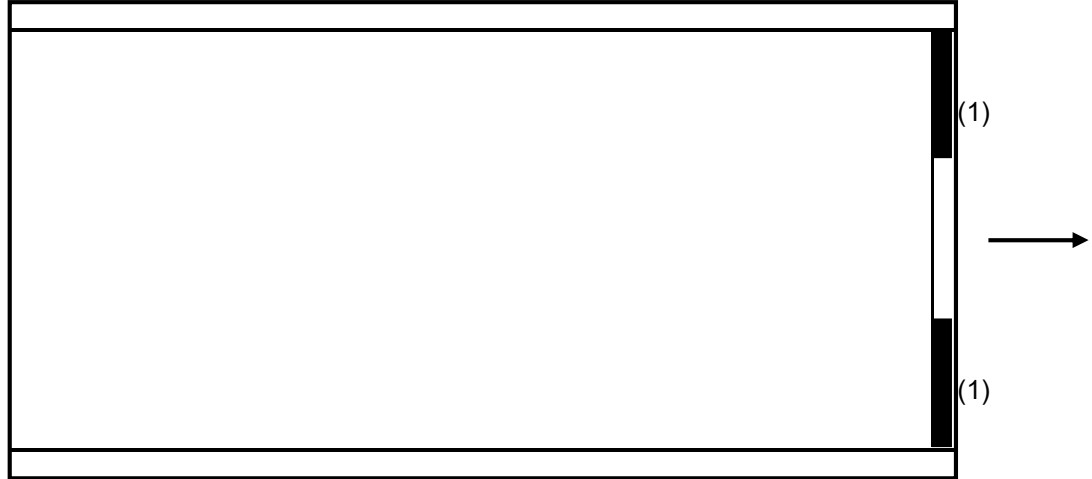
Top of Deck Span No. 6

DECK	GOOD	NEW EPOXY OVERLAY
PARAPET	GOOD	VERT. H.C.'S
JOINT	FAIR	(1) DEBRIS BLD-UP 45%

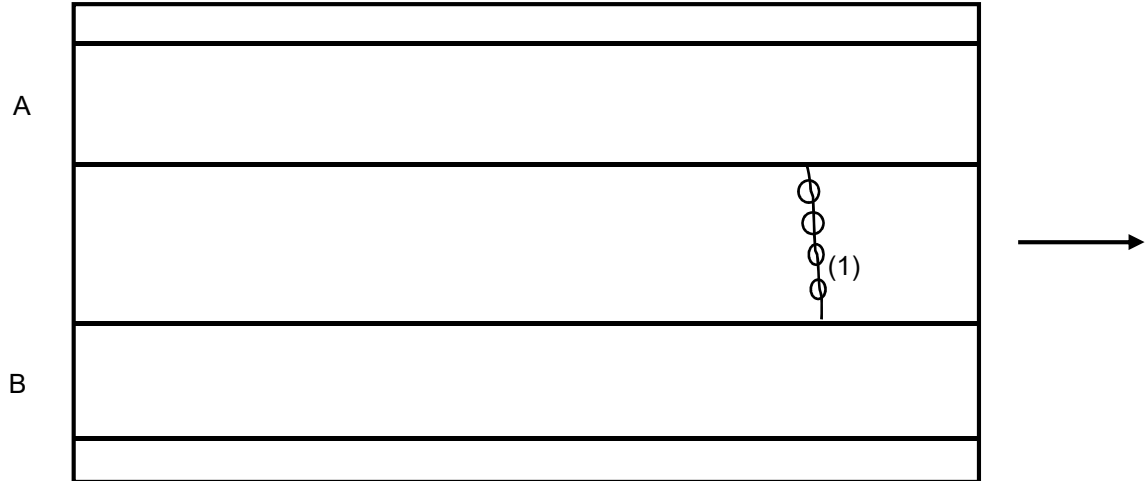
Bottom of Slab Span No. 1

DECK	FAIR	HONEYCOMB AREAS TYP. ALL SPANS, (1) SPALLS UP TO 1'0 X 1/2" DP &
		H.L. TRANSV CRACKS
DIAPH.	GOOD	REPAIRED 2017
TUBS	GOOD	REPAIRED 2017
PAINT	POOR	HVY PAINT FADING & HVY. CHALKING (ALL SPANS)
OVER-HANGS	GOOD	H.L. CRACKS W/ EFF. TYP. ALL SPANS

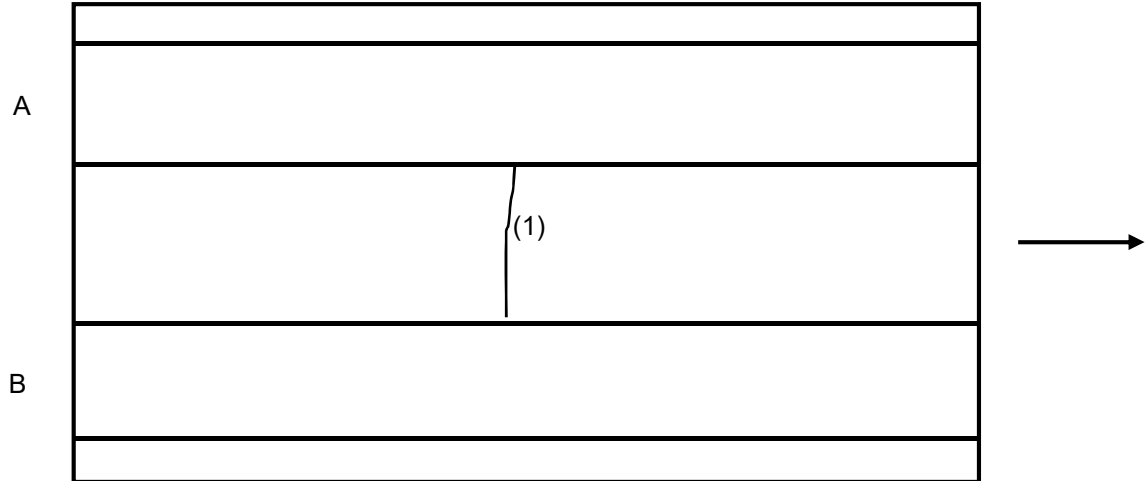
Bottom of Slab Span No. 2

DECK	GOOD	(1) H.L. TRANSV CRACK PANEL 8, TUB 'B' PANEL #18 TRANSV H.C.
DIAPH.	GOOD	REPAIRED 2017, TUB 'B' DIAPH #6-2 MISSING BOLTS & NUTS
TUBS	GOOD	REPAIRED 2017
PAINT	POOR	HVY PAINT FADING & HVY. CHALKING (ALL SPANS)
OVER- HANGS	GOOD

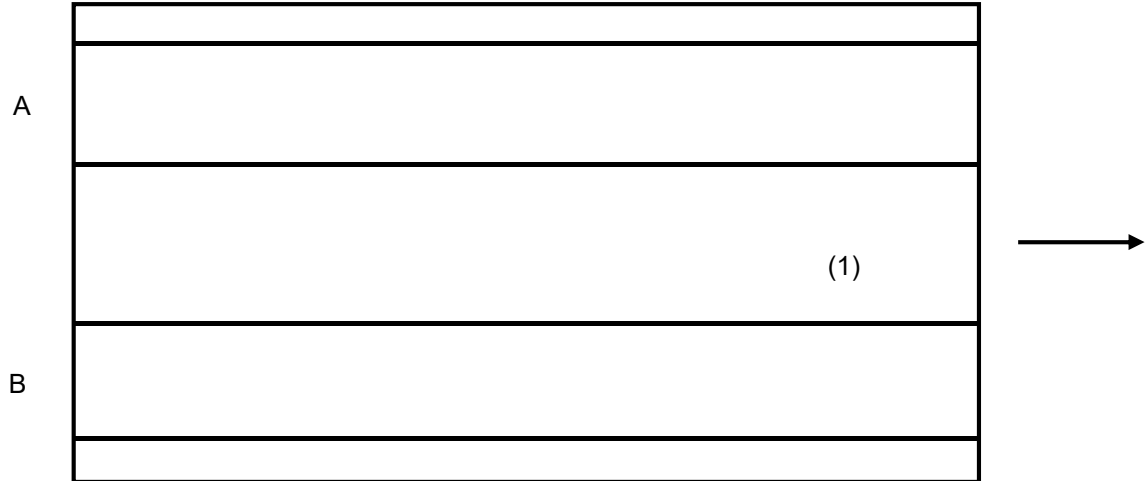
Bottom of Slab Span No. 3

DECK	GOOD	HONEYCOMB AREAS, RANDOM TRANSV. H.L. CRACKS IN DECK PANEL, (1) PANELS SHOW STAINS NEAR BENT #3, TUB 'B' DECK PANEL BTWN 7 & 8
		SPALL, TUB 'B' DECK PANEL BTWN DIAPH 11 & 12-SPALL, TUB 'B' DIAPH 14-SPALL W/EXP. STL.
DIAPH.	FAIR	REPAIRS 2017, TUB 'B' DIAPH #1 & #2-MISSIG BOLTS AND NUTS, TUB 'B' DIAPH. #10-MISSIG BOLT
TUBS	FAIR	PAINT PEELING, HVY PAINT FADING BM'S HAVE FATIGUE CRACKS AT DIAPH. CONN. SEE LIST FOR DETAILS, BM 'B' SURFACE CORROSION INSIDE ALONG BOTTOM BM 'B' CRACK @ DIAPH 26 0.010" X 2 3/8" L AT CONNECTION TO TOP FLNG.
"B"		MOD CORR ON STIFFNER @ FLOOR BTWN DIAPH 29 & 30
OVER- HANGS	GOOD

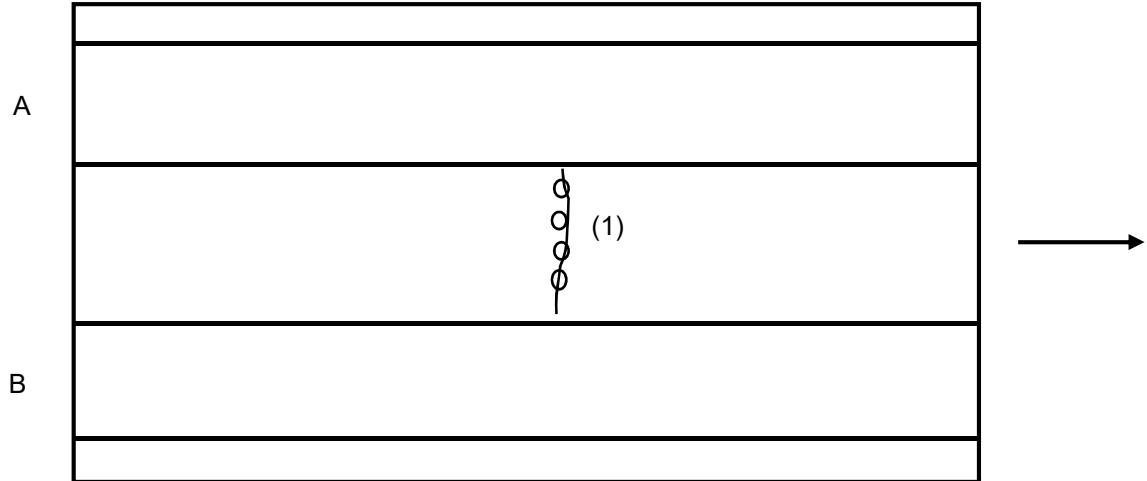
Bottom of Slab Span No. 4

DECK	FAIR	(1) PANEL #8 HAS H.L. & TRANSV CRACK & LGT SPALLS 6" X 1/2" DP, TUB 'B' DECK PANEL BTWN DIAPH #8 & #9-SPALLS
DIAPH.	FAIR	REPAIRS 2017, TUB 'B' DIAPH'S #6,#7, #8, #9 - MISSING NUT & BOLTS
TUBS	FAIR	REPAIRED 2017
OVER- HANGS	GOOD

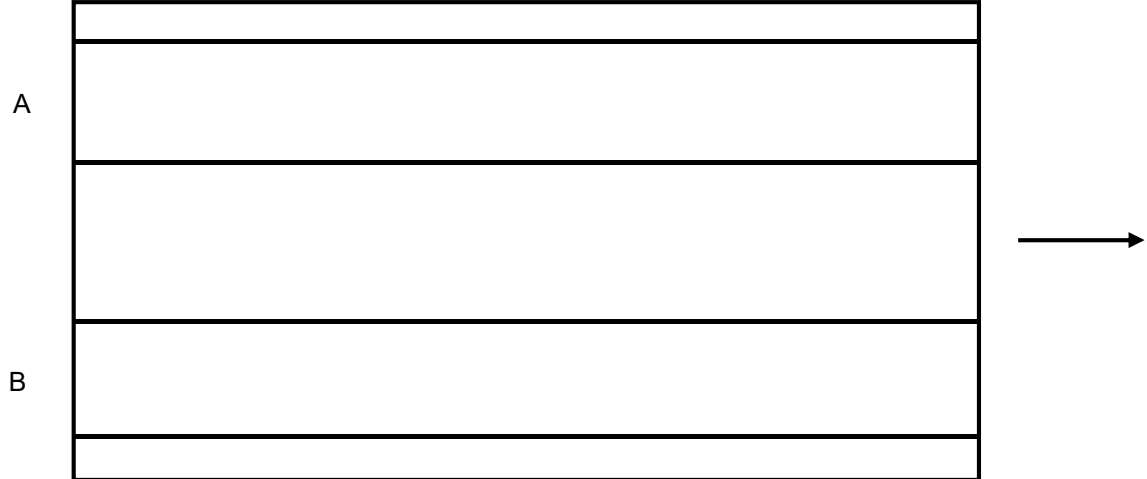
Bottom of Slab Span No. 5

DECK	GOOD	H.L. TRANS CRACK @ PANEL 5
DIAPH.	FAIR	REPAIRS 2017
TUBS	FAIR	REPAIRS 2017
OVER-	GOOD	
HANGS

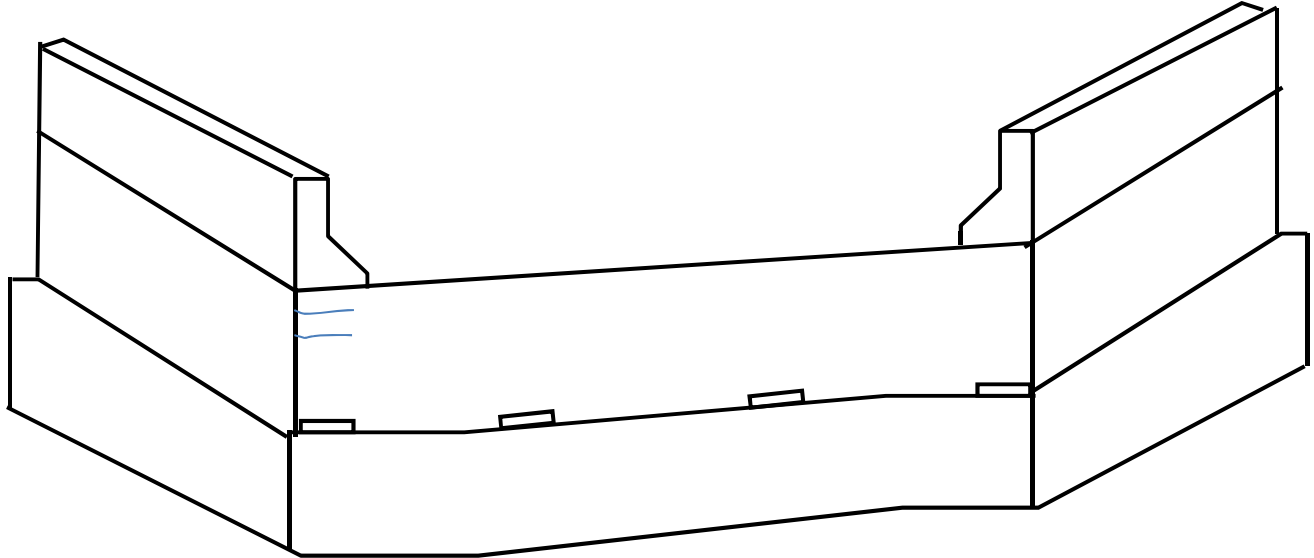
Abutment No. 1

BACKWALL	FAIR	PATTERN & MAP CRACKS
CAP	FAIR	H.L. MAP & VERT. CRACKS
WINGS	GOOD	H.L. MAP CRACKS
RISERS	GOOD	
BEARINGS	FAIR	MOD RUST & CORR. LGT PACK RUST
A' - 'B'		SHIFTED BACKSTATION 2"
"C" & "D"		SHIFTED BACKSTATION 3"

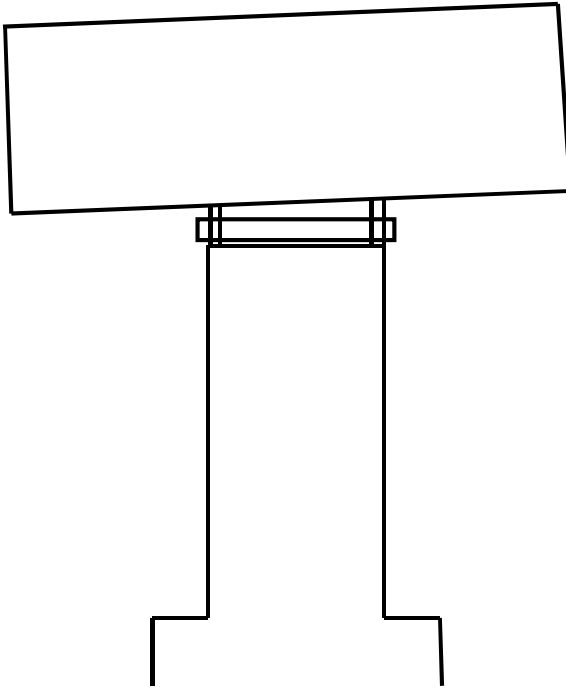
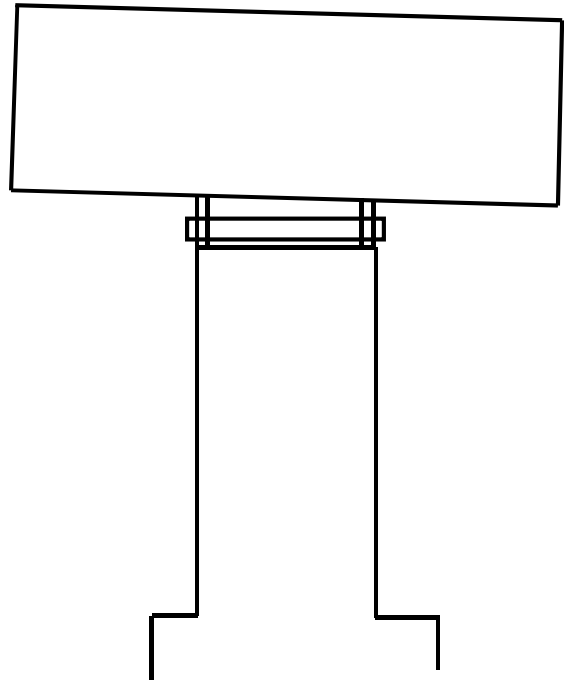
PIER # 1

CAP	GOOD	
COLUMN	GOOD	LGH. CORR.
PIN	GOOD	LGH. CORR
FOOTING	GOOD	RANDOM VERT. CRACKS 1/16" OPEN, SPALL 8" DIA.

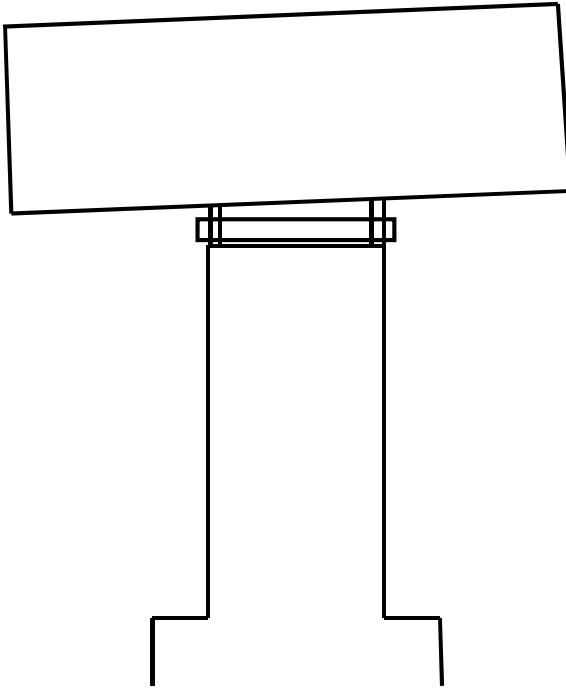
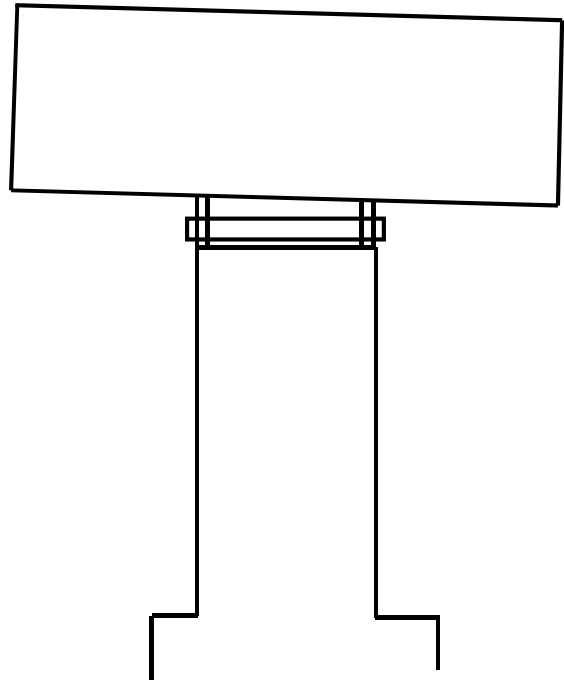
PIER # 2

CAP	GOOD	
COLUMN	GOOD	LGH. CORR.
PIN	GOOD	LGH. CORR.
FOOTING	NV

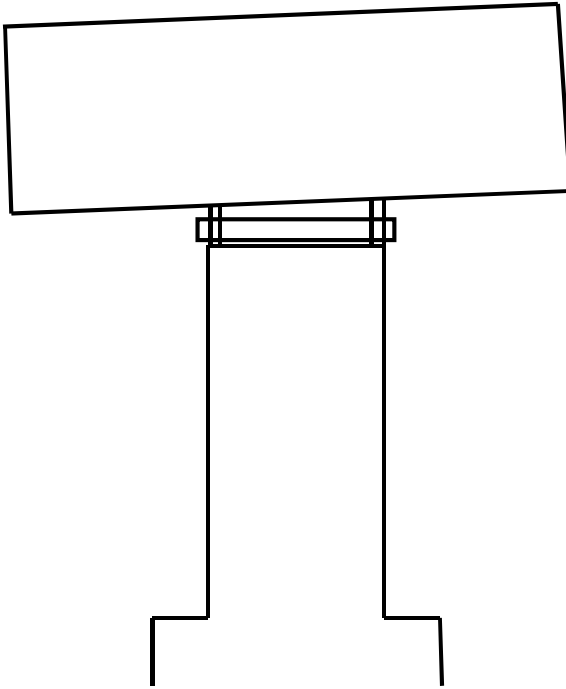
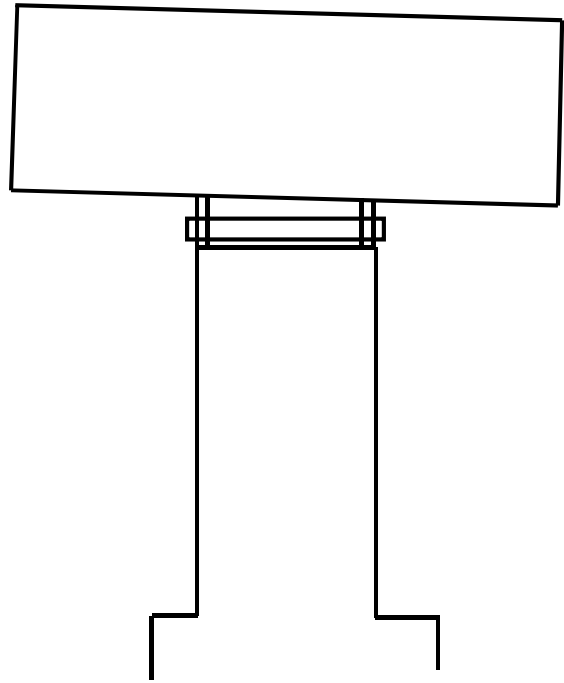
PIER # 3

CAP	GOOD	
COLUMN	GOOD	
PIN	GOOD	
FOOTING	GOOD	RANDOM VERT. HAIR CRACKS
