19100650113
19-I0440-4.85 RT
L4-SN 167 RL/L3-SN 164 & 165

BRIDGE MAINTENANCE RECOMMENDATIONS

Tennessee Department
of Transportation

BRIDGE INSPECTION REPORT

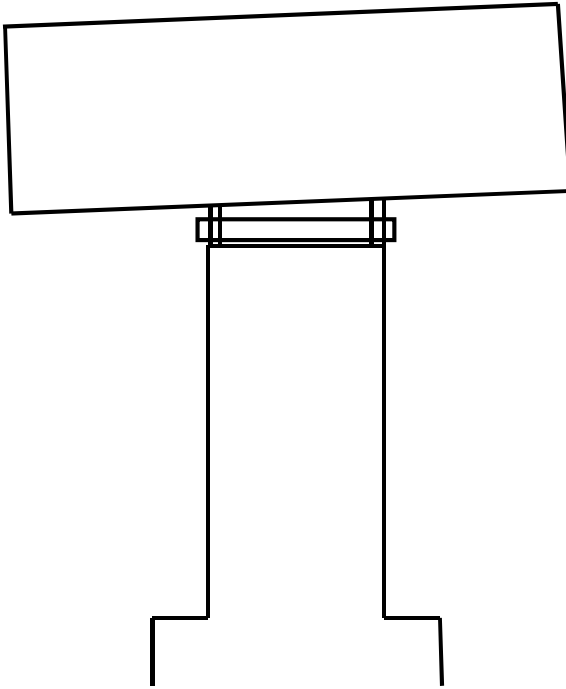
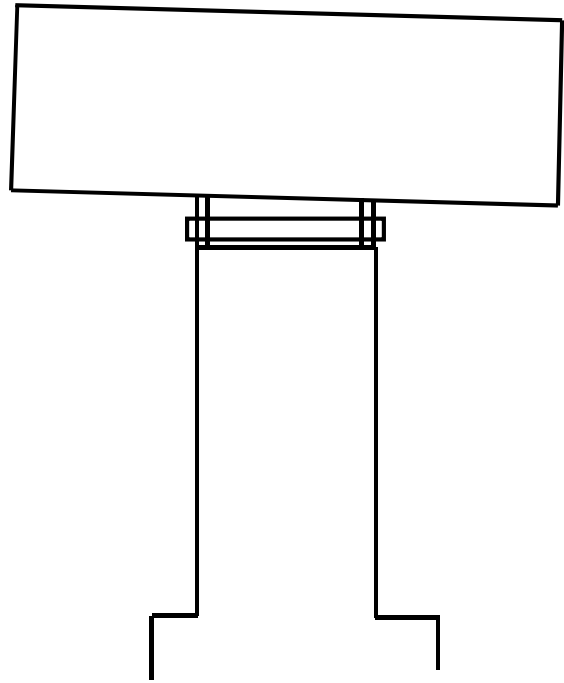
PIER # 4

CAP	GOOD	
COLUMN	GOOD	
PIN	GOOD	
FOOTING	GOOD	RANDOM VERT. HAIR CRACKS

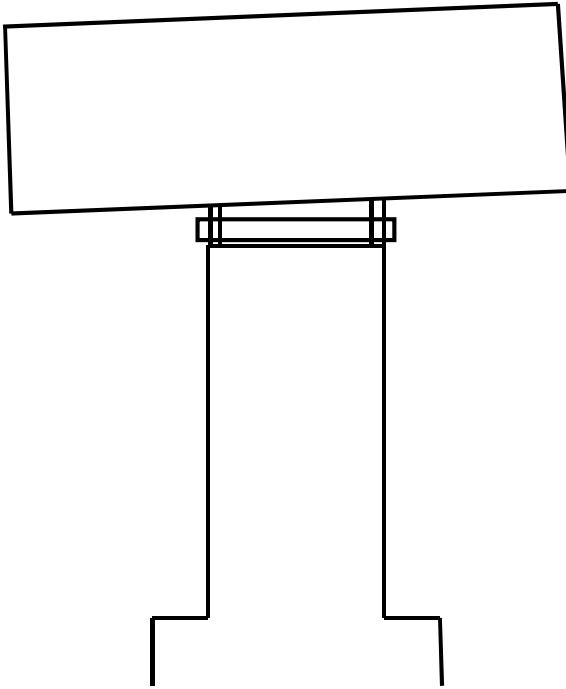
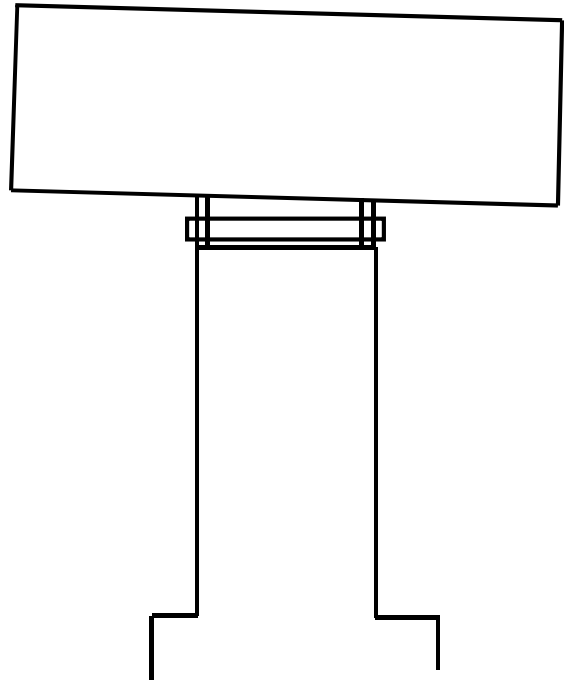
PIER # 5

CAP	GOOD	
COLUMN	GOOD	
PIN	GOOD	
FOOTING	GOOD	RANDOM VERT. HAIR CRACKS

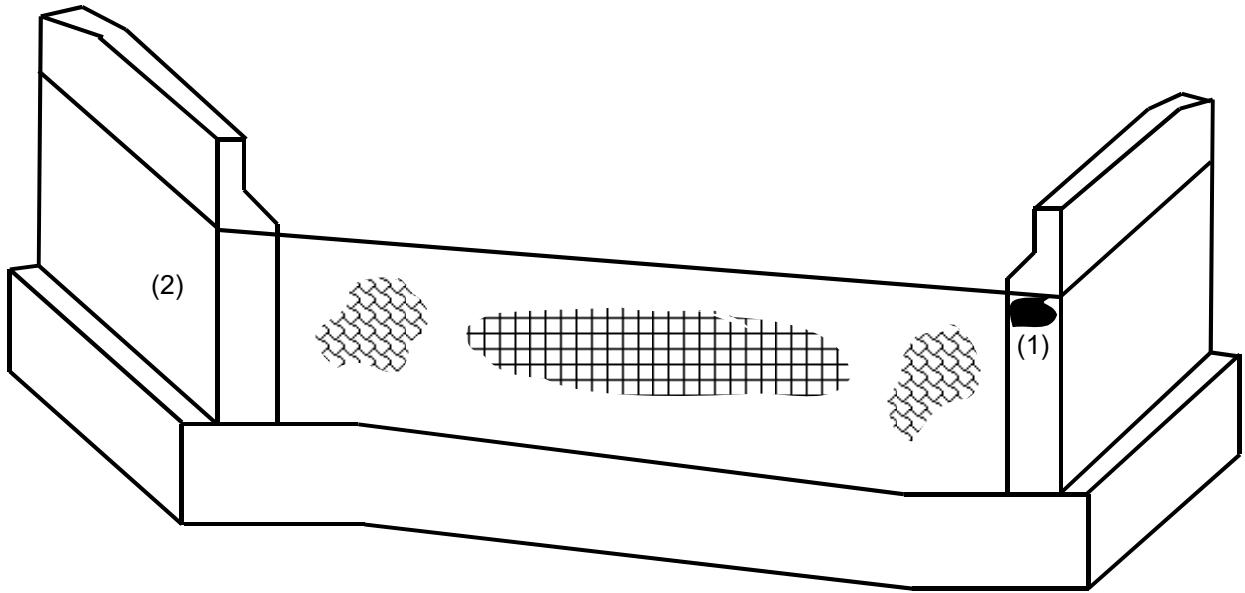
Abutment No. 2

BACKWALL	FAIR	NUMEROUS PATTERN & MAP CRACKS UPTO .010" OPEN
CAP	GOOD	VERT. CRACK UP TO 1/16" OPEN
WINGS	GOOD	(1) SPALL 1.5' DIA. X 1"DP
		(2) MAP CRACKING
RISERS	GOOD	
BEARINGS	FAIR	LIGHT RUST & CORR., ALL BEARINGS SHIFTED BACKSTATION 1"
SLP. PAVMNT	GOOD	UP TO 8" SETTLEMENT @ CAP FULL LENGTH
