BRIDGE MAINTENANCE RECOMMENDATIONS

Tennessee Department of Transportation

COUNTY: DAVIDSON
 LOCATION: 19-I0440-04.85-L
 CO. SEQ.: 1 SPEC. CASE: 0
 MILEPOST: 4.79

BRIDGE INSPECTION REPORT

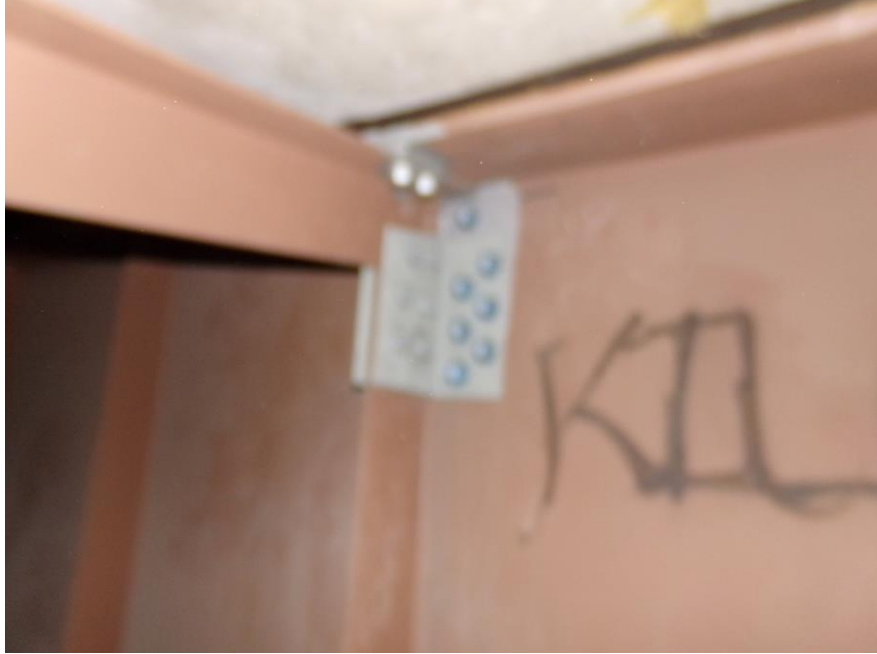
TUB "A" REPAIRS TYP.

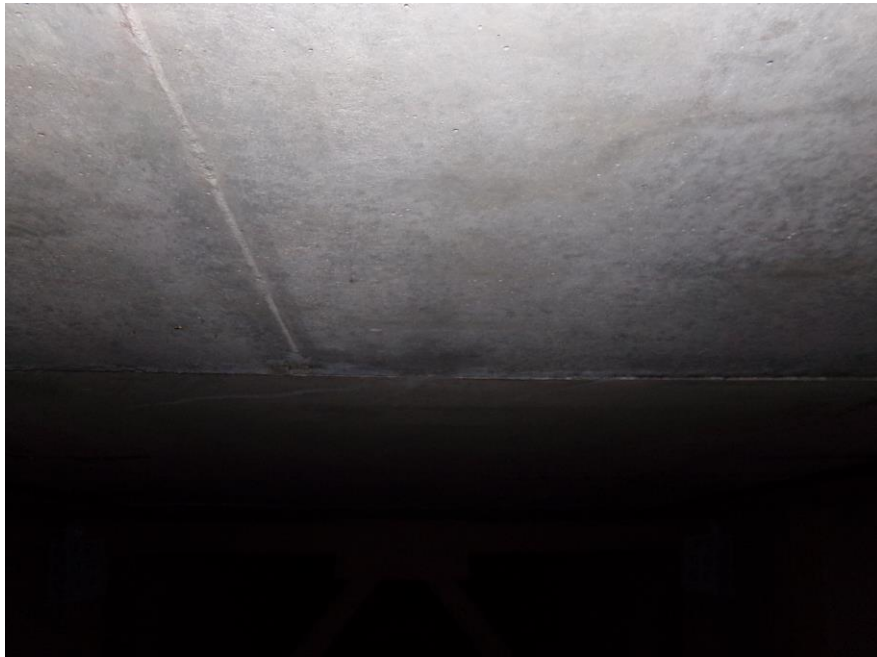
TUB "A" DECK PANEL TYP.

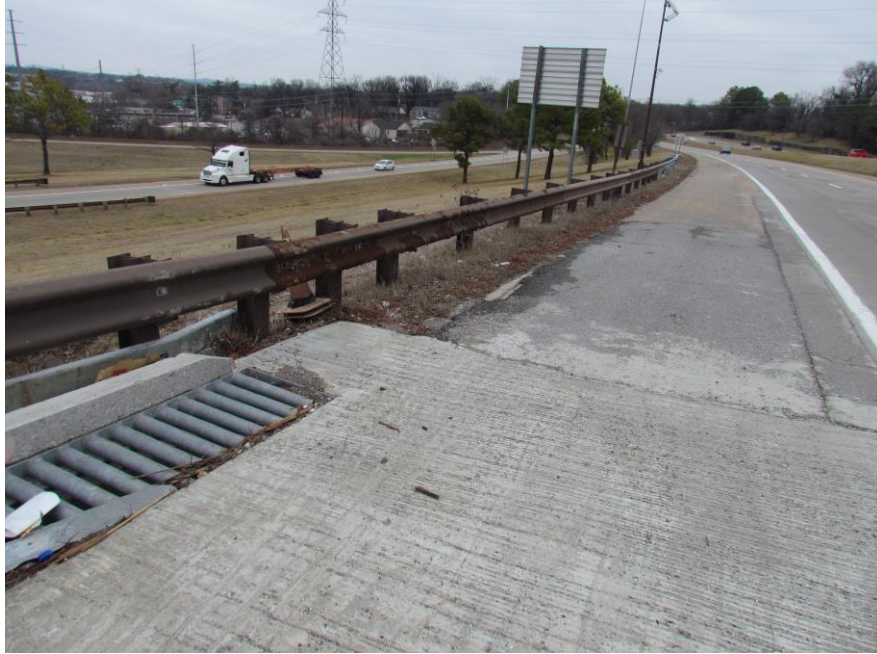
GUARDRAIL "B" LT. SIDE W/ CORROSION

| | Rating | Standard/ SubStandard | Comments |
|---|---|---|---|
| Guardrail | FAIR | SUBSTANDARD | INCORRECT BLOCKOUTS, LGH-MOD RUST |

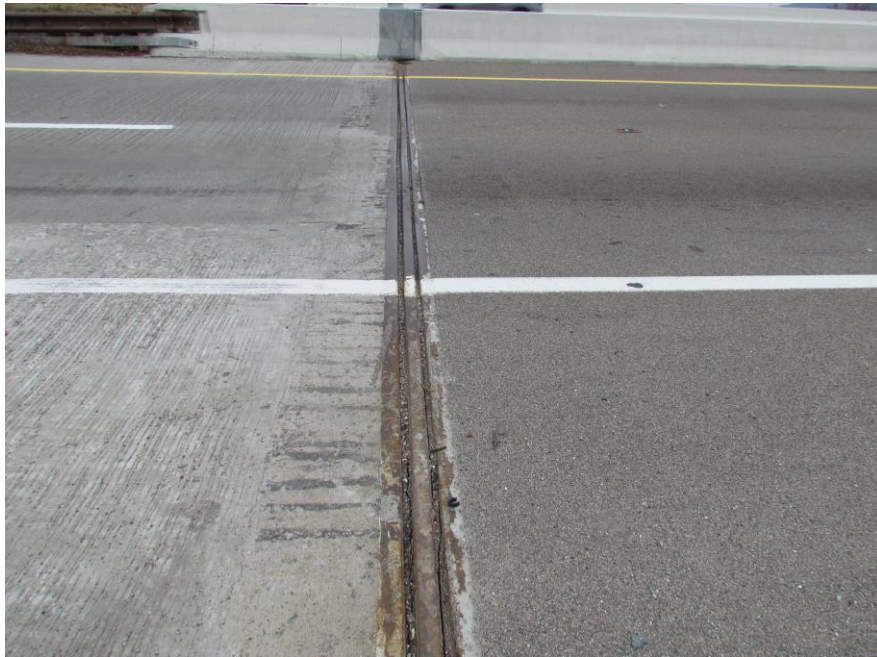
APPR. "B" JOINT W/ DEBRIS BLD-UP

| | Rating | Comments |
|---|---|--|
| Expansion Joints | FAIR | LGH. DEBRIS BLD-UP |

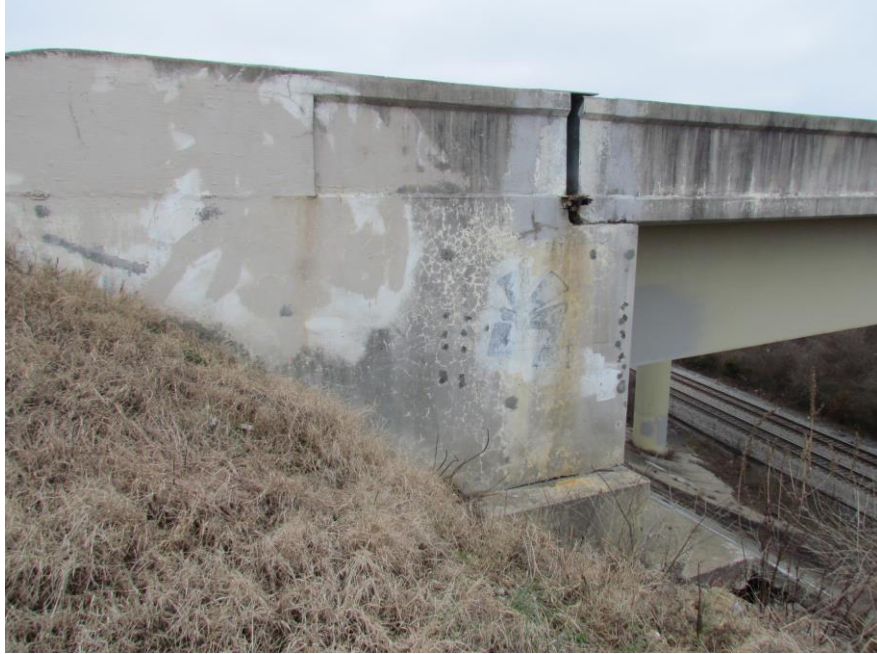
ABUTMENT #2 LT. WING W/ MAP CRACKING

| | Rating | Comments |
|---|---|---|
| Wings | FAIR | MAP CRACKING |

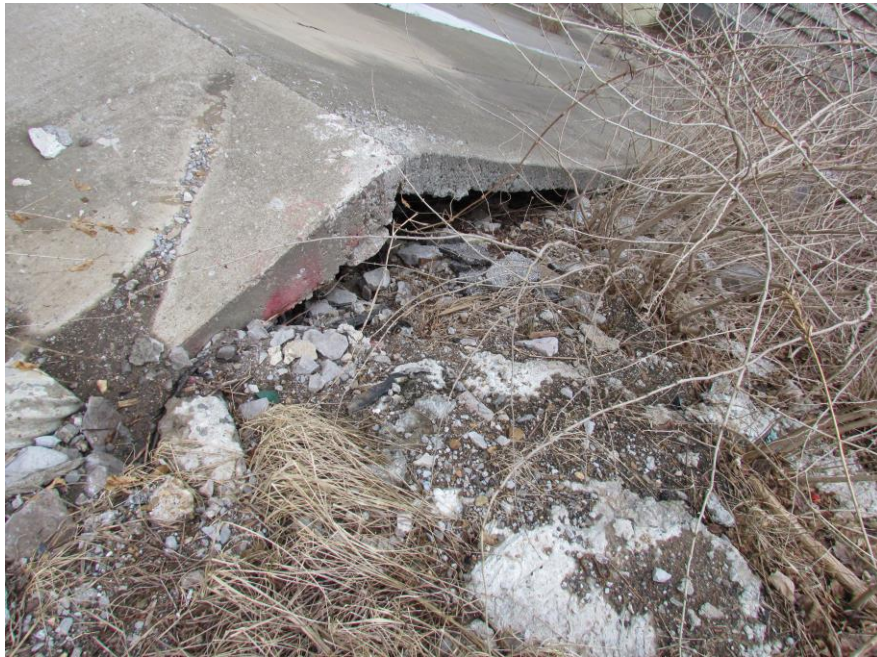
EMBANKMENT ABUTMENT #2 W/ EROSION

| | Rating | Comments |
|---|---|---|
| Embankment | FAIR | ABUT #2-EROSION LT SIDE |

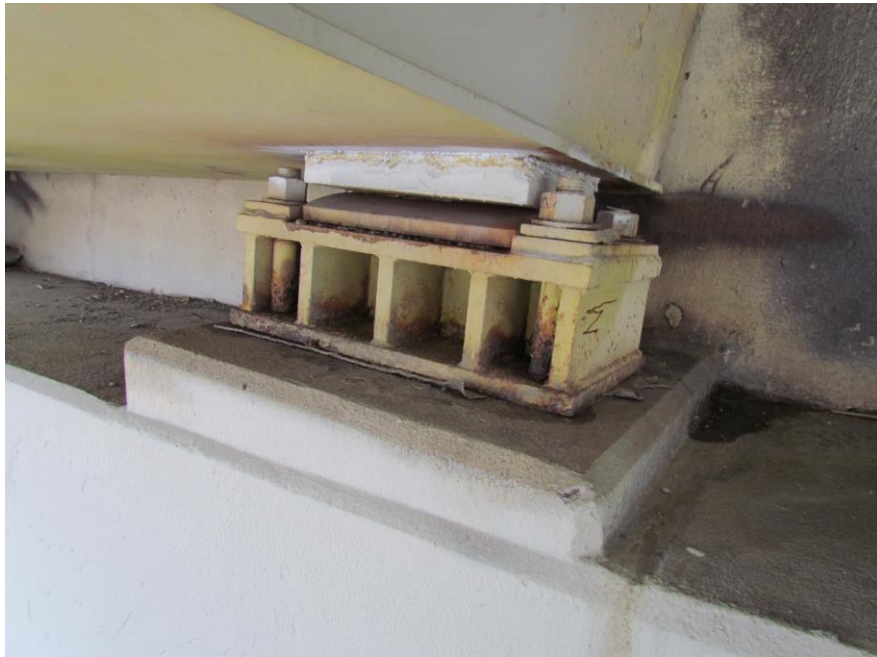
BEARING DEVICE "B" ABUTMENT #2 W/ CORROSION

| Bearing Devices | FAIR | ABUT #1 SLID BACKSTATION 2.0". ABUT #2 "A" & "B" SLID BACKSTATION 1" , MOD CORR & PACK RUST ABUT #1 |

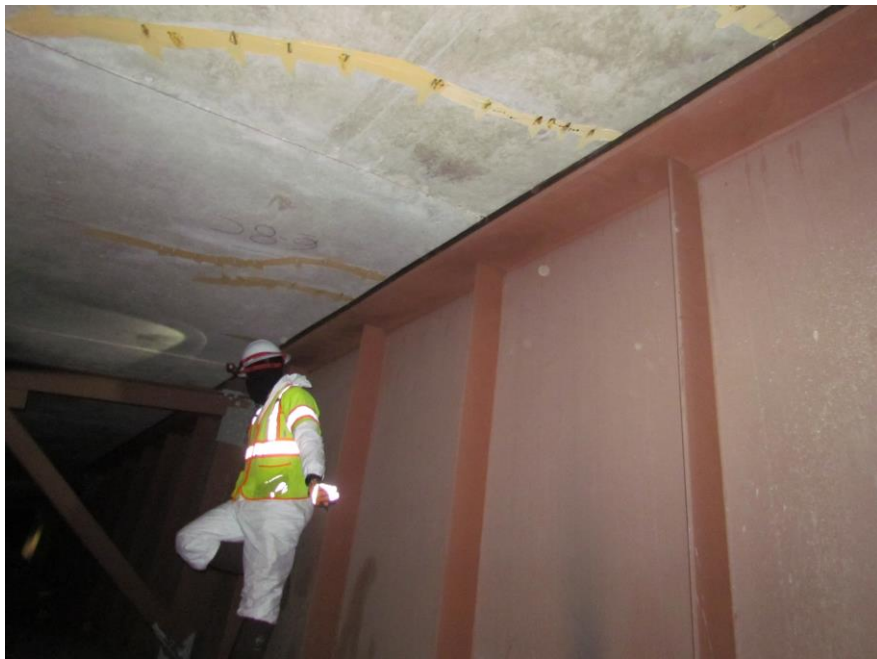
TUB "B" DECK PANEL SP. #6 W/ REPAIRS

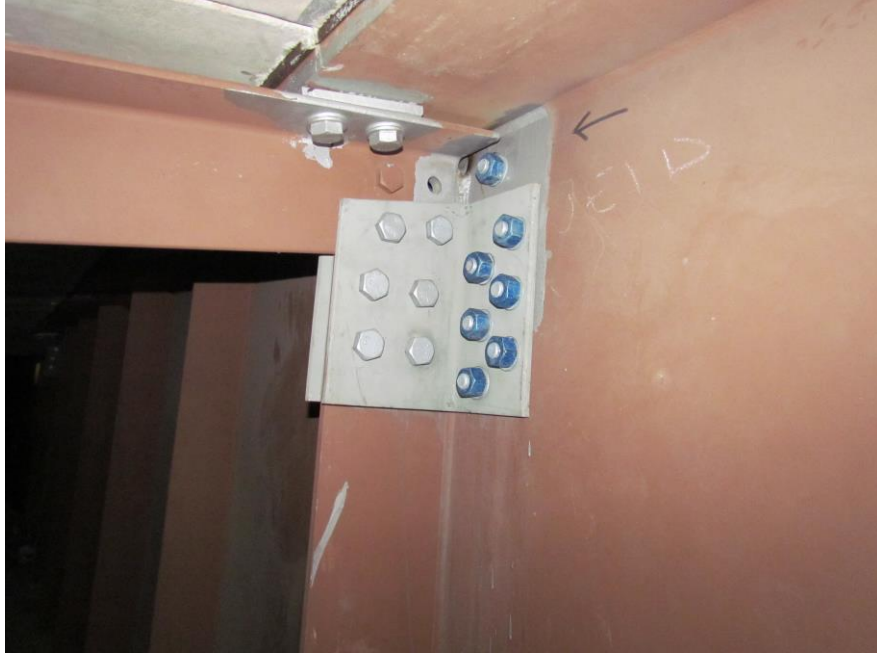
TUB "B" SP. #5 DIAPHRAGM W/ 1 MISSING BOLT

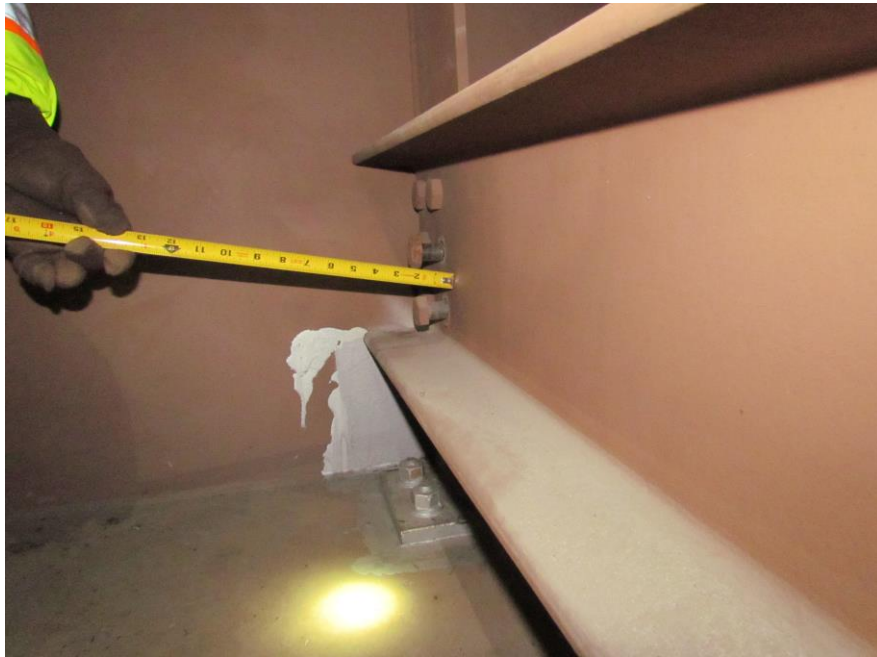
TUB "B" SP. #5 STIFFNER W/ 2 LOOSE BOLTS

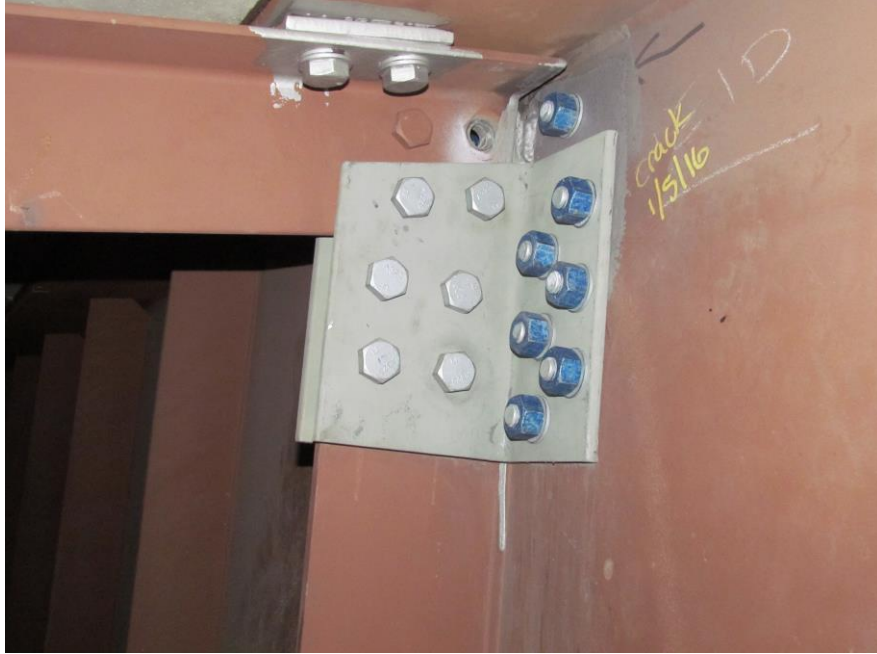
TUB "B" SP. #5 DIAPH. #5 W/ 1 MISSING BOLT

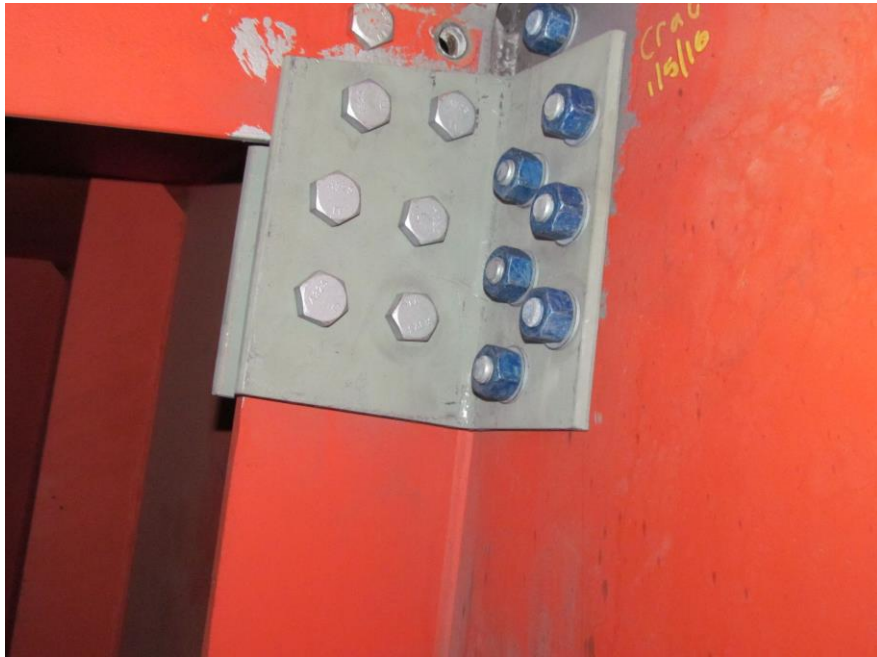
TUB "B" SP. #4 DIAPH. # 6 W/ 1 MISSING BOLT

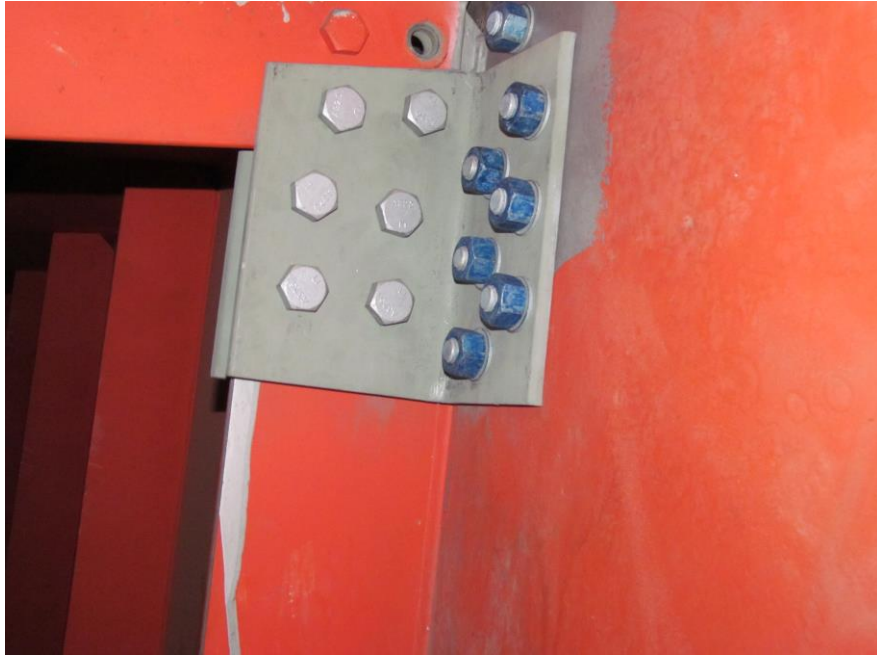
TUB "B" SP. #4 DIAPH. #5 W/ 1 MISSING BOLT

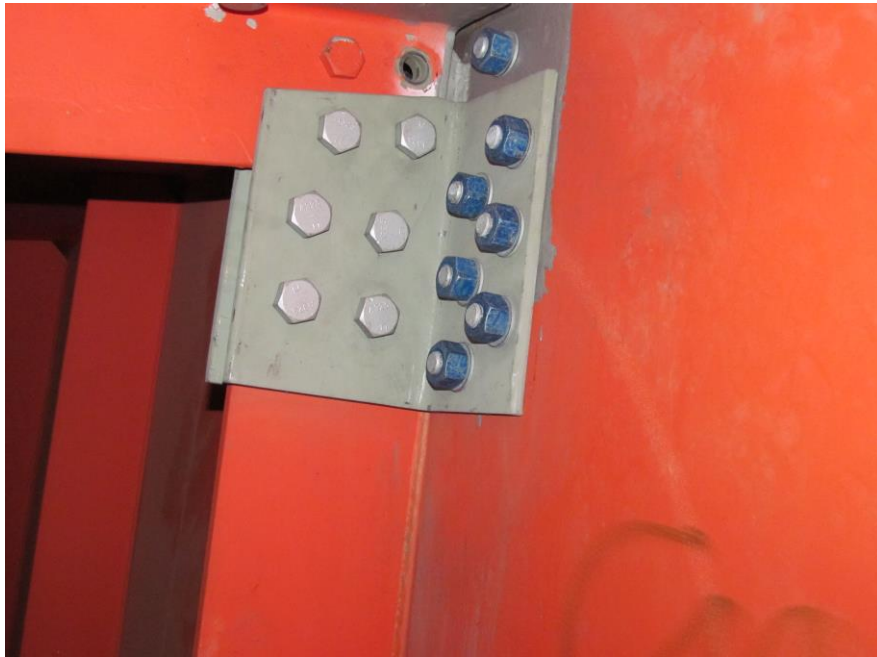
TUB "B" SP. #4 DIAPH. #3 W/ 1 MISSING BOLT

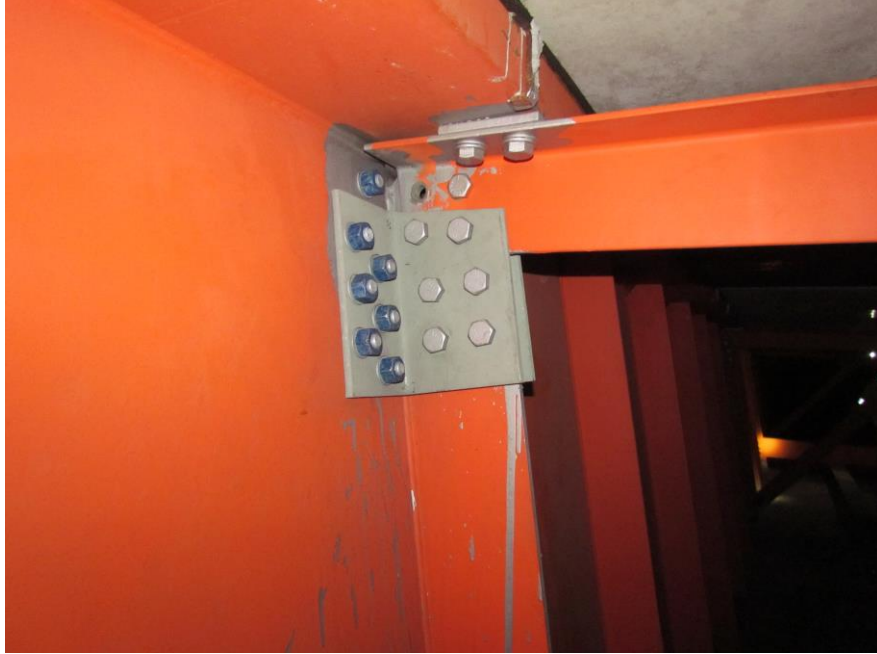
TUB "B" SP. #3 DIAPH. #6 W/ 1 MISSING BOLT

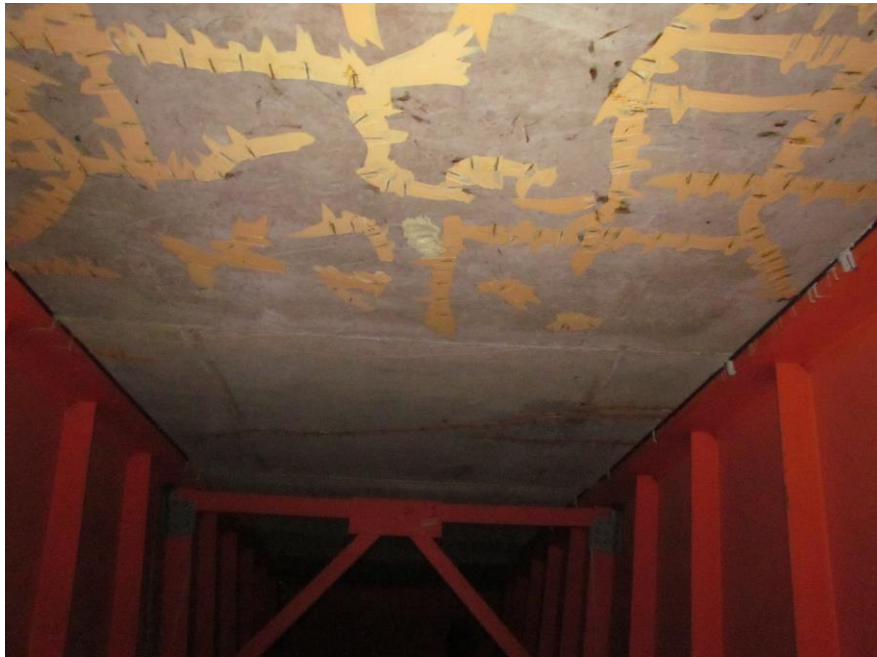
TUB "B" DECK PANELS SP. #3 W/ REPAIRS

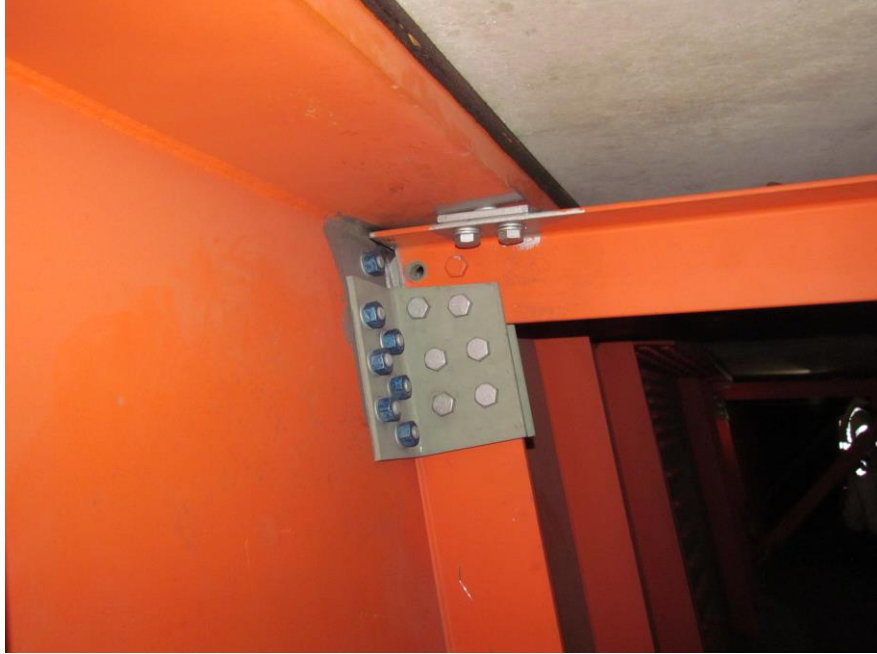
TUB "B" SP. #3 DIAPH. #4 W/ 1 MISSING BOLT

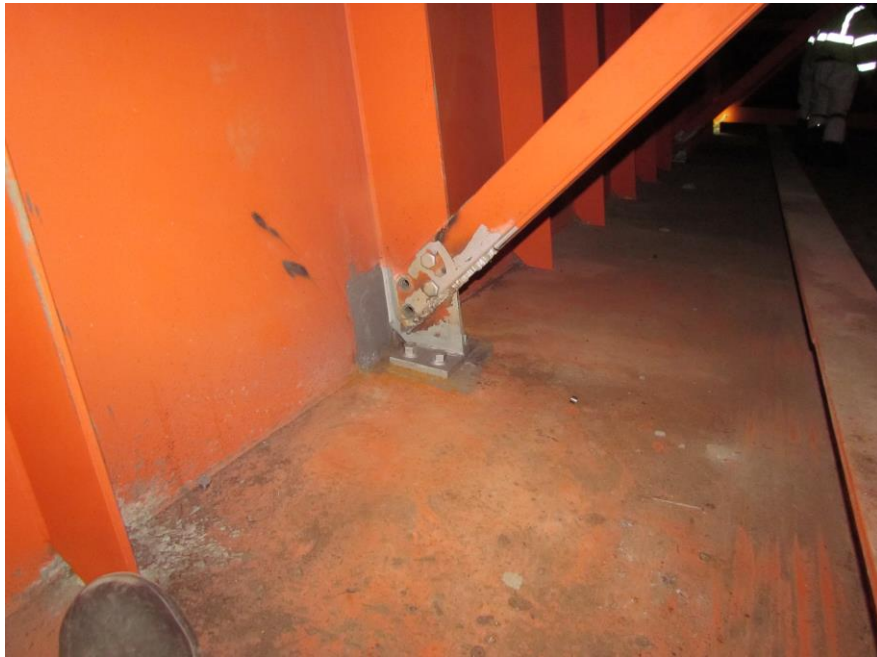
TUB "B" SP. #2 DIAPH. #6 W/ 2 MISSING BOLTS

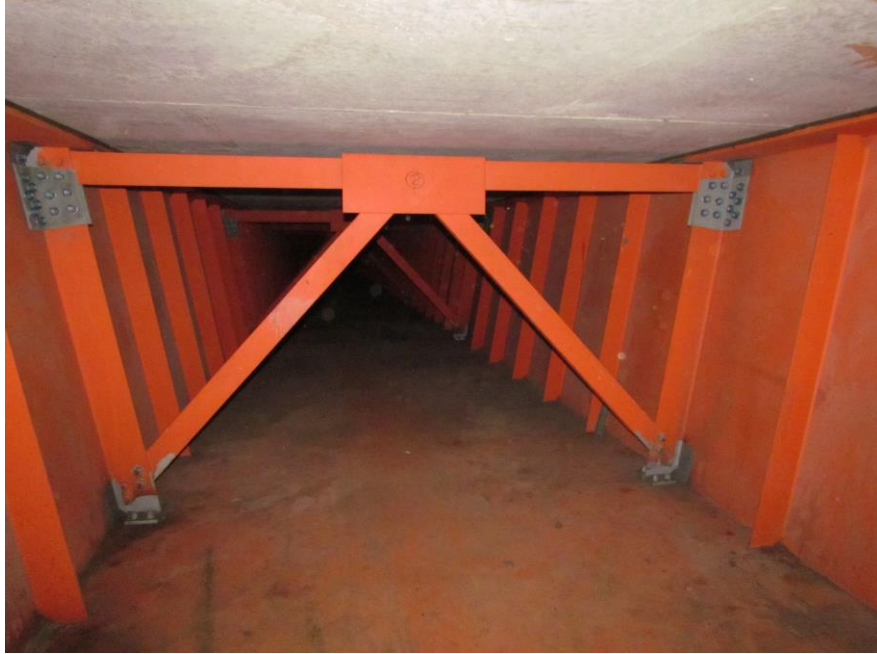
TUB "B" SP. #1 DIAPHRAGM #1 W/ REPAIRS TYP

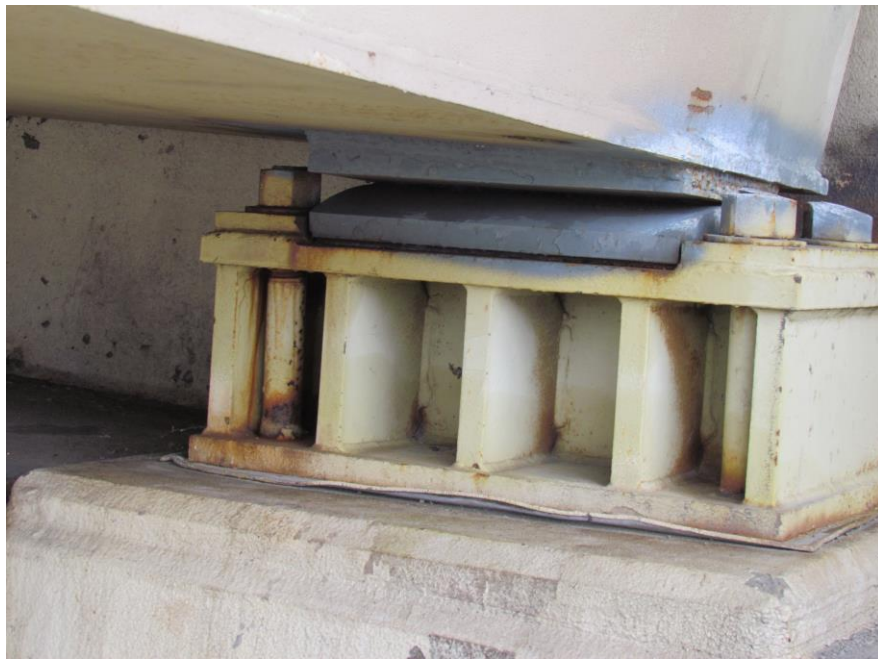
BEARING DEVICE "A" ABUT. #1 W/ REPAIR

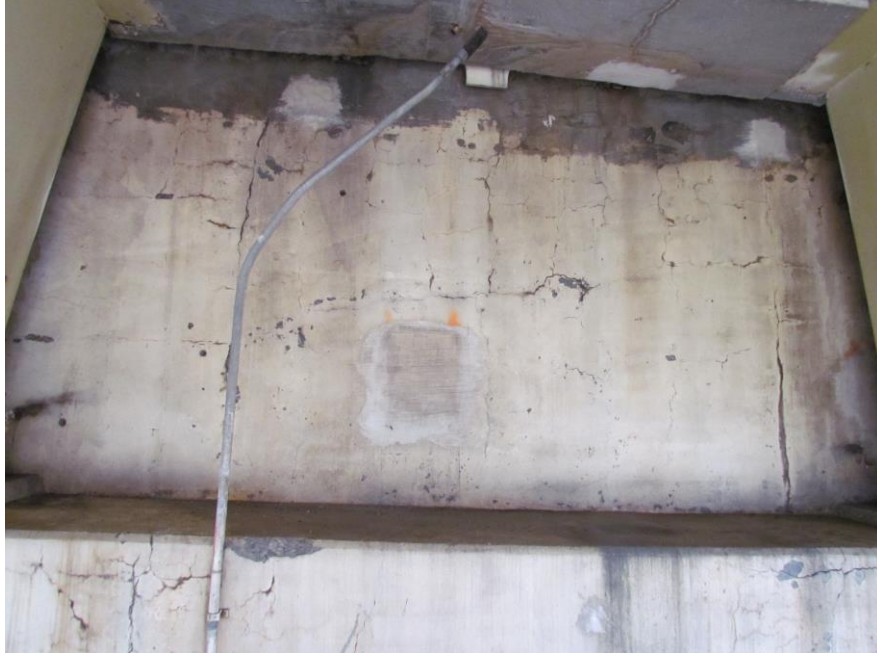
BACKWALL ABUTMENT #1 W/ MAP CRACKING

| | Rating | Comments |
|---|---|---|
| Backwall | FAIR | ABUT. #1-SPALL W/EXP STL -PATCHED 2017 |

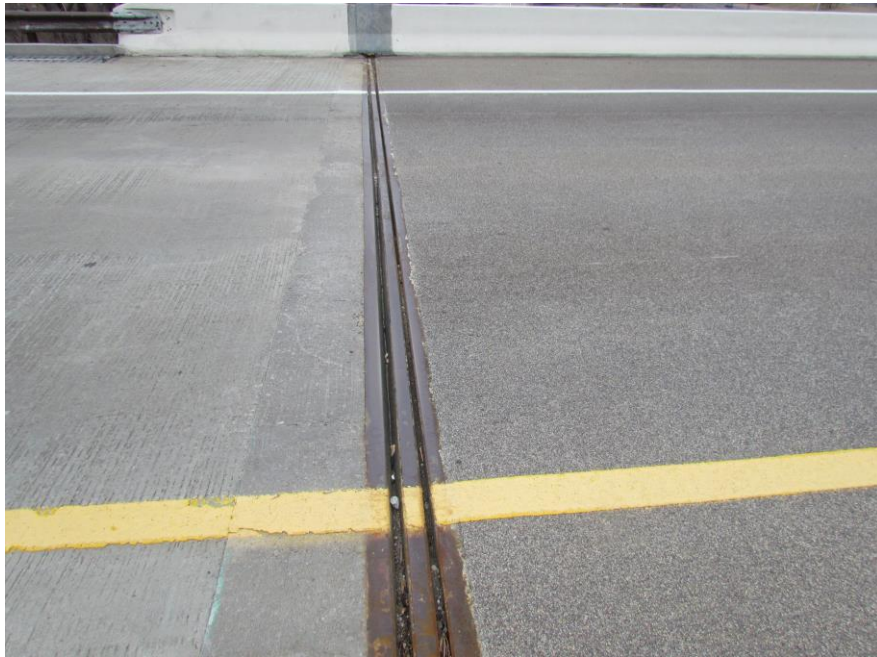
APPR. "A" JOINT W/ MEMBRANE FAILURE

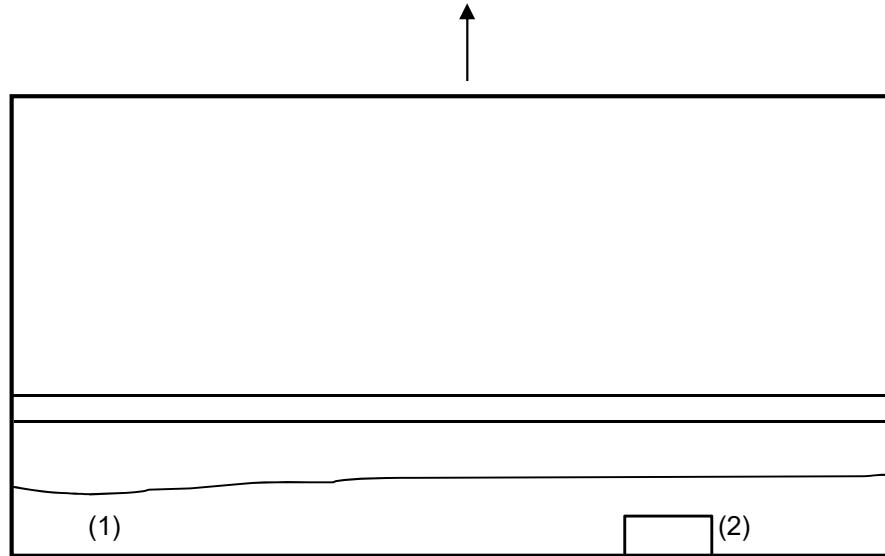
| PAVEMENT | POOR | CONCRETE- (1) TRANSV. CRACK UP TO 1/2" OPEN, (2) POTHOLE/FAILING A/C PATCHES 20'L X 8"W X 4"DP |

| No. | RECOMMENDATIONS | REPAIR DATE | REPAIRED BY |
|---|---|---|---|
| 1. | REPAIR POTHOLE AT 'A' APPROACH | | |

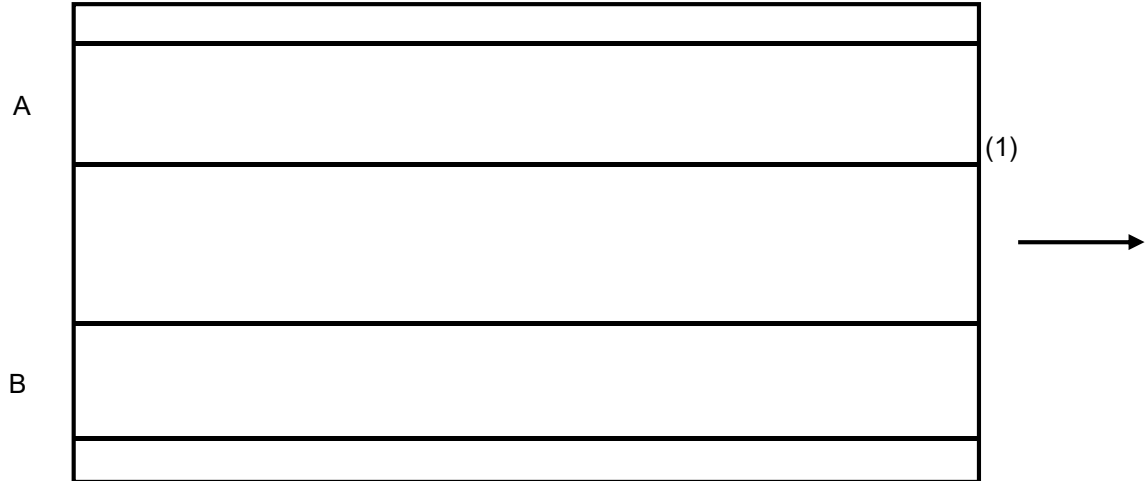
| DECK | FAIR | LIGHT HONEYCOMB AREAS TYP. ALL SPANS, NUMEROUS REPAIRED AREAS WITH EPOXY INJECTION. FAILED EXPOXY REPAIRE TUB 'A' PANEL #7 |

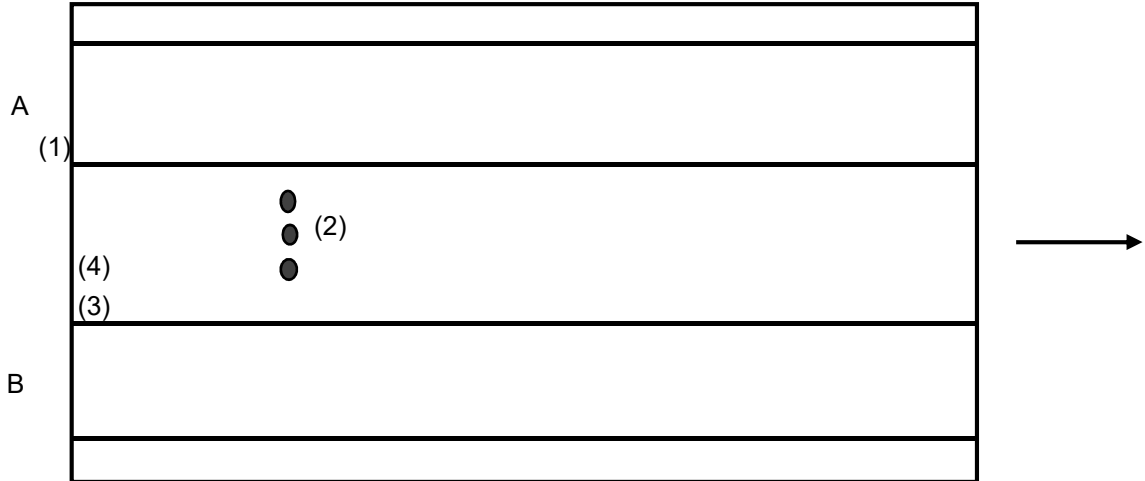
| DECK | FAIR | LIGHT HONEYCOMB AREAS TYP. ALL SPANS, NUMEROUS REPAIRED AREAS |
| | | WITH EPOXY INJECTION. (2) SPALLS UP TO 1' X 1' DP @ 6TH PANEL FROM |
| DIAPH. | FAIR | TUB 'B' DIAPH #6-2 MISSING BOLTS, REPAIRED 2017 |

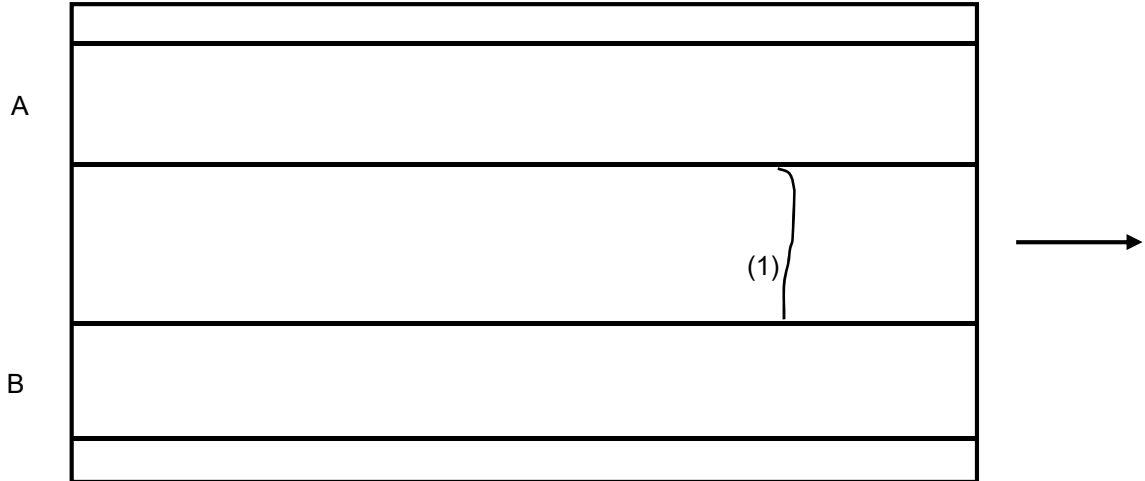
| DECK | FAIR | LIGHT HONEYCOMB AREAS TYP. ALL SPANS, NUMEROUS REPAIRED AREAS WITH EPOXY INJECTION. GIRDER 'B' PANEL #6 TRANSV H.C. W/EFF & FAILING PATCH, (1) H.L. TRANSV CRACK W/EFF @ 6TH PANEL FROM BENT 3, JOINT LEAKAGE BTWN PANELS GIRDER #6, TUB 'B' DECK PANEL BTWN DIAPH #3 & #4-SPALL 4" X 3" X 1/2" DP. |
| DIAPH. | FAIR | TUB 'B' DIAPH'S #2 & #5-MISSING BOLTS & NUTS, REPAIRED 2017 |

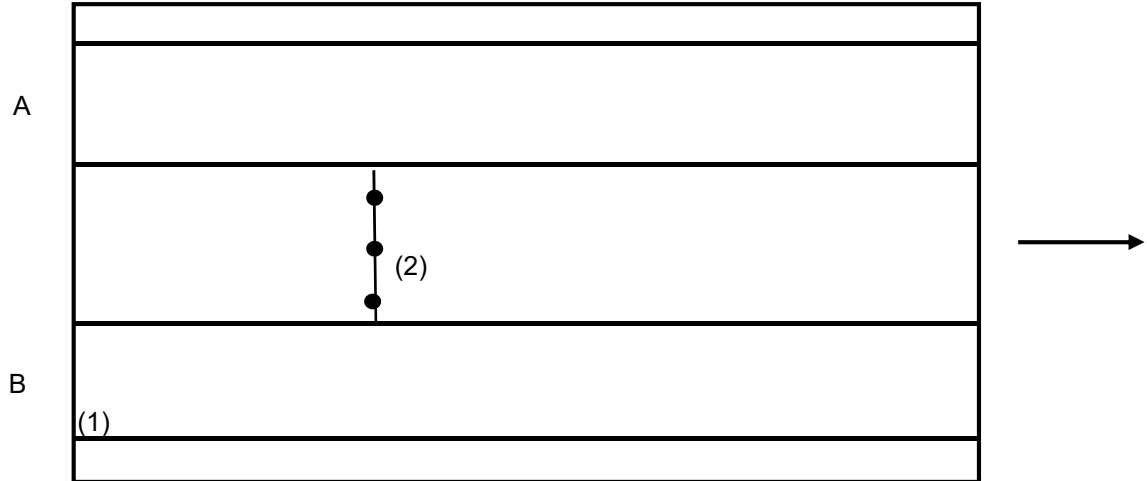
| DECK | FAIR | LIGHT HONEYCOMB AREAS TYP. ALL SPANS, NUMEROUS REPAIRED AREAS |
| | | W/EPOXY INJECTION., (2) SPALLS UP TO 6" DIA W/TRANS. H.C. @ PANEL #6 |
| DIAPH. | FAIR | REPAIRED 2017, TUB 'B' DIAPHS #2 , #3, & #5-MISSING NUTS & BOLTS |

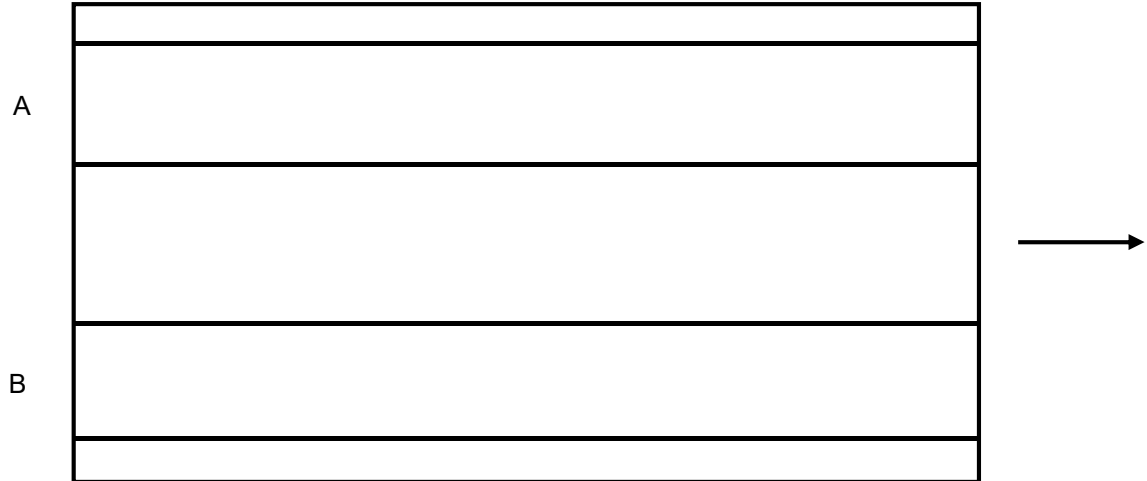
| DIAPH. | FAIR | REPAIRED 2017, TUB 'B' DIAPH #5 & #6-MISSING BOLT & NUT, TUB 'B' STRINGER BTWN DIAPH'S #3 & #4 LOOSE NUT |

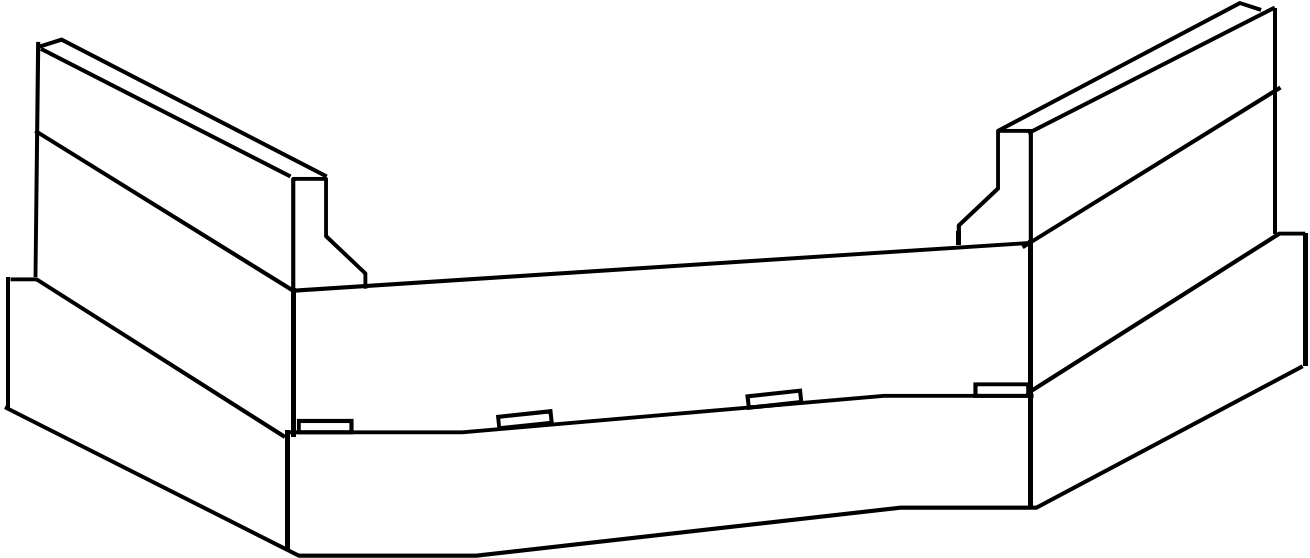
| BACKWALL | FAIR | PATTERN & MAP CRACKS, PATCHES |
| CAP | FAIR | VERT. HORIZ, & MAP CRACKS UP TO 1/16" OPEN |
| WINGS | FAIR | MAP CRACKS |
| BEARINGS | FAIR | MOD RUST, CORR., & FLAKING ALL BEARINGS ARE SHIFTED |

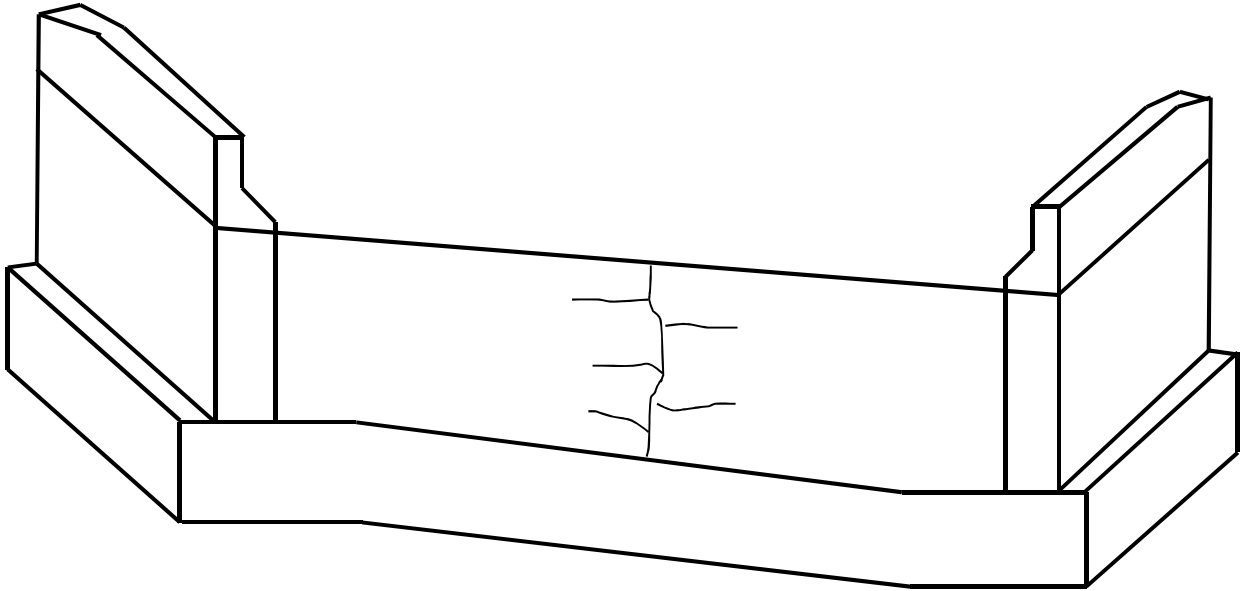
| BACKWALL | FAIR | MAP CRACKS W/ EFF. UPTO .010" OPEN |
| CAP | FAIR | VERT. MAP CRACKS UP TO 1/16" OPEN, H.S. POPOUT 1'L X 1.5"H X 1/4"DP |
| WINGS | FAIR | RANDOM H.L. MAP CRACKS |
| BEARINGS | FAIR | LIGHT RUST & CORR., ALL BEARINGS SHIFTED BACKSTATION 1" |
