19I0440001
19-I0440-0.36 RT
1440 RL/CHARLOTTE AVE

BRIDGE MAINTENANCE RECOMMENDATIONS

Tennessee Department of Transportation

BRIDGE INSPECTION REPORT

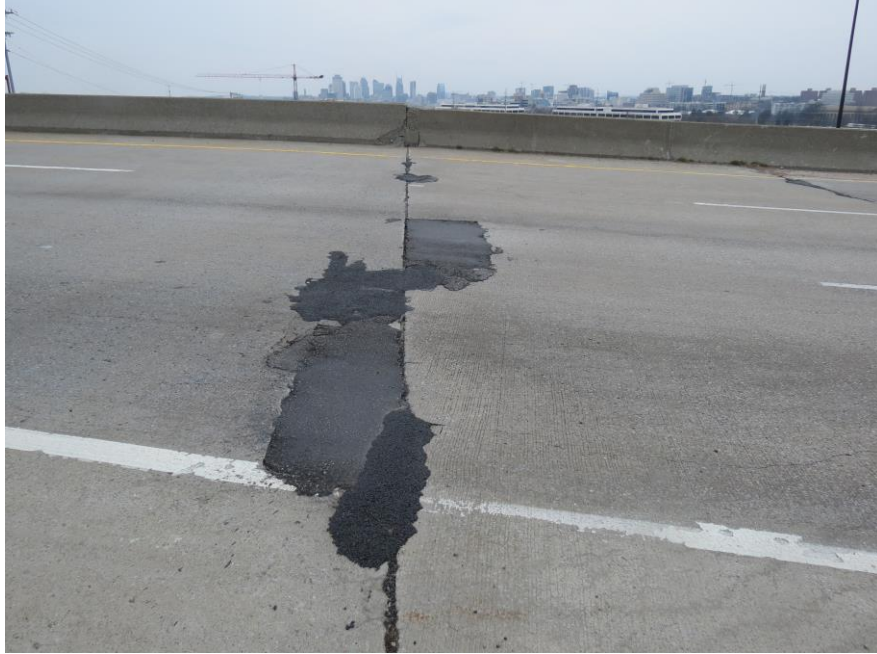
APPR. "B" END JOINT W/ PATCHES

Rating	Comments
Alignment	GOOD	
Slab	FAIR	NUMEROUS TRANSVERSE & LONGIT. 1/16" CRACKS
Joints	POOR	ADHESION FAILURES & A/C PATCHES
Pavement	NA	
Embankment	FAIR	EROSION SLAB B END 3' x 3'
Drains	NA

No.	RECOMMENDATIONS	REPAIR DATE	REPAIRED BY
1.	REPAIR APPROACH ROADWAY 'A' AND 'B' ENDS		
2.	REPAIR FILLER MATERIAL JOINTS 'A' AND 'B' ENDS

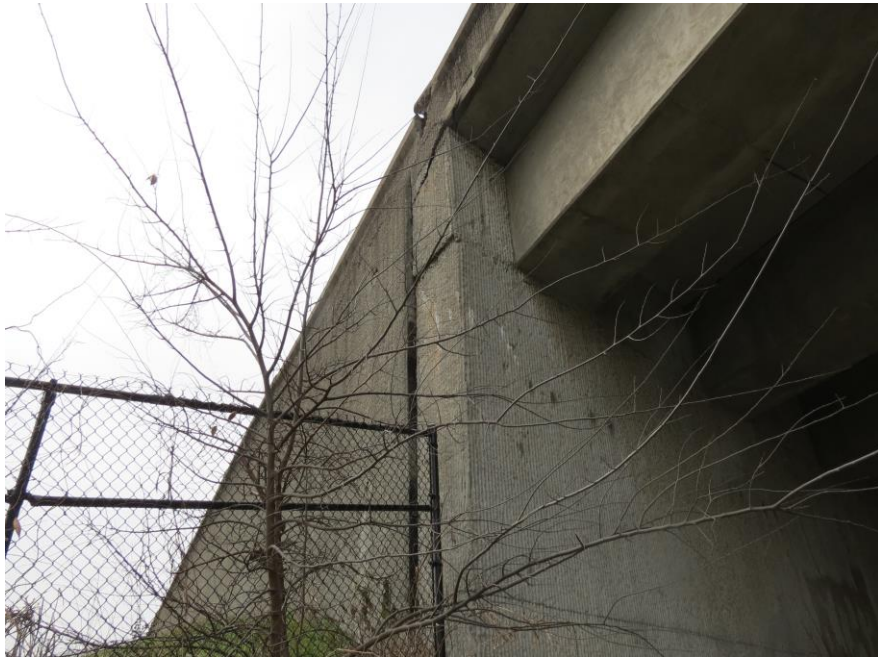
LT. WING / RETAINING WALL AT ABUT. #2 W/ TILT

Abutment wings are fair with 3” creep outward and 1/16” open crack at cold joint at both abutments. Abutment brestwalls are good with random vertical and diagonal hair cracks. Bents are good.

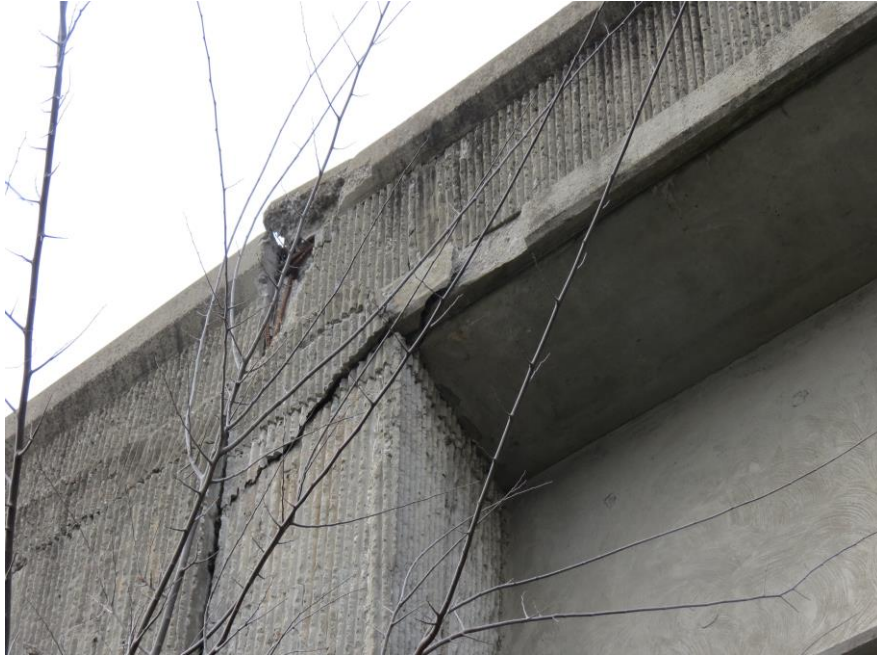
BRIDGE RAIL "B" END LT. W/ IMPACT DAMAGE

SUGGESTED ROUTINE MAINTENANCE AND COMMENTS
REPAIR BRIDGE RAIL SPAN #3 LEFT
SEAL CONCRETE WEARING SURFACE
SEAL APPROACH SLABS

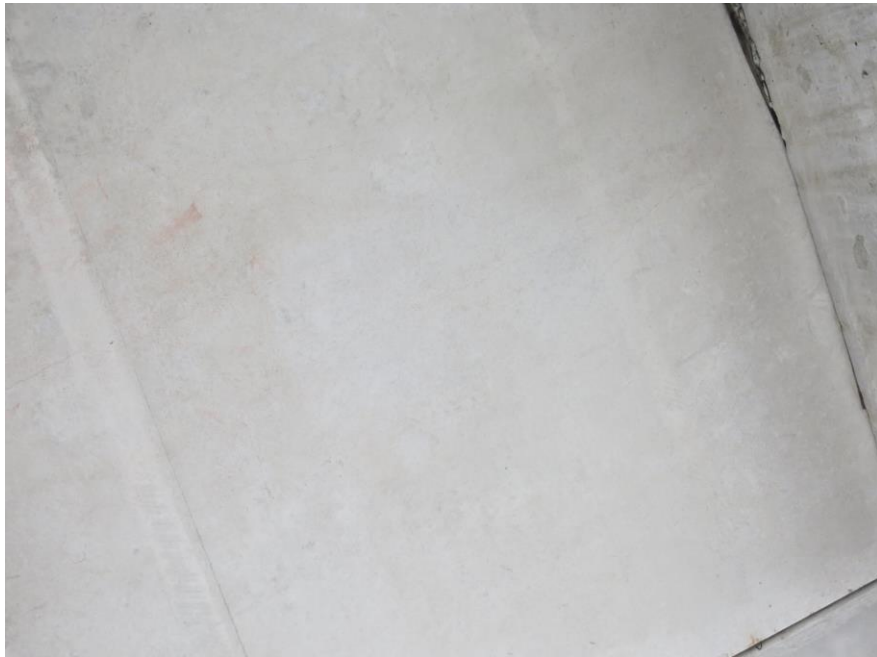
DECK PANEL BAY "B" SP. #3 W/ TRANSV. CRACK

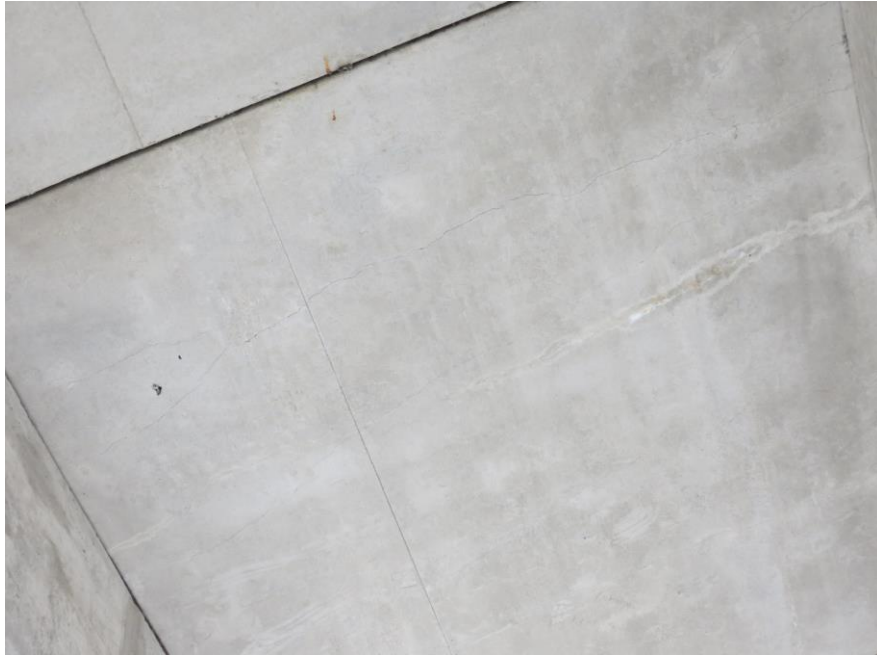
DECK PANEL BAY "C" SP. #3 W/ TRANSV. CRACK

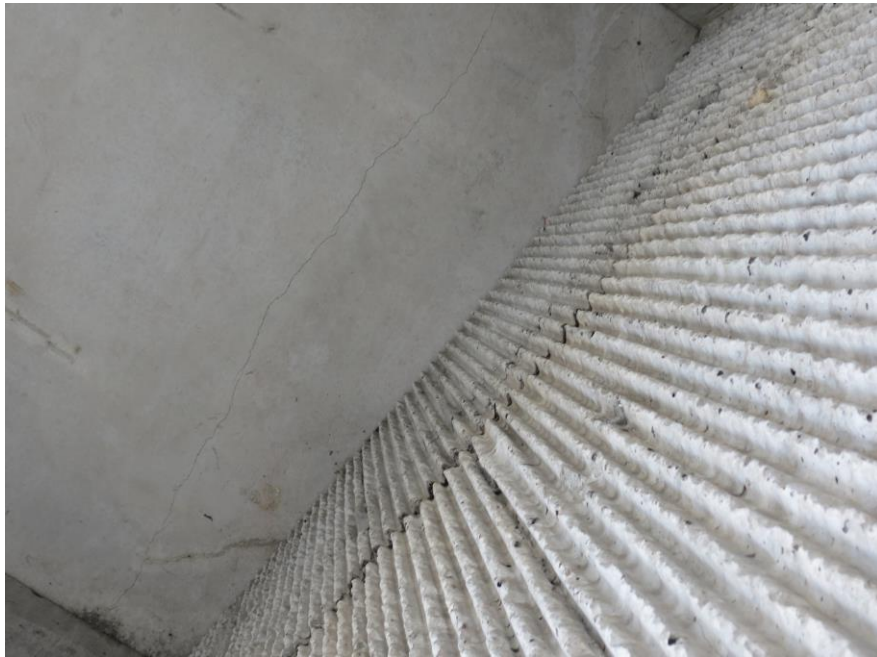
DECK PANEL BAY "A" SP. #3 W/ TRANSV. CRACK

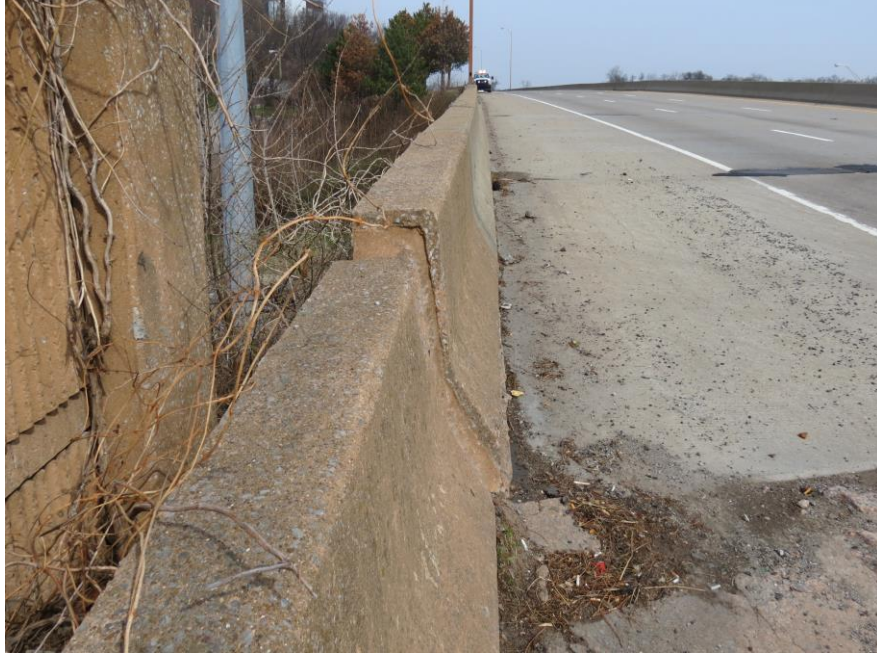
BRIDGE PARAPET "B" END RT. MISALIGNED

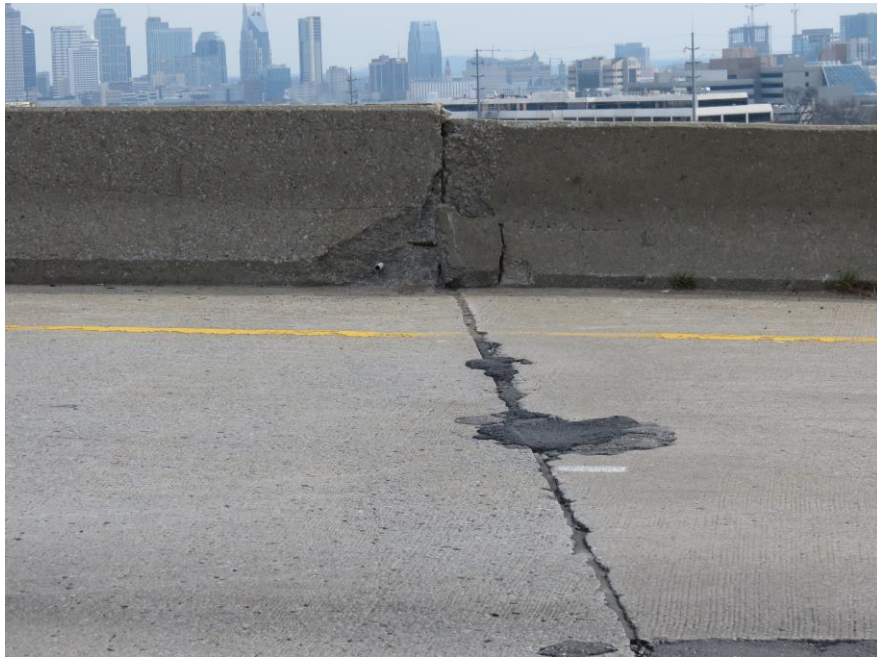
BRIDGE PARAPET "B" END LT. IMPACT DAMAGE

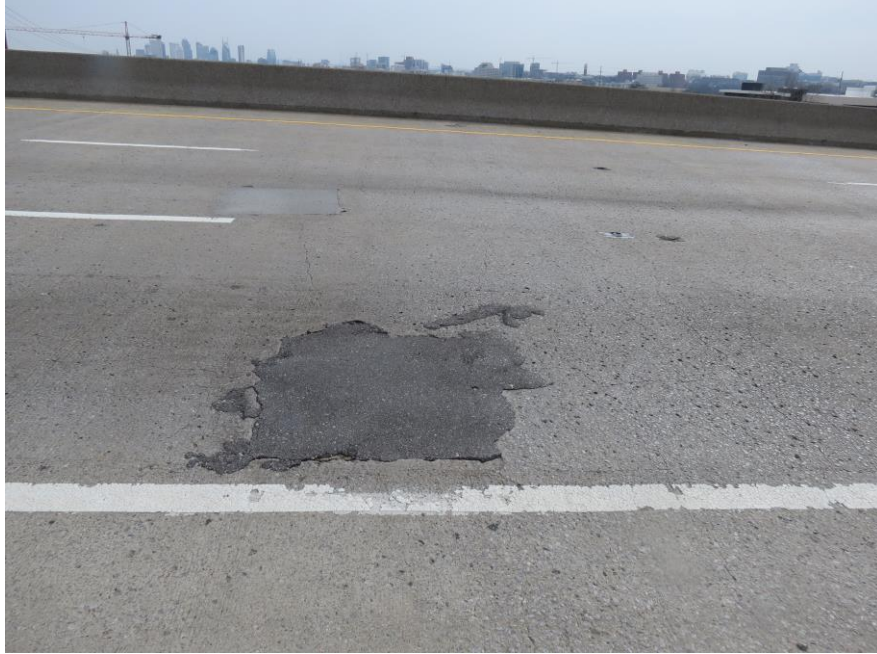
WEARING SURFACE SP. #3 W/ PATCH

The concrete wearing surface is fair with concrete patches 1/16-1/8” open transverse cracks, aggregate popouts, and light scale.

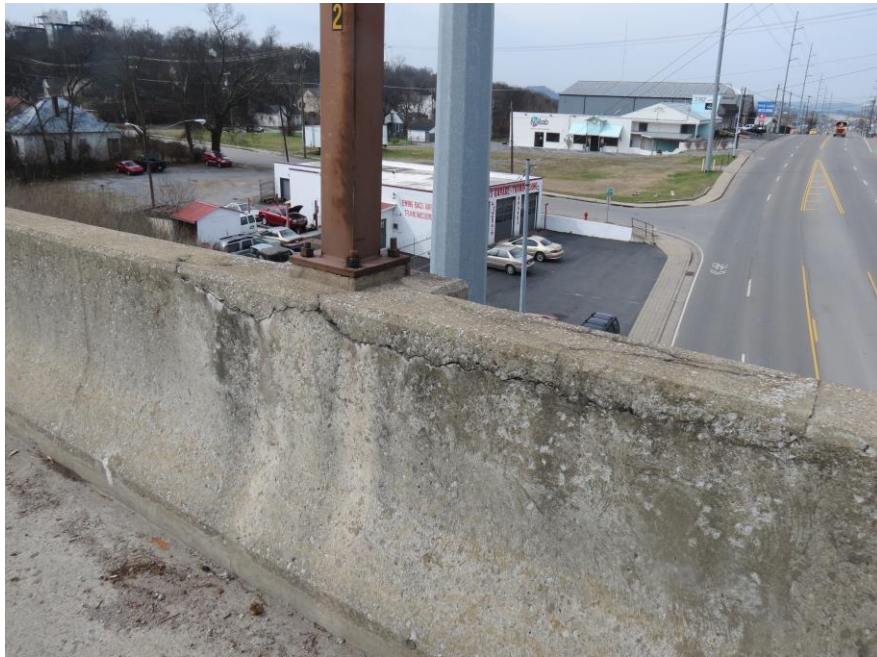
PARAPET RT. W/ I.P.B.O UNDER POLE ID # HM02

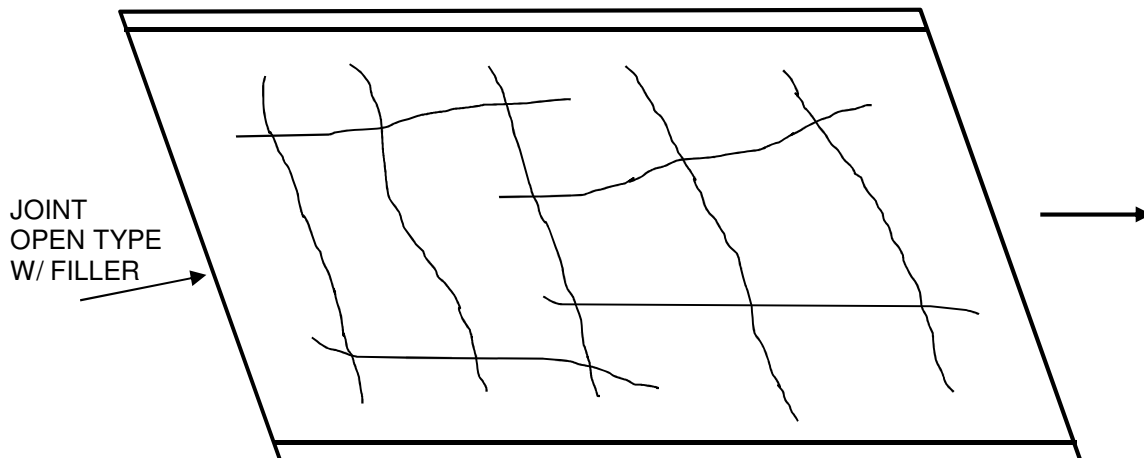
Top of Deck Span No. 1

DECK	FAIR	1/16" TRANSV. & HORZ. CRACKS ALL SPANS, MOD. SCALE &
		AGG POPOUTS
PARAPET	GOOD	
JOINTS	FAIR	ADHESION FAILURES

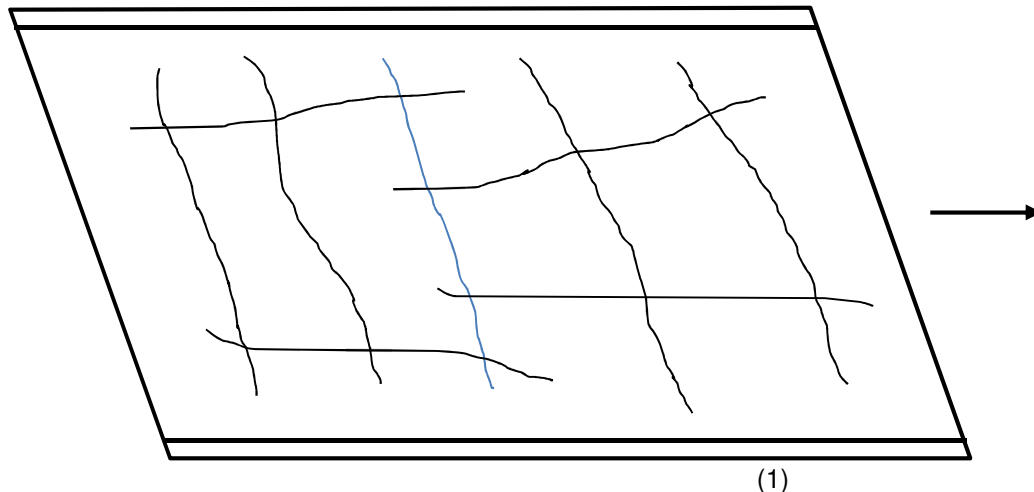
Top of Deck Span No. 2

DECK	FAIR	1/16" TRANSV. & HORZ. CRACKS ALL SPANS, MOD. SCALE & AGG POPOUTS
PARAPET	GOOD	LIGHT SURFACE SCALE, (1) LONGIT. CRACKS @ LIGHTING STANDARD 6'L X 1/16" OPEN

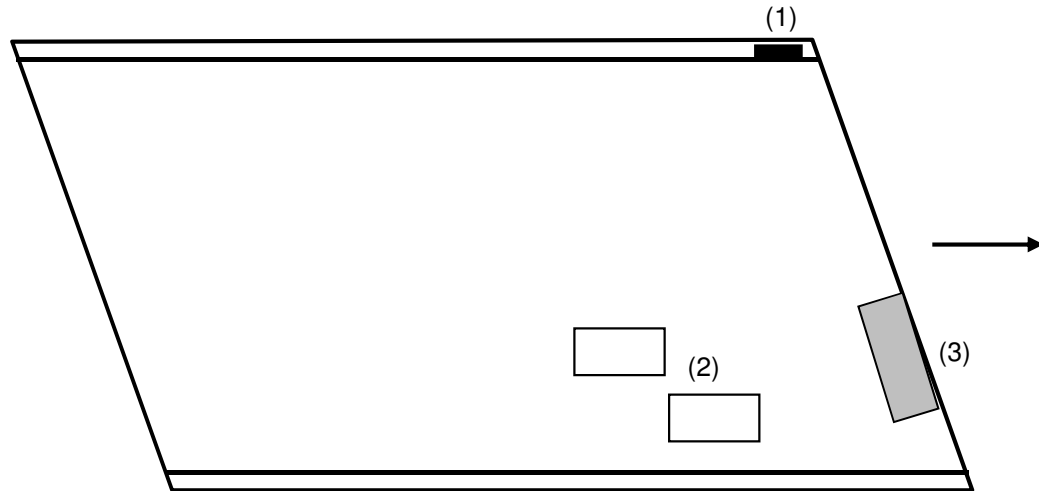
Top of Deck Span No. 3

DECK	FAIR	1/8" TRANSV. & HORZ. CRACKS ALL SPANS, MOD. SCALE & AGG.
		POPOUTS, (2) CONC. PATCH W/ SPALL 3" DP, (3) A/C PATCHES ' 12' X 2'
PARAPET	GOOD	(1) SPALL 2' X 2' X 1" DP
JOINTS	FAIR	A/C PATCHES

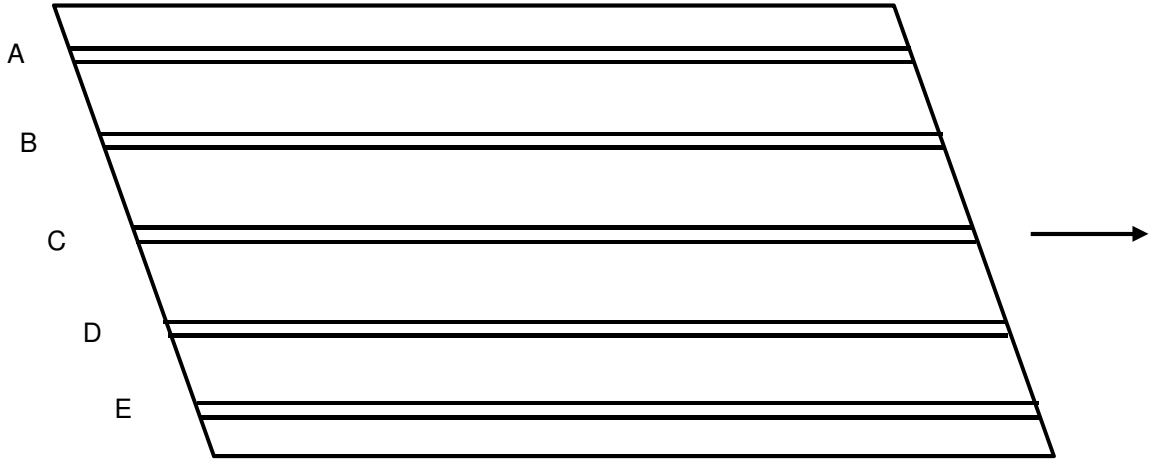
Bottom of Slab Span No. 1

DECK	GOOD	
DIAPHRAGMS	GOOD	LONGIT. H.C.'S @ BENT #2
BEAMS	GOOD	
		ADHESION FAILURES
OVERHANG	GOOD

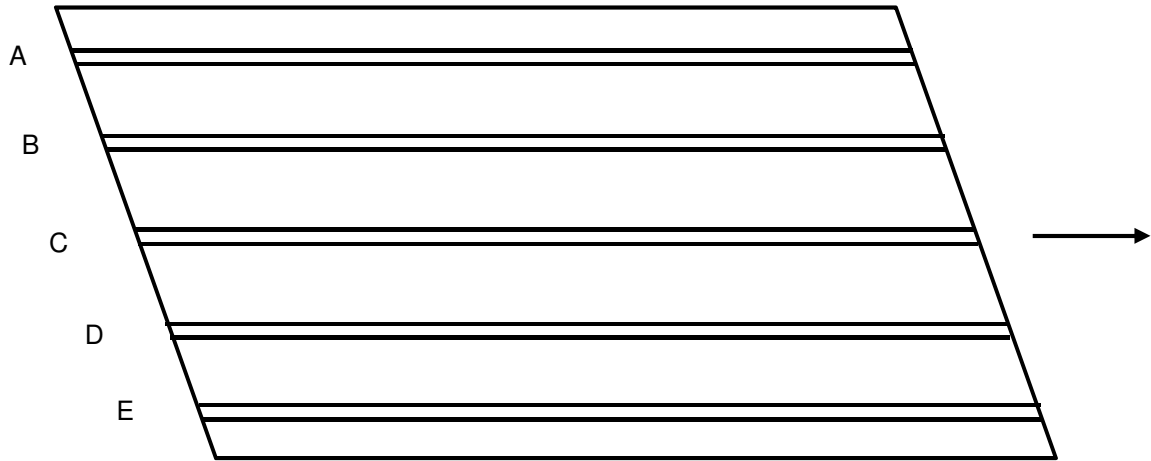
Bottom of Slab Span No. 3

DECK	GOOD	TRANSV. CRACKS UP TO 1/16" OPEN- PANEL#6, BAY 'R', TRANSV.
		H.C.'S PANEL #1 BAY 'D', TRANSV/DIAG H.C.'S PANEL #4-6 BAY 'C',
		TRANSV. H.C. PANEL 6 BAY 'B'
DIAPHRAGMS	GOOD	
BEAMS	GOOD	
OVERHANG	GOOD

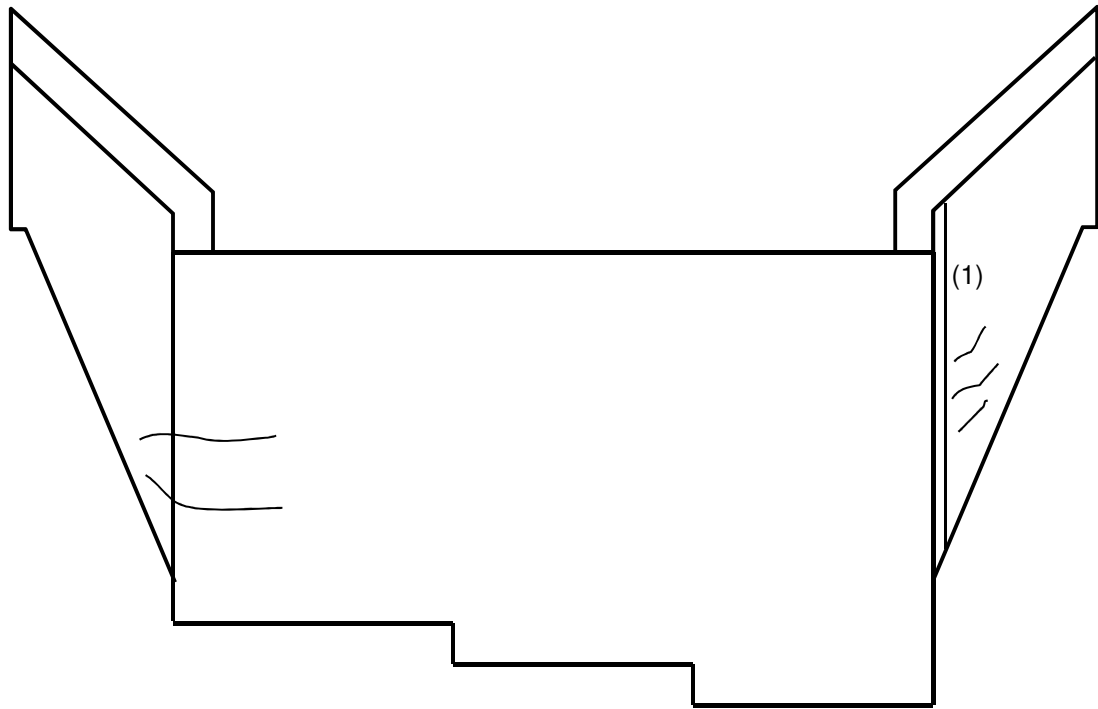
Abutment No. 1

BREASTWALL	GOOD	RANDOM DIAG./VERT H.C.'S UP TO 1/16" OPEN-UP TO FULL HEIGHT
WINGS	FAIR	(1) RETAINING WALL TITLED OUT 3" W/ 1/16" OPEN CRACKS THIS TILT MEAS. EVEN FROM TOP & BTM., RANDOM I.P.B.O'S UP TO 6" DIA
BEARINGS	NV	ENCASED IN CONCRETE
SLOPE PVT	GOOD

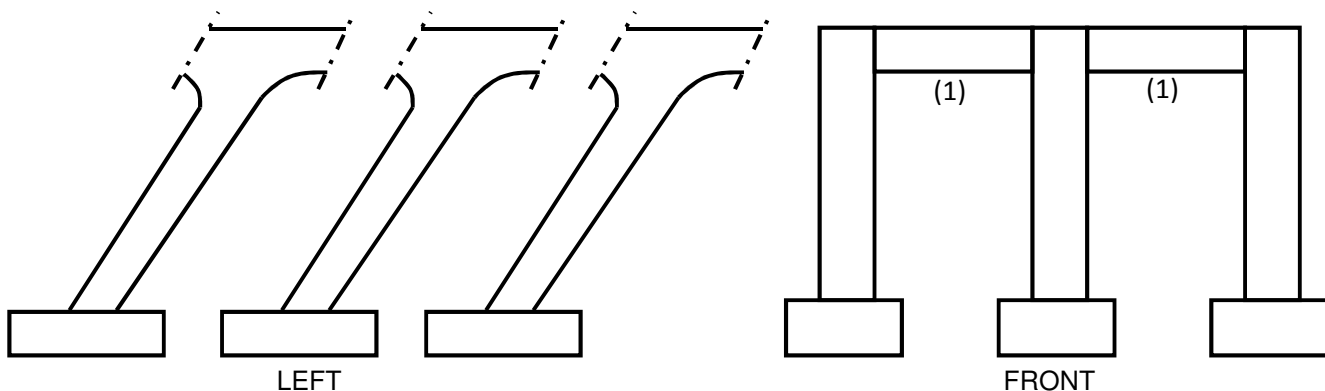
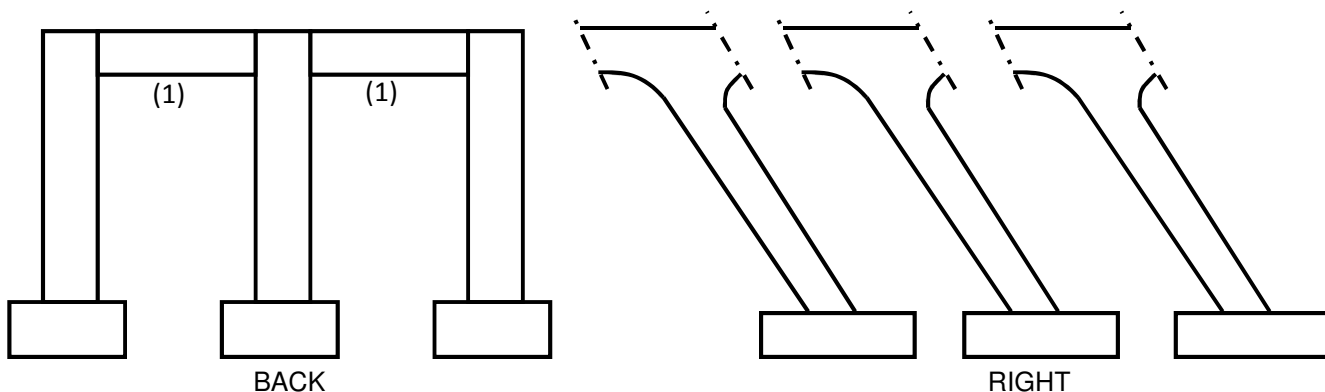
Bent No. 1

COLUMNS	GOOD	
CAP BEAM	GOOD	(1) LONGIT. H.C.'S

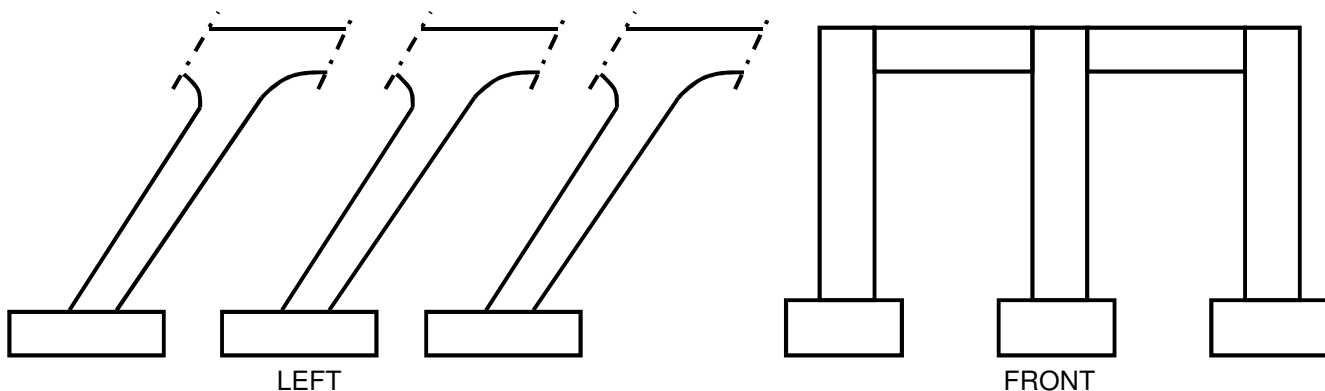
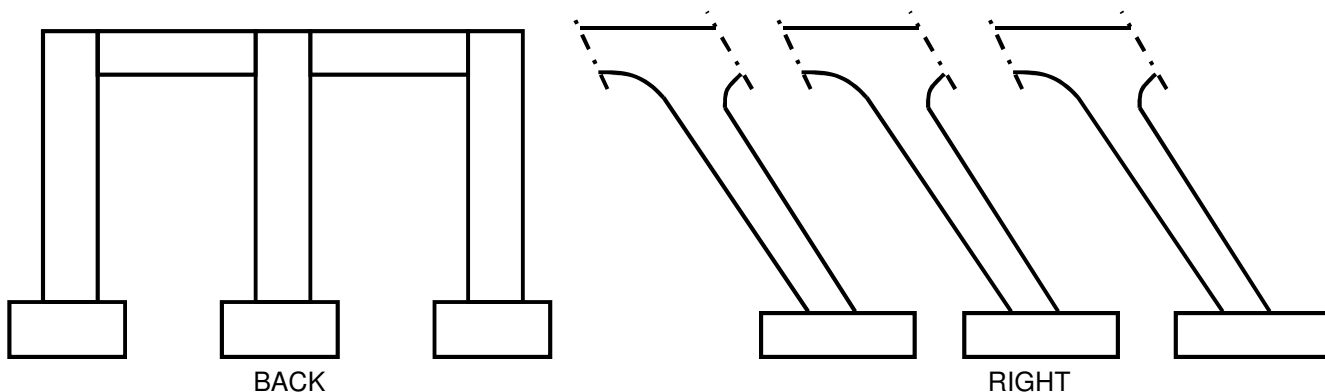
Bent No. 2

COLUMNS	GOOD	
CAP BEAM	GOOD	LONGIT. H.C.'S

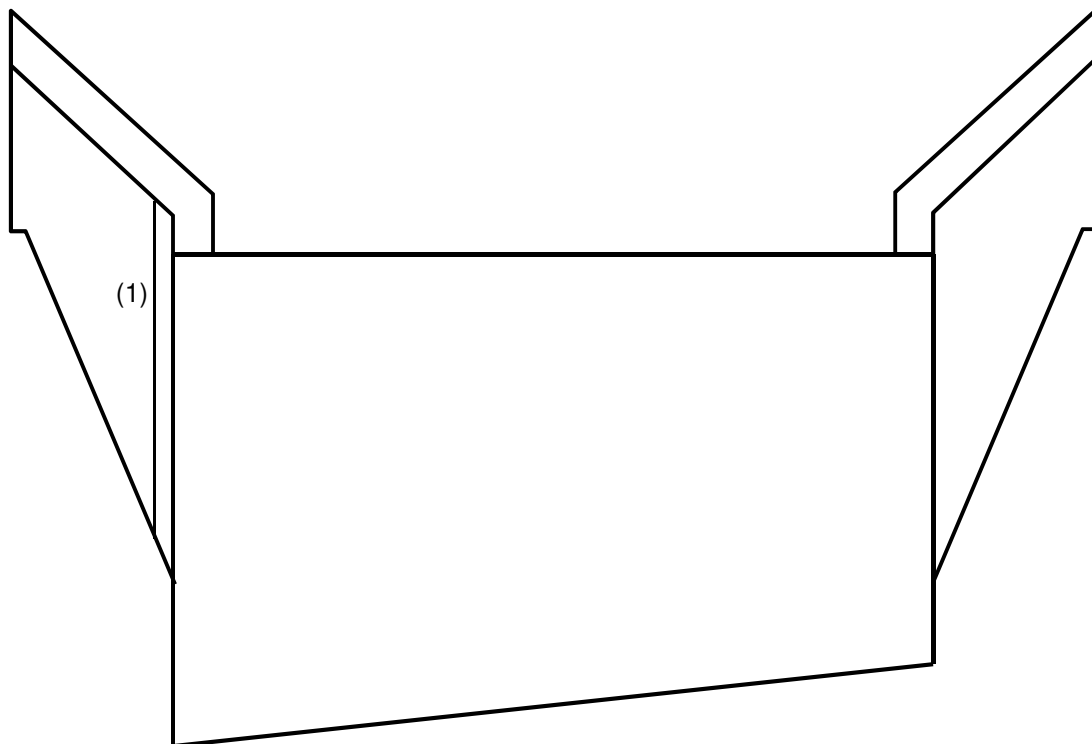
Abutment No. 2

BREASTWALL	GOOD	RANDOM VERT./DIAG H.C.'S UP TO .040" X FULL HEIGHT
WINGS	FAIR	(1) RETAINING WALL TITLED OUT 3" W/ 1/16" OPEN CRACKS THIS TILT MEAS. EVEN FROM TOP & BTM.
BEARINGS	NV	ENCASED IN CONCRETE
SLOPE PAV.	GOOD
