19I0440002
19-I0440-0.36 LT
1440 LL/CHARLOTTE AVE

BRIDGE MAINTENANCE RECOMMENDATIONS

BRIDGE INSPECTION REPORT

SUMMARY
19-I440-0.36 LT
2/22/2016

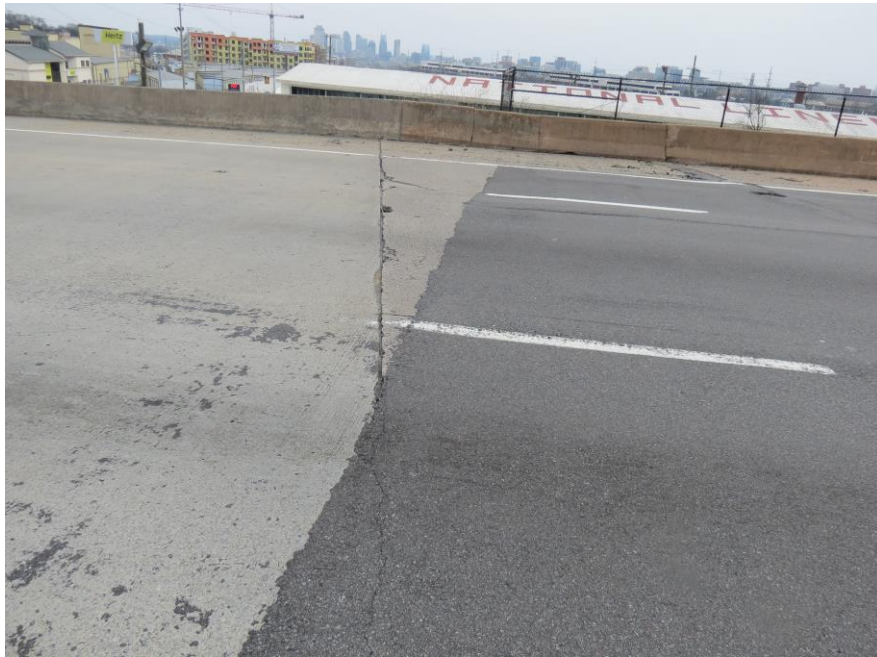
APPR. "B" END JOINT PAVED OVER

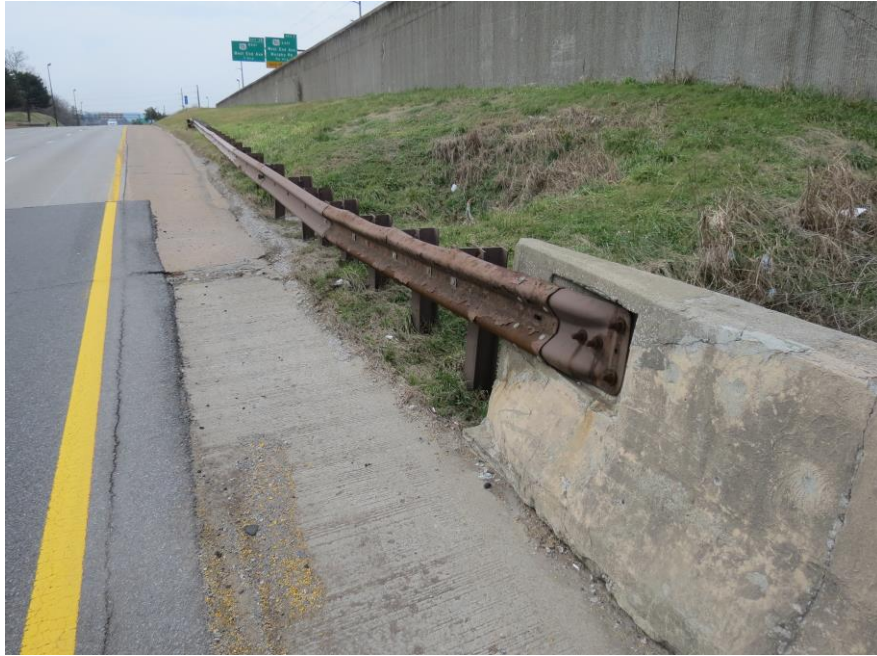
GUARDRAIL "B" END RT. W/ CORROSION

Rating	Standard/ SubStandard	Comments
Bridgerailing	GOOD	STANDARD	
Transitions	FAIR	SUBSTANDARD	INCORRECT BLOCKOUTS, RUST/CORR 'B' END RT.
Guardrail	FAIR	SUBSTANDARD	INCORRECT BLOCKOUTS, RUST/CORR. 'B' END RT.
Guardrail Terminal	NA

Approach rails are poor but substandard with moderate-heavy corrosion at 'B' end right.

No.	RECOMMENDATIONS	REPAIR DATE	REPAIRED BY
1.	REPLACE APPROACH GUARDRAIL @ 'B' END RIGHT

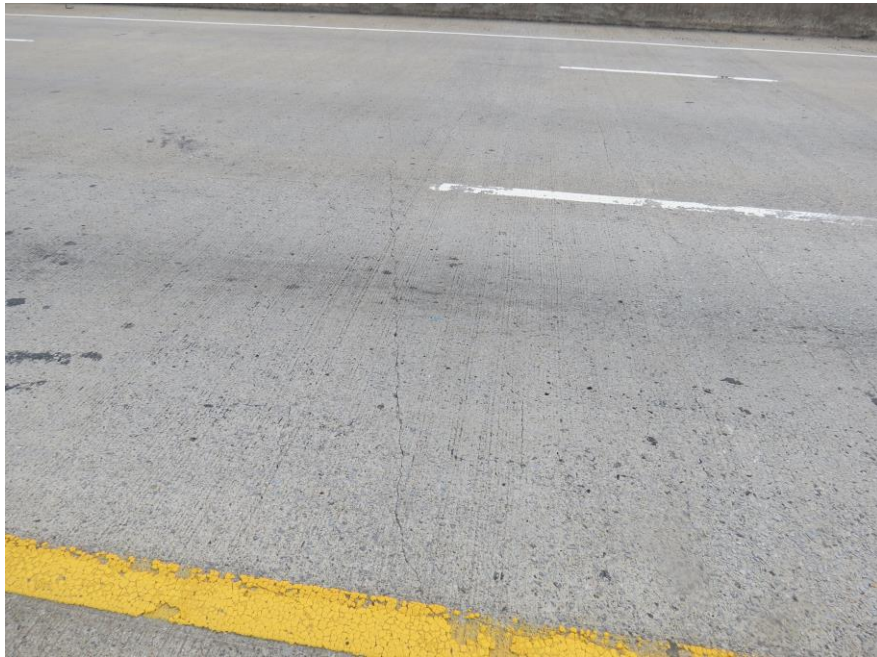
WEARING SURFACE SP. #3 W/ SCALE & CRACKS

Rating	Comments
Wearing Surface	FAIR	CONCRETE- 1/16" TRANSVERSE & LONGIT. CRACKS, AGG POPOUTS, MOD SURFACE SCALE
Deck - Structural Condition	GOOD	SP #1 H.L. TRANSV CRACKS BAY 'A' PANEL #5
Curbs	NA	
Median	NA	
Sidewalks	NA	
Parapet	GOOD	LGH-SURFACE SCALE
Railing	NA	
Paint	NA	
Drains	NA	
Lighting Standards	GOOD	MOD RUST AT BASE
Utilities	NA	
Joint Leakage	GOOD	
Expansion Joints	NV	PAVED OVER

The concrete wearing surface is fair with 1/16-1/8" cracks, moderate surface scale, and aggregate popouts. Bottom deck panels are good. However; span #1 bay 'A' panel #3 has hairline transverse cracks. Open type joints with membrane are poor with filler loss.

SUGGESTED ROUTINE MAINTENANCE AND COMMENTS
SEAL CONCRETE WEARING SURFACE
APPROACH GUARDRAIL TERMINALS ARE SUBSTANDARD
REPAIR APPROACH A/C 'A' & 'B' ENDS

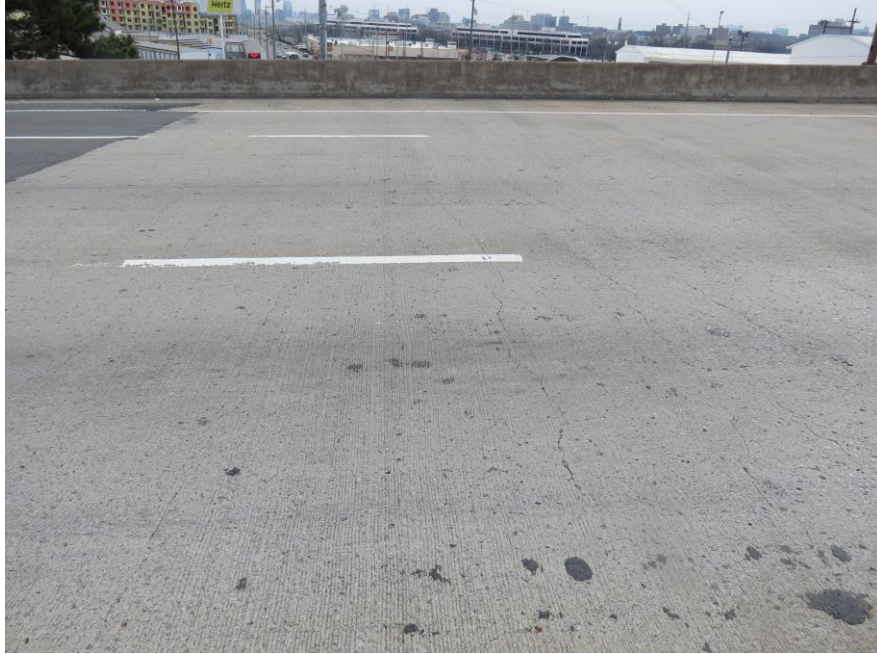
WEARING SURFACE SP. #1 W/ SCALE & CRACKS

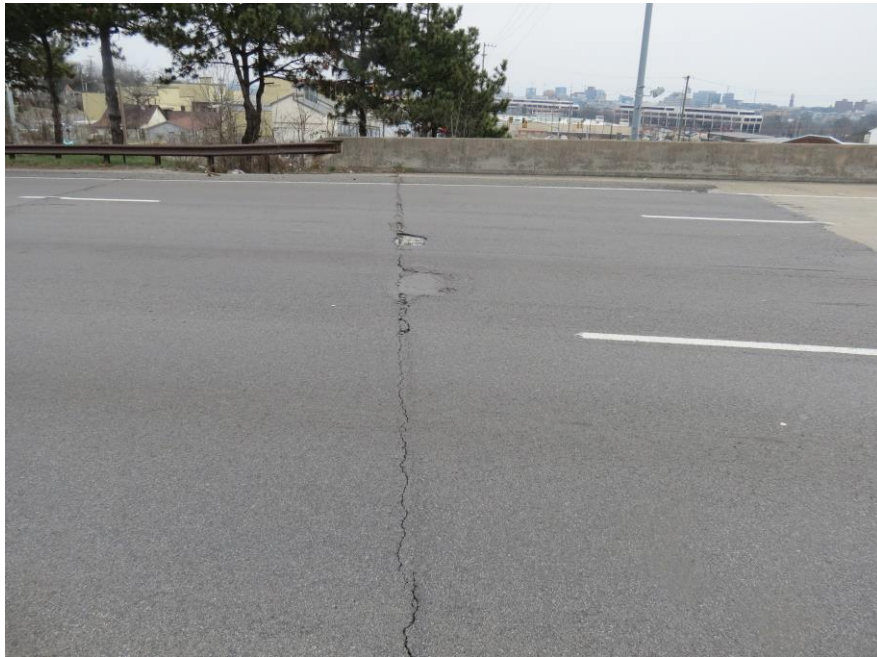
APPR. "A" END PAVEMENT W/ POTHLES

Rating	Comments
Alignment	GOOD	
Slab	NV	PAVED OVER
Joints	NV	PAVED OVER
Pavement	POOR	POTHoles UP TO 2' X 1' X 1" DP, MOD SETTLEMENT
Embankment	GOOD	
Drains	NA

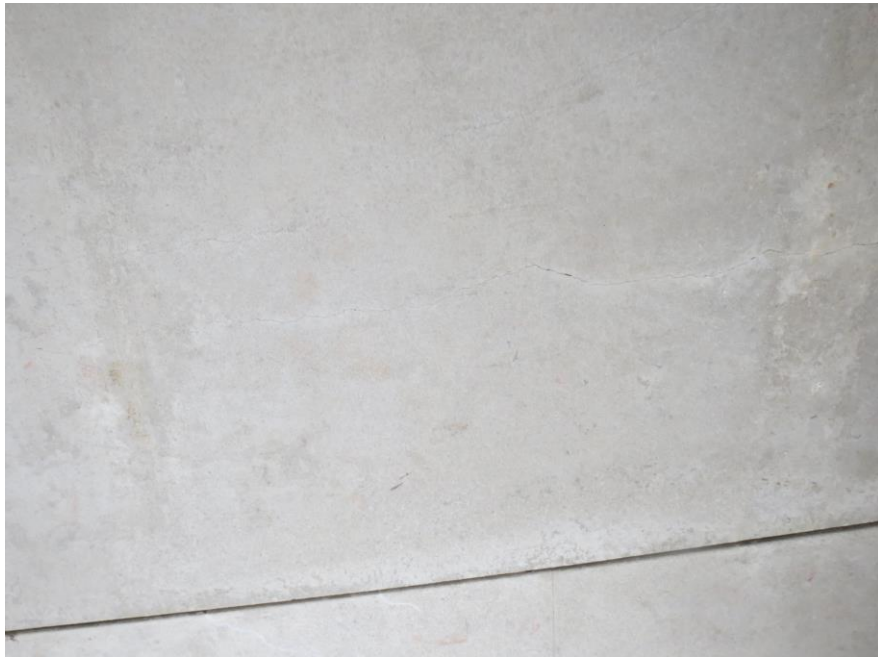
DECK PANEL BAY "B" SP. #3 W/ CRACK

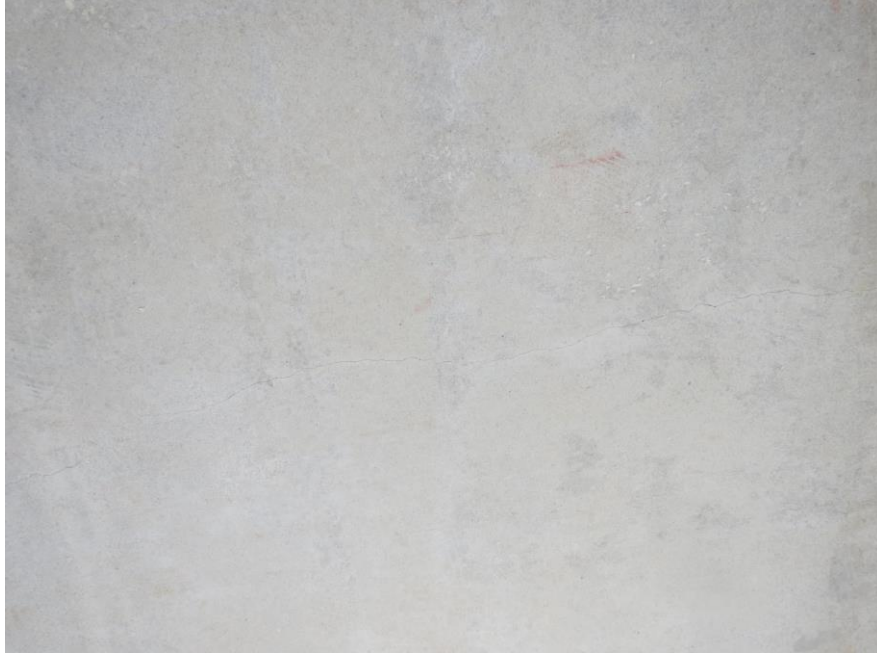
DECK PANEL BAY "A" SP. #3 W/ CRACK

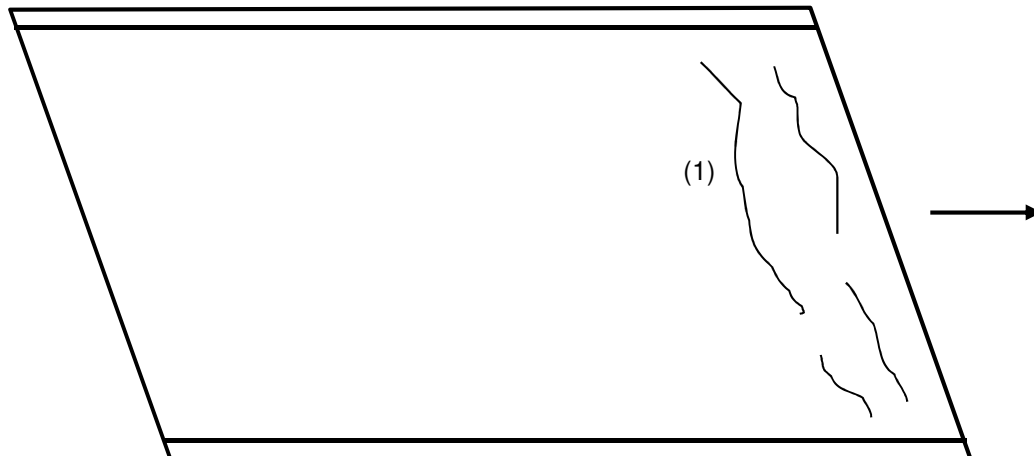
Top of Deck Span No. 1

DECK	FAIR	(1) 1/16" TRANSV. CRACKS OVER SUPPORTS, MOD SURFACE
		SCALE, AGG POPOUTS
PARAPET	GOOD	LIGHT SCALE
JOINTS	N/V	PAVED OVER

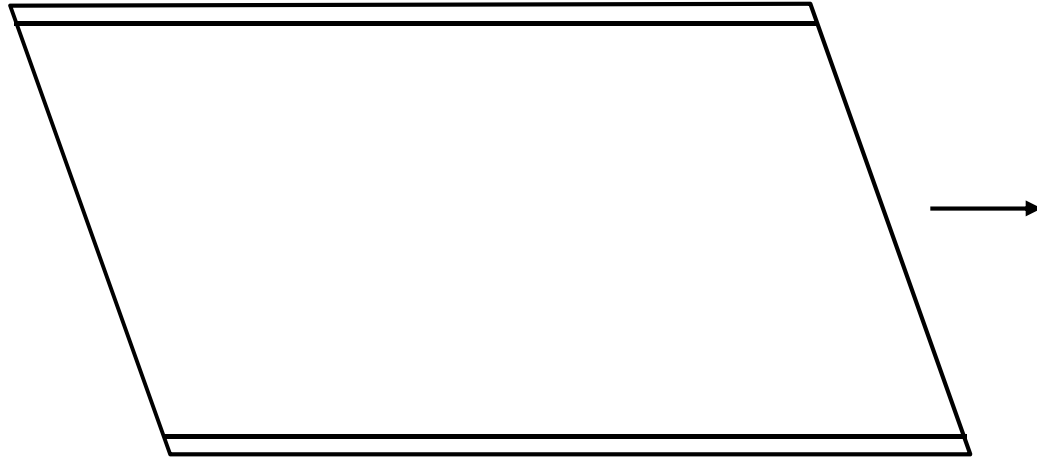
Top of Deck Span No. 2

DECK	FAIR	LGH TRANSV. H.C., MOD SURFACE, AGG POPOUTS
PARAPET	GOOD	LGT SCALE

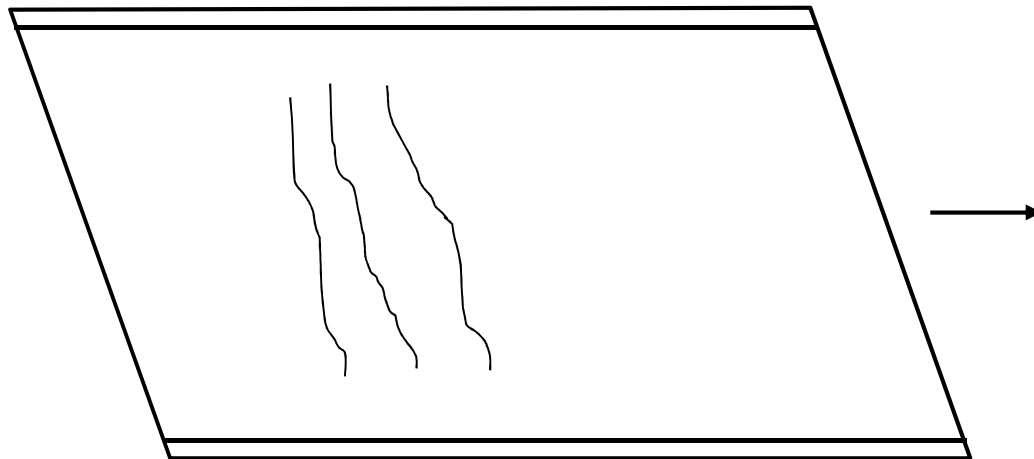
Top of Deck Span No. 3

DECK	FAIR	(1) 1/16" TRANSV. CRACKS OVER SUPPORTS, MOD SURFACE SCALE
		AGG POPOUTS
PARAPET	GOOD	LIGHT SCALE
JOINTS	NV	PAVED OVER

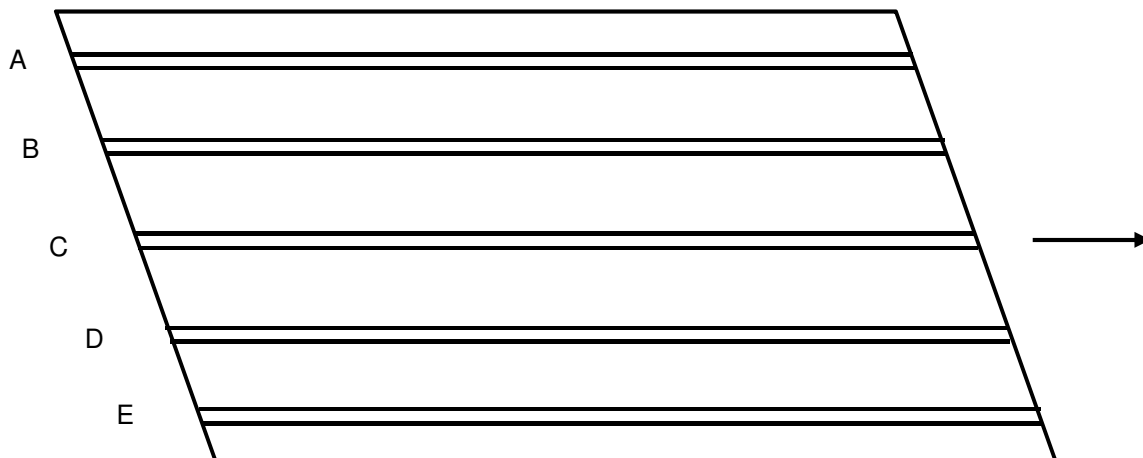
Bottom of Slab Span No. 1

DECK	GOOD	H/L TRANSV CRACK, PANEL 3, BAY 'A', PANEL 3 BAY 'C'
DIAPHRAGMS	GOOD	
BEAMS	GOOD	LGT VERT & HORIZ H.L. CRACKS @ ALL BEAMS, 8'-10' FROM ABUT #1
OVERHANG	GOOD

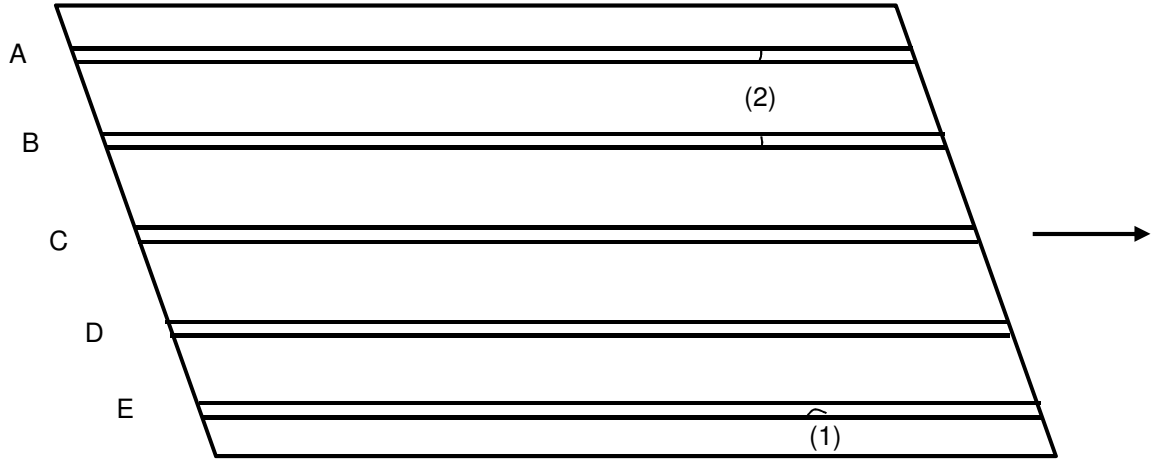
Bottom of Slab Span No. 2

DECK	GOOD	
DIAPHRAGMS	GOOD	
BEAMS	GOOD	
"E"	GOOD	(1) COLL. SCRAPES & SM. 1/4" DP B.O.
		(2) LIGHT H.L. CRACKS ON BOTT. OF BMS & SIDE BEAMS @ REPAIRS
"C"	GOOD	DIAG. H.C. W/EFF. 30' FROM BNT #1 RT
OVERHANG	GOOD

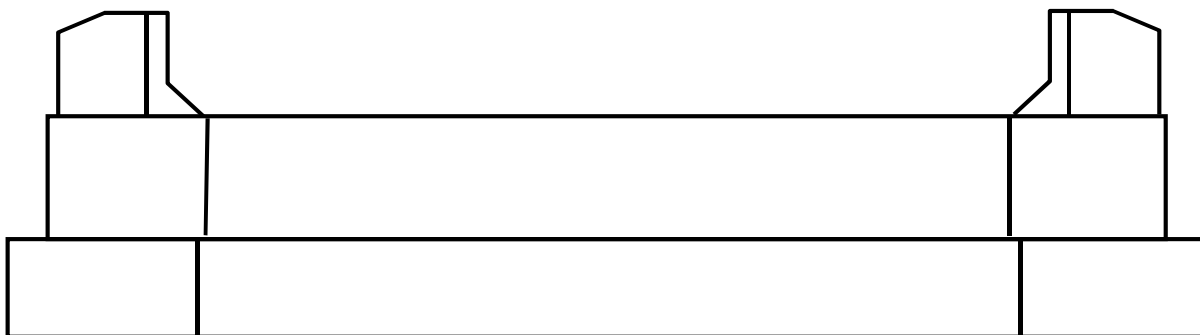
Abutment No. 1

BACKWALL	GOOD	RANDOM HORIZ H.C'S
CAP	GOOD	
WINGS	GOOD	
BEARINGS	NV	ENCASED IN CONCRETE
SLOPE PVT	GOOD

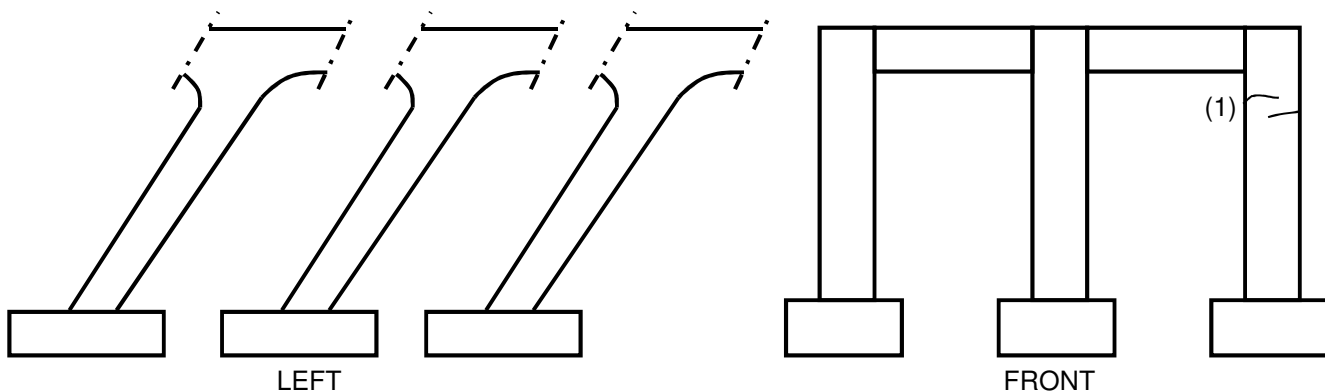
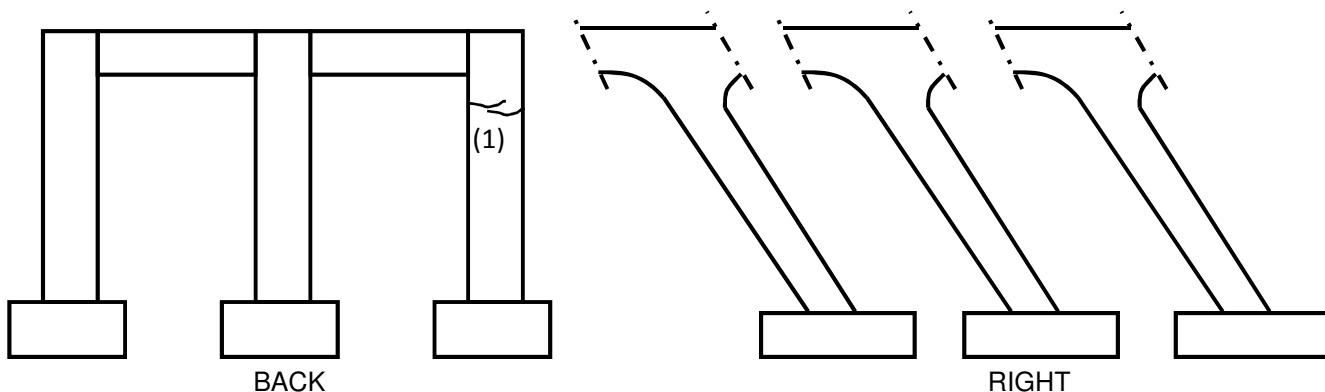
Bent No. 1

COLUMNS	GOOD	(1) PATCHED, H.L. HORIZ. CRACKS IN PATCHES
CAP BEAM	GOOD	LONGIT H.C.'S

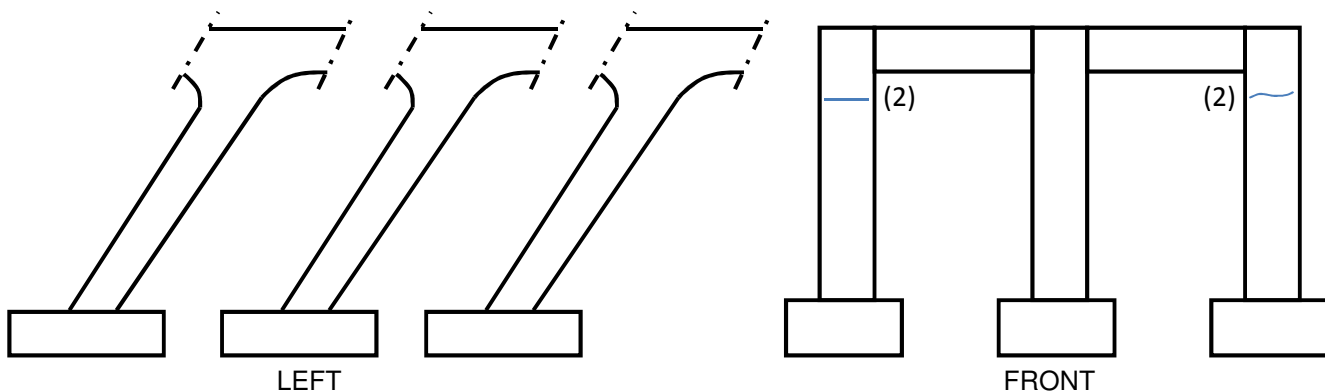
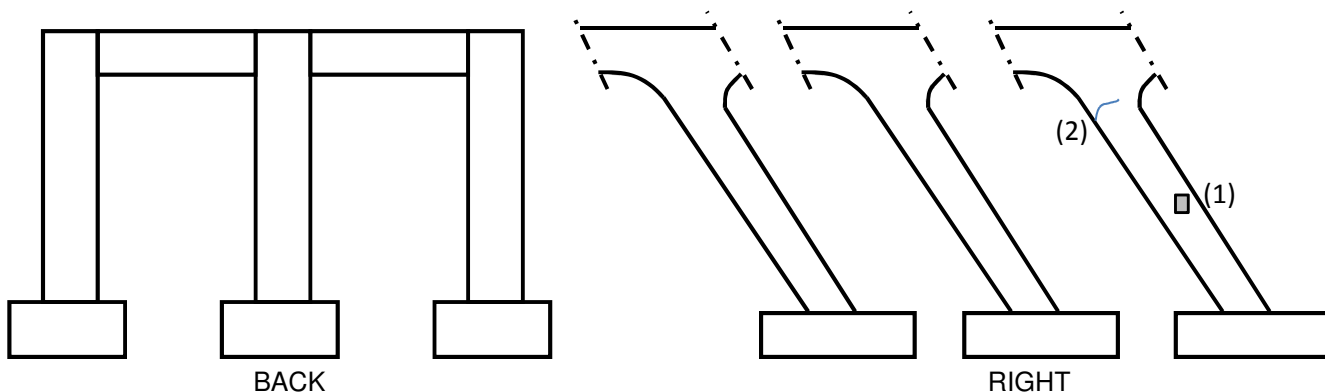
Bent No. 2

COLUMNS	GOOD	(2) PATCHED, H.L. MAP CRACKS IN PATCHES, (1) H.S. POPOUT
CAP BEAM	GOOD	LONGIT. H.C.'S

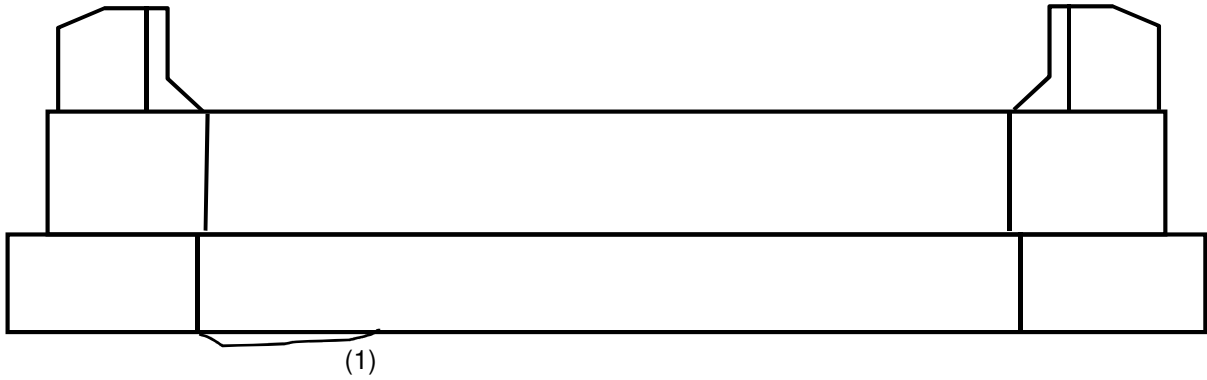
Abutment No. 2

BACKWALL	NV	RANDOM HORIZ H.C.'S
CAP	GOOD	
WINGS	GOOD	
BEARINGS	NV	
SLOPE PVT	GOOD	3" SETTLEMENT 6' L FROM WING
