19I0440003
19-I0440-0.72 RT
1440 RL/CSX RR

BRIDGE MAINTENANCE RECOMMENDATIONS

BRIDGE INSPECTION REPORT

SUMMARY
19-I440-0.72 RT
02/22/2016

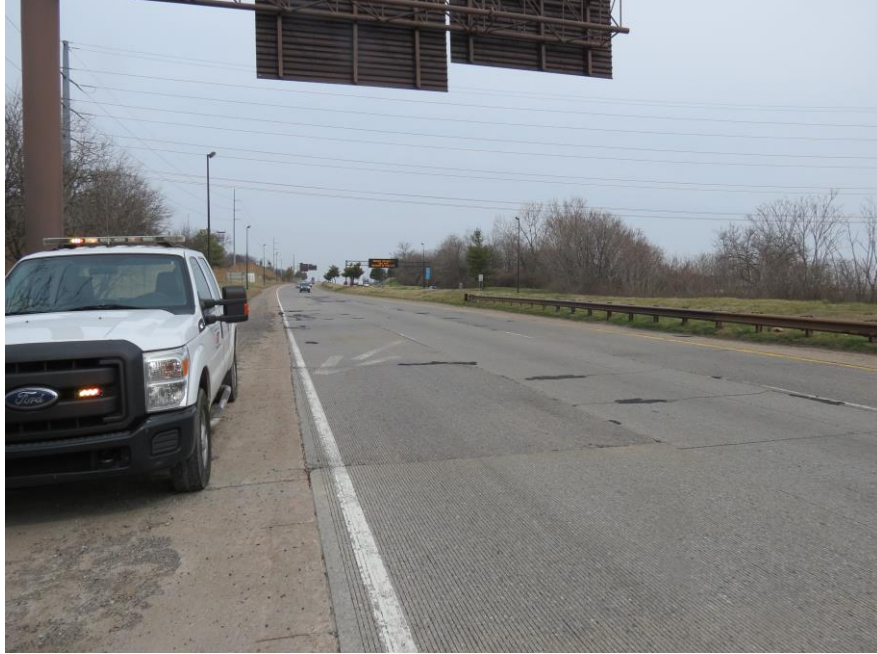
APPROACH "A"

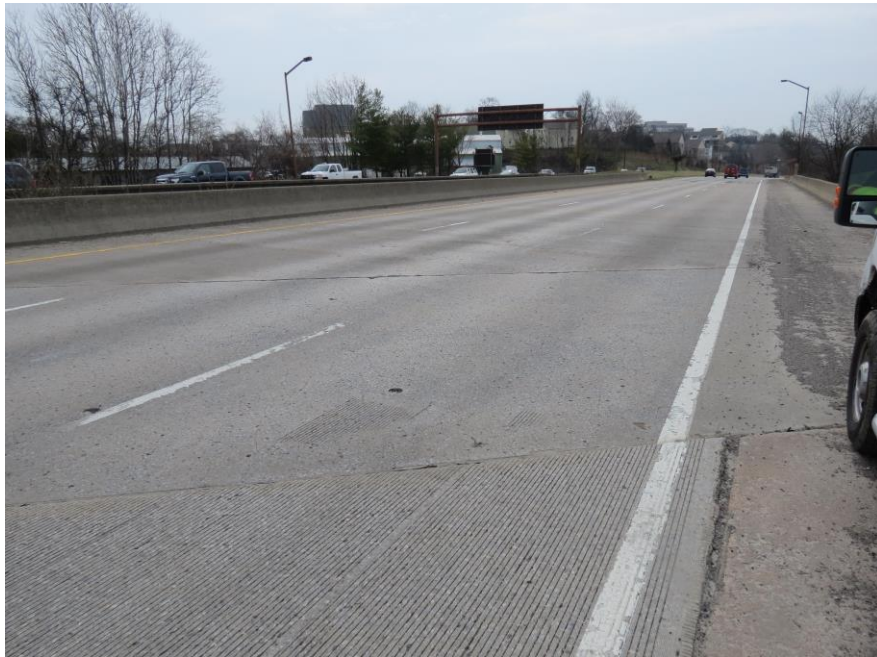
VIEW ACROSS TOP OF WEARING SURFACE

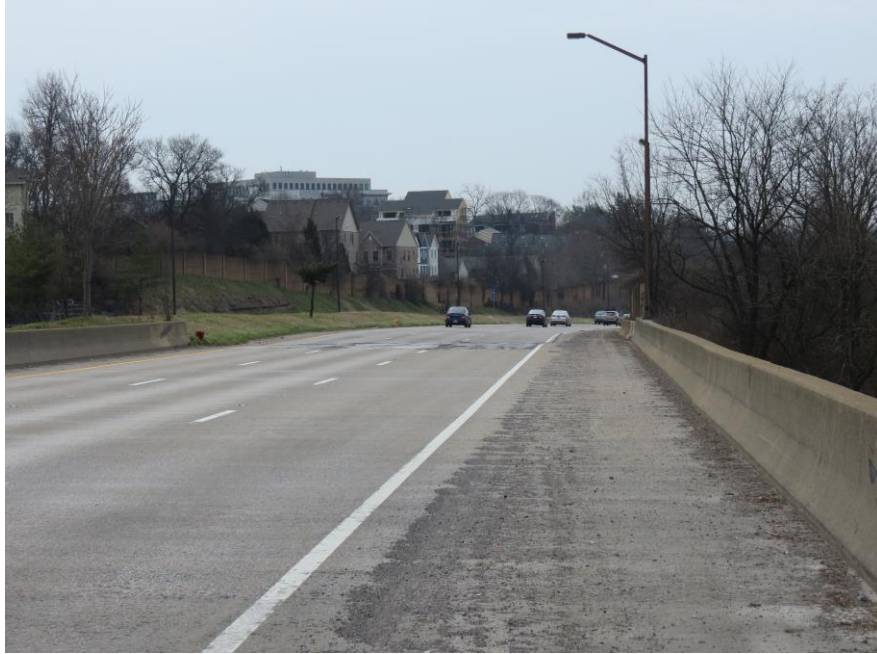
APPROACH "B"

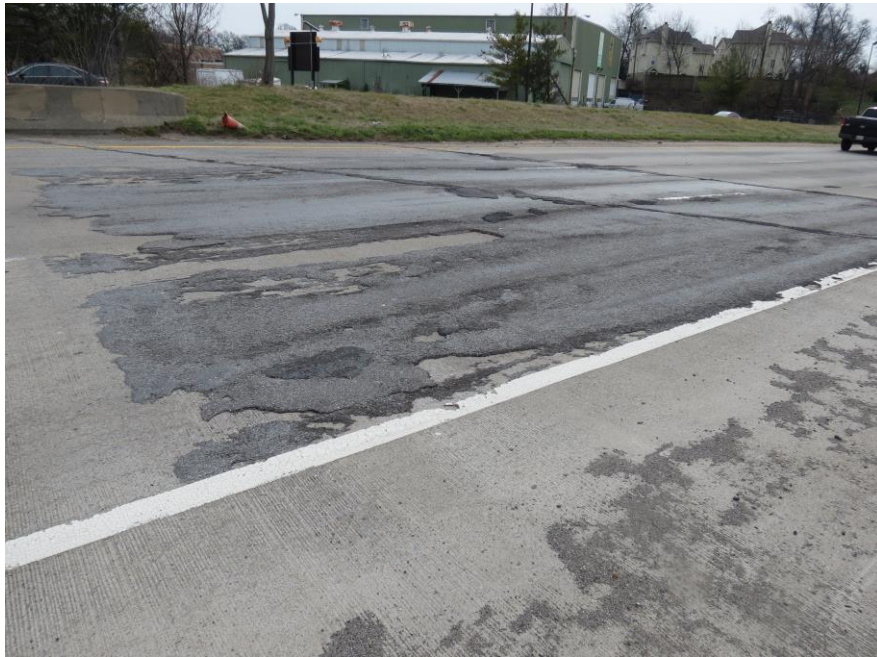
WEARING SURFACE SP. #3 W/ ROUGH A/C , SCALE

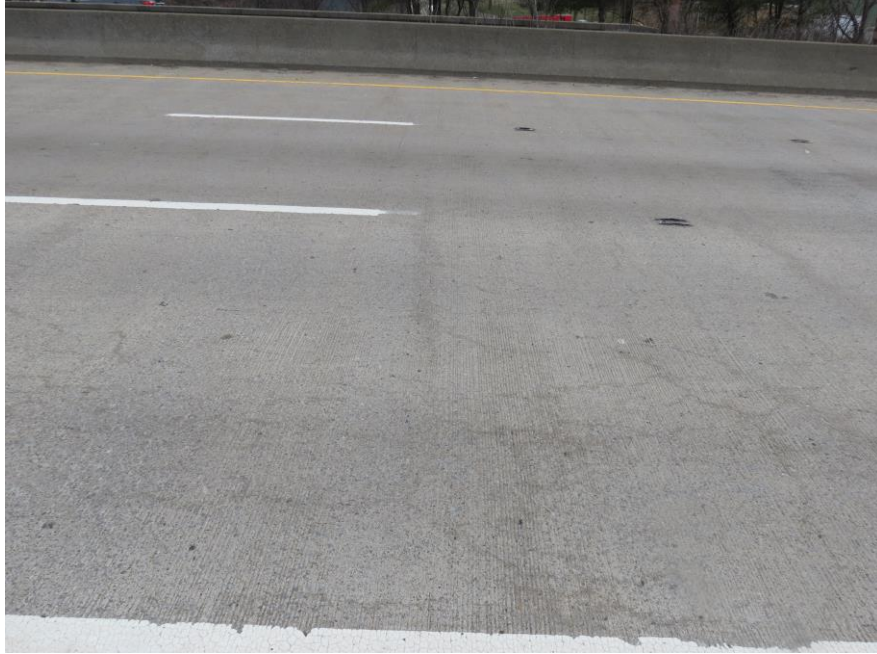
WEARING SURFACE SP. #2 W/ CRACKS

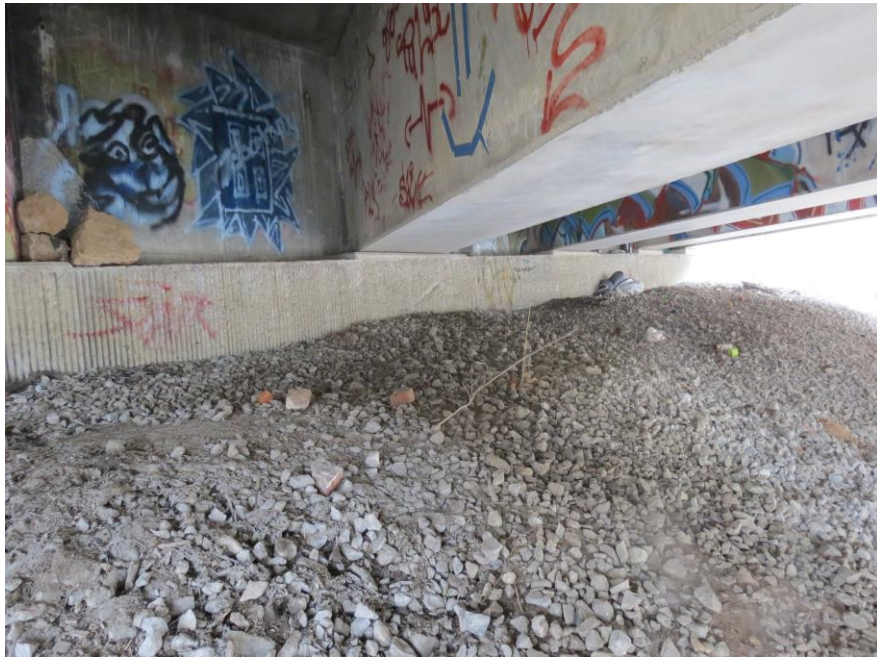
ABUTMENT #1

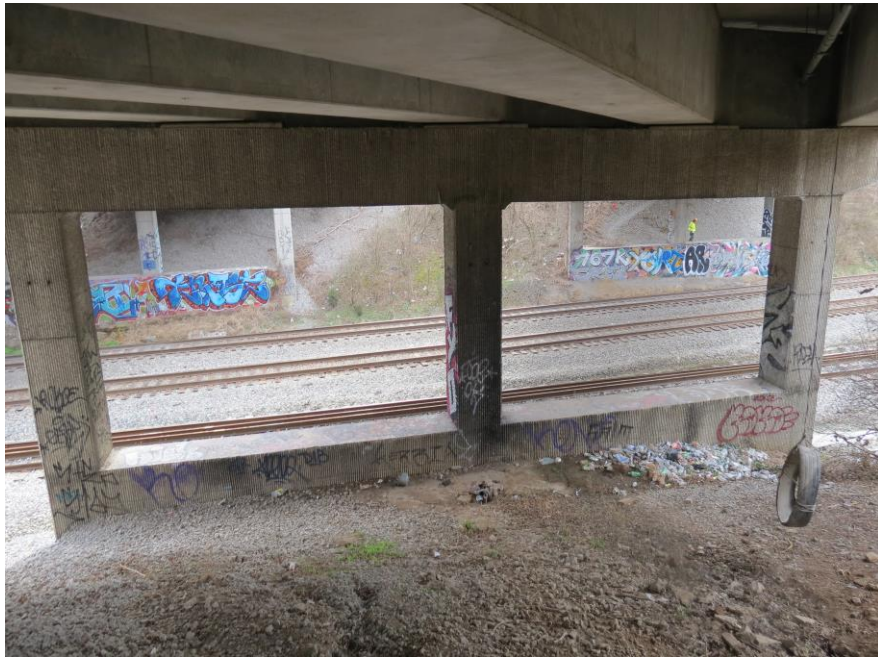
BENT #1 - FRONT VIEW

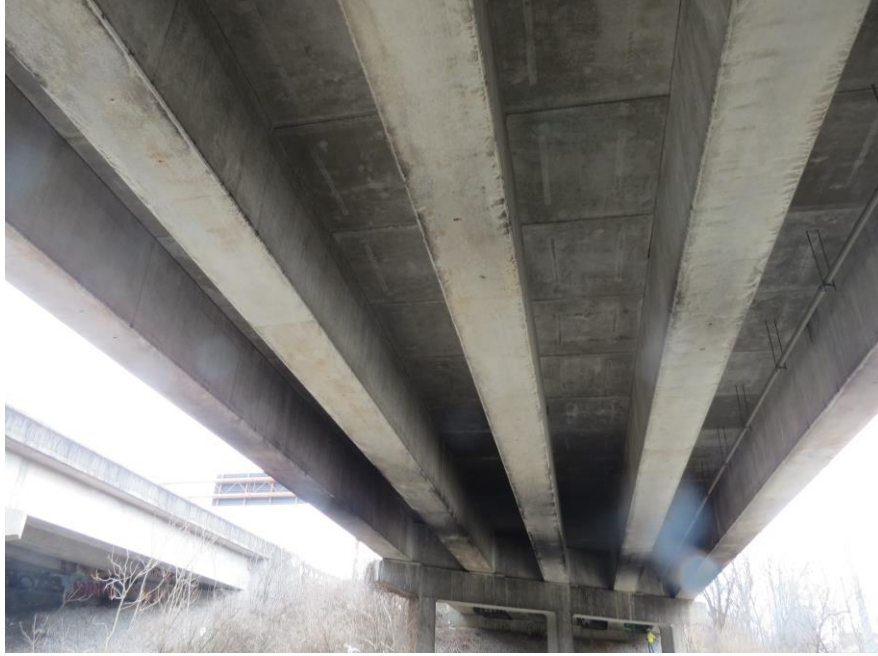
BTM DECK VIEW SP. #2

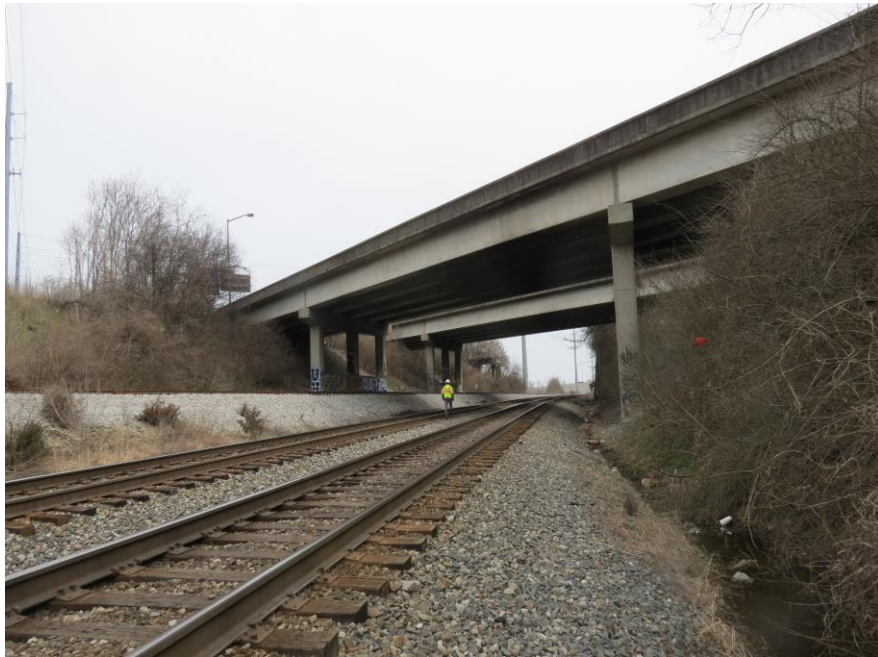
CLEARANCE VIEW RT. SIDE

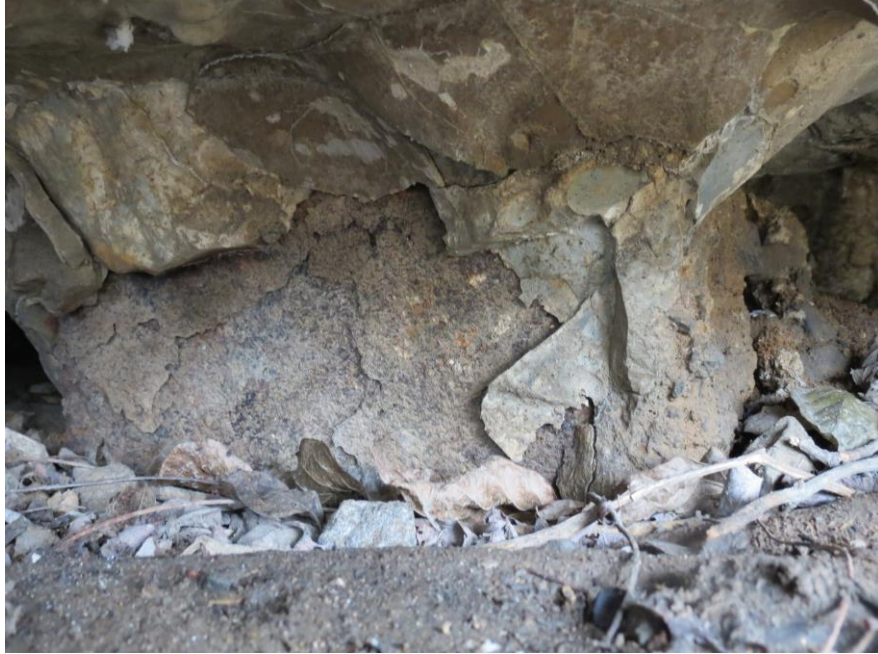
EXP. PILE AT ABUT. #2

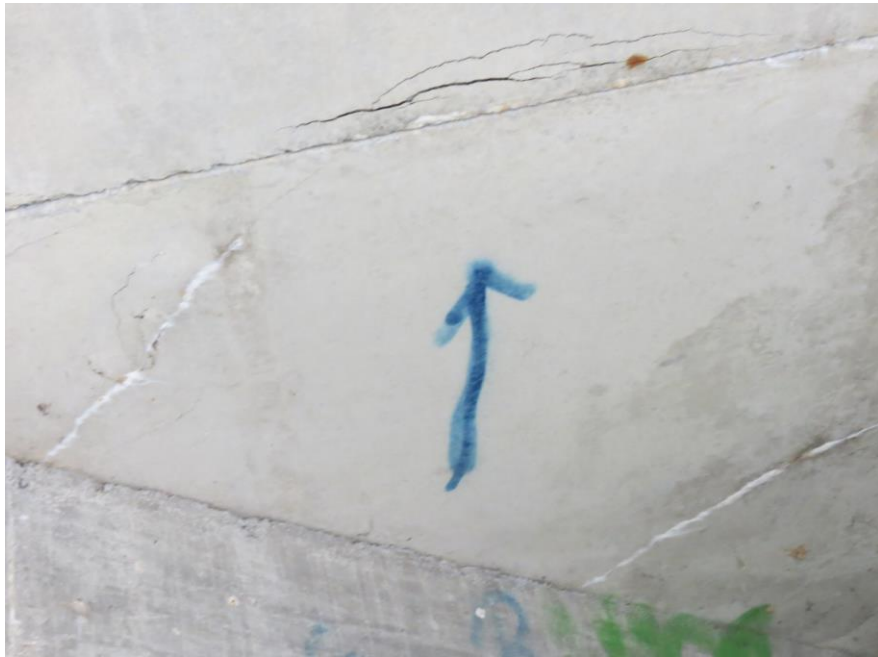
DECK PANEL BAY "D" ABUT.#2 W/ CRACKS

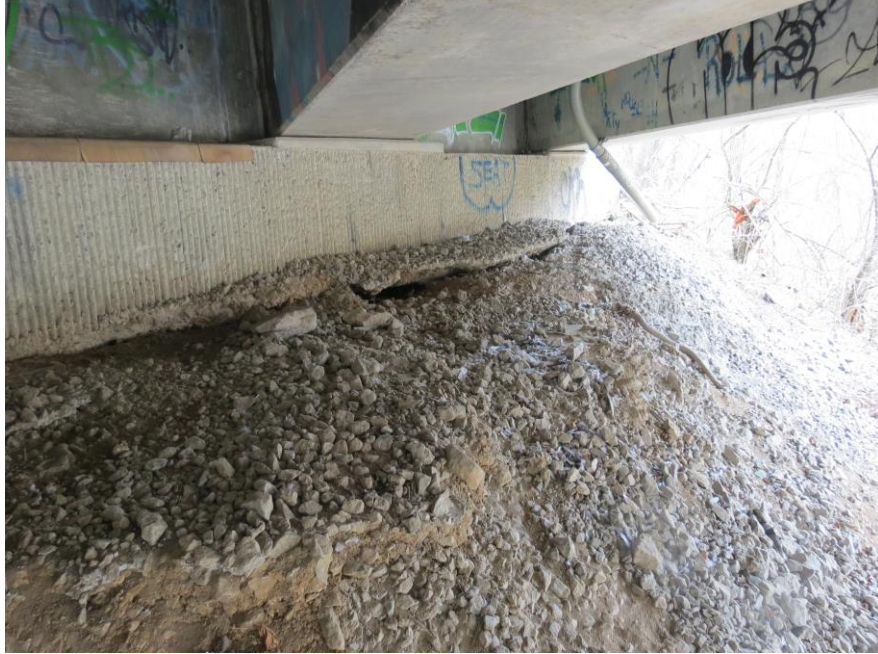
SETTLEMENT AT ABUTMENT #2

SUGGESTED ROUTINE MAINTENANCE AND COMMENTS
REPAIR SETTLEMENT @ ABUTMENT #2
SEAL CONCRETE WEARING SURFACE
REPAIR EXPANSION JOINTS @ BOTH ENDS
REPAIR APPROACH EMBANKMENT "B" END RIGHT SIDE
REPAIR BRIDGE PARAPET RAILING SPAN #3 RIGHT

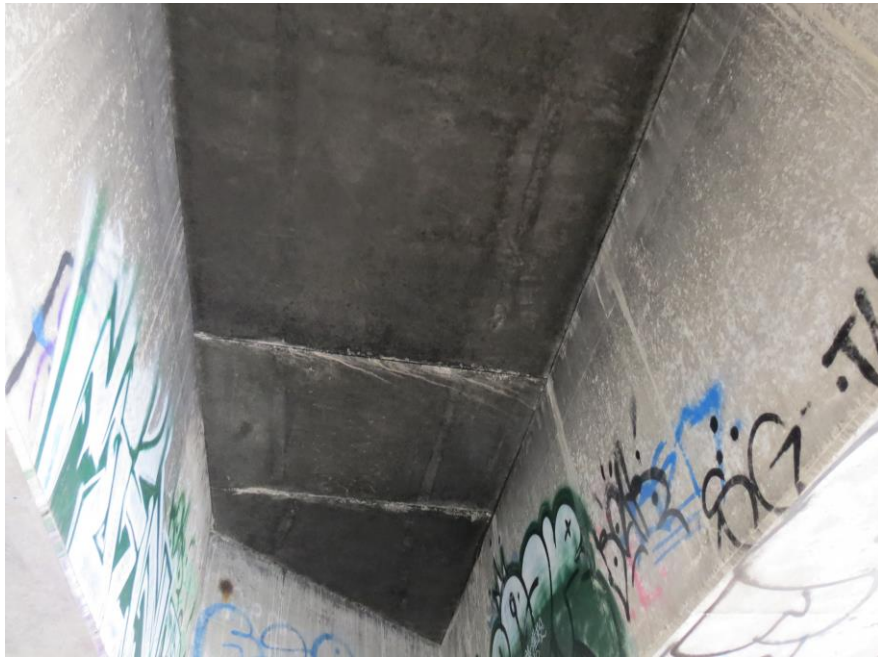
DECK PANEL BAY "B" ABUT. #2 W/ FIRE DAMAGE

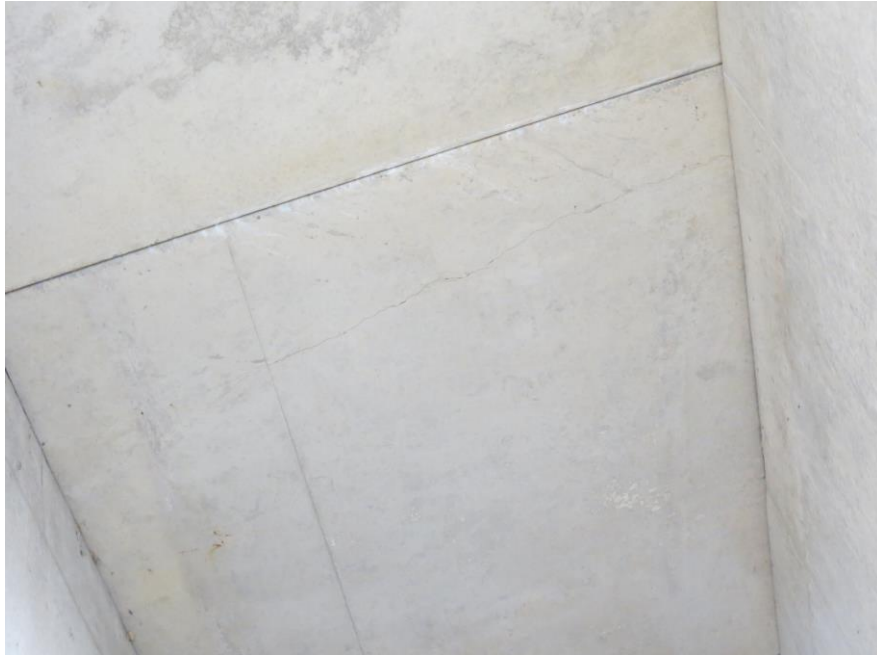
DECK PANEL BAY "A" ABUT. #2 W/ CRACK

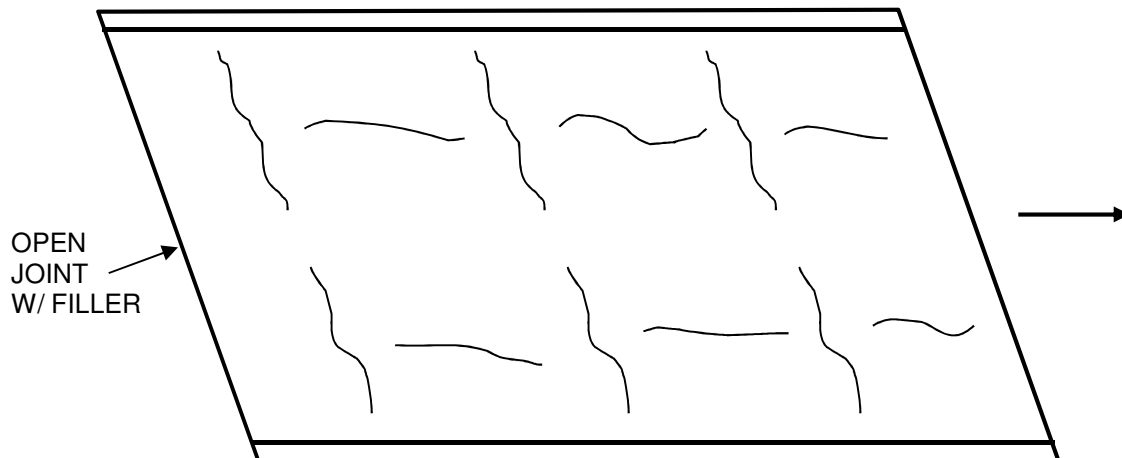
Top of Deck Span No. 1

DECK	FAIR	CONCRETE- LGH-MOD. SCALE 1/4" DP, TRANSV., DIAG.,
		& LONGIT CRACKS 1/8" OPEN
PARAPET	GOOD	STANDARD-LGH SURFACE SCALE, AGG POPOUTS
JOINTS	POOR	HVY FILLER LOSS & MOD. BREAKOUTS 'A' END

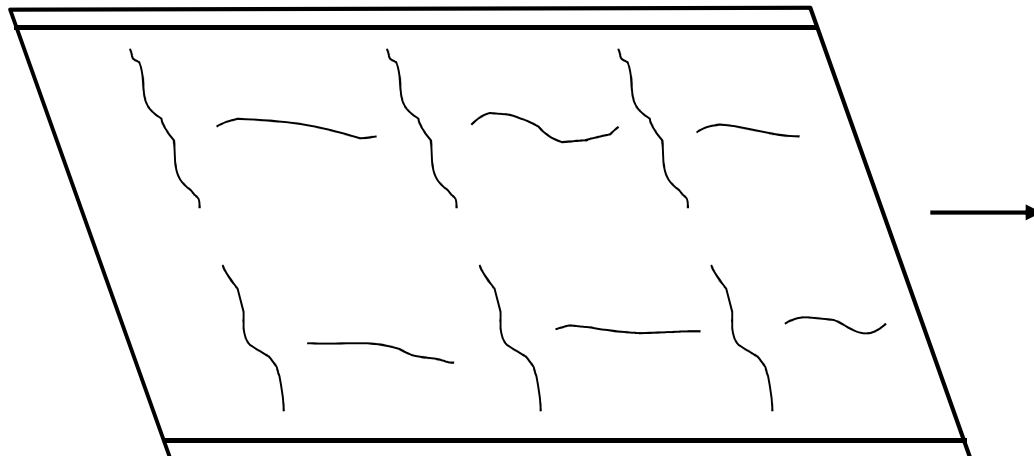
Top of Deck Span No. 2

DECK	FAIR	CONCRETE- LGH-MOD. SCALE 1/4" DP, TRANSV., DIAG.,
		& LONGIT CRACKS 1/8" OPEN
PARAPET	GOOD	LGH. SCALE, AGG POPOUTS

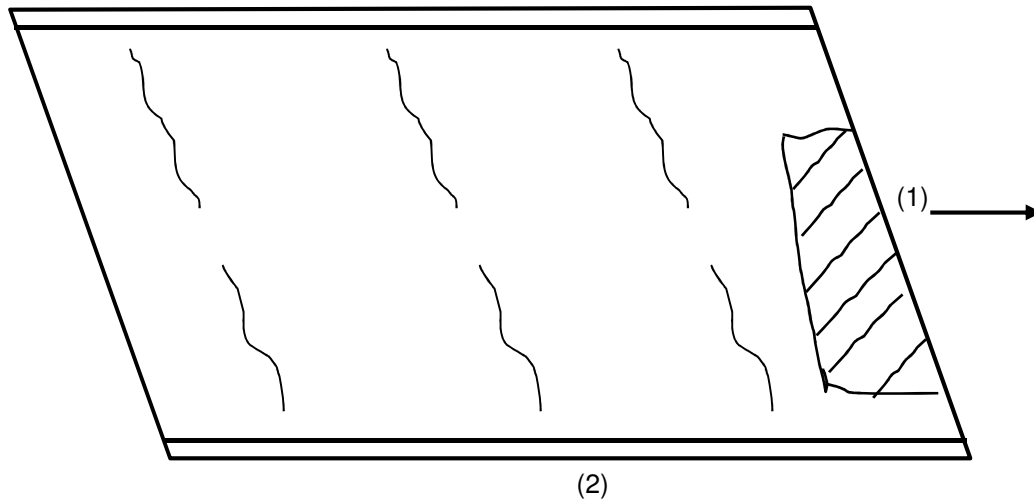
Top of Deck Span No. 3

DECK	FAIR	CONCRETE-LGH. TRANSV. LGH. H.C.'S, LGH-MOD SCALE, (1) ROUGH A/C OVERLAY
PARAPET	FAIR	(2) MOD. - HVY SCALE W/EXP. STL.
JOINTS	POOR	FILLED W/ ASPHALT, FAILING A/C PATCHES

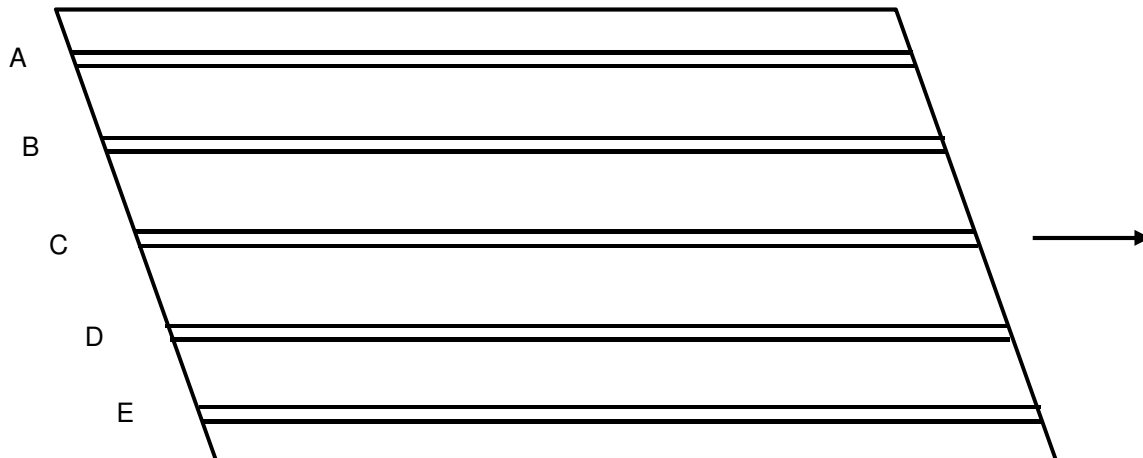
Bottom of Slab Span No. 1

DECK	GOOD	SOOT STAINS
DIAPHRAGMS	GOOD	
BEAMS	GOOD	H.L. MAP CRACKS ALL BEAMS @ ABUT.
OVERHANG	GOOD

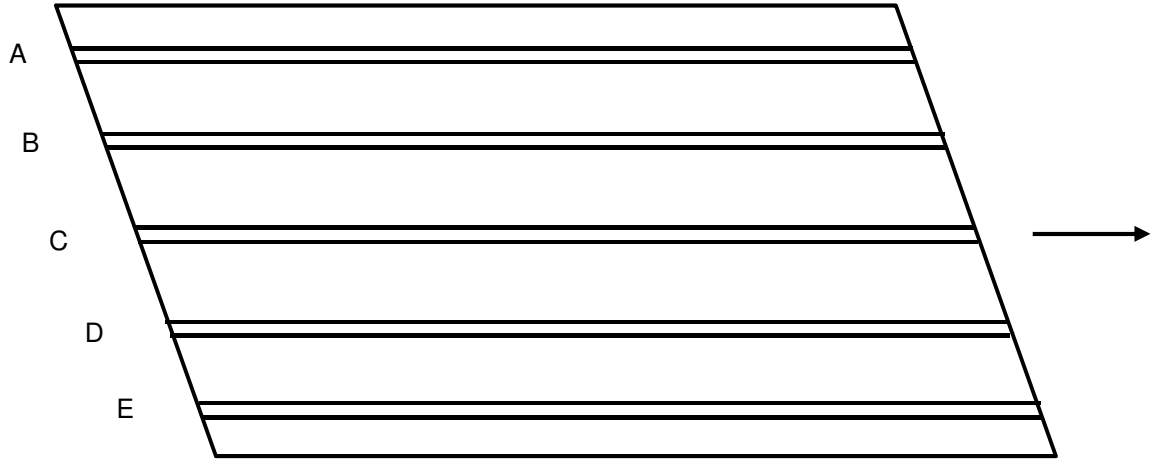
Bottom of Slab Span No. 2

DECK	GOOD	HVY SOOT STAINS
DIAPHRAGMS	GOOD	
BEAMS	GOOD	HVY SOOT STAINS
OVERHANG	GOOD	H.C.'S W/ EFF.

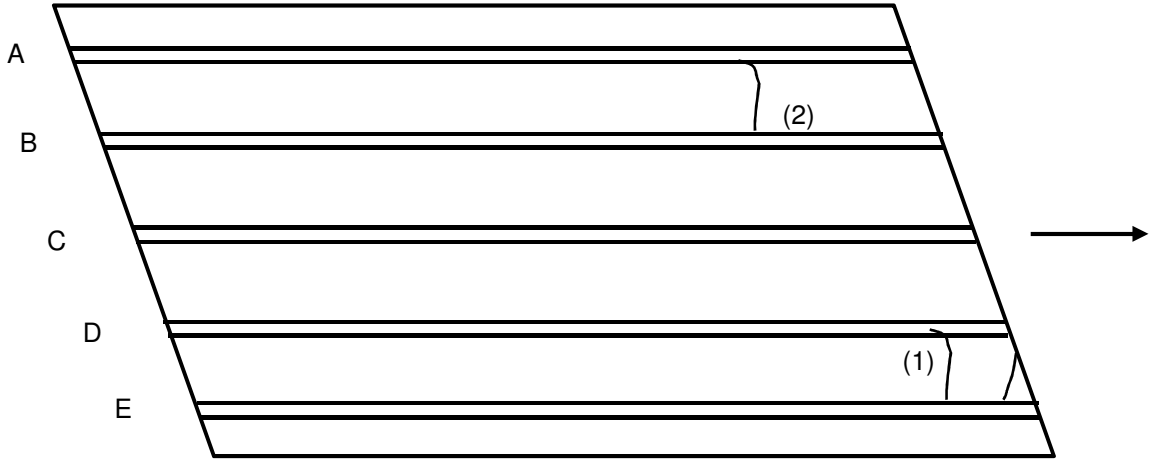
Bottom of Slab Span No. 3

DECK	GOOD	(1) I.P.B.O. 6" DIA, TRANSV CRACKS W/EFF, BAY 'D' PANEL 7 & 8, (2) TRANSV. CRACKS @ PANEL 7 BAY 'A' UP TO 1/16" OPEN.
DIAPHRAGMS	GOOD	
BEAMS	GOOD	H.L. MAP CRACKS ALL BEAMS @ ABUT.
OVERHANG	GOOD

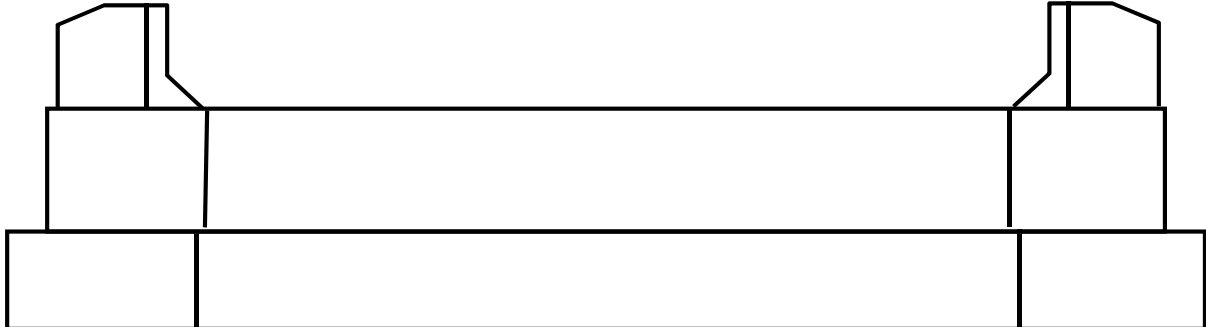
Abutment No. 1

BACKWALL	GOOD	RANDOM DIAG VERT H.C.'S W/EFF, SPALL 3' H X 2' W X 1' DP
		BETWEEN BEAMS 'D' & 'E'
CAP	GOOD	
WINGS	GOOD	
BEARINGS	GOOD	
EMBANKMENT	GOOD

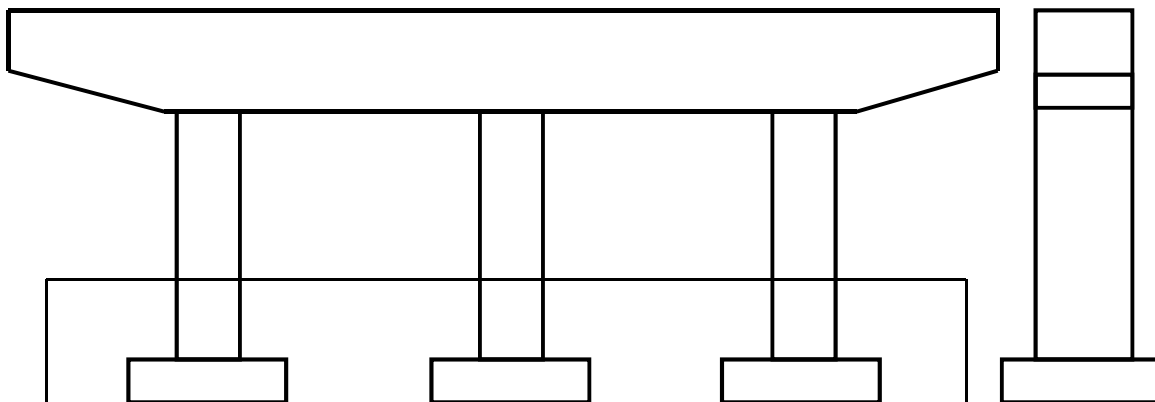
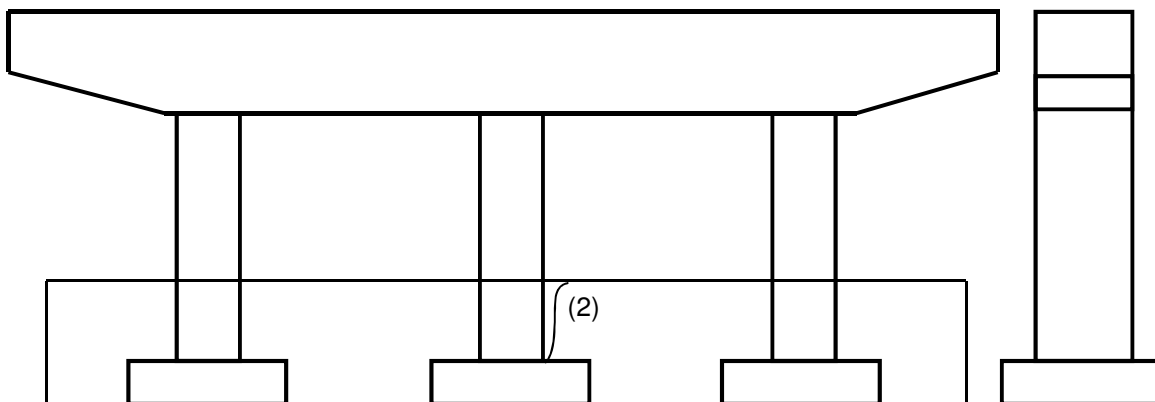
Bent No. 1

CAP	GOOD	I.P.B.O., RANDOM LONGIT H.C.'S
COLUMNS	GOOD	
FOOTINGS	NV	
BEARINGS	GOOD	
CRASH WALL	GOOD	(2) VERT. CRACK 1/8" FULL HEIGHT

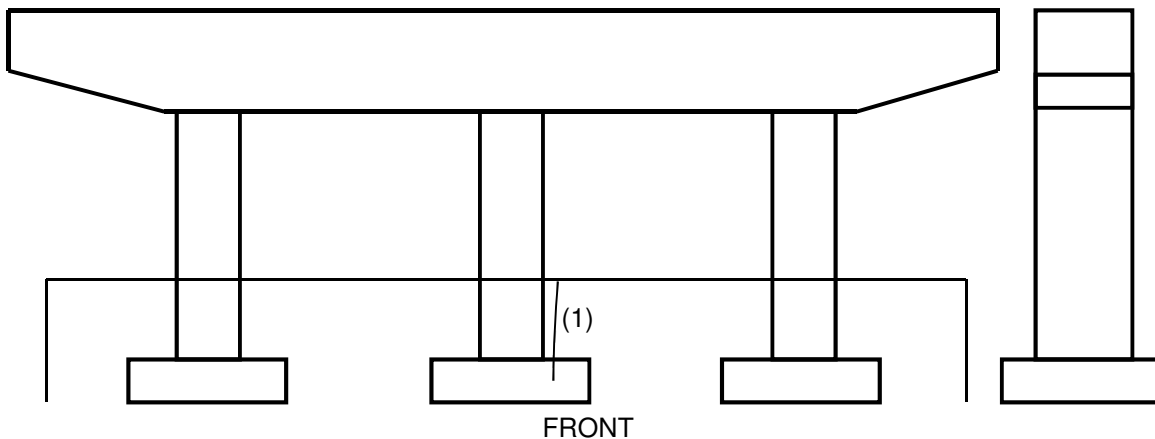
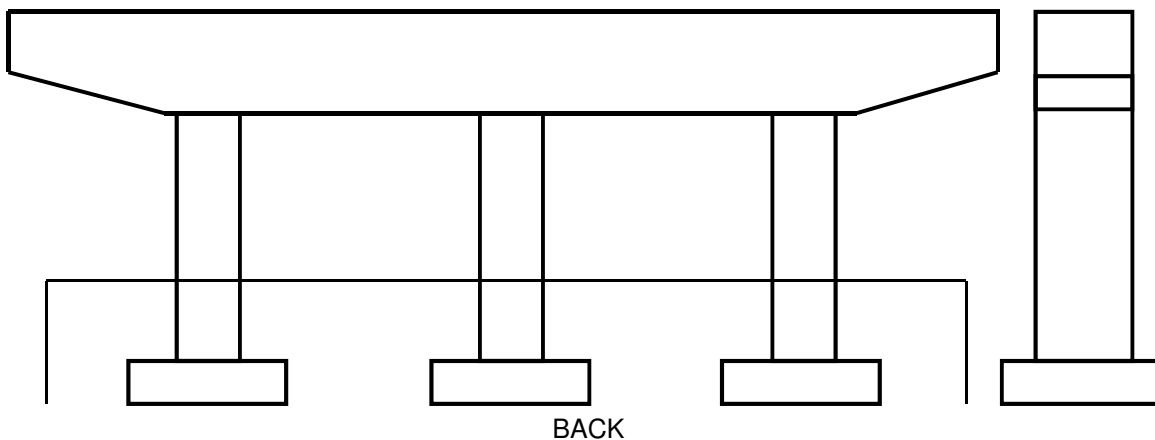
Bent No. 2

CAP	GOOD	RANDOM H.S. POPOUTS
COLUMNS	GOOD	
FOOTINGS	NV	
BEARINGS	GOOD	
CRASH WALL	GOOD	(1) VERT. CRACK 1/8" X 7' L

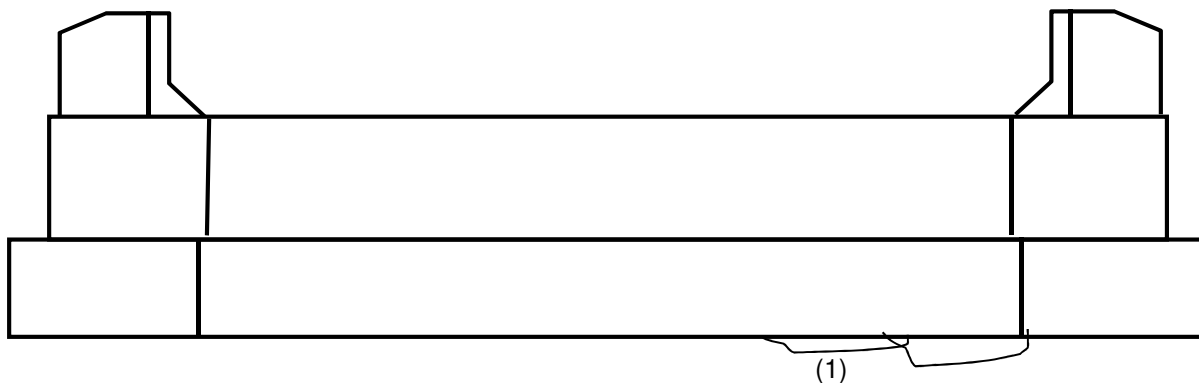
Abutment No. 2

BACKWALL	GOOD	
CAP	GOOD	
WINGS	GOOD	
BEARINGS	GOOD	
EMBANKMENT	FAIR	(1) SETTLEMENT 6" H X 20' L W/1 EXP. PILE
PILES	GOOD	LIGHT CORROSION
