19104400004 19-10440-0.72 LT 1440 LL/CSX RR

BRIDGE MAINTENANCE RECOMMENDATIONS COUNTY: DAVIDSON LOCATION: 19-I0440-00.72-L CO. SEQ.: 1 SPEC. CASE: 0 MILEPOST: 0.63 CROSSING: I440-LL / CSX RR REPA FED. BRIDGE NO.: 19I04400004

BRIDGE INSPE	ECTION REPORT		Page No
Form BIR 3.0	Field Report No.	20	Date 2/22/2016
(Rev. 9-22-98)	Previous Report No.		Date 2/25/2014
DT-0069	Plans:	DESIG	<u>SN</u>
Bridge No. 19104400004	Bridge Location No.	19 -	10440 - 0.72 L
Eleven Digit No.		Co.	Route Log Mile
I440 over CSX	Crossing	Structu	ure Name (If Named)
Year Constructed 1986 ACTUAL	County Davidson		enance District 37
Year Widened	Year Rehabilitated		
FEATURES			INSPECTORS
Wearing Surface CONCRETE De	epth(in.)	1.	BILLINGSLEY TL
Flared Width NO Median	Width OPEN	2.	VOGEL
Navigational Control NO Bridge	Skew 52 °RT	3.	BROWN
Structure Type (Main Span) HBB		4.	LOVE
Structure Type (Appr.Spans)		5.	
No. Main Spans 3 No. Approach 9	Spans	6.	
Maximum Span Length 114.5' (**.* ft.))	7.	
Total Length 248' (**.* ft.))	8.	
		I	
<u>WIDTHS</u> (*.* ft.) Deck Out-to-Out 56'	CLEARANCES Min. Vertical Clearance ov	or Dool	(2011" (ft in)
			(
Roadway Curb/Curb	Min. Vertical Under Cleara		<u>25'2"</u> (ftin.)

SUMMARY 1

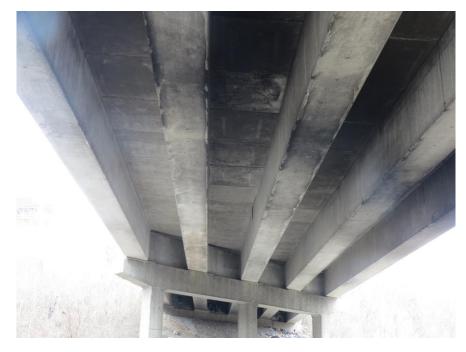
BTM DECK VIEW SP. #2

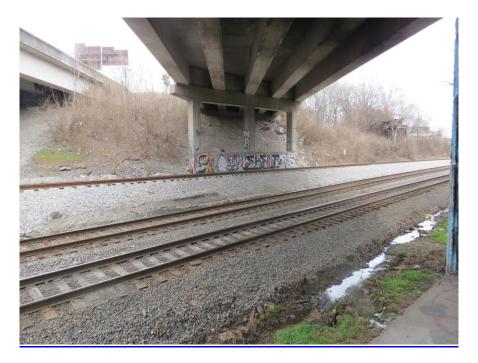
BENT #1 - BACK VIEW

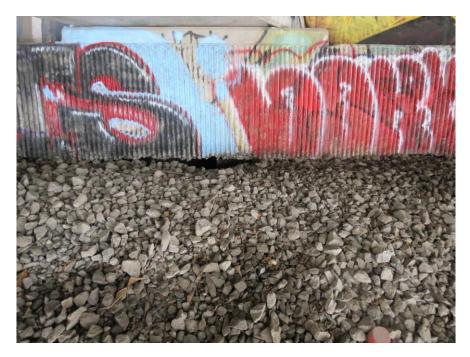
SETTLEMENT AT ABUTMENT #2

Abutments and bents are good. Abutment #1 has moderate settlement with two exposed piles. Abutment #2 has moderate settlement with two exposed piles with light rust.

SUGGESTED ROUTINE MAINTENANCE AND COMMENTS
REMOVE TRASH @ ABUTMENTS
REPAIR SETTLEMENT @ BOTH ABUTMENTS
SEAL CONCRETE WEARING SURFACE
REPAIR EXPANSION JOINT AT APPROACH SLAB "A" END
REPAIR CONCRETE BASE UNDER LIGHT FIXTURE
SEAL BRIDGE PARAPET

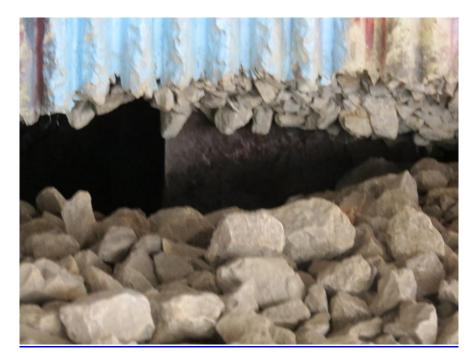
EXP. PILE W/ CORROSION AT ABUT. #2

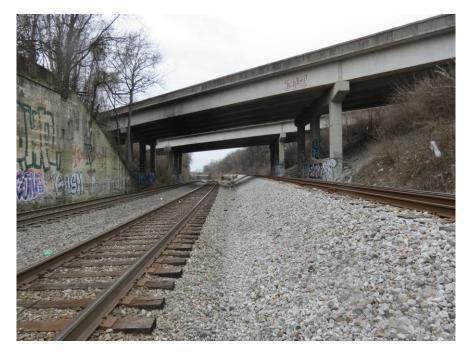
CLEARANCE VIEW LT. SIDE

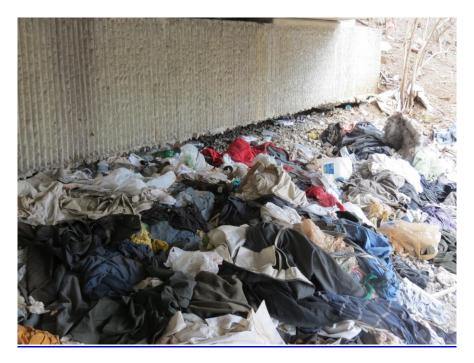
SETTLEMENT AT ABUTMENT #1

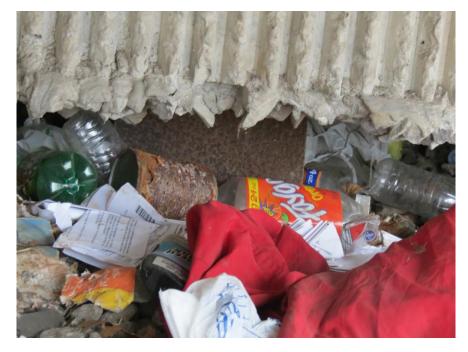
EXP. PILE W/ PITTING AT ABUT. #1

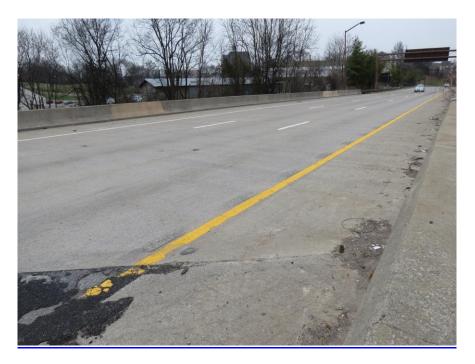
VIEW ACROSS TOP OF WEARING SURFACE

The concrete wearing surface is fair with moderate to heavy longitudinal and transverse cracks and moderate scaling. Expansion joints are poor with failing filler and breakouts.

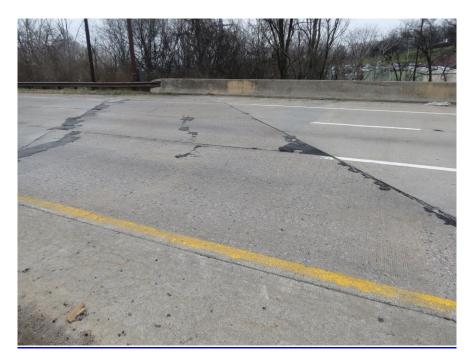
APPR. "B" END W/ PATCHES

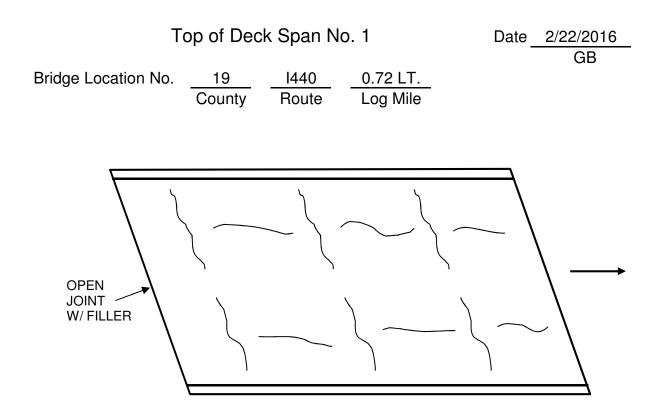
DECK	FAIR	CONCRETE- MOD - HVY TRANSV. & LONGIT CRACKS 1/8" OPEN,	
		MOD. SCALE, AGG POPOUTS	
PARAPET	GOOD	STANDARD-LGH SCALE, AGG POPOUTS, LONGIT CRACKS	
		1/16" OPEN	
JOINTS	POOR	OPEN TYPE W/ FILLER LOSS OF FILLER, A/C PATCHES

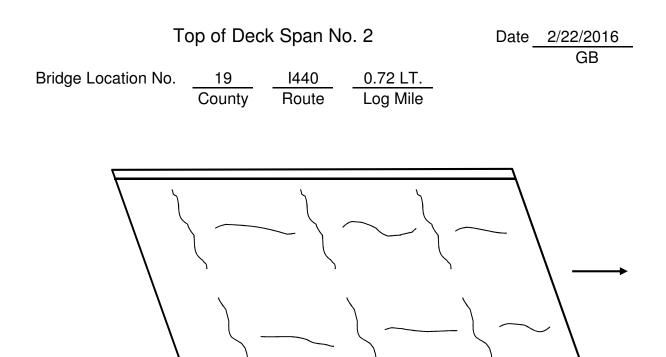
DECK	FAIR	CONCRETE-MOD - HVY TRANSV. & LONGIT CRACKS 1/8" OPEN,	
		MOD. SCALE	
PARAPET	GOOD	STANDARD-LGH SCALE, LONGIT CRACKS 1/16" OPEN

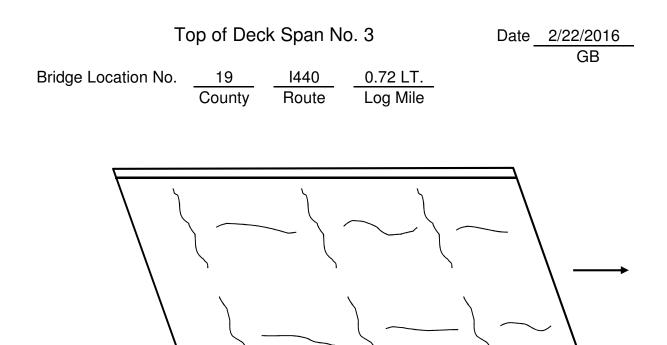
DECK	FAIR	CONCRETE-MOD - HVY TRANSV. & LONGIT CRACKS 1/8" OPEN,	
		MOD. SCALE,& AGG. POPOUTS	
PARAPET	GOOD	STANDARD-LGH. SCALE, AGG POPOUTS	
JOINTS	FAIR	FILLER LOSS, ADHESIVE FAILURES

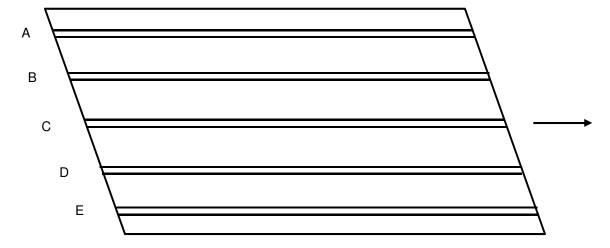
DECK	GOOD	
DIAPHRAGMS	GOOD	
BEAMS	GOOD	H.L. MAP CRACKS ALL BEAMS @ ABUT.
OVERHANG	GOOD

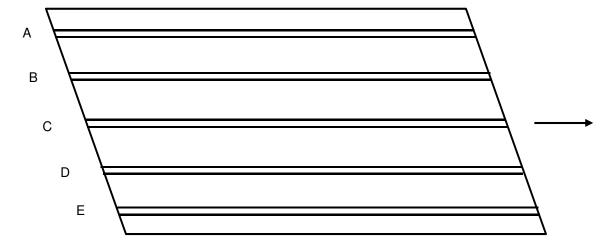
DECK	GOOD	SOOT STAINS
DIAPHRAGMS	GOOD	
BEAMS	GOOD	SOOT STAINS
OVERHANG	GOOD

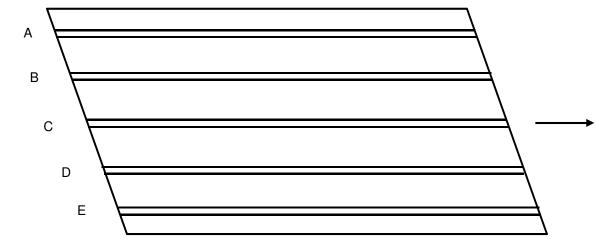
DECK	GOOD	TRANSV./LONGIT. H.C.'S PANEL #7, BAYS 'C' & 'D'
DIAPHRAGMS	GOOD	
BEAMS	GOOD	H.L. MAP CRACKS ALL BEAMS @ ABUT.
OVERHANG	GOOD

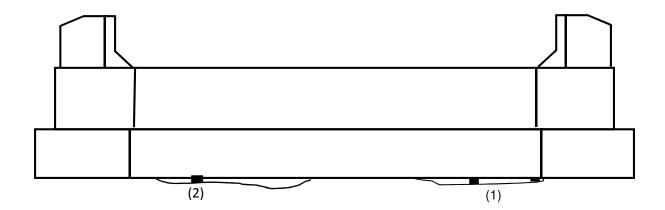
BACKWALL	GOOD	RANDING H.C.'S
CAP	GOOD	
WINGS	GOOD	
BEARINGS	GOOD	
EMBANKMENT	FAIR	(1) SETTLEMENT 6" DP X 2.5' UNDER X 16' L W/ 2 EXPOSED PILES
		HVY TRASH BLD. UP, (2) SETTLEMENT 4"DP X 2.5' UNDER X 12'L
		W/1 EXP. PILE
PILES	GOOD	LIGHT CORR. (3 EXPOSED)

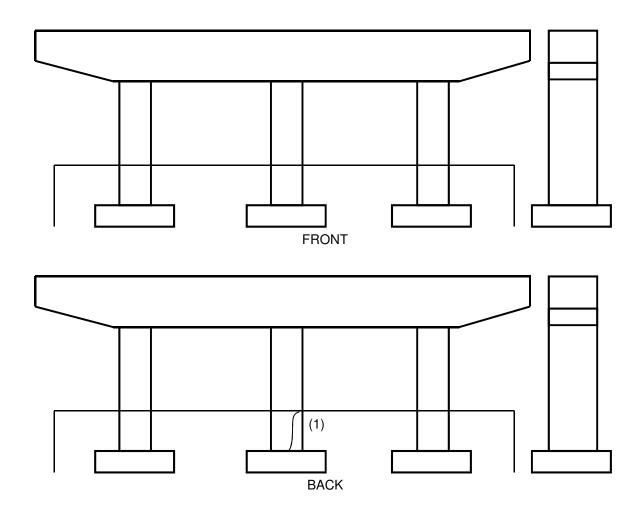
CAP	GOOD	H.C.'S		
COLUMNS	GOOD			
FOOTINGS	NV			
	0000			
BEARINGS	GOOD			
			PRODUCED PURSUAN	ТО
CRASH WALL	GOOD	(1) 1/8" OPEN VERT. CRACK FULL HEIGHT	PUBLIC RECORDS REQ	UEST
			This document is covered by 23 And its production pursuant t	
			document records request d waive the provisions of §	oes not

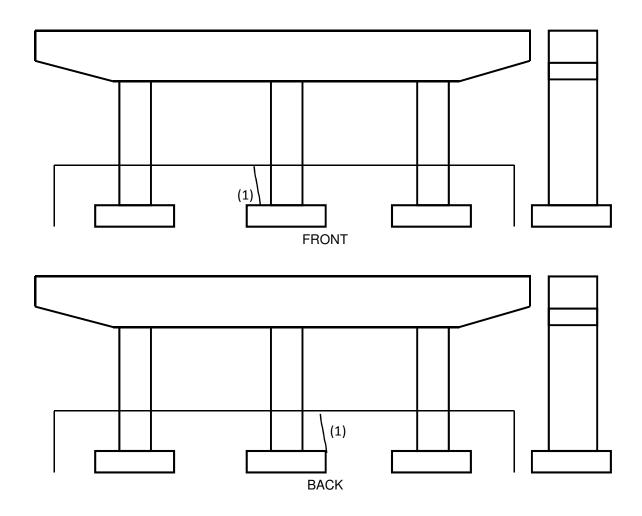
CAP	GOOD			
COLUMNS	GOOD			
FOOTINGS	NV			
BEARINGS	GOOD			
			PRODUCED PURSUANT TO	
CRASH WALL	GOOD	(1) 1/8" VERT. OPEN CRACK	PUBLIC RECORDS REQUEST This document is covered by 23 USC §4 And its production pursuant to a public	
			document records request does not waive the provisions of §409	UC .

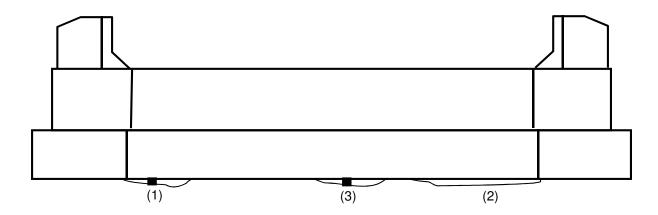
BACKWALL	GOOD	
CAP	GOOD	
WINGS	GOOD	
BEARINGS	GOOD	
EMBANKMENT	FAIR	(1) SETTLEMENT 3" H X 2' UNDER X 6' L W/ 1 EXPOSED PILE
		(2) SETTLEMENT 3" H X 1' UNDER X 25' L , HVY TRASH BLD-UP
		(3) SETTLEMENT 3' L X 4" H X 2' UNDER W/ 1 EXPOSED PILE
PILES	GOOD	(1) & (3) LIGHT CORR. (2 EXPOSED)
