19104400027
19-10440-4.17 RT
10440 RL/LELAND LANE

BRIDGE INSPECTION REPORT

Field Report No. 21 Date 3/4/2016
Previous Report No. 20 Date 3/6/2014
Plans: DESIGN

SUMMARY
19-I440-4.17 RT
3/4/2016

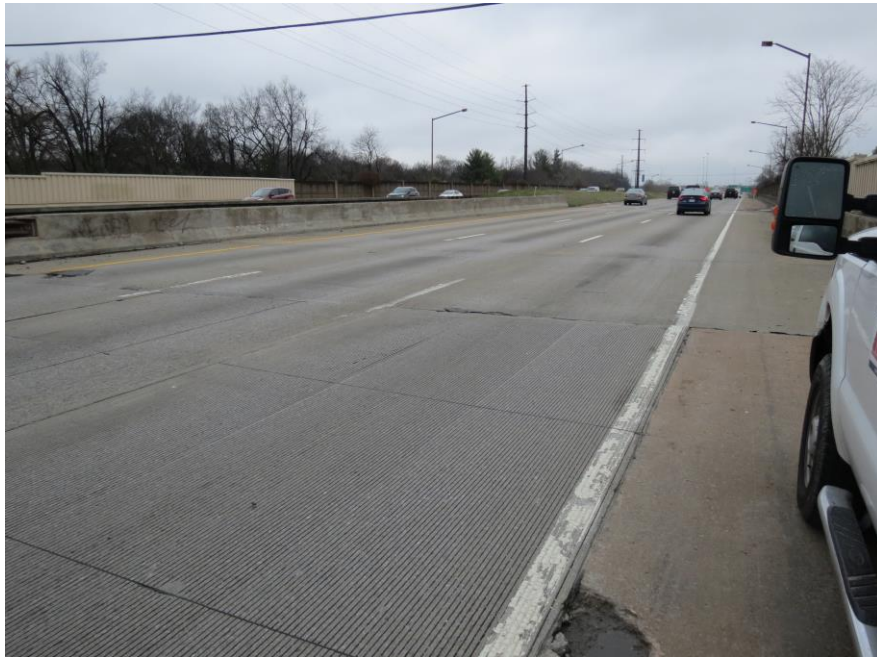
VIEW ACROSS TOP OF WEARING SURFACE EBL

The concrete wearing surface is fair due to longitudinal and transverse cracks up to 1/16" open and a 4' X 4' failing patch. Expansion joints are poor due to minor breakouts and 100% loss of filler.

SEAL CRACK(S) IN DECK WEARING SURFACE

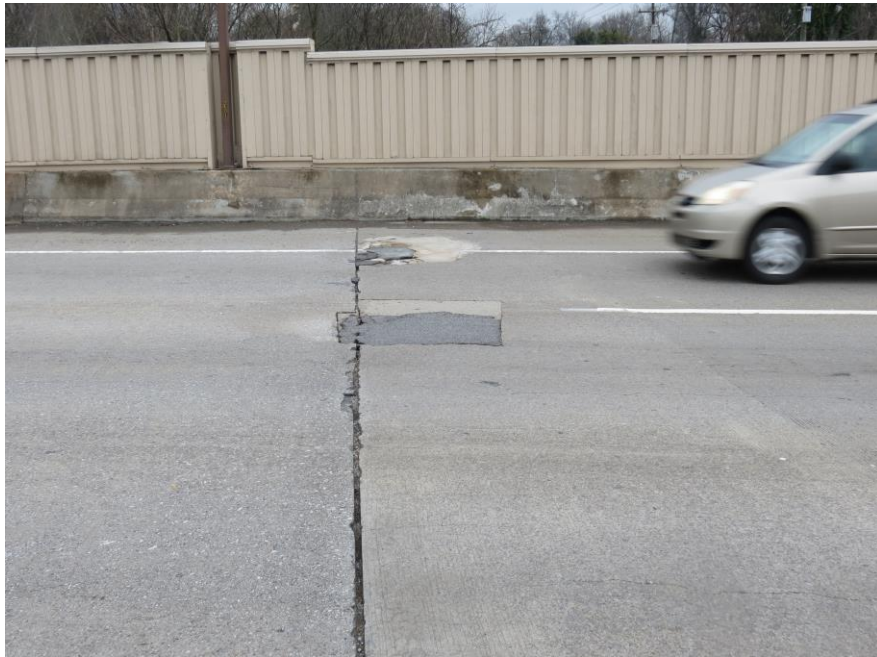
WEARING SURFACE "B" END W/ PATCHES & POTHOLE

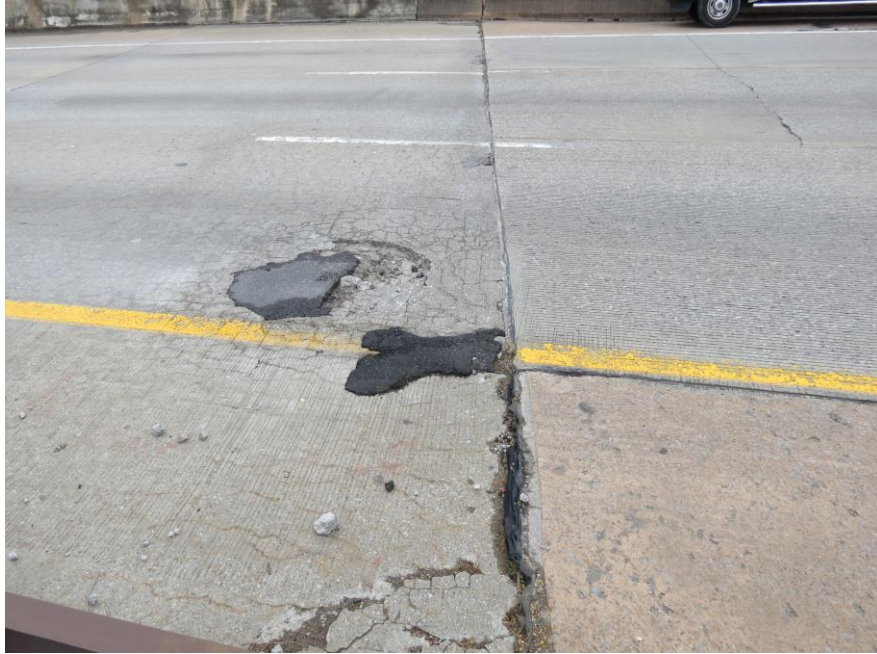
WEARING SURFACE "A" END W/ PATCHES

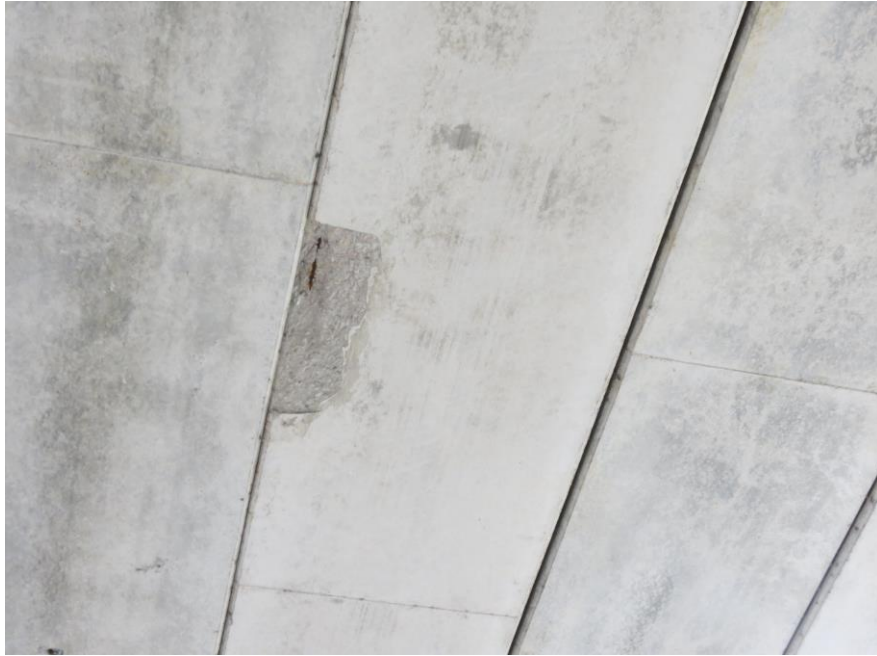
BOX BEAM "H" W/ SPALL & EXP. REBAR

Bearing Devices	GOOD	
Girders or Beams	GOOD	BEAM 'H' SPALLS W/ EXP. STEEL 4" DP, BMS 'A' & 'M'- LONGIT & DIAG. CRACKS
Floor Beams	NA	
Stringers	NA	
Diaphragms	NV	
Bracing	NA	
Trusses - General	NA	
Portals	NA	
Bracing	NA	
Paint	NA	
Alignment of Members	GOOD

Beam "H" is fair due to 2' x 1' x 4" deep spall with exposed steel.

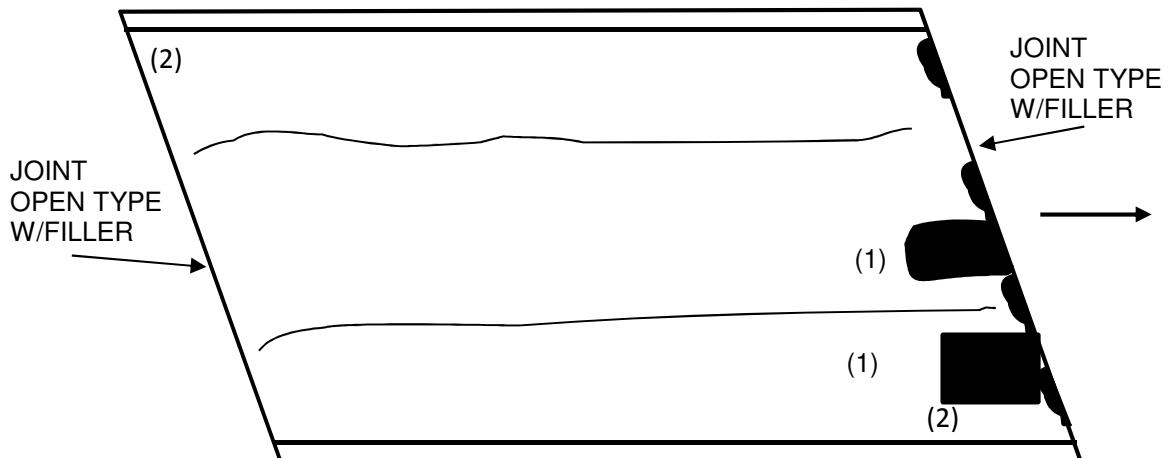
Top of Deck Span No. 1

DECK	FAIR	MOD. LONGIT CRACK 1/16" OPEN & (1) PATCHES 4' X 4' AND 6' X 3'. CONC. B.O.'S @ SAW CUT JOINT 'B' END, (2) POT HOLE 2' DIA.
PARAPET	GOOD	STANDARD= SURFACE SCALE & H.L. VERT. CRACKS
JOINTS	POOR	MOD. B.O.'S AND HVY DEBRIS W/FILLER LOSS "B" END

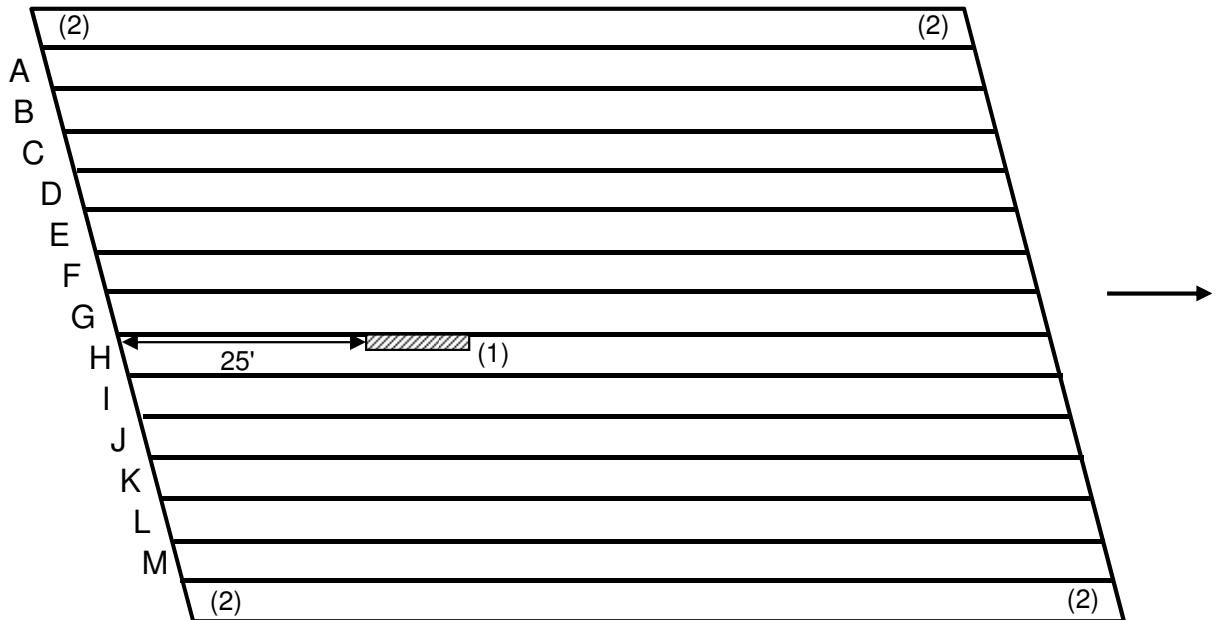
Bottom of Slab Span No. 1

DECK	NV	
BEAMS	GOOD	(1) BEAM 'H' HAS A 1' X 2' SPALL W/ EXPOSED REBAR 4" DP
"A" & "M"	GOOD	(2) LONGIT. CRACK .010" OPEN X FULL LENGTH
"A"	GOOD	DIAG. H.C. @ ABUT #1
OVERHANGS	GOOD

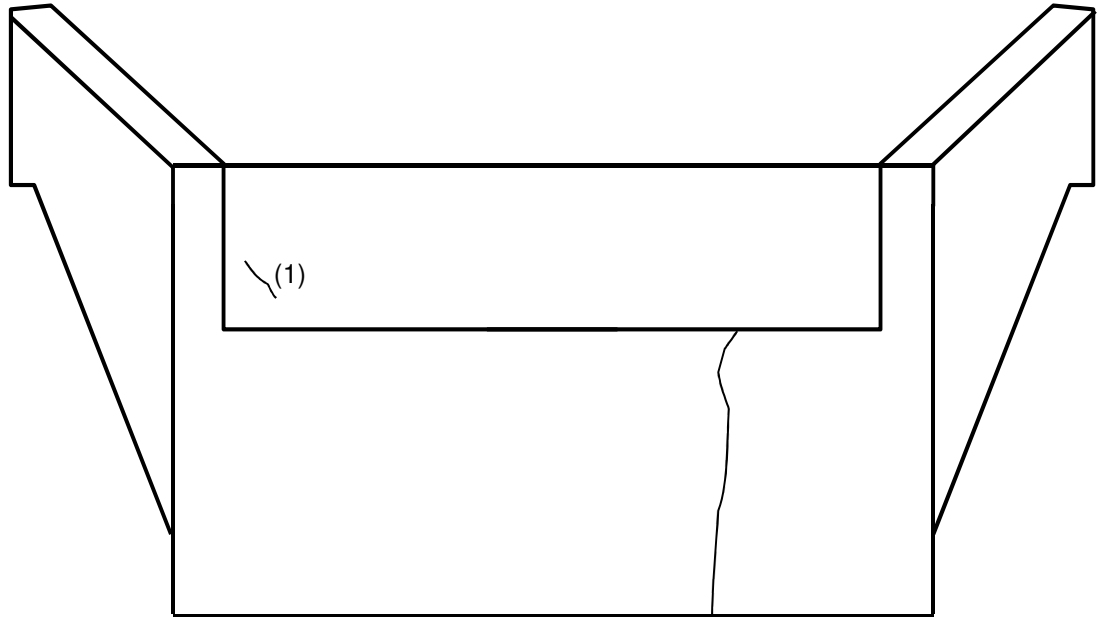
Abutment No. 1

BACKWALL	GOOD	(1) DIAG. H.C. W/ EFF.
WALL	GOOD	RANDOM VERT H.C.'S
WINGS	GOOD	
BEARINGS	NV

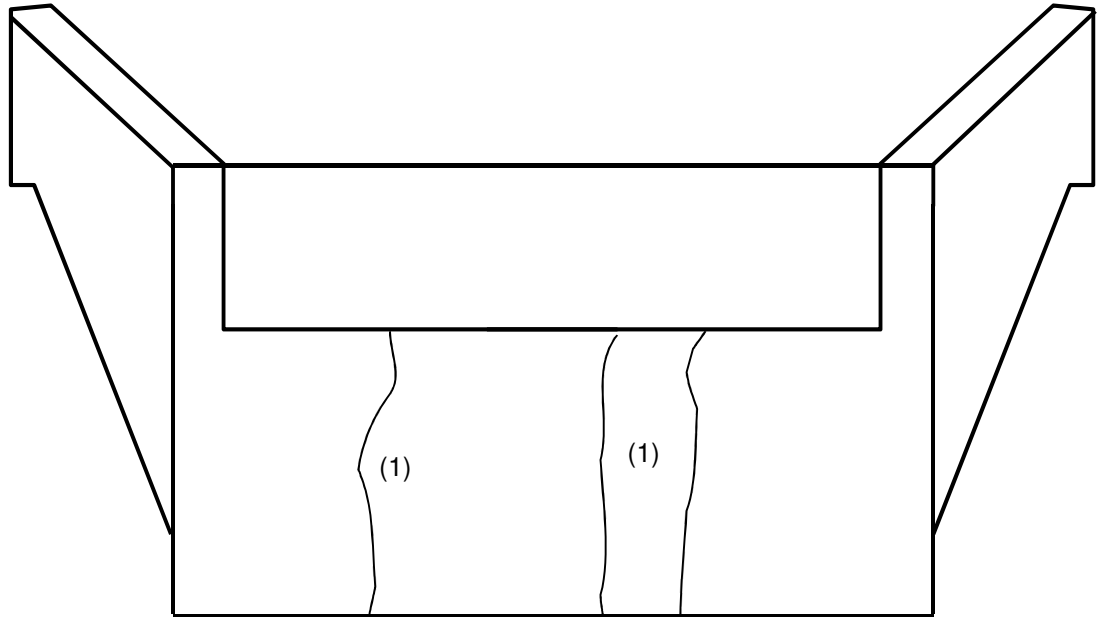
Abutment No. 2

BACKWALL	GOOD	
WALL	GOOD	(1) VERT. CRACK UP TO 1/16" OPEN FULL HEIGHT,
WINGS	GOOD	
BEARINGS	NV
