19104400028
19-10440-4.17 LT
10440 LL/LELAND LANE

BRIDGE MAINTENANCE RECOMMENDATIONS

Bridge Condition Coding Form

BRIDGE INSPECTION REPORT

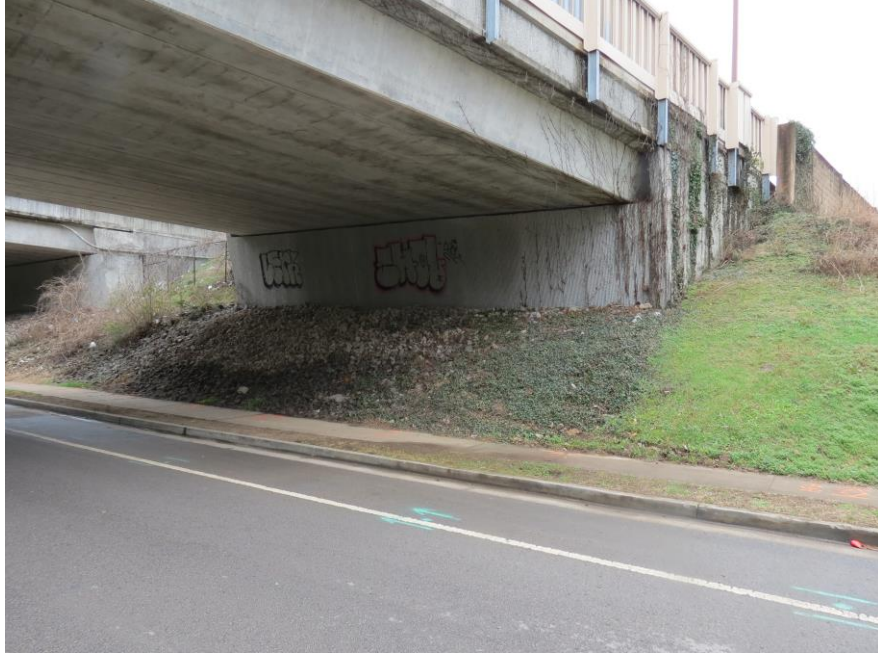
ABUTMENT #1

Rating	Comments
Caps	NA	
Breastwall	GOOD	<i>RANDOM VERT H.C.'S</i>
Wings	GOOD	
Backwall	NV	
Plumb	GOOD	
Footing	NV	
Piles	NV	
Embankment	GOOD	
Bearing Surface	GOOD	
Slope Paving	NA	
Rip Rap	GOOD	<i>SHOT ROCK</i>

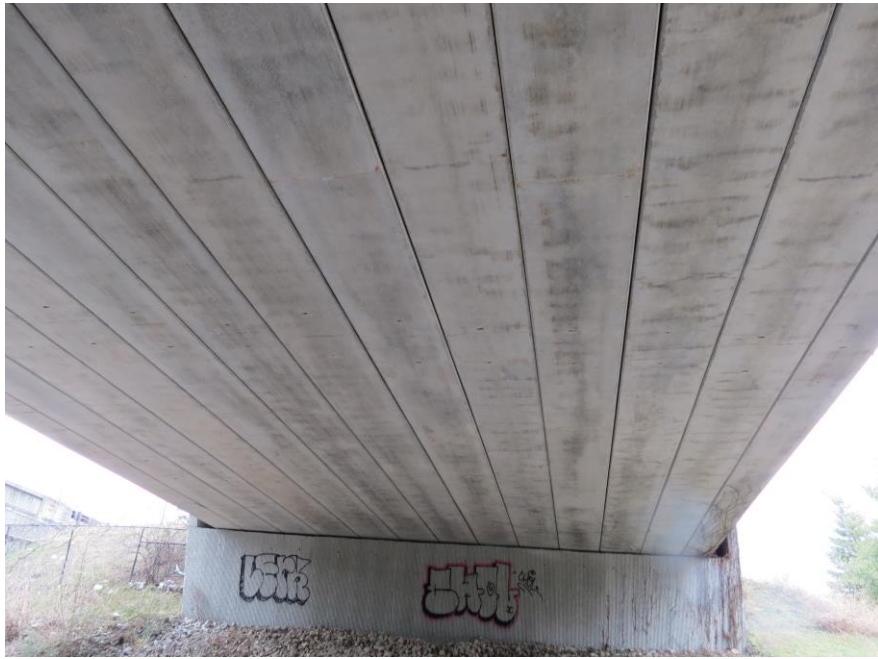
UNDERSIDE VIEW H.B.B.

Bearing Devices	GOOD	
Girders or Beams	GOOD	1/8" LONGIT. CRACKS FULL LENGTH BMS A & M, BM 'E'-LGHT SPALL
Floor Beams	NA	
Stringers	NA	
Diaphragms	NV	
Bracing	NA	
Trusses - General	NA	
Portals	NA	
Bracing	NA	
Paint	NA	
Alignment of Members	GOOD

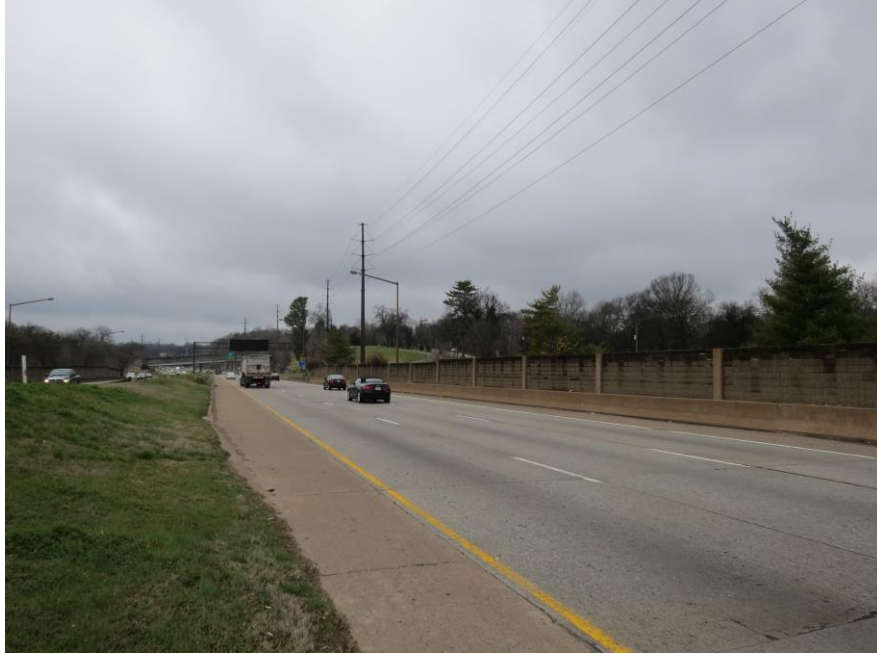
APPROACH "A" - WBL

Rating	Comments
Alignment	GOOD	
Slab	FAIR	<i>1/8" OPEN LONGIT CRACKS 'A' & 'B' ENDS</i>
Joints	FAIR	<i>A/C PATCHES & B.O.'S 'A' & 'B' END MISSING FILLER</i>
Pavement	FAIR	<i>A/C PATCHES</i>
Embankment	GOOD	
Drains	NA

No.	RECOMMENDATIONS	REPAIR DATE	REPAIRED BY
1.	REPAIR APPROACH PAVEMENT "A" AND "B" ENDS		
2.	REPAIR EXPANSION JOINTS AT "A" AND "B" ENDS

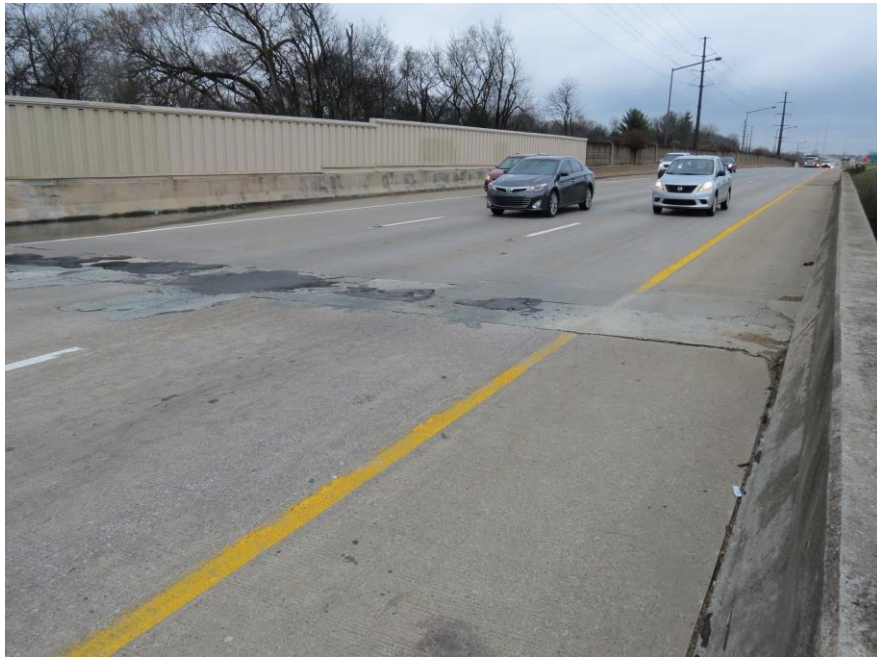
VIEW ACROSS TOP OF WEARING SURFACE WBL

The concrete wearing surface is fair with longitudinal cracks noted in top slab up to 1/8” open. Expansion joints are poor at “A” and “B” ends with concrete patches and heavy filler loss.

SUGGESTED ROUTINE MAINTENANCE AND COMMENTS
CLEAN AND SEAL TOP DECK
CLEAN & SEAL APPROACH SLABS

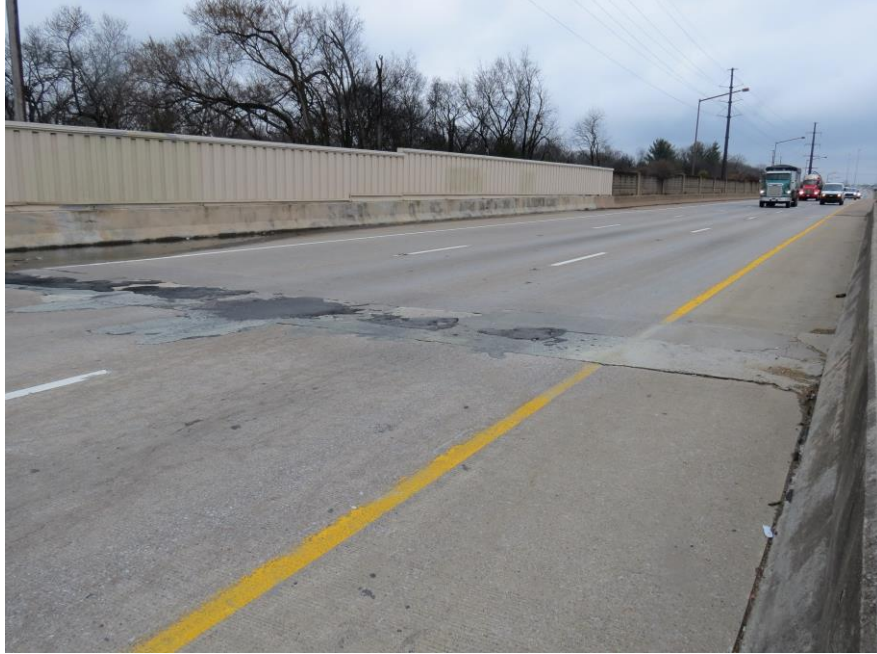
APPROACH "B" - WBL

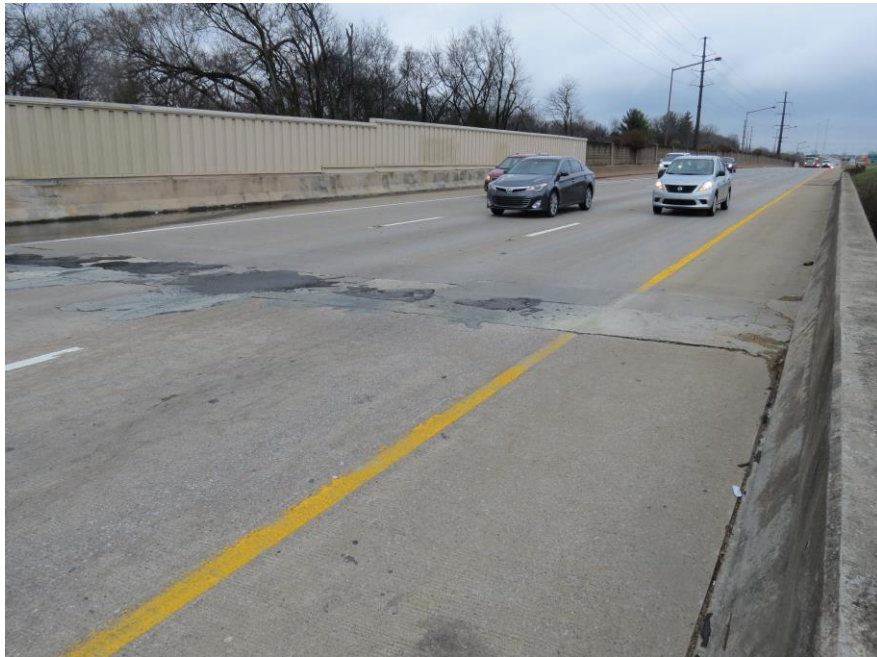
APPR."A" END JOINT W/ PATCHES WBL

Rating	Comments
Wearing Surface	FAIR	CONCRETE--1/8" LONGIT CRACKS & CONCRETE PATCHES 5' X FULL WIDTH
Deck - Structural Condition	FAIR	(BTM--N/V) SIDE-BY-SIDE BOX BEAMS. OVERHANGS GOOD
Curbs	NA	
Median	NA	
Sidewalks	NA	
Parapet	GOOD	STANDARD-SURFACE SCALE, VERT H.C.'S
Railing	NA	
Paint	NA	
Drains	NA	
Lighting Standards	GOOD	
Utilities	NA	
Joint Leakage	GOOD	
Expansion Joints	POOR	HVY LOSS OF FILLER AND UP TO 90% PAVED OVER

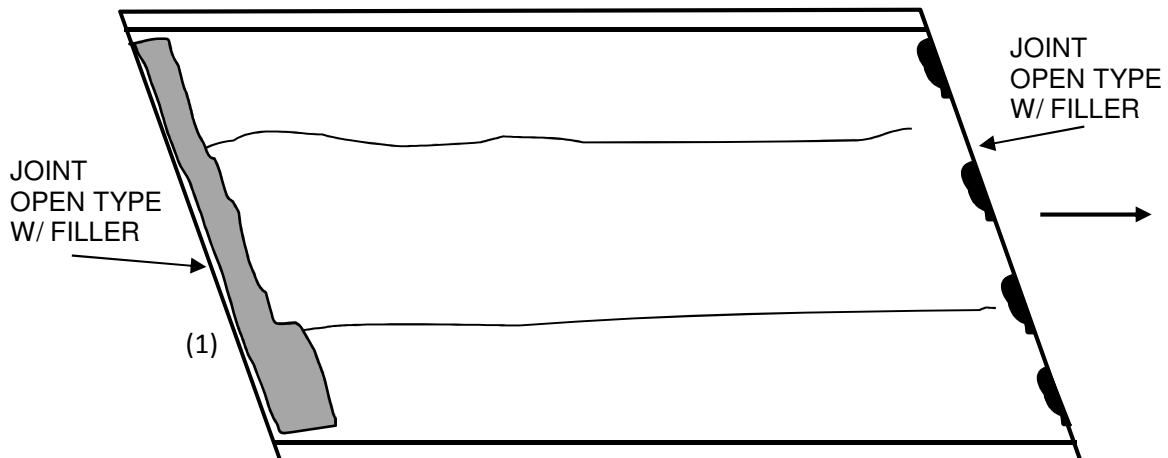
Top of Deck Span No. 1

DECK	FAIR	1/8" OPEN LONGIT CRACK, (1) CONC. PATCH 5' X FULL WIDTH
PARAPET	FAIR	STANDARD- SURFACE SCALE & H.L. VERT CRACKS
JOINTS	POOR	90% PAVED OVER @ "A" END. "B" END HAS PATCHES WITH 70% FILLER LOSS AND HVY DEBRIS

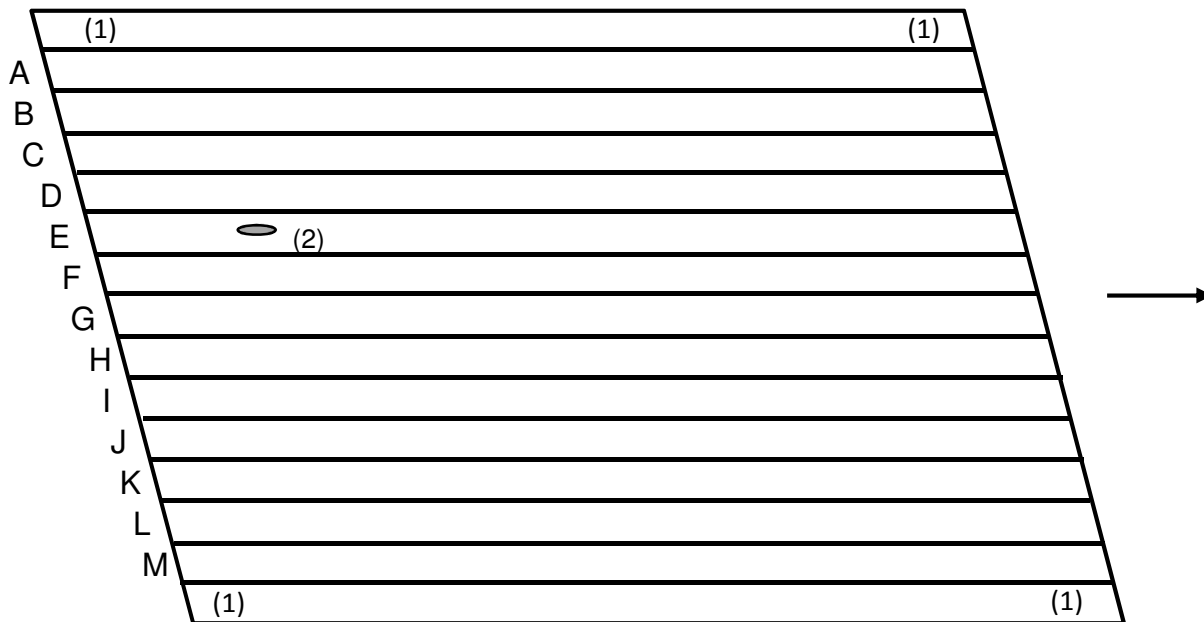
Bottom of Slab Span No. 1

DECK	NV	
BEAMS	GOOD	
"A" & "M"	GOOD	(1) LONGIT. CRACKS .010" OPEN X FULL LENGTH
"E"	GOOD	(2) B.O. 1'L X 4" W X 1/2" DP
OVERHANGS	GOOD

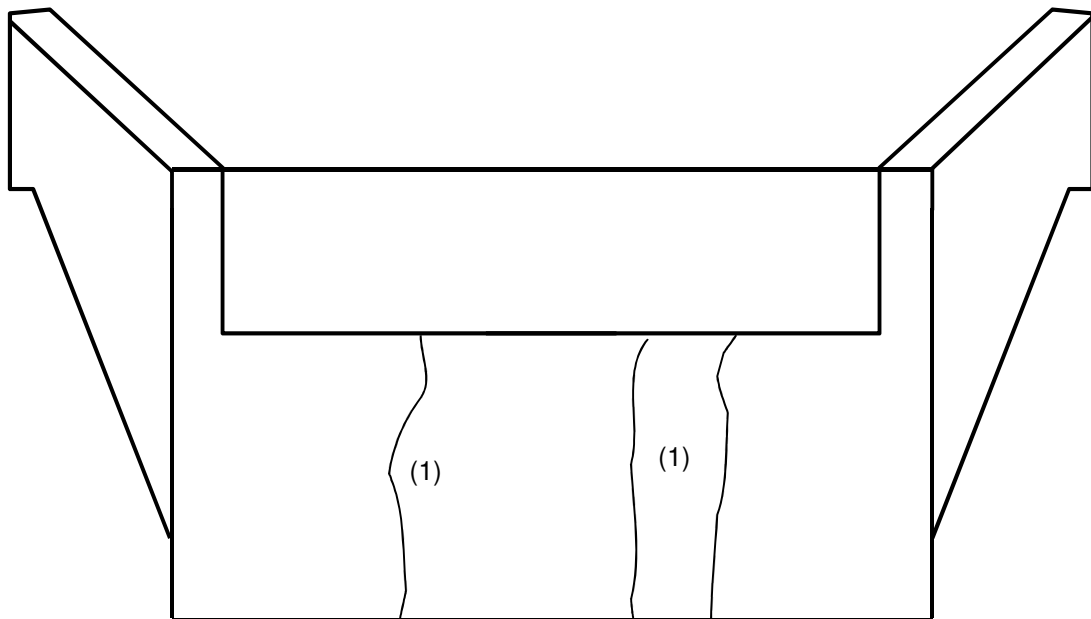
Abutment No. 1

BACKWALL	GOOD	
WALL	GOOD	(1) VERT. CRACK .UP TO 1/16" OPEN FULL HEIGHT
WINGS	GOOD	
BEARINGS	NV
