**19104400029
19-10440-4.36 RT
10440 RL/CRAIG AVE.**

BRIDGE MAINTENANCE RECOMMENDATIONS

BRIDGE INSPECTION REPORT

SUMMARY
19-I440-4.36 RT
3/4/2016

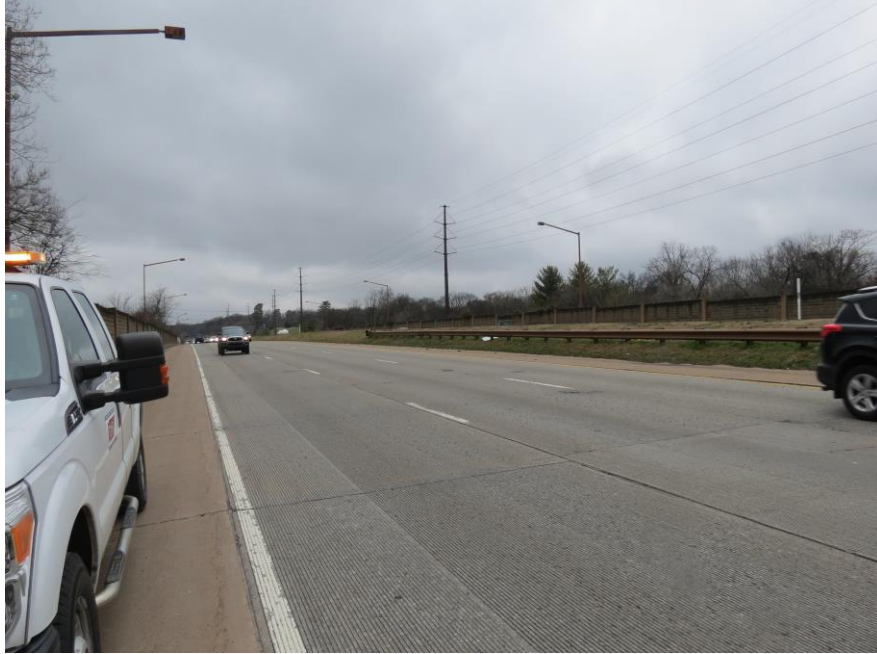
APPROACH "A" - EBL

This bridge was inspected and found to be in **fair** condition. Approach pavement is fair with breakouts and patches “A” and “B” end and moderate settlement ‘A’ end right shoulder area. Approach alignment is good. Bridge parapet rail is fair and standard with scale and vertical hair cracks. Approach traffic safety features at ‘A’ end left are good but substandard.

No.	RECOMMENDATIONS	REPAIR DATE	REPAIRED BY
1.	REPAIR BRIDGE JOINTS		
2.	REPAIR APPROACH PAVEMENT 'A' & 'B' ENDS		
3.	SEAL APPROACH SLABS		
4.	REPAIR APPROACH JOINTS

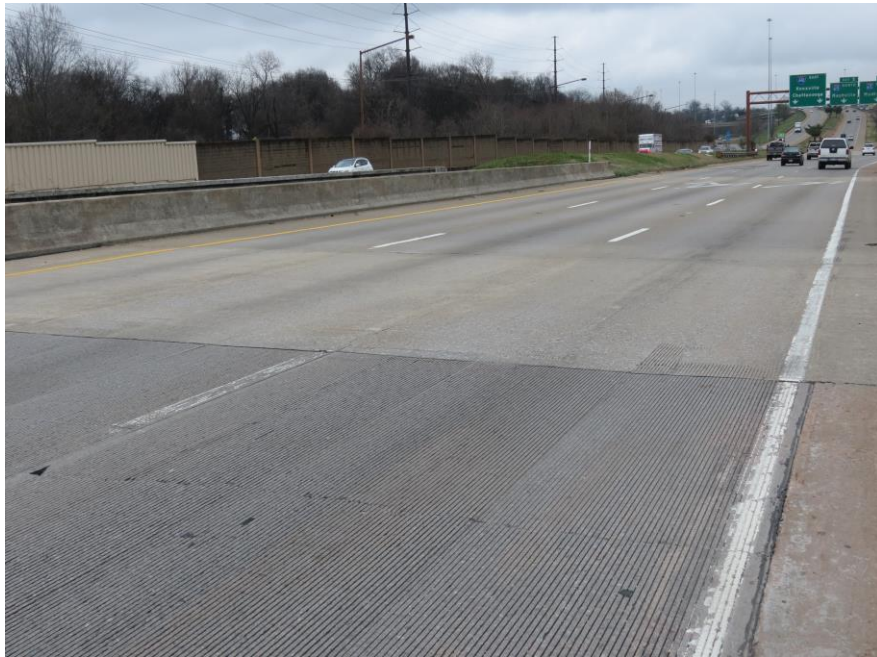
VIEW ACROSS TOP OF WEARING SURFACE EBL

The concrete wearing surface is fair with longitudinal and transverse cracks 1/8” open. Open type joints with filler are poor with B.O.’s ‘A’ and ‘B’ end, debris build-up, and filler loss.

SUGGESTED ROUTINE MAINTENANCE AND COMMENTS
SEAL CONCRETE DECK
REPAIR APPROACH SHOULDER "A" END RT
TEXTURE COAT BRIDGE PARAPET RAIL

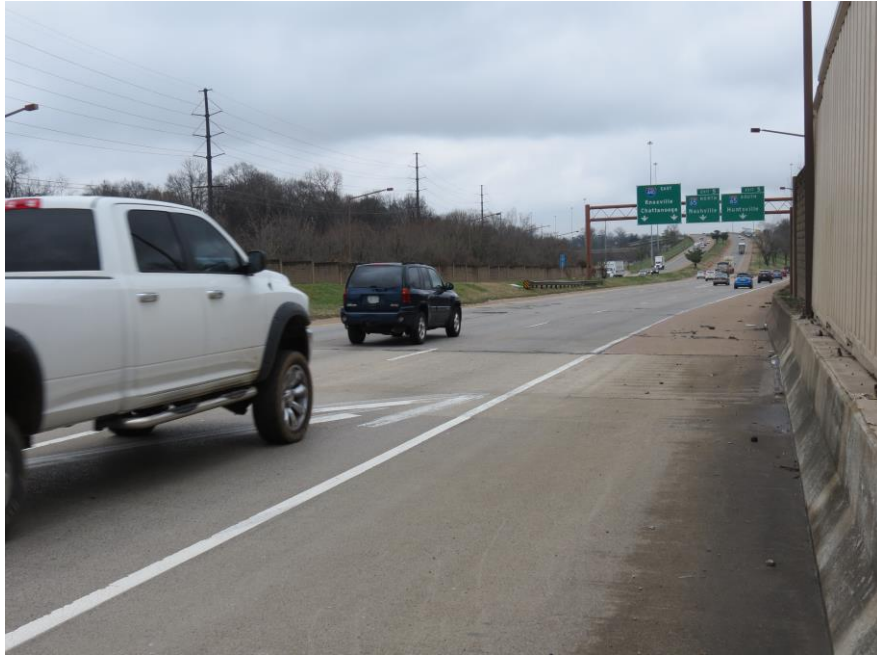
APPROACH "B" - EBL

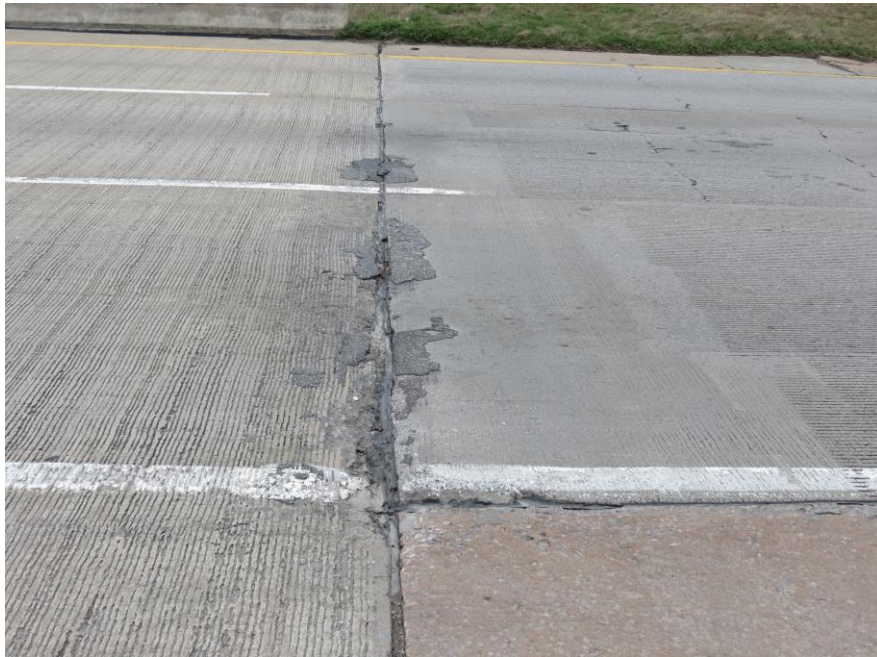
APPR. "B" END JOINT W/ PATCHES EBL

Rating	Comments
Wearing Surface	FAIR	CONCRETE W/TRANSV & LONGIT CRACKS UP TO 1/16" OPEN
Deck - Structural Condition	FAIR	(BTM--G)
Curbs	NA	
Median	NA	
Sidewalks	NA	
Parapet	FAIR	H.C.'S & MOD. SCALE
Railing	NA	
Paint	NA	
Drains	NA	
Lighting Standards	GOOD	
Utilities	NA	
Joint Leakage	GOOD	
Expansion Joints	POOR	LOSS OF FILLER & DEBRIS BLD-UP

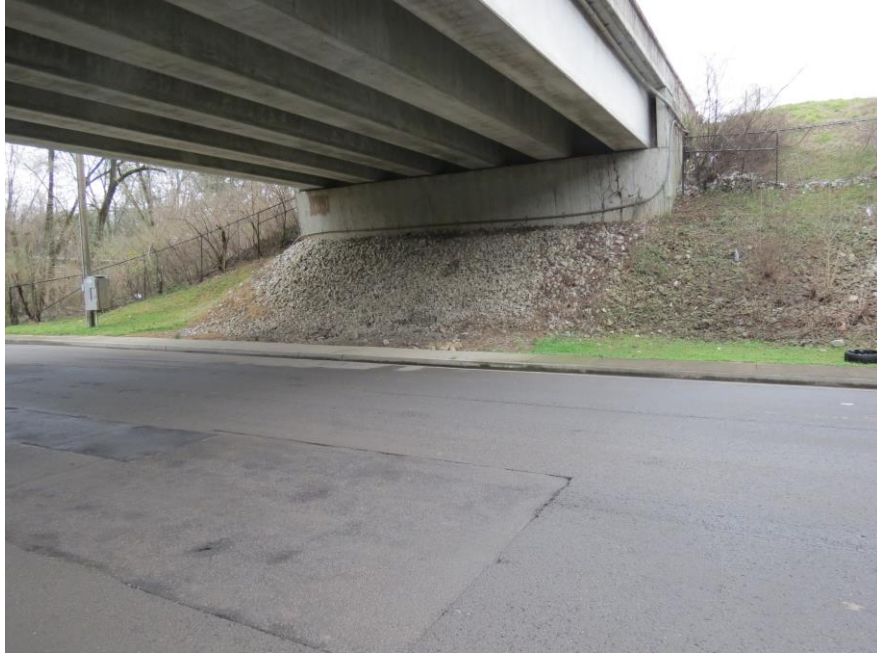
ABUTMENT #1

BACKWALL	GOOD	RANDOM VERT H.C.'S W/EFF
WALL	GOOD	RANDOM VERT H.C.'S
WINGS	GOOD	
BEARINGS	GOOD

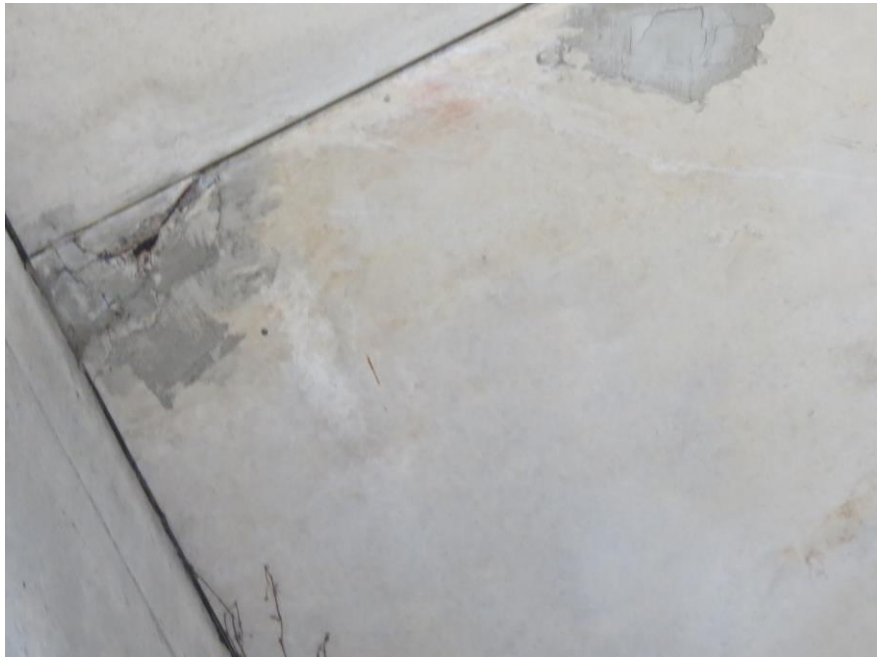
DECK PANEL BAY "A" ABUT. #2 W/ FAILED PATCH

DECK	GOOD	PATCHES BAYS 'B' & 'D' END PANELS @ ABUT #2, FAILED PATCHES, I.P.B.O. 1'L X 6"W X 1"DP BAY 'B' END PANEL @ ABUT #2
DIAPHRAGMS	GOOD	
BEAMS	GOOD	(1) MULTIPLE .010" OPEN LONGIT. CRACKS FROM 3' TO 20' LONG BM A, (2) LONGIT. CRACK .010" OPEN X 5' L BM F (3) LONGIT CRACKS UPTO 5' L X .010" OPEN BM D
OVERHANG	GOOD

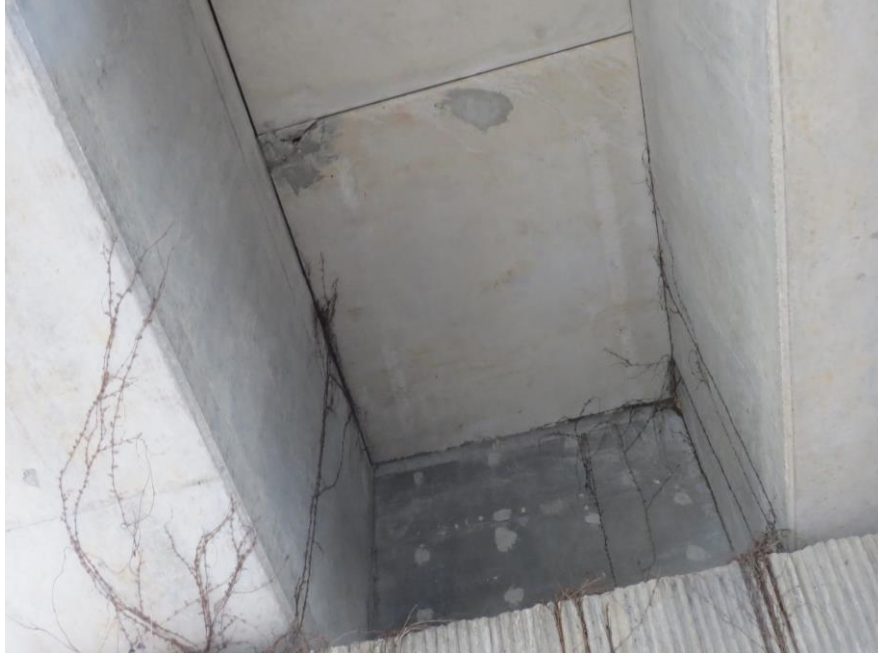
DECK PANEL BAY "A" ABUT. #2 OVERALL VIEW

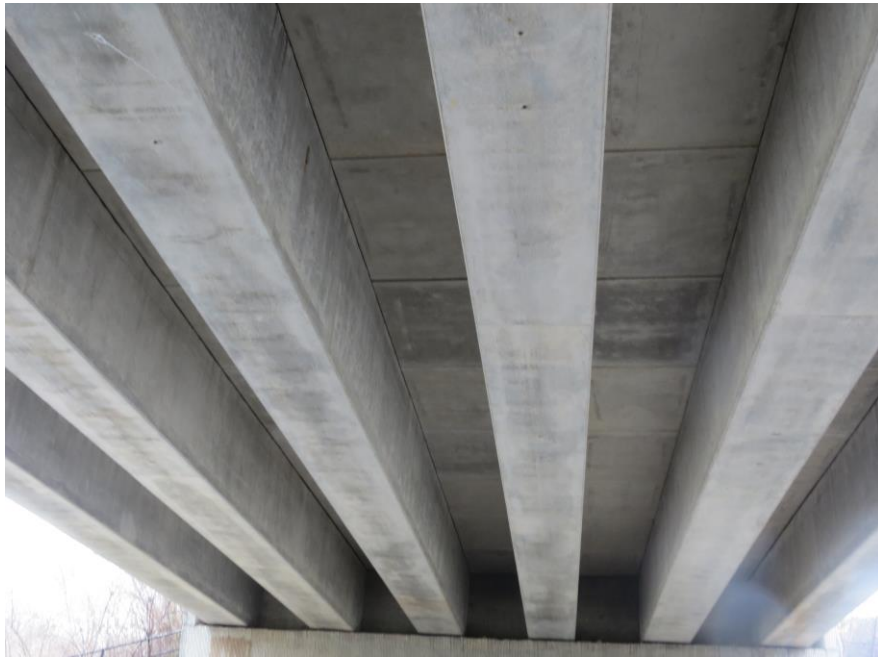
BOTTOM OF DECK

Bottom deck, box beams, and substructure units are good.

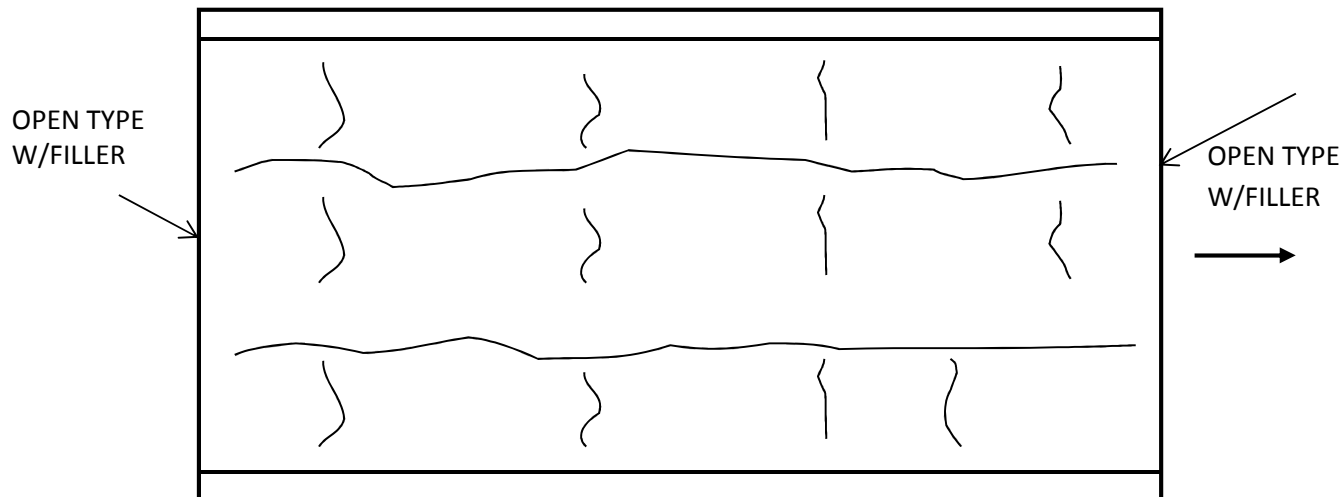
Top of Deck Span No. 1

DECK	FAIR	CONCRETE-TRANSV. CRACKS & LONGIT. 1/8" OPEN
PARAPET	FAIR	STANDARD-LT. SCALE W/ H.C.
JOINTS	POOR	OPEN TYPE JOINTS W/ HVY DEBRIS & FILLER LOSS

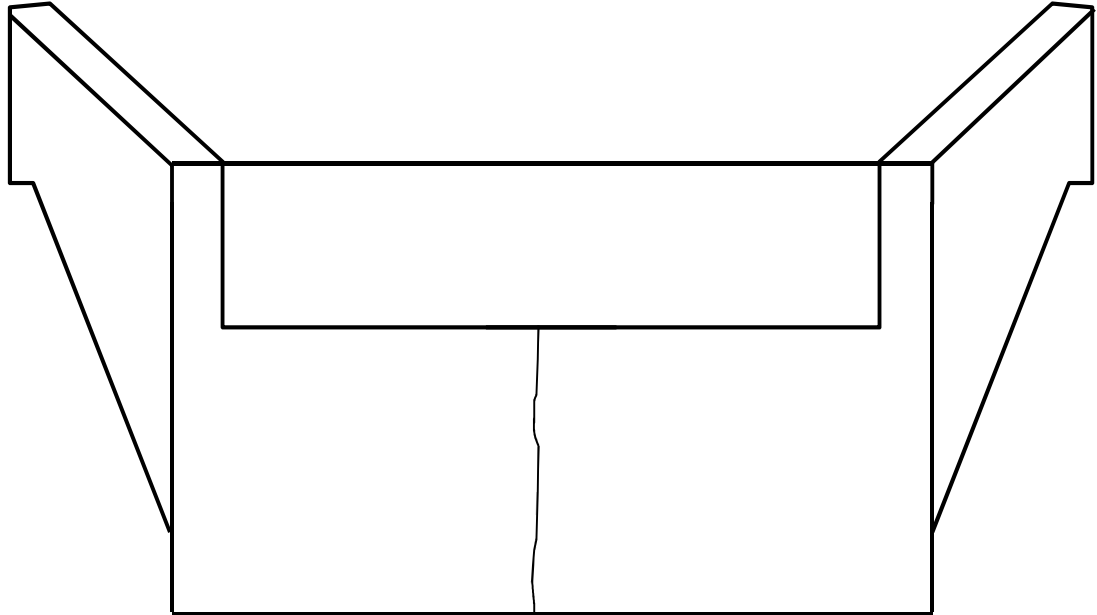
Abutment No. 2

BACKWALL	GOOD	RANDOM VERT. H.C.'S
WALL	GOOD	RANDOM VERT H.C.'S
WINGS	GOOD	
BEARINGS	GOOD
