**19104400030
19-10440-4.36 LT
10440 LL/CRAIG AVE.**

BRIDGE MAINTENANCE RECOMMENDATIONS

BRIDGE INSPECTION REPORT

I440 over CRAIG AVE
Road Name Crossing Structure Name (If Named)

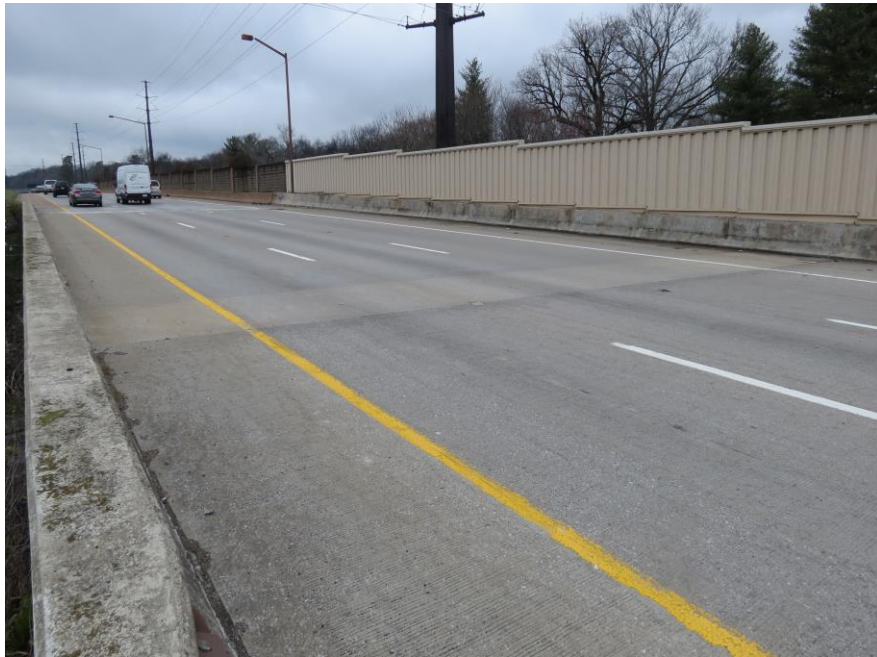
VIEW ACROSS TOP OF WEARING SURFACE WBL

The concrete wearing surface is fair due to longitudinal and transverse cracks up to 1/8" open and large concrete patch 5' x full width. Bottom deck is fair having spalls with exposed steel. Open type expansion joints are poor being paved over at "A" end, and "B" end is saw cut with heavy debris.

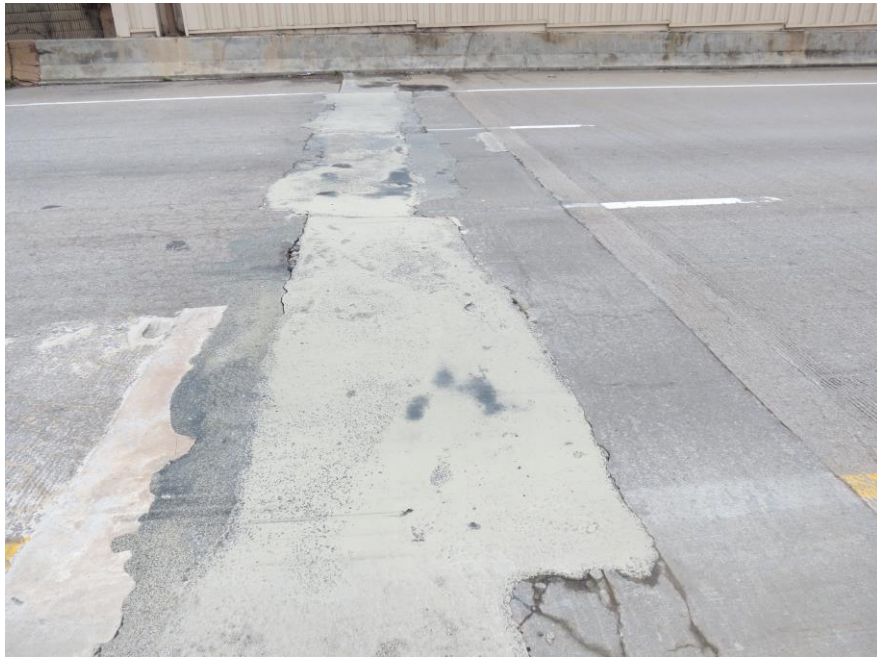
APPR. "A" END JOINT W/ PATCHES WBL

No.	RECOMMENDATIONS	REPAIR DATE	REPAIRED BY
1.	REPAIR BRIDGE JOINTS		
2.	REPAIR APPROACH JOINTS		
3.	LEVEL THE WEARING SURFACE AT APPROACH #2

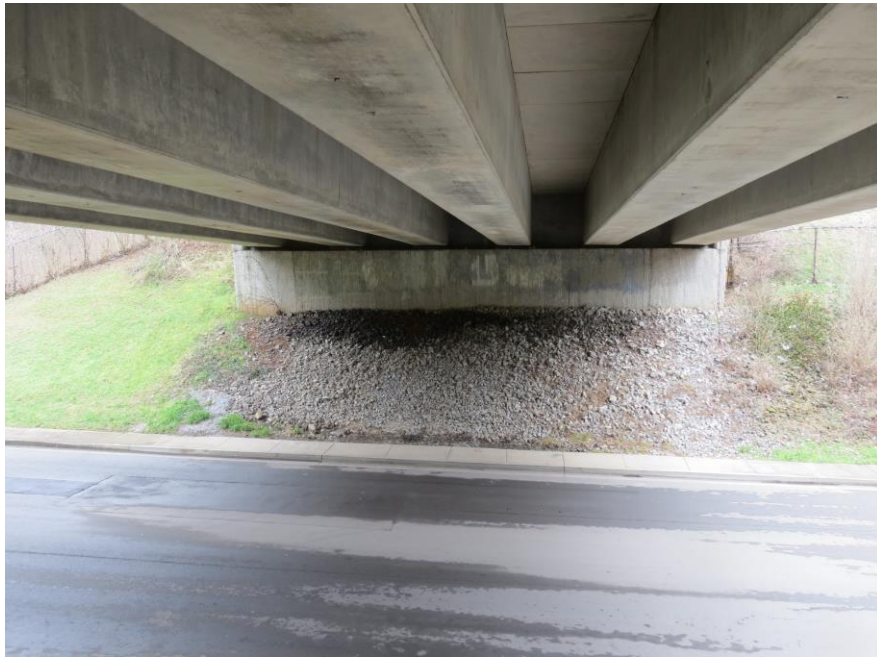
ABUTMENT #2

BACKWALL	GOOD	RANDOM VERT. H.C.'S
WALL	GOOD	RANDOM VERT. H.C.'S
WINGS	GOOD	(1) H.L. MAP CRACKS
BEARINGS	GOOD

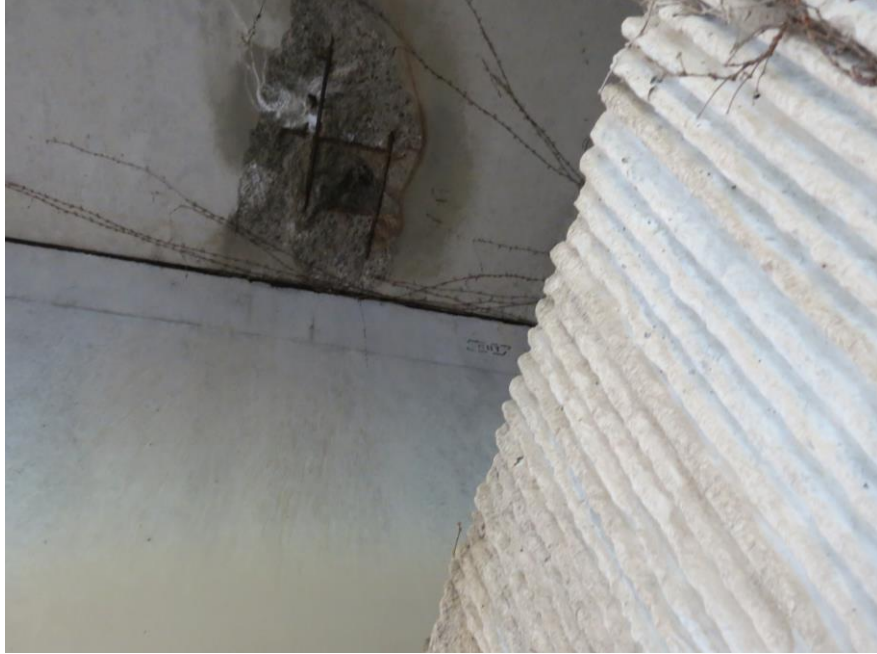
DECK PANEL BAY "B" ABUT. #1 SPALL & EXP. STL

DECK	GOOD	(6) SPALL W/ EXP. STL. 4' W X 3' L X 6" DP, END PANEL @ ABUT #1
		(7) SPALL 1.5' DIA. X 6" DP, SPALLS UP TO 6" DIA., BAYS 'A' & 'B',
		END PANELS ABUT #2
DIAPHRAGMS	GOOD	
BEAMS	GOOD	(1) H.L. CRACK ON RT. SD. OF BEAMS 'D','E', & 'F' UP TO 10'L BOTH SIDES
		(2) H.L. CRACK ON RT. SD. OF BEAM 'A' UP TO 10'L
		(3) H.L. CRACK ON SD. OF BEAM 'D' 2 @ 15' LONG
		(4) H.L. CRACK ON RT. SD. OF BEAM 'A' 2 @ 5'-6' LONG
		(5) H.L. CRACK VERT. BEAM 'C' W/ EFF.

SUGGESTED ROUTINE MAINTENANCE AND COMMENTS
REPAIR BOTTOM DECK BAY'S 'A', 'B', & 'D'
SEAL CONCRETE DECK
SEAL APPROACH SLABS
RETEXTURE COAT PARAPETS LEFT AND RIGHT

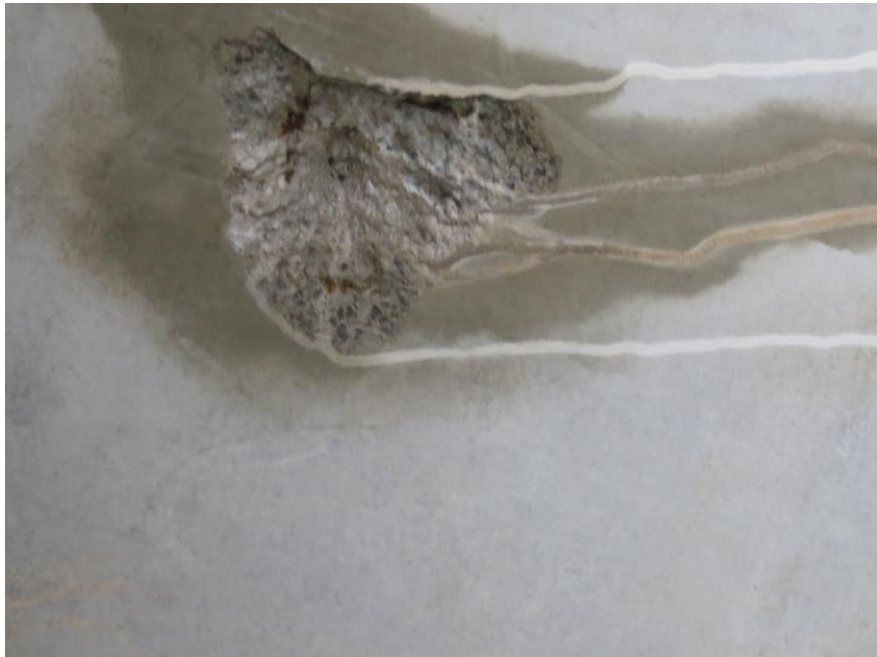
DECK PANEL BAY "D" ABUT. #1 W/ SPALL

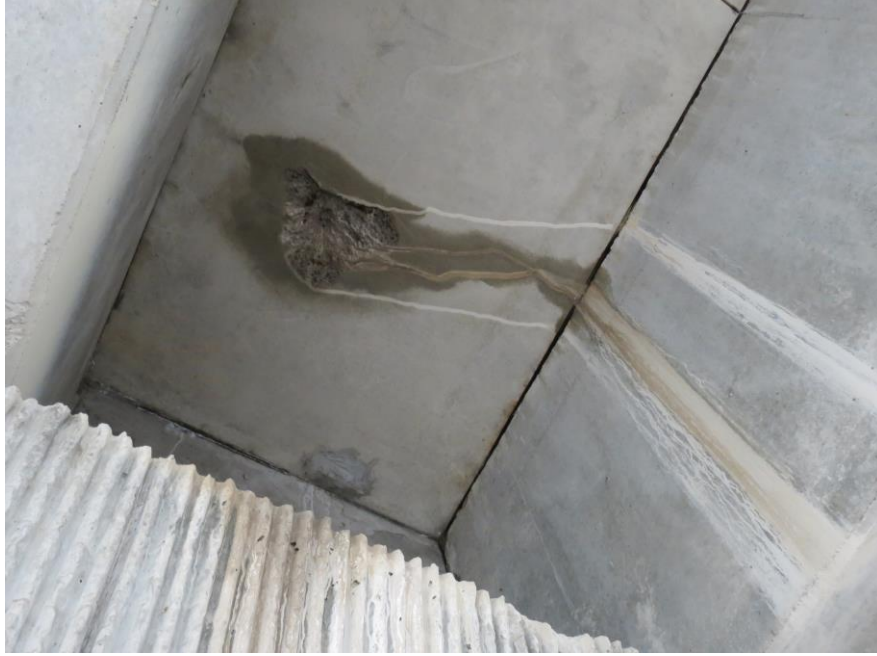
DECK PANEL BAY "D" ABUT. #1 OVERALL VIEW

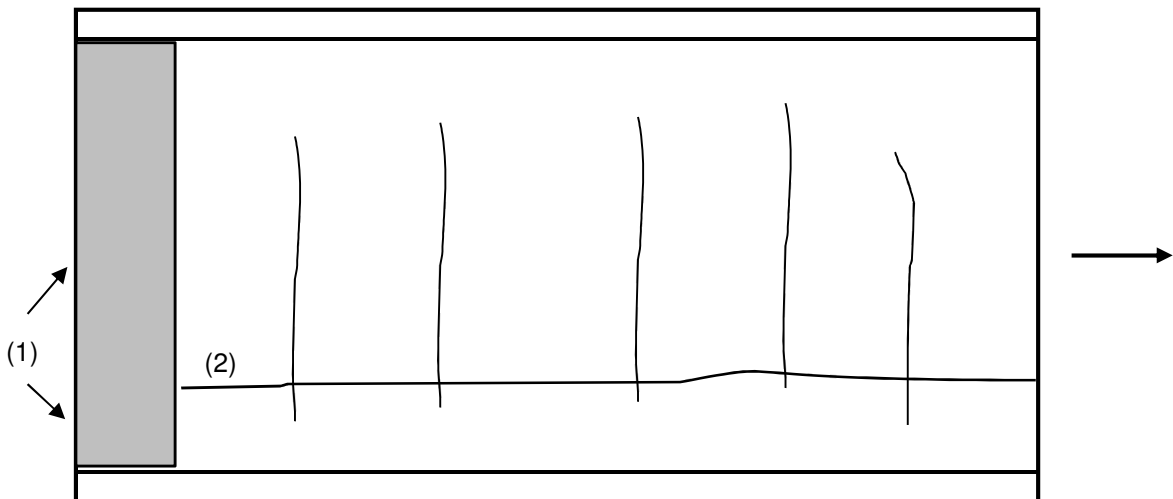
Top of Deck Span No. 1

DECK	FAIR	TRANSV. CRACKS UPTO 1/8" OPEN (1) CONC. PATCHES 5' X FULL WIDTH, (2) LONGIT. HAIRCRACK RUNS ENTIRE LENGTH OF DECK
PARAPET	FAIR	STADARD- H.C.'S & LT. SCALE
JOINTS	POOR	OPEN TYPE W/FILLER-FILLER LOSS, HVY DEBRIS BLD-UP

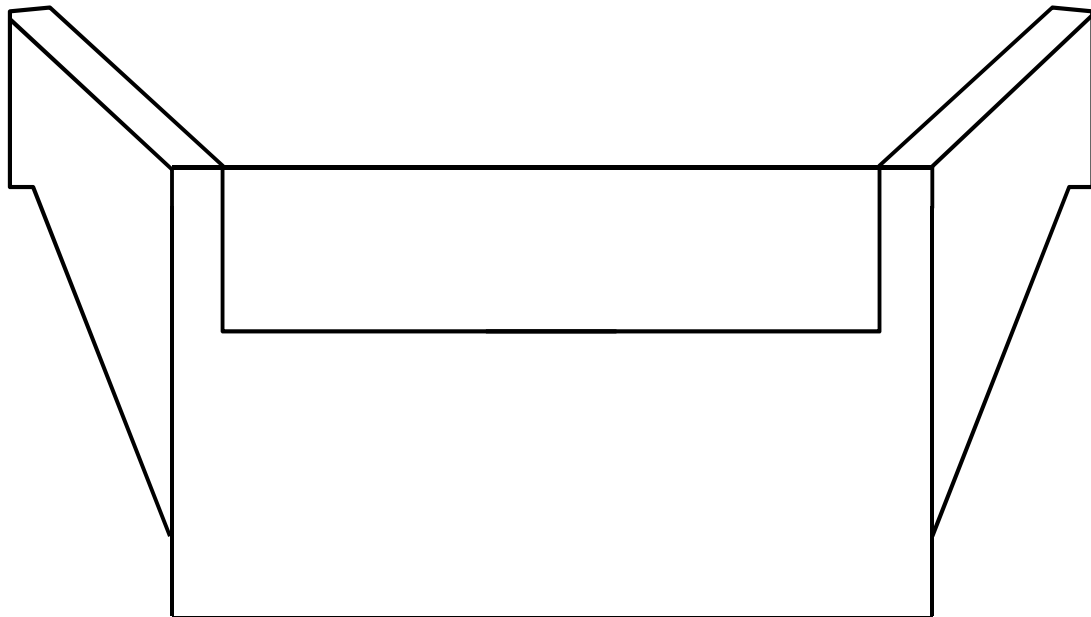
Abutment No. 1

BACKWALL	GOOD	RANDOM H.C.'S W/ EFF.
WALL	GOOD	RANDOM VERT/DIAG H.C.'S
WINGS	GOOD	
BEARINGS	GOOD
