**1910440041**  
**19-10440-5.44**  
**10440/BRANSFORD AVE**

**BRIDGE MAINTENANCE RECOMMENDATIONS**

# Photographs

# BRIDGE INSPECTION REPORT

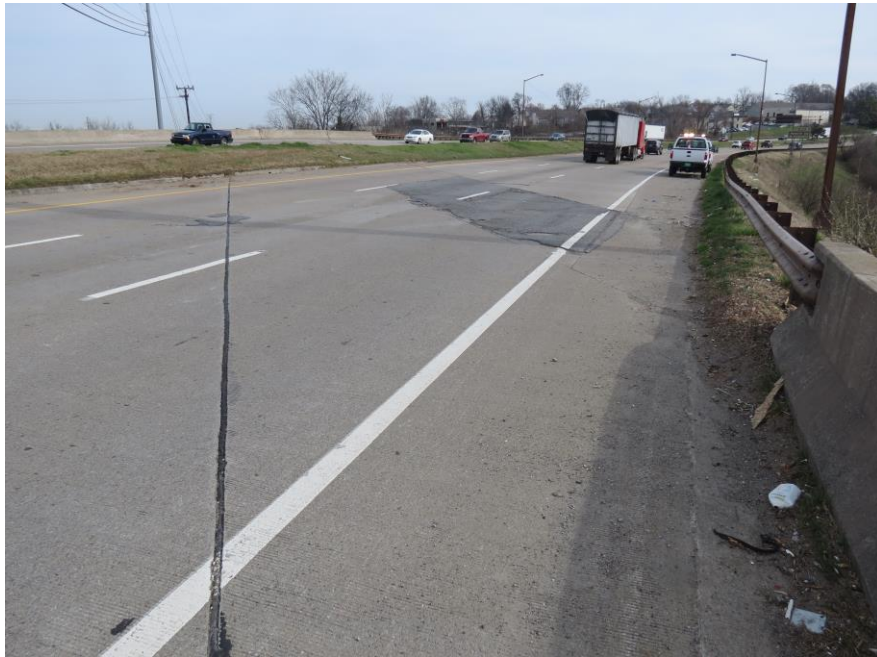
APPR. "B" END JOINT W/ TORN FILLER EBL

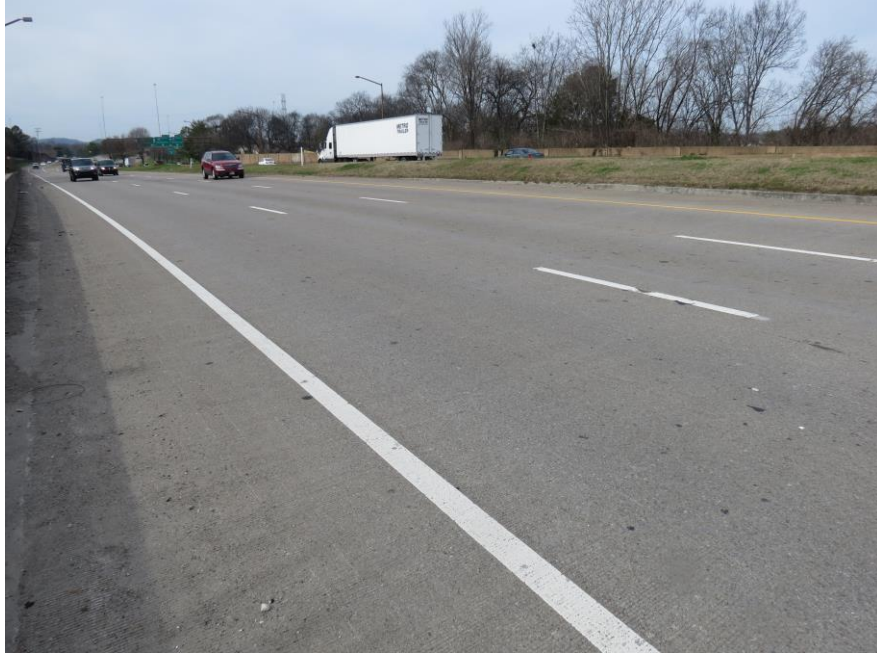
VIEW ACROSS TOP OF WEARING SURFACE EBL

Concrete wearing surface is fair with heavy cracking up to ¼” open ‘A’ and ‘B’ ends. Open type expansion joints with filler are good.

No.	RECOMMENDATIONS	REPAIR DATE	REPAIRED BY
1.	REPAIR CONCRETE WEARING SURFACE 'B' END E.B.L. & 'A' END W.B.L.		
2.	REPAIR APPROACH ROADWAY 'A' AND 'B' ENDS		
3.	REPAIR APPROACH SLABS		
4.	REPAIR APPROACH PARAPET RAIL 'A' END E.B.L. & MID SPAN W.B.L.

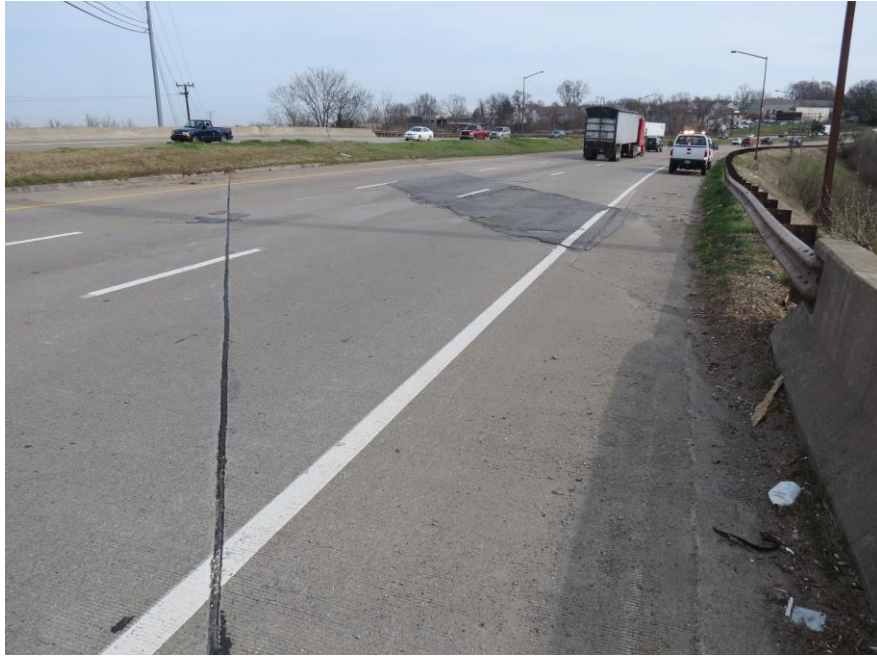
APPR. "B" END ROADWAY W/ PATCHES EBL

This bridge was inspected and found to be in **fair** condition. Approach alignment is good. Approach pavement is poor with large pattern cracks and delamination at the “A” end in left lane, longitudinal cracks, breakouts in patched areas and settlement in right lane at “B” approach. Bridge parapet rail is poor with moderate-heavy impact damage left side on top of parapet and ‘A’ end right. Approach parapet is fair but standard due to 3/16” vertical cracks, 6” deep spall with exposed steel “A” end right, and impact damage at ‘B’ end E.B.L. Approach guardrail and transitions are good but substandard.

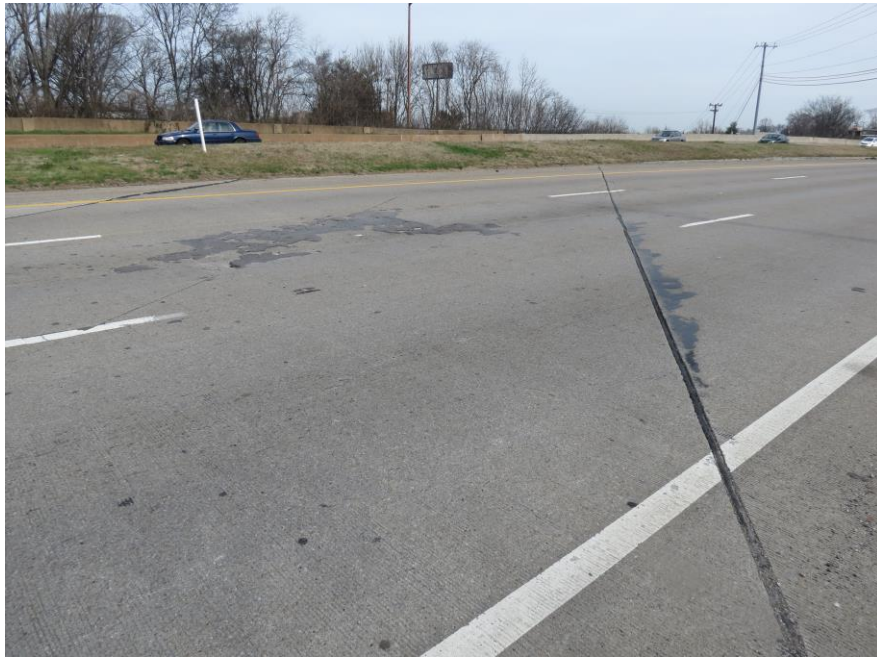
APPR. "A" END ROADWAY W/ PATCHES EBL

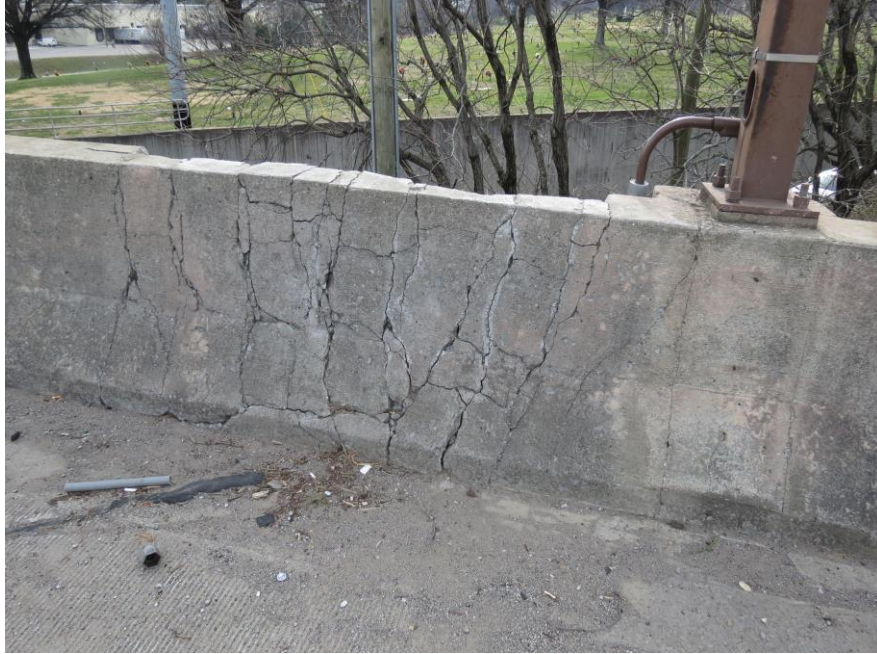
BRIDGE PARAPET "A" RT. W/ IMPACT DAMAGE EBL

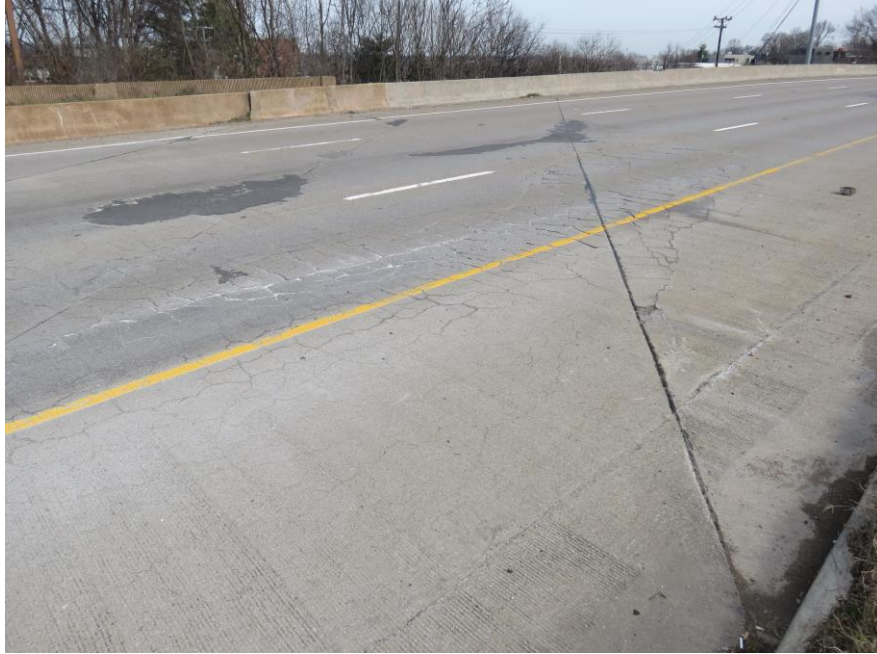
APPR. "A" END ROADWAY W/ PATCHES WBL

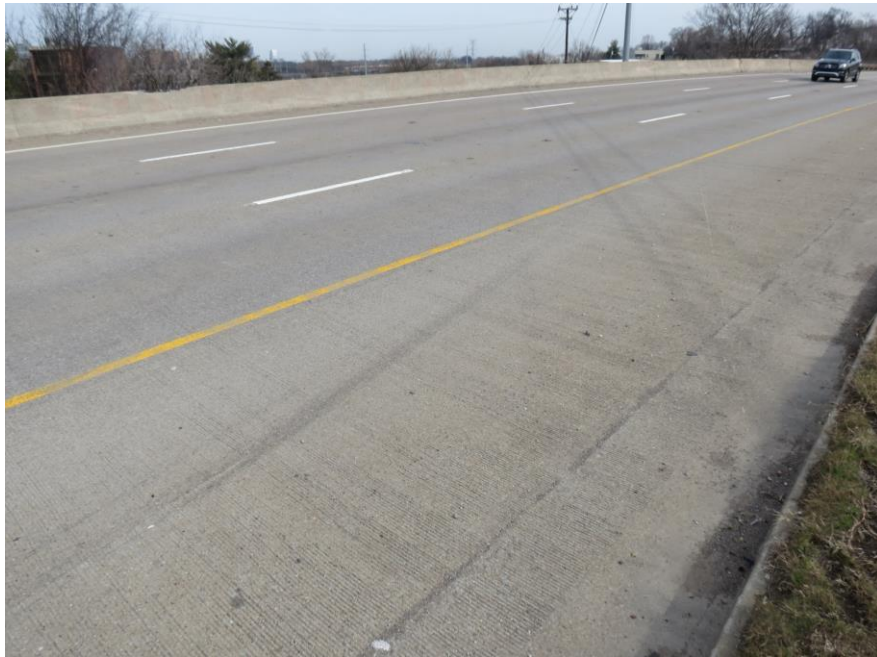
VIEW ACROSS TOP OF WEARING SURFACE WBL

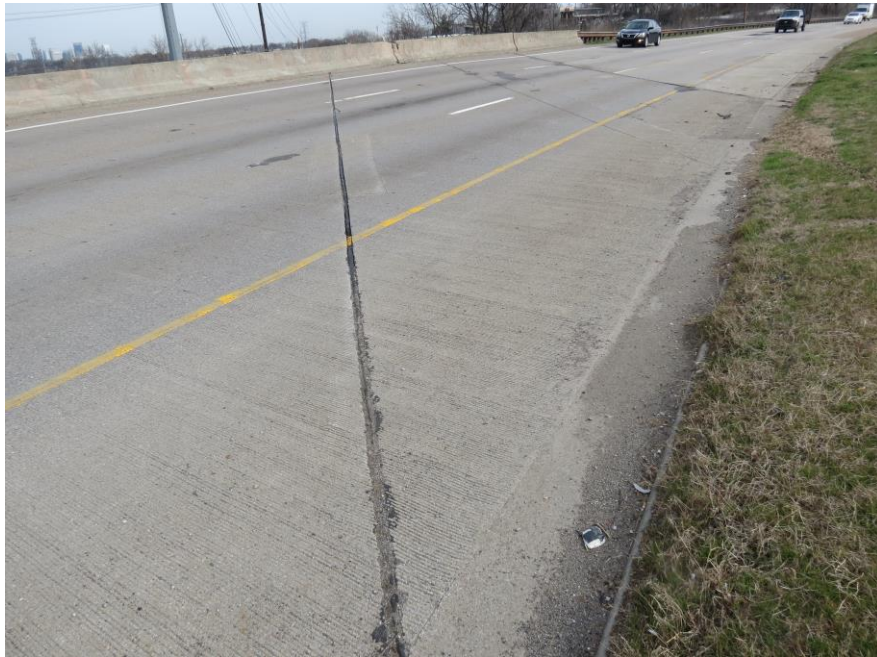
APPR. "B" END JOINT W/ TORN FILLER WBL

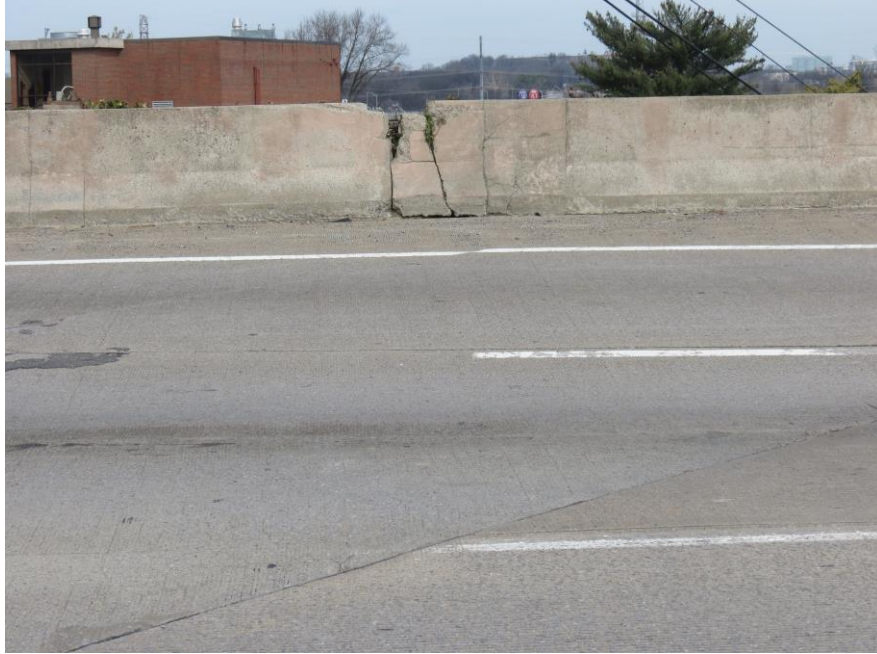
BRIDGE PARAPET "B" LT . W/ IMPACT DAMAGE WBL

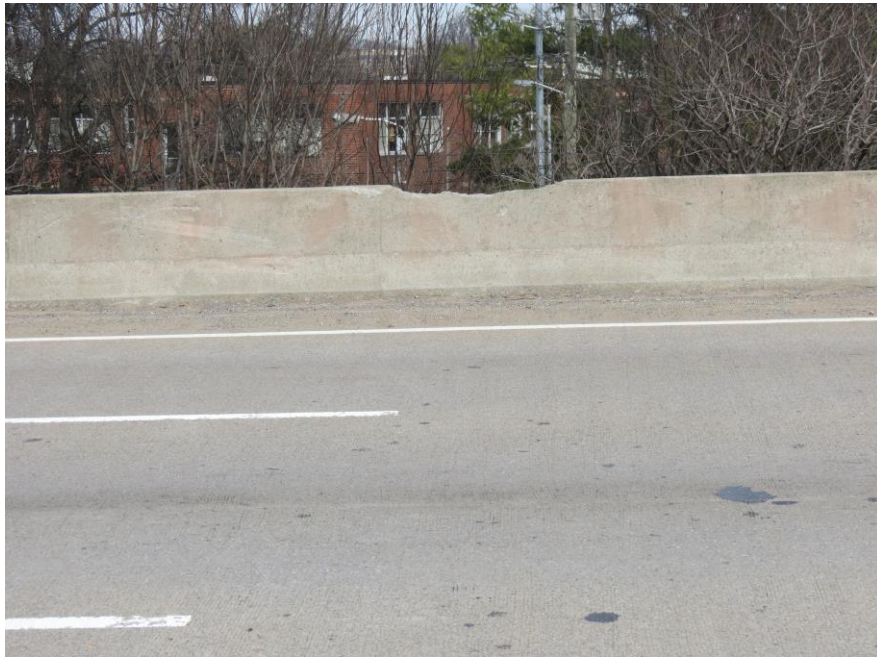
BRIDGE PARAPET LT. SIDE W/ IMPACT DAMAGE WBL

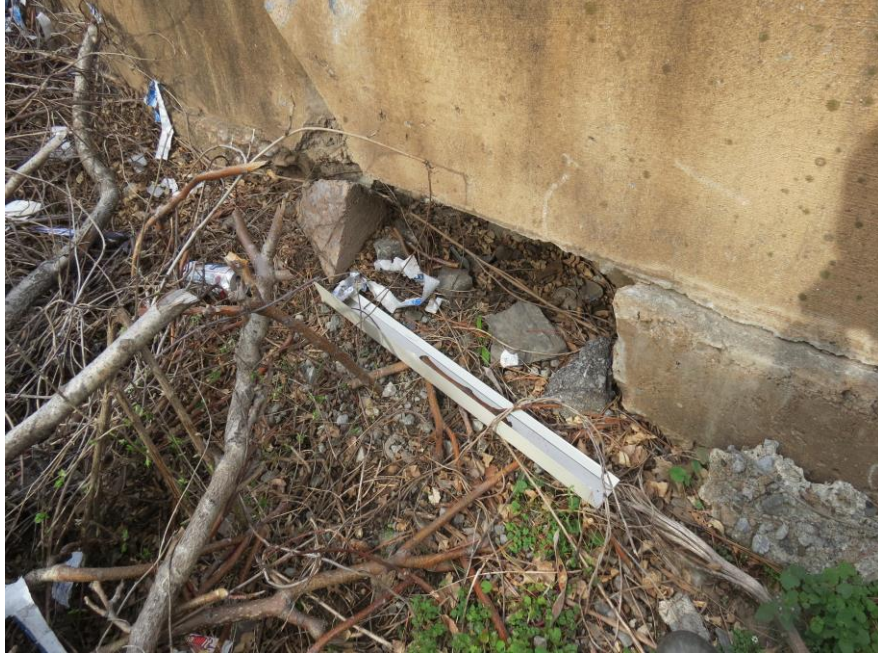
APPR. "A" END RT. SIDE W/ EROSION EBL

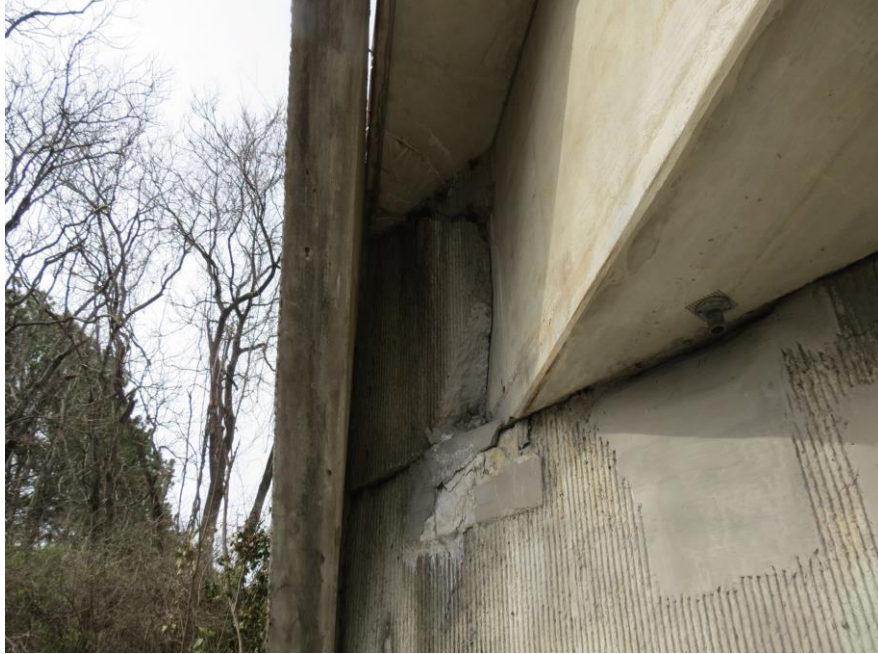
ABUTMENT #1 WALL W/ PATCHES AND SPALLS

Abutments are fair with failing concrete patches spalls, and cracks at abutment #1. Abutment #1 right wing is poor with 3” separation and tilt. Embankment and other areas are good.

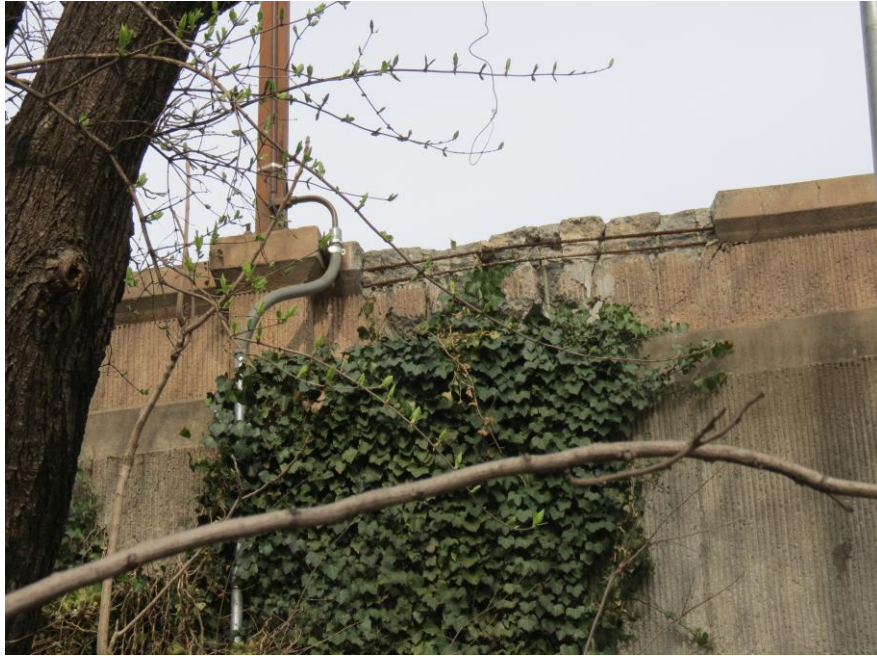
IMPACT DAMAGE APPR. "A" END RT. SIDE EBL

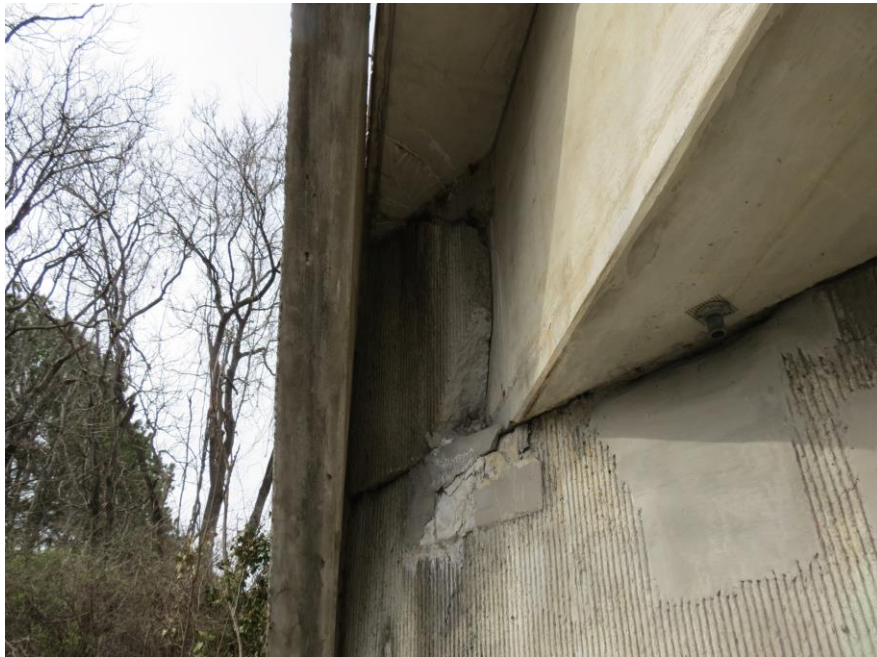
RT. WING ABUT. #1 W/ TILT & MISALIGNED

STABILIZE WINGWALL AT ABUTMENT #1

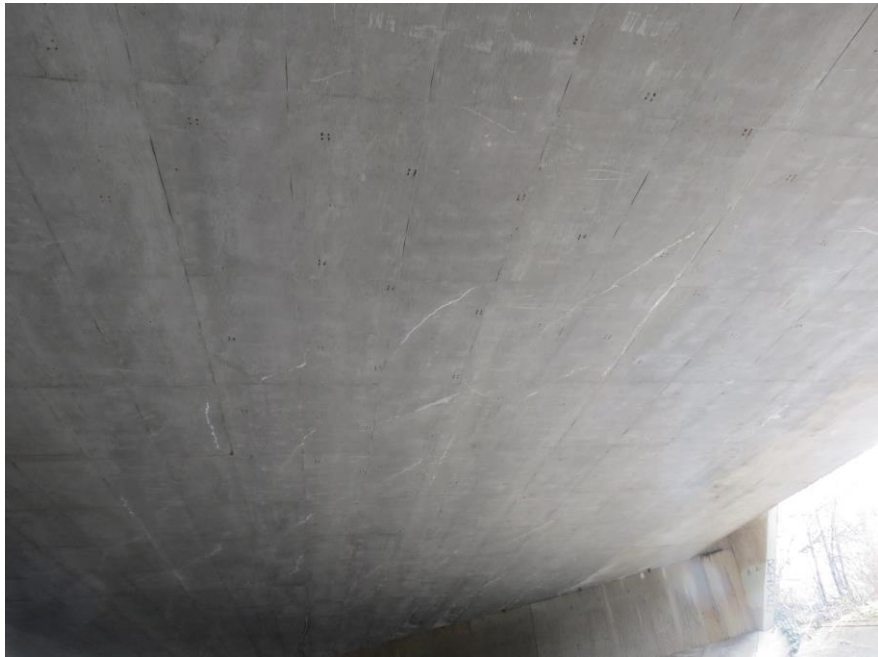
UNDERSIDE OF H.B.G W/ OPEN CRACKS & EFF.

Beams are fair with hair cracks with leaching. Alignments of members are good.

SEAL CRACKS IN CONCRETE BEAM

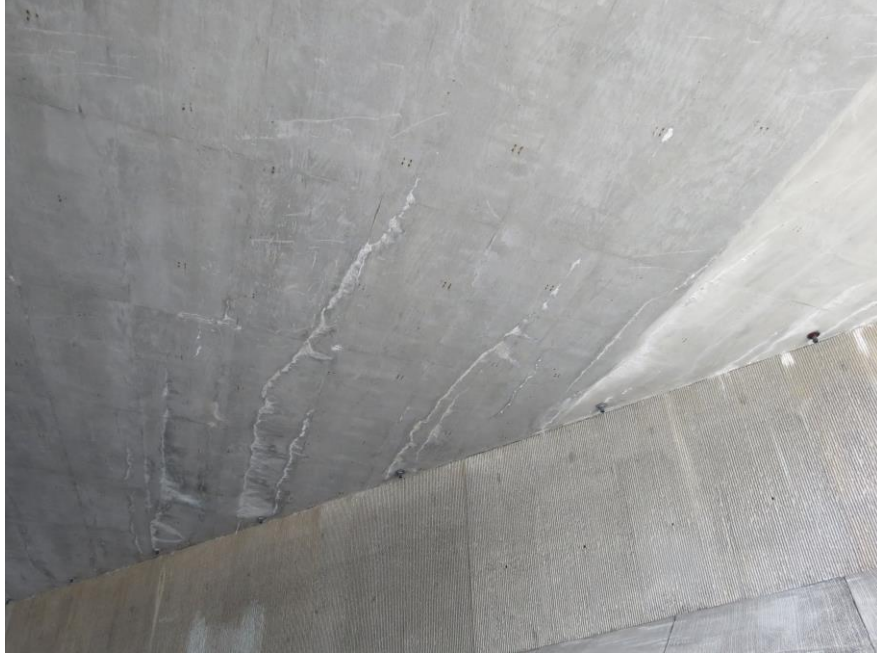
UNDERSIDE AT ABUT. #2 W/ OPEN CRACKS & EFF.

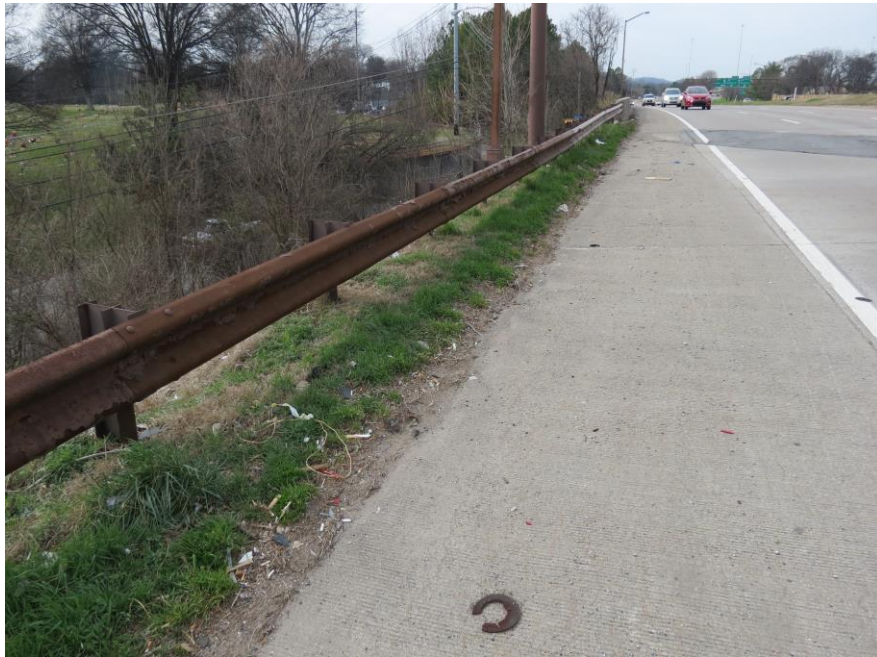
GUARDRAIL AT APPR. "B" END RT. W/ RUST EBL

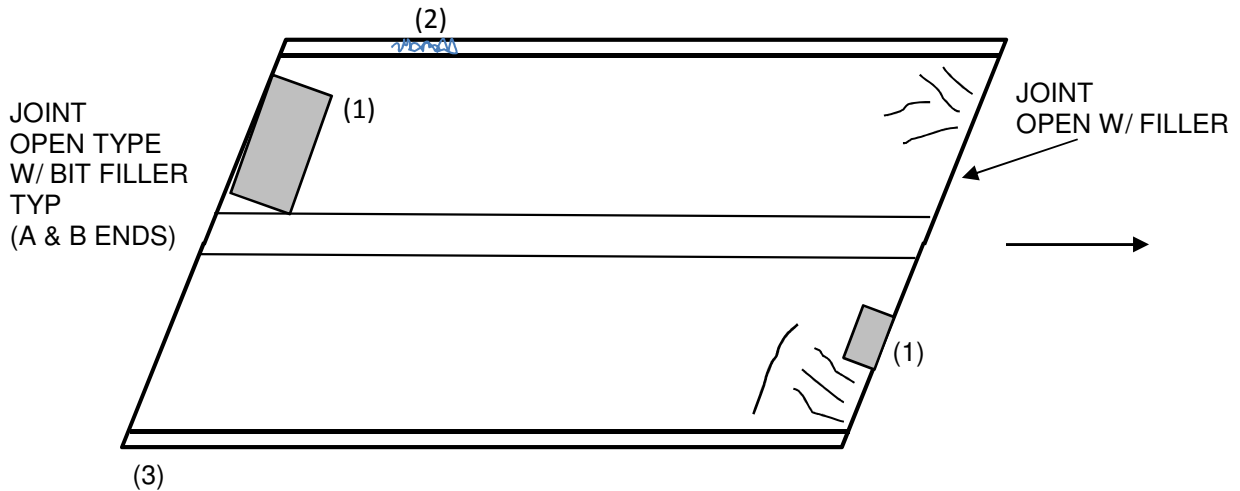
Top of Deck Span No. 1

DECK	FAIR	CONCRETE- RANDOM PATTERN CRACKS @ ENDS UP TO 3/8" OPEN
		(1) HVY MAP CRACKING UPTO 1/4" OPEN W/ IMPENDING POTHOLES
		RANDOM A/C PATCHES
PARAPET	FAIR	(2) IMPACT DAMAGE, B.O. 3'L X 5"DP,
		(3) IMPACT DAMAGE 5'L X 3' X 6"DP W/EXP. STL.
JOINTS	GOOD	OPEN TYPE W/BITUMINOUS FILLER

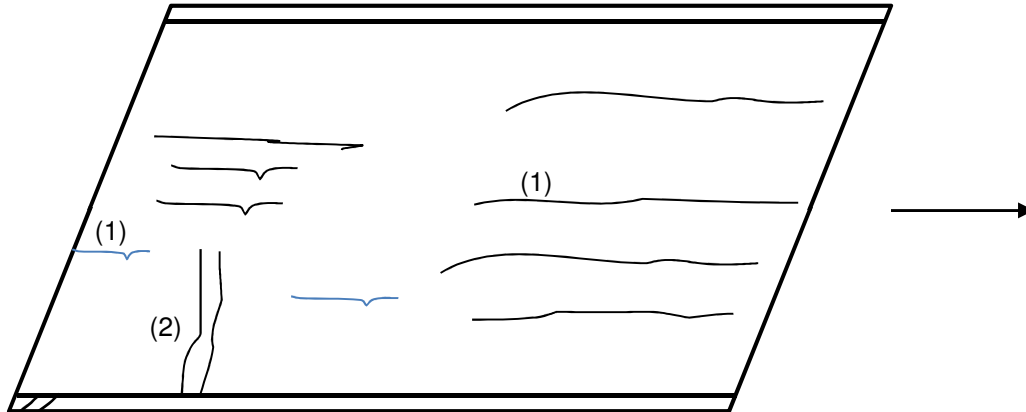
Bottom of Slab Span No. 1

DECK	NV	
OVERHANG	GOOD	DIAG. H.C.'S W/EFF. @ ABUT #1 RT. SIDE
BEAM	FAIR	(2) COLLISION SCRAPES < 1/16", (1) LONGIT. CRACKS W/EFF. UP TO 1/16" OPEN UP TO 30'L
LIGHTS	GOOD

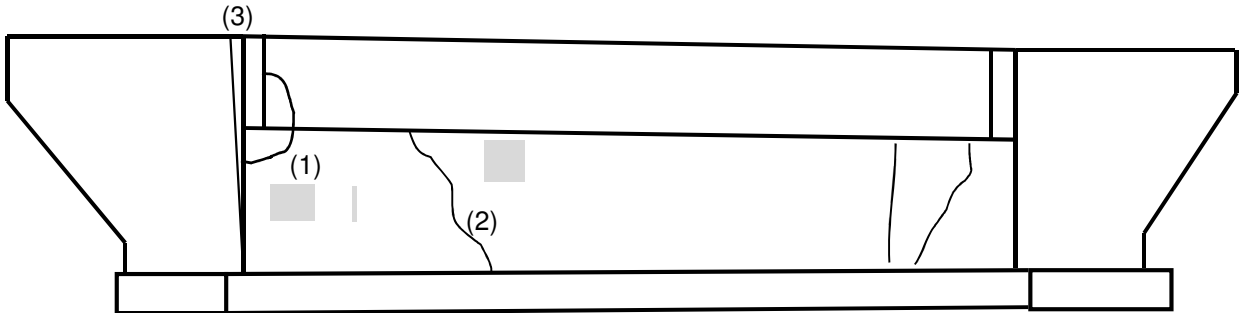
Abutment No. 1

BACKWALL	NV	
WALL	FAIR	(1) SPALL, FAILED PATCH 3'L X 1'H X 6" DP, (2) FULL HEIGHT H.L. CRACKS @ REPAIRS, RDM SPALLS UP TO 1.5'L X 8" H X 1" DP
WINGS	POOR	(3) HORZ. MISALIGNMENT 3" SEPARATION & TILT
FOOTING	NV	
BEARINGS	NV	
SLOPE PVT	GOOD

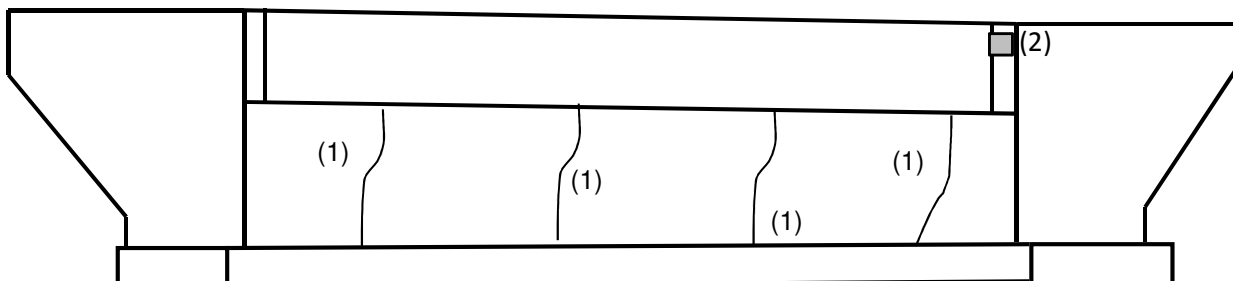
Abutment No. 2

BACKWALL	NV	
WALL	GOOD	(1) VERT. CRACKS UP TO 1/16" OPEN (RANDOM) FULL HEIGHT, (2) SPALL 3' L X 1.5' H X 2" DP
WINGS	GOOD	RANDOM MAP CRACKS
FOOTING	NV	
BEARINGS	NV	
SLOPE PVT	GOOD
