BRIDGE MAINTENANCE RECOMMENDATIONS

Tennessee Department
of Transportation

CROSSING: I440-LL/GLENROSE AVE CSX
 FED. BRIDGE NO.: 19I04400054
 MAINT. DIST.: 19

BRIDGE INSPECTION REPORT

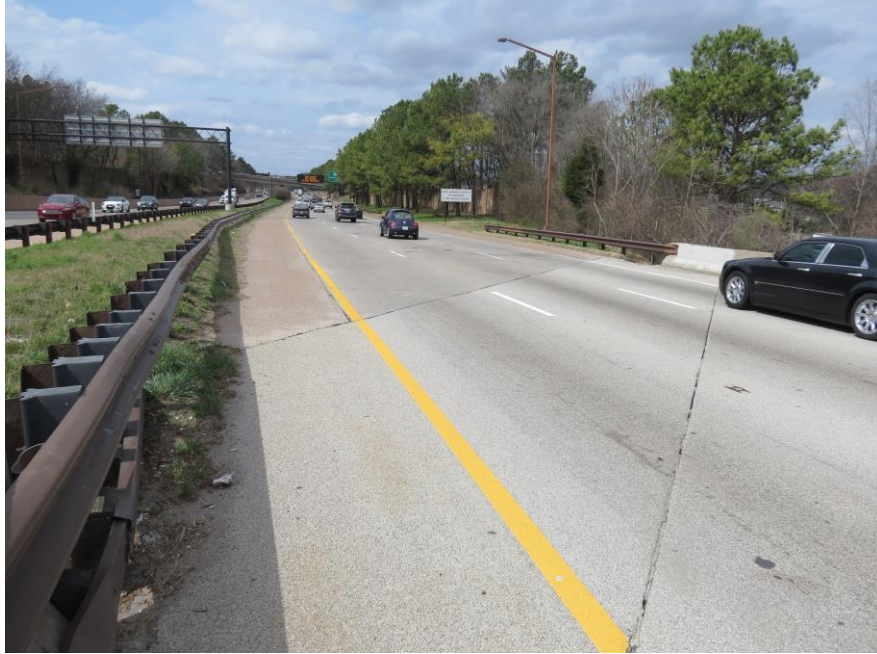
APPROACH "A" - WBL

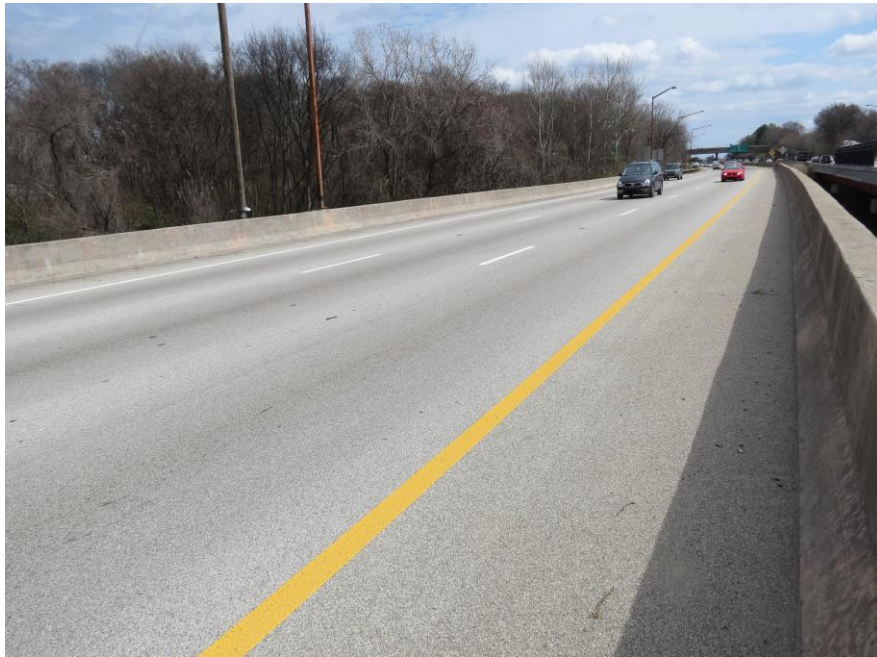
VIEW ACROSS TOP OF WEARING SURFACE WBL

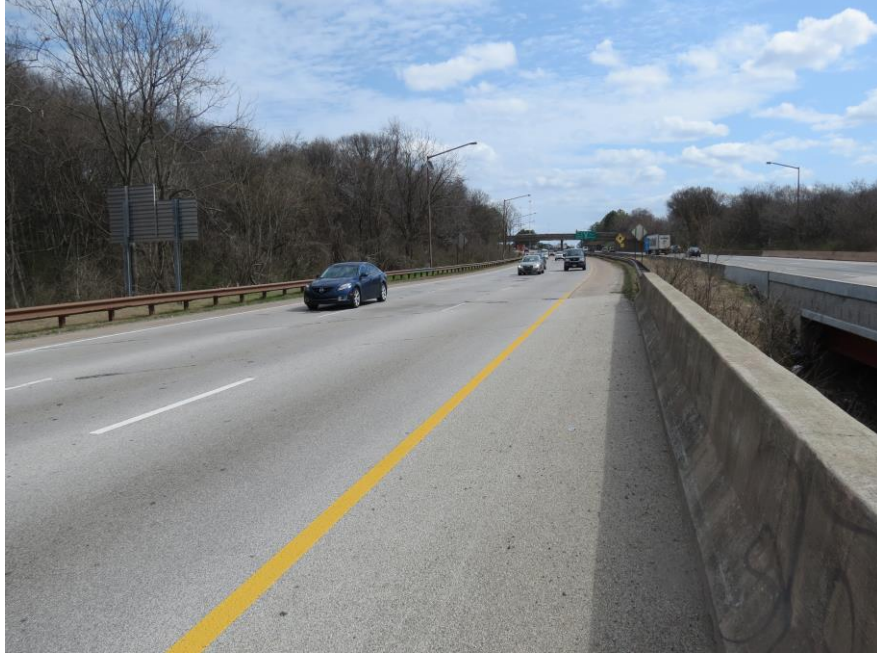
APPROACH "B" - WBL

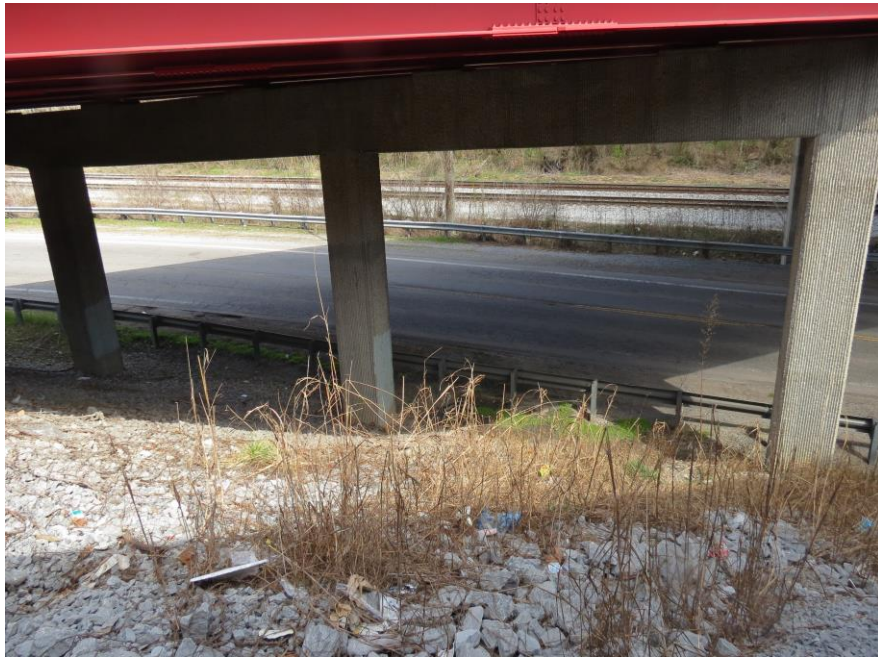
BENT #1 - FRONT VIEW

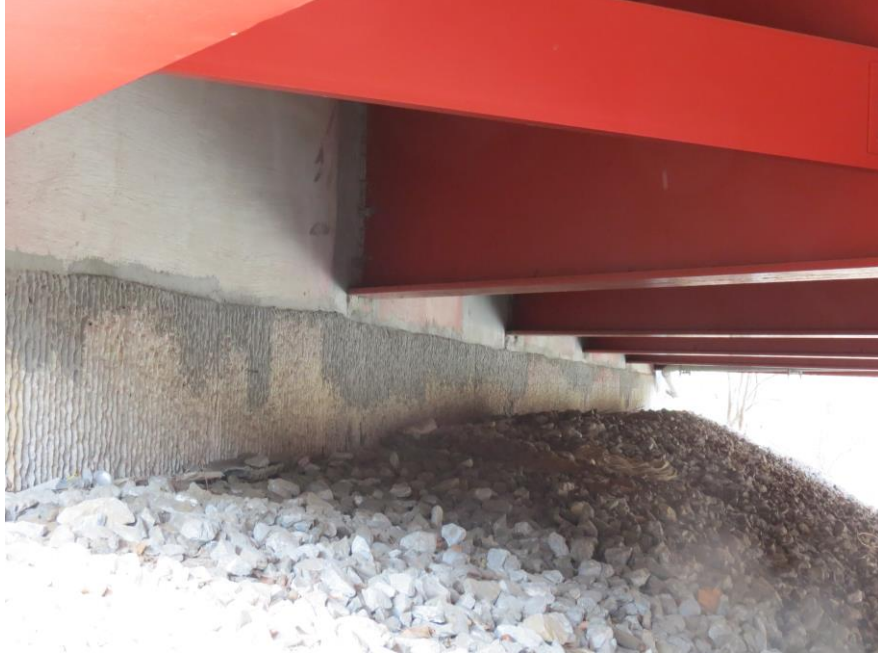
ABUTMENT #1

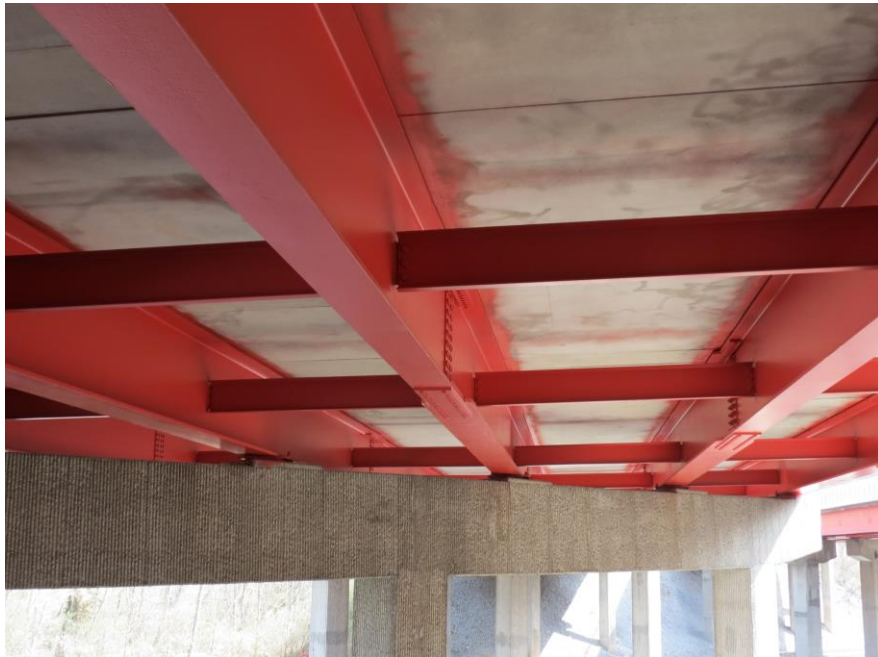
BOTTOM OF DECK VIEW SP. #1

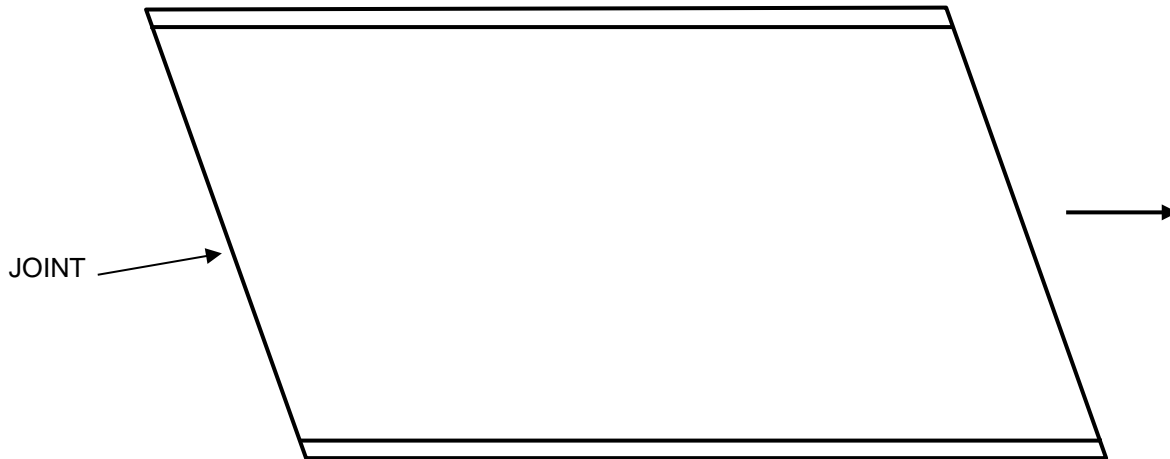
Top of Deck Span No. 1

DECK	NV	ANTI-SKID OVERLAY-GOOD- (2013)
PARAPET	GOOD	RANDOM IMPACT SCRAPES
JOINT	GOOD

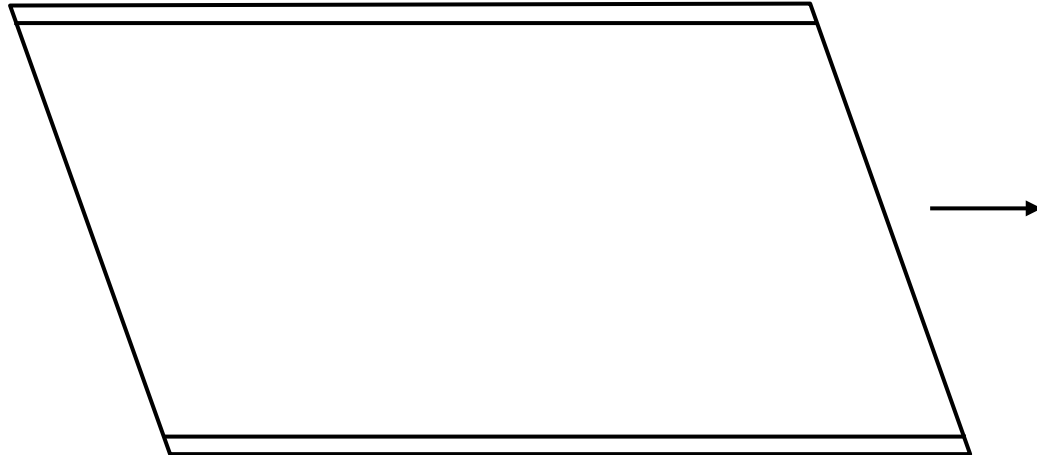
Top of Deck Span No. 2

DECK	NV	ANTI-SKID OVERLAY-GOOD- (2013)
PARAPET	GOOD	RANDOM IMPACT SCRAPES

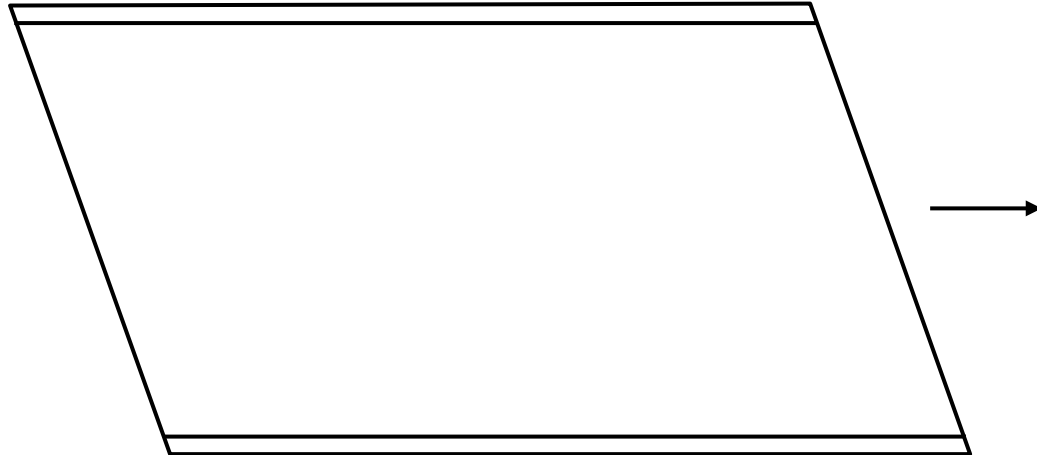
Top of Deck Span No. 3

DECK	NV	ANTI-SKID OVERLAY-GOOD- (2013)
PARAPET	GOOD	RANDOM IMPACT SCRAPES

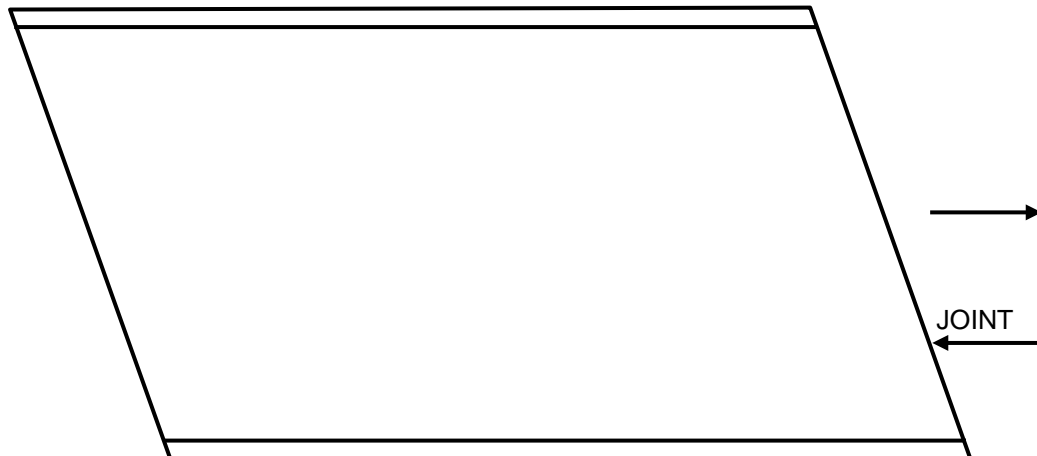
Top of Deck Span No. 4

DECK	NV	ANTI-SKID OVERLAY-GOOD- (2013)
PARAPET	GOOD	RANDOM IMPACT SCRAPES
JOINT	GOOD

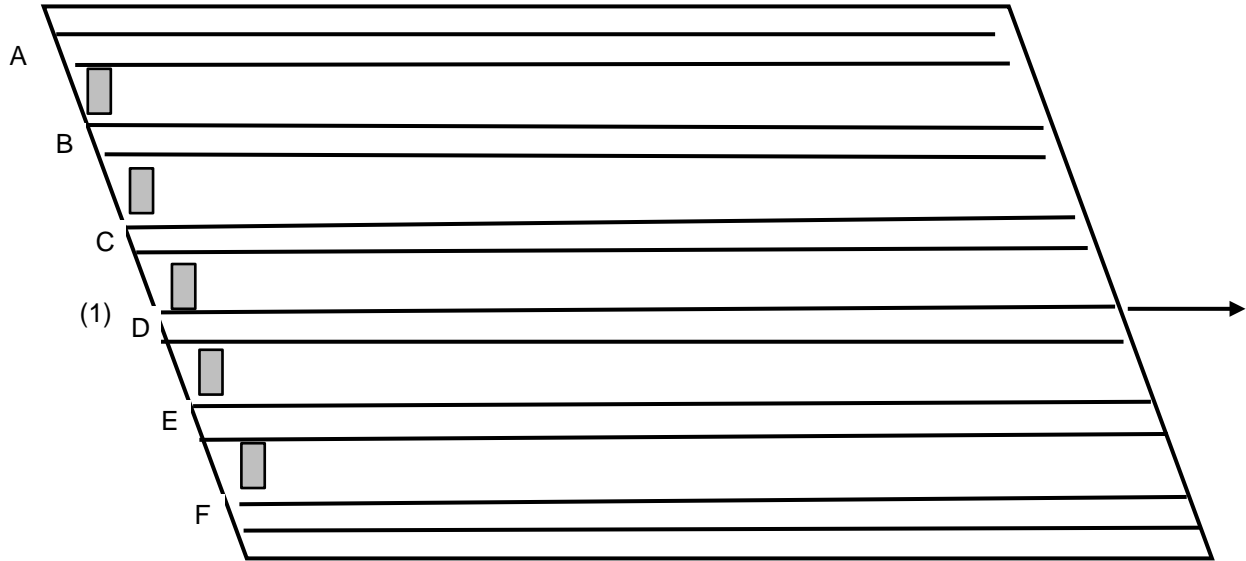
Bottom of Slab Span No. 1

DECK	FAIR	DECK PANELS-(1) CONC. REPAIRS W/RANDOM H.C.'S W/EFF.,
		BAY 'A' PANEL #1 & #2- TRANSV H.L. CRACKS,
		BAY 'C' PANEL #2,#3,#4, & #5 TRANSV & LONGIT CRACKS UP TO 1/16"
		OPEN,BAY 'E' PANEL #1 & #2 TRANSV CRACKS UP TO 1/16" OPEN,
		BAY 'D' PANEL #2 TRANSV H.L. CRACKS
DIAPHRAGMS	GOOD	
BEAMS	GOOD	
PAINT	GOOD	2012-13

SUGGESTED ROUTINE MAINTENANCE AND COMMENTS
 REPAIR EROSION AT ABUTMENT #2 EMBANKMENT LEFT SIDE
 SEAL CRACKS IN DECK PANELS

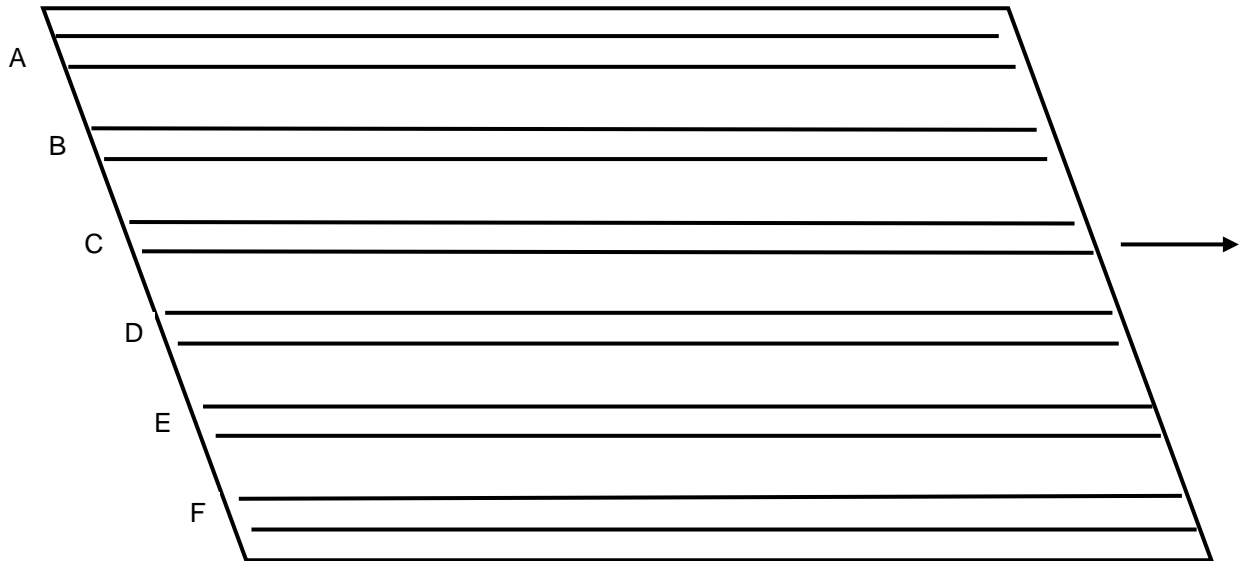
Bottom of Slab Span No. 2

DECK	GOOD	DECK PANELS- RANDOM RUST STAINS
DIAPHRAGMS	GOOD	
BEAMS	GOOD	
PAINT	GOOD	2012-13

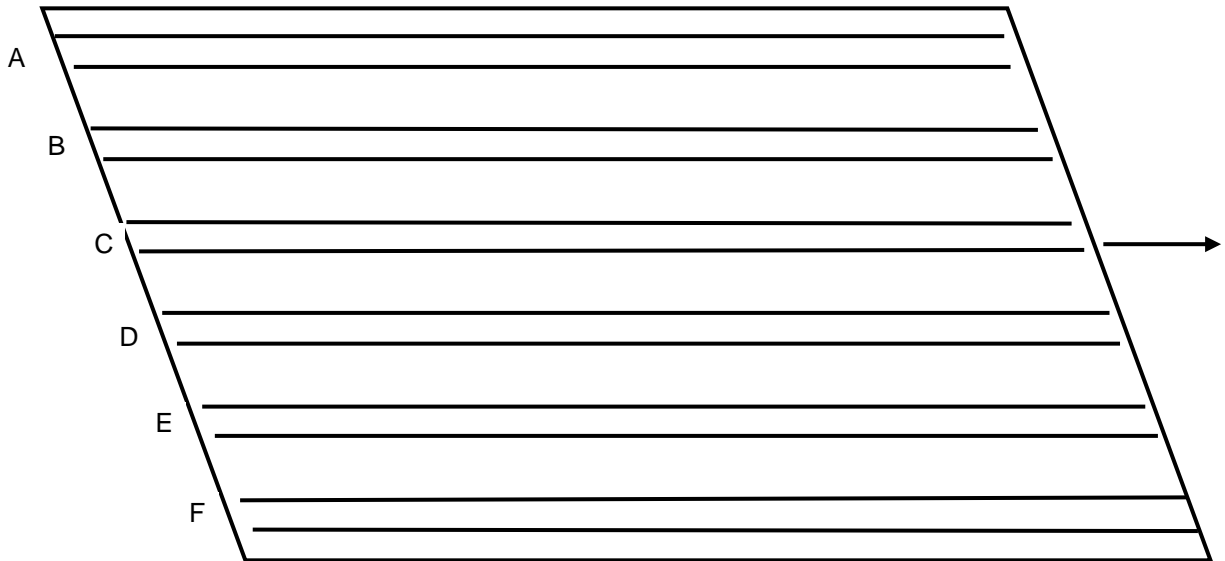
Bottom of Slab Span No. 3

DECK	GOOD	DECK PANELS & MOD SOOT STAINS OVER TRACKS
DIAPHRAGMS	GOOD	
BEAMS	GOOD	SOOT FROM TRAINS
PAINT	GOOD	2013

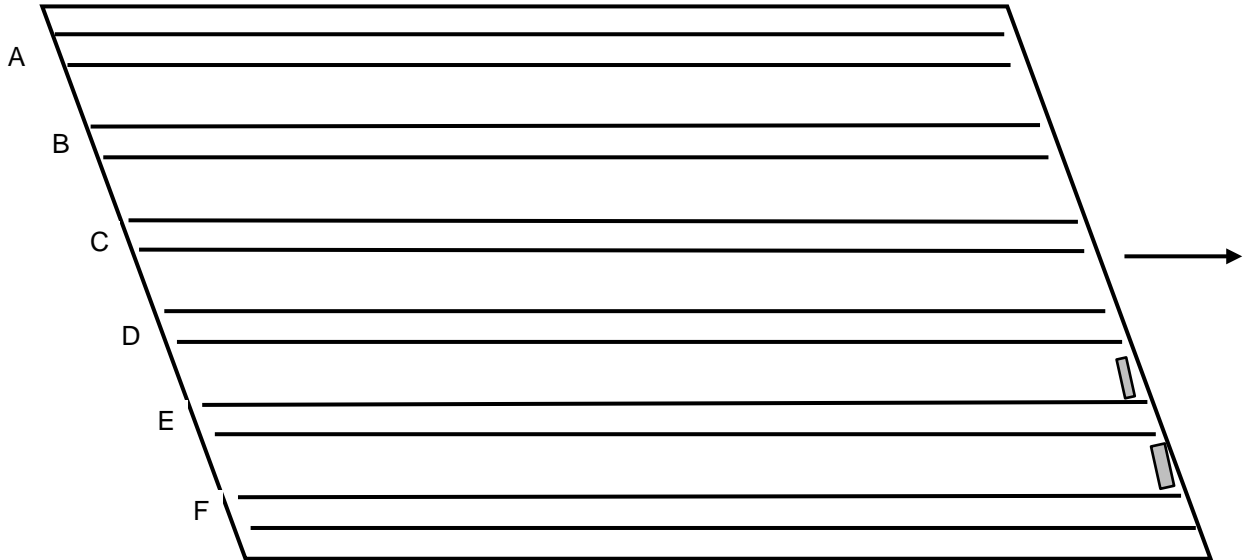
Bottom of Slab Span No. 4

DECK	GOOD	BAY 'C' PANEL #3 FROM BENT #3 TRANSV. CRACKS UP TO 1/16"
		OPEN
DIAPHRAGMS	GOOD	
BEAMS	GOOD	HVY STAINS BTWN BM 'C' & 'D'
PAIN	GOOD	2012-13

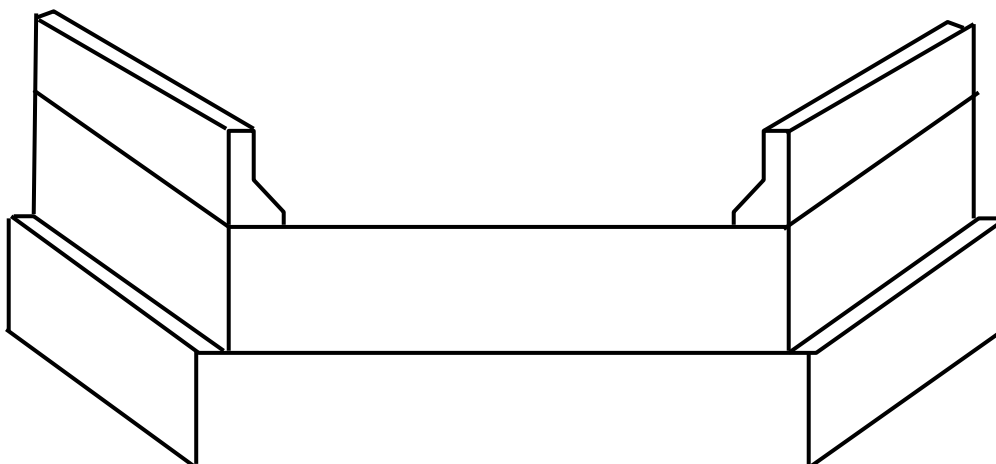
Abutment No. 1

BACKWALL	N.V.	
WALL	GOOD	RANDOM H.C.'s
WINGS	GOOD	
BEARINGS	NV

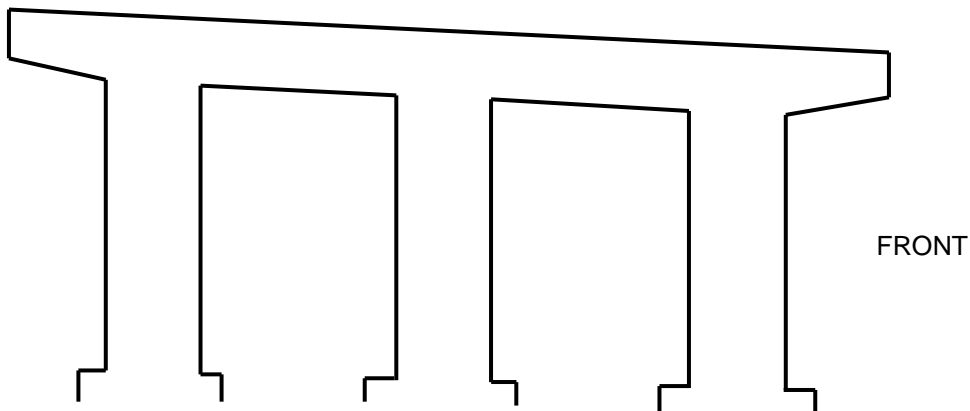
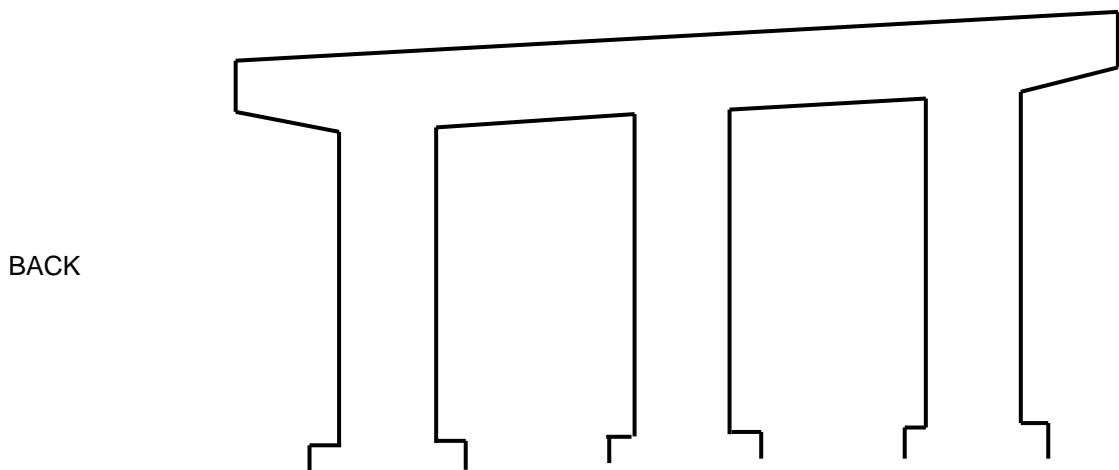
BENT # 1

CAP	GOOD	
COLUMNS	GOOD	
FOOTINGS	NV	
BEARINGS	GOOD

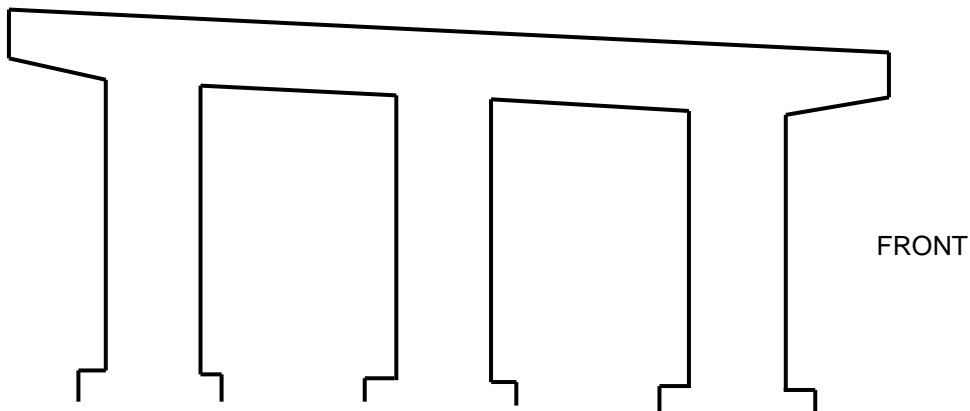
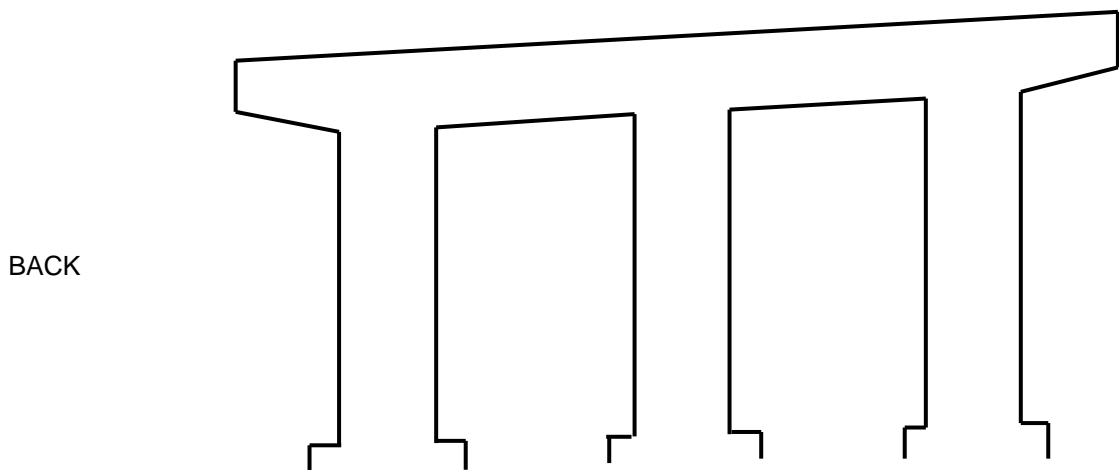
BENT # 2

CAP	GOOD	
COLUMNS	GOOD	
FOOTINGS	NV	
BEARINGS	GOOD

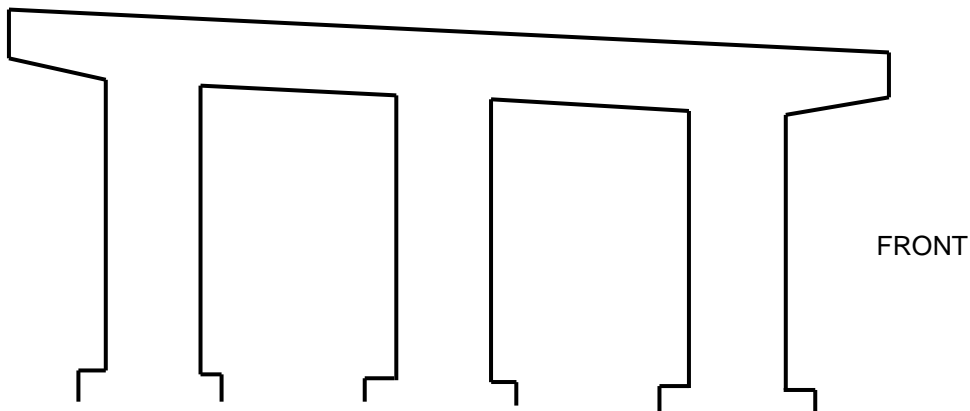
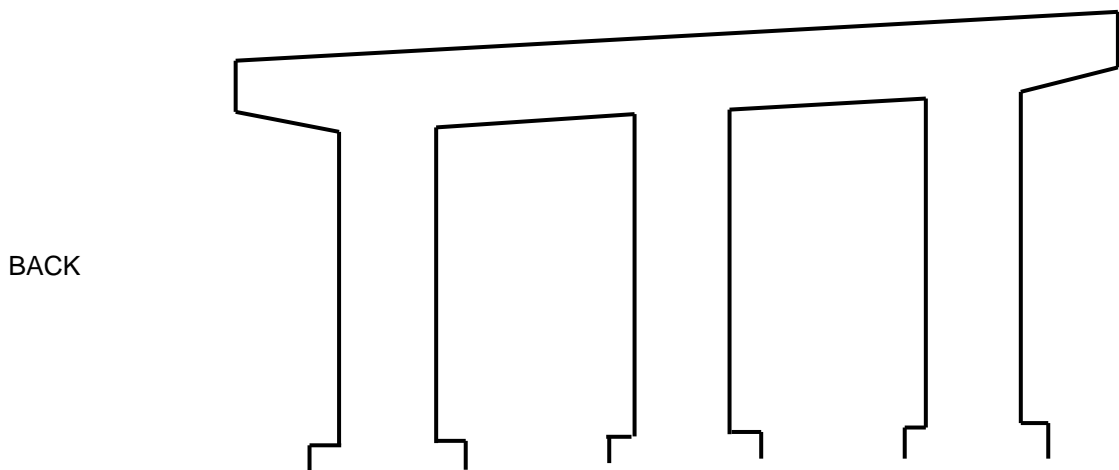
BENT # 3

CAP	GOOD	
COLUMNS	GOOD	
FOOTINGS	NV	
BEARINGS	GOOD	
B'	GOOD	EXTRA LONG BOLT W/ LOOSE NUT

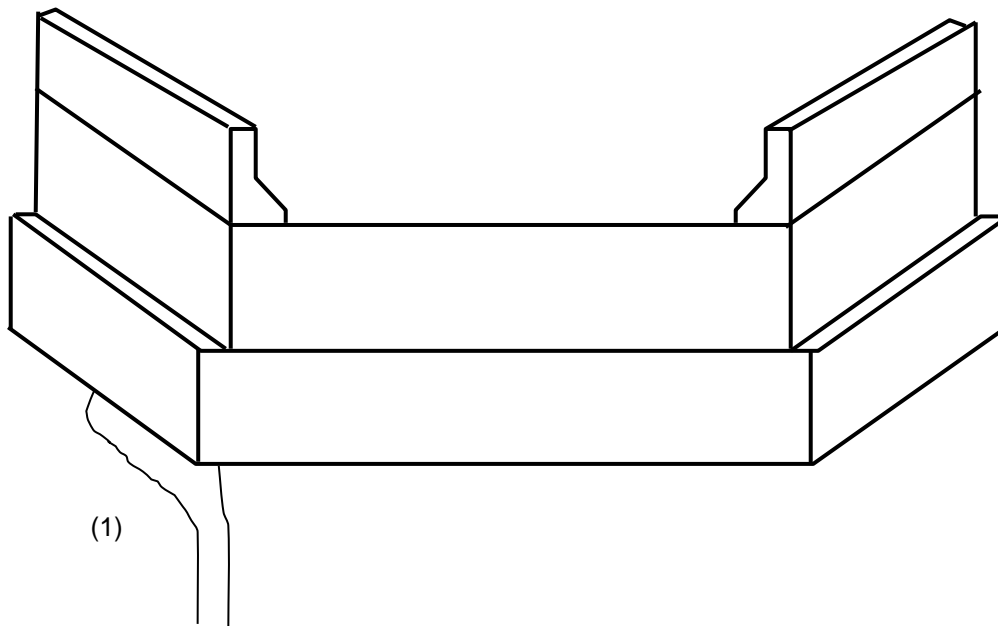
Abutment No. 2

Concrete girders and bearings are in good condition. Abutments are good. Moderate embankment erosion was noted at abutment #2 left side.

BACKWALL	N.V.	
WALL	GOOD	SOOT STAINS @ BMS 'C' & 'D', HORIZ. H.L. CRACKS @ BEAMS
WINGS	GOOD	
BEARGINS	NV	
EMBANKM	FAIR	(1) EROSION 3' W X 20' L X 3' DP
