## Images listed below are possible future issues.

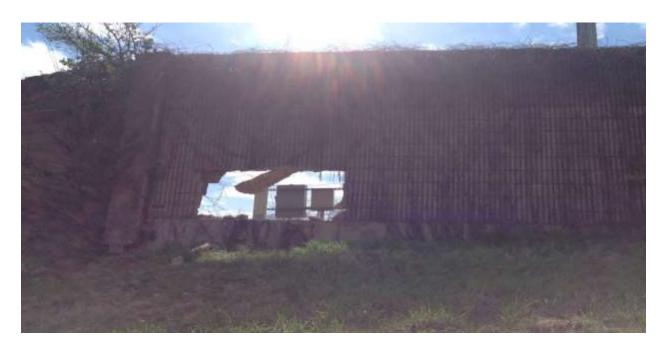
1440 EB @ mm 7.0

Height of Wall 20' From Grass

Steep slope with ditch, will be difficult to reach, may need a pad put down

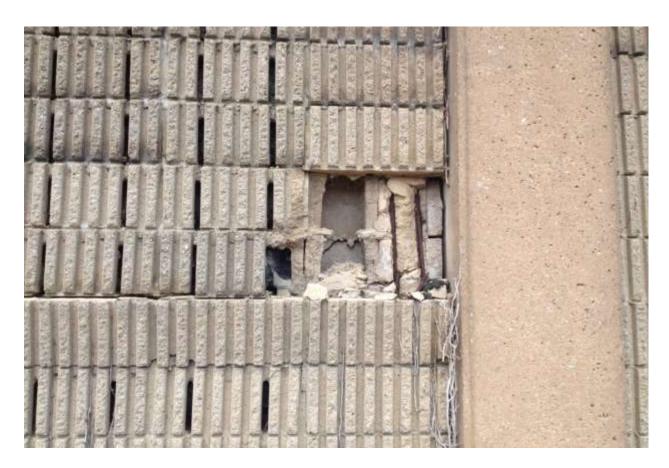
1440 WB @ mm 4.4

Height of Wall 10' From Road

8' x 15' = 120 SF

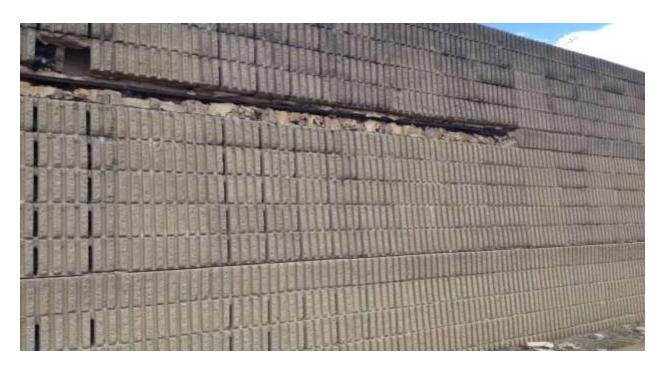
1440 WB @ mm 4.4

Height of Wall 14' From Road

8' x 16' = 128 SF

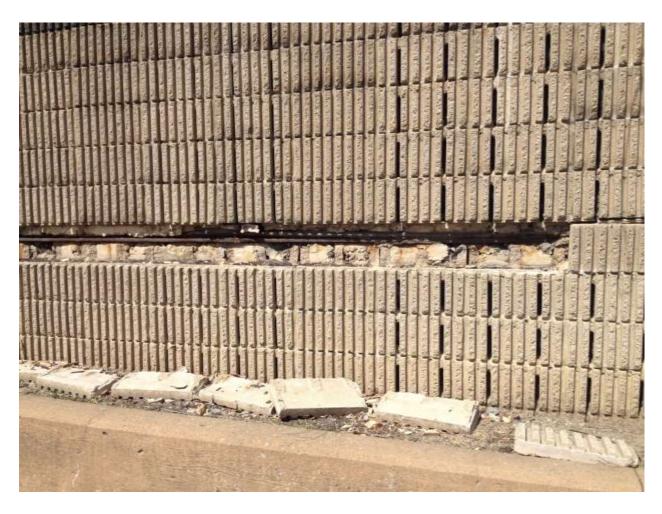
1440 WB @ mm 4.4

Height of Wall 10' From Road

10' x 20' = 200 SF

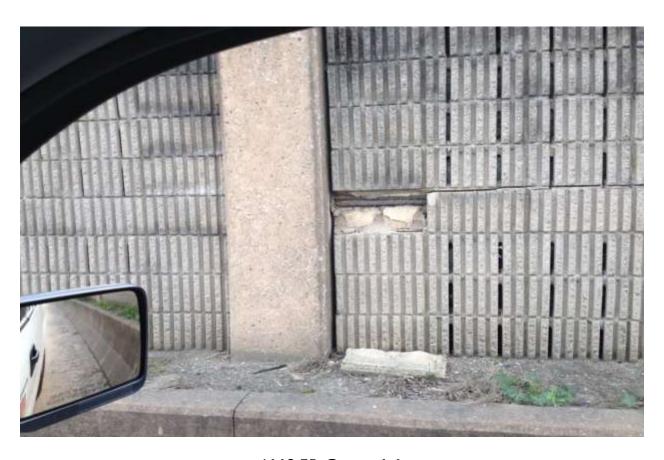
1440 EB @ mm 4.4

Height of Wall 10' From Road

4' x 24' = 96 SF

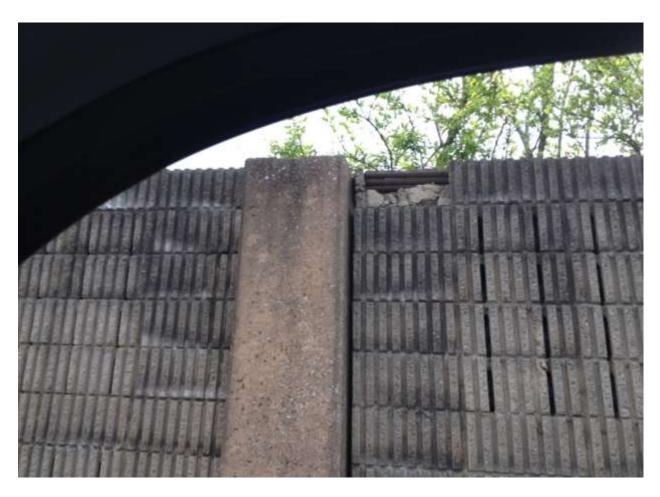
1440 EB @ mm 4.1

Height of Wall 10' From Road

8' x 24' = 192 SF

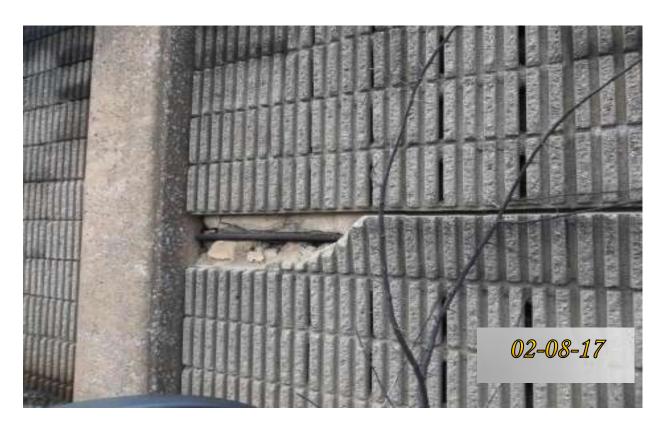
1440 EB @ mm 4.1

Height of Wall 10' From Road

4' x 24' = 96 SF

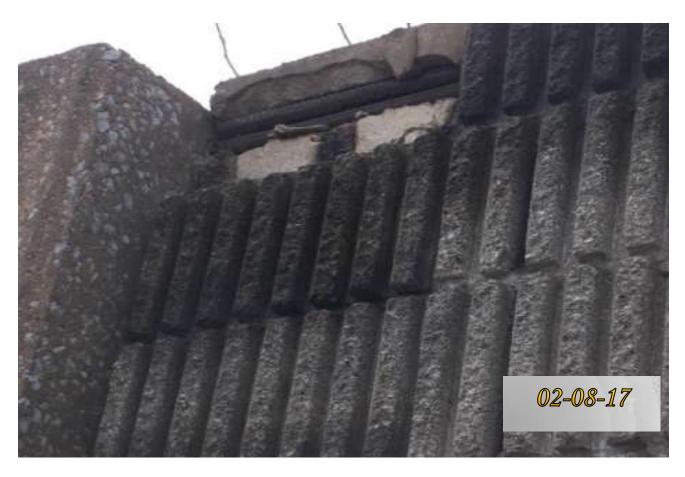
1440 EB @ mm 4.1

Height of Wall 10' From Road

3' x 24' = 72 SF

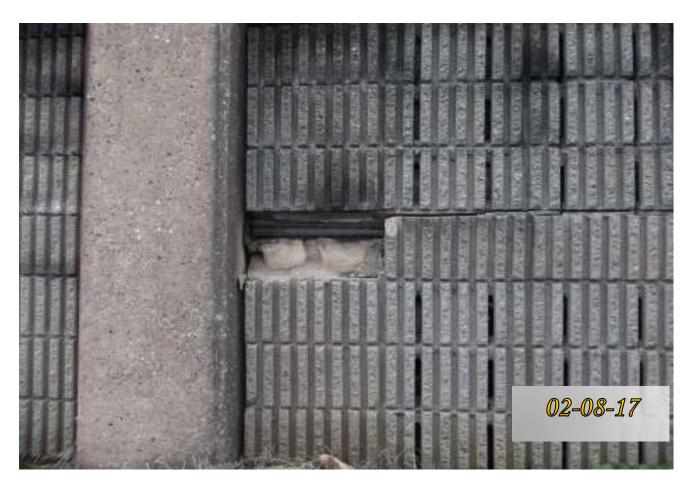
1440 EB @ mm 4.2

13' Off White Line

Height of Wall 10' From Road

4' x 24' = 96 SF

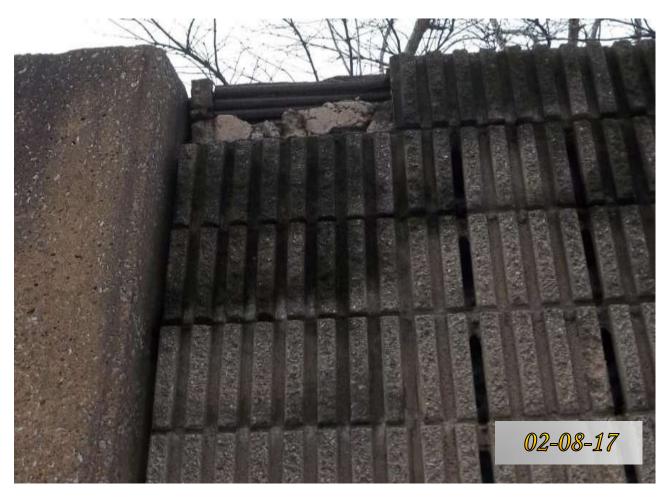
1440 EB @ mm 4.2

13' Off White Line

Height of Wall 10' From Road

4' x 24' = 96 SF

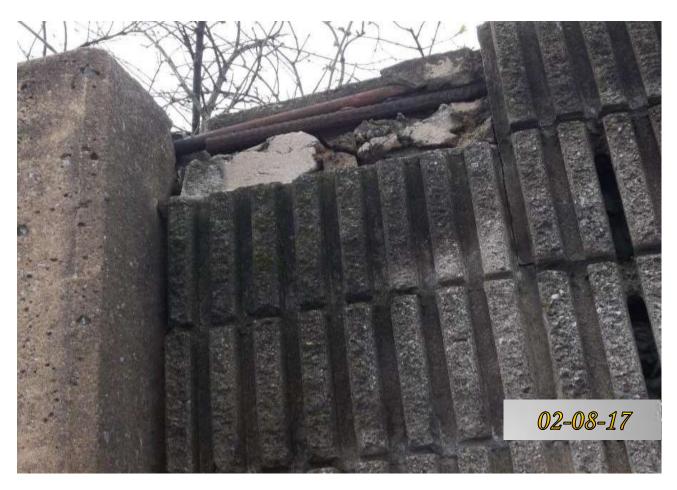
1440 EB @ mm 4.2

Height of Wall 10' From Road

4' x 24' = 96 SF

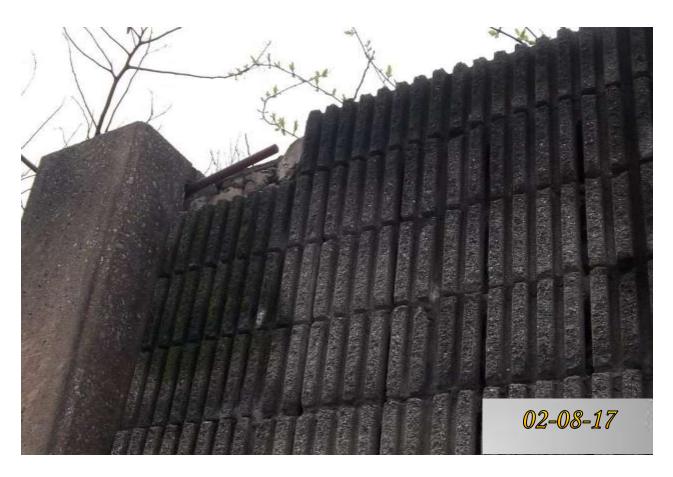
1440 EB @ mm 4.4

Height of Wall 10' From Road

4' x 24' = 96 SF

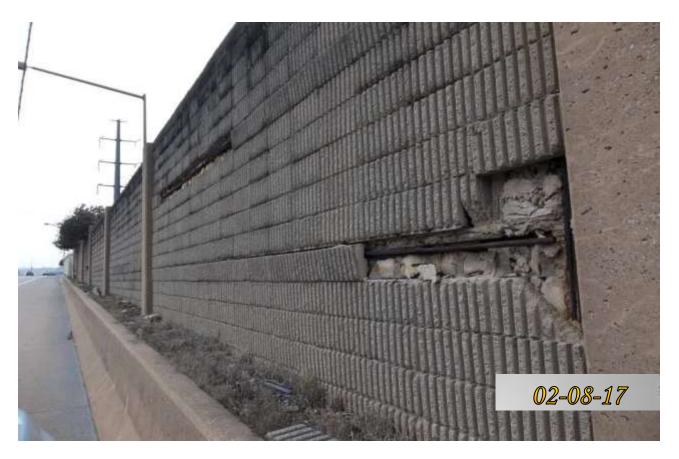
1440 WB @ mm 4.4

Height of Wall 14' From Road

4' x 24' = 96 SF

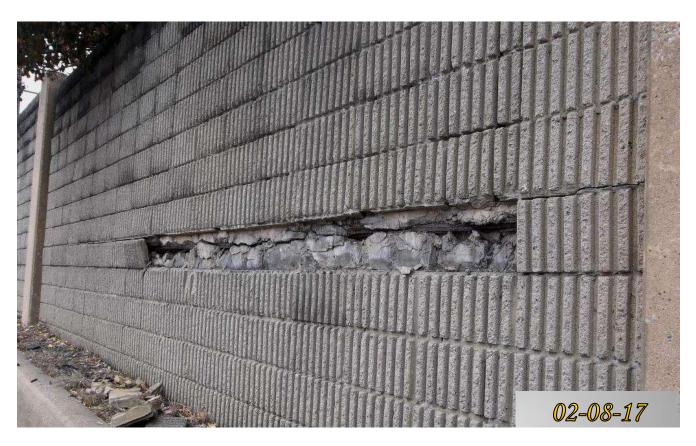
1440 WB @ mm 4.4

Height of Wall 13' From Road

8' x 14' = 112 SF

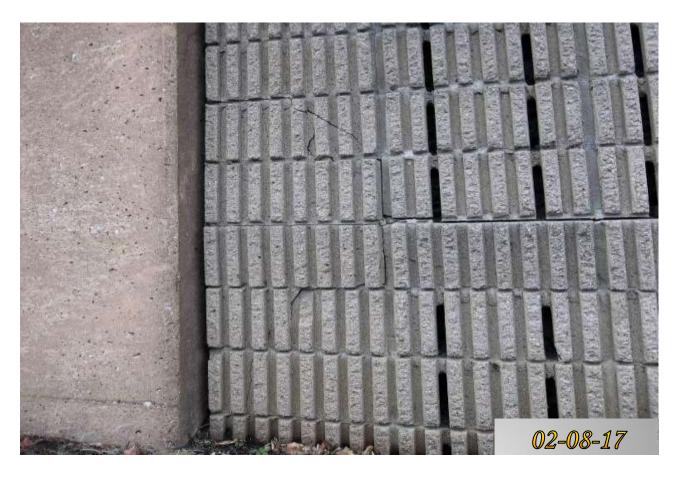
1440 WB @ mm 4.4

Height of Wall 10' From Road

4' x 24' = 96 SF

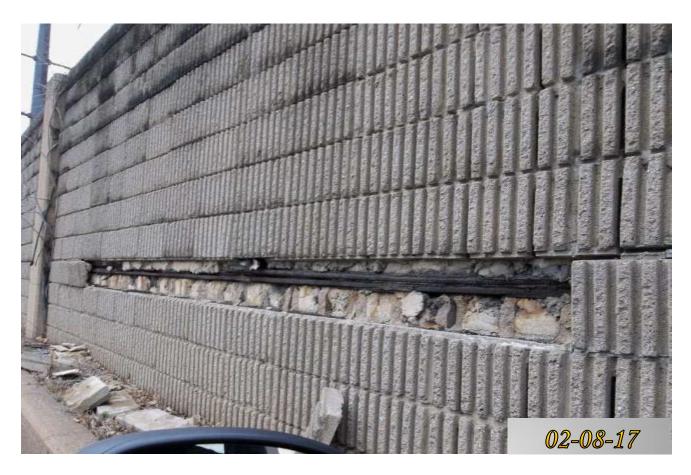
1440 WB @ mm 4.4

Height of Wall 12' From Road

4' x 24' = 96 SF

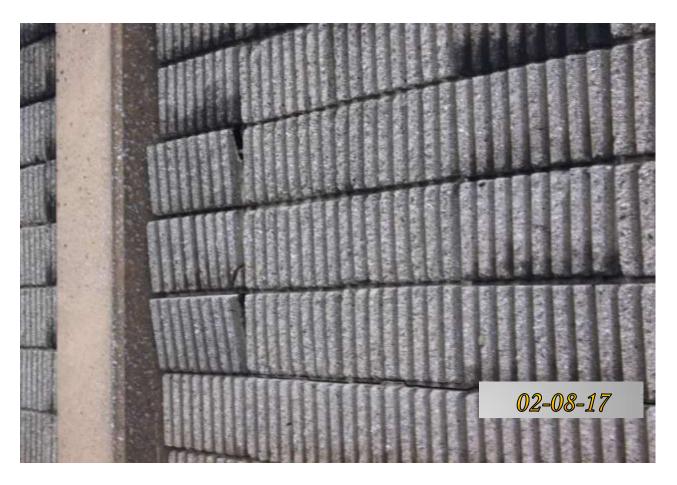
1440 WB @ mm 4.3

13' Off White Line

Height of Wall 10' From Road

8' x 24' = 192 SF

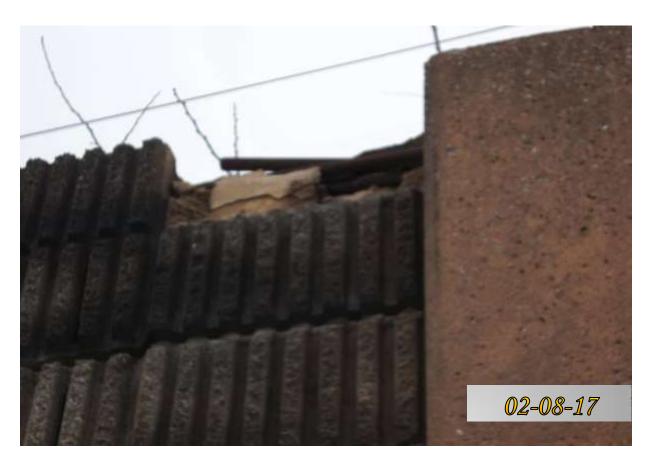
1440 WB @ mm 4.2

Height of Wall 8' From Road

4' x 24' = 96 SF

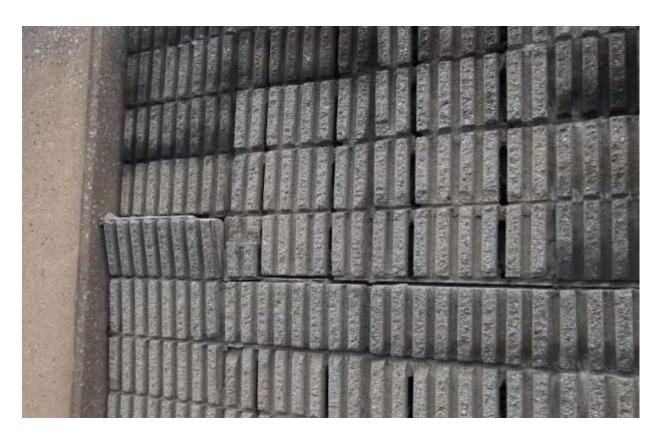
1440 WB @ mm 4.2

Height of Wall 8' From Road

8' x 10' = 80 SF

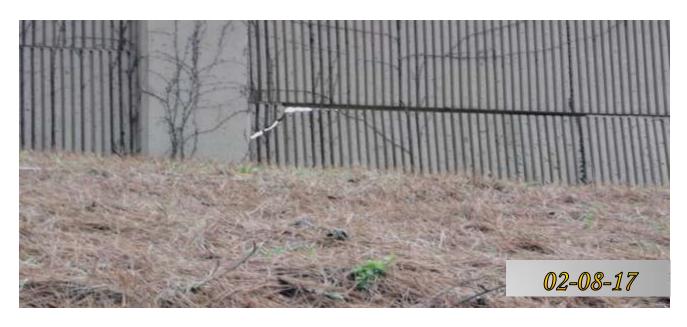
1440 WB @ mm 6.4

Height of Wall 12' From Grass

Steep slope with pine trees, will be difficult to reach, may need a pad put down, may not be able to use crane due to the trees in the area

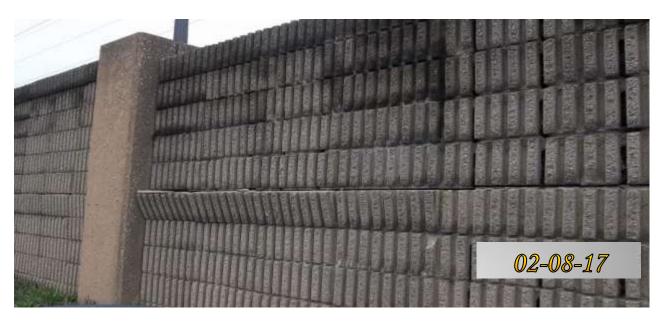
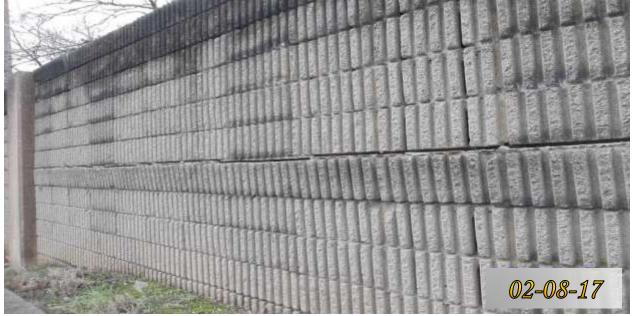
I-440 Eastbound

There are multiple areas with bowing in the middle and top of the panels, leaning away from the roadway.

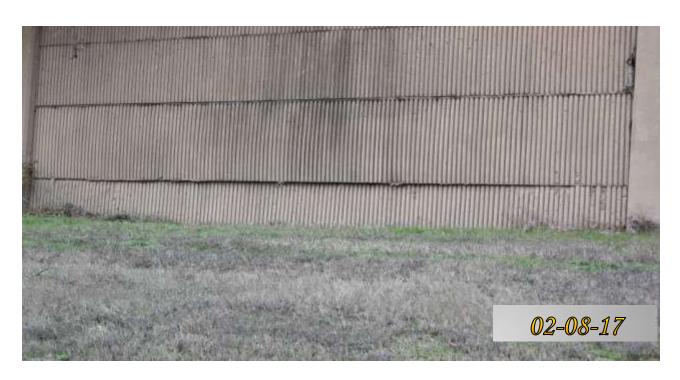
I-440 6.10 MM Westbound Bowing at the bottom 20'  $\times$  6' = 120 sf

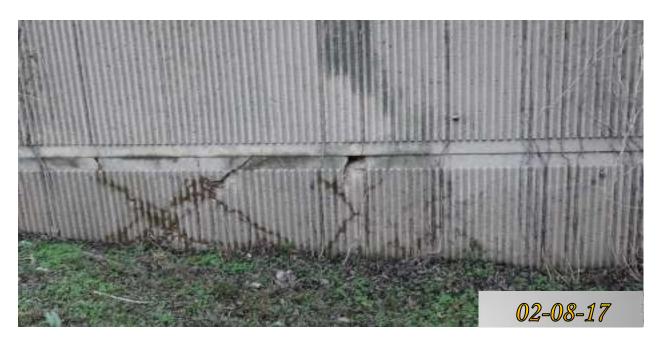
I-440 @ 0.6MM Eastbound

1 Section Chipped and cracking (10' x 6' = 60sf)

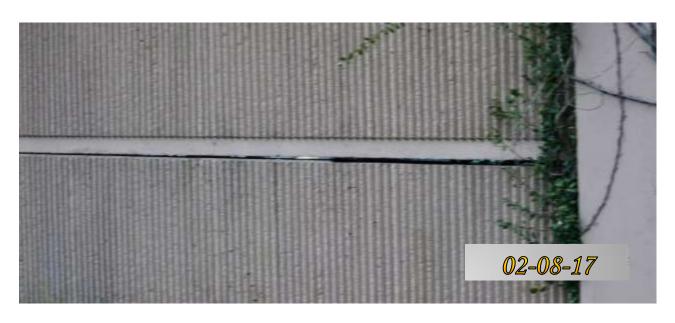
I-440 @ 3.00 MM Westbound Settling issues. Whole panel

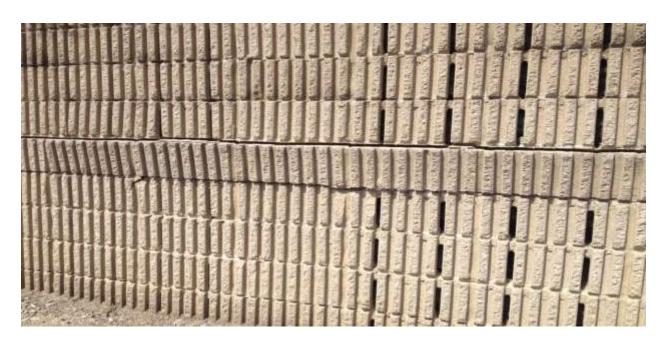
I-440 4.40MM Westbound-3
Bulging Issues all over I440
