## Polk County

### Regular Inspection Report

Location: 70-SR040-03.12

14 Span Bridge

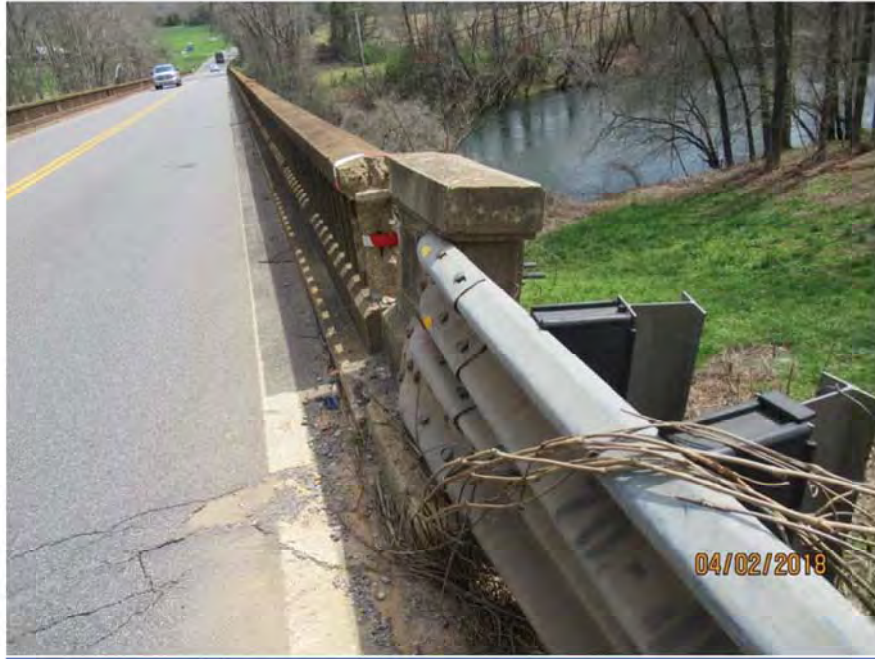
APPROACH 1 - RIGHT - RAIL DAMAGE

REPAIR BRIDGE RAIL - APPROACH 1 - RIGHT

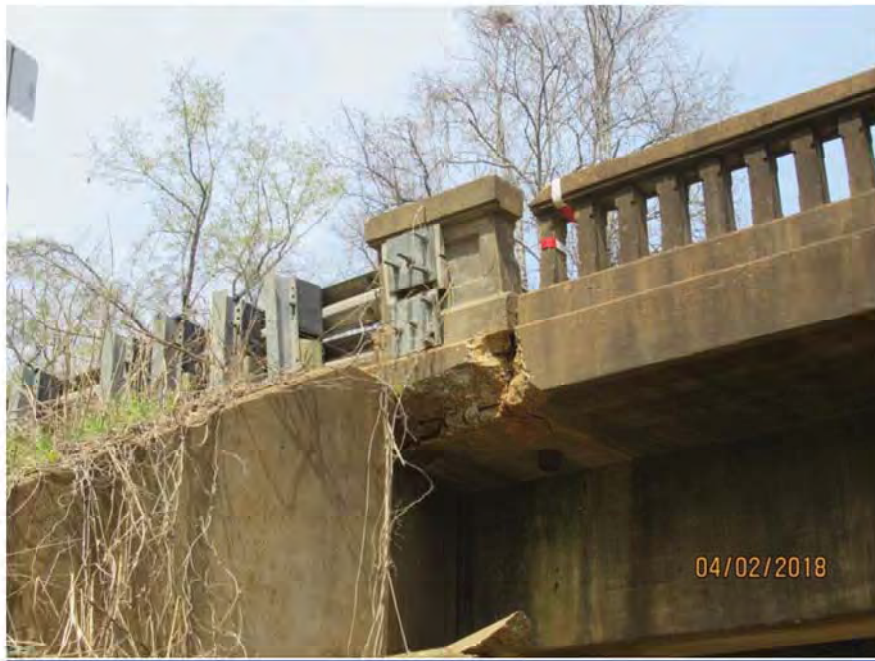
APPROACH 1 - RIGHT - RAIL DAMAGE

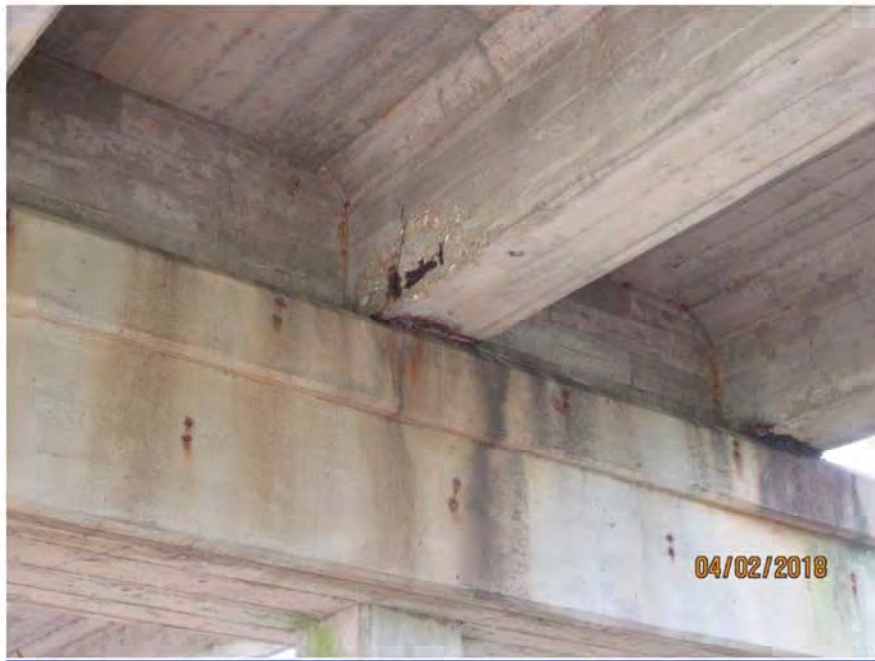
SPAN 9 - BENT 8 - BEAM B - REBAR SPALL

REPAIR THE SEVERAL CAPBEAM REBAR SPALLS

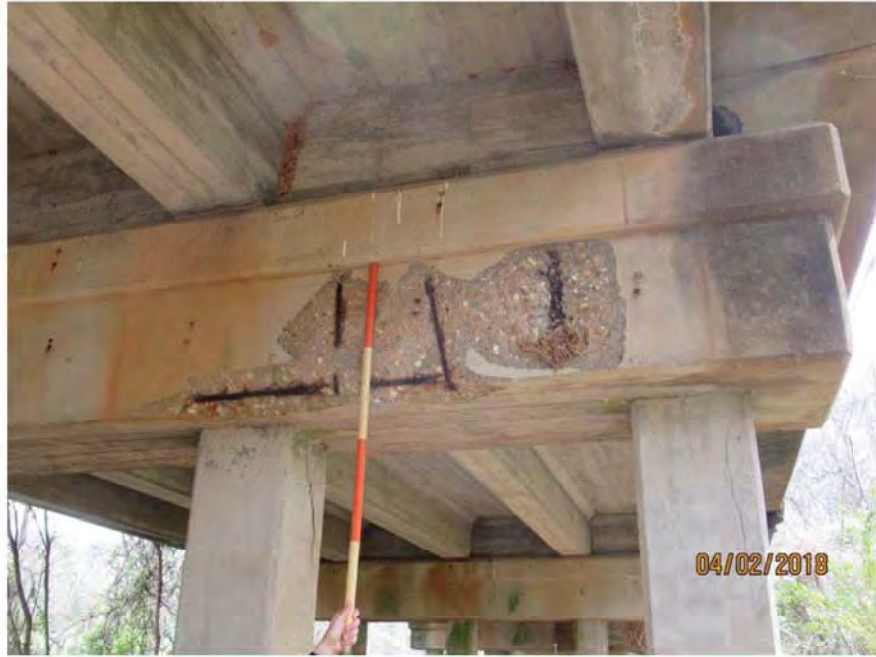
SPAN 9 - BENT 9 - BETWEEN COLUMNS D & E - REBAR SPALL

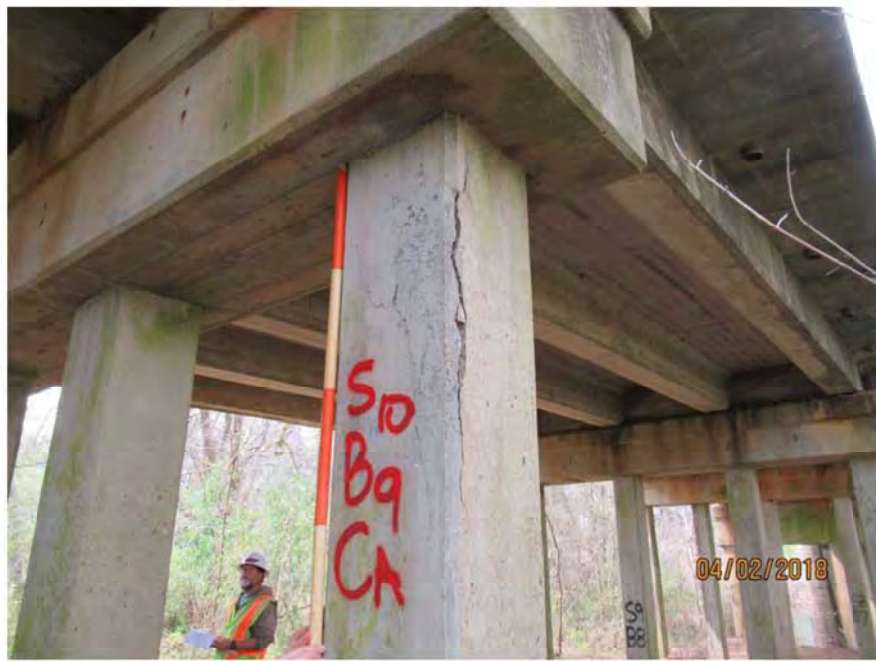
SPAN 10 - BENT 9 - COLUMN A - SPALL/DELM

REPAIR THE SEVERAL COLUMN REBAR SPALLS

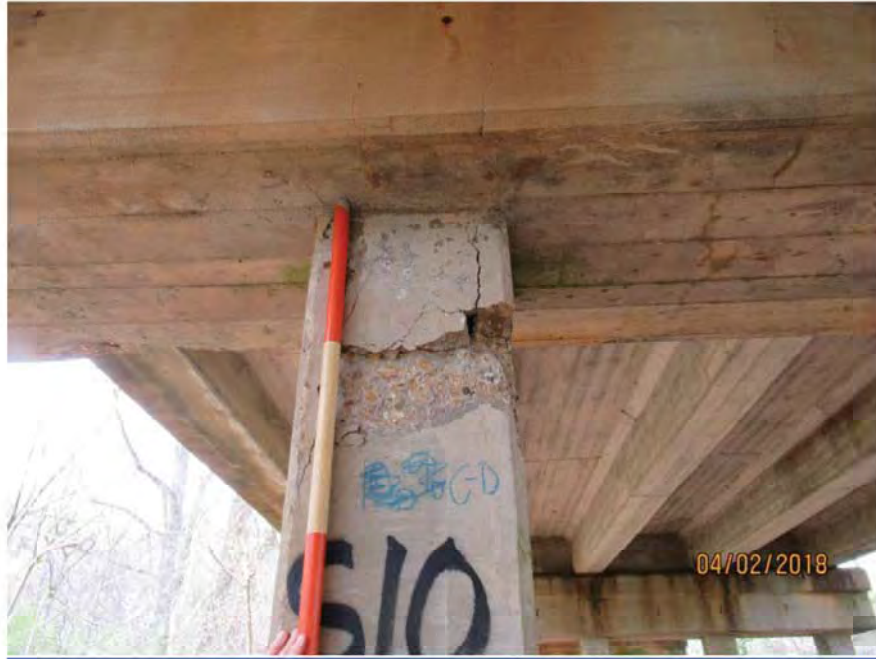
SPAN 10 - BENT 9 - COLUMN D - SPALL

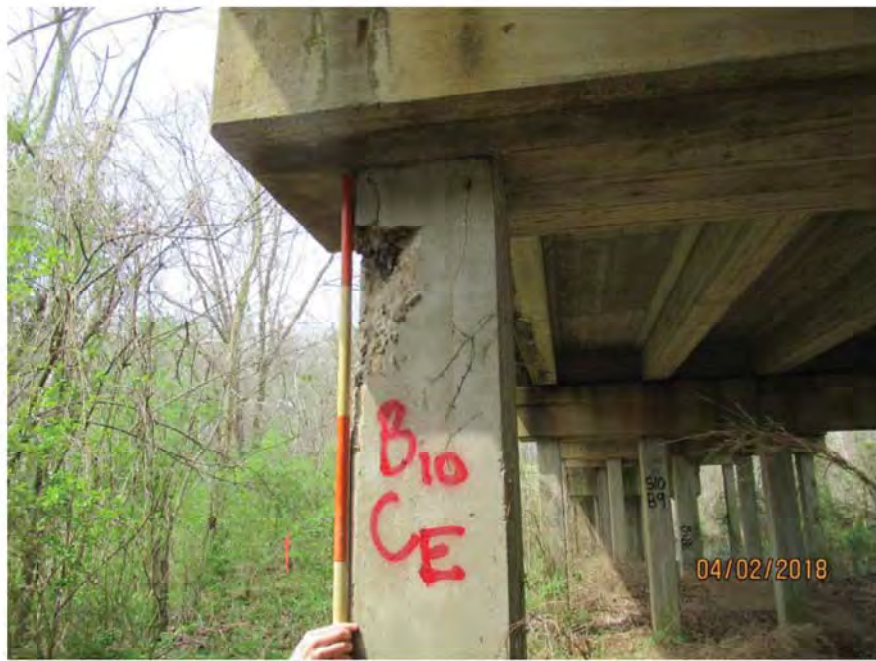
BENT 10 - COLUMN E - SPALL

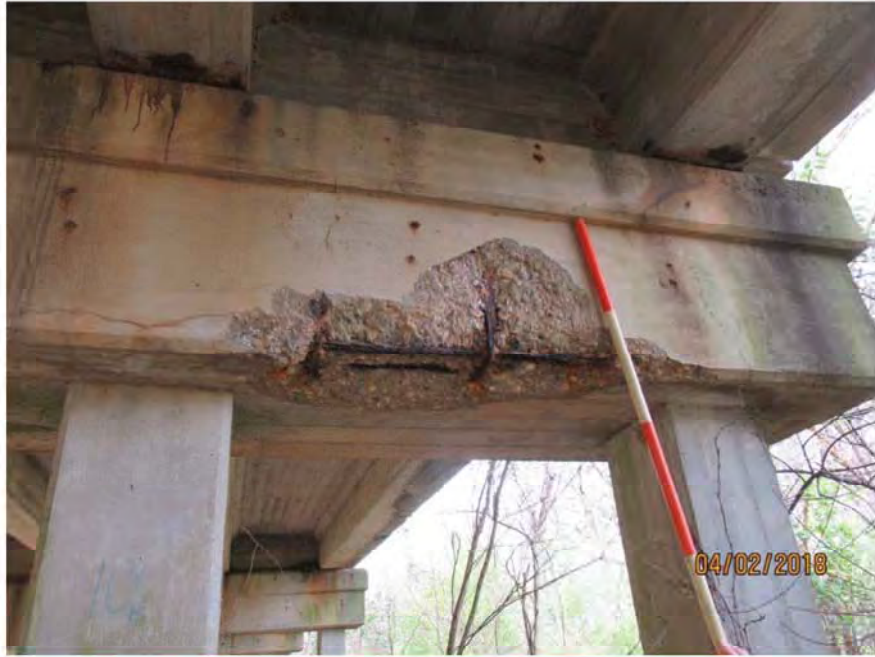
SPAN 11 - BENT 10 - BETWEEN COLUMNS A & B - REBAR SPALL

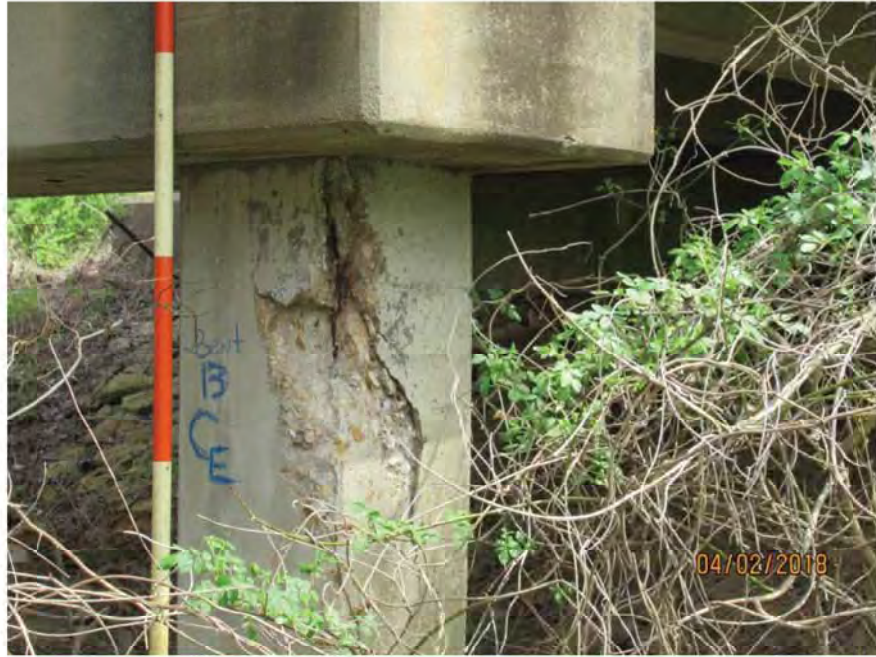
SPAN 13 - BENT 13 - COLUMN E - REBAR SPALL

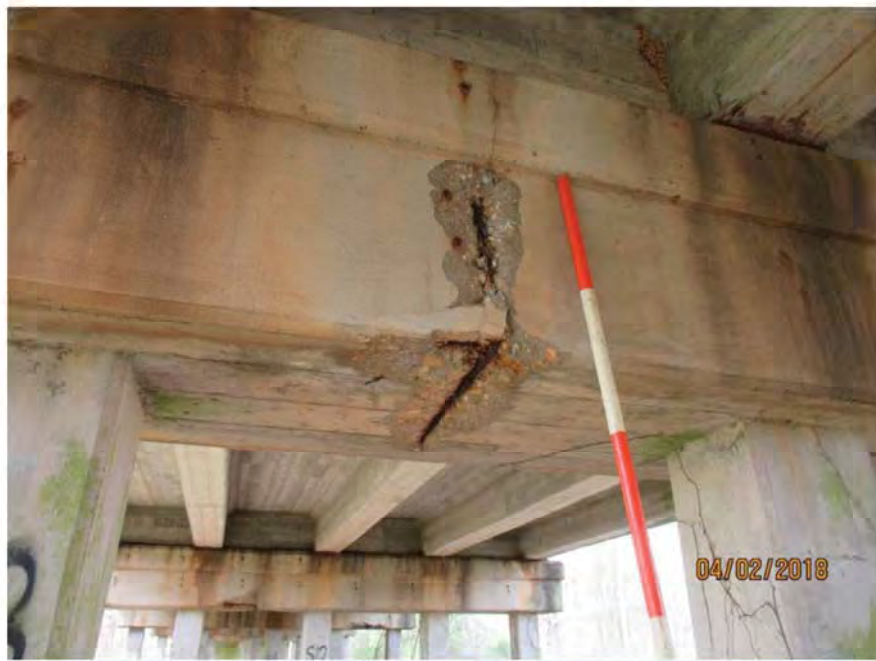
SPAN 13 - BENT 12 - BETWEEN C AND D - SPALL

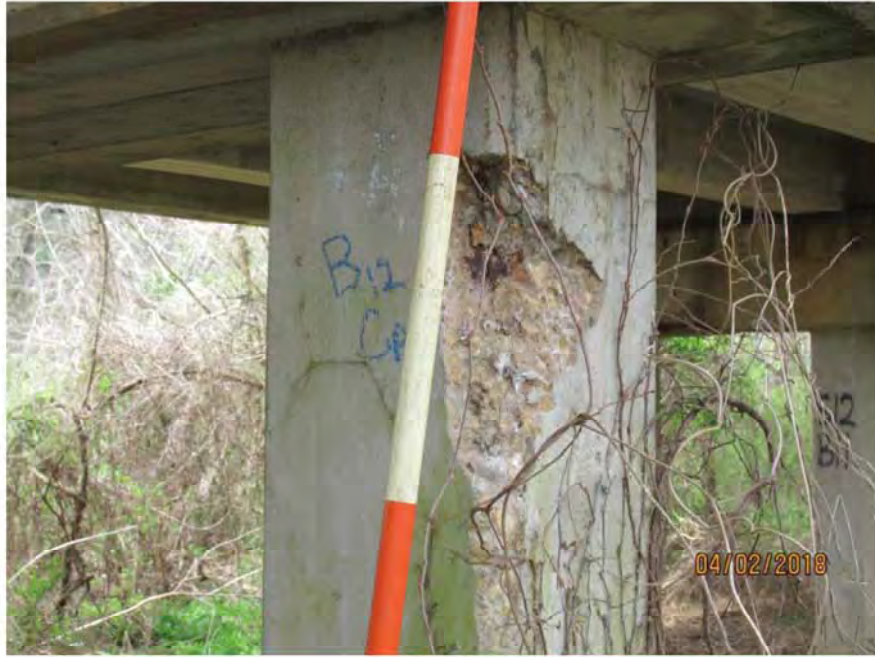
SPAN 13 - BENT 12 - COLUMN A - SPALL

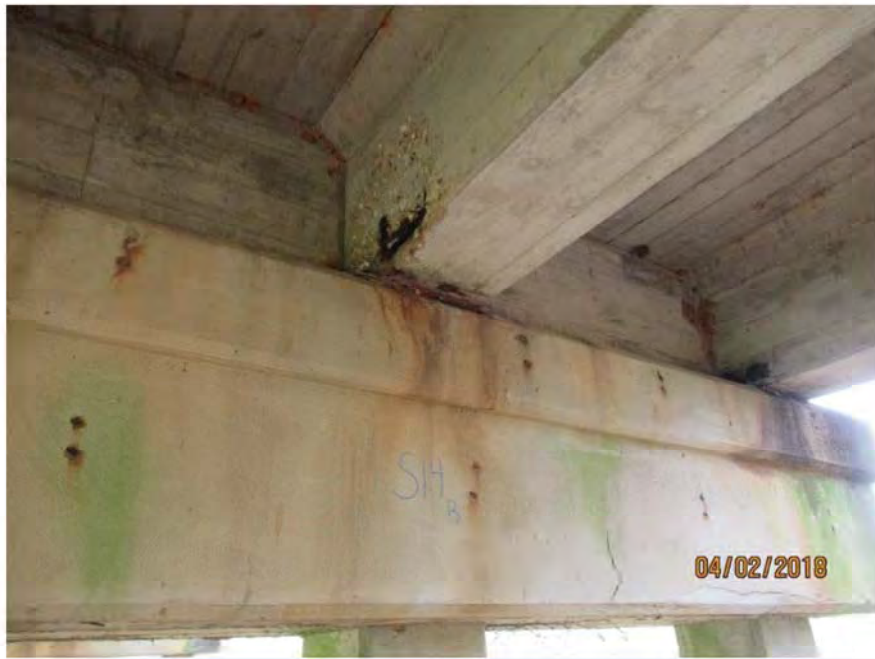
SPAN 14 - BENT 13 - BEAM B - SPALL
