951004000012
95-I40-7.43L
OVER
WILSON
CREEK

BRIDGE MAINTENANCE RECOMMENDATIONS

BRIDGE INSPECTION REPORT

SUMMARY
95-I40-7.43 LT
2/26/2010

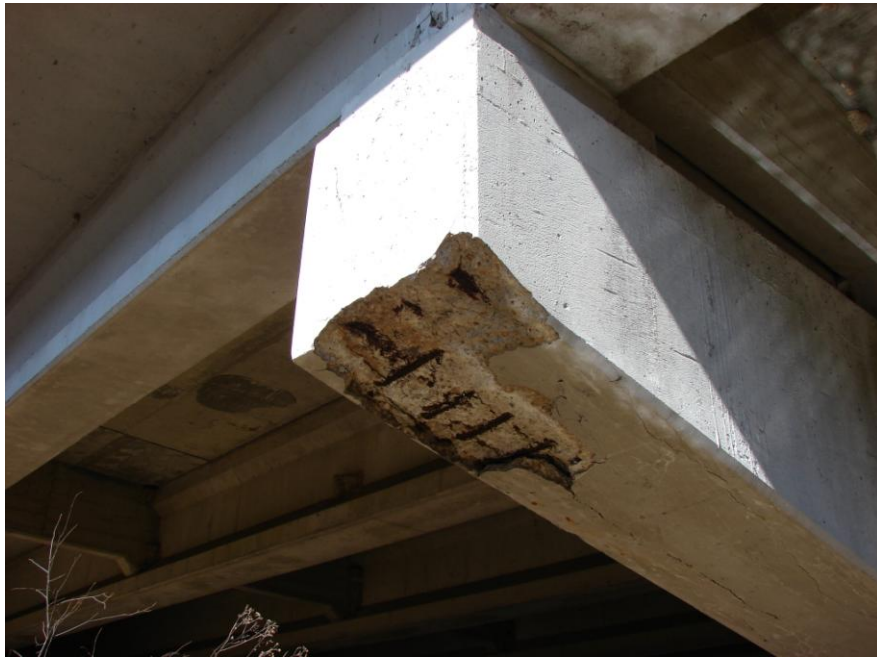
SPALL W/EXP REBAR @ BOTTOM OF CAP R.S. BENT-1

Caps	FAIR	LARGE SPALLS ON BENT CAP (BENT #1)
Columns	GOOD	
Plumb	GOOD	
Footings	GOOD	
Piles	NA	
Bearing Surface	GOOD

SUGGESTED ROUTINE MAINTENANCE AND COMMENTS
REPAIR BENT CAP ON BENT #1
REPAIR APPROACH ASPHALT

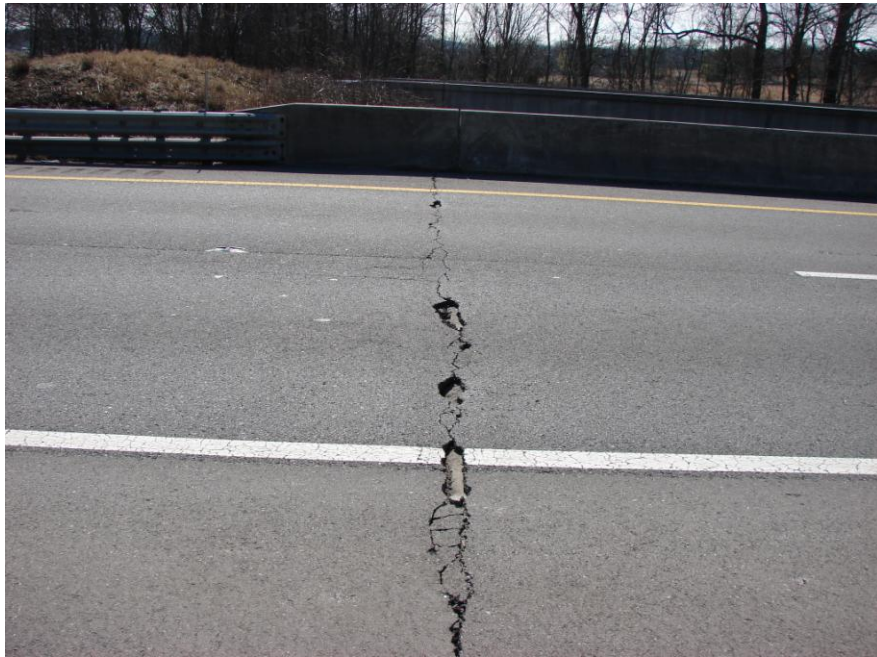
POTHOLES @ B-APPROACH JOINT

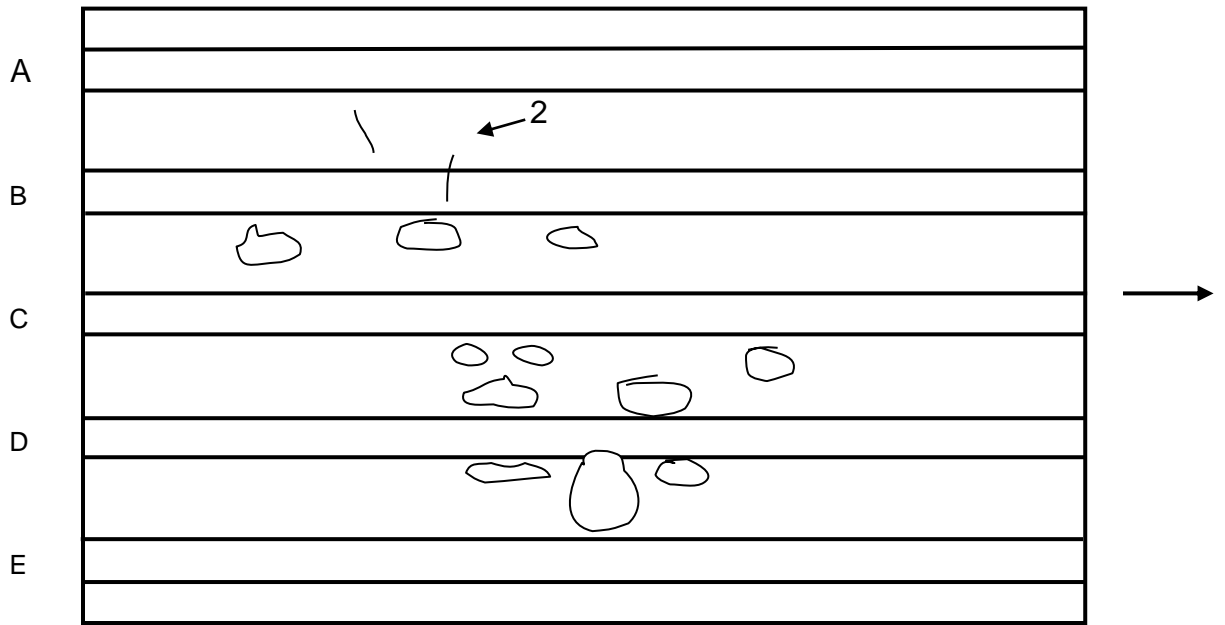
Bottom of Slab Span No. 1

DECK	GOOD	PATCHED AREAS
		2) HAIR CRACK WITH LEACH
DIAPHRAGMS	GOOD	
BEAMS	GOOD

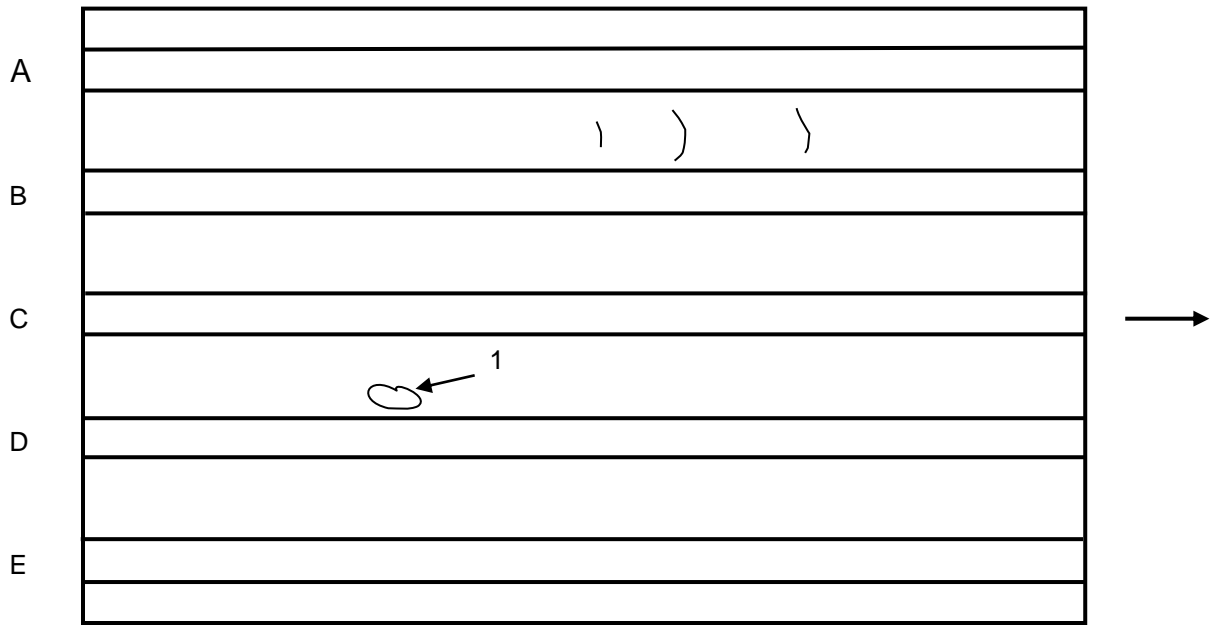
Bottom of Slab Span No. 2

DECK	GOOD	PATCHED AREAS
		1) SPALL 1" DEEP 2' X 1'
DIAPHRAGMS	GOOD	
BEAMS	GOOD

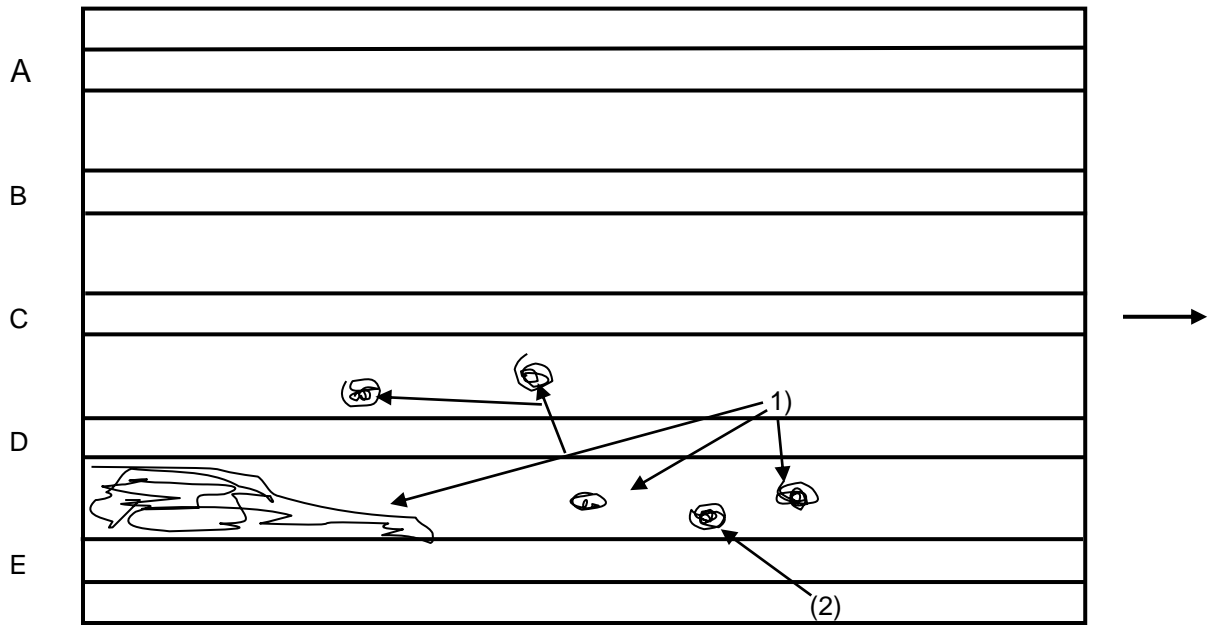
Bottom of Slab Span No. 3

DECK	GOOD	(1) PATCHED AREA
		(2) SPALLED 1" DEEP 1' X 8"
DIAPHRAGMS	GOOD	
BEAMS	GOOD

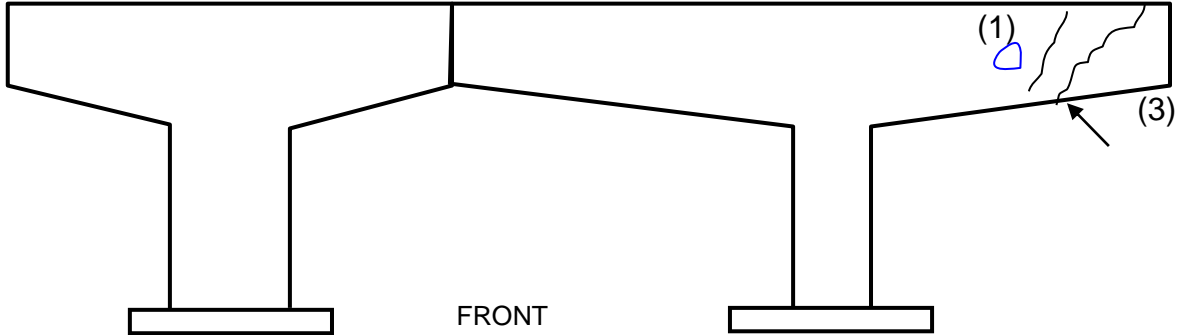
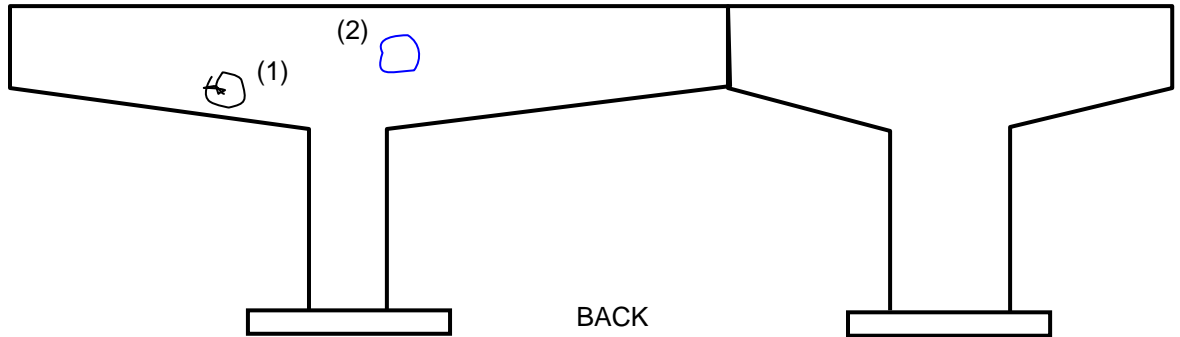
BENT # 1

CAP	FAIR	(1) AREA OF DELAM WITH REBAR 1'H X 6"W X 1" DEEP
		(3) B.O. 3' L X WIDTH OF CAP UP TO 6" DEEP W/EXP REBAR
COLUMN	GOOD	
FOOTING	NV	
BEARING	GOOD

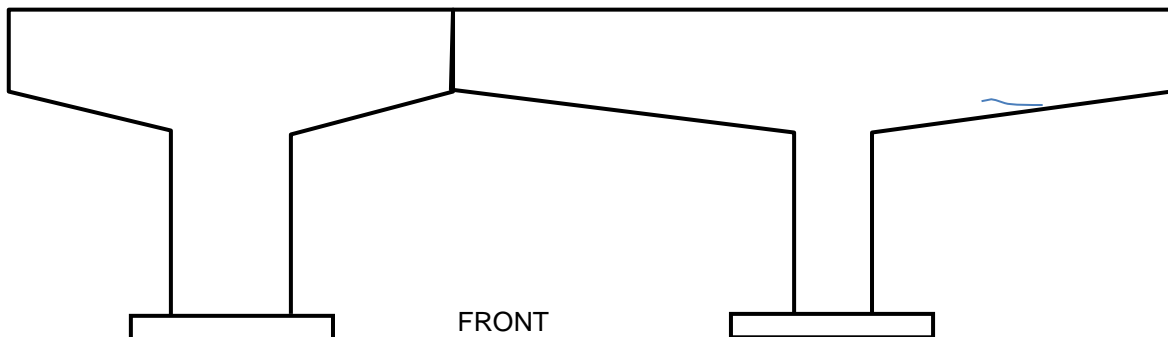
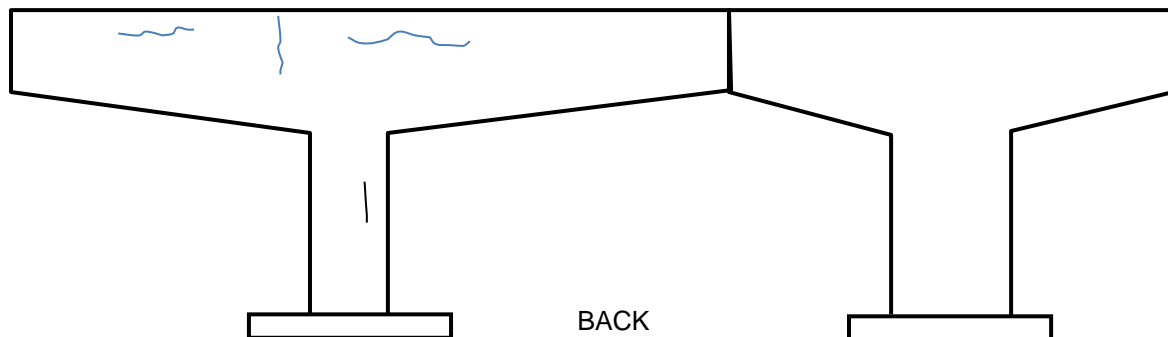
BENT # 2

CAP	GOOD	RANDOM 1/8" OPEN CRACKS
COLUMN	GOOD	RANDOM 1/8" OPEN CRACKS
FOOTING	NV	
BEARING	GOOD
