# HAYWOOD COUNTY

**38-SR001-0213**

Crossing: MUDDY CREEK

# BRIDGE INSPECTION REPORT

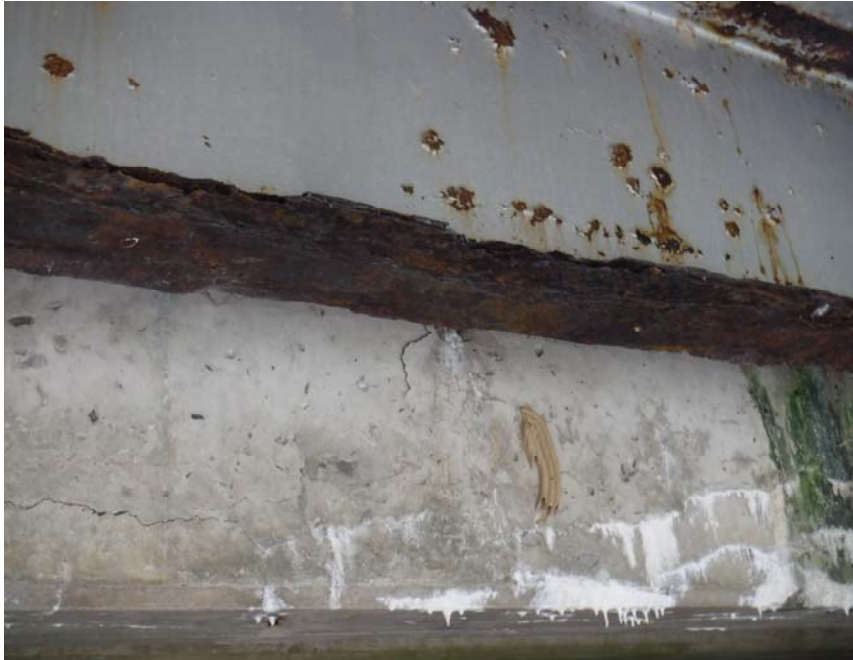
**SPAN 1 BEAM "B"**

SPAN # 1 STEEL I BEAMS "A, B, H & I" & SPAN # 2 STEEL I BEAMS "B & H" HAS HEAVY CORROSION & SECTION LOSS

REPAIR STEEL BEAM "A, B, H &amp; I" IN SPAN NO.1

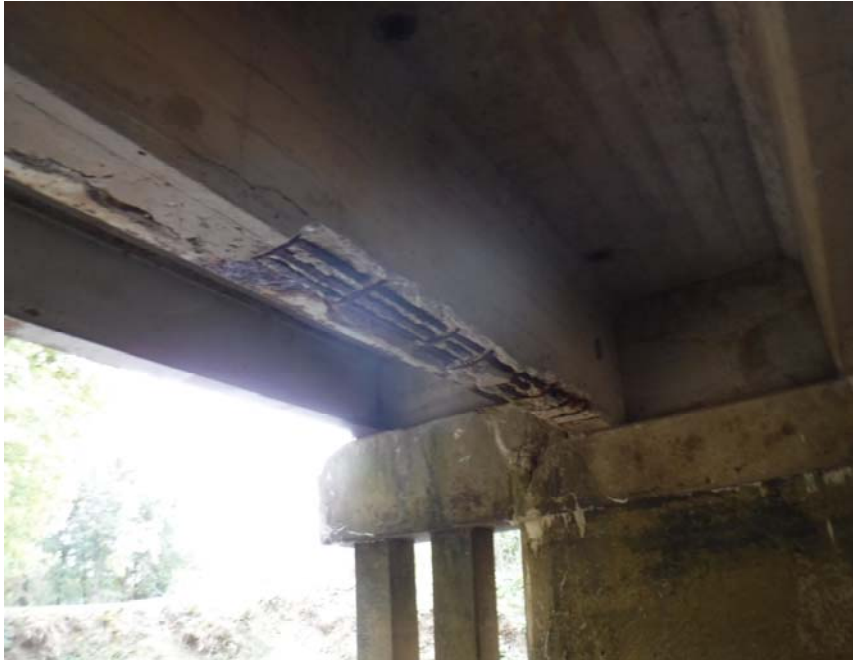
**SPAN 2 BEAM "G"**

SPAN # 2 CONCRETE DECK GIRDERS "C & G" HAS SPALL TO STEEL AREAS

REPAIR CONCRETE GIRDER " C &amp; G " IN SPAN NO.2

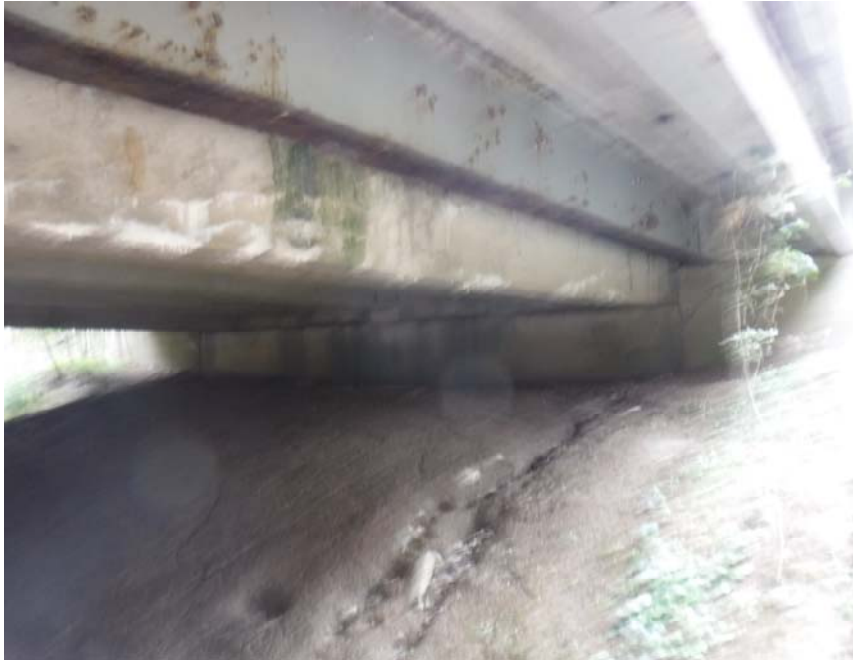
**ABUTMENT 1**

SUBSTRUCTURE HAS HAIRLINE CRACKS & SPALL AREAS

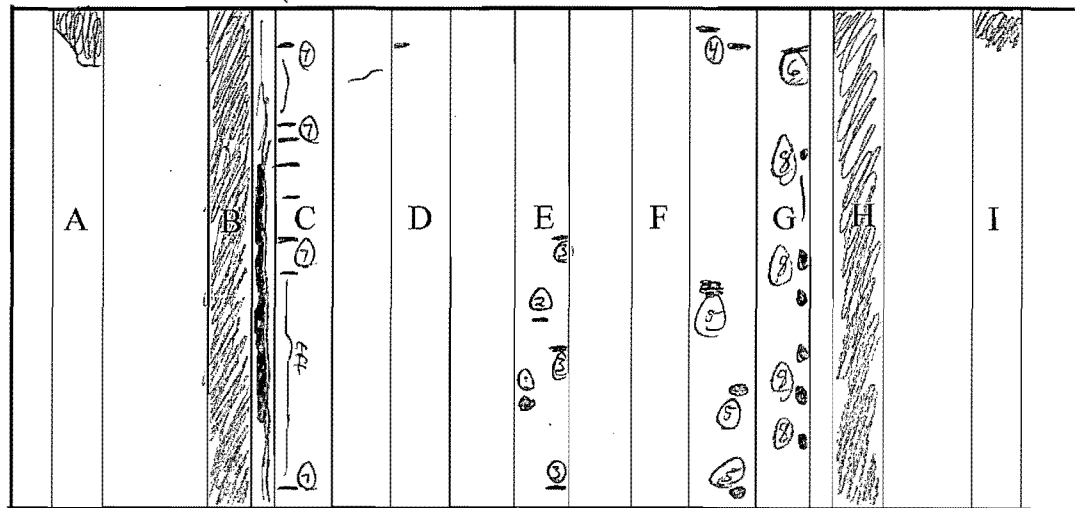
LOOKING AHEAD (4) before spall  
8" diam.

(7) spall/steel  
2'4"x3"Lx1"D(3) spall/steel  
8'4"x2"Lx1"D(5) spall & steel  
1' diam. x 1"D

(6) spall steel  
6"Wx1'Hx3"Lx1"D(8) spall  
6" diam. x 1"D

| ELEMENT | | RATING | COMMENT |
|---|---|---|---|
| BOTTOM DECK | | G (F) P C | Fine cracks w/eff, spalling 18'Lx4"Wx3"D, (4), (5) |
| GIRDER | C | G (F) P C | (7) spall steel 2'4"x3"Lx1"D, fine cracks w/eff |
| | E | G (F) P C | (1) spall 6" diameter x 1"D, (2) spall steel 6"Wx2'Lx1"D, (3) |
| | G | G (F) P C | (6), (1), (8), fine crack w/eff |

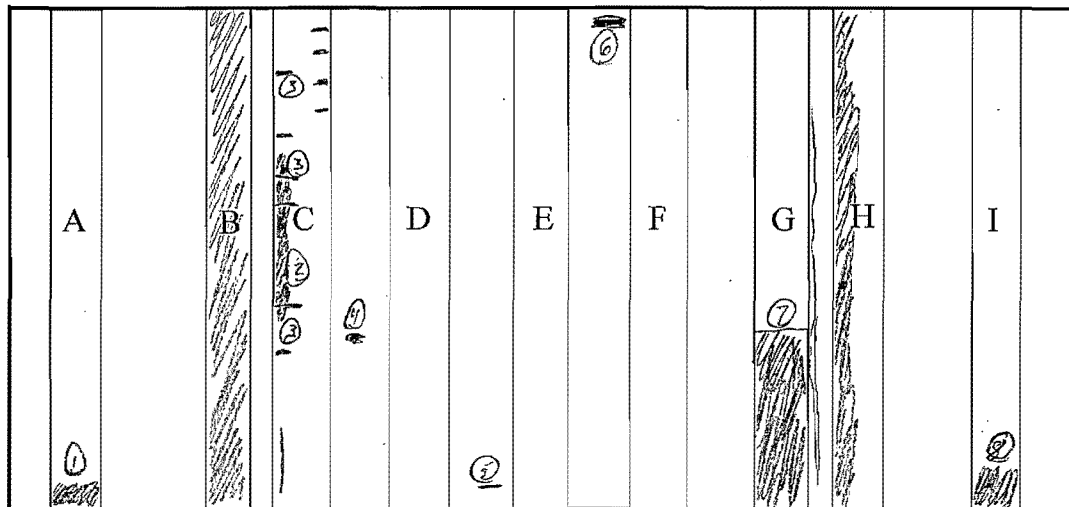
LOOKING AHEAD ⑥ before spall  
2'W x 8" L

① Mod. corr.  
minor sect. loss  
8" L x 8" W

② spall steel  
10' L x 8" W x 2" D  
④ delam 6" diam.

⑤ spall steel  
1' W x 2" L x 1" D

⑦ spall steel  
10' L x 1' W x 3" D

③ spall steel  
1' H x 3" L x 1" D

⑧ Heavy corrosion  
1/8" sect. loss  
1' L x 1' W

| ELEMENT | | RATING | COMMENT |
|---|---|---|---|
| BOTTOM DECK | | G (F) P C | ④, ⑤, ⑥, hairline cracks w/eff |
| GIRDER | C | G F (P) C | ②, ③; fine crack |
| | G | G F (P) C | ⑦ |
