# HAYWOOD COUNTY

**38-SR001-0213**

Crossing: MUDDY CREEK

**BRIDGE INSPECTION REPORT**Form BIR 3.0  
(Rev. 9-22-98)  
DT-0069Field Report No.: \_\_\_\_\_ Date: 9/9/19  
Previous Report No.: 24 Date: 10/31/17  
Co. Seq 01 Plans: YES ( ) NO ( )Bridge No. 38SR0010001 Bridge Location No. 38 - SR001 - 0213  
Eleven Digit No. Co. Route Log Mile OVER/UNDER PASSHWY 79 MUDDY CREEK  
Road Name Feature Intersected CITYYear Constructed 1926 County Haywood Maint. Dist: 48 Maint.Resp: 02

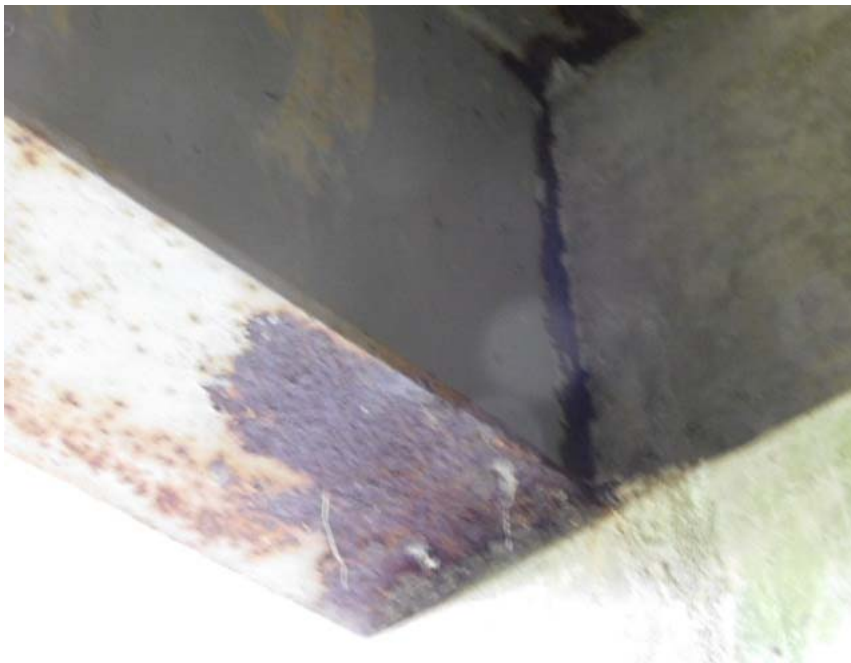
**SPAN # 1 STEEL I BEAM "A" HEAVY CORROSION**

REPAIR STEEL BEAM "A, B, H &amp; I" IN SPAN NO.1

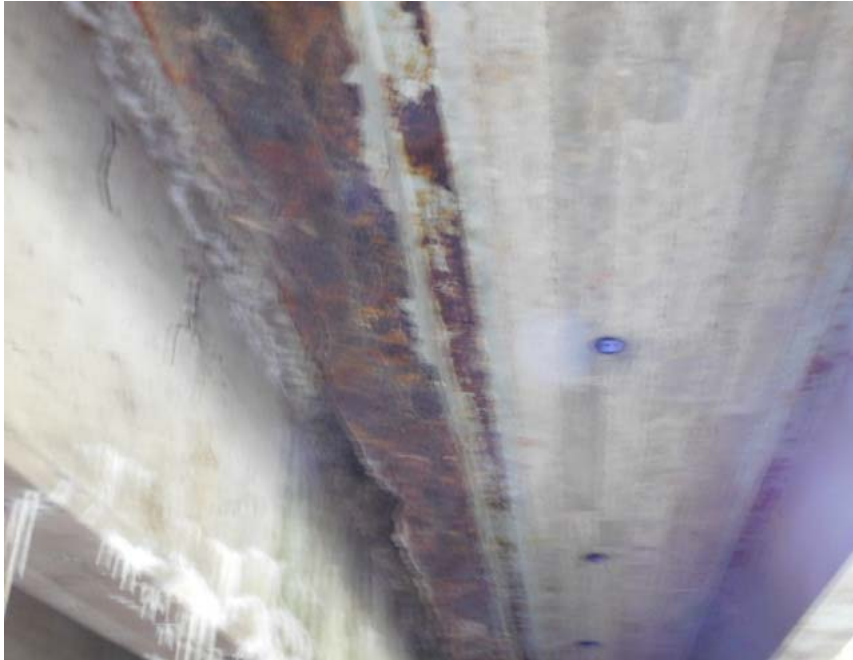
**SPAN # 1 STEEL I BEAM "B" SECTION LOSS**

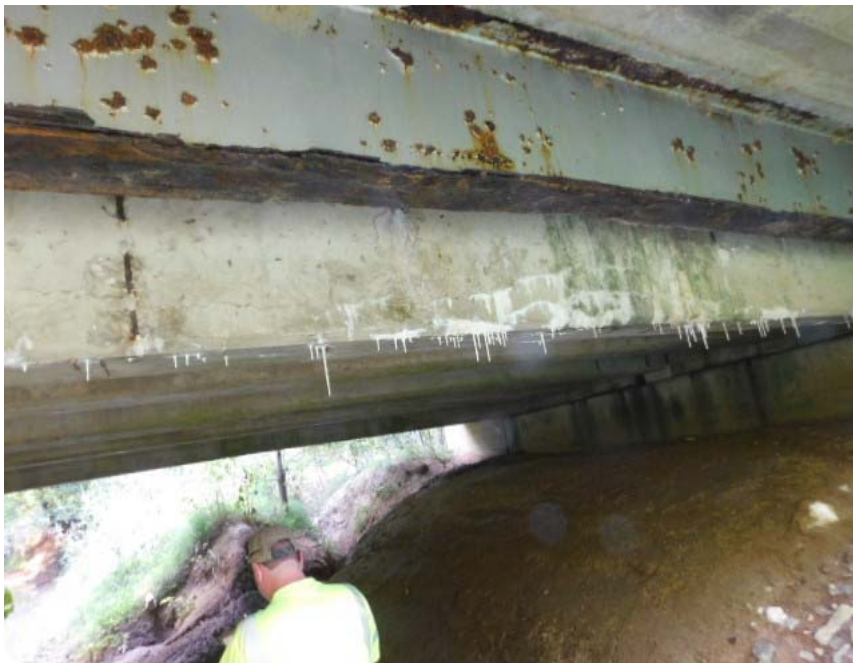
**SPAN # 1 GIRDER "C" SPALLING TO STEEL & CRACKING**

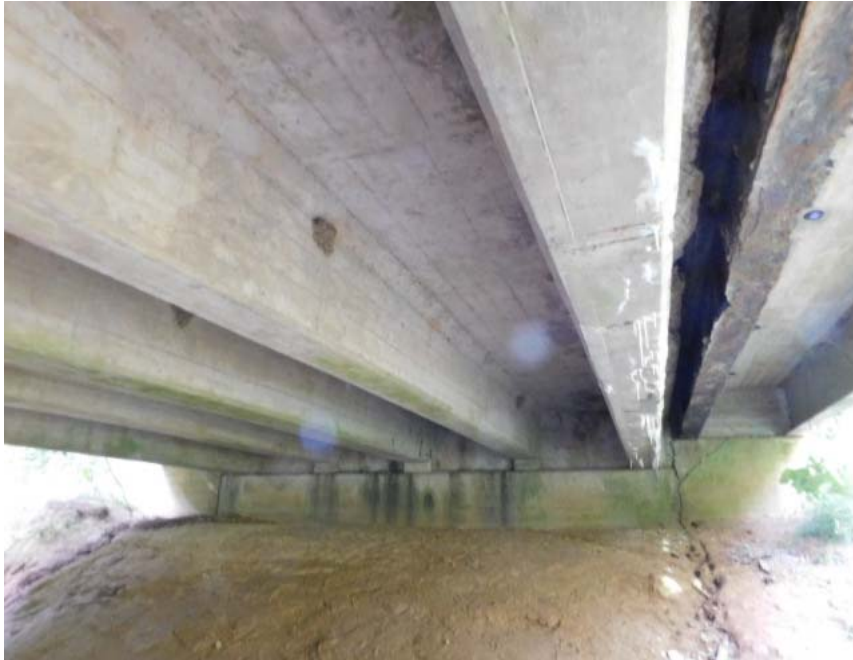
**SPAN # 1 BOTTOM DECK**

PATCH BOTTOM OF DECK IN SPAN NO.1

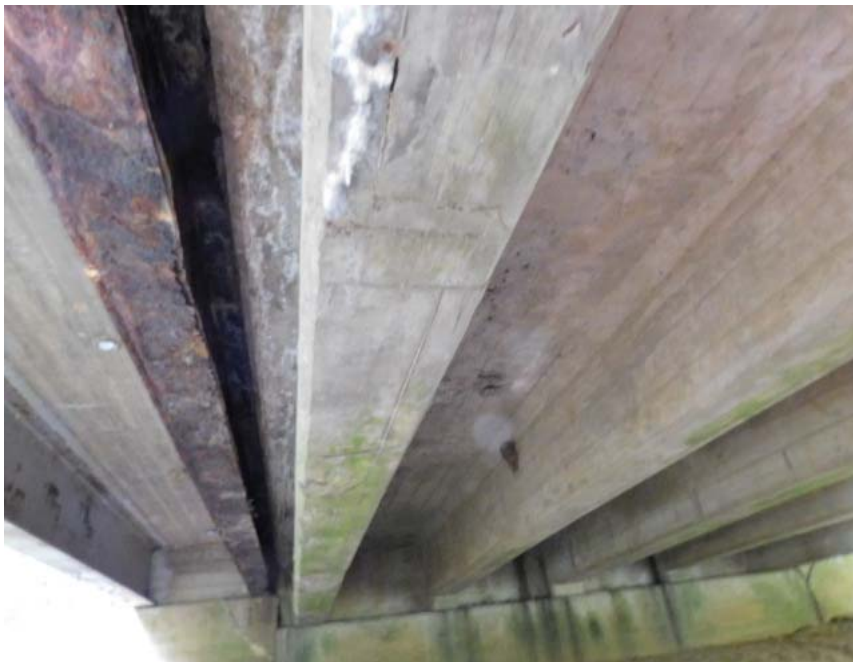
**SPAN # 1 GIRDER "G" SPALLING TO STEEL & CRACKING**

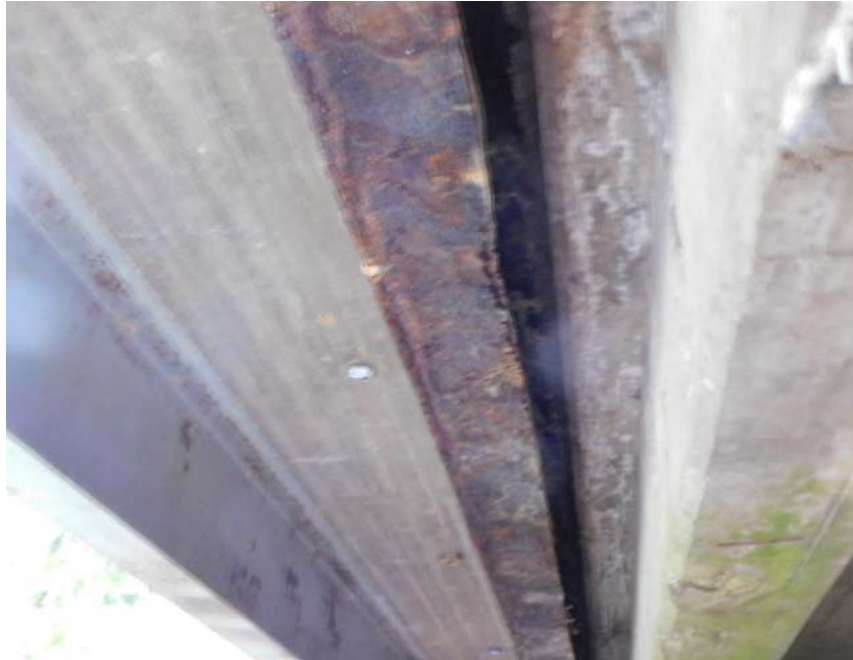
**SPAN # 1 STEEL I BEAM "H" HEAVY CORROSION & SECTION LOSS**

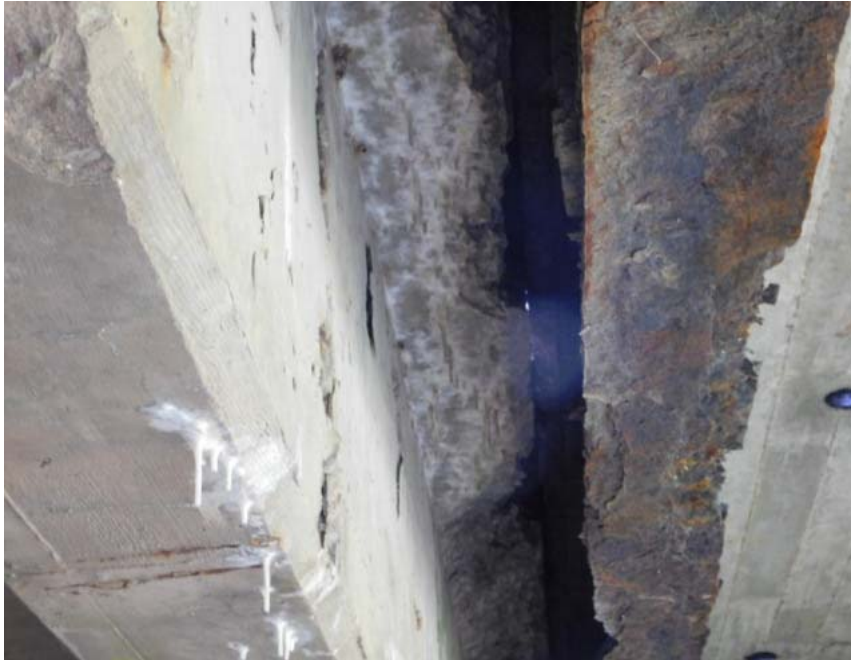
**SPAN # 1 BOTTOM DECK**

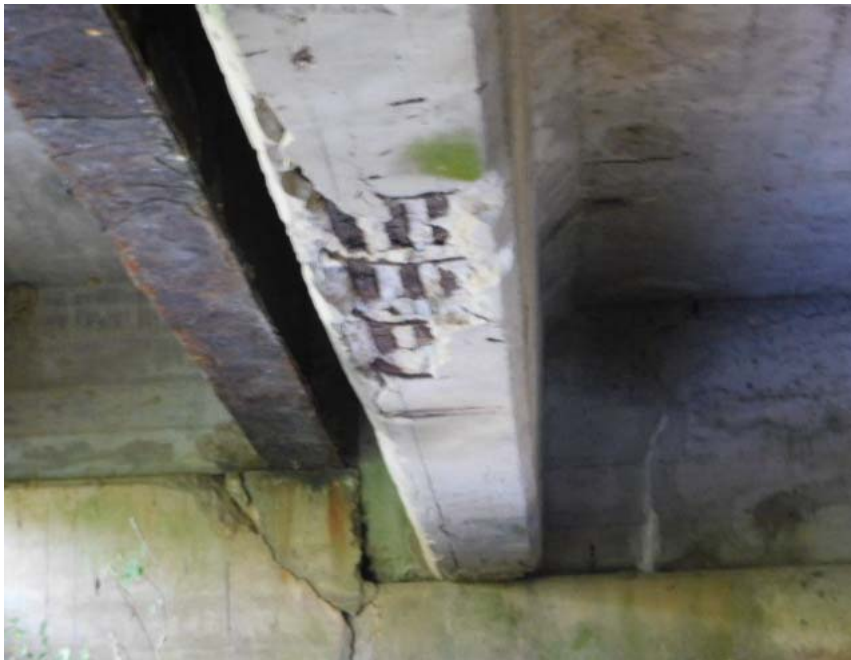
**SPAN # 2 GIRDER "C" SPALLED TO STEEL**

REPAIR CONCRETE GIRDER " C &amp; G " IN SPAN NO.2

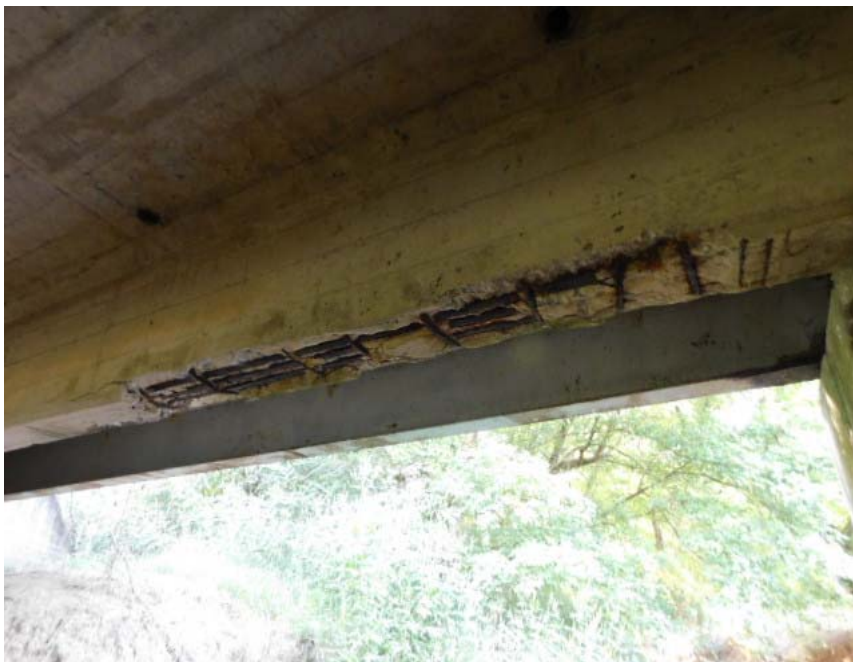
**SPAN # 2 GIRDER "G" SPALLED TO STEEL**

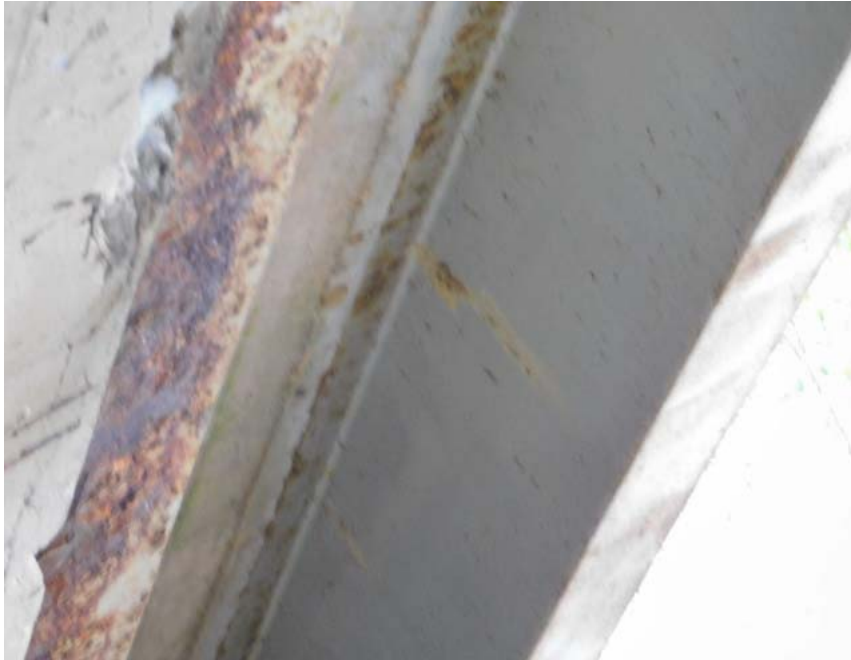
**SPAN # 2 STEEL I BEAM "H" HEAVY CORROSION**

REPAIR STEEL BEAM "B &amp; H" IN SPAN NO.2

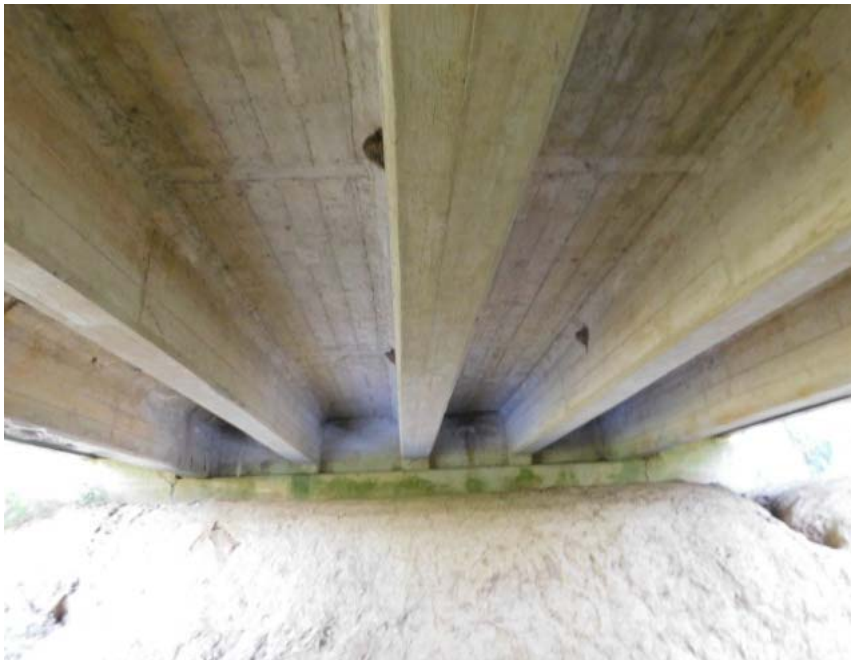
**SPAN # 2 BOTTOM DECK**

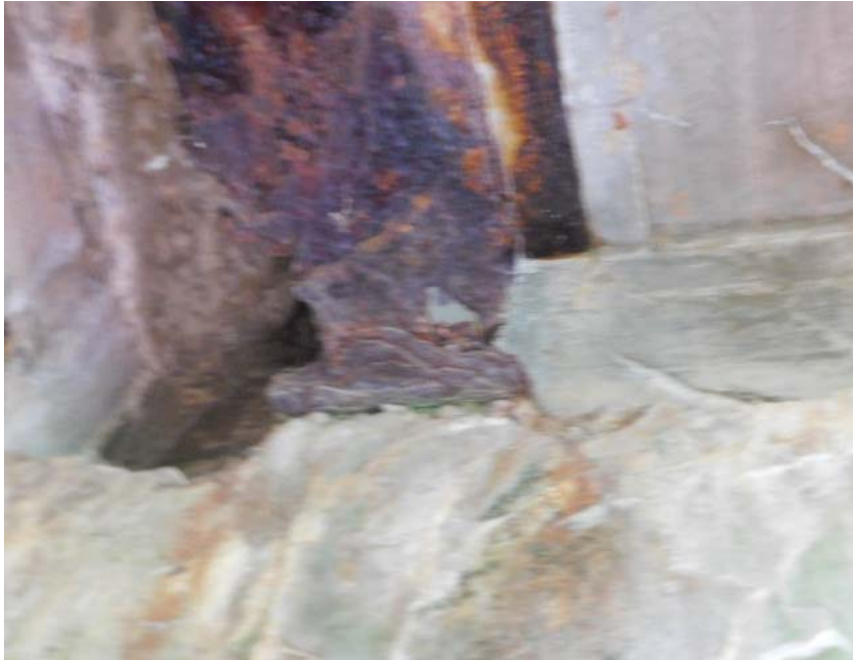
**SPAN # 1 STEEL I BEAM "H" SECTION LOSS**

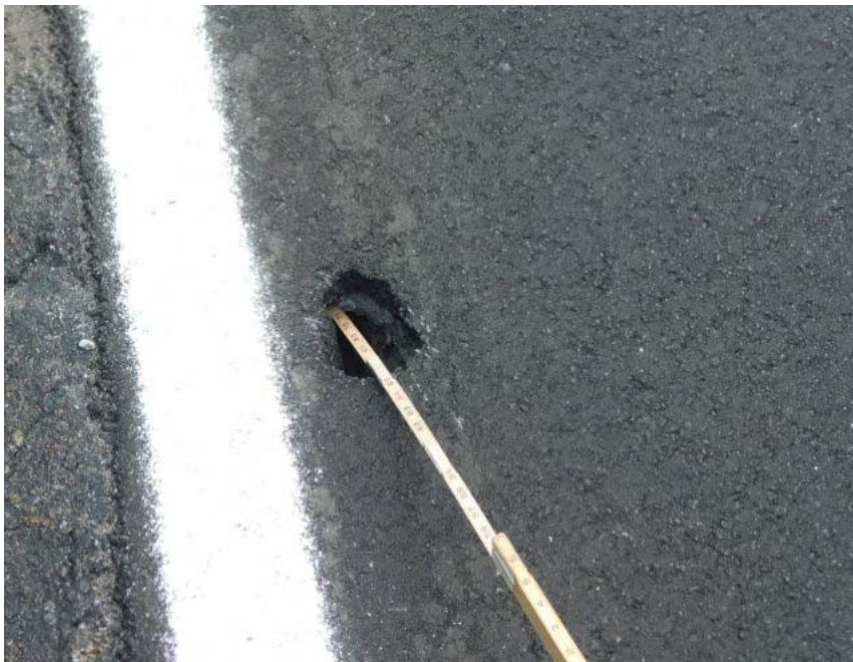
**SPAN # 1 HOLE IN TOP DECK**

REPAIR DECK IN SPAN NO.1

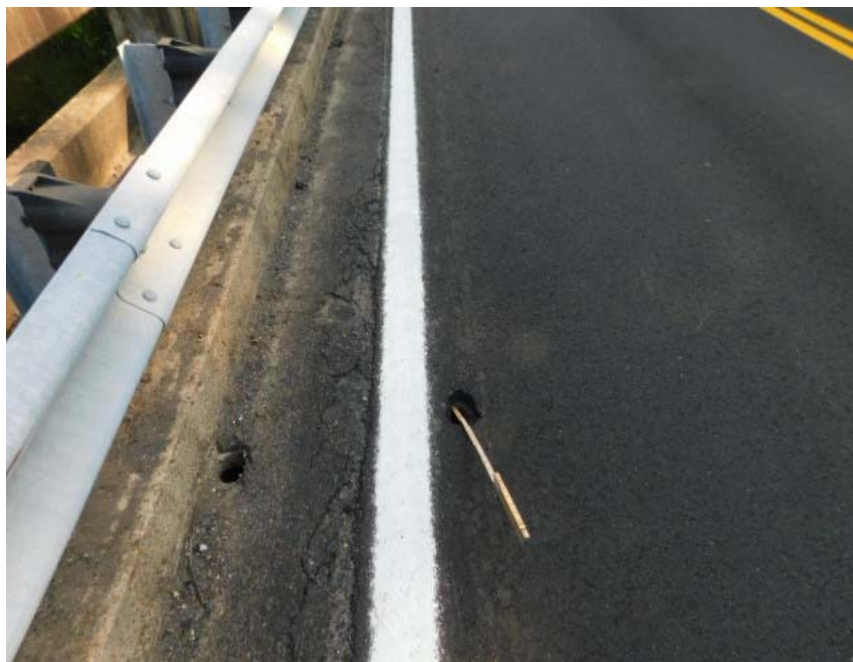
**SPAN # 1 HOLE IN TOP DECK**

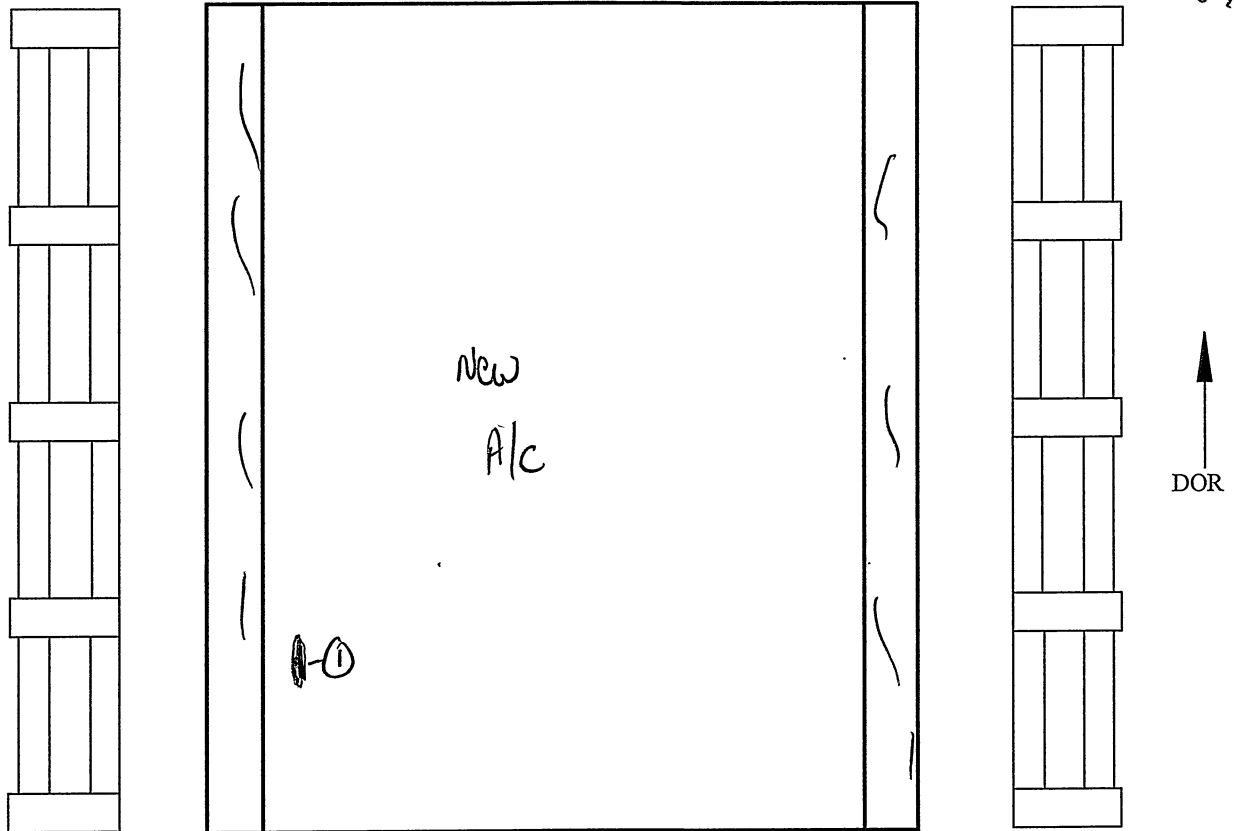
① Hole in Alc  
 $7\frac{1}{2}'' \times 5\frac{1}{2}'' \times$  Through Deck

ELEMENT	RATING	COMMENT
TOP DECK	G F (P) C	See ①
CURBS	G (F) P C	Fine Cracks & light Sealing
RAIL & POST	(G) F P C	
DRAINS	(G) F P C	
<del>JOINT</del>	G F P C	
	G F P C

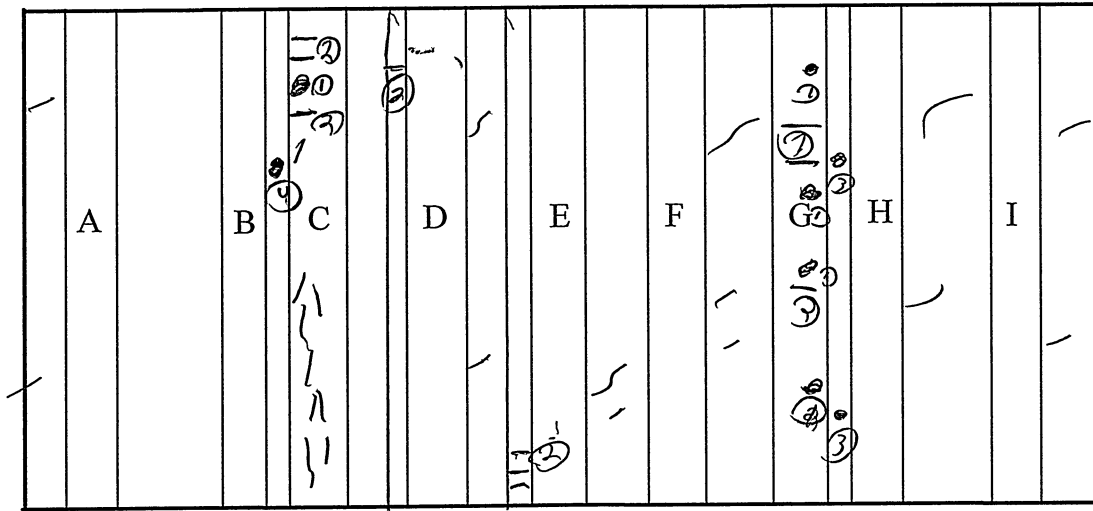
① spalls  
6" h x 1" b

② spalled  
to steel 8" h x 3" l x 1" b

③ spalled to steel  
1' D x 1.5" D

④ Hole in deck  
Due to joint

8" L x 5" W see top deck Allows A/C to fall thru

ELEMENT		RATING	COMMENT
BOTTOM DECK		G (F) (P) C	up to fine cracks + see 3+4
S.I.B.	A	G F (P) C	see detail sheet
	B	G F (P) C	
GIRDER	C	G (F) P C	Fine cracks with eff + see 1+2
	D	G (F) P C	see ②
	E	G (F) P C	11 "
	F	(G) F P C	
	G	G (F) P C	see 1+2
S.I.B.	H	G F (P) C	see detail sheet
	I	G F (P) C	
PAINT		G F (P) C	up to 75% missing
BACKWALLS		(G) F P C	
DIA.		(G) F P C

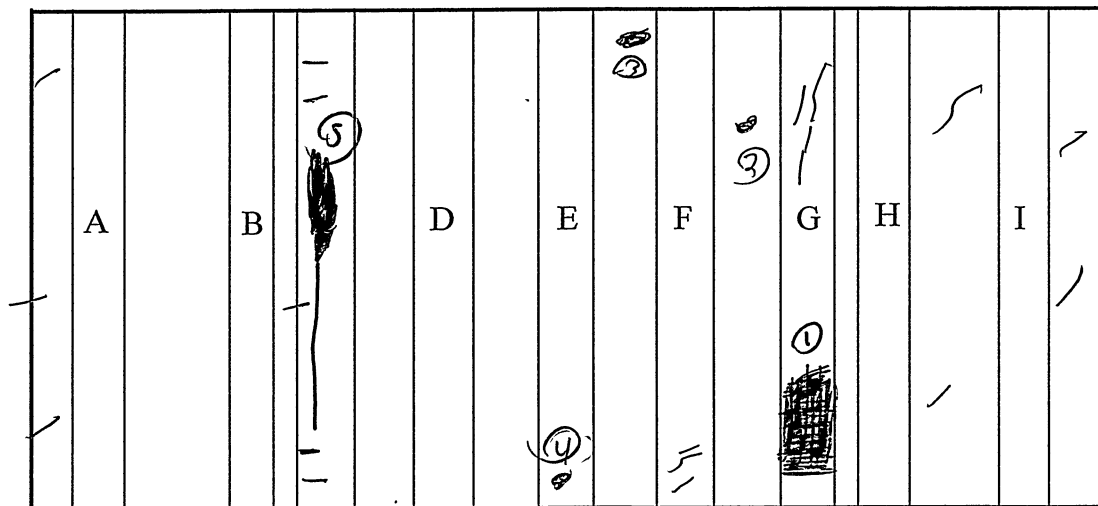
① spilled to steel  
9' L x 8' W x 2' D

② spilled to steel  
5' D x 1' W

③ spilled  
12' W x 6' L x 1' D

④ spilled  
5' W x 1' D

⑤ spilled to steel  
6' L x 6' W  
x 2' D

ELEMENT		RATING	COMMENT
BOTTOM DECK		G (F) P C	up to fine cracks + see 2 & 3
S.I.B.	A	G (F) P C	light corrosion no section loss
	B	G F (P) C	see detail sheet
GIRDER	C	G F (P) C	up to 1/4" cracks + see 5
	D	G (F) F P C	
	E	G (F) P C	see ④
	F	G (F) P C	up to 1/16" cracks
	G	G F (P) C	up to 1/16" cracks + see ①
S.I.B.	H	G F (P) C	see detail sheet
	I	G (F) P C	light corrosion
PAINT		G F (P) C	up to 75% missing
BACKWALLS		G (F) P C	
DIA.		G (F) P C	up to fine cracks

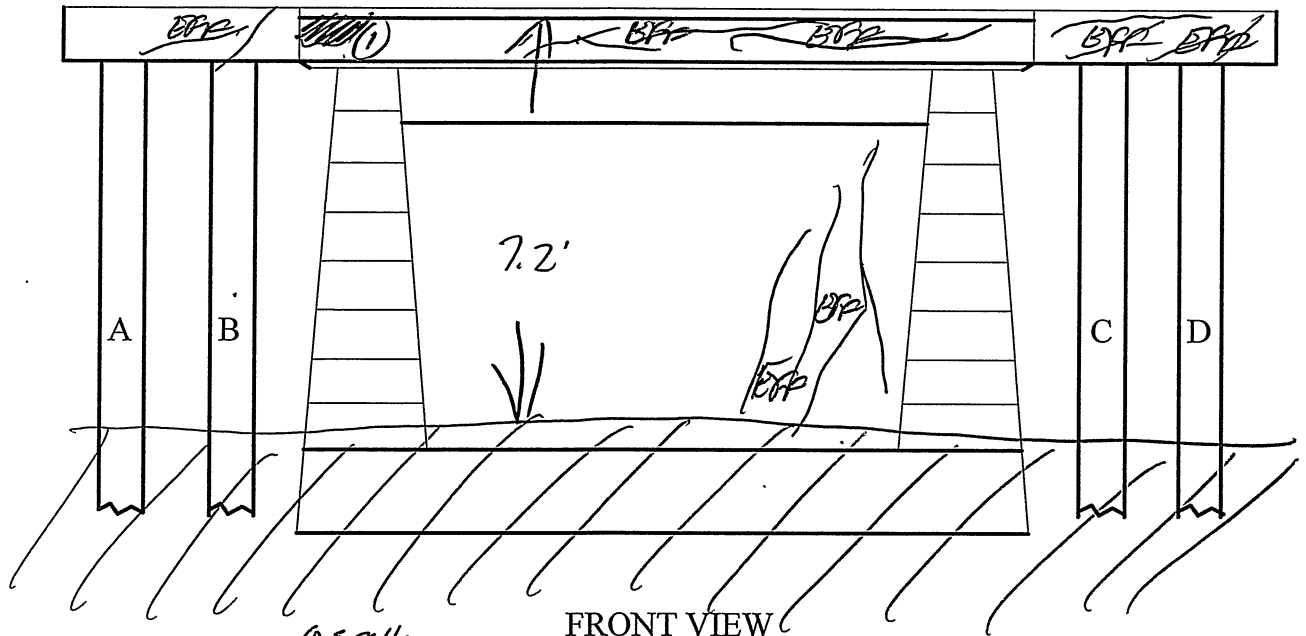
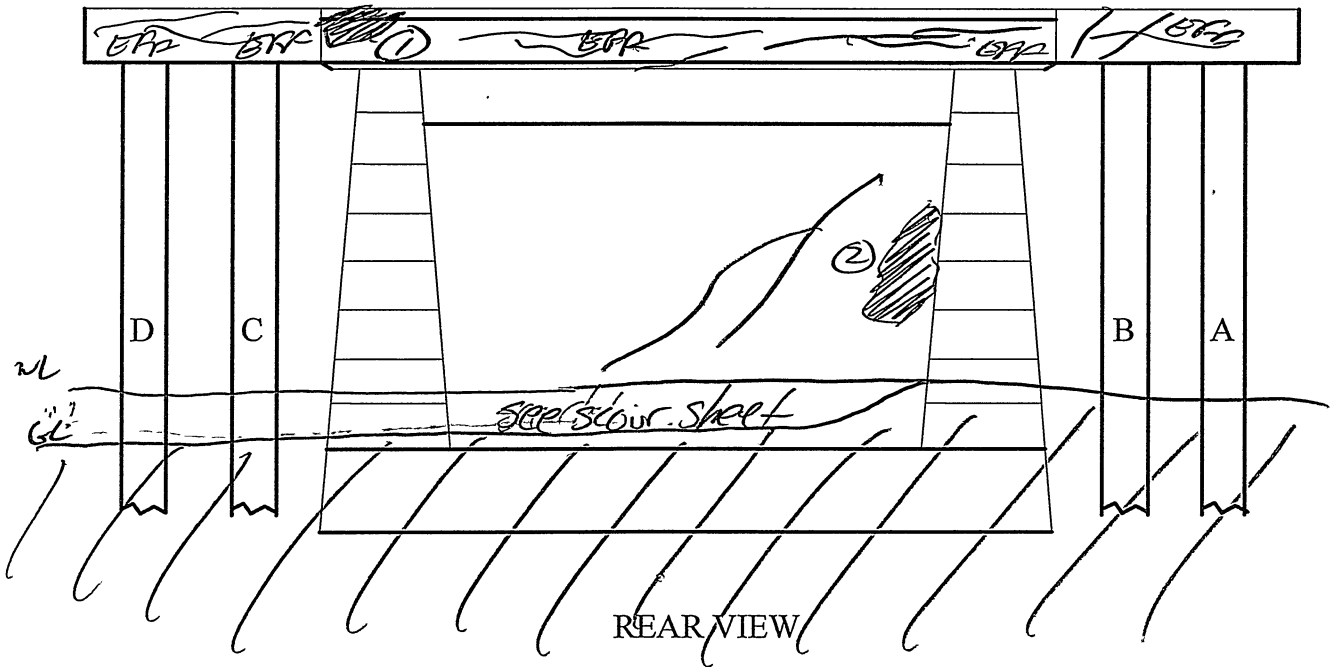
① Spalling  
10" Dia x 1" D

② Spalling  
2' H x 10" W x 1" D

ELEMENT	RATING	COMMENT
BEARINGS	G F P C	NV
PAINT	G F P C	NV
CAP	G <u>F</u> P C	Firecracks with EPP & see ①
PIER	G <u>F</u> P C	Firecracks with EPP & see ②
PILING	<u>G</u> F P C	
	G F P C
