38-SR001-0289

BRIDGE MAINTENANCE RECOMMENDATIONS

Tennessee Department
of Transportation

BRIDGE INSPECTION REPORT

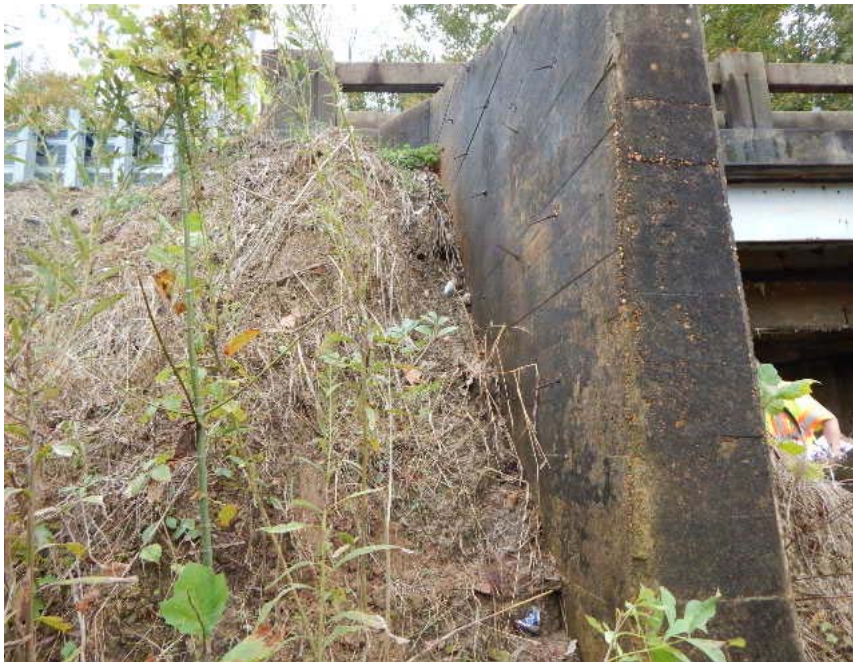
ABUTMENT 2 LEFT WING WALL (WASHING BEHIND)

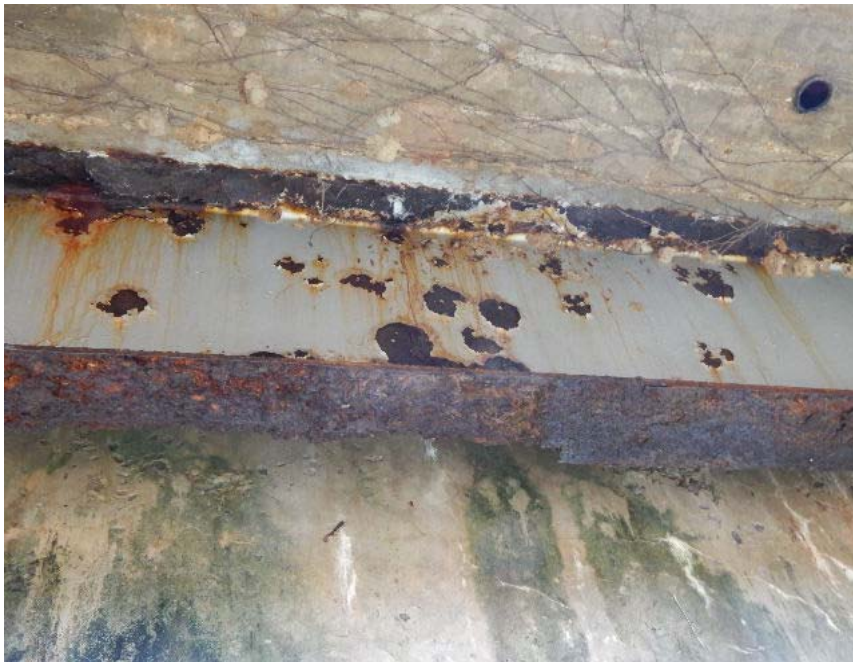
STEEL I BEAM "B"

REPAIR STEEL BEAM "B & H" IN SPAN NO.1

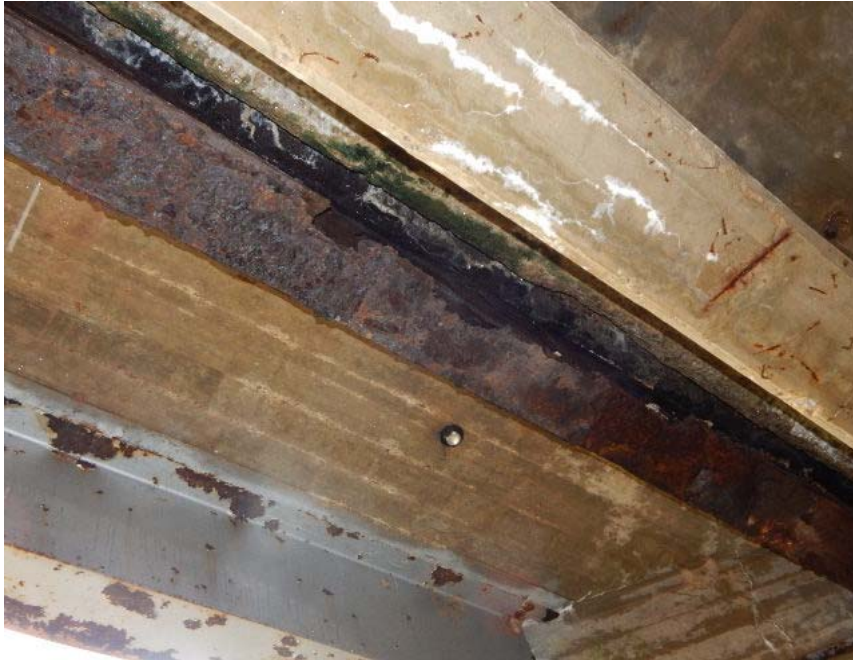
STEEL I BEAM "B"

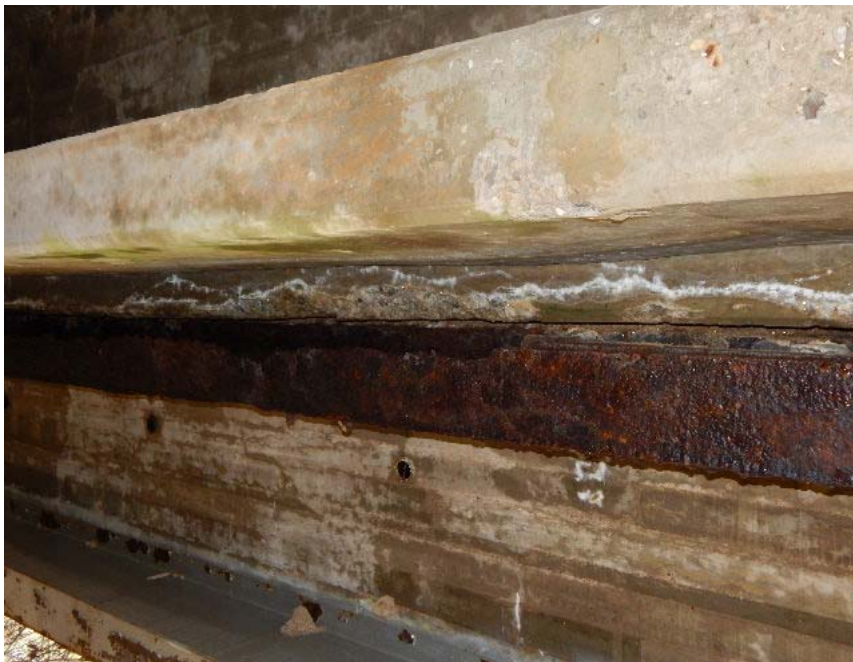
STEEL I BEAM "H"

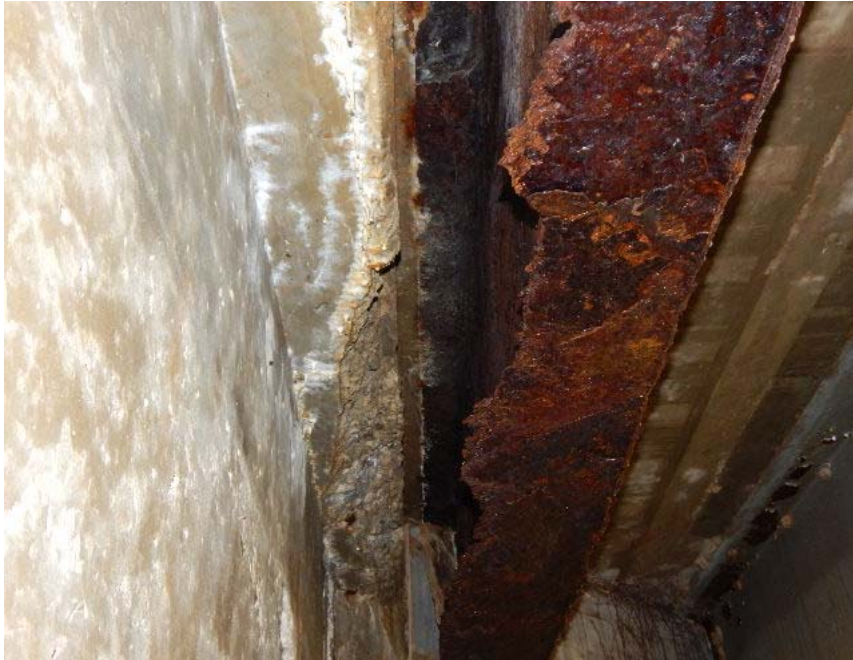
BETWEEN G & H BOTTOM DECK

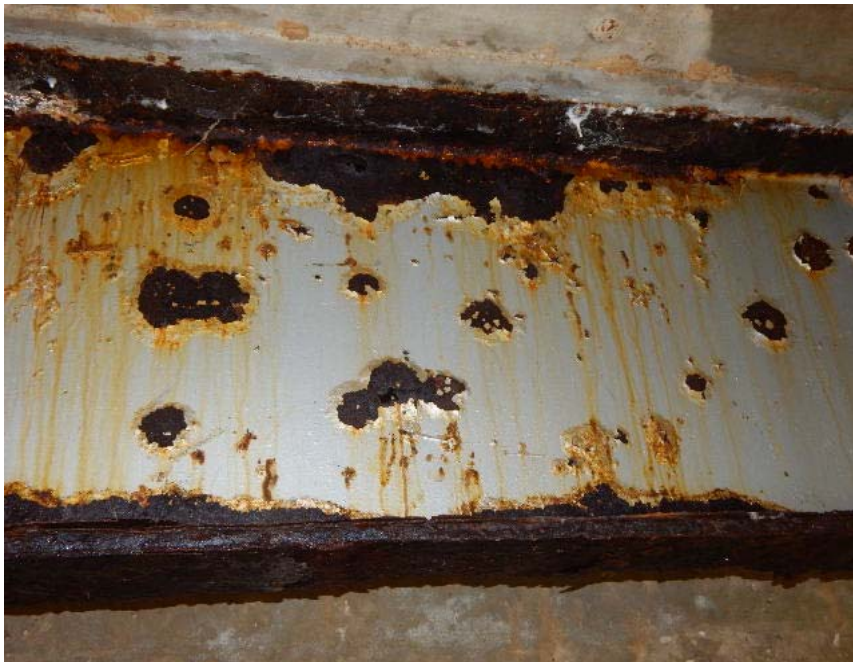
STEEL I BEAM "H"

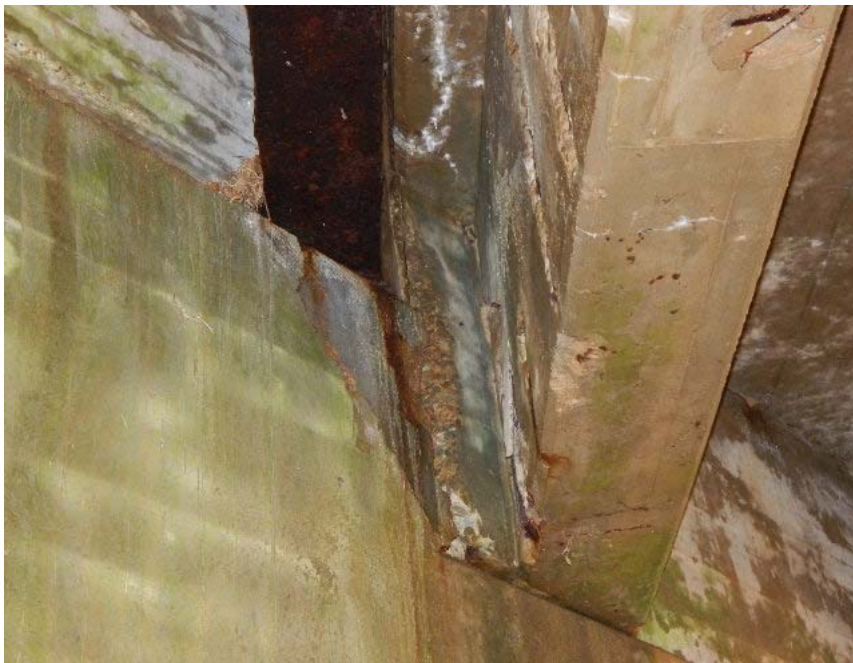
BREAST WALL- IMPENDING SPALL UNDER BEAM "H"

REPAIR BREASTWALL AT ABUTMENT NO.1

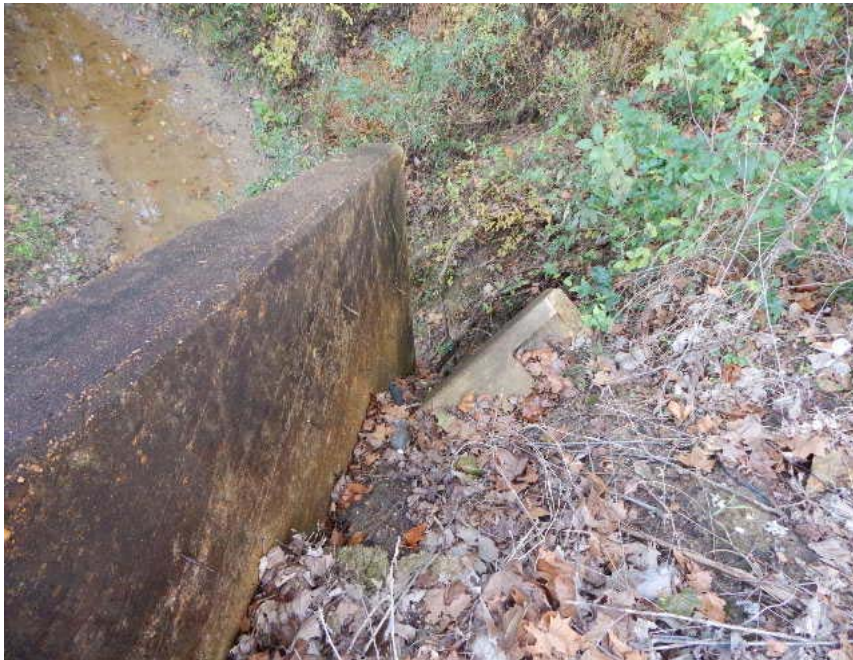
ABUTMENT 1 RIGHT WING WALL (WASHING BEHIND)

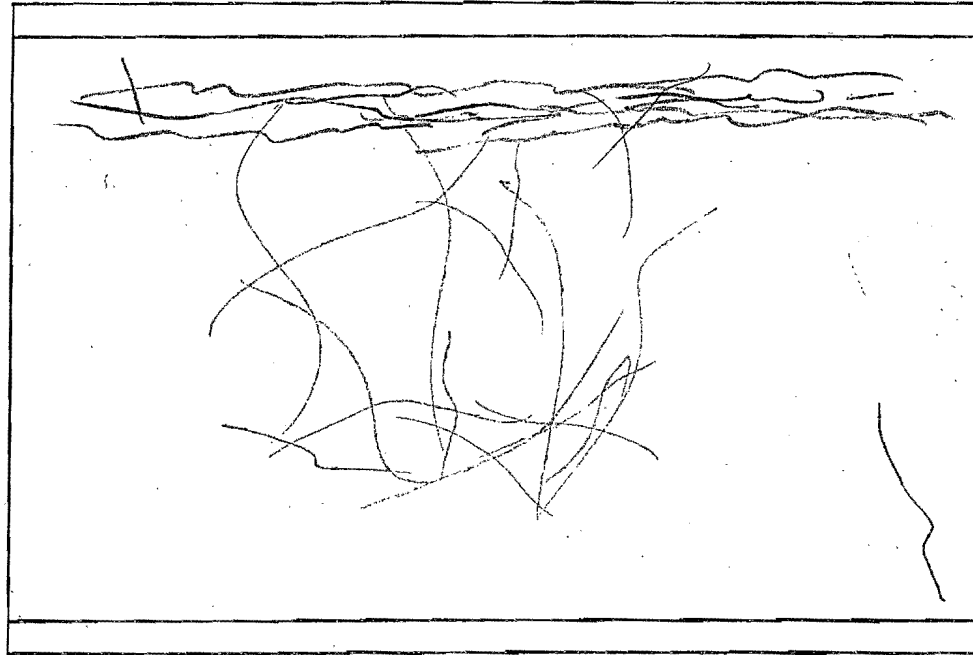
① Spalling 30" L x 6" H x 12" W x 1.5" D

② Spalling 23' L x 10" W x 1" D

ELEMENT	RATING	COMMENT
TOP DECK	G F <u>P</u> C	Heavy Cracking, Rough Patch
CURBS	G <u>F</u> P C	See 1
RAIL & POST	<u>G</u> F P C	
DRAINS	G F <u>P</u> C	6 Drains Blocked
JOINT	G F P C	NA
	G F P C

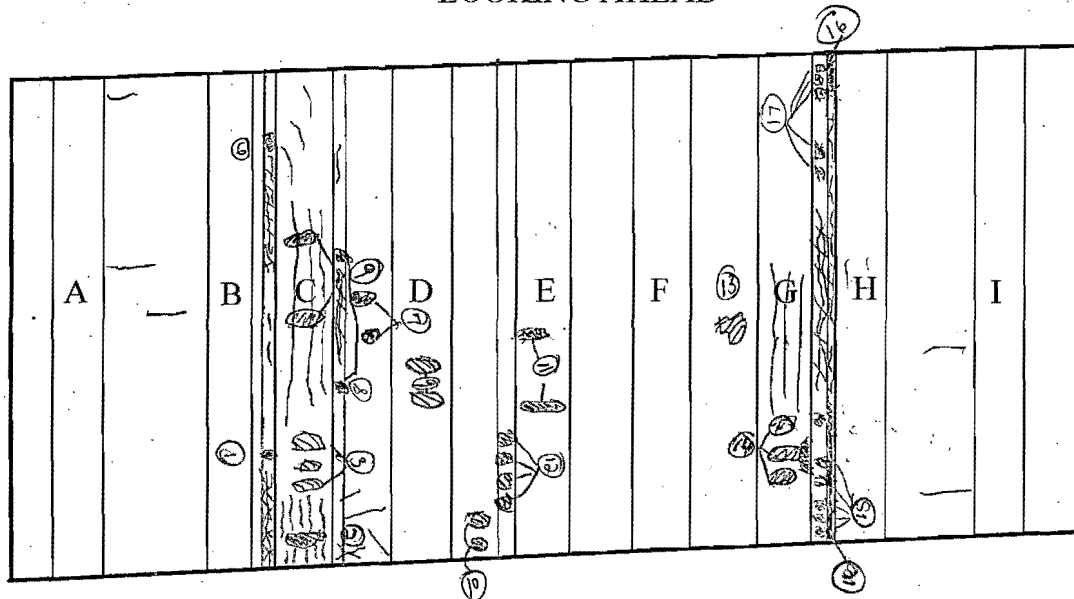
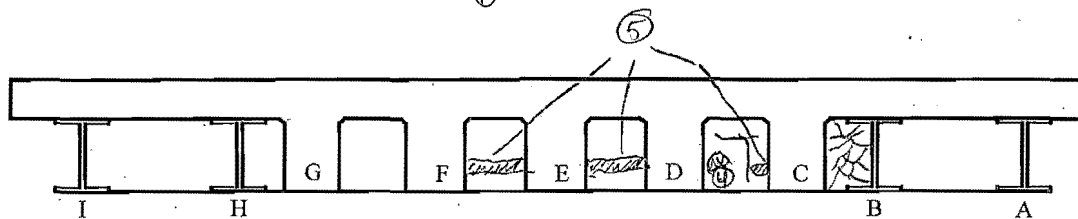
ELEMENT		RATING	COMMENT
BOTTOM DECK		G (F) P C	hairline cracks w/EFF (7) Spall to Steel 1'WX 8" LX 1/2"D
S.I.B.	A	G (F) P C	medium corrosion (19) impending spall 2'WX 10" L
	B	G F (P) C	heavy corrosion (13) " 8" dia (14) scaling 8"WX 8" H length of span
GIRDER	C	G (F) P C	See detail sheet (1) spall to steel 1'HX 6" LX 1/2"D (6) Spalling 2' LX 6" W
	D	G (F) P C	(2) " " 1'WX 3" LX 1/2"D (8) Spall to Steel
	E	G (F) P C	(4) spall to steel 1'WX 3" LX 1/2"D (2'HX 4" LX 1"D
	F	G (F) P C	(10) 10'WX 4" LX 1/2"D hairline cracks w/EFF
	G	(G) F P C	(11) spall to steel 1'WX 2" WX 1/4"D
	H	G F (P) C	(12) 1'HX 2" LX 1/4"D
	I	G (F) P C	(14) Spall to Steel 1'WX 2" LX 1/2"D + hairline cracks w/EFF
S.I.B.	H	G F (P) C	(15) Spall to steel 3'HX 5" LX 1"D (17) Chipped to steel
	I	G (F) P C	see detail sheet heavy corrosion 9" to 36" H up to 7" X 1/2" to 1" D
PAINT		G (F) P C	heavy surface rust (20) Chipped to Steel
BACKWALLS		G (F) P C	light scaling on 'A+I' (21) Impending Spall

G F P C	hairline cracks w/EFF (19) Spalled spot
		G F P C	(18) Spalled Area 15" HX 1' WX 2"D

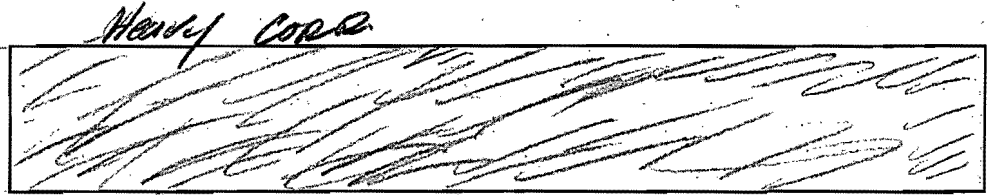
S.I.B. (B)

Note: Heavy scalling and section loss on RT. inside web.

⑤ section of Fly missing
15.0/L x up to 4"W

⑥ section of Fly missing
18"L x up to 4"W

① section of Fly missing
4"/L x 1"W

② Hole 1.0/L x 6"/H

④ Hole in web
4"/dia

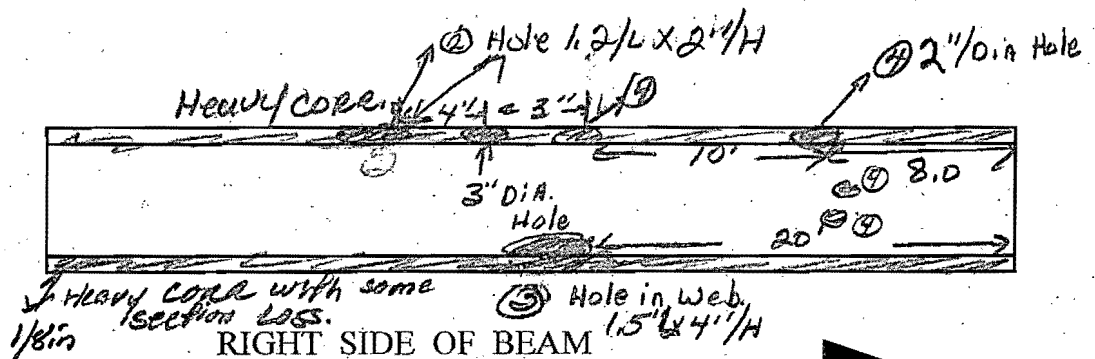
S.I.B. (H)

Heavy CORR.

① Flg. Missing up to 4' W x

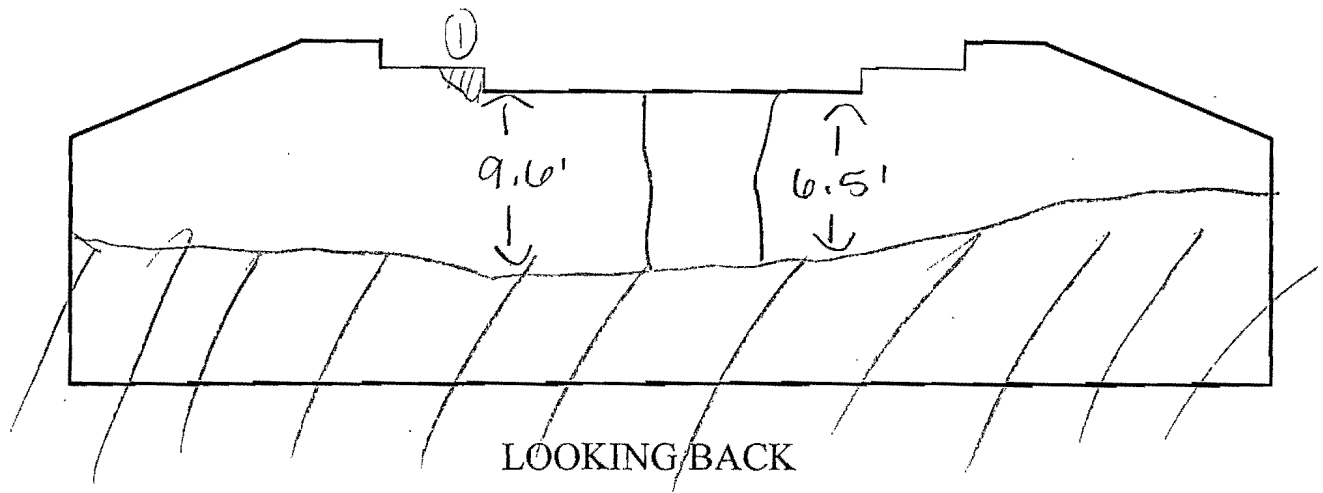
① Impending spall
 18" W x 2' H x ?" D
 Under Beam 'H'

ELEMENT	RATING	COMMENT
BEARING	G F P C	
PAINT	G F P C	
BREASTWALL	G F <u>P</u> C	① 1/16" cracks
WINGS	<u>G</u> F P C	
EMBANKMENT	G <u>F</u> P C	Washing behind Right wing wall
RIP RAP	G F P C	
VEGETATION	G <u>F</u> P C	medium growth

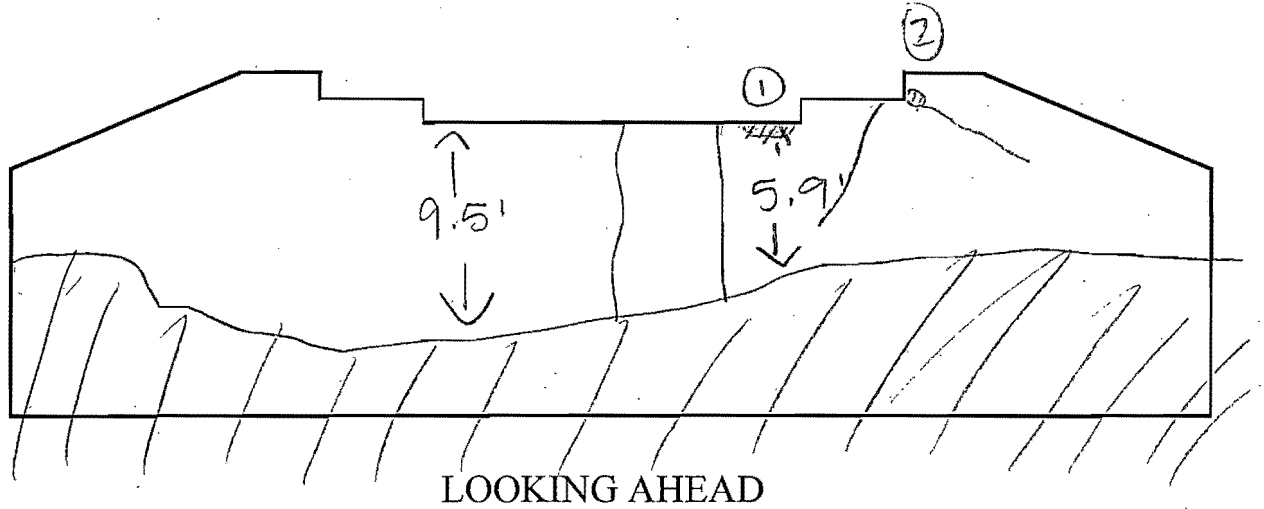
① Spalling
 18" W X 8" H X 1" D

② Spalling 10" W X 8" H X 1" D

ELEMENT	RATING	COMMENT
BEARING	G F P C	
PAINT	G F P C	
BREASTWALL	G (F) P C	1/16" CRACKS ①
WINGS	G (F) P C	1/16" CRACKS ②
EMBANKMENT	G (F) P C	Washing behind left wing wall
RIP-RAP	G F P C	
VEGETATION	G F (P) C	Tree growth
