HAYWOOD COUNTY

38-SR001-0289

BRIDGE MAINTENANCE RECOMMENDATIONS

BRIDGE INSPECTION REPORTForm BIR 3.0
(Rev. 9-22-98)
DT-0069

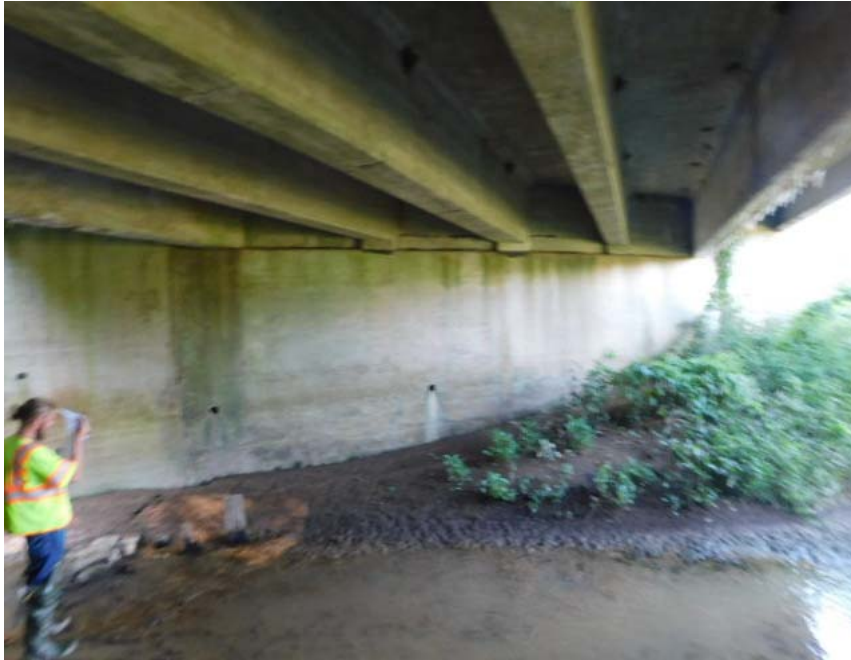
SPAN # 1 GIRDER "C" HEAVY CRACKING

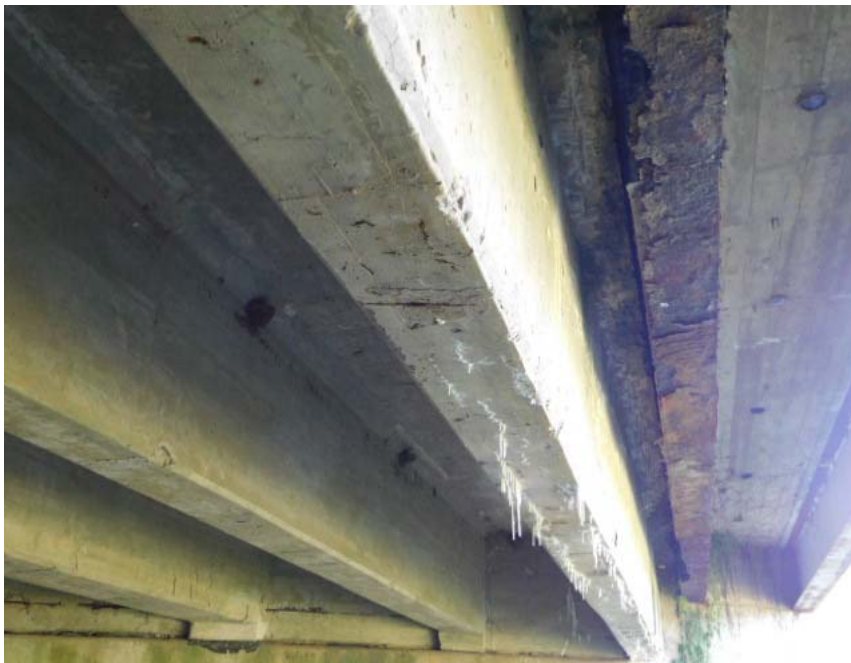
STEEL I BEAM "B" HEAVY CORROSION & SECTION LOSS

No.	RECOMMENDATIONS	REPAIR DATE	REPAIRED BY
1.	REPAIR STEEL BEAM "B & H" IN SPAN NO.1

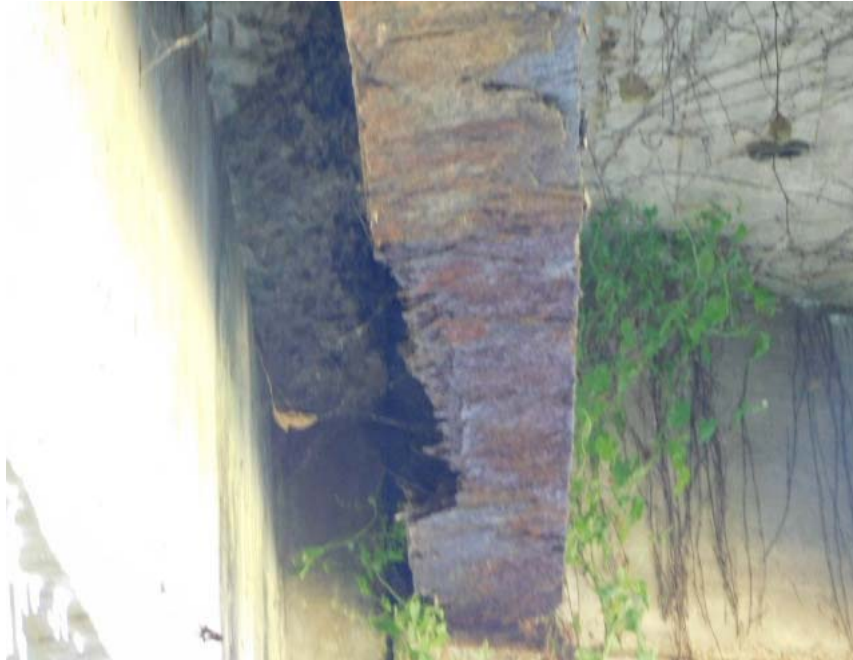
STEEL I BEAM "H" HEAVY CORROSION & SECTION LOSS

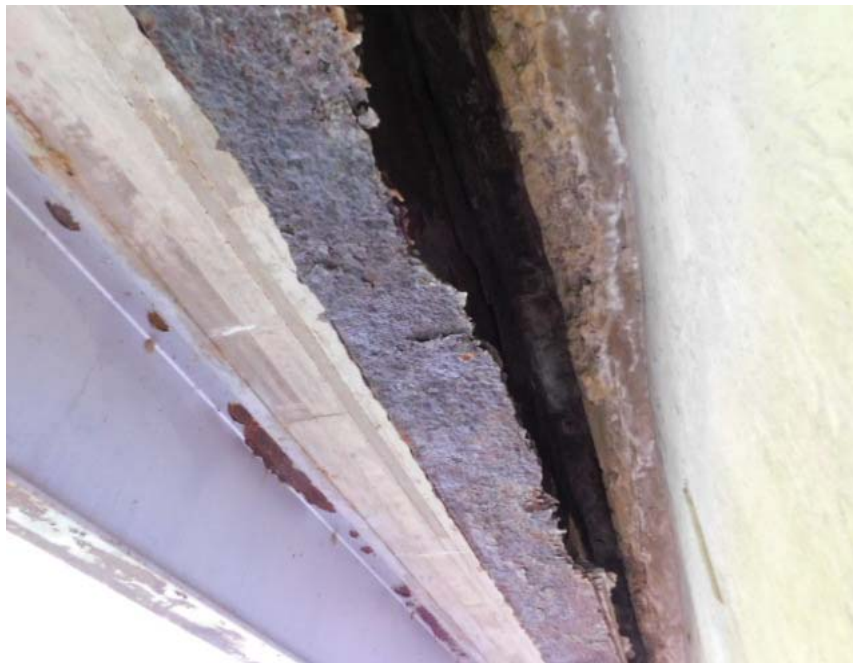
STEEL I BEAM "H" HEAVY CORROSION & SECTION LOSS

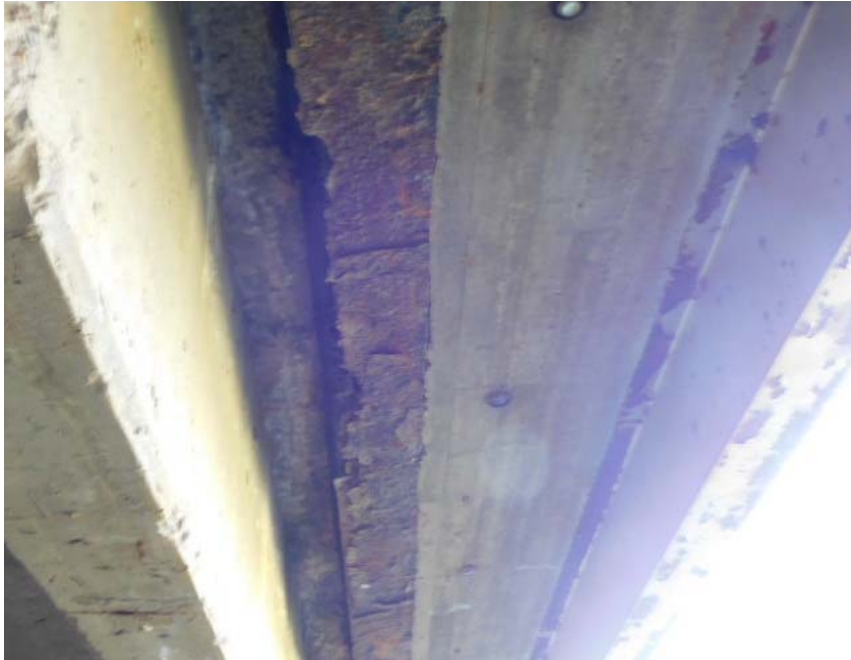
STEEL I BEAM "B" HEAVY CORROSION & SECTION LOSS

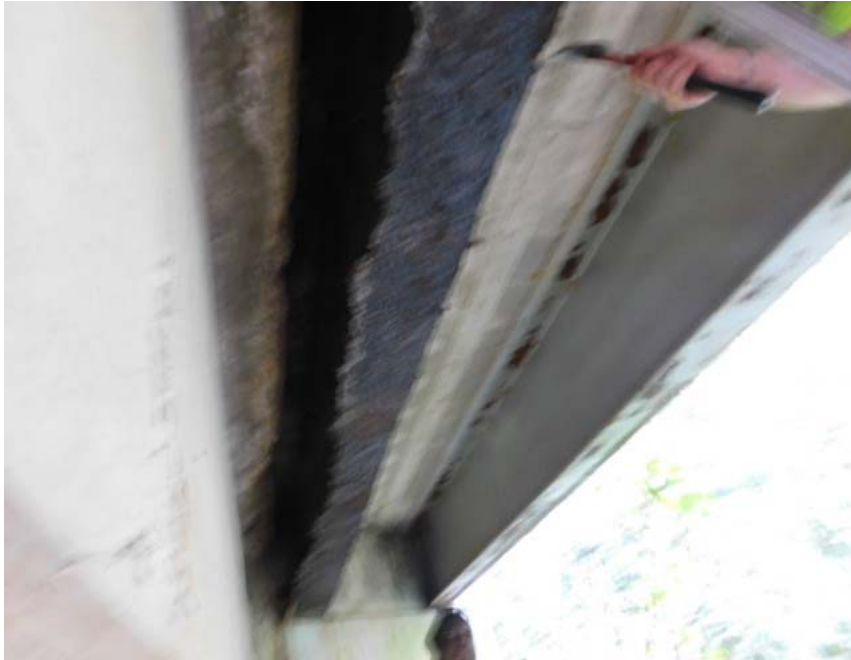
SPAN # 1 STEEL I BEAM "H" HEAVY CORROSION & SECTION LOSS

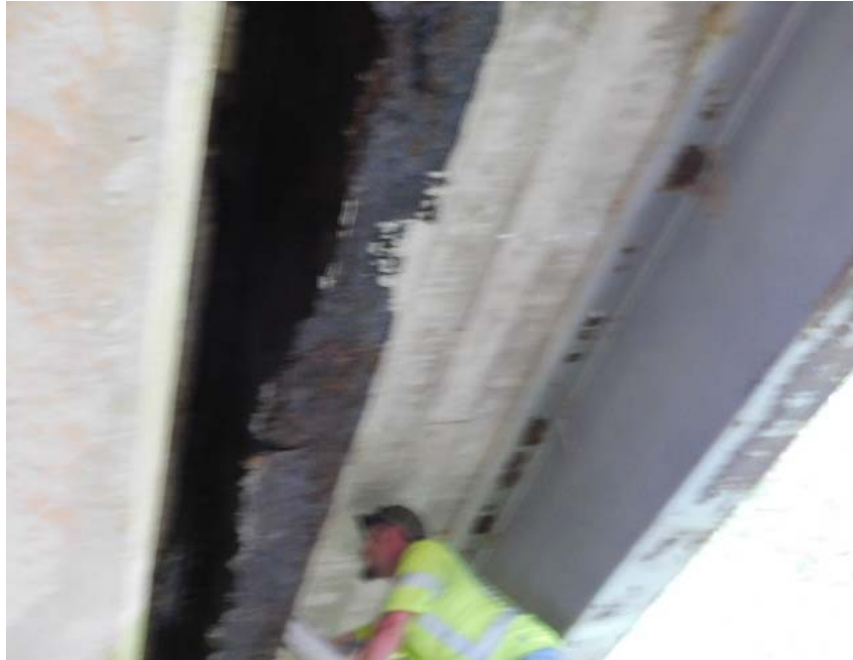
SPAN # 1 STEEL I BEAM "H" HEAVY CORROSION & SECTION LOSS

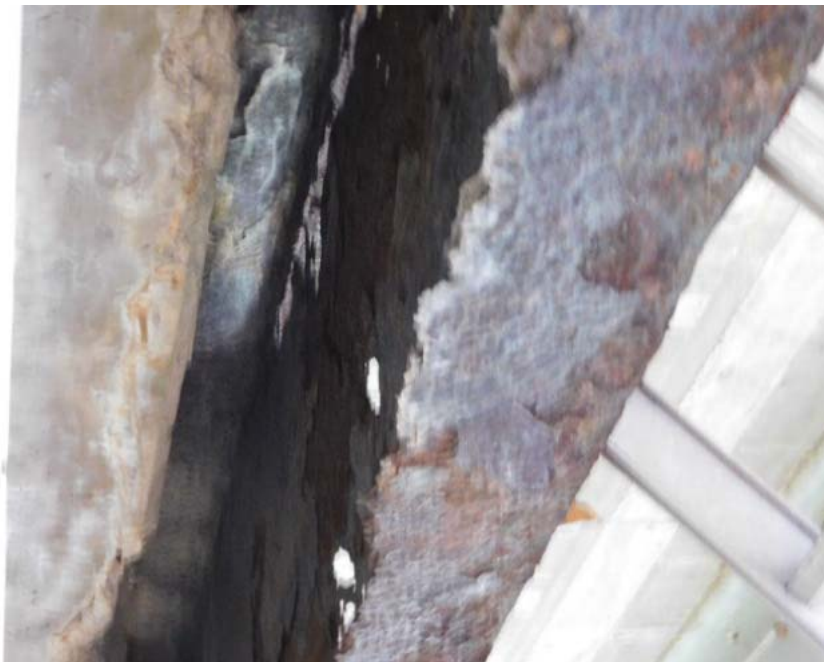
SPAN # 1 HOLE IN STEEL I BEAM "H"

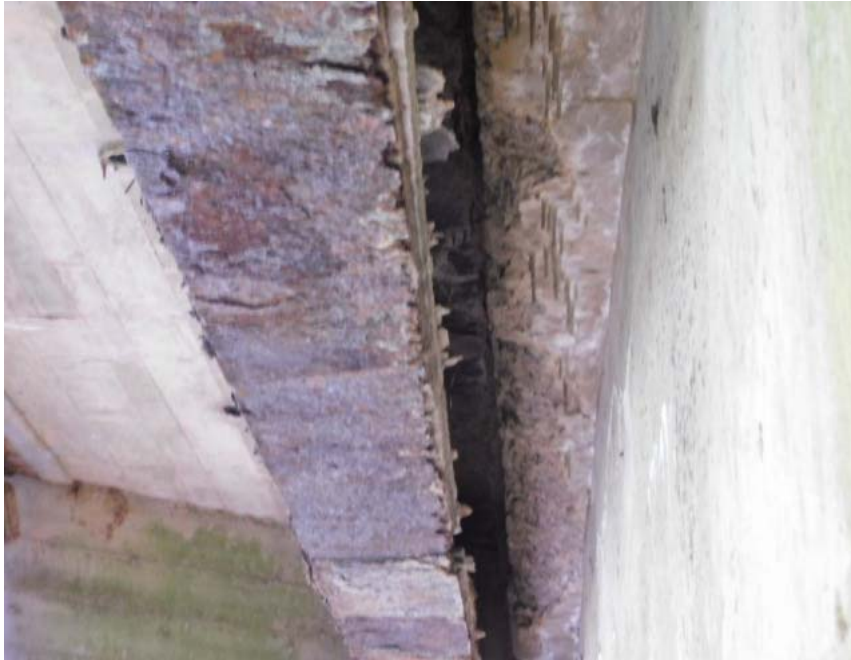
SPAN # 1 BOTTOM DECK SPALLING

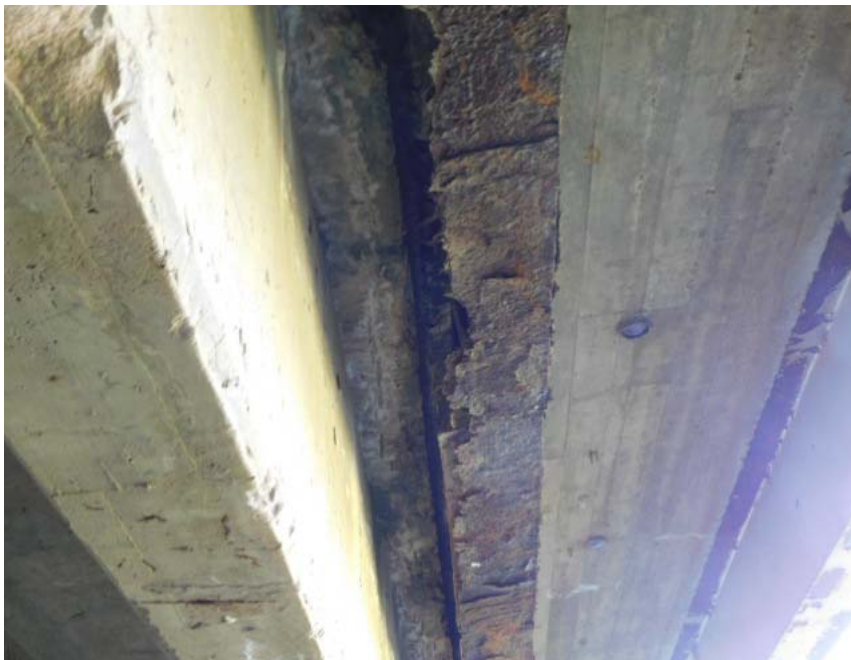
SPAN # 1 BOTTOM DECK SPALLING BETWEEN BEAMS "B & C"

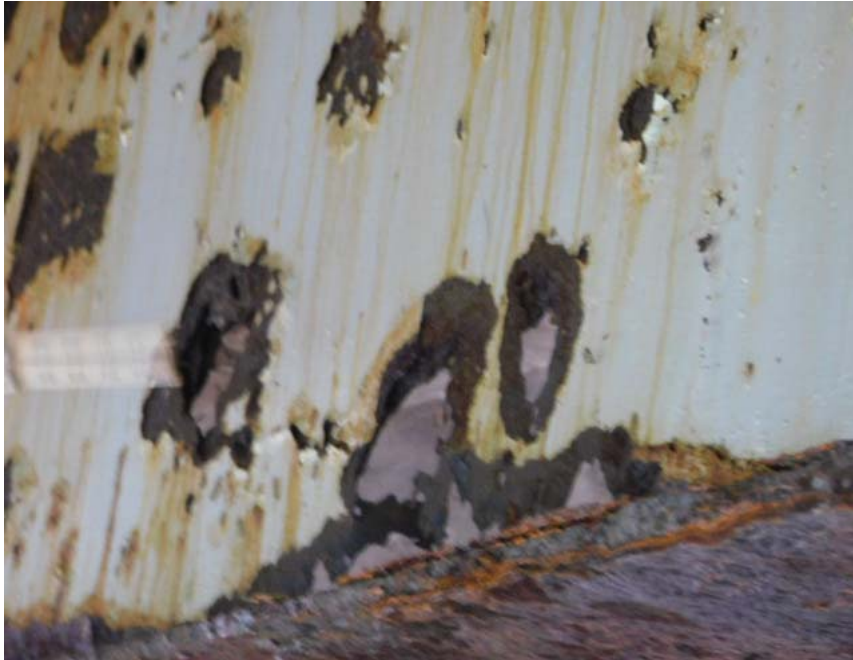
SPAN # 1 HOLE IN STEEL I BEAM "H" & HEAVY CORROSION

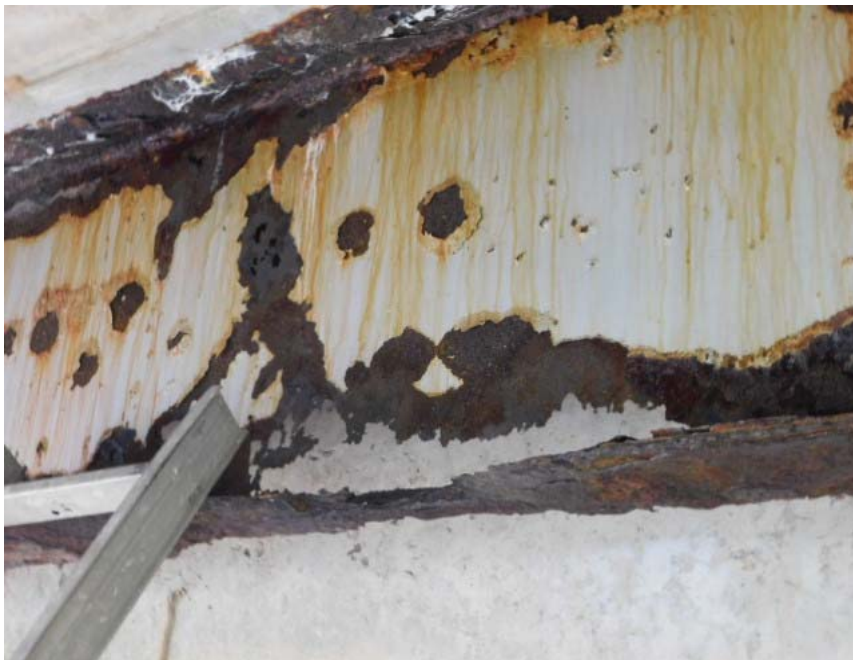
SPAN # 1 STEEL I BEAM "H" HEAVY CORROSION

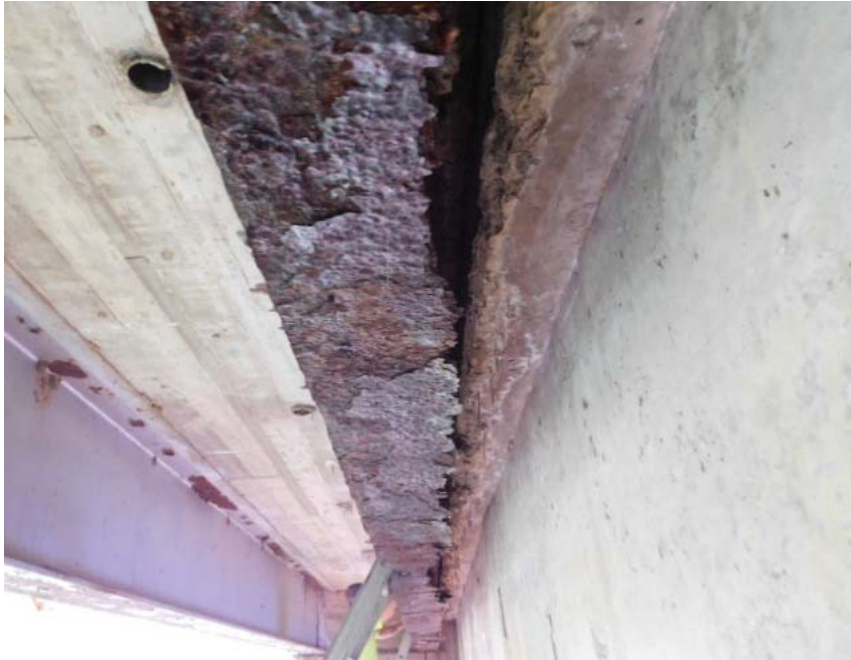
SPAN # 1 STEEL I BEAM "H" HEAVY CORROSION

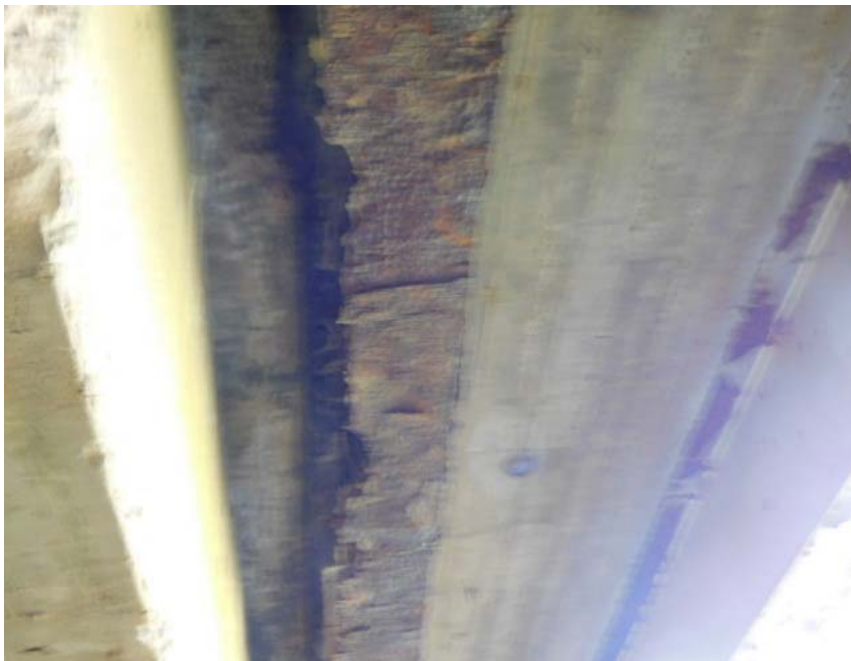
SPAN # 1 STEEL I BEAM "B" SECTION LOSS

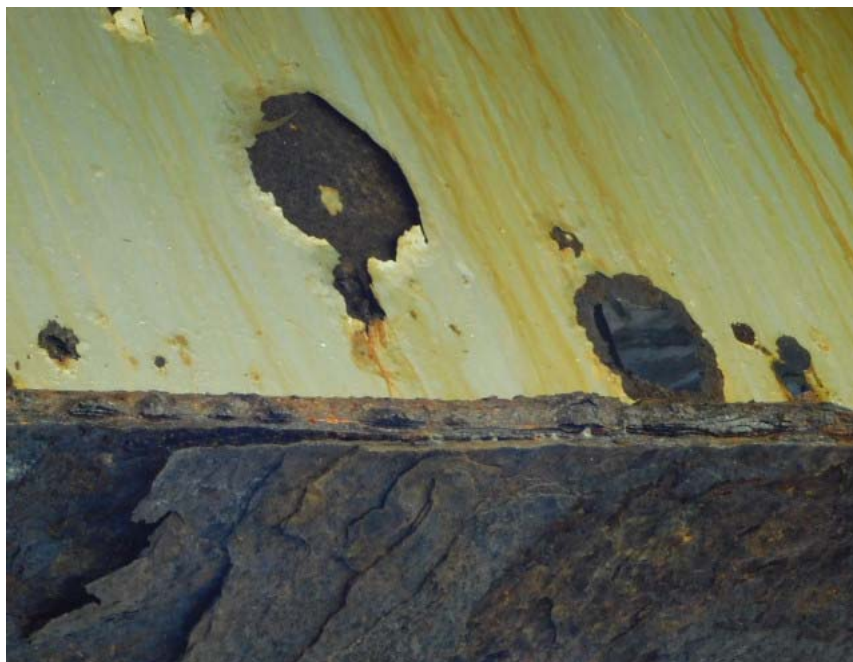
SPAN # 1 HOLE IN STEEL I BEAM "B"

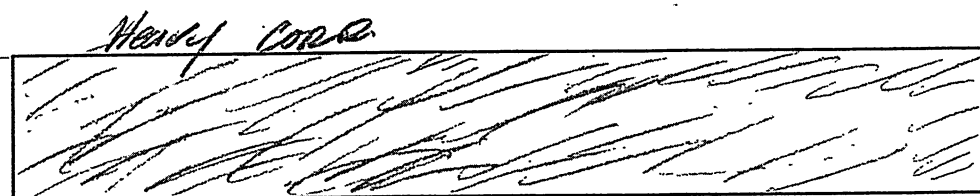
S.I.B. (B)

Note: Heavy scalling and section loss on RT. inside web,

⑤ section of Fly missing
15.0/L x up to 4"/W

⑥ section of Fly missing
1.2"/L x up to 4"/W

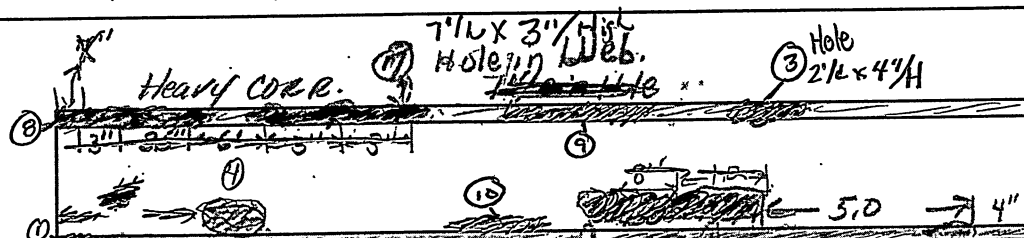
① section of Fly missing
8 1/2 L x 3 1/4 W.

④ Hole in web
3.5 L x 6 H

⑤ Hole in Top of web
4 L x 6 H

⑥ Hole in top of web
8.5 L x up to 6 H

⑩ Hole in Bottom of
web
20 L x 3 H

⑬ 1/2" Section loss on
Bottom flange
length of Beam

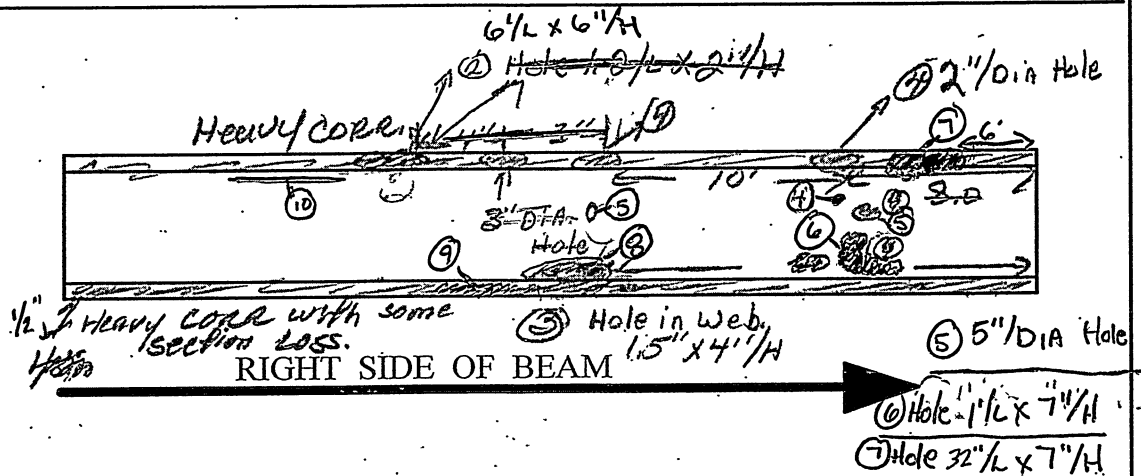
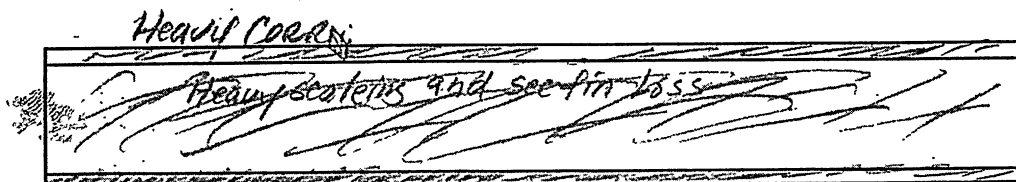
S.I.B. (F-1)

1 Flg. Missing up to 4' W x

8 Hole 3' L x 8' High

9 Heavy Section loss on Bottom Flange
90' 3.5' Long

10 Hole 2' L x 3' H

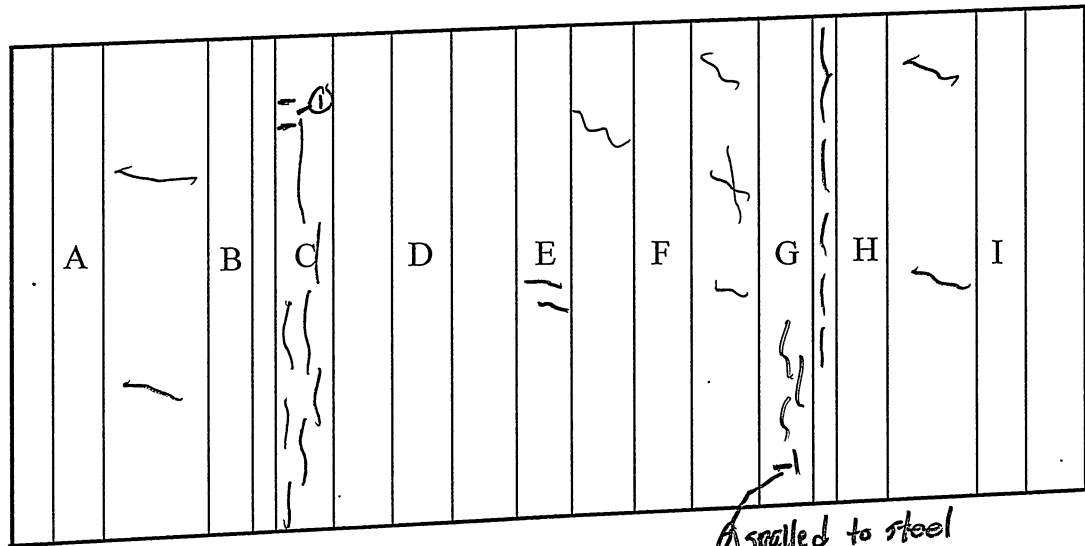
Spalled to steel
6" W x 1" L x 1 1/2" D

Spalled to steel
Areas on Lt side
1 1/4" x 4 1/2" W x 1 1/2" D
