BRIDGE MAINTENANCE RECOMMENDATIONS

COUNTY: LAUDERDALE

LOCATION: 49-SR087-03.88-

FED. BRIDGE NO.: 49SR0870011

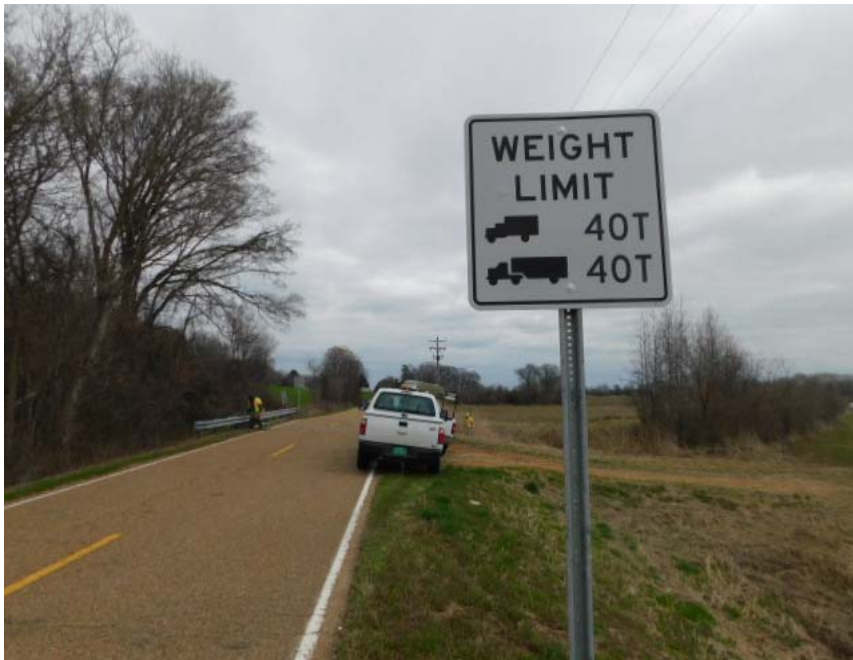
APPROACH 1 WEIGHT LIMIT SIGN 40 T - 40 T

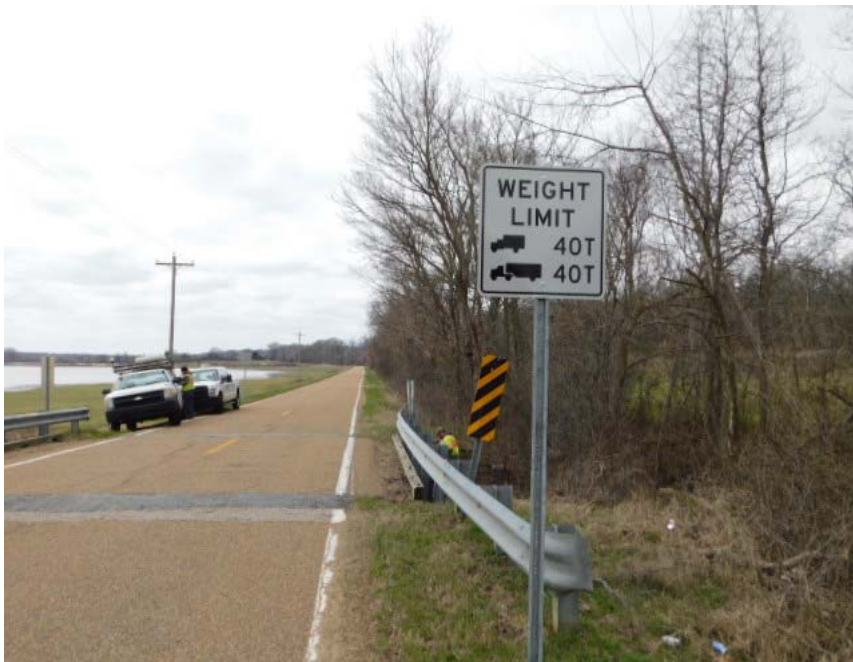
APPROACH 2 WEIGHT LIMIT SIGN 40 T- 40 T

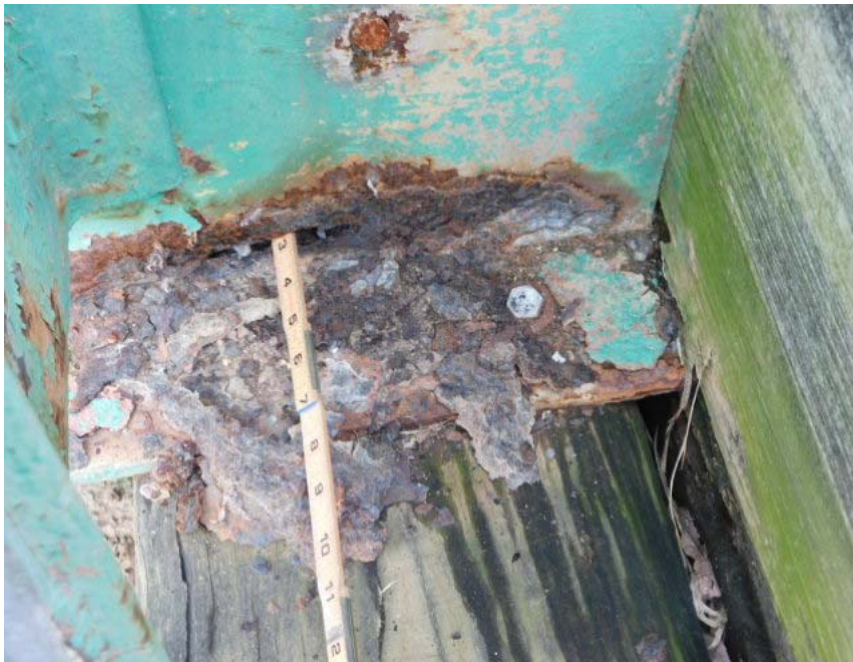
SPAN 1 HOLE IN STEEL I BEAM

REPAIR STEEL BEAM " N " IN SPAN NO.1

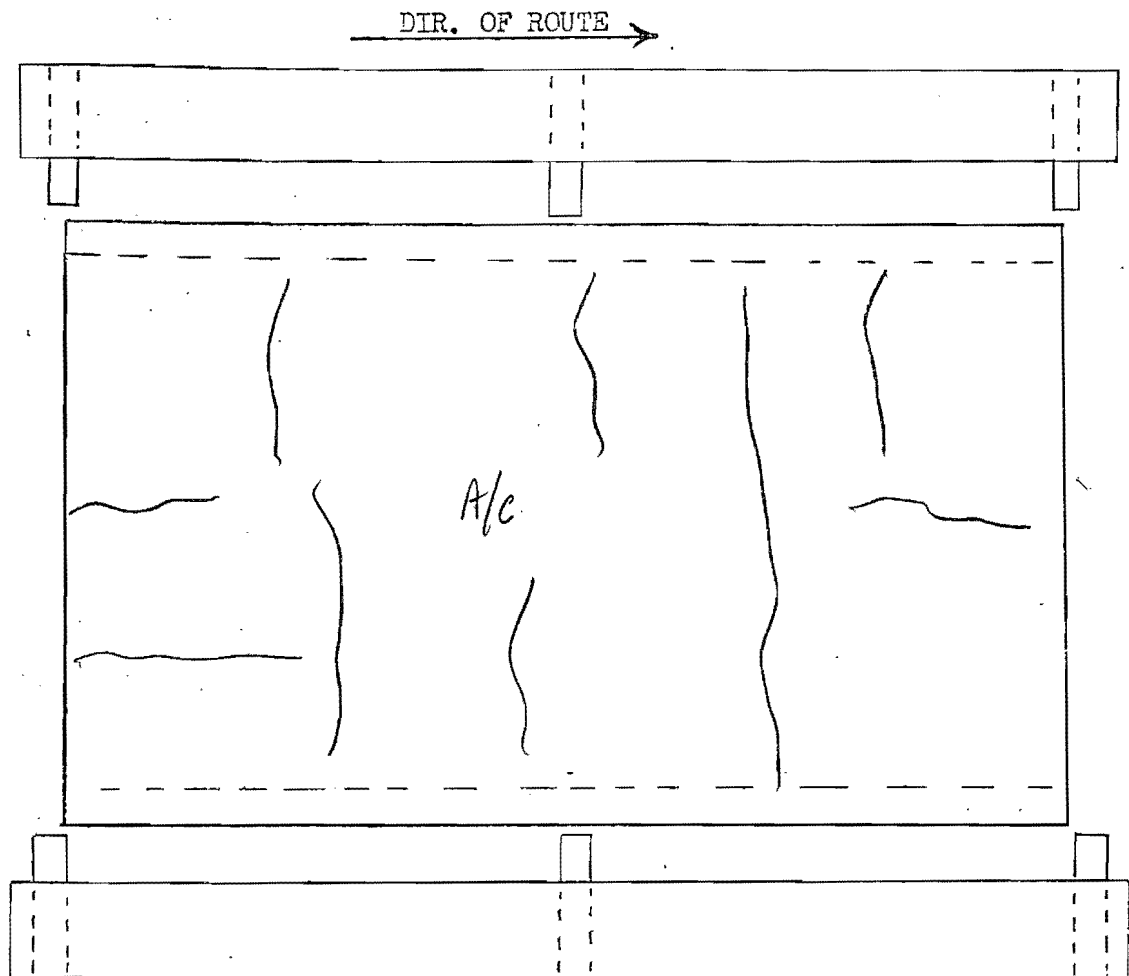
SPAN NO. 1

ELEMENT	RATING	COMMENT
TOP DECK	G <u>F</u> P C	1/8" cracks
RAILS & POST	G <u>F</u> P C	
PAINT	G F P C	light weathering
DRAINS	G F P C	
JOINTS	G F P C	
W/G	G <u>F</u> P C

BR. NO. 49 87 3.98 SKEN 90° MAR 07 2018
 ① Light Corrosion W/ NO MEAS. SEC. LOSS @ Top Flange 3.90 ② Hole
 52" (Cross-Section)
 6" L x 1" H
 X 1/4" Through Beam

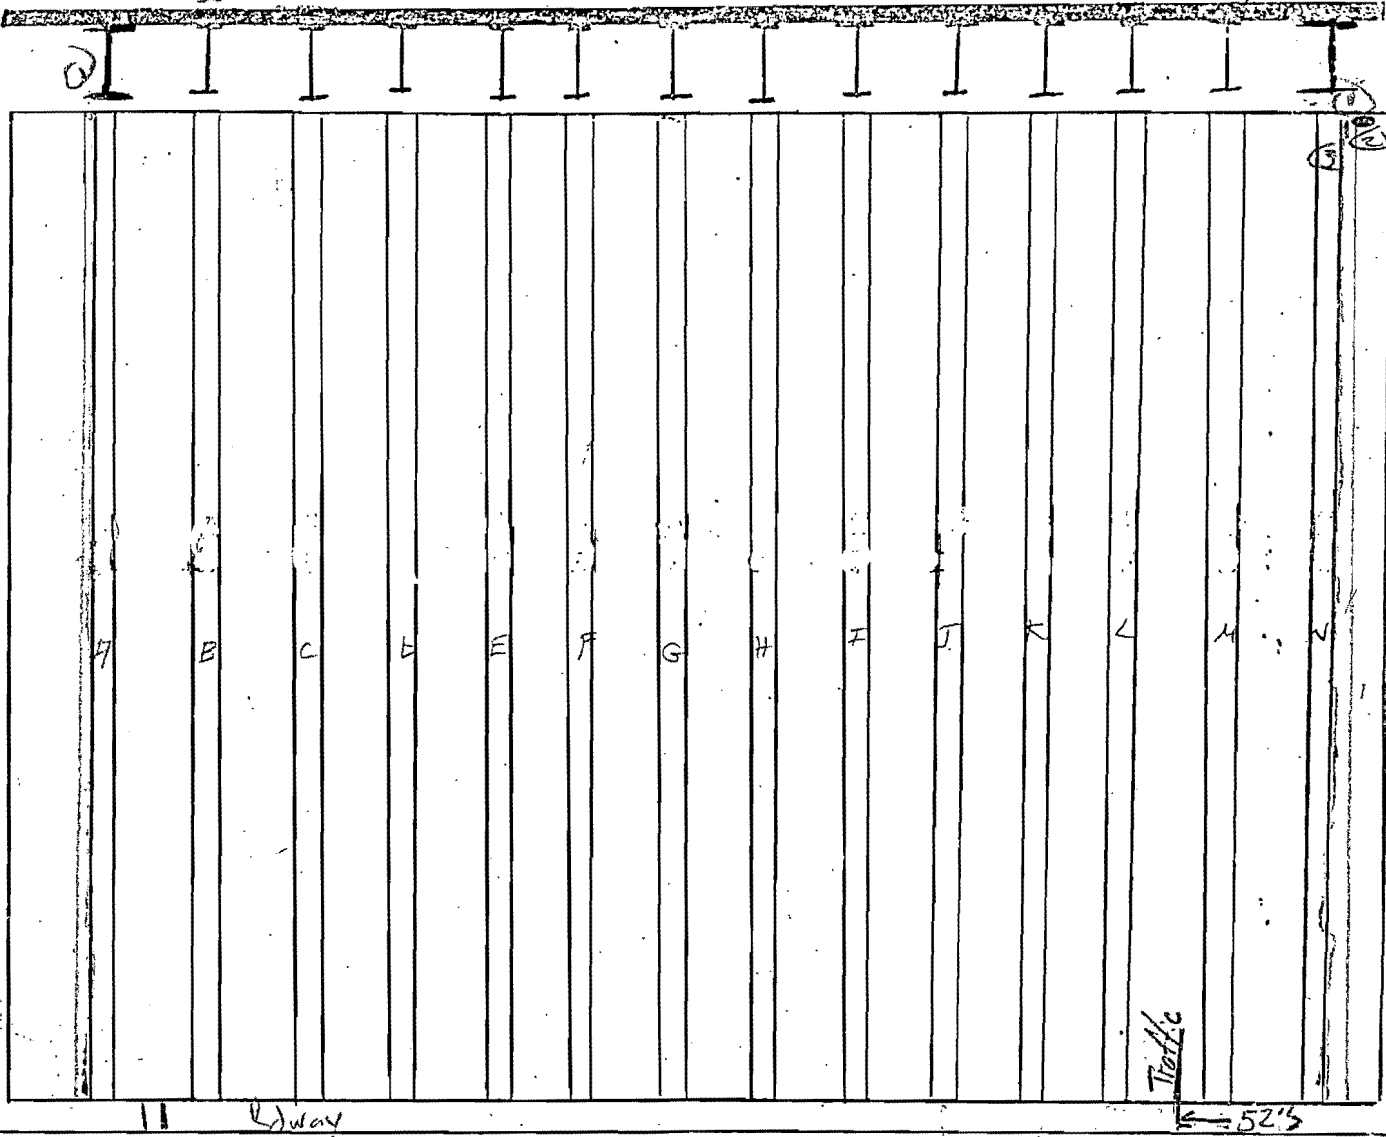
ELEMENT	RATING	COMMENT
BOTTOM DECK	G (F) P C	Med. Weathering
S. I. B.		
A B-M	G (F) P C	Light Surface Rust
A	G (F) P C	sec ①
N	G F (P) C	②
DIA.	G F P C	
PAINT	G F P C	
Flm. Nailers	G F P C

③ Heavy Corrosion @ Top Flange (SER "N")
 1/2" Sec. Loss
 (1' Length)
 ④ Beam "N" is
 * 52" from
 Net. Eastbound
 Lane (Under
 Line)

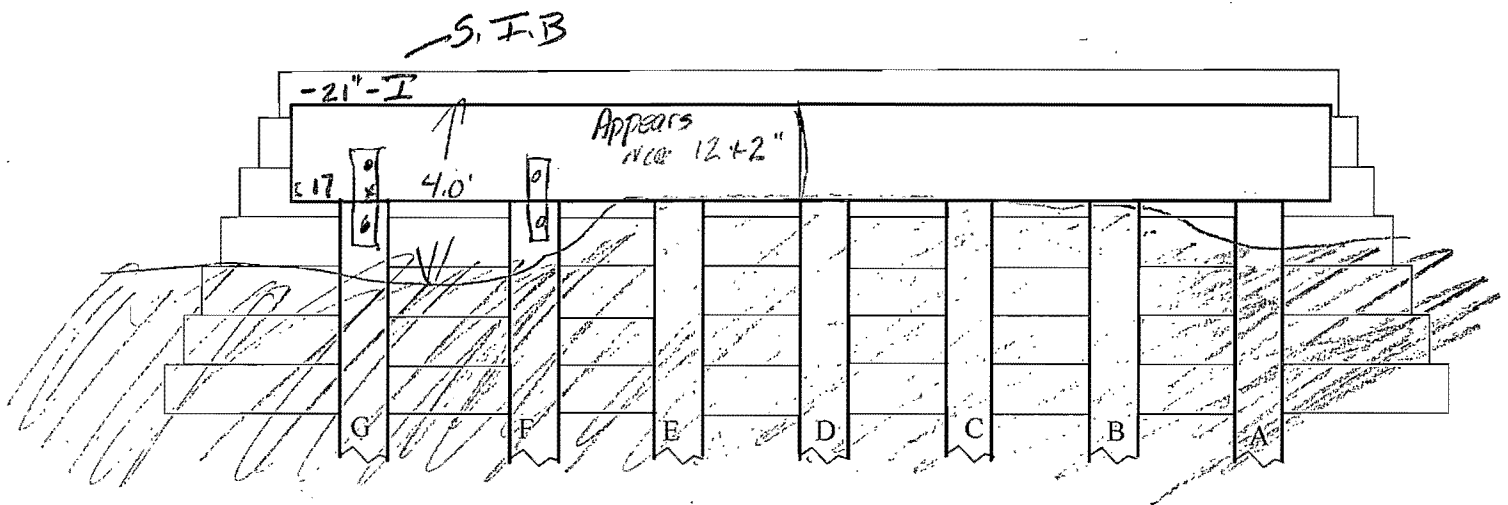
LOOKING BACK

ELEMENT	RATING	COMMENT
CAP	G (F) P C	med weather
WINGS	G (F) P C	
PILES A	G (F) P C	med weather
B	G F P C	N/A
C	G F P C	
D	G F P C	
E	G F P C	
F	G F P C	med weather
G	G (F) P C	
BREASTWALL	G (F) P C	med weather
EMB.	(G) F P C	
VEG.	G F (P) C	heavy growth
RIP - RAP	G F P C	N/A
Ret wall	G (F) P C	med weather
	G F P C	
	G F P C

CUT AND REMOVE VEGETATION FROM CHANNEL

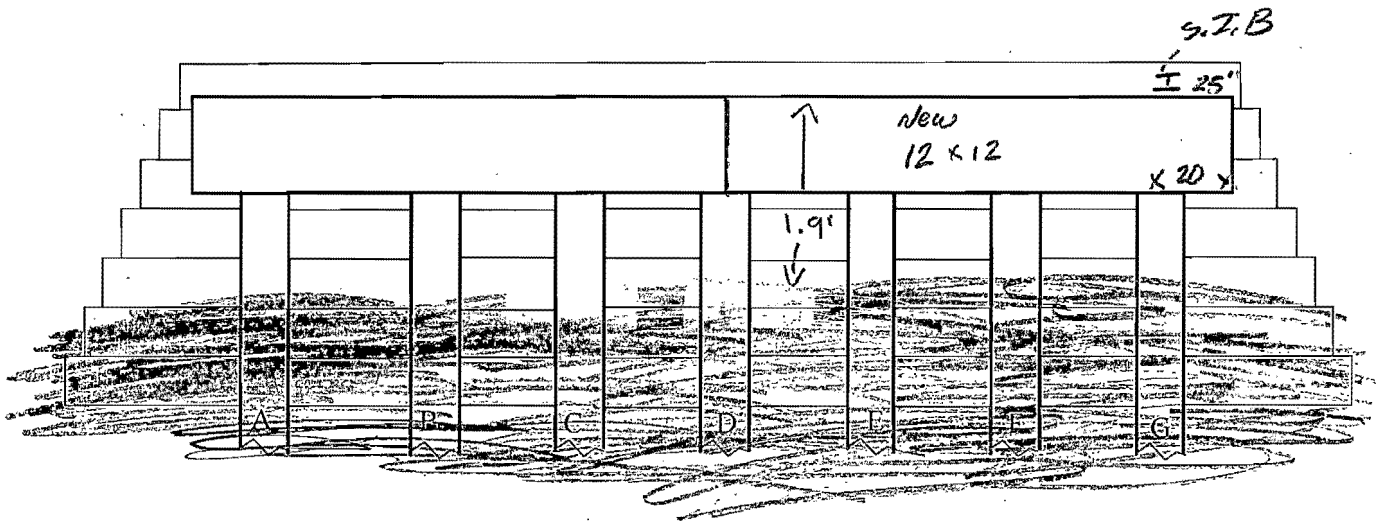
LOOKING AHEAD

ELEMENT	RATING	COMMENT
CAP	G (F) P C	up to med weathering
WINGS	G (F) P C	
PILES A	G (F) P C	
B	G (F) P C	
C	G (F) P C	
D	G (F) P C	
E	G (F) P C	
F	G (F) P C	
G	G (F) P C	
BREASTWALL	G (F) P C	
EMB.	G (F) P C	
VEG.	G (F) P C	light growth
RIP - RAP	G F P C	N/A
	G F P C	
	G F P C	
	G F P C
