MADISON COUNTY

FIRST INSPECTION

57-SR223-0228

Road Name: SHADY GROVE ROAD

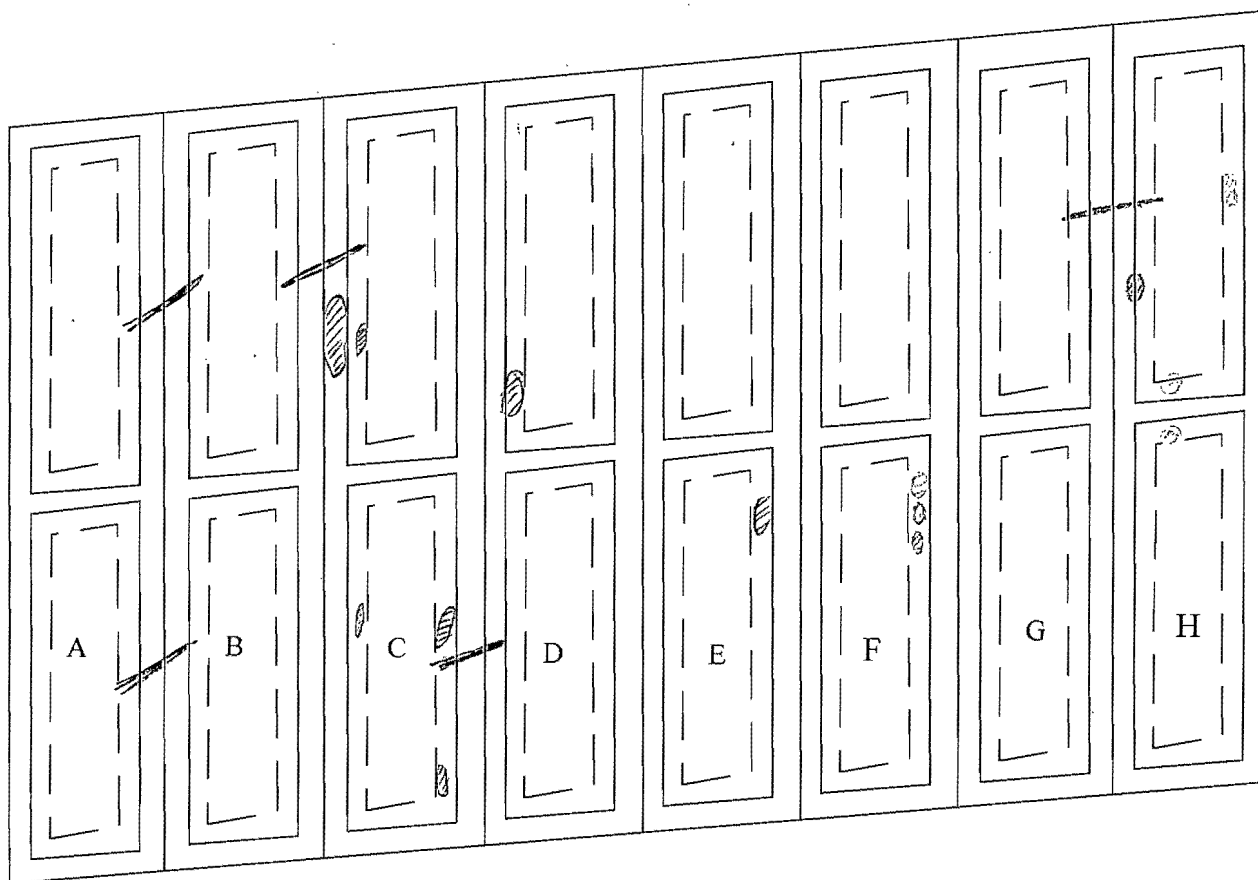
SPAN. NO. 1

| ELEMENT | RATING | COMMENT |
|---|---|---|
| C | (G) (F) P C | Spalling upto 2' Lx 6" Wx 1" D |
| D | (G) (F) P C | Spalling 6" Lx 4" H x 1/2" D |
| E | (G) (F) P C | Spalling 10" Lx 4" H x 1" D |
| F | (G) F P C | chipped areas upto 3" Dia x 1/4" D |
| H | (G) F P C | chipped areas upto 3" Dia x 1" D |
| BOLTS | (G) (F) P C | 5 BOLTS missing |

| ELEMENT | RATING | COMMENT |
|---|---|---|
| | | IN PROCESS of PUTTING<br>REMAINDER of BOLTS IN<br>PLACE |

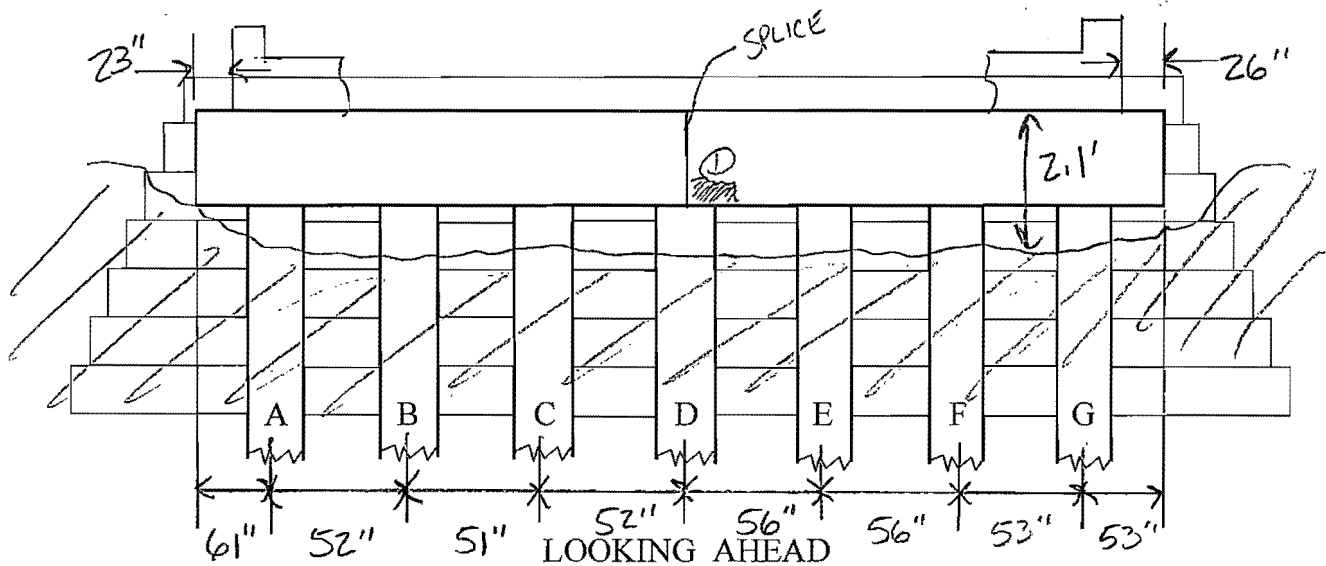
| ELEMENT | RATING | COMMENT |
|---|---|---|
| CAP 14" X 14" | (G) F P C | ① - SPLINTERED 10" W X 4" H X 1/8" D |
