# MADISON COUNTY

**57-SR223-0228**

**Road Name: SHADY GROVE ROAD**

# BRIDGE INSPECTION REPORT

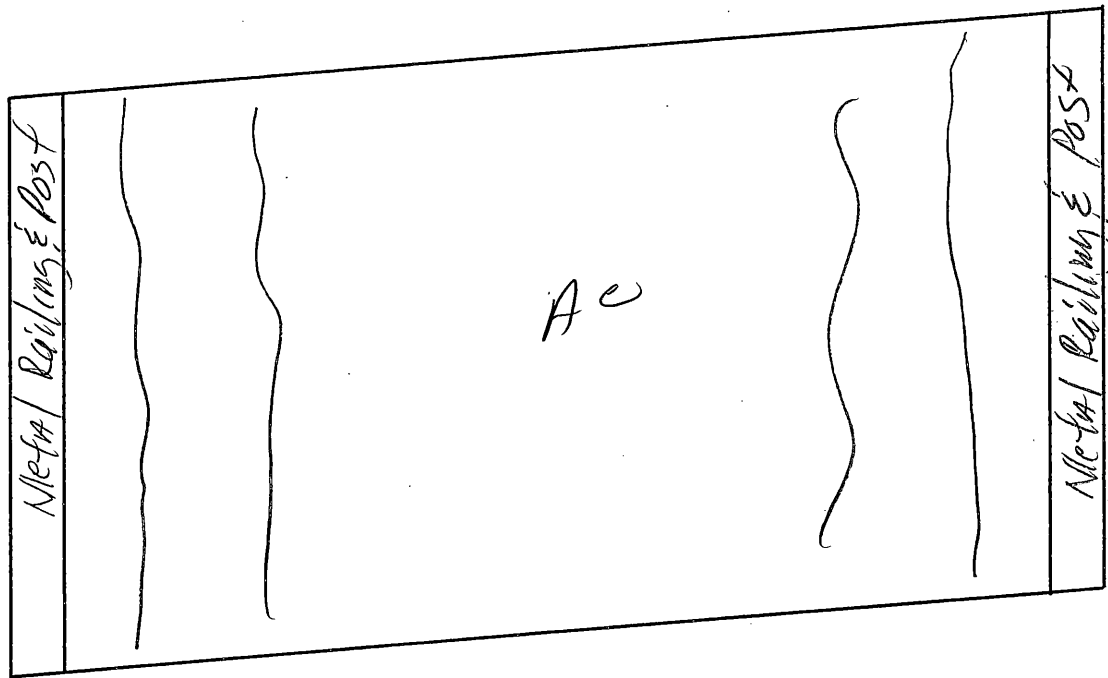
ELEMENT	RATING	COMMENT
TOP DECK	G F P C	Fine cracks
CURBS	G F P C	
DRAINS	G F P C	
JOINTS	G F P C	N/A
	G F P C

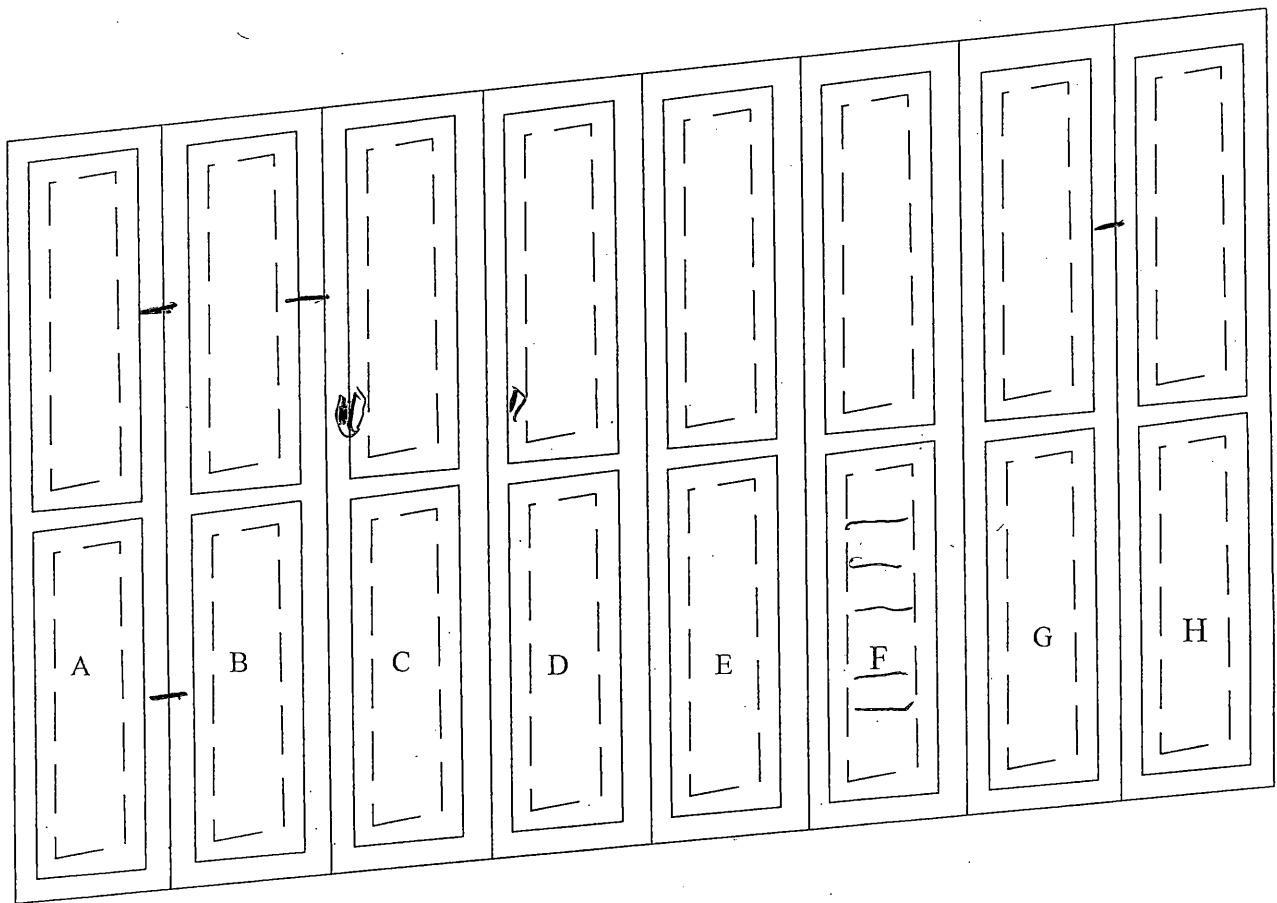
ELEMENT	RATING	COMMENT
SLABS A	G F P C	
B	G F P C	
C	G F P C	Spall 1' L 6" w 2" deep
D	G F P C	Spall 1' L 3" tall 1/2" deep
E	G F P C	
F	G F P C	Horizontal cracks
G	G F P C	
H	G F P C	
BOLTS	G F P C	4 missing

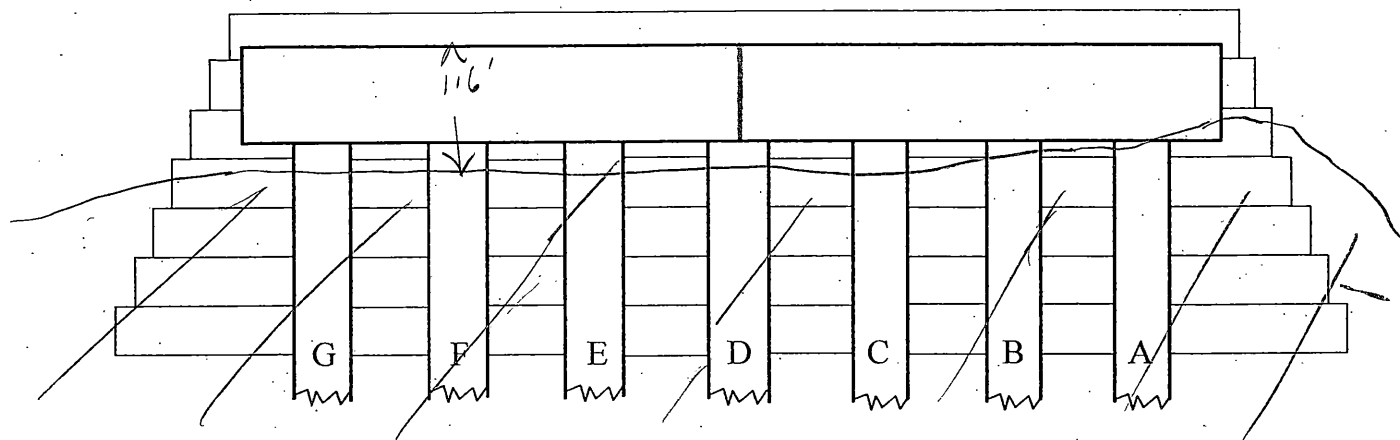
LOOKING BACK

ELEMENT	RATING	COMMENT
CAP	G (F) P C	Light to medium weathering
WINGS	G (F) P C	
PILES A	G (F) P C	
B	G F P C	
C	G F P C	
D	G F P C	
E	G F P C	
F	G F P C	
G	G F P C	
BREASTWALL	G (F) P C	
EMB.	G F P C	Light growth
VEG.	G (F) P C	
RIP - RAP	G F P C	
	G F P C

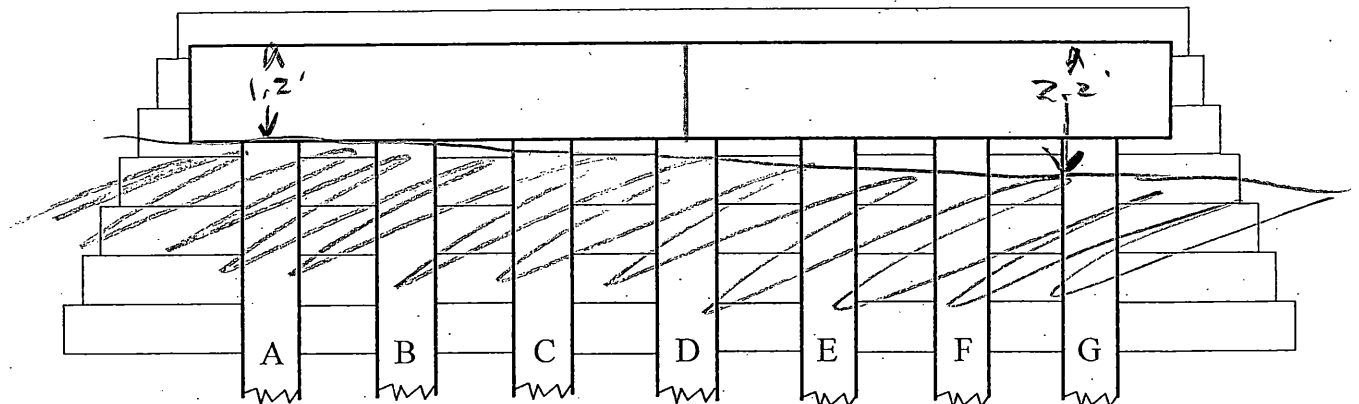
LOOKING AHEAD

ELEMENT	RATING	COMMENT
CAP	G <u>F</u> P C	light weathering
WINGS	G <u>F</u> P C	
PILES A	G F P C	NV
B	G F P C	NV
C	G <u>F</u> P C	light weathering
D	G <u>F</u> P C	
E	G <u>F</u> P C	
F	G <u>F</u> P C	
G	G <u>F</u> P C	
BREASTWALL	G <u>F</u> P C	
EMB.	G <u>F</u> P C	
VEG.	G <u>F</u> P C	
RIP - RAP	G F P C	N/A
	G F P C	
	G F P C
