2021 Underwater Bridge Inspection Report

Bridge ID Number: 90S23860001

**SR353 (Bailey Bridge Road) over
Nolichucky River**

Inspection Date: August 14th, 2021

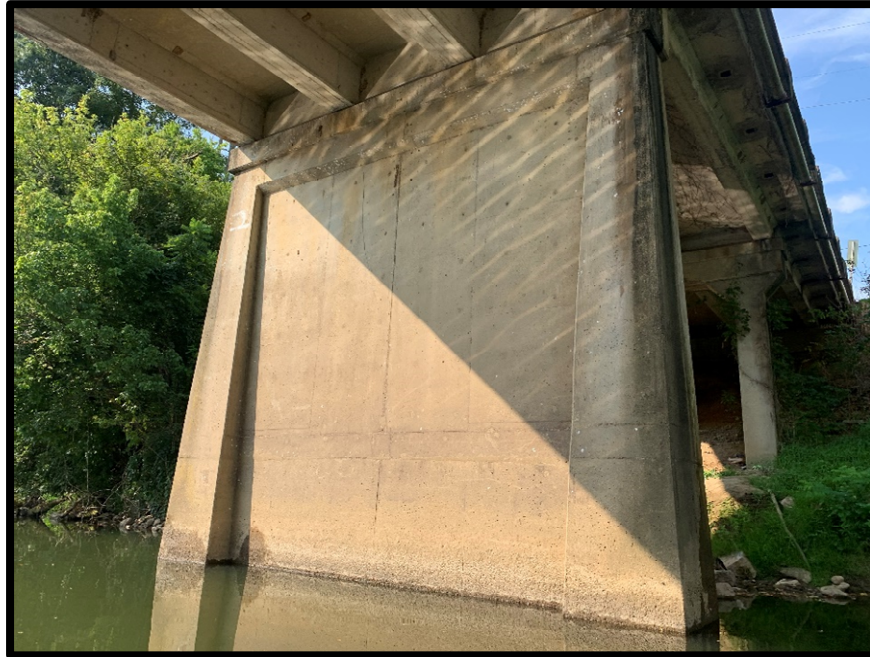
A four (4) inch diameter popout with exposed rebar was observed on the south side of the downstream column. Light drift debris was observed on the upstream column. Light biological growth was noted with up to eighty (80) percent of surface coverage from the waterline to the channel bottom. The streambed material around Pier No. 1 consists of sand and silt, as well as rip-rap scattered around the upstream column. The footing was not exposed and no scour or undermining was found.

Photo 5: Pier No. 1 Looking Back

Pier No. 1, Pier No. 2, Pier No. 3, Pier No. 4, Pier No. 5:
Recommend removal of drift accumulation.

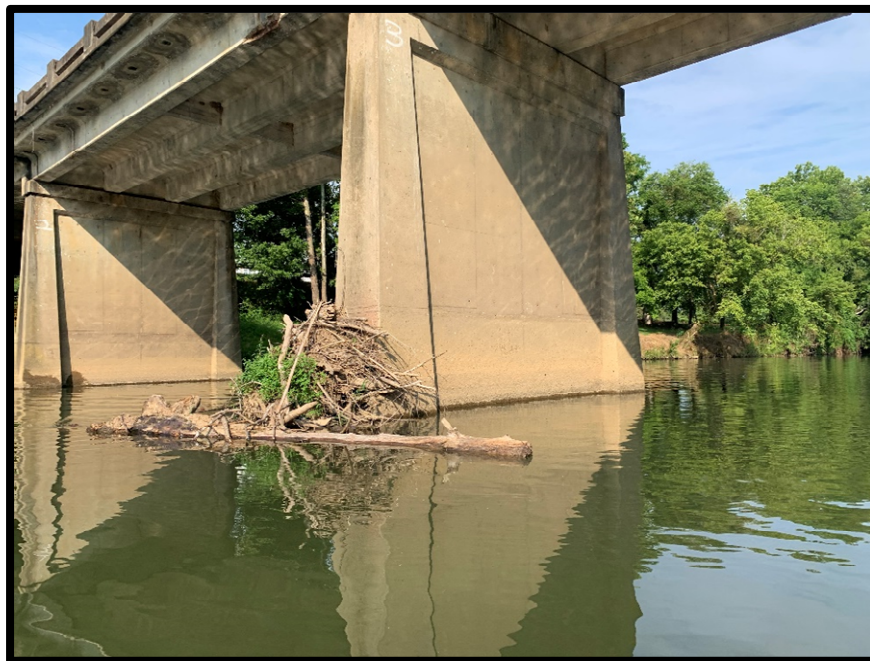
Heavy drift debris was noted on the upstream column and south face of the pier, and extending from the upstream column across the south face of the web wall, consisting of large logs and additional small branches. The footing was exposed on the north side of the pier around the upstream column with no vertical exposure. No scour or undermining was noted. The streambed material around Pier No. 2 consists of sand and silt.

Photo 6: Pier No. 2 Looking Back At Drift Debris on Upstream Nose

Pier No. 2, Pier No. 3, Pier No. 4:
Continue to monitor footing exposure for development of scour and undermining.

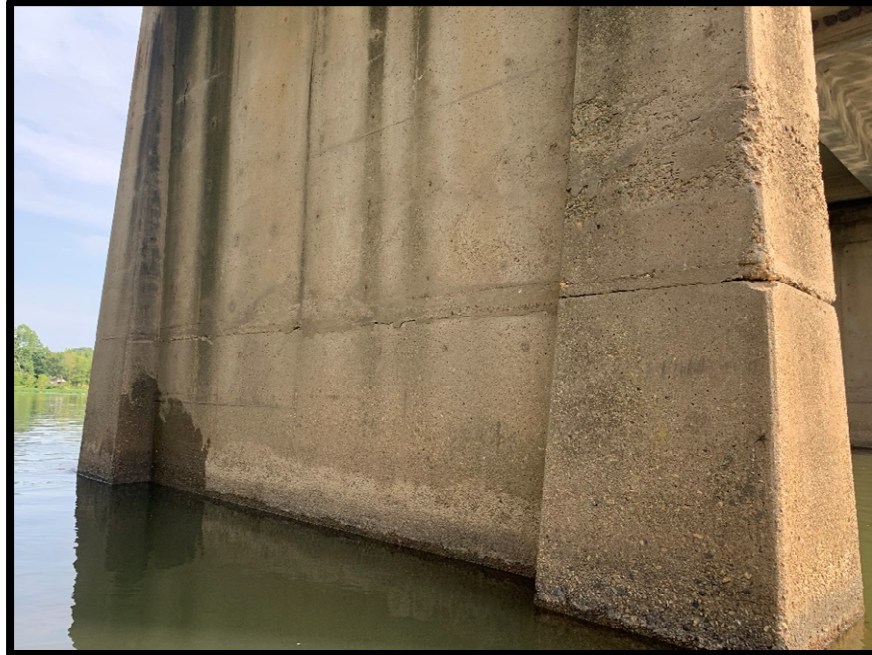
Light drift debris was noted on the upstream column; a single twelve (12) foot log measuring five (5) inches in diameter was found. One minor spall approximately one (1) feet six (6) inches above the waterline on the south web wall was noted. Most of the footing was exposed on the north side of the pier and partially exposed on the south side of the pier. Up to ten (10) inches of vertical exposure was noted, but no undermining or scour was found. For approximate limits and locations of deficiencies, see Appendix C. The streambed material around Pier No. 3 consists of sand and silt.

Photo 7: Pier No. 3 Looking Back

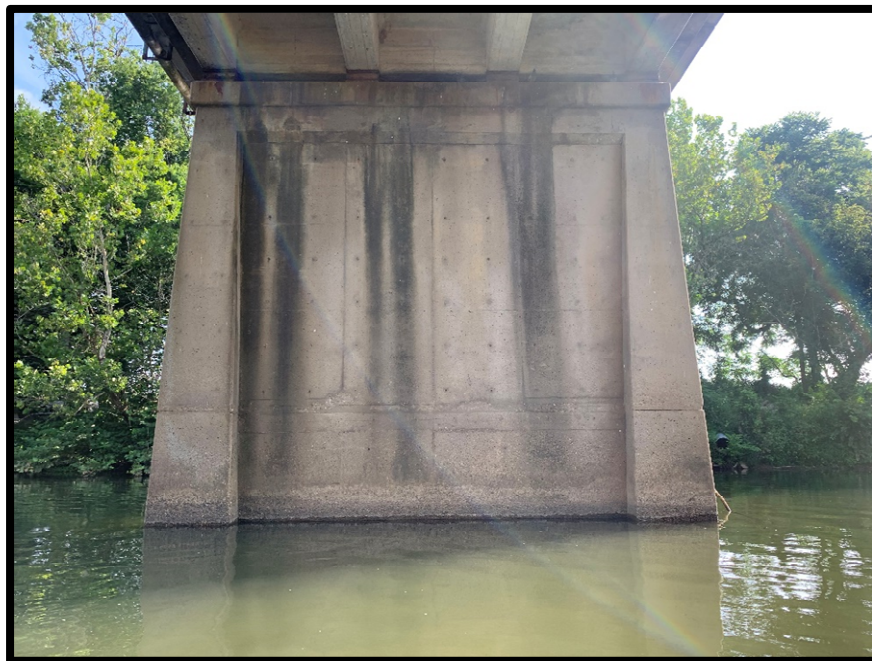
Light drift debris was observed at the upstream column consisting of a six (6) inch diameter log ten (10) feet in length. The footing was partially exposed in the middle of the web wall on the north side with no vertical exposure noted. No undermining or scour was noted. The streambed material around Pier No. 4 consists of sand and silt.

Photo 8: Pier No. 4 Looking Forward

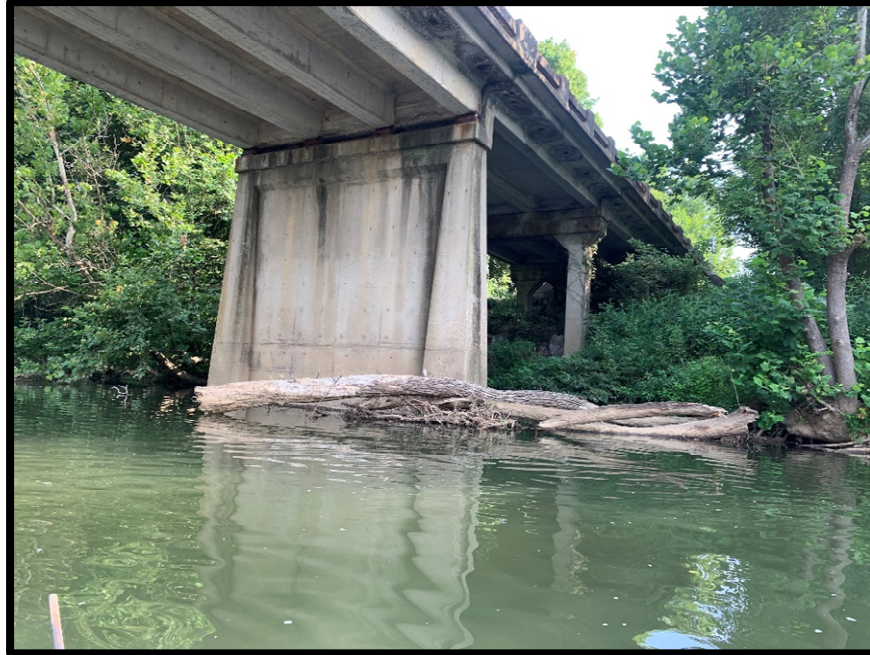
Moderate drift debris was observed at the upstream column and wrapped around both the north and sides of the column, consisting of numerous large logs and small branches. The streambed material around Pier No. 5 is sand and silt. The footing was not exposed and no scour or undermining was noted.

Photo 9: Pier No. 5 Looking Forward

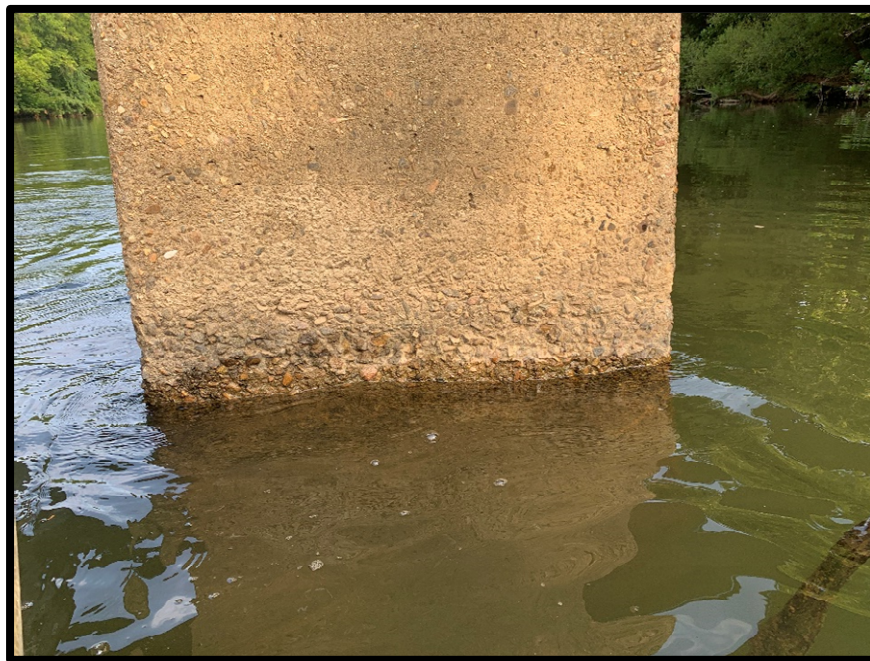
This bridge in Washington County along SR353 (Bailey Bridge Road) over Nolichucky River was inspected by diving. Light scaling was noted on all piers, up to one-quarter ($\frac{1}{4}$) inch depth from the channel bottom extending to eighteen (18) inches above the waterline. The streambed was sounded at ten (10) foot increments on all sides and is noted in Appendix B.

Photo 10: Scaling at Waterline (Typ.)

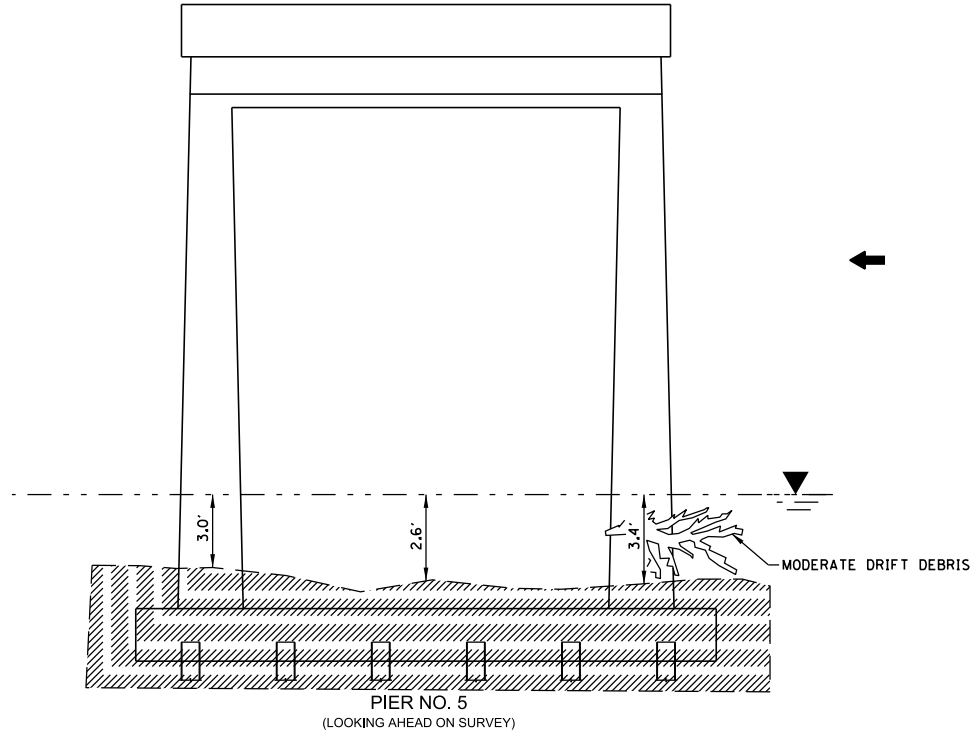
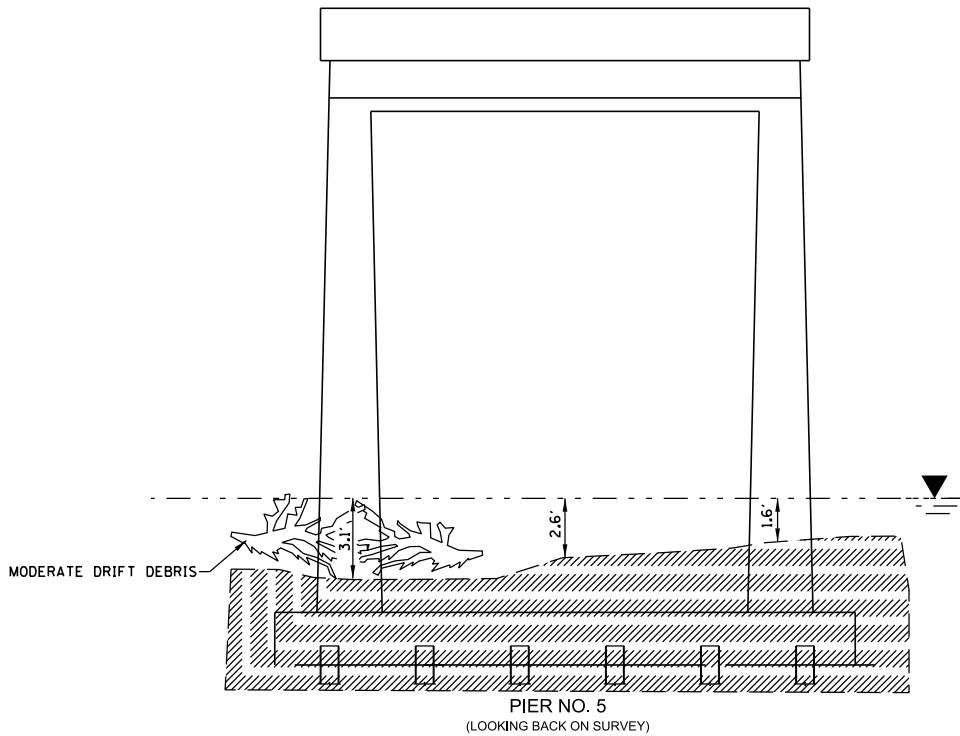
PIER NO. 5
SCALE: NONE

MODERATE DRIFT DEBRIS
(TYP.)
