BAILEY BRIDGE RD. Crossing NOLICHUCKY RIVER

90 - LAST INSPECTION DATE 07/02/2024

IDENTIFICATION	
(1) State Names	47 - Tennessee
(8) Structure Number	90S23860001
(5) Inventory Route	1
(2) Highway Agency District	Region 1
(3) County Code	90 - Washington

Inspection Team's Summary

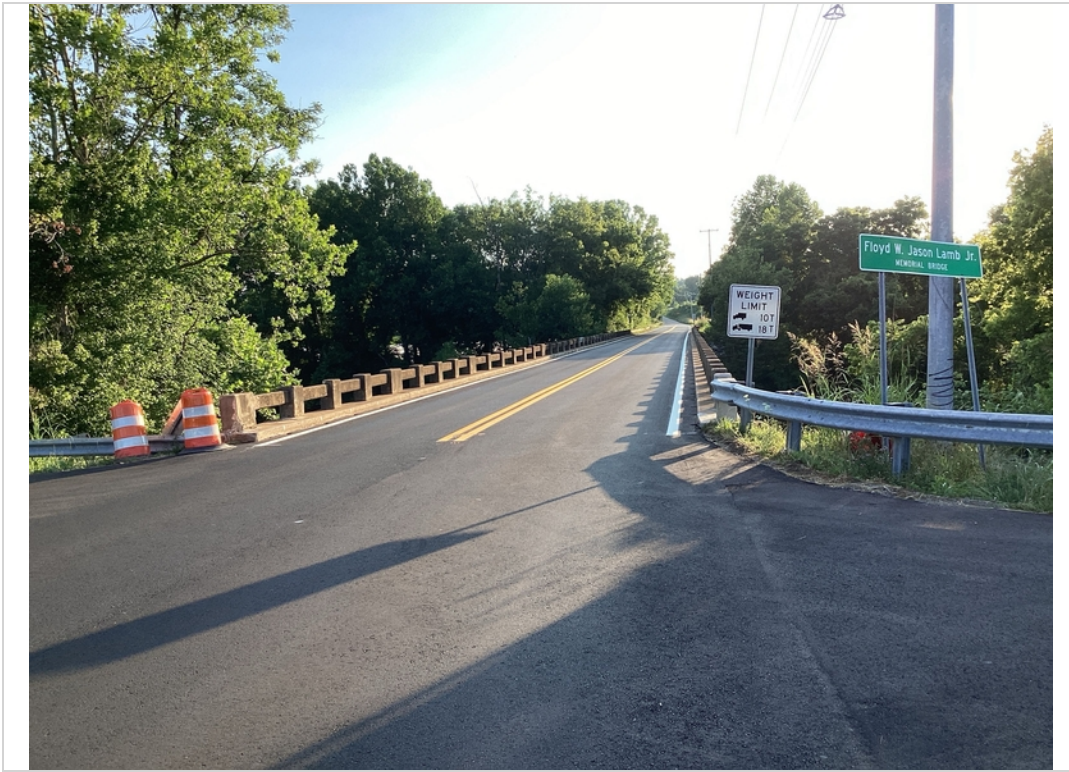
Forward on log with weight posting

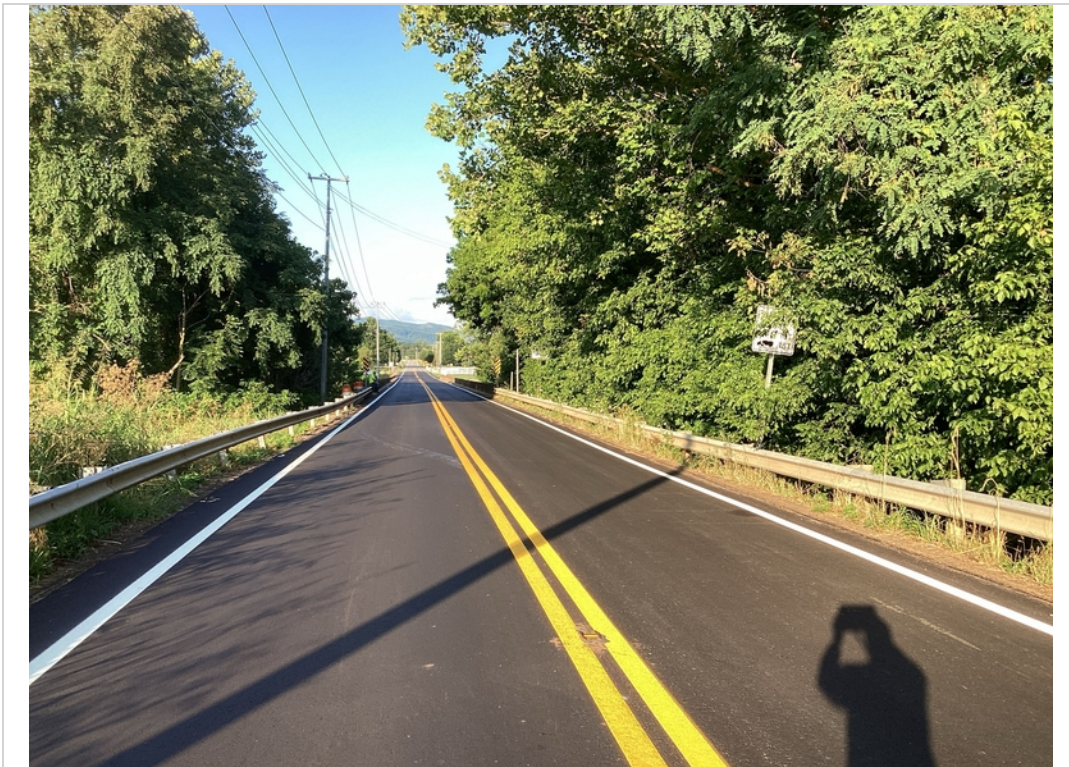
Back on log with weight posting obscured by vegetation

Date Added	Recommendation	Priority
01/24/2006	BRIDGERAILS ARE SUBSTANDARD	
01/26/2006	CLEAN & PAINT BEARING - ALL	
10/26/2022	REINSTALL WEIGHT POSTING SIGNS AT BOTH APPROACHES	4

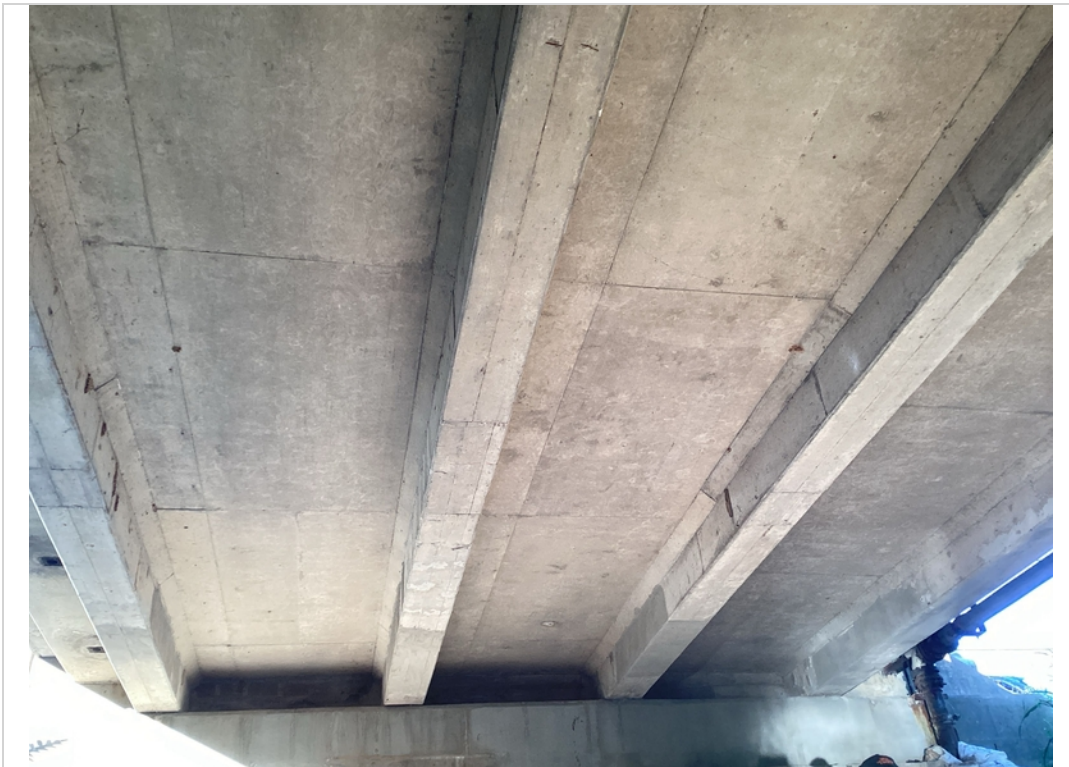
Repaired bottom of superstructure span #1, typical all

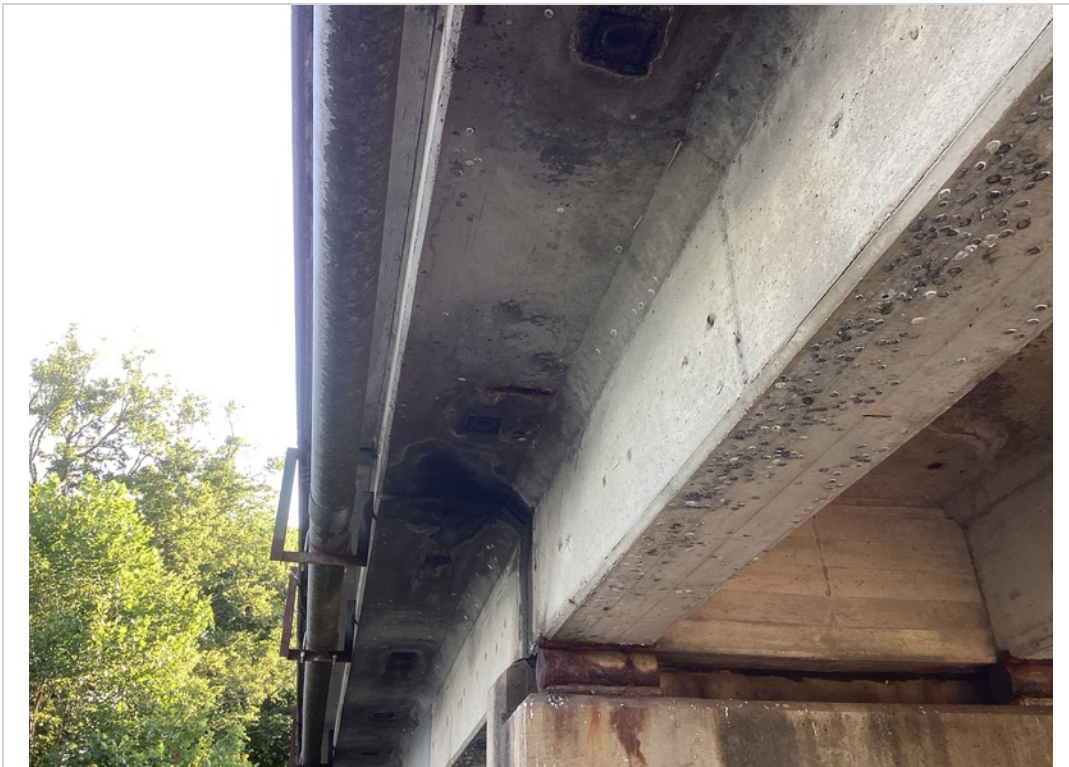
Wearing Surface Type		Asphalt	Wearing Surface Depth	4
Wearing Surface	(Good)			
Deck - Structural Condition	(Good)	Previous deficiencies have been repaired in spans 1-9 with the following exceptions: Span #9: Heavy spalling right side overhang and in-place spalling Span #5: In place spall/delamination and high steel popout span #5 left overhang Span #1: In place spall/delamination in left overhang		
Curbs	(Good)	Minor scale, minor spall outside edge span #1, high steel pop-outs spans #3 & #8		
Parapet	(Fair)	Repaired bridge rail right side approach #1		
Railing	(Good)	Concrete patches, minor scale, high steel pop-outs, minor spall right side span #5		
Deck Drains	(Good)			
Expansion Joints	(Poor)	All are paved over expansion joints

Span #5: In place spall/delamination and high steel popout span #5 left overhang

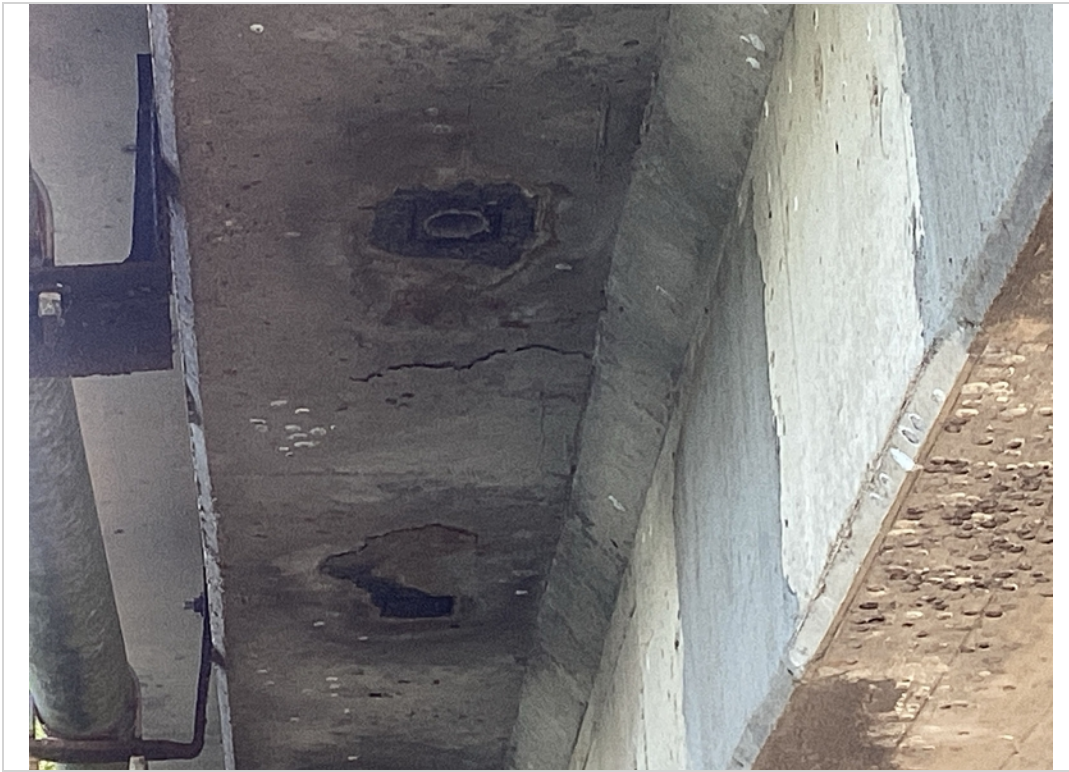
In place spall/delamination in left overhang span #1

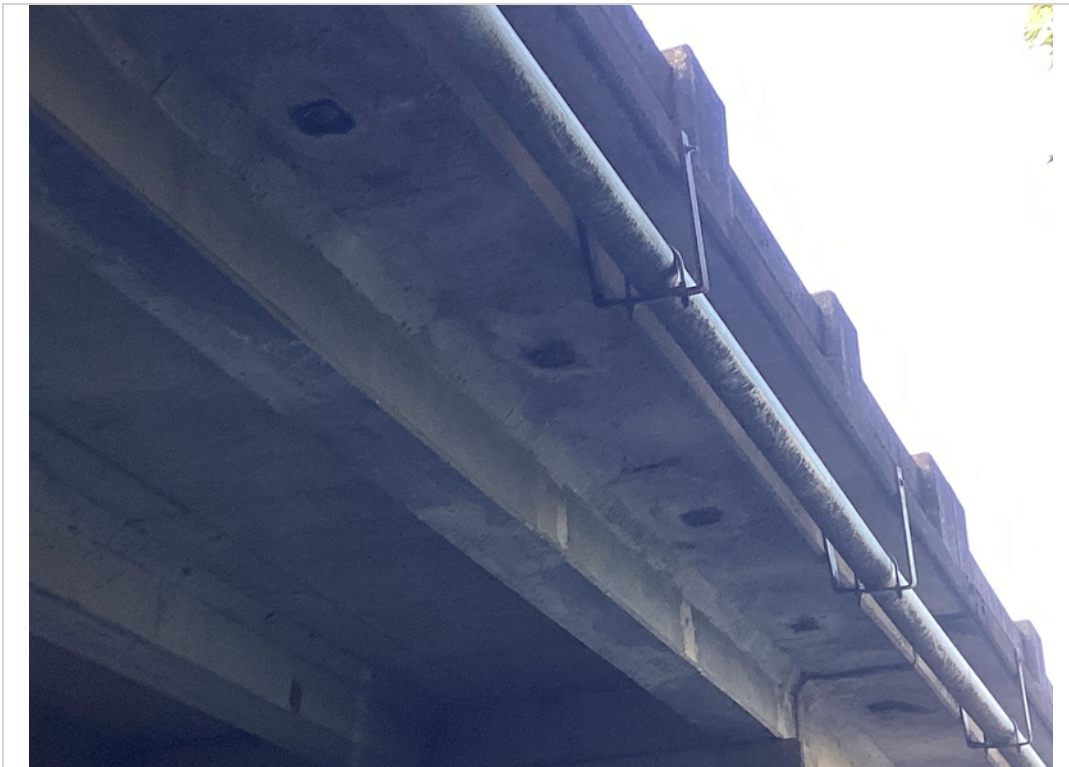
Repairs to spalling around drains all spans

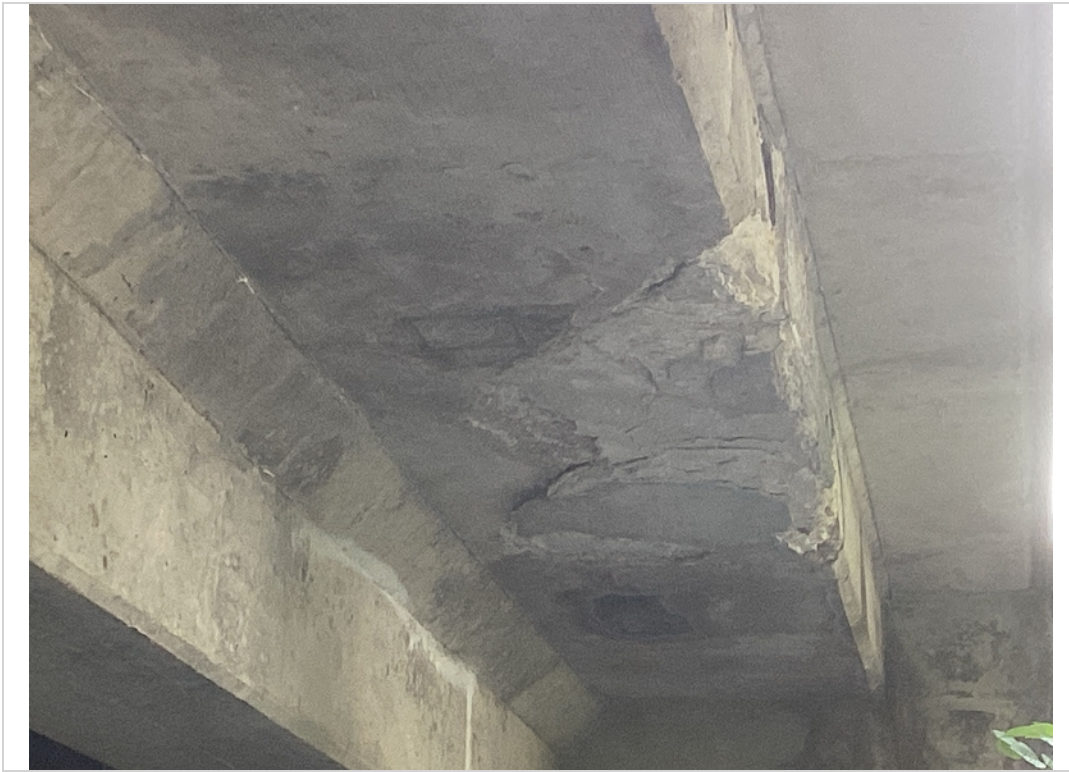
Span #9: In-place spalling right side overhang

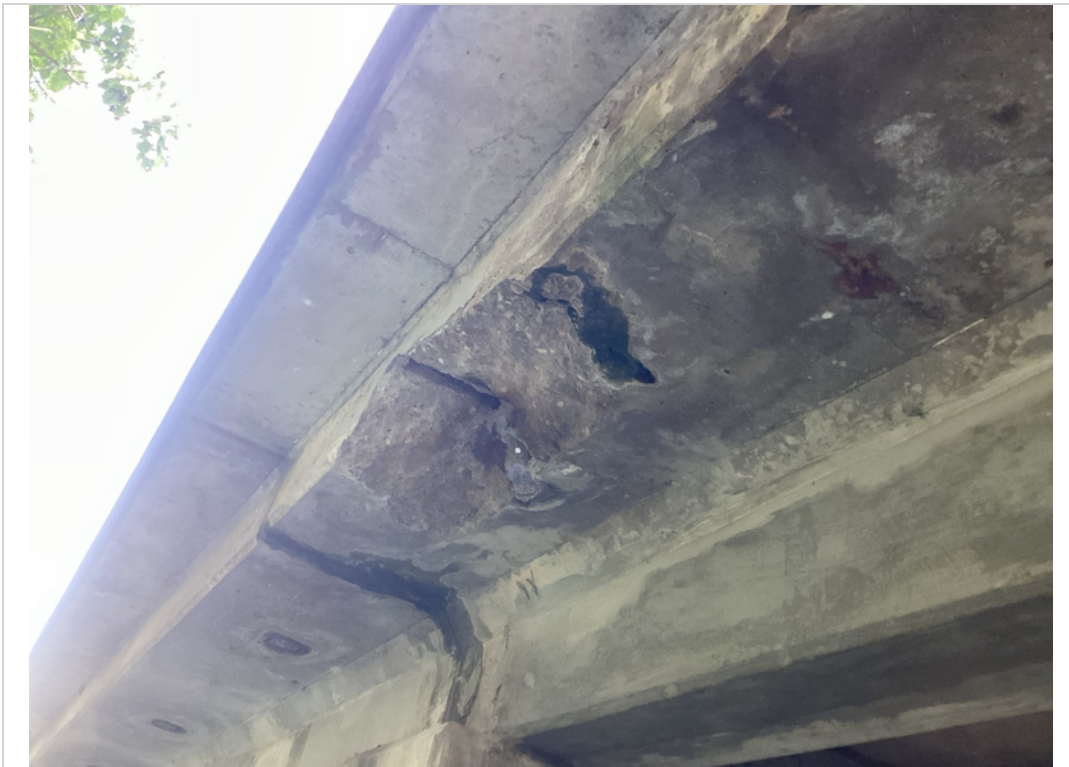
Span #9: Heavy spalling right side overhang

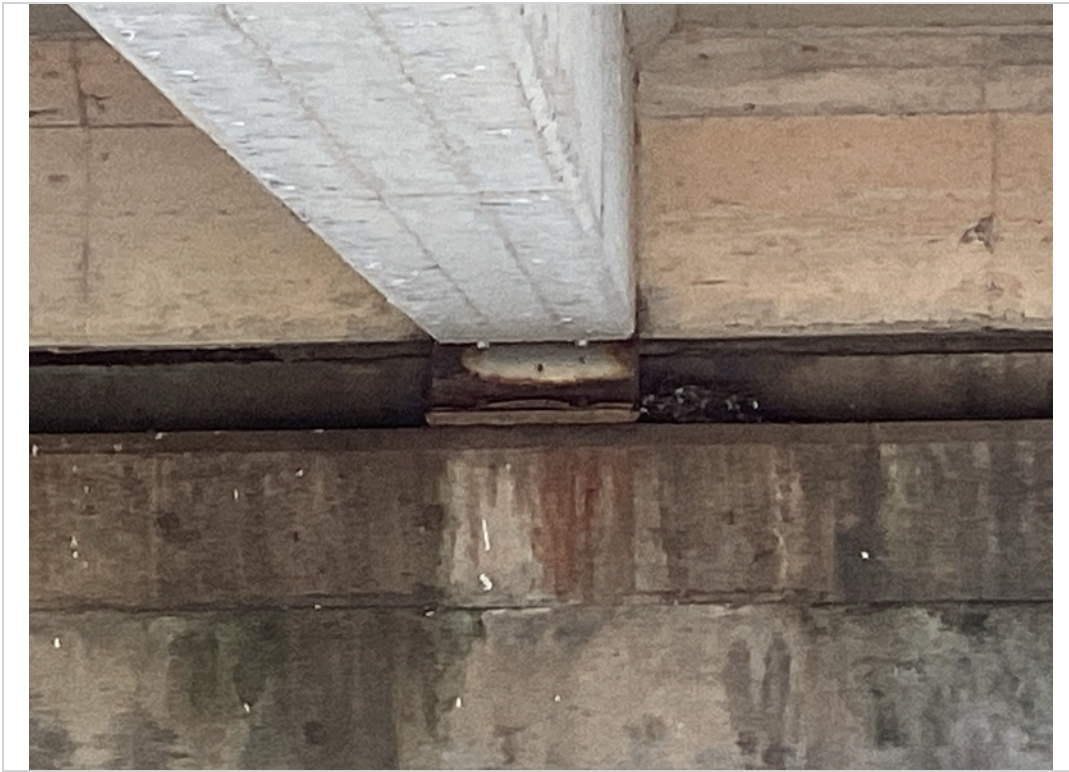
Bearing Devices	(Fair)	Heavy corrosion, flaking, pitting & section loss spans #3 - #6
Girders	(Good)	Cracking and spalls have been repaired in all beams and spans with the following exceptions: Hairline to 1/8" longitudinal crack beam "A" at midspan span #6
Diaphragms	(Good)	Hairline cracks
Alignment of Members	(Good)

Heavy corrosion, flaking, pitting & section loss bearings spans #3 - #6

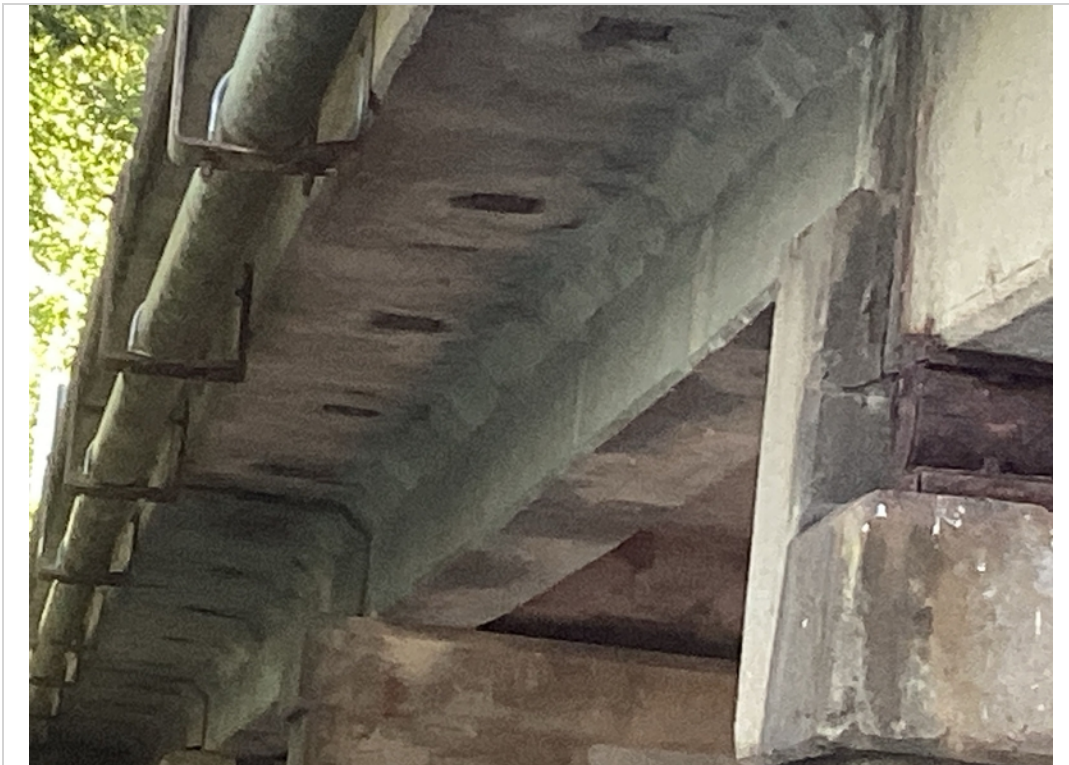
Crack repairs to beam "A" span #7

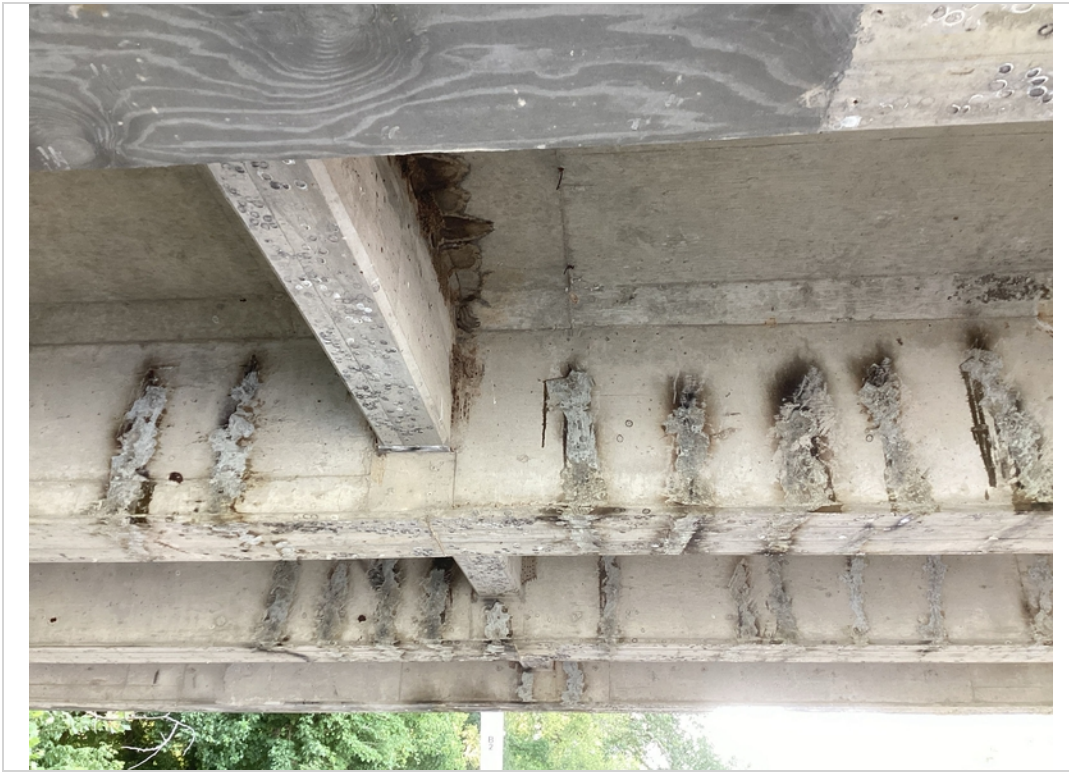
Crack repairs to beams "B, C, & D" span #6

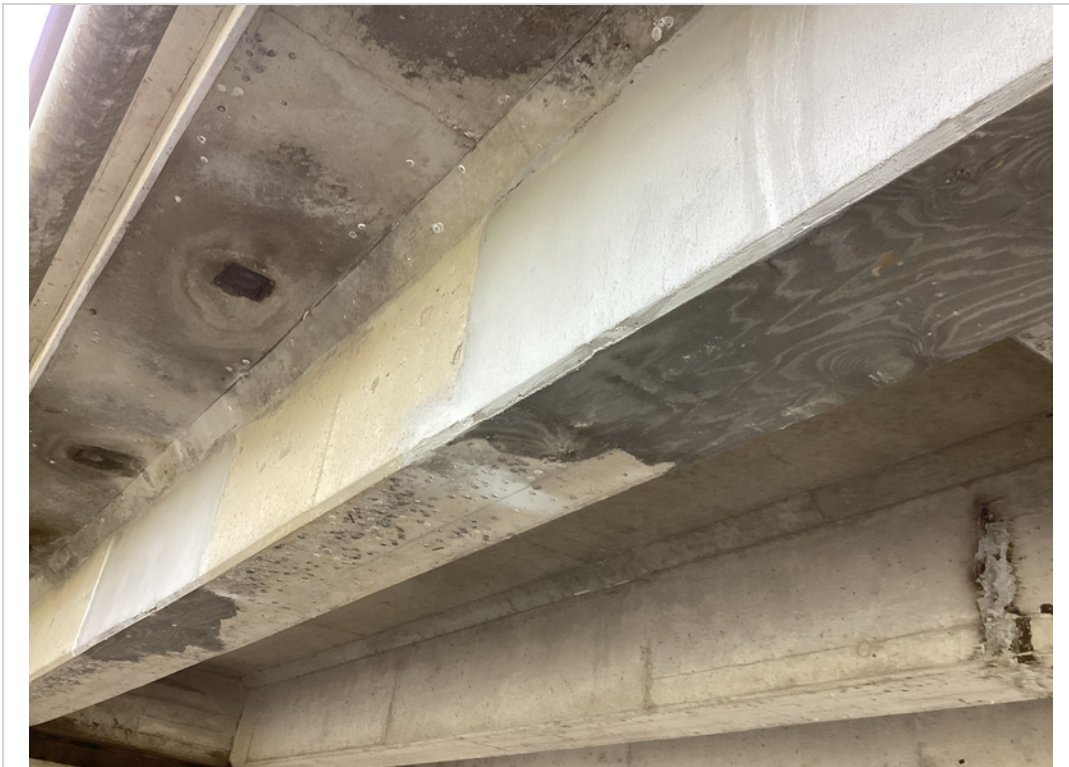
Repairs to beam "A" span #6

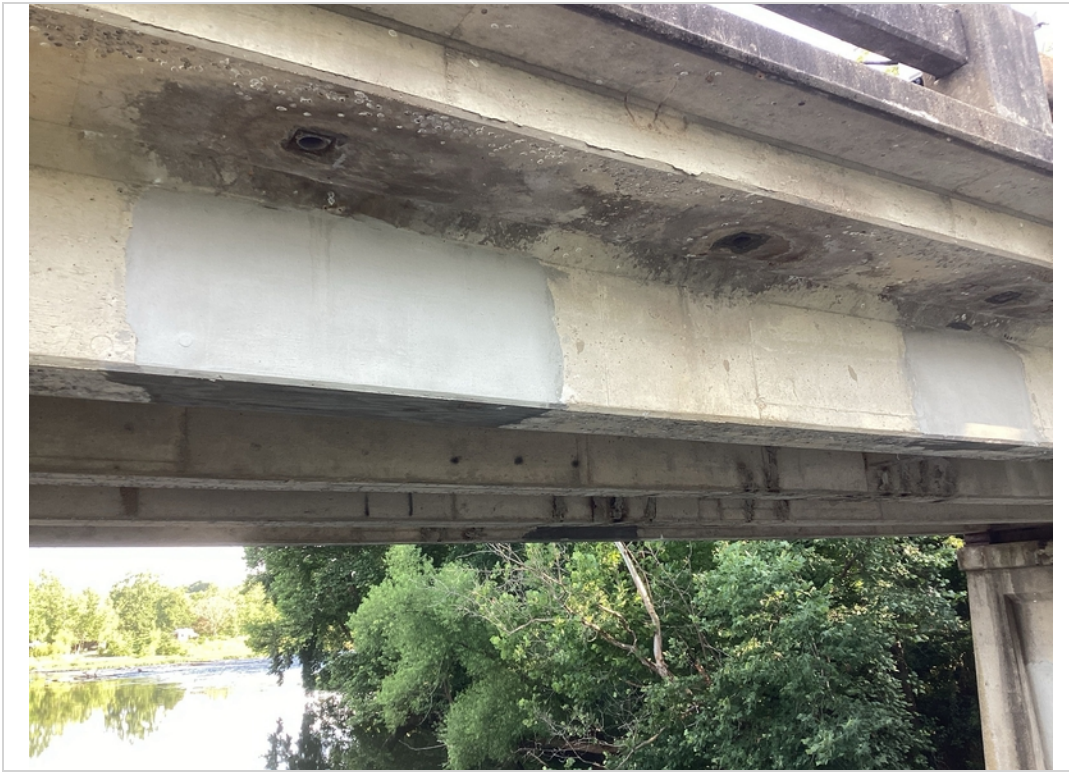
Repairs to beam "D" span #6

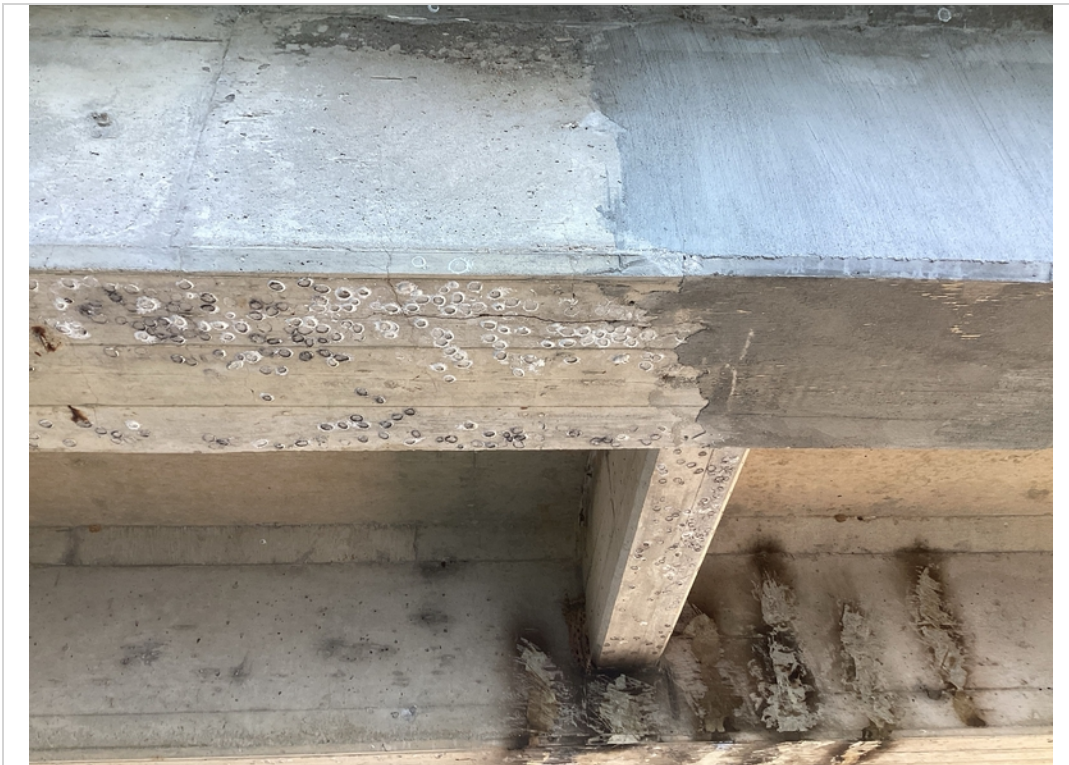
Hairline to 1/8" longitudinal crack beam "A" at midspan span #6

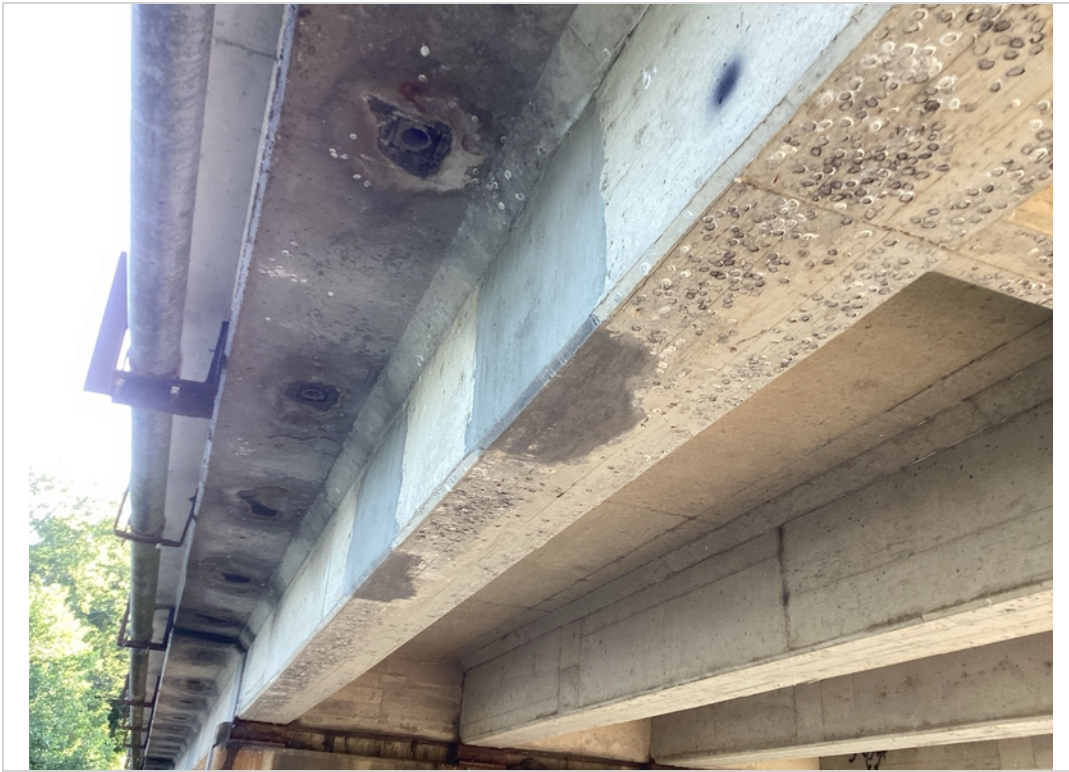
Crack repairs to beam "A" span #4

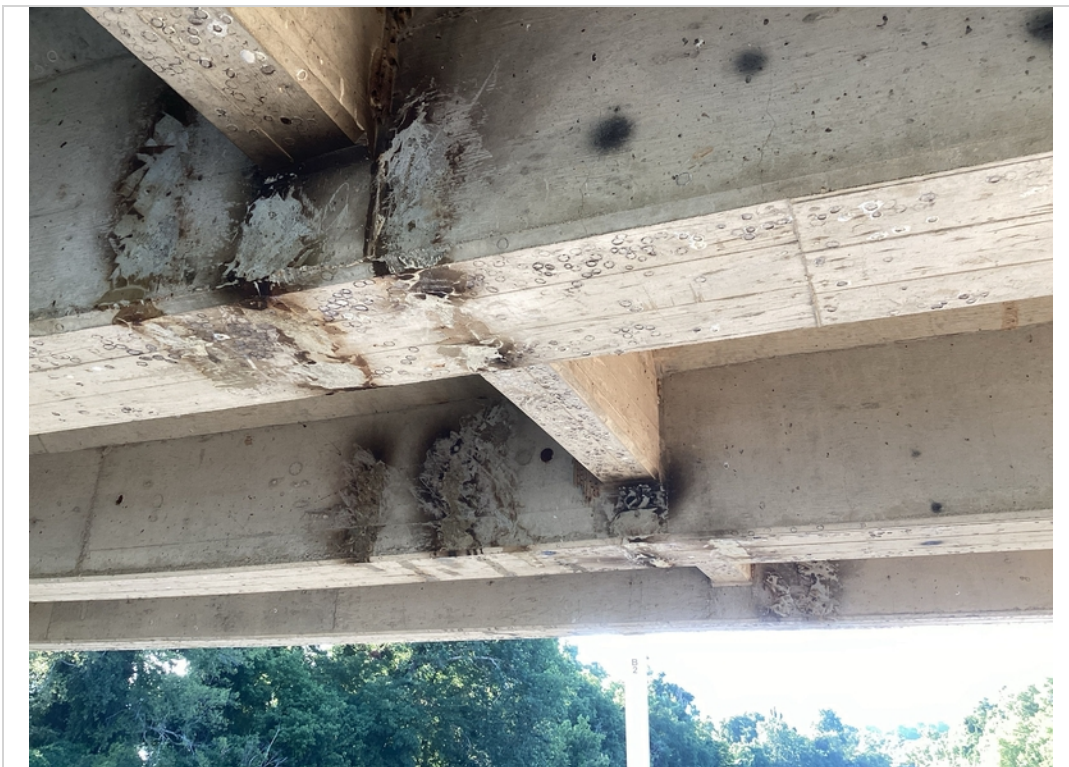
Crack repairs to beams in span #4

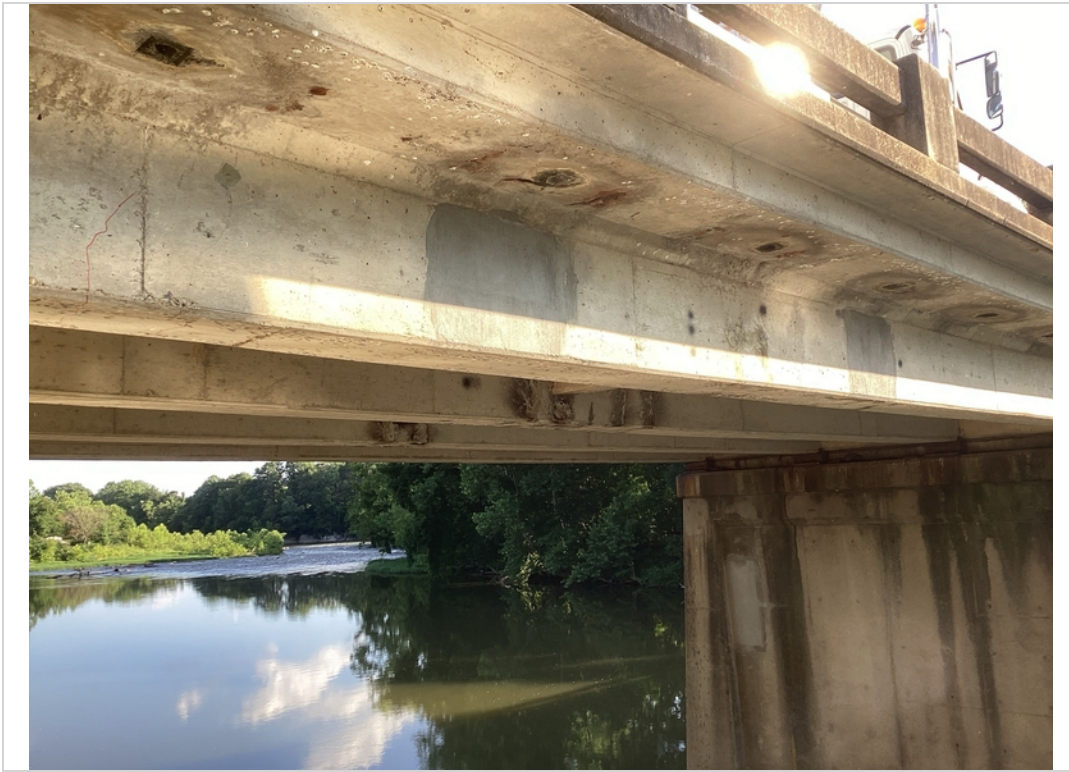
Patches on beam "D" span #4

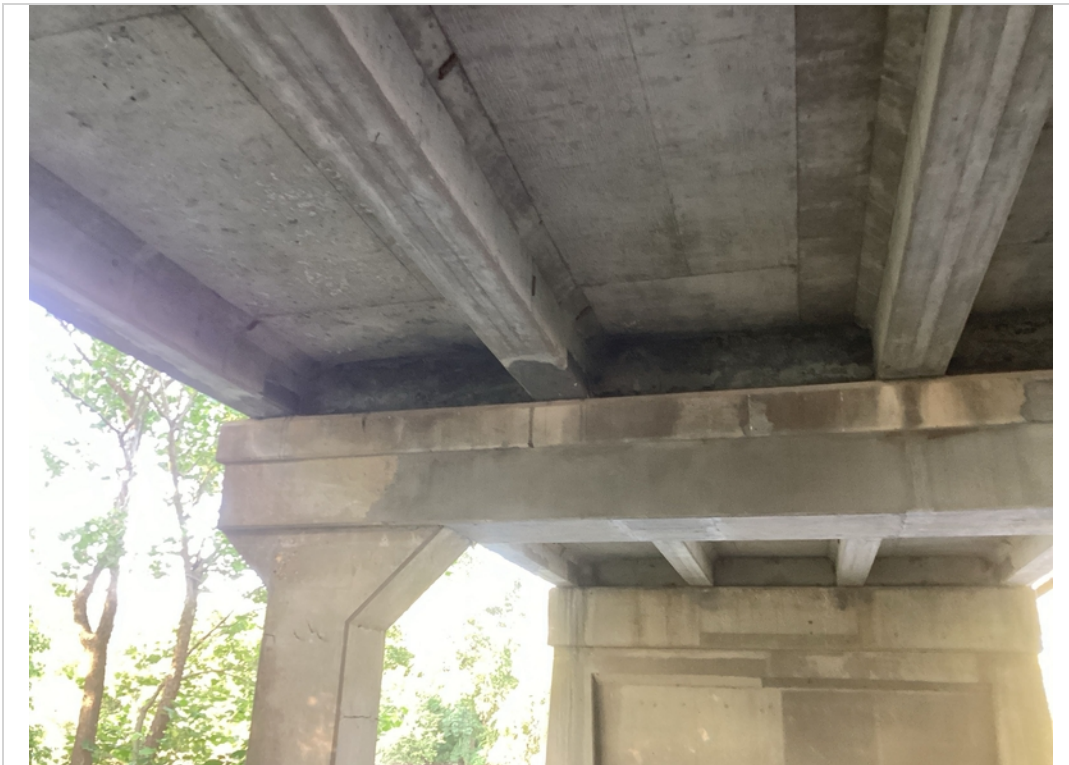
Repairs to beam "B" span #8, typical all

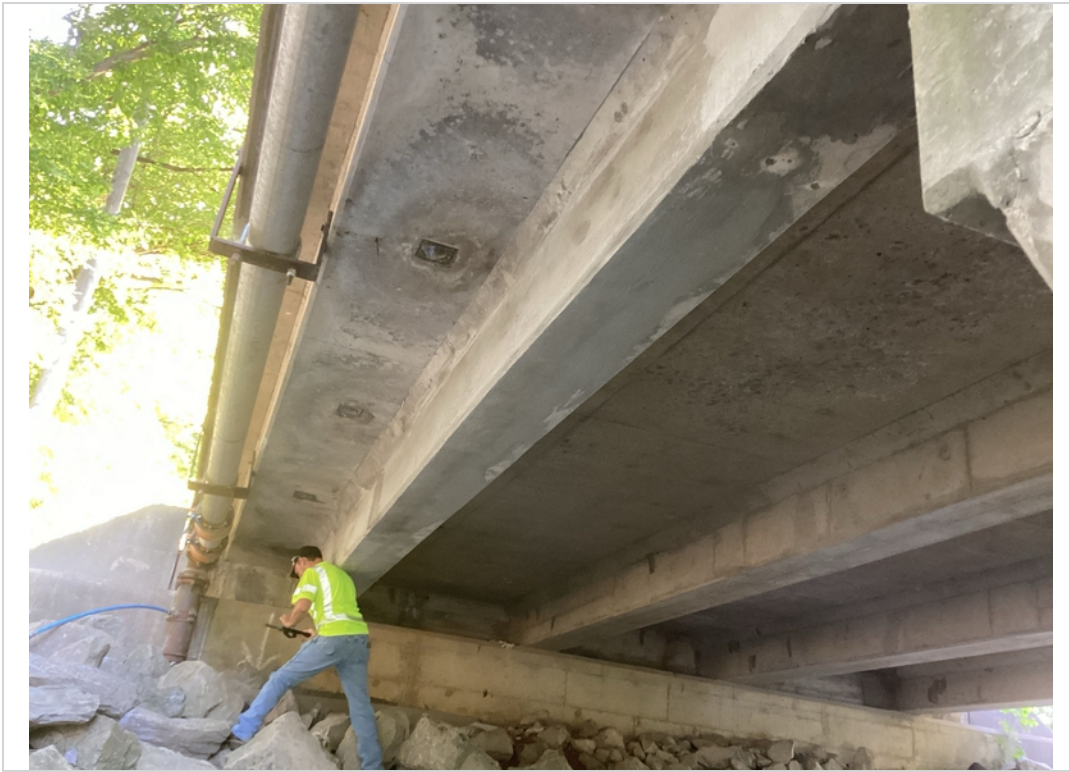
Repairs to beam "A" span #9

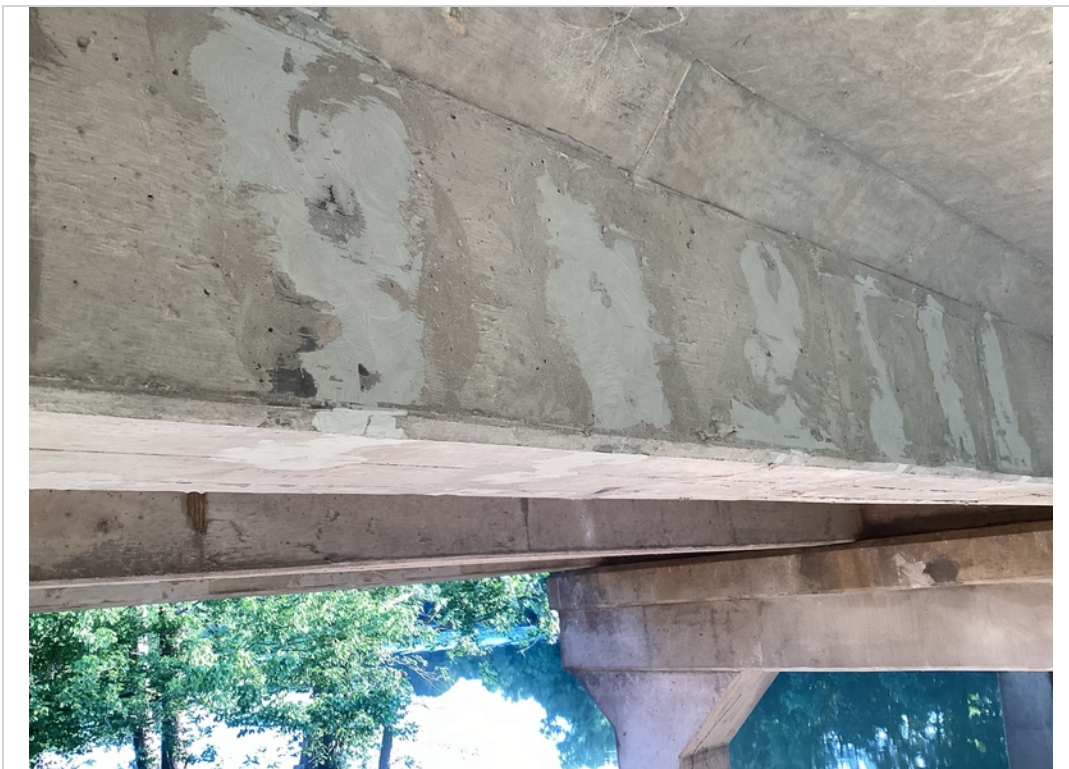
Repairs to vertical and transverse hairline to 1/8" cracks in all spans

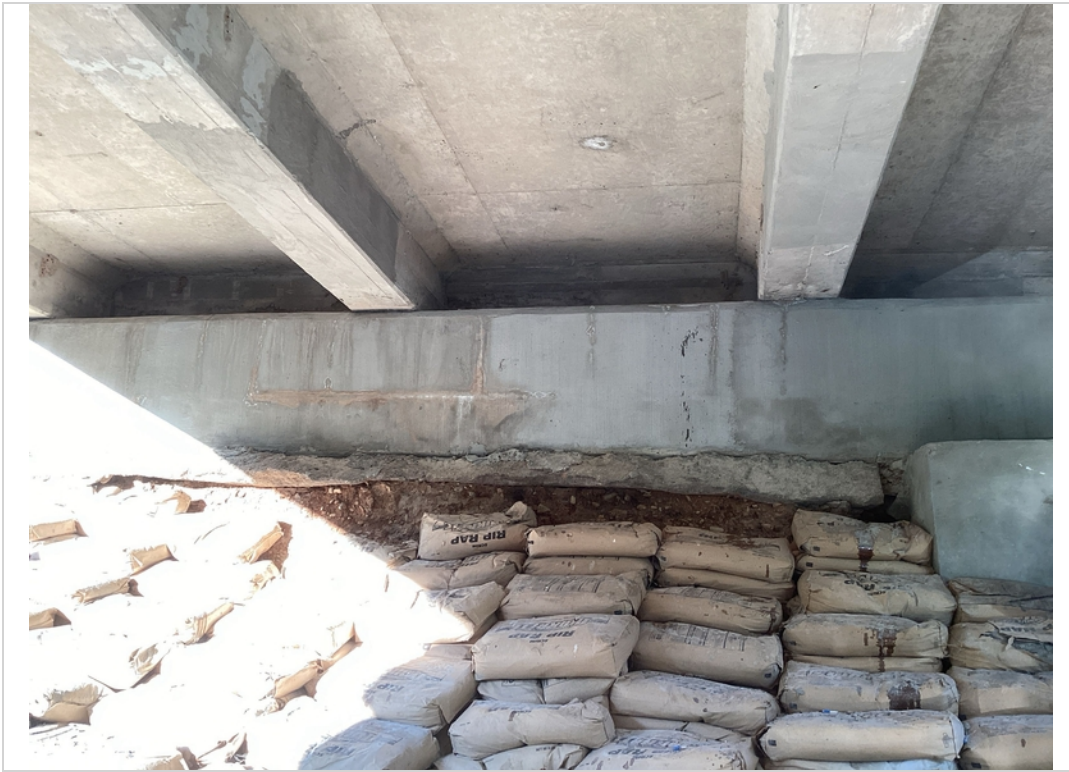
Abutment caps have been repaired with new concrete

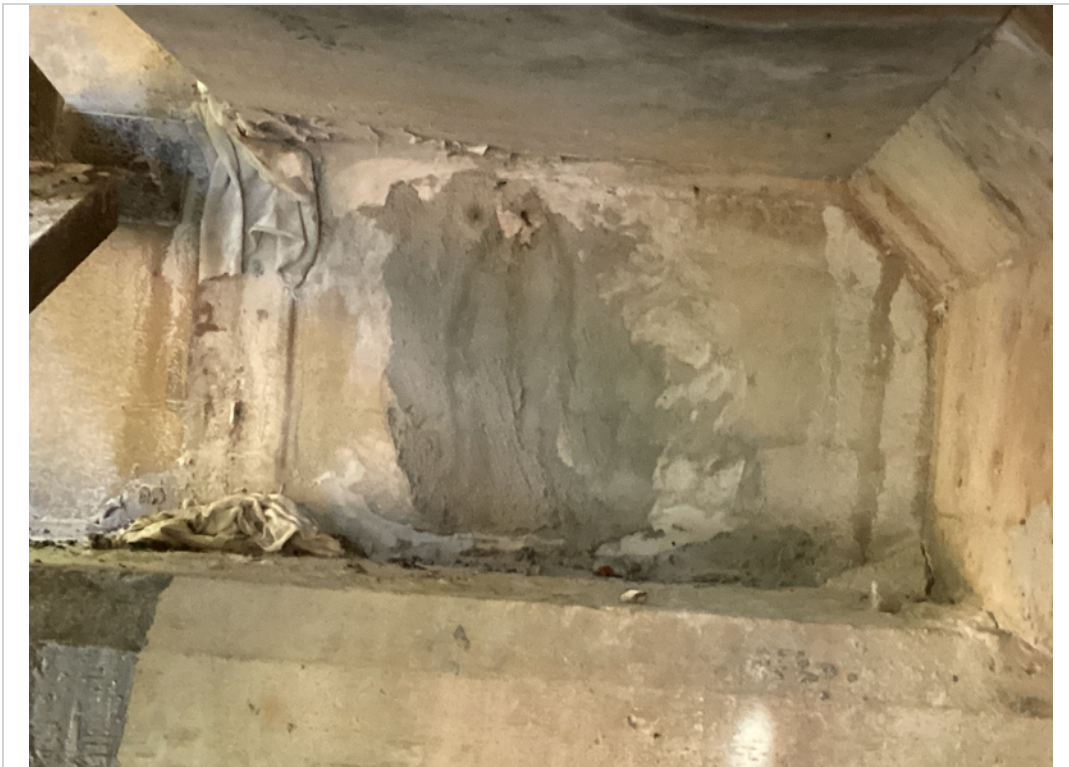
Previous cracks in abutment #2 backwall have been repaired

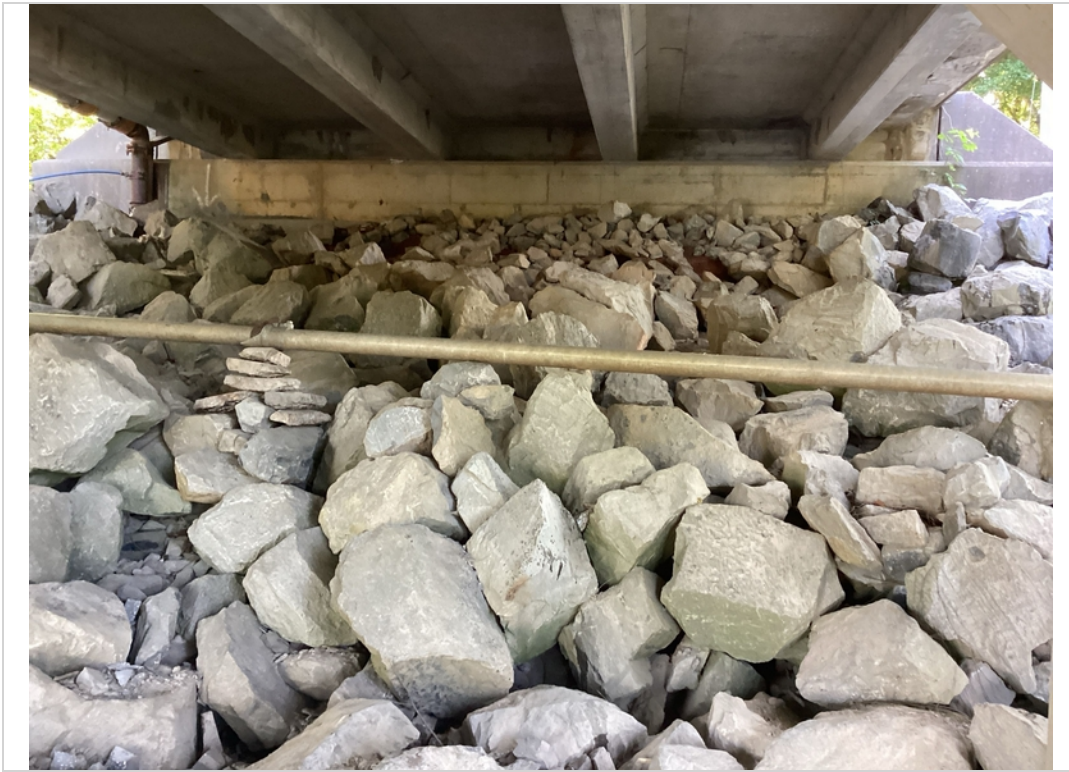
Shot rock added to abutment #2 bank

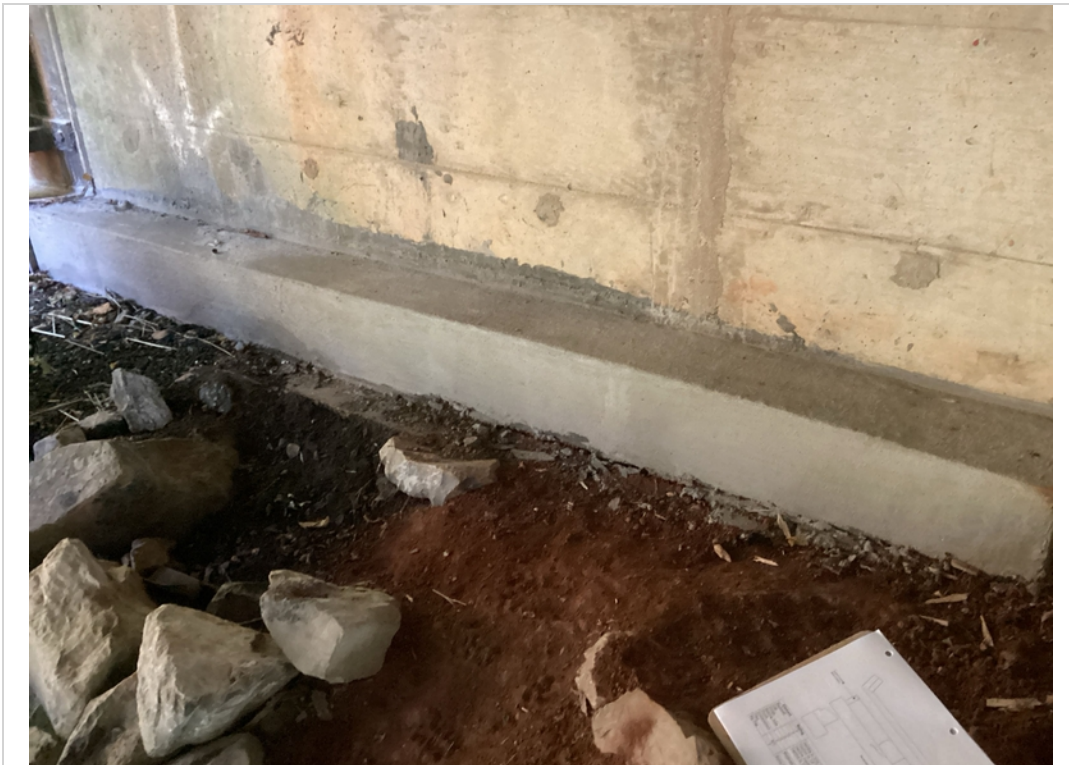
Previous settlement at abutment #2 has been repaired with a concrete cap

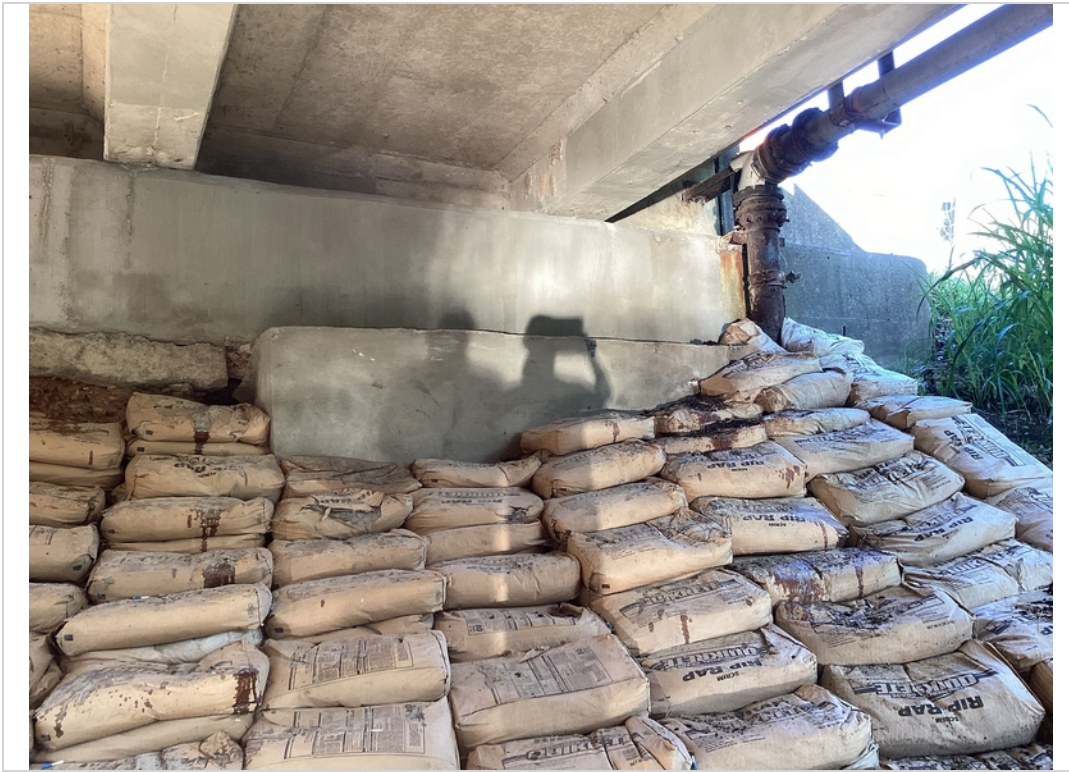
Previous void at abutment #1 has been repaired with a concrete cap, rip rap added to bank

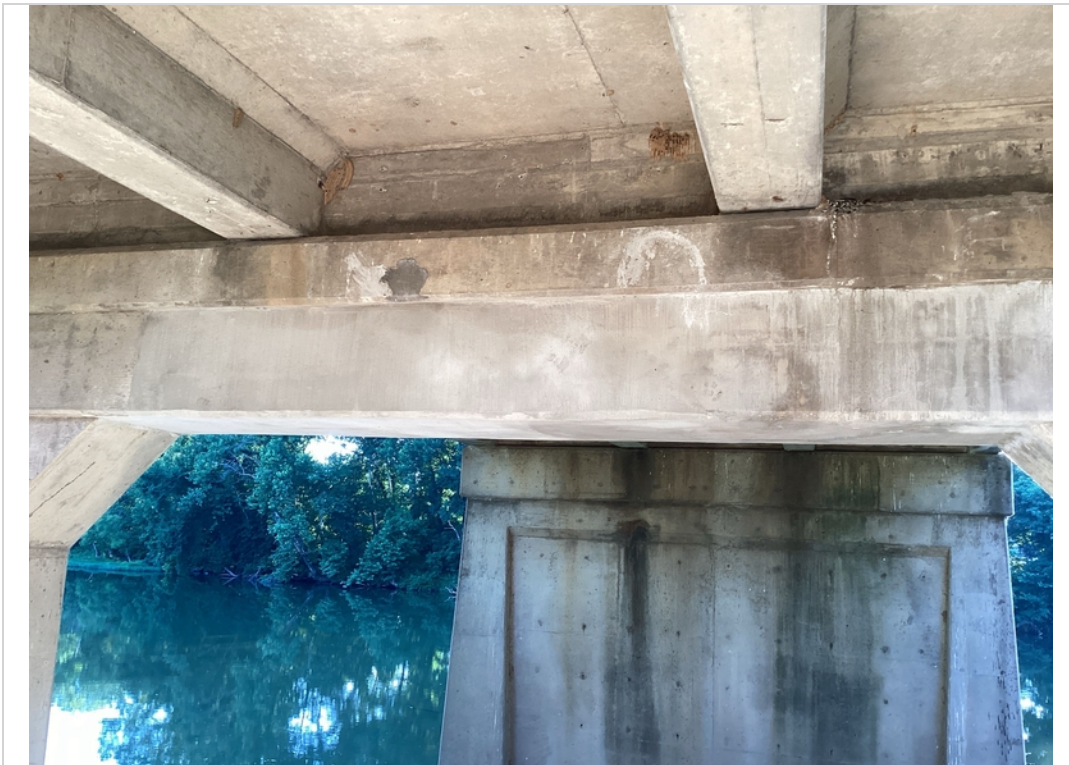
Bent caps have been repaired with new concrete

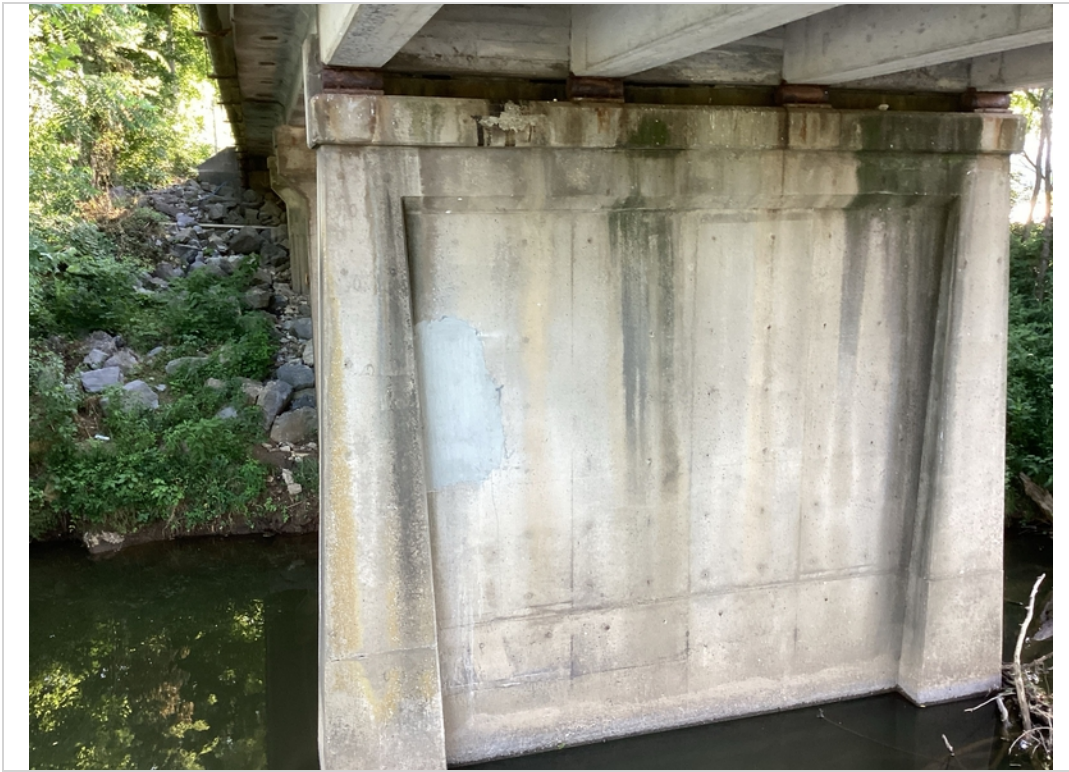
Patch on pier #5
