BAILEY BRIDGE RD. Crossing NOLICHUCKY RIVER

90 - LAST INSPECTION DATE 07/02/2024

IDENTIFICATION	
(1) State Names	47 - Tennessee
(8) Structure Number	90S23860001
(5) Inventory Route	1
(2) Highway Agency District	Region 1
(3) County Code	90 - Washington

Inspection Team's Summary

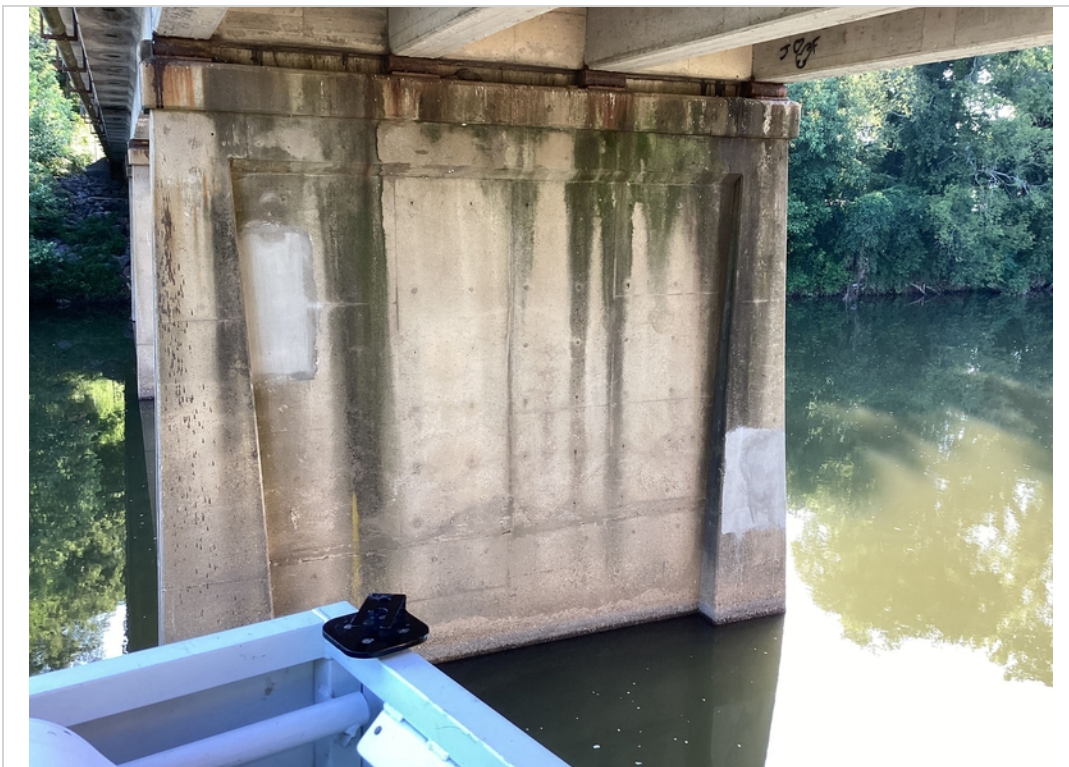
Spall and delamination repairs pier #3

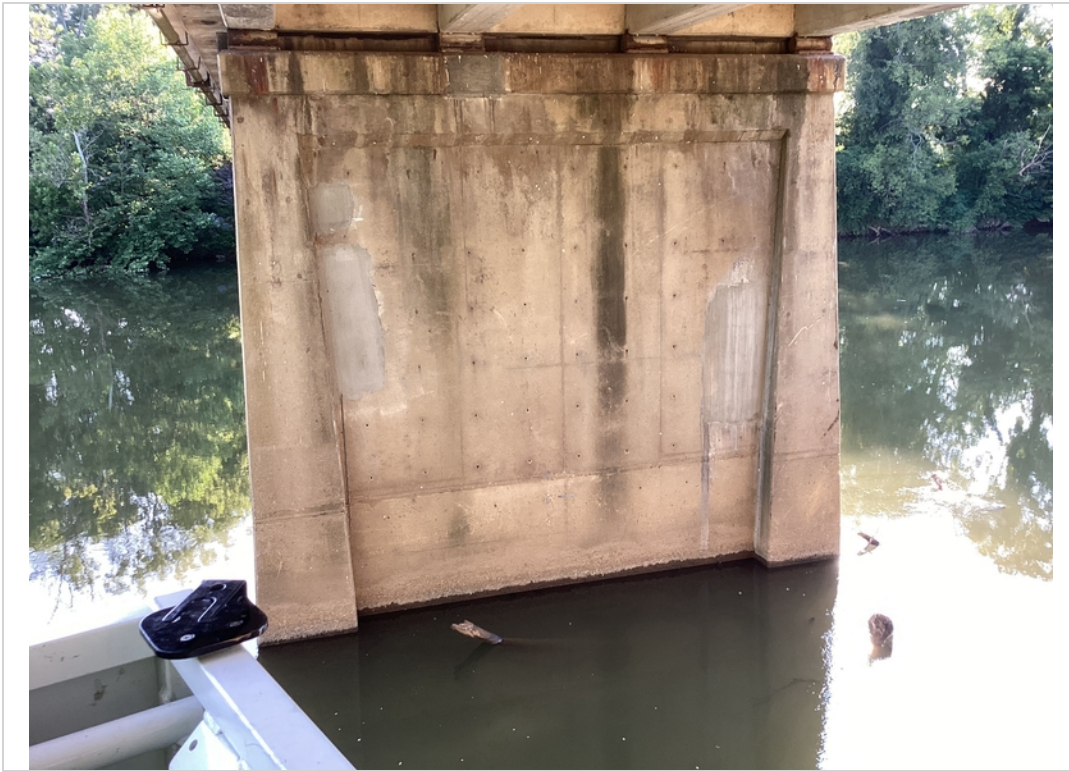
Spall repairs pier #2

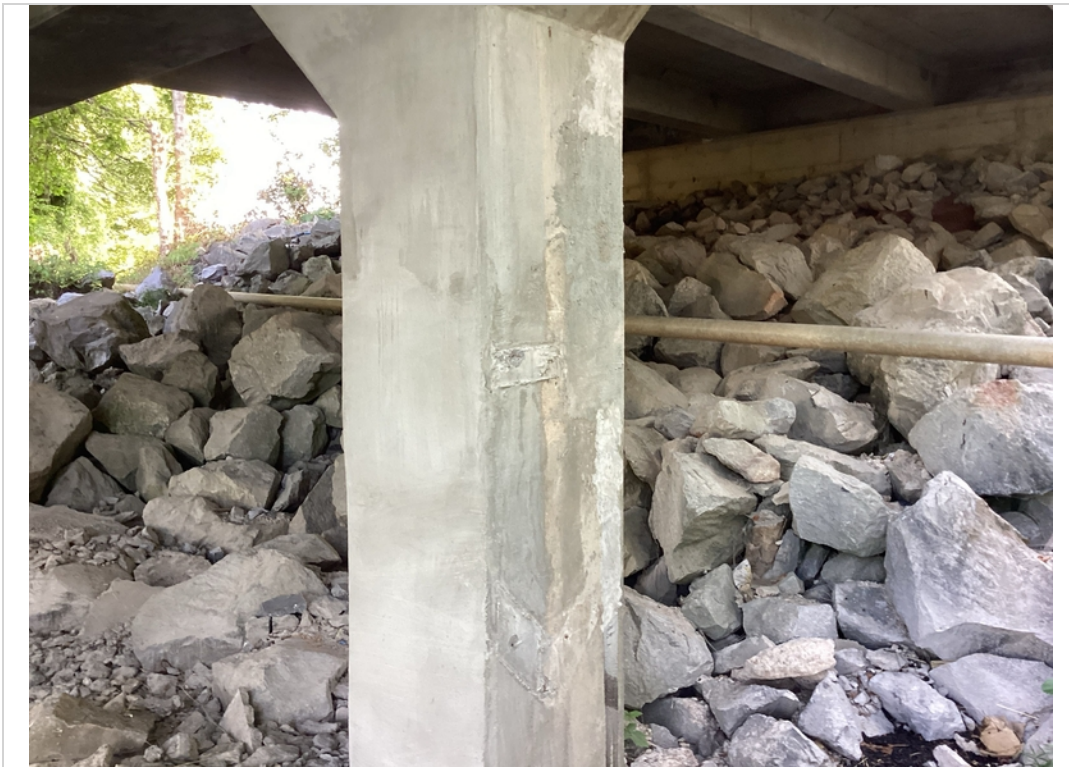
Cracking and spalls in bent columns have been repaired

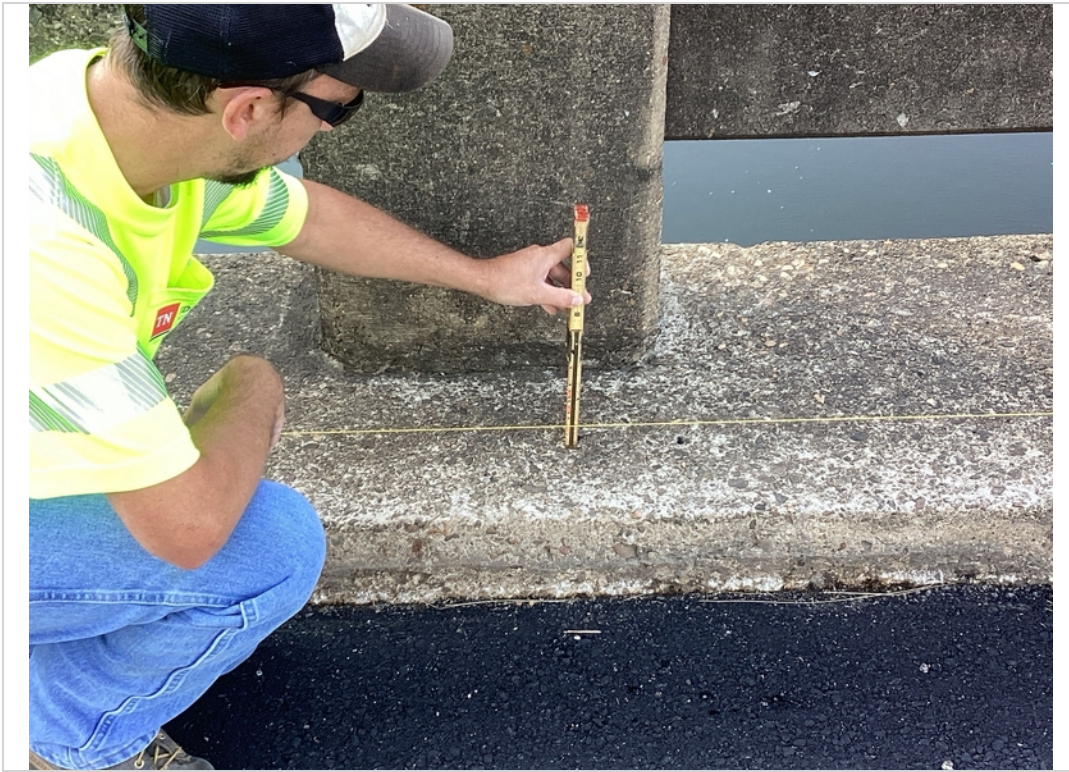
The wearing surface is good. The expansion joints are poor and have all been paved over. The underside deck is fair with hairline cracks and map cracks throughout. Previous deficiencies in deck have been repaired in spans 1 through 9, except span #1 and #9 have heavy spalling, span #5 has an in place spalling and high steel pop out. The girders are fair with cracking and spalls having been repaired in all spans except, beam "A" in span #6 has 1/8" longitudinal crack at mid span. Dead load deflection in span #6 was measured at 1.5".

1.5" dead load deflection span #6

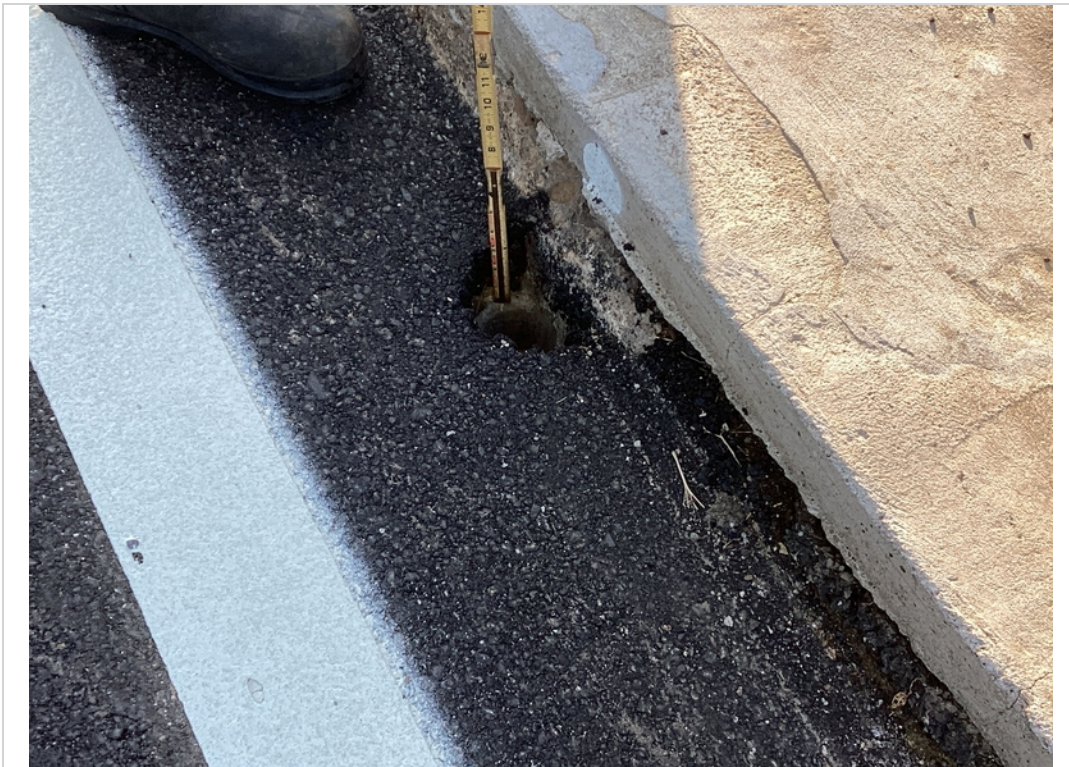
4" asphalt depth

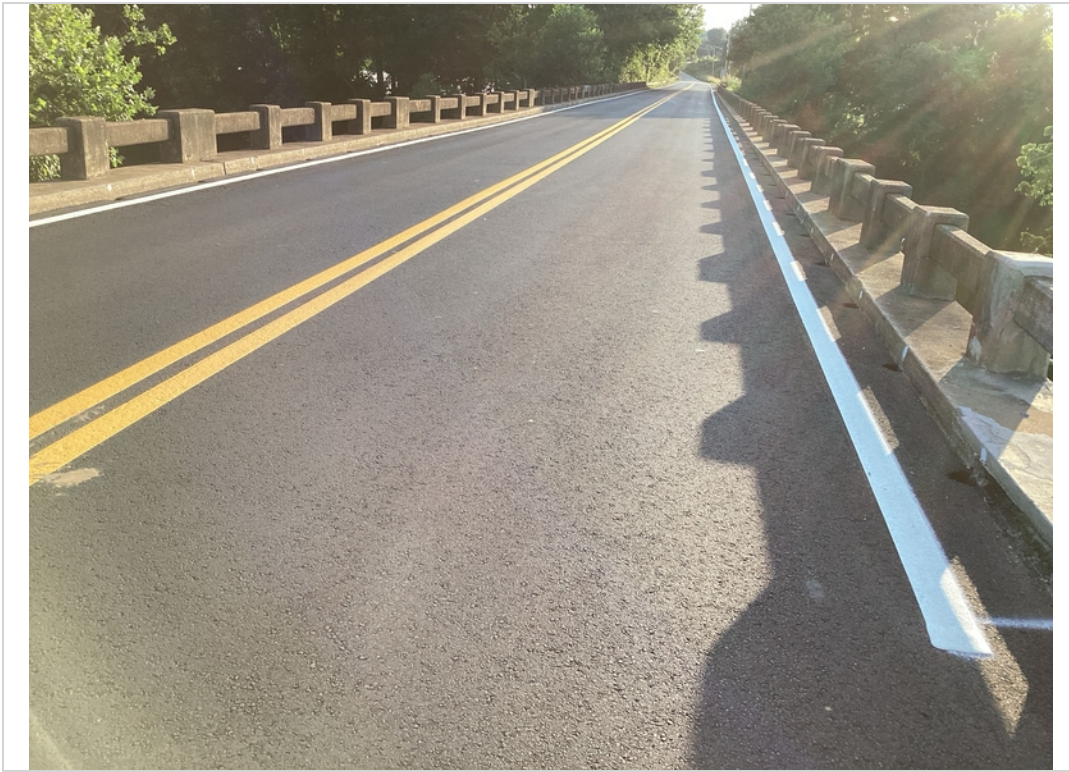
New wearing surface
